City of Karratha  
Dampier Stormwater Management Study  
Report  
Part B  
June 2015

## Appendix **C** – 2010 encroachment reviews

**Rio Tinto Iron Ore**  
Report on Dampier Drainage  
Review  
Block 1 Encroachments  
June 2010

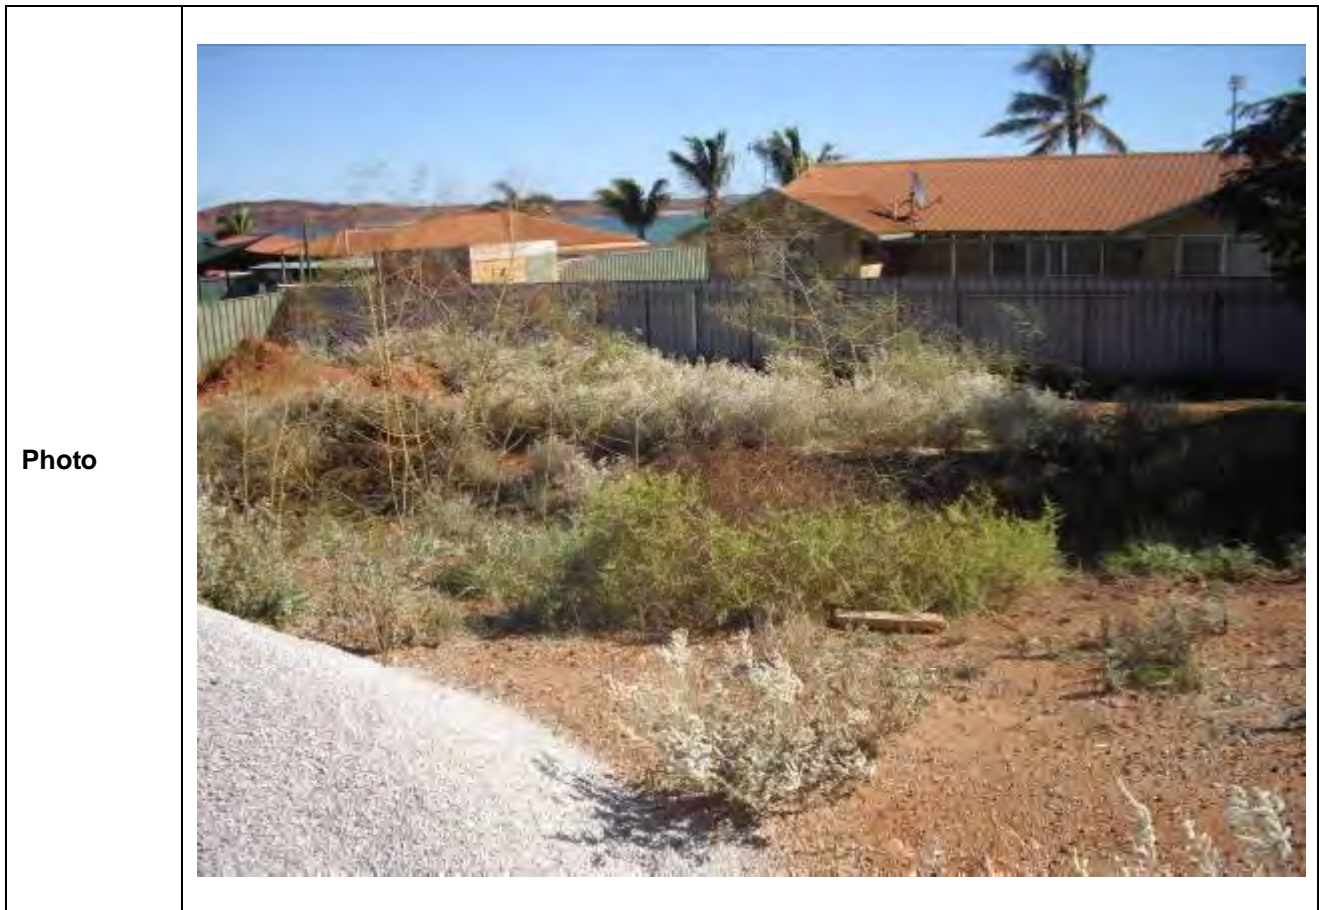
## 2.5 Lot No. 4 Blackwood Crescent

<b>Category</b>	Drain Maintenance
<b>Type</b>	Vegetation Fill
<b>Description</b>	Semi - dense vegetation Blue metal and loose soil.
<b>Photo ID</b>	707
<b>Scope of Works</b>	L - Vegetation is to be slashed to a nominal height of 50 mm above ground with the exception of large, established trees of height in excess of 5 m, which shall remain; L – Remove stored blue metal and loose soil.

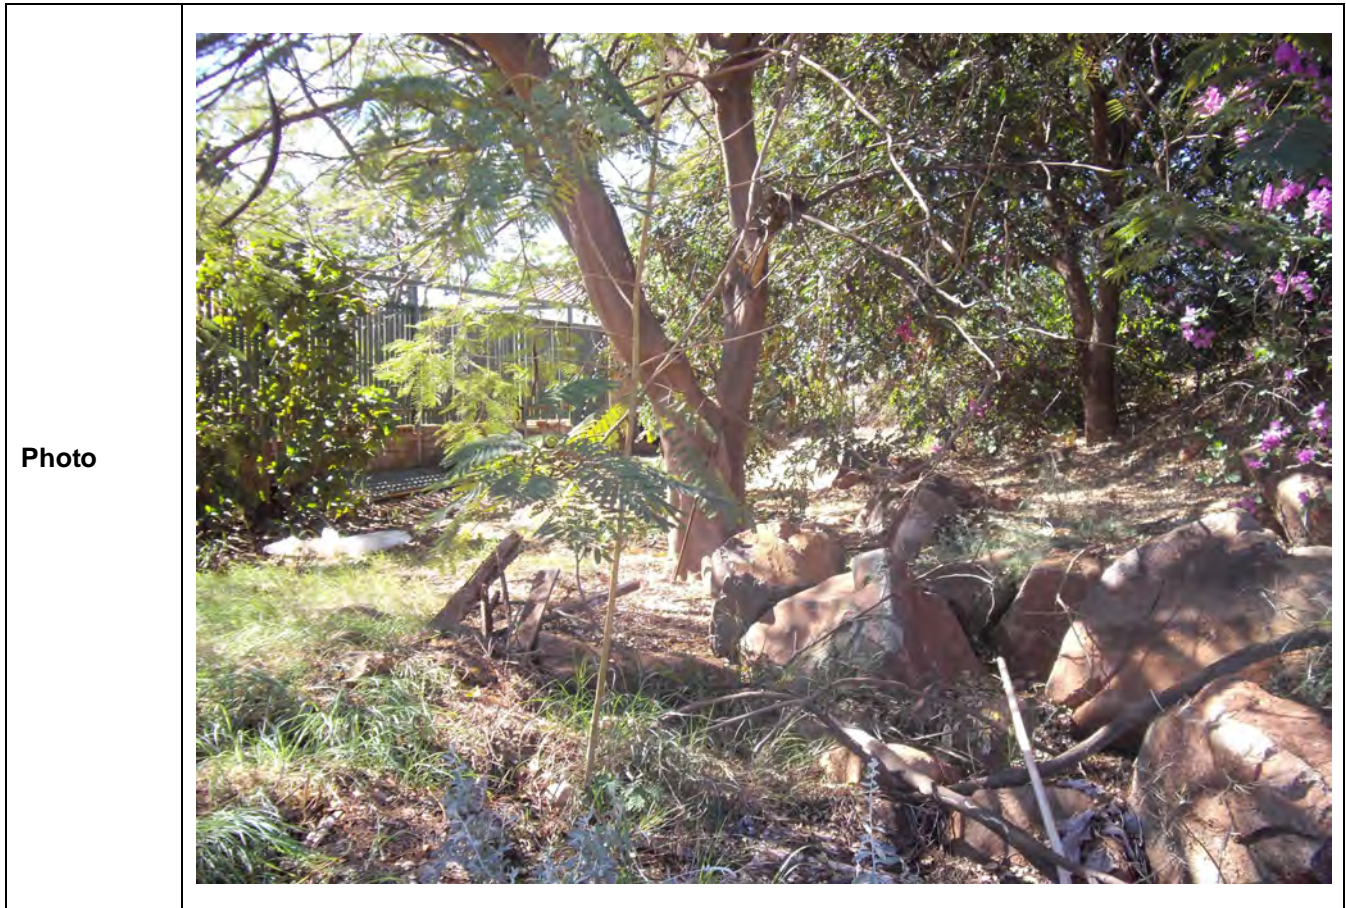
## 2.6 Lot No. 5 Blackwood Crescent

<b>Category</b>	Encroachment / Drain maintenance
<b>Type</b>	Boundary extension; Vegetation; Flow path
<b>Description</b>	Building and landscaping encroachment from lot and extended road width encroaching from Crescent; Semi-dense vegetation; Flow path modified
<b>Photo ID</b>	1017
<b>Scope of Works</b>	M – Remove property extension and relocate to within property boundary – confirmation required from survey; Remove landscaping and extended road width. M – Move building back to property boundary. M - Vegetation is to be slashed to a nominal height of 50 mm above ground with the exception of large, established trees of height in excess of 5 m, which shall remain; M – Reinststate drainage flow path as defined by the natural channel invert of downstream lot (No. 4).

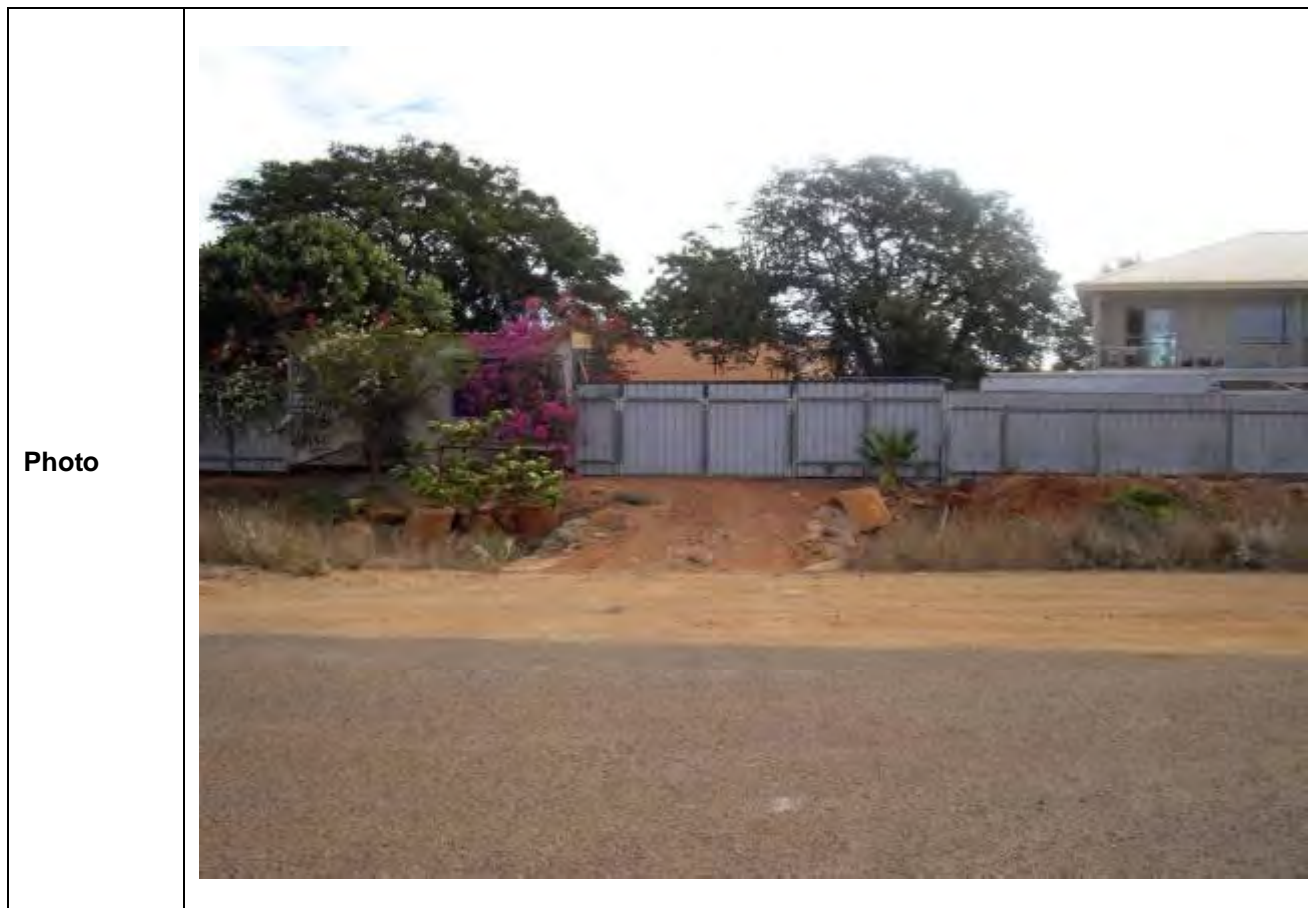
### 3.1 Lot No. 7 Durack Crescent

<b>Category</b>	Encroachment
<b>Type</b>	Side access driveway Rear access with culvert
<b>Description</b>	Side access driveway follows natural topography; Rear access impedes flow.
<b>Photo ID</b>	422 & 455
<b>Scope of Works</b>	Illegal side access noted – no works required H - Remove rear access and reinstate drainage flow path as defined by the natural channel invert of downstream channel.

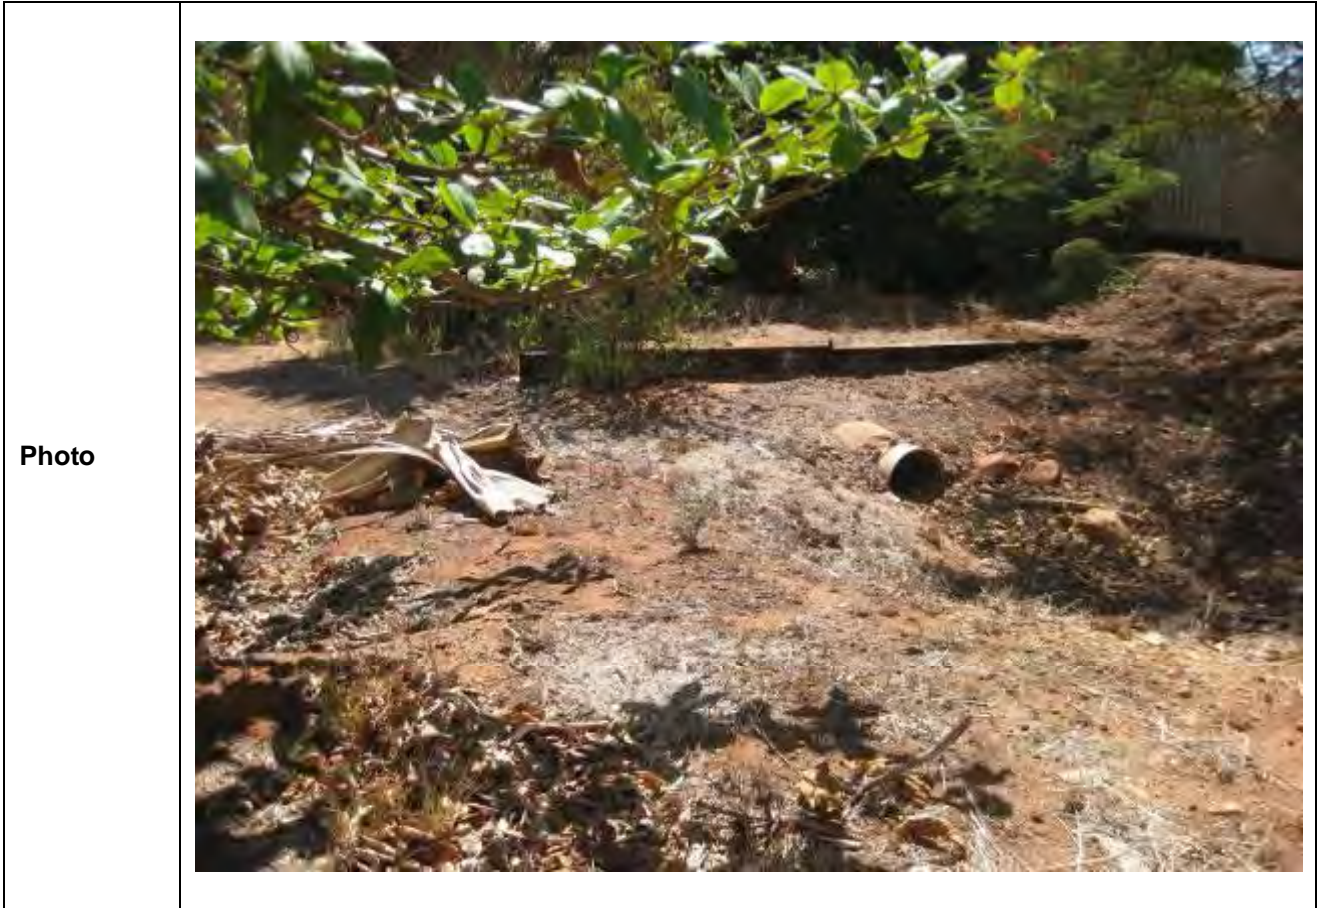
### 3.2 Lot No. 8 Durack Crescent

<b>Category</b>	Encroachment
<b>Type</b>	Rear access
<b>Description</b>	Rear access with culvert
<b>Photo ID</b>	31
<b>Scope of Works</b>	H - Remove rear access and reinstate drainage flow path as defined by the natural channel invert of downstream channel.

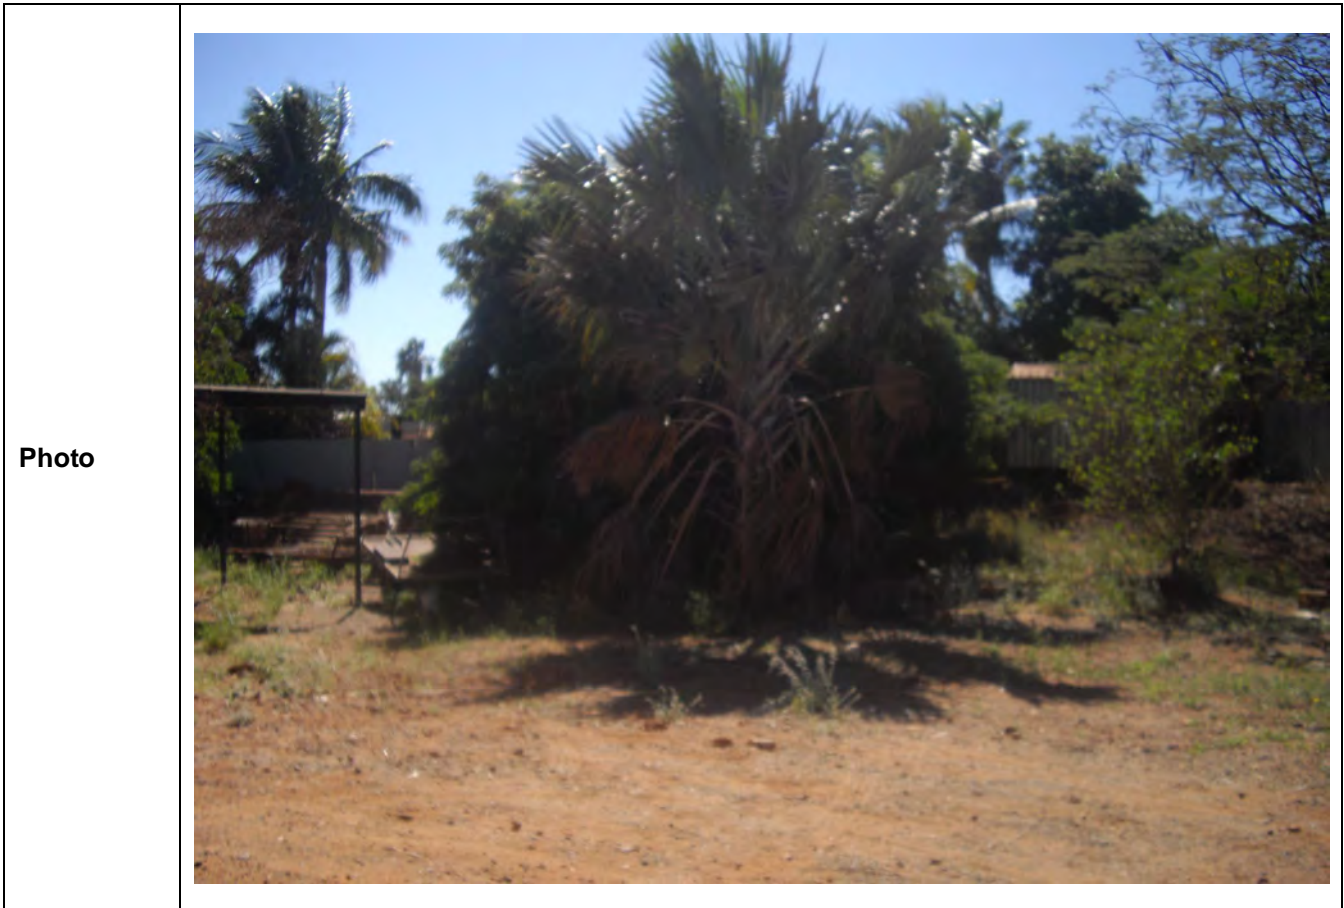
### 3.5 Lot No. 11 Durack Crescent

<b>Category</b>	Encroachment
<b>Type</b>	Rear access Boundary extension
<b>Description</b>	Rear access with Inadequate culvert due to invert level to high; Shed.
<b>Photo ID</b>	1029, 452
<b>Scope of Works</b>	H - Remove rear access.and reinstate drainage flow path as defined by the natural channel invert of downstream channel; L - Remove shed.

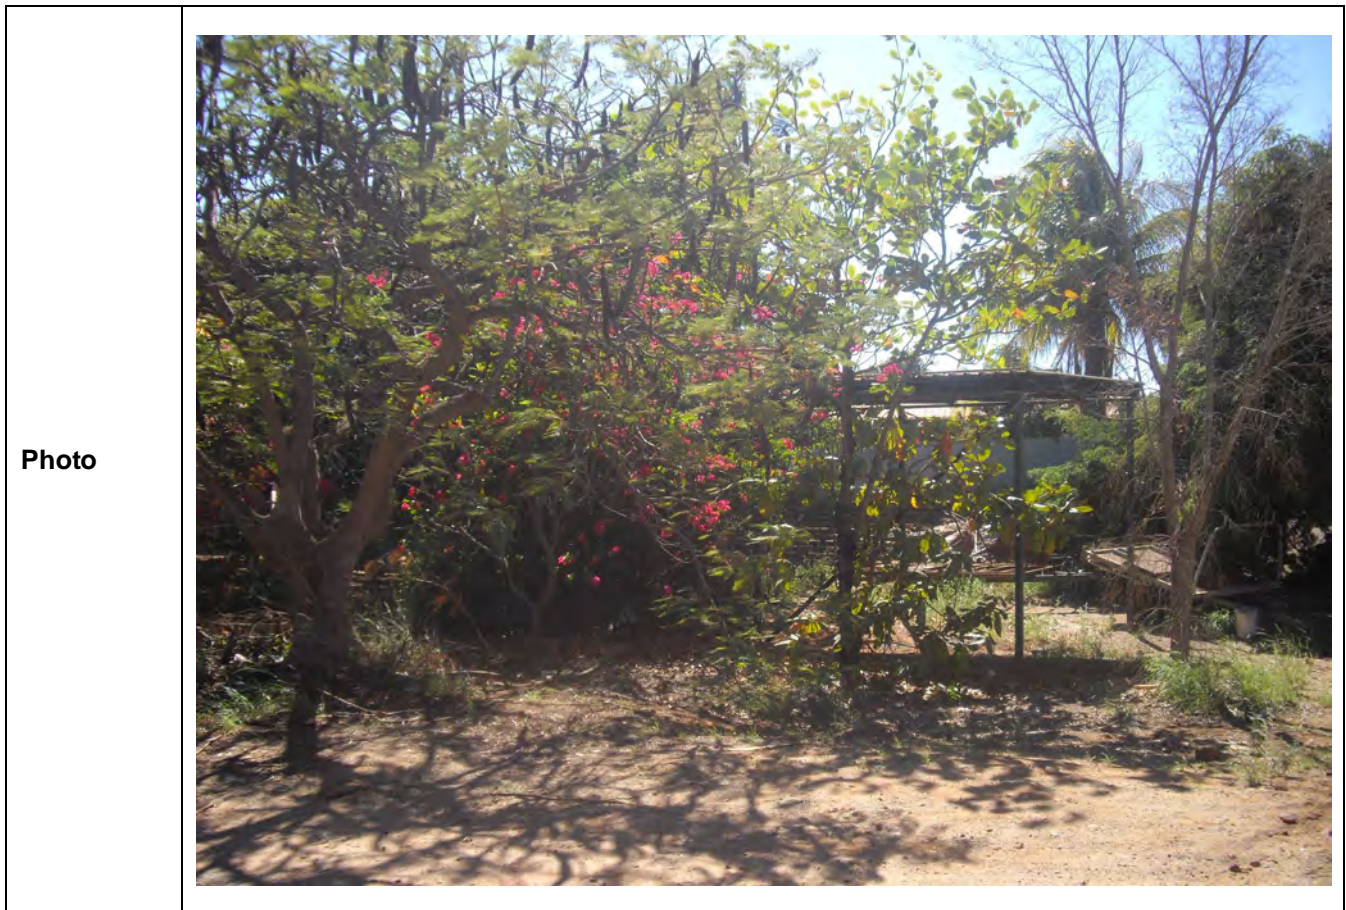
### 3.6 Lot No. 12 Durack Crescent

<b>Category</b>	Encroachment / Drain Maintenance
<b>Type</b>	Boundary extension; General items; Rear access
<b>Description</b>	Shed; Trailers; Rocks not but no impact on flow. Rear access plus modified topography impedes flow from Lot 11
<b>Photo ID</b>	1030, 453
<b>Scope of Works</b>	L – Remove shed; L – Remove trailer; H - Remove rear access and reinstate drainage flow path as defined by the natural channel invert of downstream channel

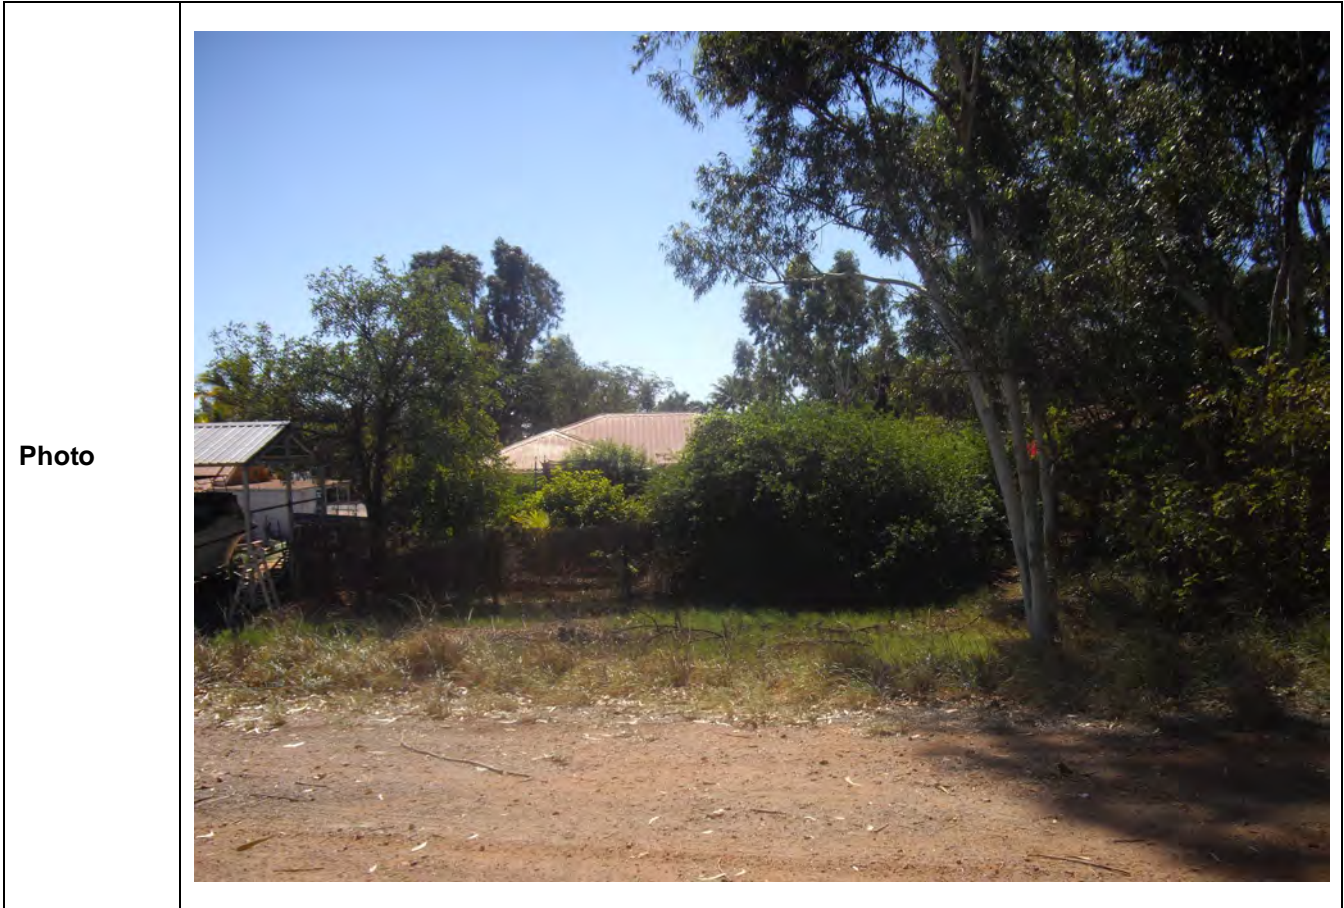
<b>Category</b>	Drain Maintenance
<b>Type</b>	Flow path; Culvert entry Vegetation.
<b>Description</b>	Flow path low point is within the property boundary Un-engineered culvert entry point from road reserve, potential flooding hazard to property.
<b>Photo ID</b>	1025, 715
<b>Scope of Works</b>	M - Reinstate drainage flow path as defined by the natural channel invert of downstream channel; M - Vegetation is to be slashed to a nominal height of 50 mm above ground with the exception of large, established trees of height in excess of 5 m, which shall remain.

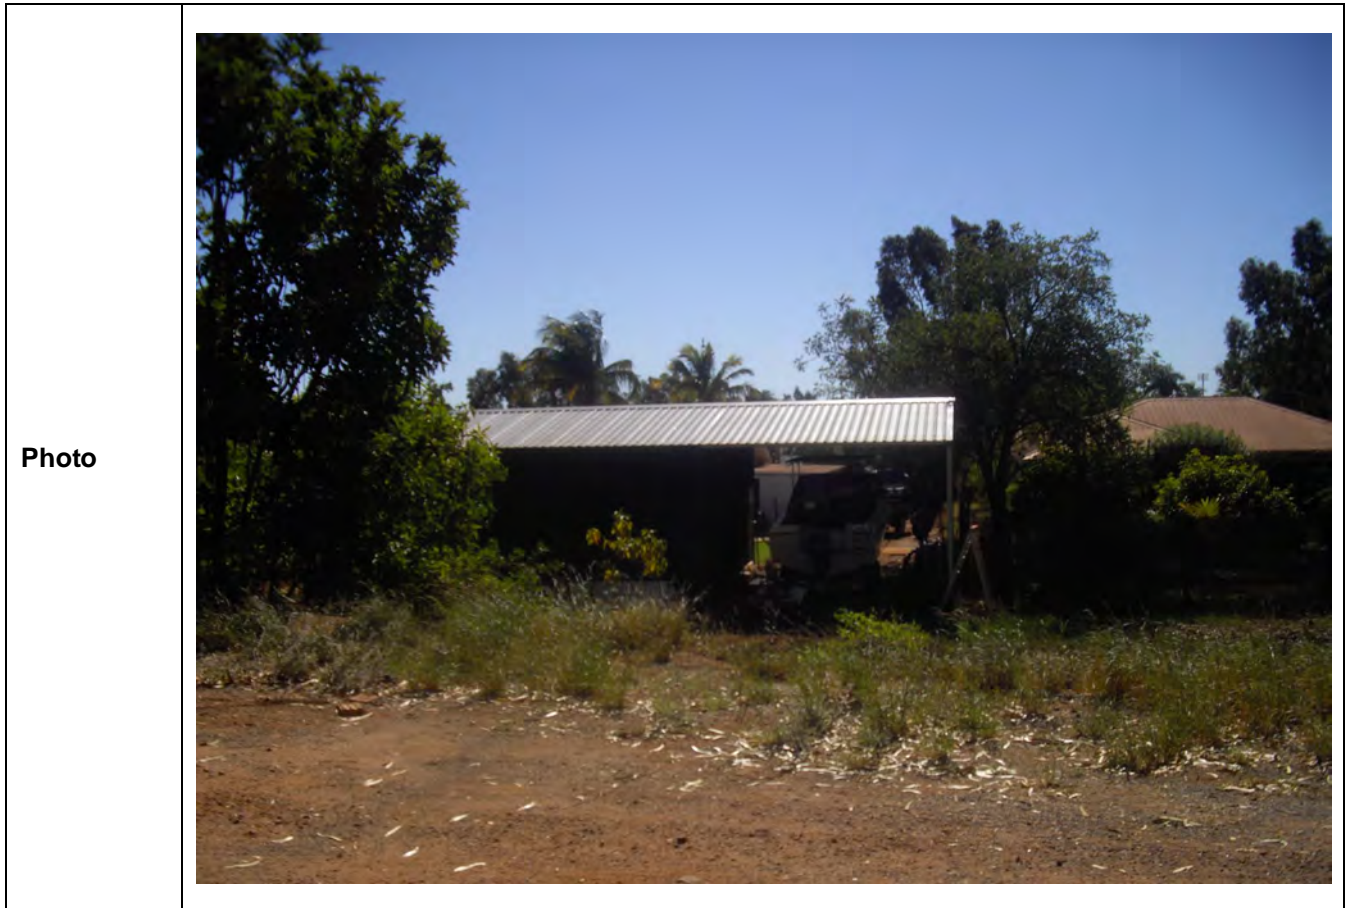
<b>Category</b>	Encroachment
<b>Type</b>	General items; Flow path
<b>Description</b>	Rubbish; Drainage flow path low point is not contained within drainage reserve.
<b>Photo ID</b>	1026
<b>Scope of Works</b>	H - Remove rubbish; H - Reinststate drainage flow path within reserve as defined by the natural channel invert of downstream channel.

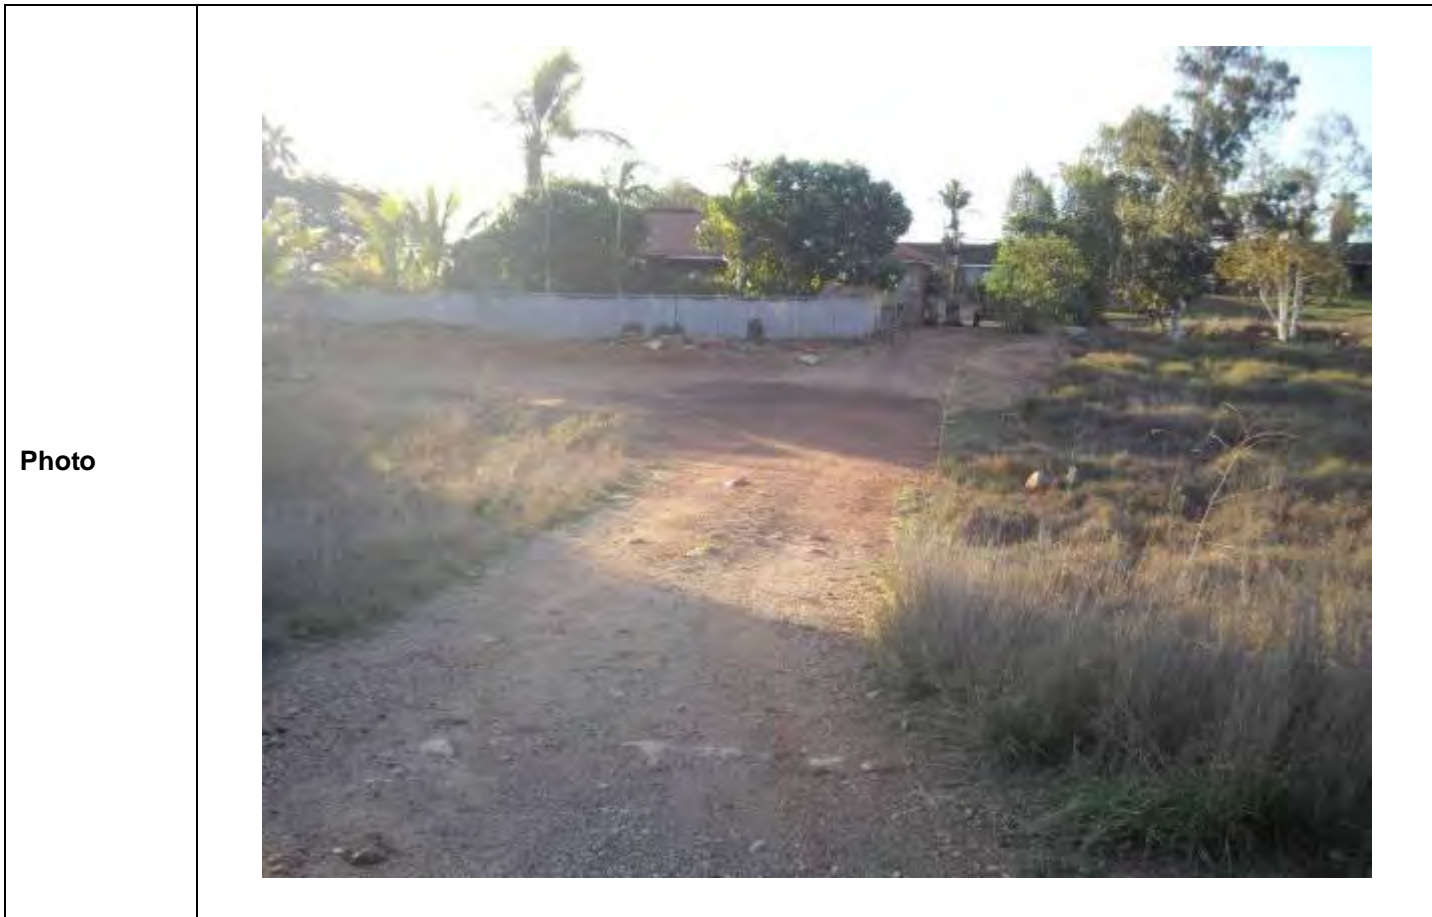
<b>Category</b>	Encroachment
<b>Type</b>	Rear access
<b>Description</b>	Rear access follows natural topography with minimal impact on flow.
<b>Photo ID</b>	677
<b>Scope of Works</b>	L - Remove access driveway and reinstate drainage flow path as defined by the natural channel invert of downstream lot.

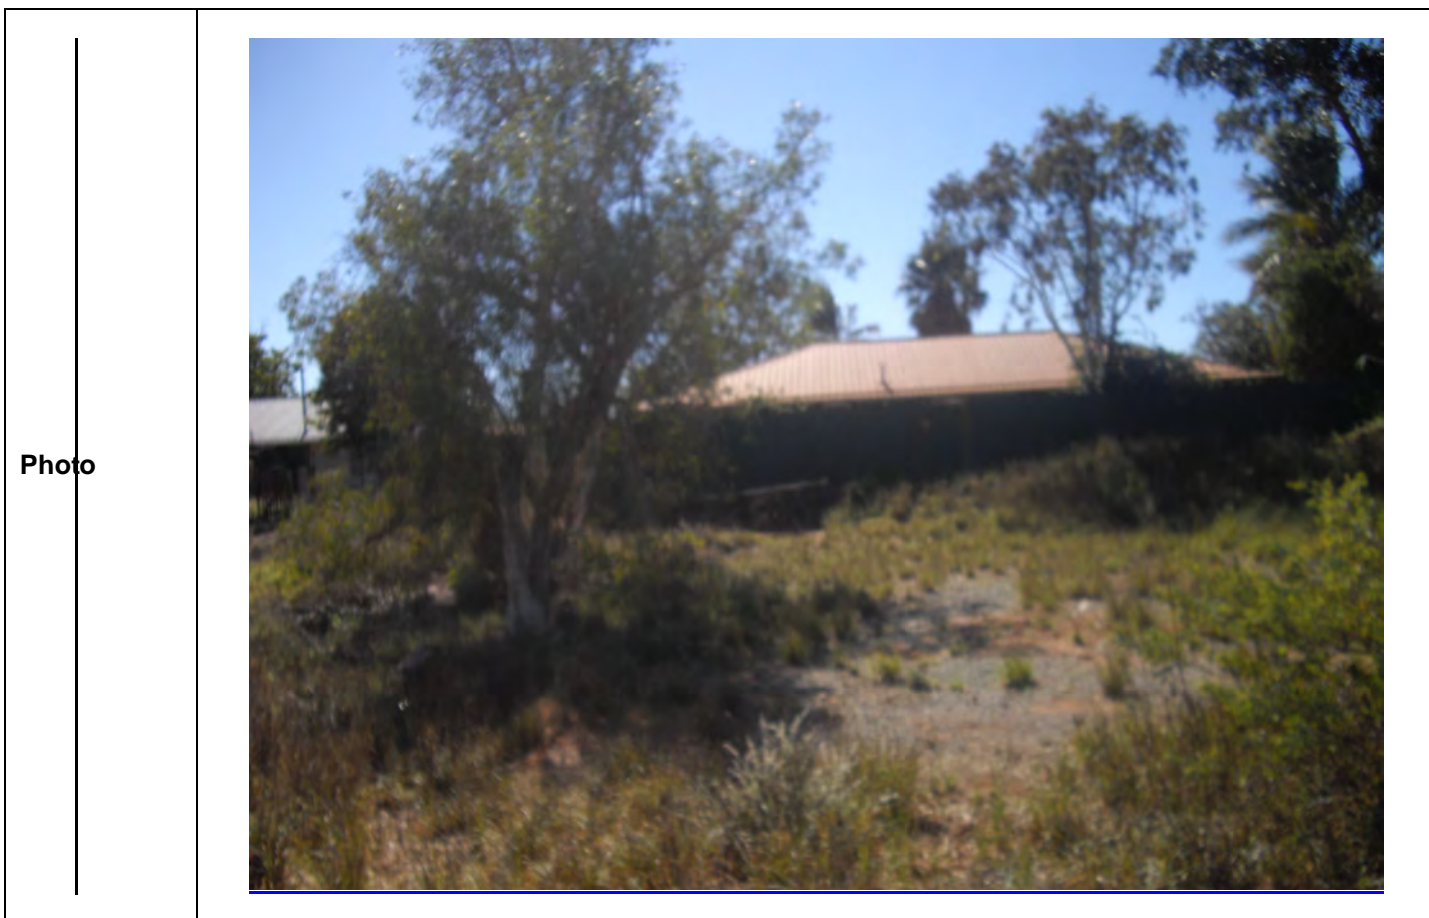
<b>Category</b>	Drain Maintenance
<b>Type</b>	Vegetation
<b>Description</b>	Semi-dense vegetation.
<b>Photo ID</b>	376
<b>Scope of Works</b>	M - Vegetation is to be slashed to a nominal height of 50 mm above ground with the exception of large, established trees of height in excess of 5 m, which shall remain L - Reinststate drainage flow path as defined by the natural channel invert of downstream lot.

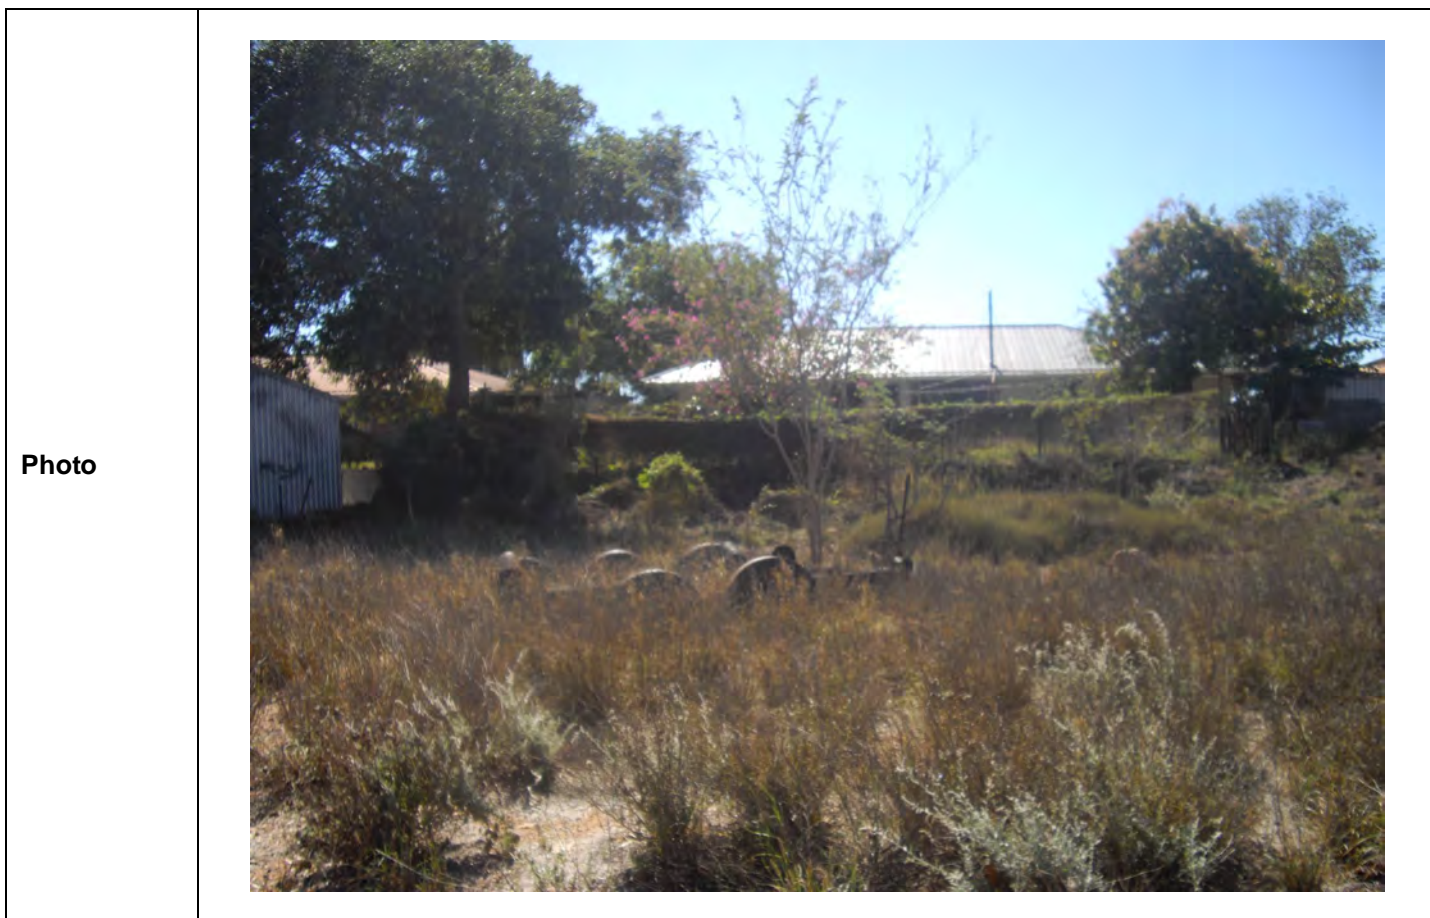
<b>Category</b>	Drain Maintenance
<b>Type</b>	Vegetation
<b>Description</b>	Semi-dense vegetation
<b>Photo ID</b>	376
<b>Scope of Works</b>	M - Vegetation is to be slashed to a nominal height of 50 mm above ground with the exception of large, established trees of height in excess of 5 m, which shall remain.

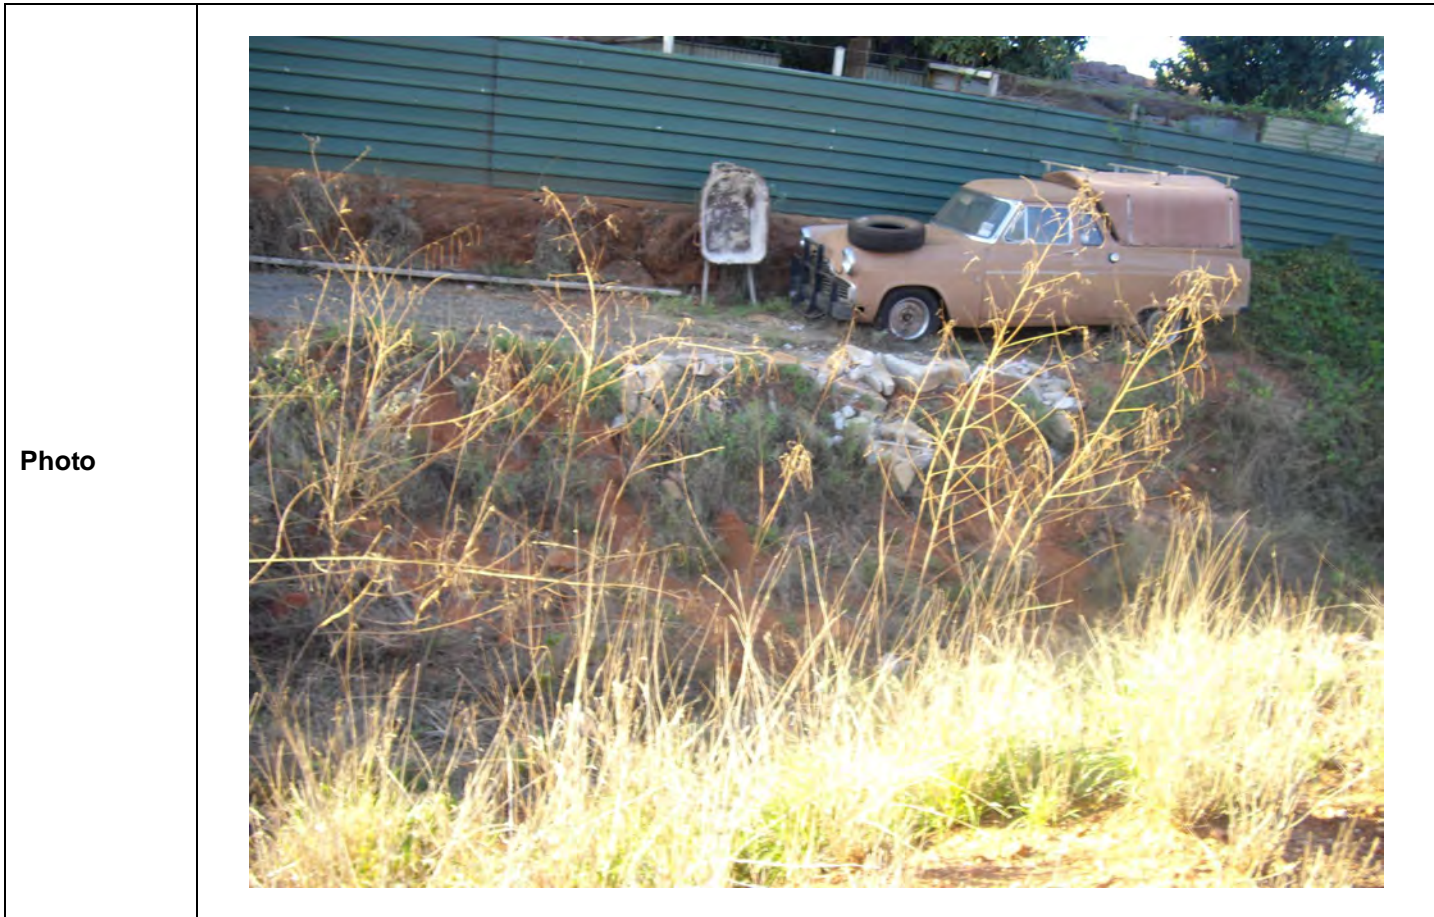
<b>Category</b>	Encroachment
<b>Type</b>	Side access driveway General items. Boundary extension
<b>Description</b>	Side access driveway follows natural topography. Car (on southern side of property), trailer (on western side of property) Parking area (southern side of property) creating a batter encroachment and reducing cross sectional capacity and fence encroachment.
<b>Photo ID</b>	678 & 469 – photo is of southern side of subject property
<b>Scope of Works</b>	Side access driveway noted. No works required. L – Remove trailer and car; L – Remove parking area and batter encroachment and reinstate drainage flow path as defined by the natural channel invert of downstream lot. H - Remove existing fence and relocate to within property boundary.

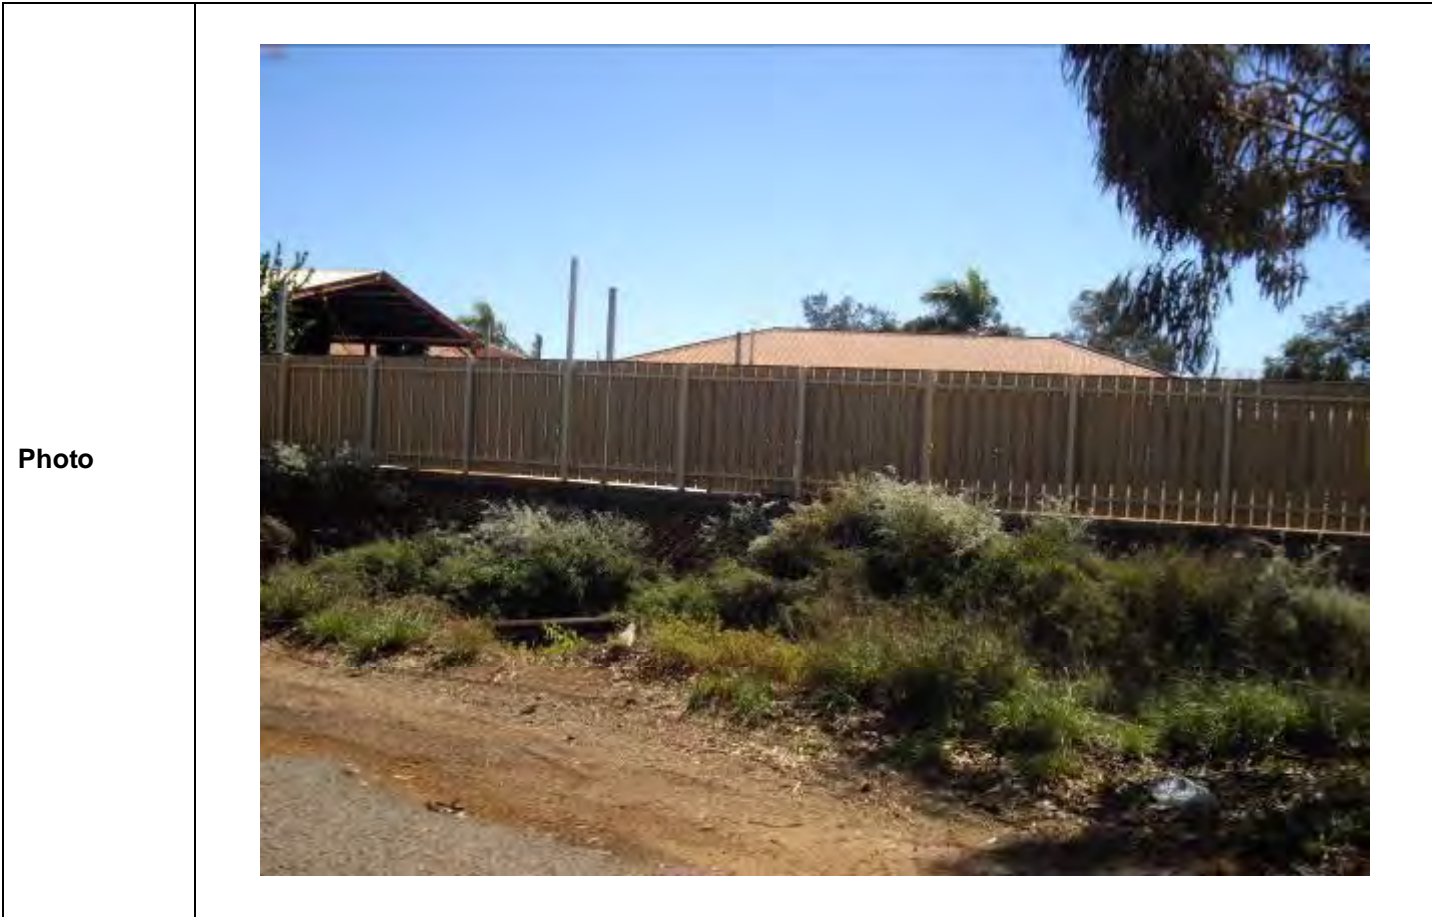
<b>Category</b>	Drain Maintenance / Encroachment
<b>Type</b>	Vegetation Boundary Extension
<b>Description</b>	Vegetation overgrowth impeding on flow. Well defined channel. Fence on south western corner is within drainage reserve.
<b>Photo ID</b>	752
<b>Scope of Works</b>	L - Vegetation is to be slashed to a nominal height of 50 mm above ground with the exception of large, established trees of height in excess of 5 m, which shall remain. L – Remove existing fence and relocate to within property boundary – get confirmation from survey.

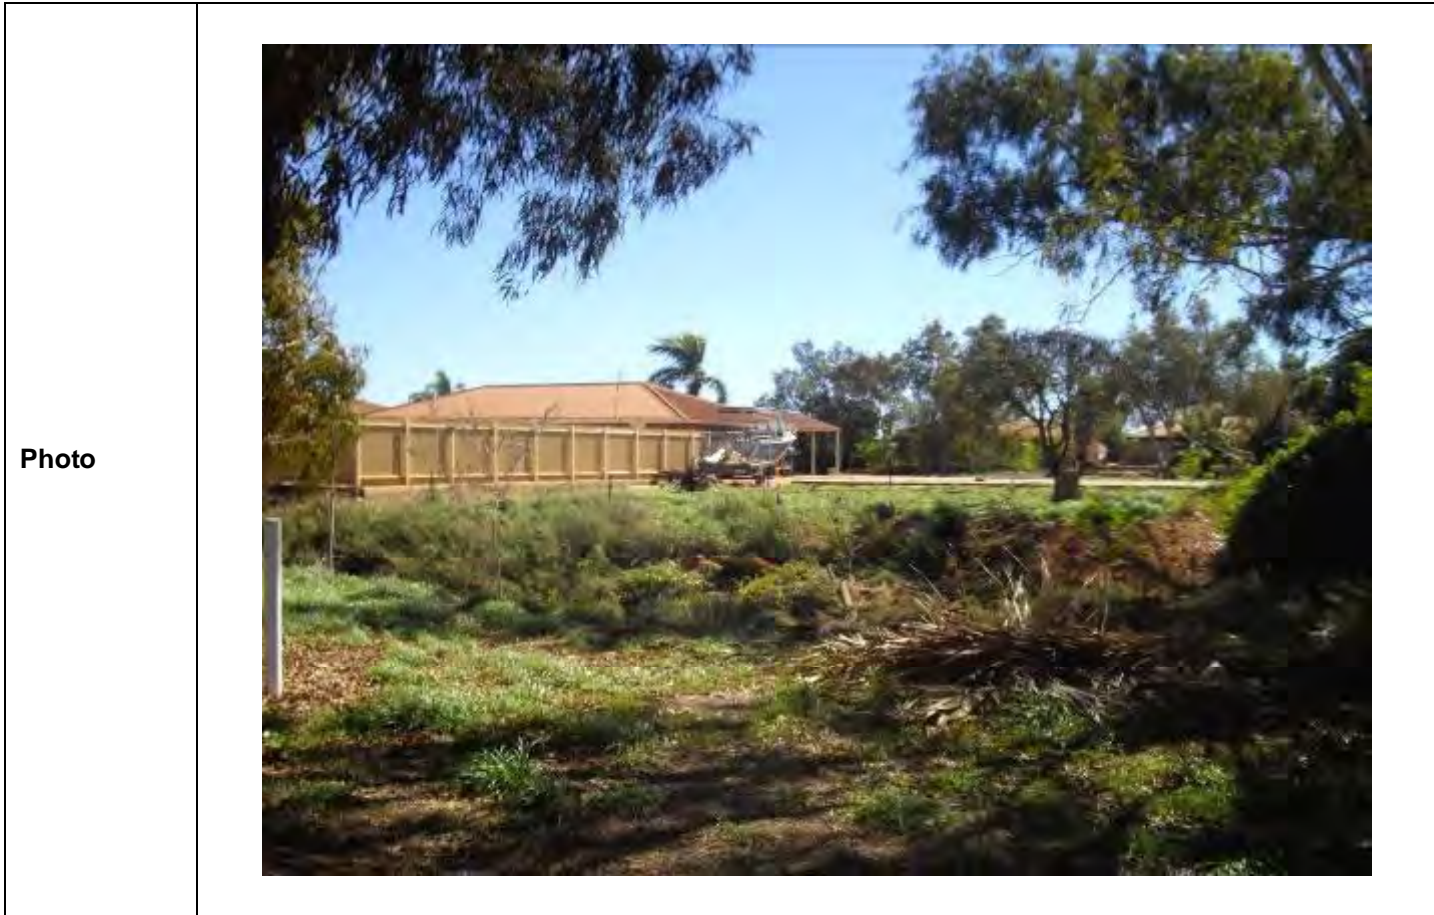
<b>Category</b>	Drain Maintenance
<b>Type</b>	Vegetation
<b>Description</b>	Dense Vegetation inhibiting flow.
<b>Photo ID</b>	751
<b>Scope of Works</b>	L - Vegetation is to be slashed to a nominal height of 50 mm above ground with the exception of large, established trees of height in excess of 5 m, which shall remain

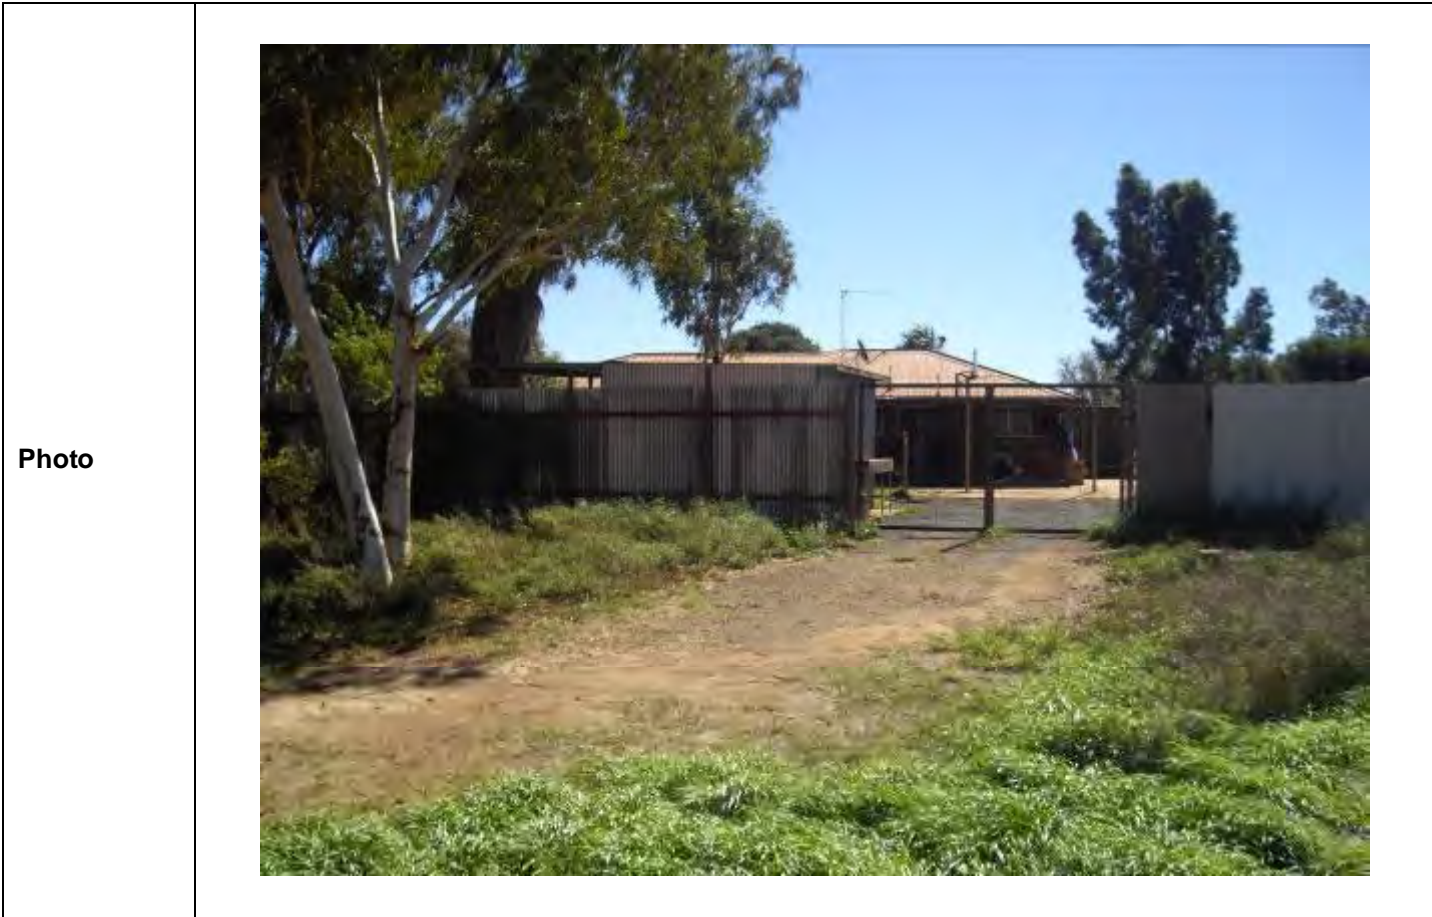
<b>Category</b>	Encroachment / Drain Maintenance
<b>Type</b>	Rear access Vegetation
<b>Description</b>	Rear access with culvert.
<b>Photo ID</b>	750
<b>Scope of Works</b>	H - Remove access driveway and reinstate drainage flow path as defined by the natural channel invert of downstream lot L - Vegetation is to be slashed to a nominal height of 50 mm above ground with the exception of large, established trees of height in excess of 5 m, which shall remain.

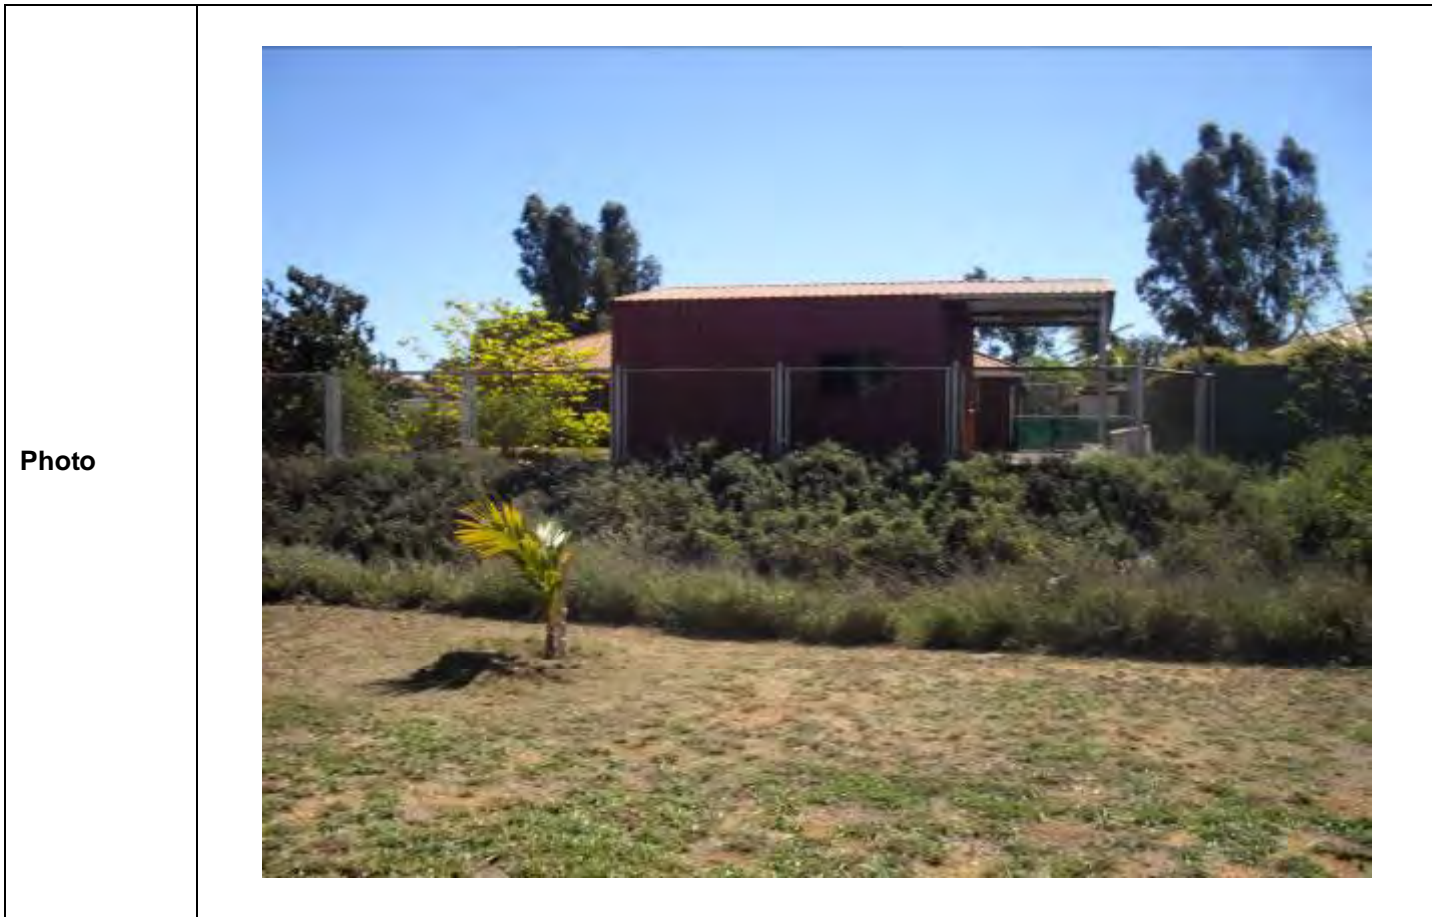
<b>Category</b>	Drain Maintenance
<b>Type</b>	Vegetation; Modified reserve.
<b>Description</b>	Vegetation impeding flow; Maintained parking area within the drainage reserve. Drainage reserve has a defined channel which contains flow meaning the maintained parking area does not impact on flow.
<b>Photo ID</b>	749
<b>Scope of Works</b>	H - Vegetation is to be slashed to a nominal height of 50 mm above ground with the exception of large, established trees of height in excess of 5 m, which shall remain. L – Illegal activity - noted, using drainage reserve for parking area.
