City of Karratha  
Dampier Stormwater Management Study  
Report  
Part B  
June 2015

## Appendix **C** – 2010 encroachment reviews

**Rio Tinto Iron Ore**  
Report on Dampier Drainage  
Review  
Block 1 Encroachments  
June 2010

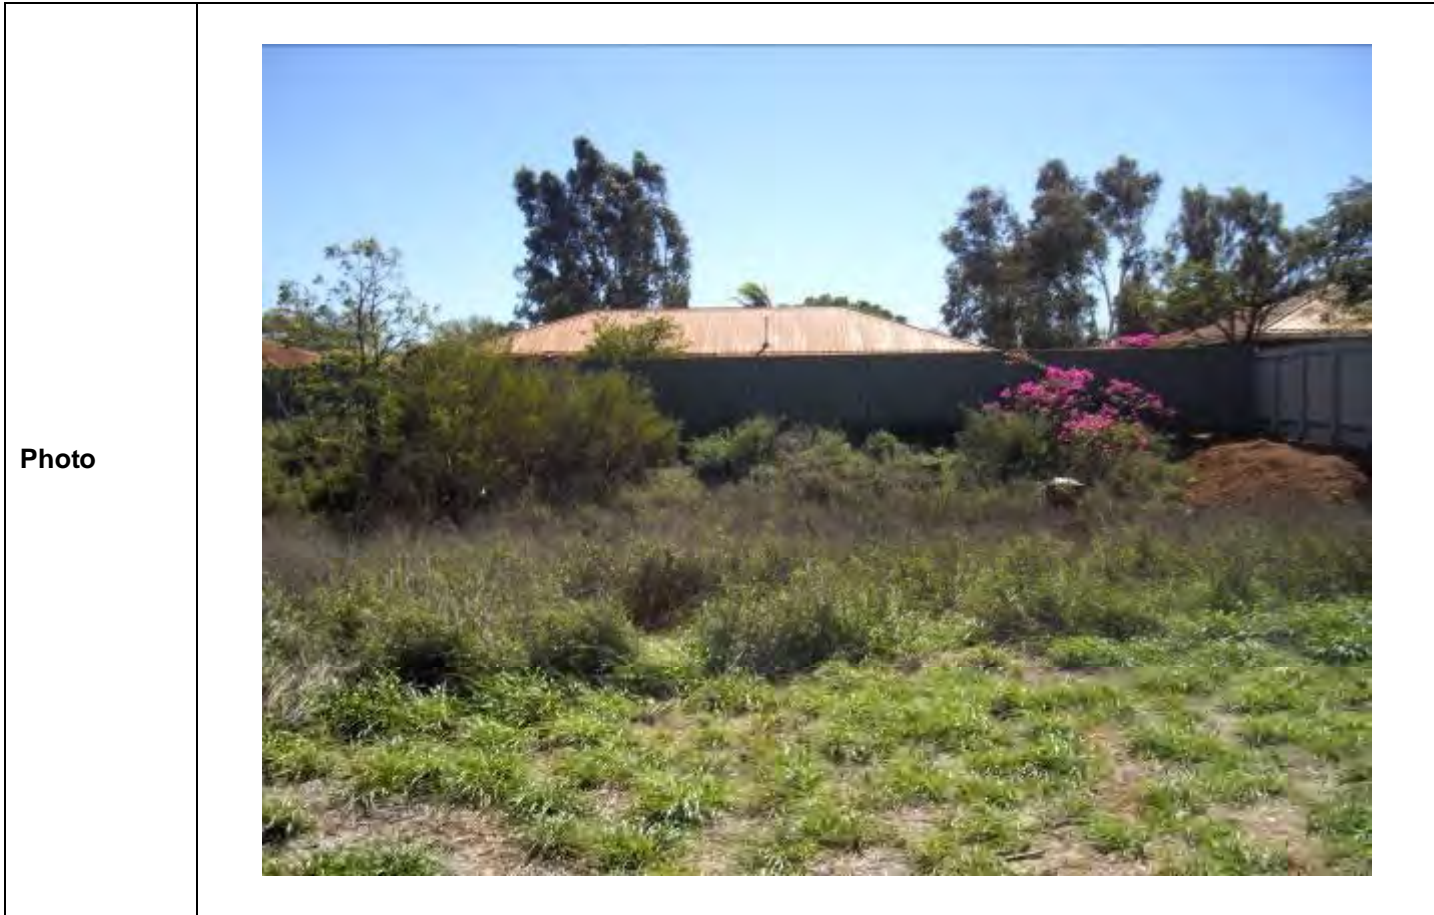
<b>Category</b>	Drain Maintenance
<b>Type</b>	Vegetation;
<b>Description</b>	Dense low lying vegetation
<b>Photo ID</b>	748
<b>Scope of Works</b>	L - Vegetation is to be slashed to a nominal height of 50 mm above ground with the exception of large, established trees of height in excess of 5 m, which shall remain

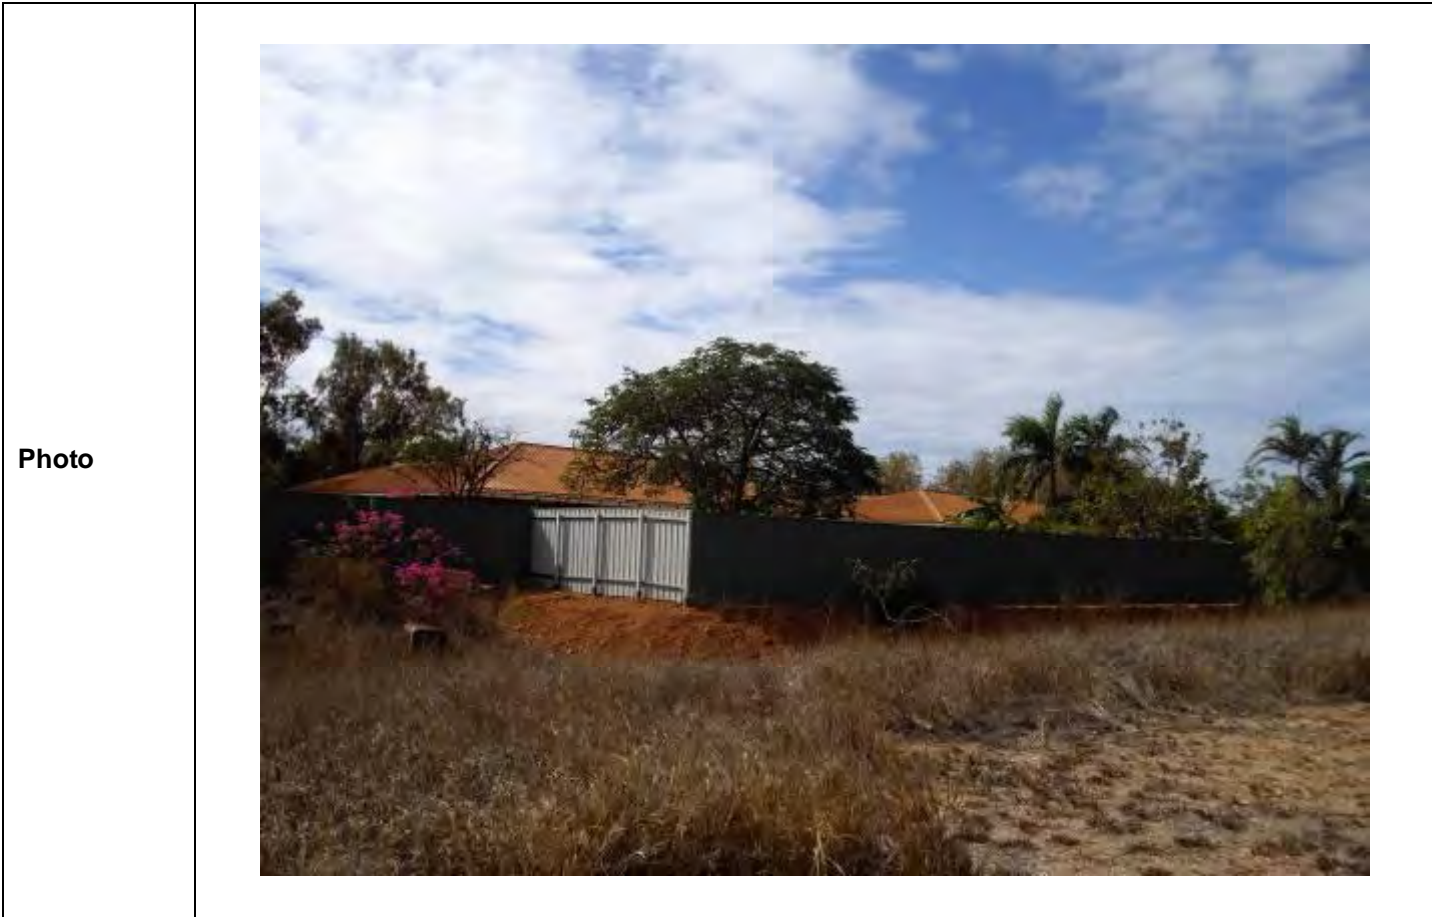
<b>Category</b>	Encroachment
<b>Type</b>	Boundary extension Vegetation
<b>Description</b>	Fence encroachment altering the flow path. Semi dense vegetation
<b>Photo ID</b>	465 – subject property in middle of photo with green fence.
<b>Scope of Works</b>	H – Remove existing backyard encroachment and relocate to within property boundary. L - Vegetation is to be slashed to a nominal height of 50 mm above ground with the exception of large, established trees of height in excess of 5 m, which shall remain.

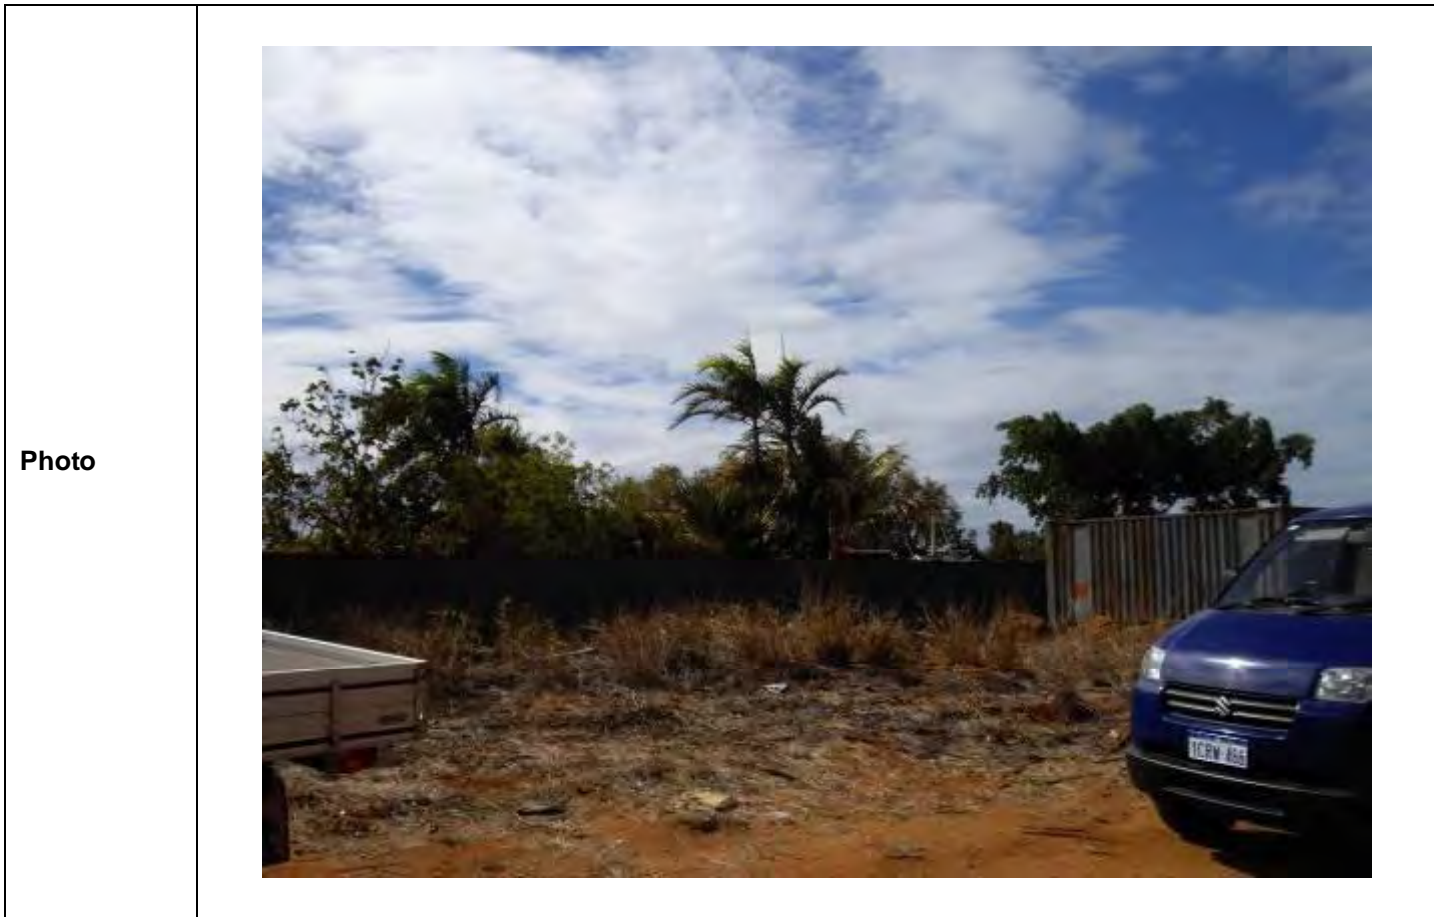
<b>Category</b>	Encroachment
<b>Type</b>	Rear access General item
<b>Description</b>	Rear access with culvert with unknown entry point. Sheds
<b>Photo ID</b>	466
<b>Scope of Works</b>	H – Remove rear access and reinstate drainage flow path as defined by the natural channel capacity and invert of downstream lot. L – Remove sheds

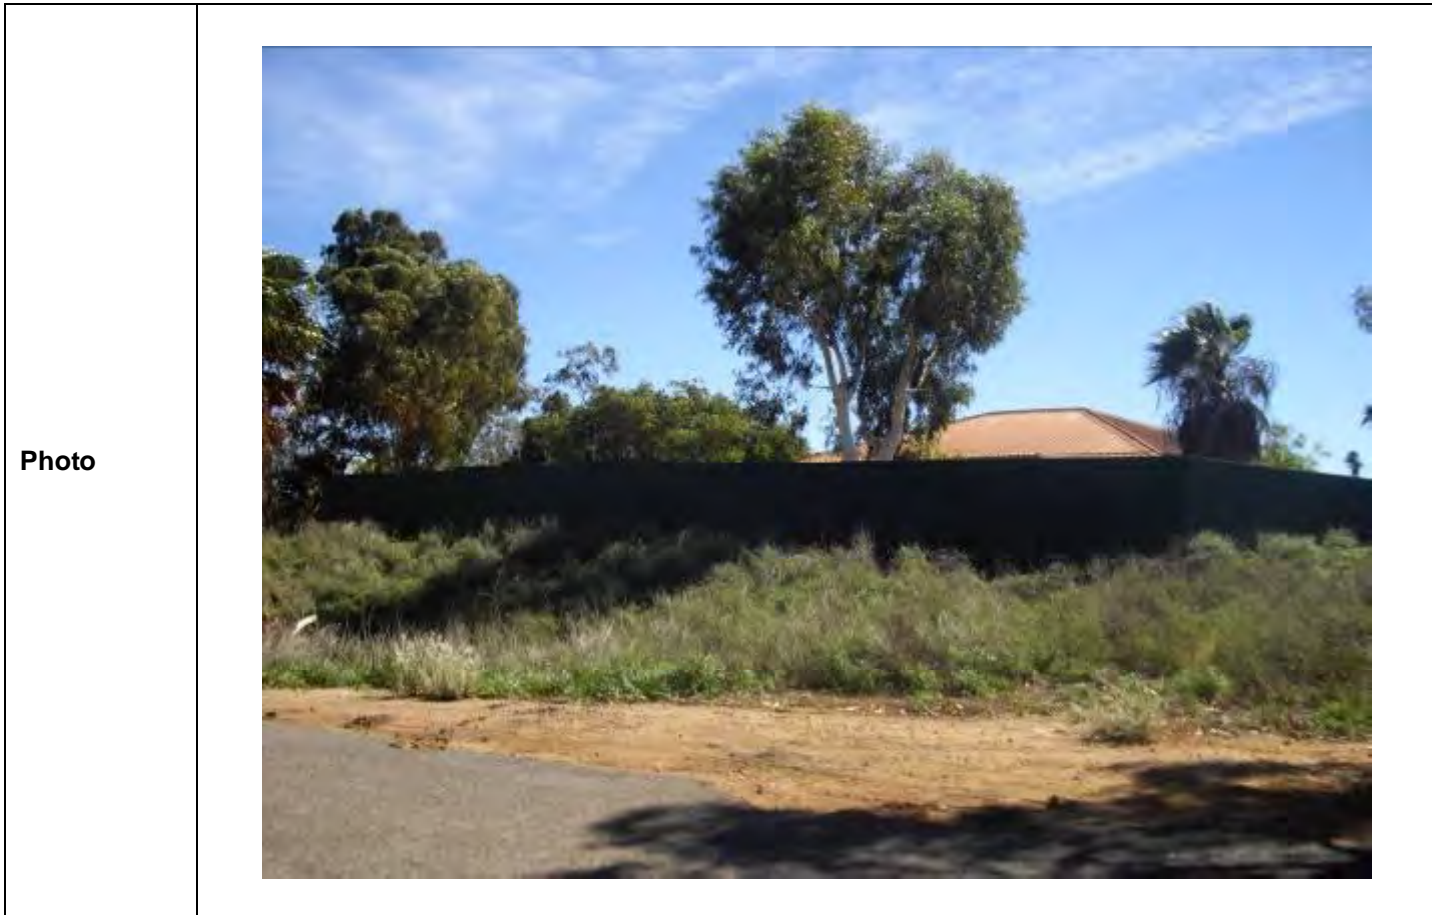
<b>Category</b>	Drain Maintenance
<b>Type</b>	Vegetation Flow path
<b>Description</b>	Semi – dense vegetation. Downstream lot of West to East drainage and there is little to no definition of flow path. Original intended design intent not apparent.
<b>Photo ID</b>	764
<b>Scope of Works</b>	L - Vegetation is to be slashed to a nominal height of 50 mm above ground with the exception of large, established trees of height in excess of 5 m, which shall remain; H Reinstatement drainage flow path as defined by the natural channel capacity and invert of downstream lot.

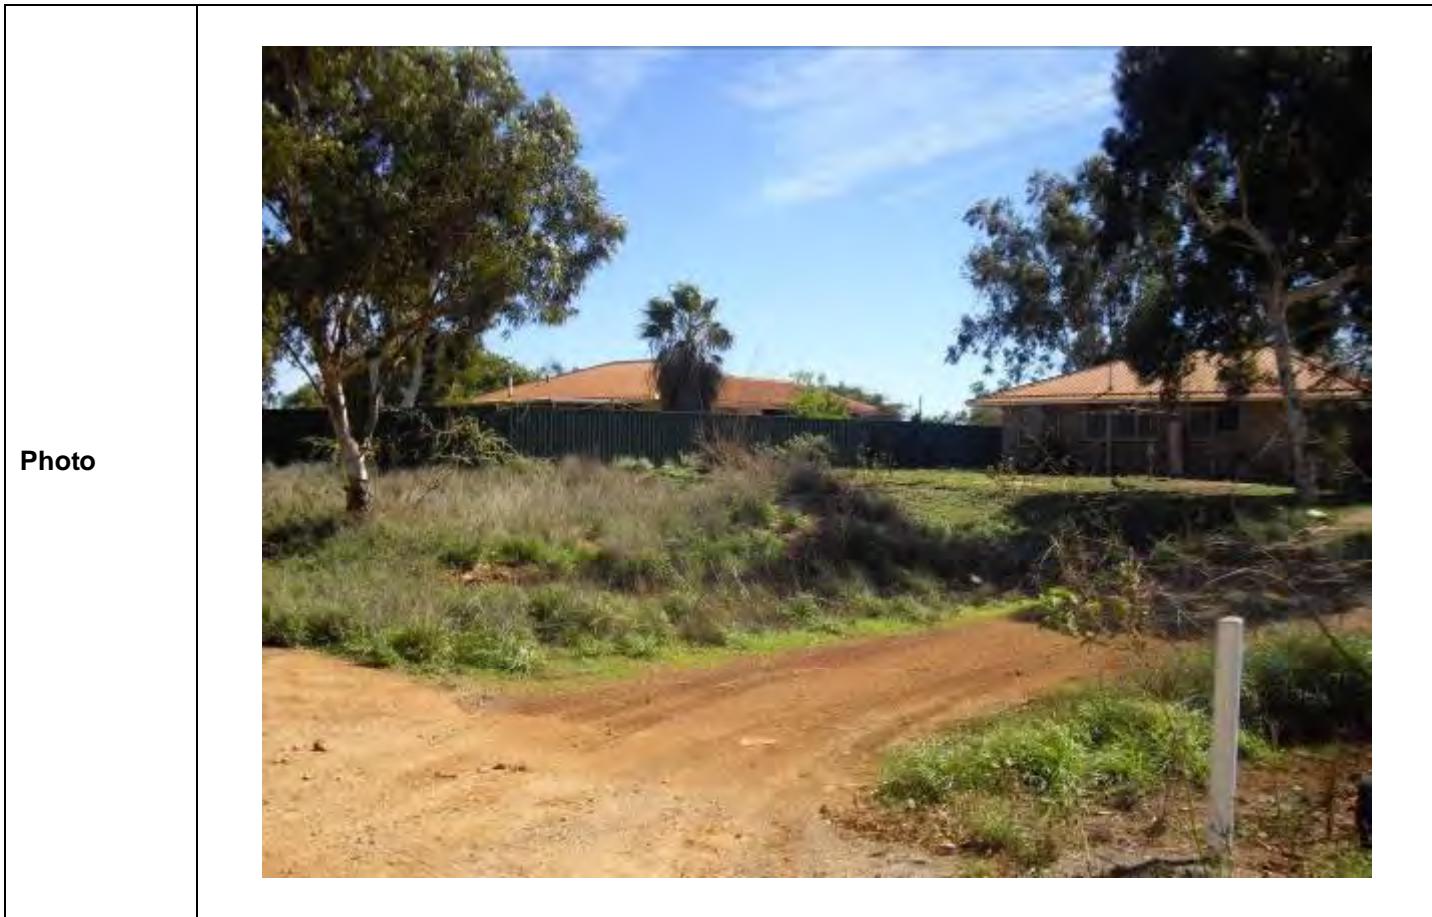
<b>Category</b>	Drain Maintenance/ Encroachment
<b>Type</b>	Rear access Flow path Vegetation
<b>Description</b>	Rear access Modified flow path Semi dense vegetation
<b>Photo ID</b>	763 – subject lot on the middle right of photo with rear access.
<b>Scope of Works</b>	H - Remove rear access and reinstate drainage flow path as defined by the natural capacity and invert of downstream lot channel L - Vegetation is to be slashed to a nominal height of 50 mm above ground with the exception of large, established trees of height in excess of 5 m, which shall remain

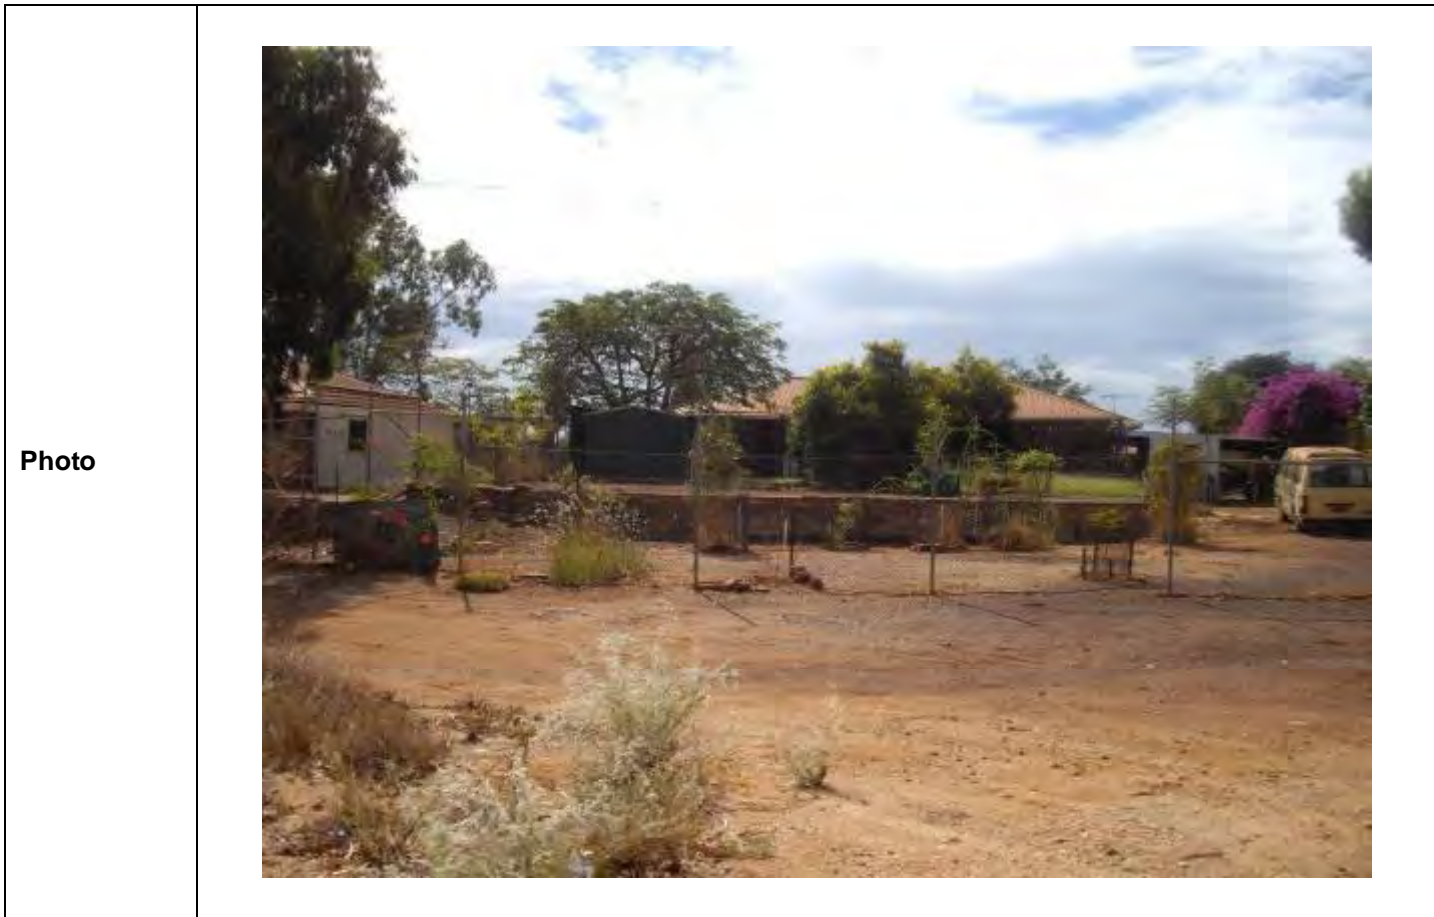
<b>Category</b>	Encroachment
<b>Type</b>	Rear access; Boundary extension; General items; Flow path.
<b>Description</b>	Rear access and modified topography; Fence Sea container (to the right (outside) of photograph.) No defined drainage flow path due to modified topography.
<b>Photo ID</b>	468
<b>Scope of Works</b>	L - Remove rear access L - Remove existing fence and relocate to within property boundary L - Remove sea container H – Reinststate drainage flow path as defined by the natural capacity and invert of downstream lot channel

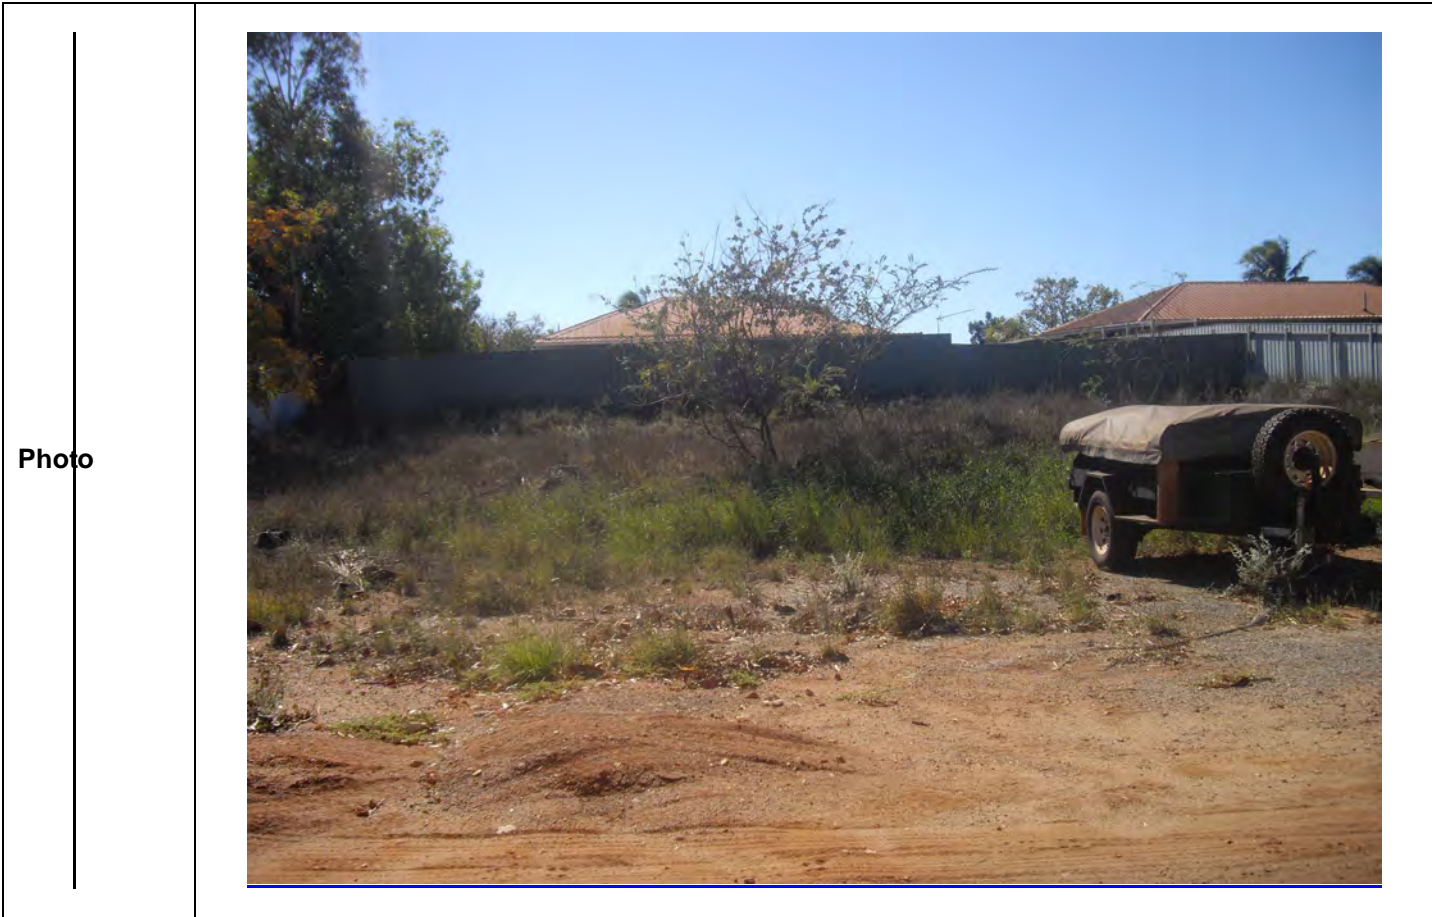
<b>Category</b>	Encroachment / Drain Maintenance
<b>Type</b>	Vegetation General items Filled materials
<b>Description</b>	Semi-dense vegetation; Trailer.
<b>Photo ID</b>	19
<b>Scope of Works</b>	L - Vegetation is to be slashed to a nominal height of 50 mm above ground with the exception of large, established trees of height in excess of 5 m, which shall remain L – Remove trailer and fill material M - Reinststate drainage flow path as defined by the natural capacity and invert of downstream lot channel

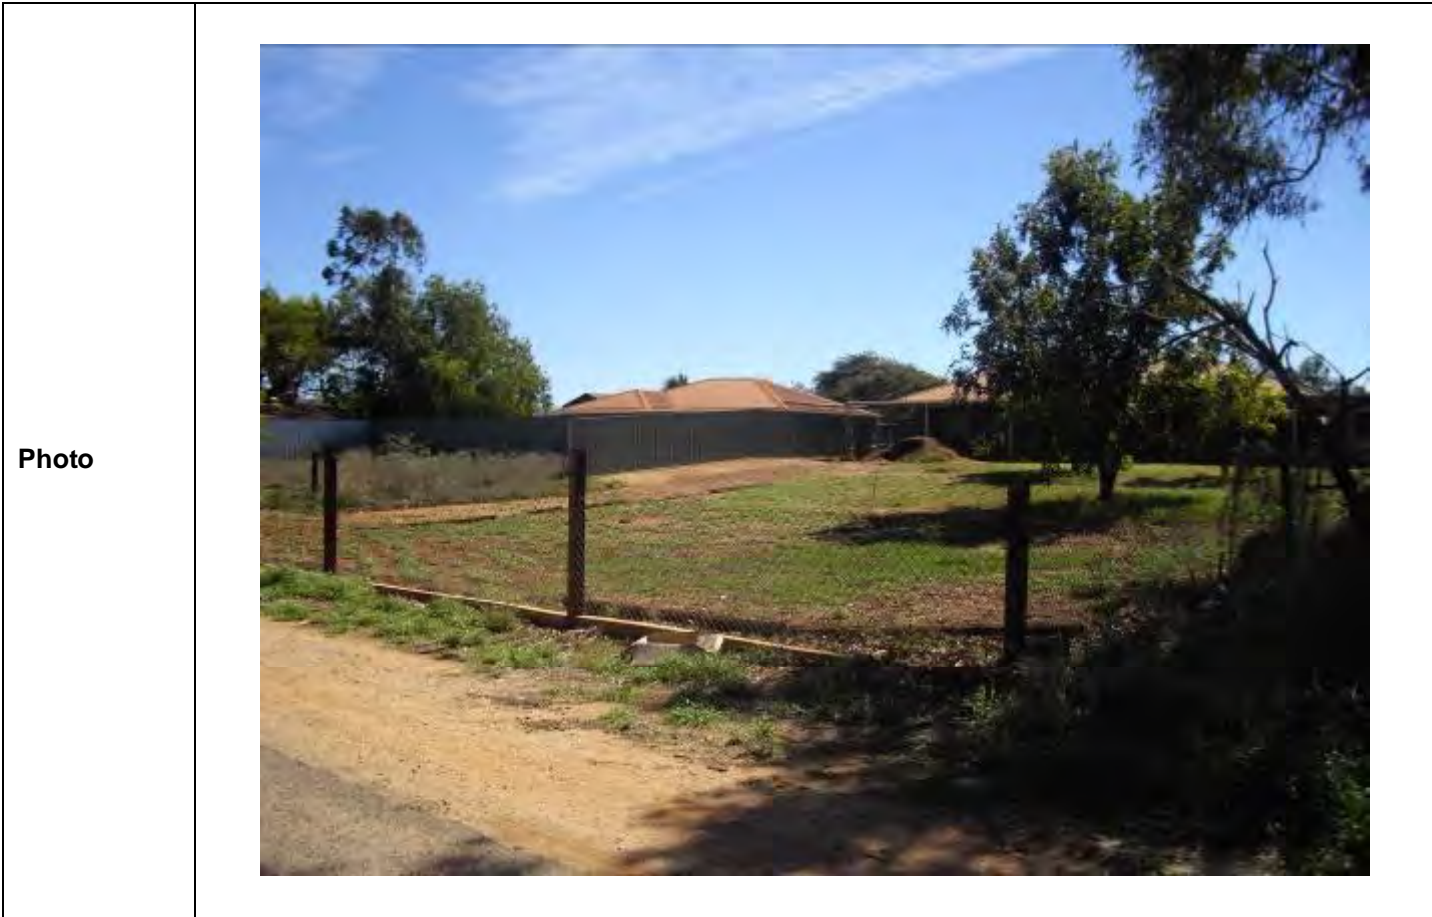
<b>Category</b>	Encroachment / Drain Maintenance
<b>Type</b>	Boundary extension; Rear access; Ill defined flow path.
<b>Description</b>	Fence; Rear access and modified topography; No defined flow path within reserve due to modified topography.
<b>Photo ID</b>	759
<b>Scope of Works</b>	H - Remove existing fence and relocate to within property boundary; L - Remove rear access; H - Reinstate drainage flow path as defined by the natural capacity and invert of downstream lot channel

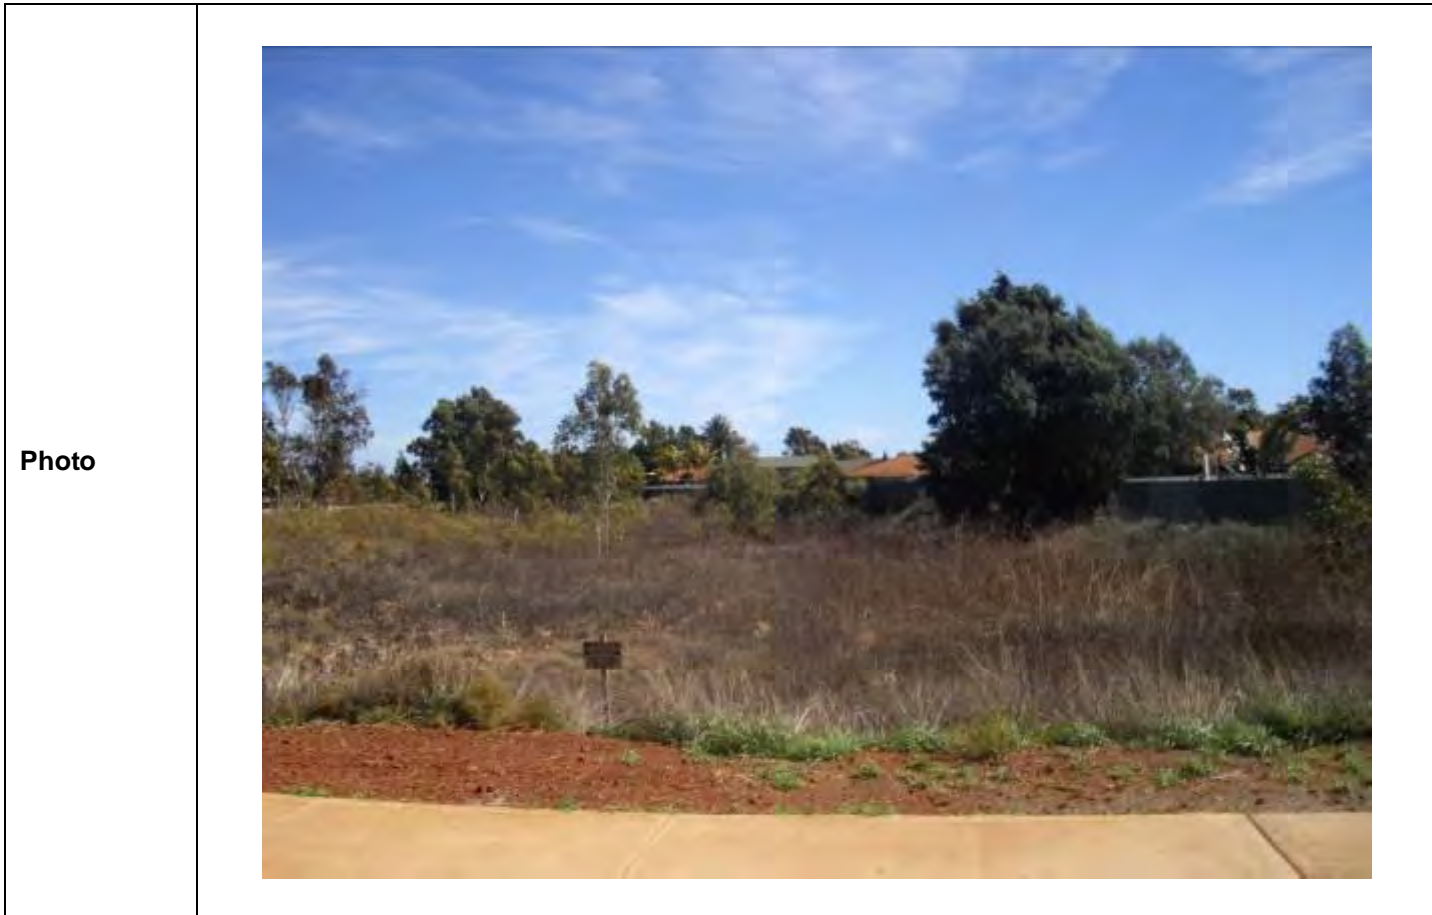
<b>Category</b>	Drain Maintenance
<b>Type</b>	Vegetation.
<b>Description</b>	Vegetation impeding flow but the reserve is of a large capacity created by the raising of the road reserve and lot boundary.
<b>Photo ID</b>	765
<b>Scope of Works</b>	None required

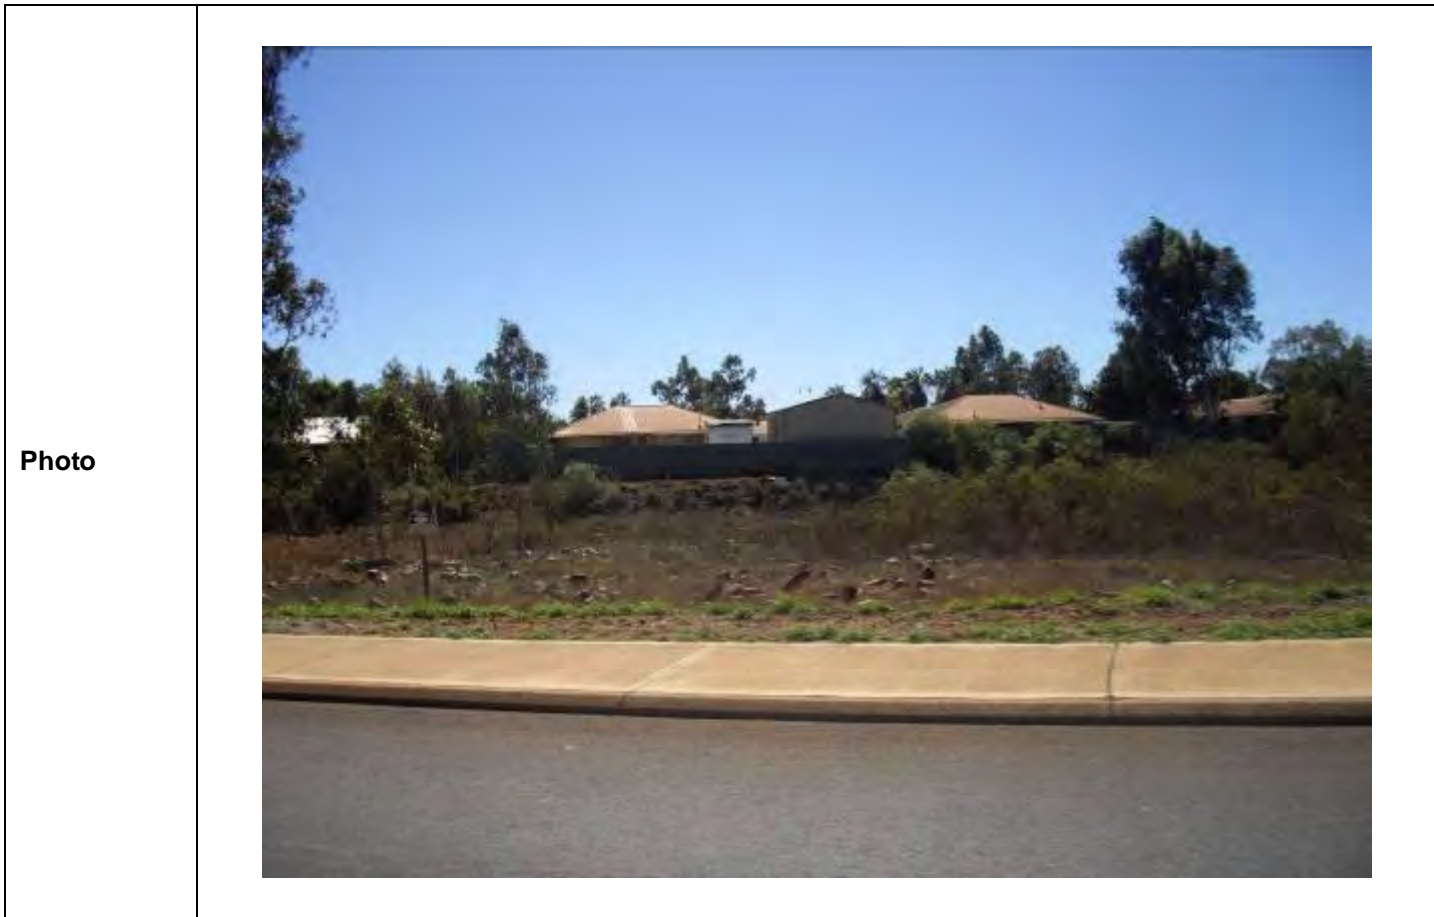
<b>Category</b>	Drain Maintenance
<b>Type</b>	Vegetation.
<b>Description</b>	Vegetation impeding flow but the reserve is of a large capacity created by the raising of the road reserve and lot boundary.
<b>Photo ID</b>	767
<b>Scope of Works</b>	None required

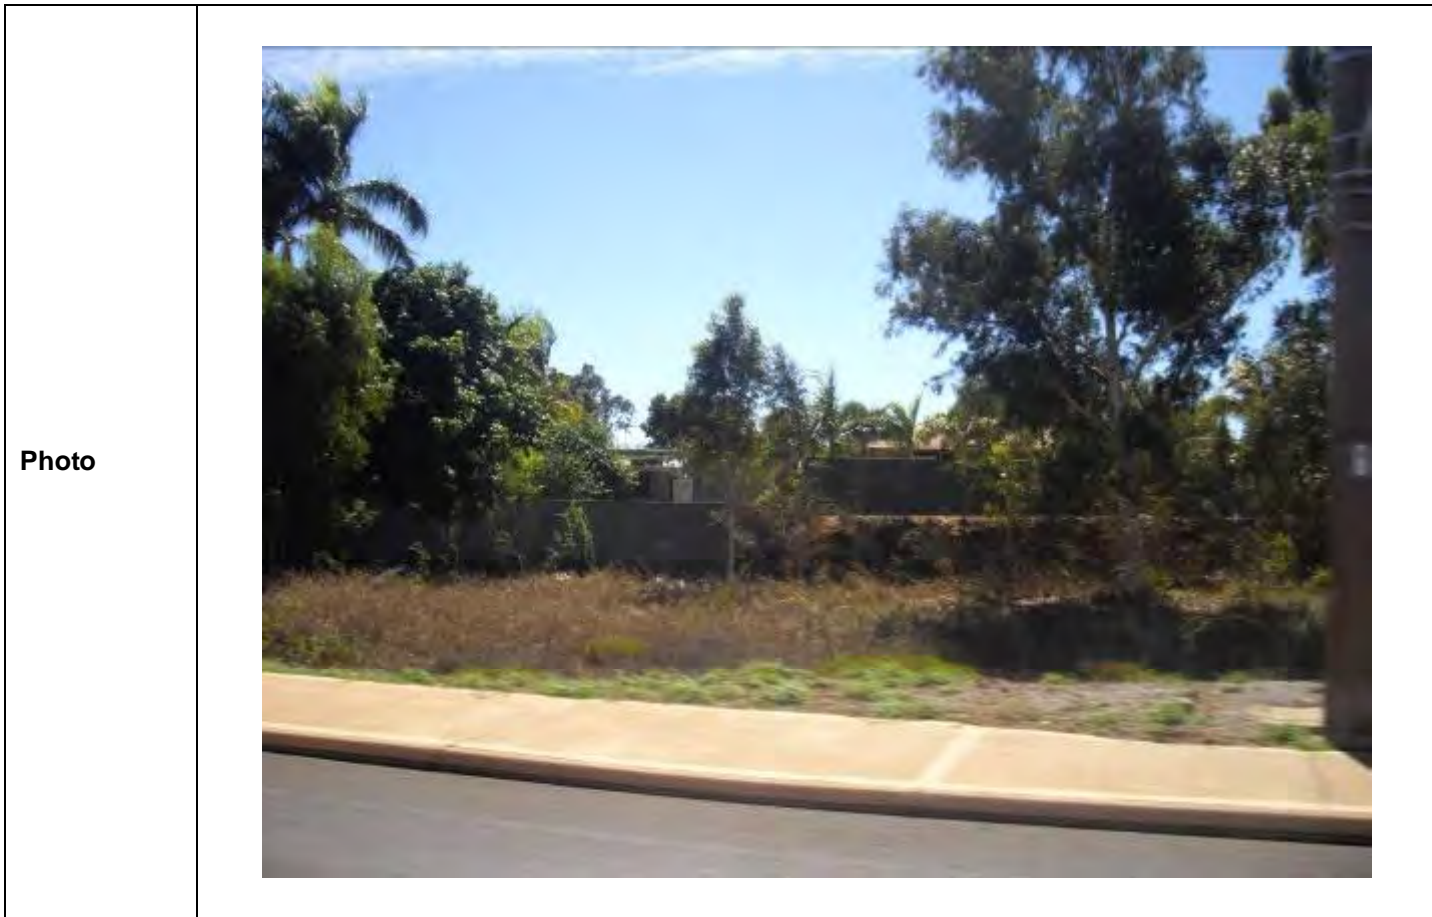
<b>Category</b>	Drain Maintenance
<b>Type</b>	Vegetation
<b>Description</b>	Vegetation impeding flow but the reserve is of a large capacity created by the raising of the road reserve and lot boundary.
<b>Photo ID</b>	769
<b>Scope of Works</b>	None required

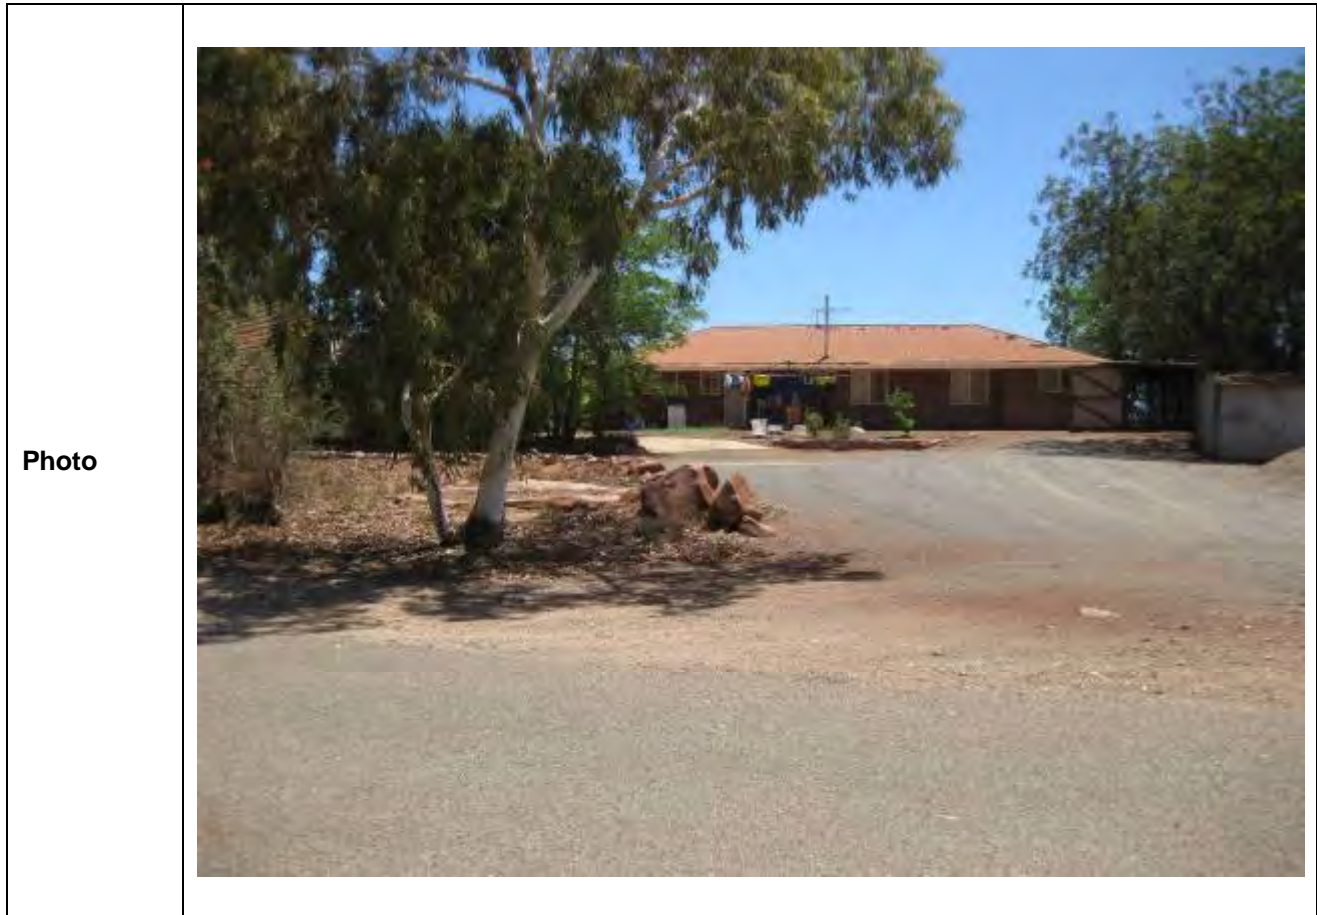
<b>Category</b>	Encroachment
<b>Type</b>	Rear access
<b>Description</b>	Rear access follows natural topography; No defined channel in drainage reserve; Flow is directed towards road reserve.
<b>Photo ID</b>	9
<b>Scope of Works</b>	L - Remove rear access and reinstate flow path directed toward road reserve.

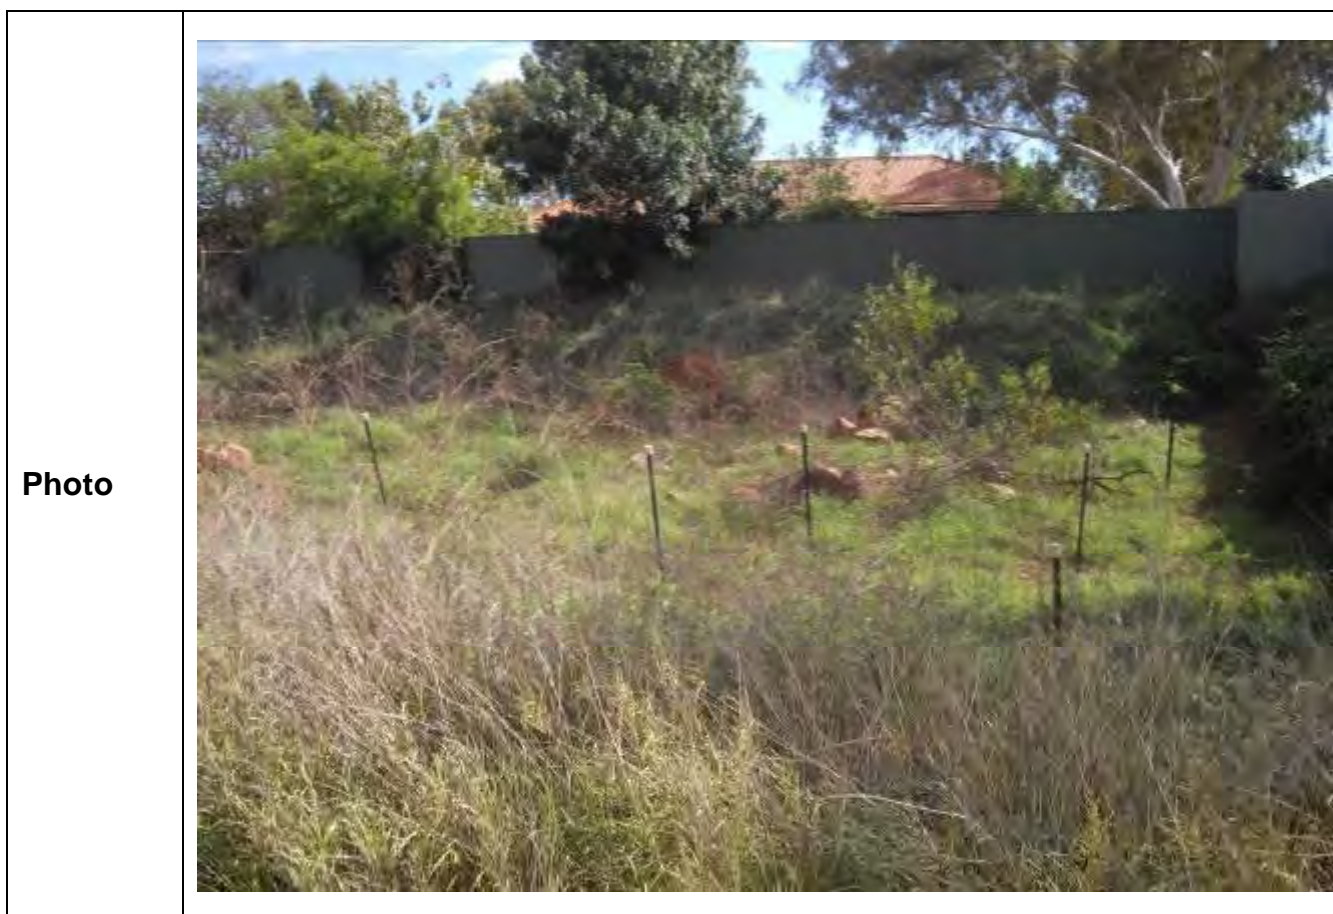
<b>Category</b>	Drain Maintenance / Encroachment
<b>Type</b>	Sump - blocked; Vegetation.
<b>Description</b>	Drainage reserve has sump that is meant to discharge under lot 324 to north of Patterson. Sump is blocked and overgrown with vegetation - does not function as required. Condition of inlet and outlet pipes unknown. Dense vegetation - impeding flow.
<b>Photo ID</b>	978, 773
<b>Scope of Works</b>	<p>H – Clean out material and vegetation blocking sump. Rock pitch around sump outlet. Stabilise inlet and outlet pipes with concrete headwalls. Check condition of outlet pipe.</p> <p>H - Vegetation is to be slashed to a nominal height of 50 mm above ground with the exception of large, established trees of height in excess of 5 m, which shall remain.</p> <p>L – Land to be rezoned as drainage reserve or redesigned by certified engineer to not encroach on property boundary.</p>

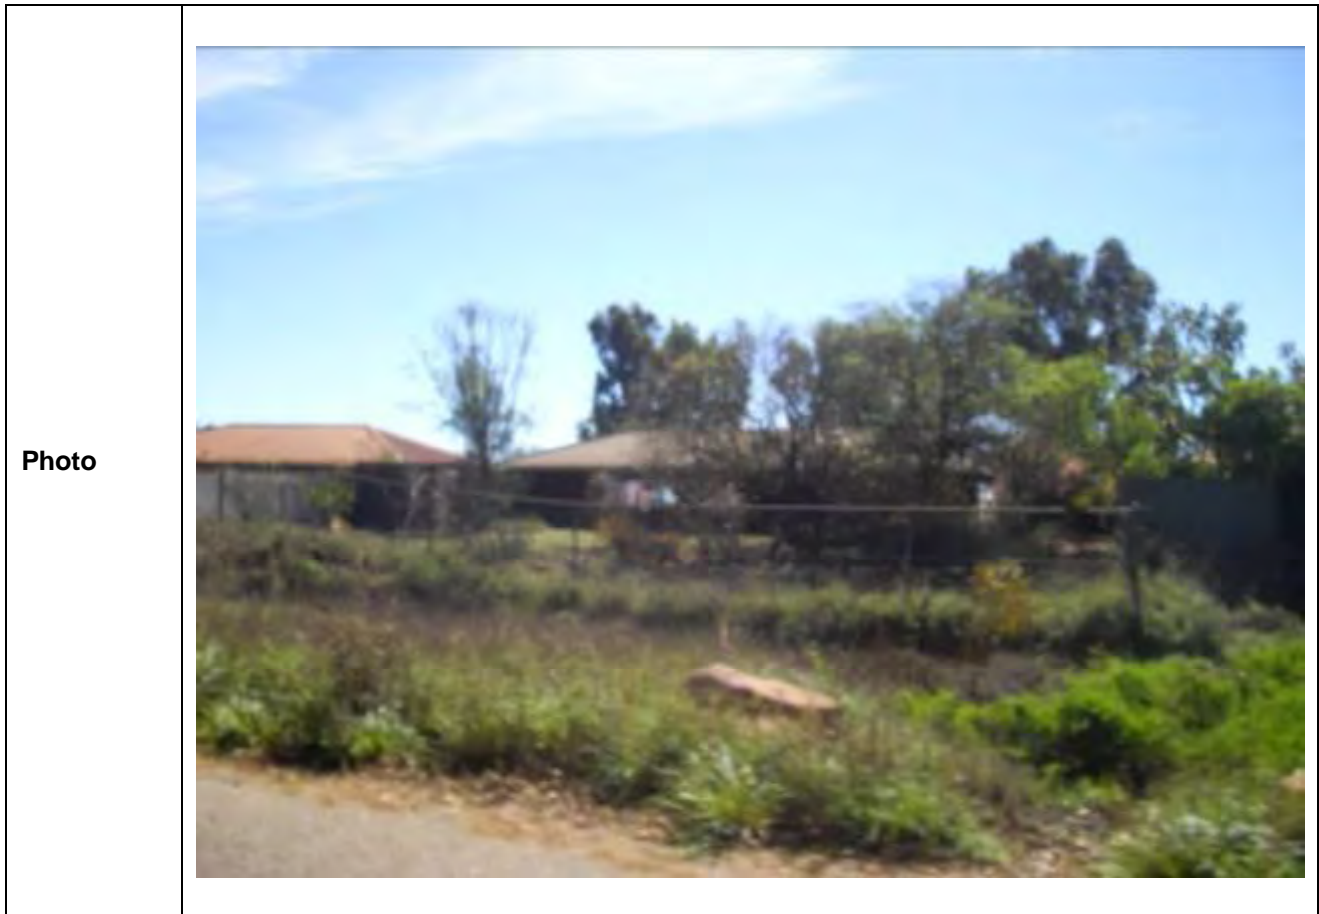
<b>Category</b>	Drain Maintenance / Encroachment
<b>Type</b>	Rear access; Vegetation.
<b>Description</b>	Rear access follows natural topography; Dense vegetation impeding flow.
<b>Photo ID</b>	774
<b>Scope of Works</b>	M - Remove rear access and construct defined channel directing flow east to lot 324 sump; M - Vegetation is to be slashed to a nominal height of 50 mm above ground with the exception of large, established trees of height in excess of 5 m, which shall remain

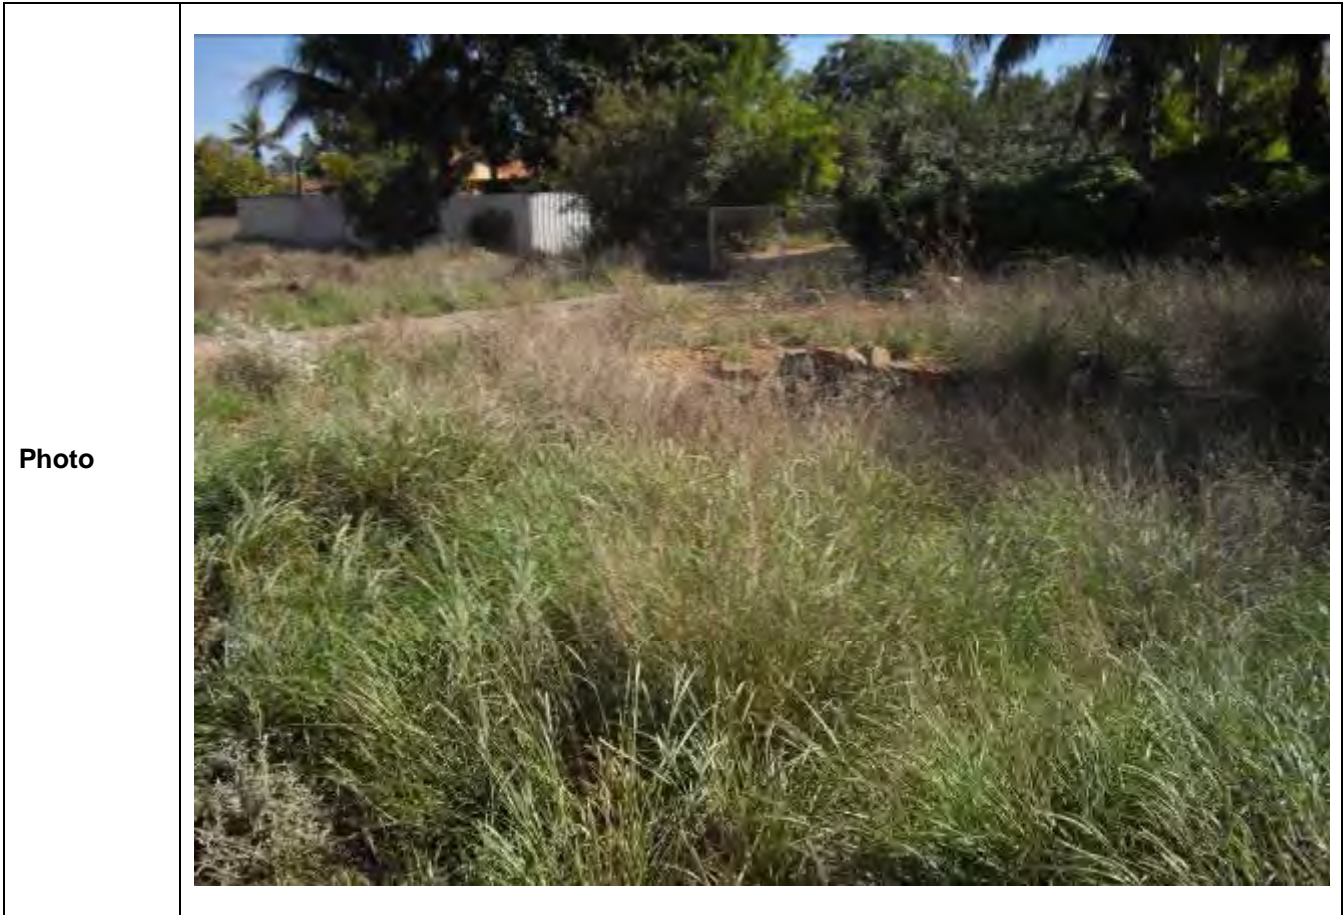
<b>Category</b>	Encroachment / Drain Maintenance
<b>Type</b>	Rear access; Vegetation.
<b>Description</b>	Rear access with culvert Drainage reserve has sump that is meant to discharge under lot 336 to Patterson lot 324. Sump is blocked and overgrown with vegetation - does not function as required. Condition of inlet and outlet pipes unknown Dense vegetation within channel and reserve – impedes flow
<b>Photo ID</b>	983
<b>Scope of Works</b>	H - Remove rear access and reinstate drainage flow path. H – Clean out material and vegetation blocking sump. Rock pitch around sump outlet. Stabilise inlet and outlet pipes with concrete headwalls. Check condition of outlet pipe. H - Vegetation is to be slashed to a nominal height of 50 mm above ground with the exception of large, established trees of height in excess of 5 m, which shall remain.

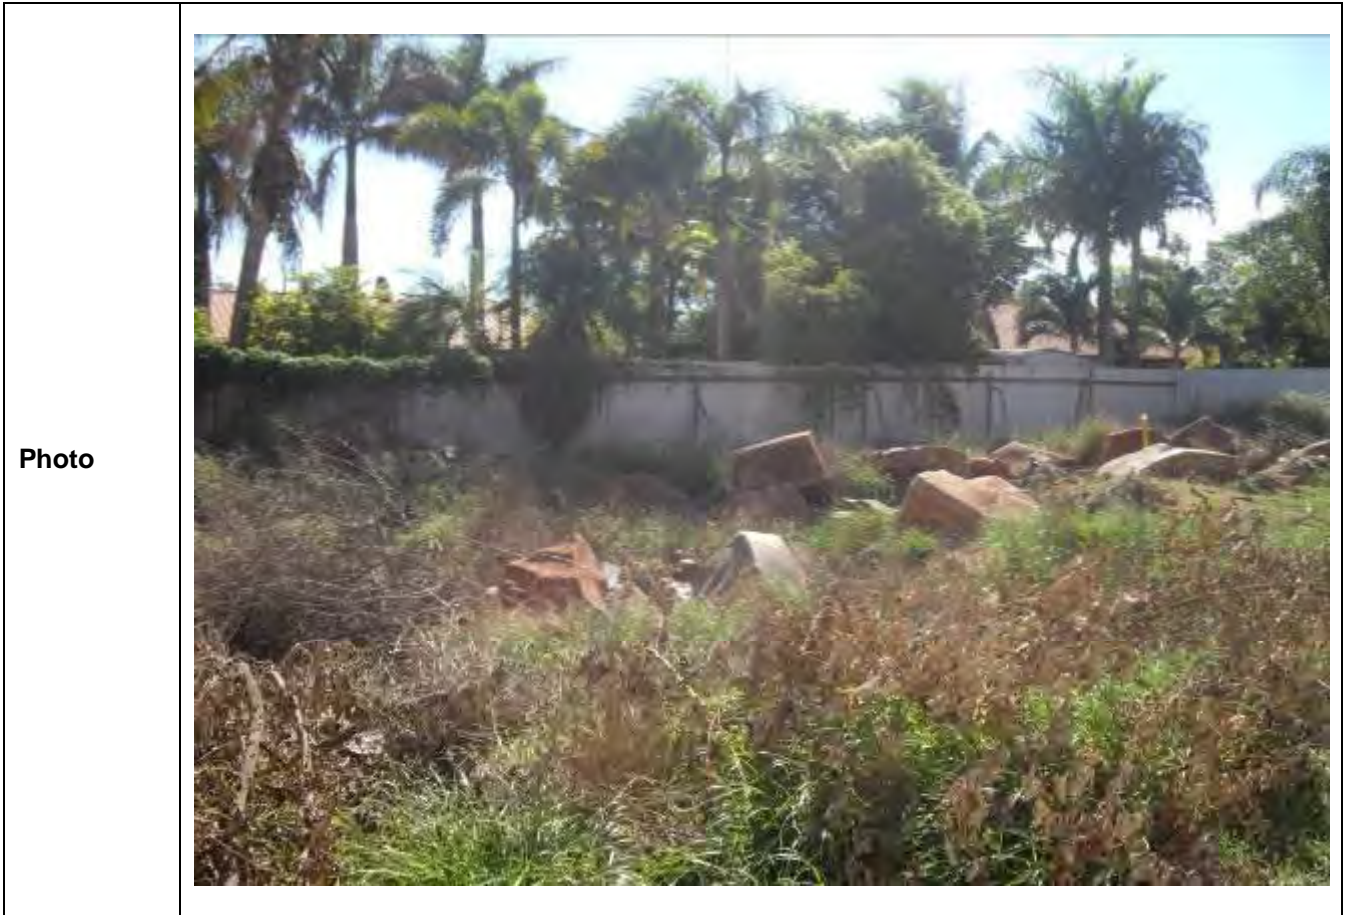
<b>Category</b>	Drain Maintenance
<b>Type</b>	Vegetation Rocks
<b>Description</b>	Thick low lying vegetation that will impede flow Rocks form catchment divide do not impede flow
<b>Photo ID</b>	982
<b>Scope of Works</b>	H - Vegetation is to be slashed to a nominal height of 50 mm above ground with the exception of large, established trees of height in excess of 5 m, which shall remain. L – Rocks form catchment divide - do not impede flow
