City of Karratha  
Dampier Stormwater Management Study  
Report  
Part B  
June 2015

## Appendix **C** – 2010 encroachment reviews

**Rio Tinto Iron Ore**  
Report on Dampier Drainage  
Review  
Block 1 Encroachments  
June 2010

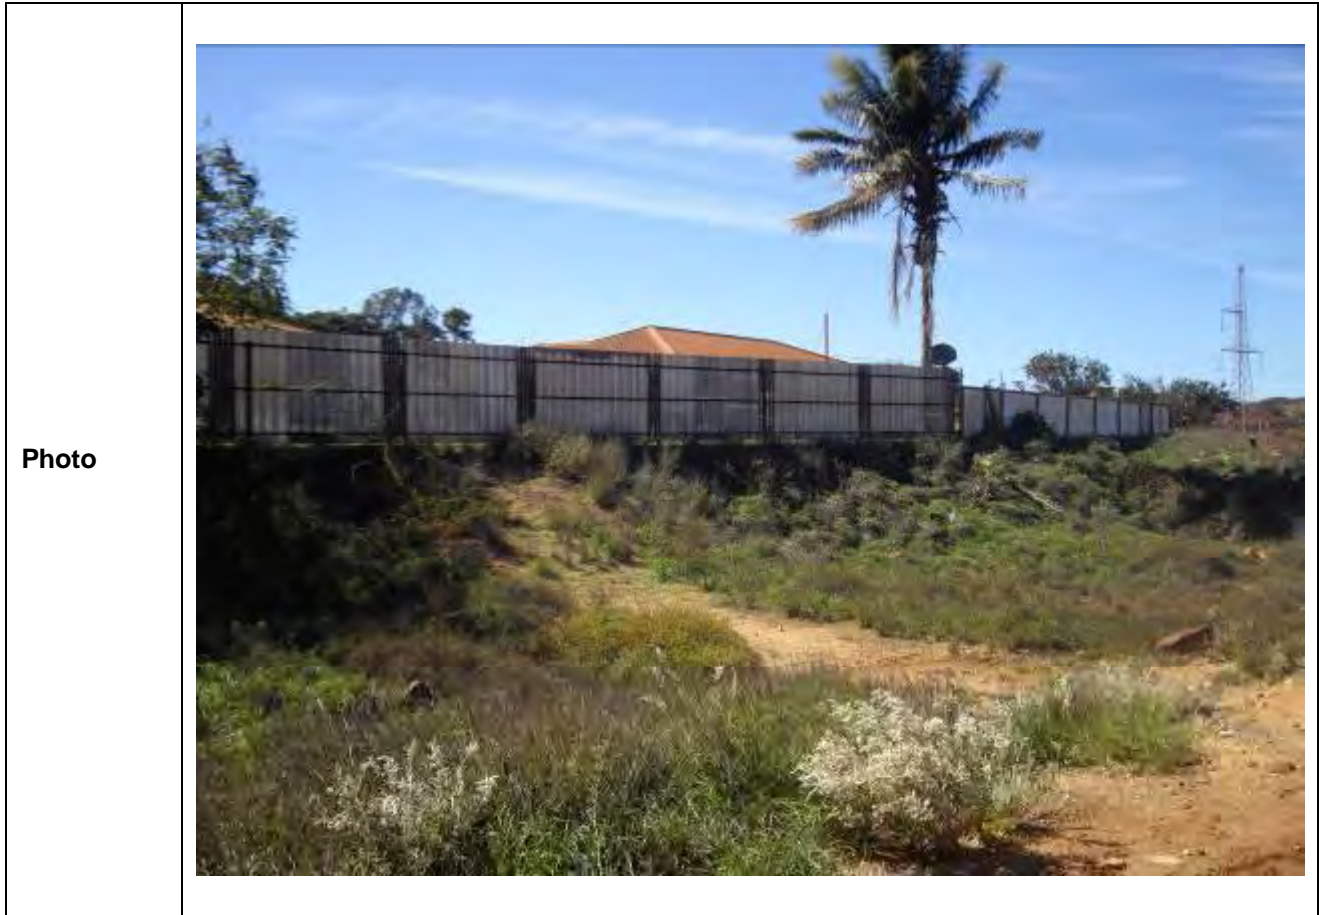
<b>Category</b>	Encroachment
<b>Type</b>	Rear access
<b>Description</b>	Rear access follows natural topography - not impeding flow, natural slope provides flow path.
<b>Photo ID</b>	779
<b>Scope of Works</b>	L - Rear access noted, no works required.

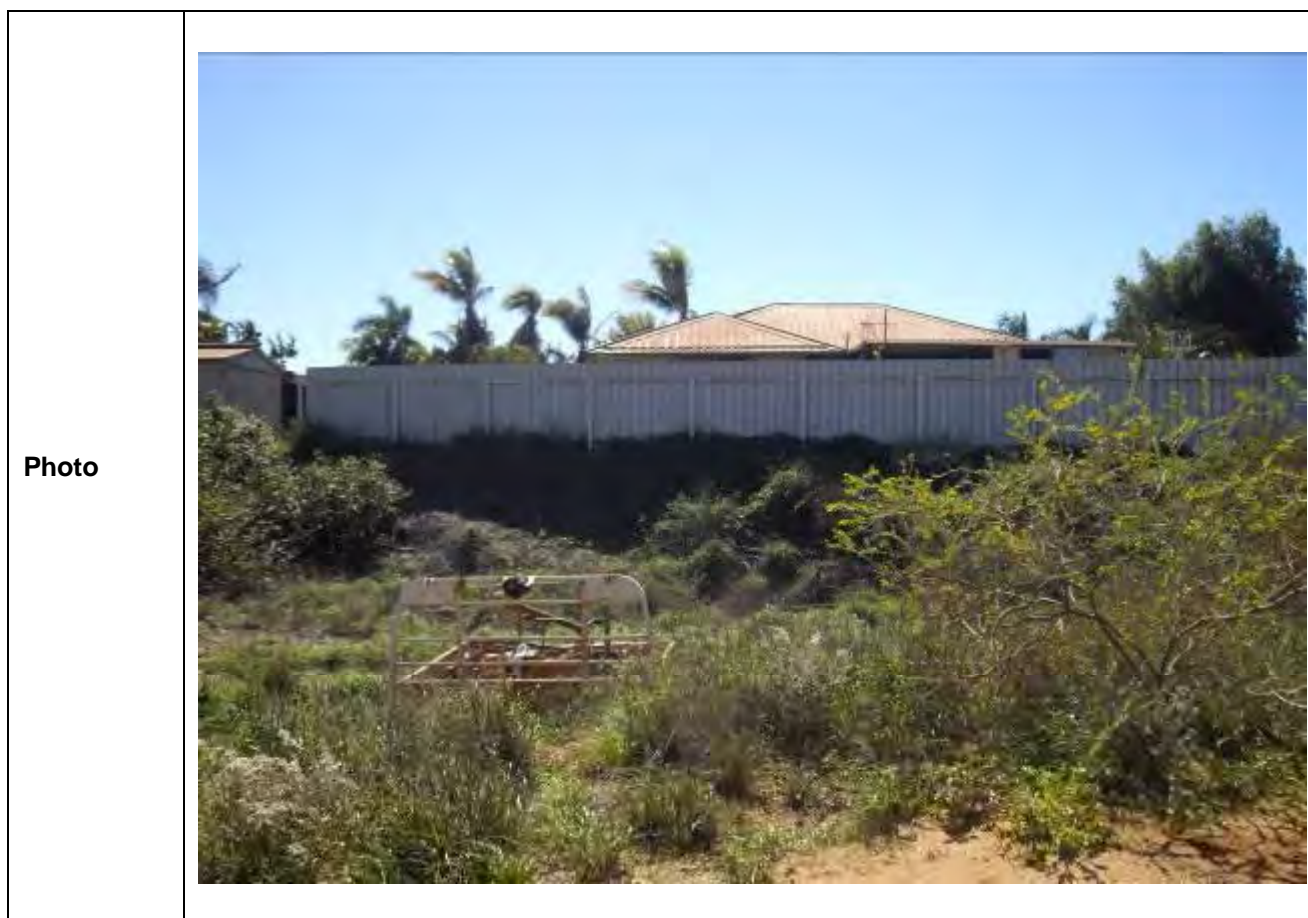
<b>Category</b>	Encroachment / Drain Maintenance
<b>Type</b>	General items; Vegetation.
<b>Description</b>	Rubbish; Dense vegetation.
<b>Photo ID</b>	780
<b>Scope of Works</b>	L - Remove rubbish; L - Vegetation is to be slashed to a nominal height of 50 mm above ground with the exception of large, established trees of height in excess of 5 m, which shall remain;

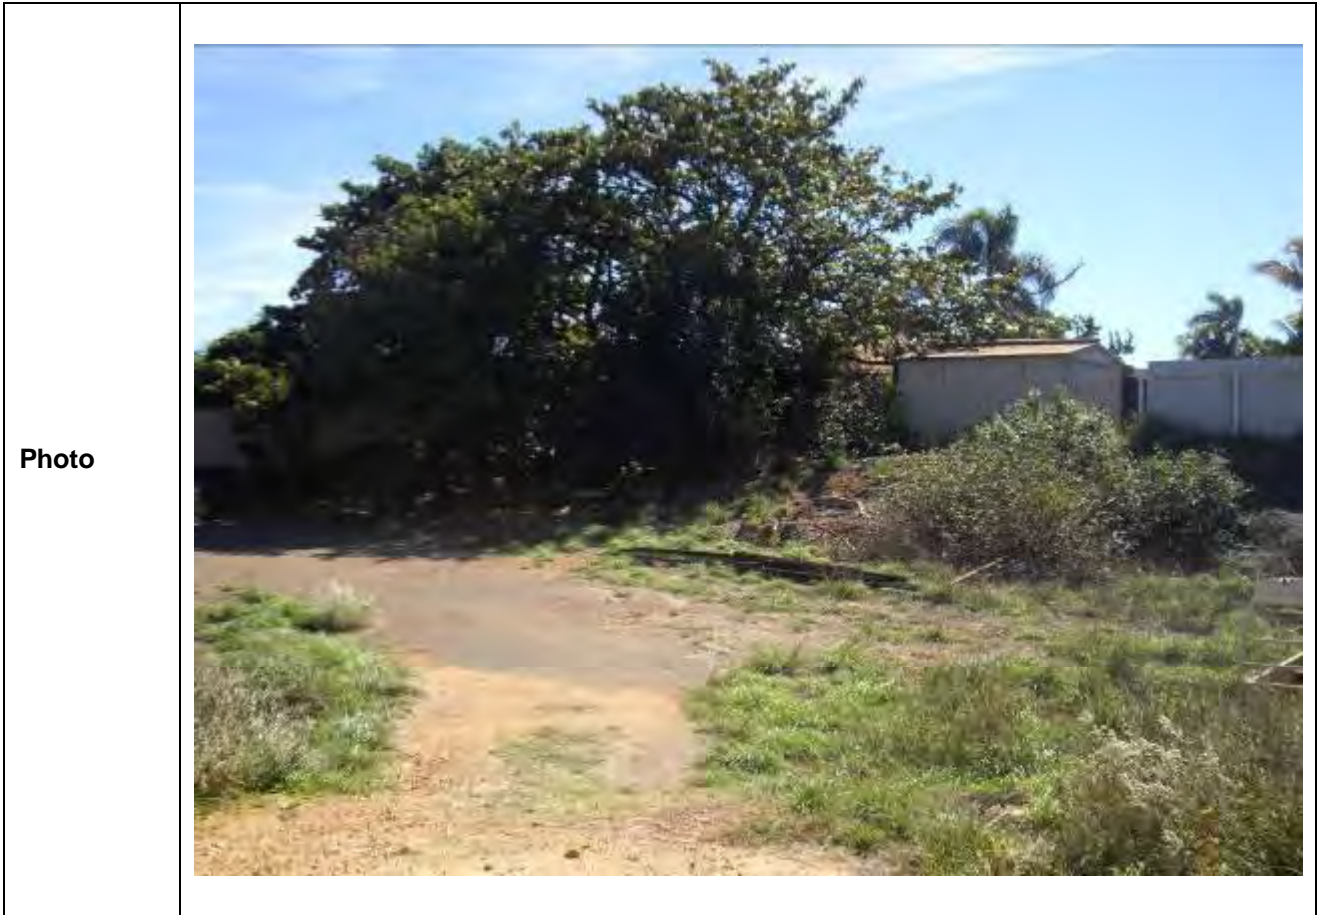
<b>Category</b>	Encroachment
<b>Type</b>	Hard stand area
<b>Description</b>	Hard stand area follows drain contours to the east - not impeding flow.
<b>Photo ID</b>	781
<b>Scope of Works</b>	L - Hard stand area noted - no works required.

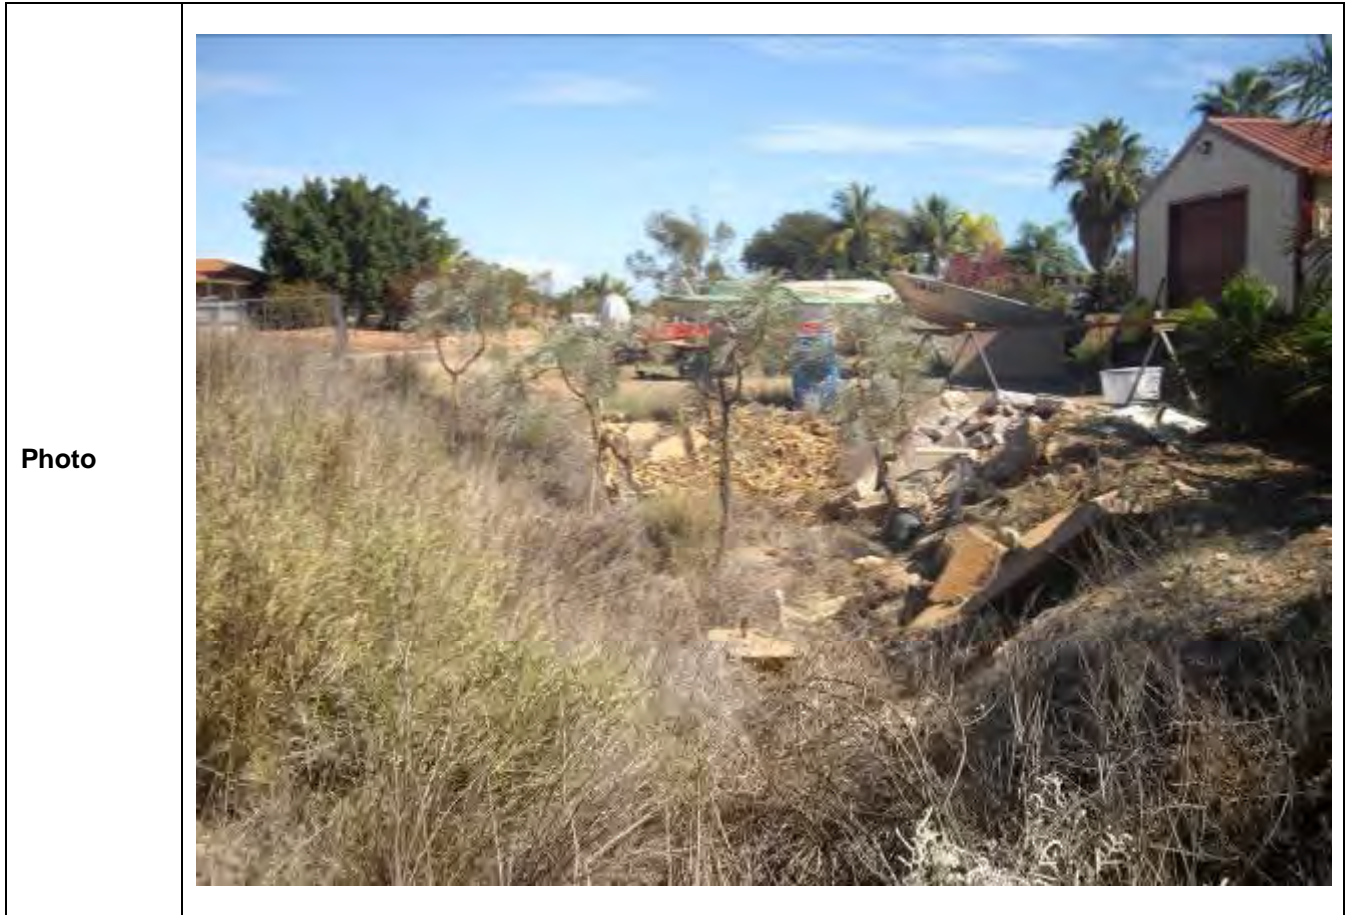
<b>Category</b>	Encroachment
<b>Type</b>	Rear access General items
<b>Description</b>	Rear access impeding flow; 2 x boat, trailer; Rubble.
<b>Photo ID</b>	1000, 999, 1001, 1002, 15
<b>Scope of Works</b>	H - Remove rear access and reinstate drainage channel to direct flow east. L - Remove boats and trailer H – Remove rubble

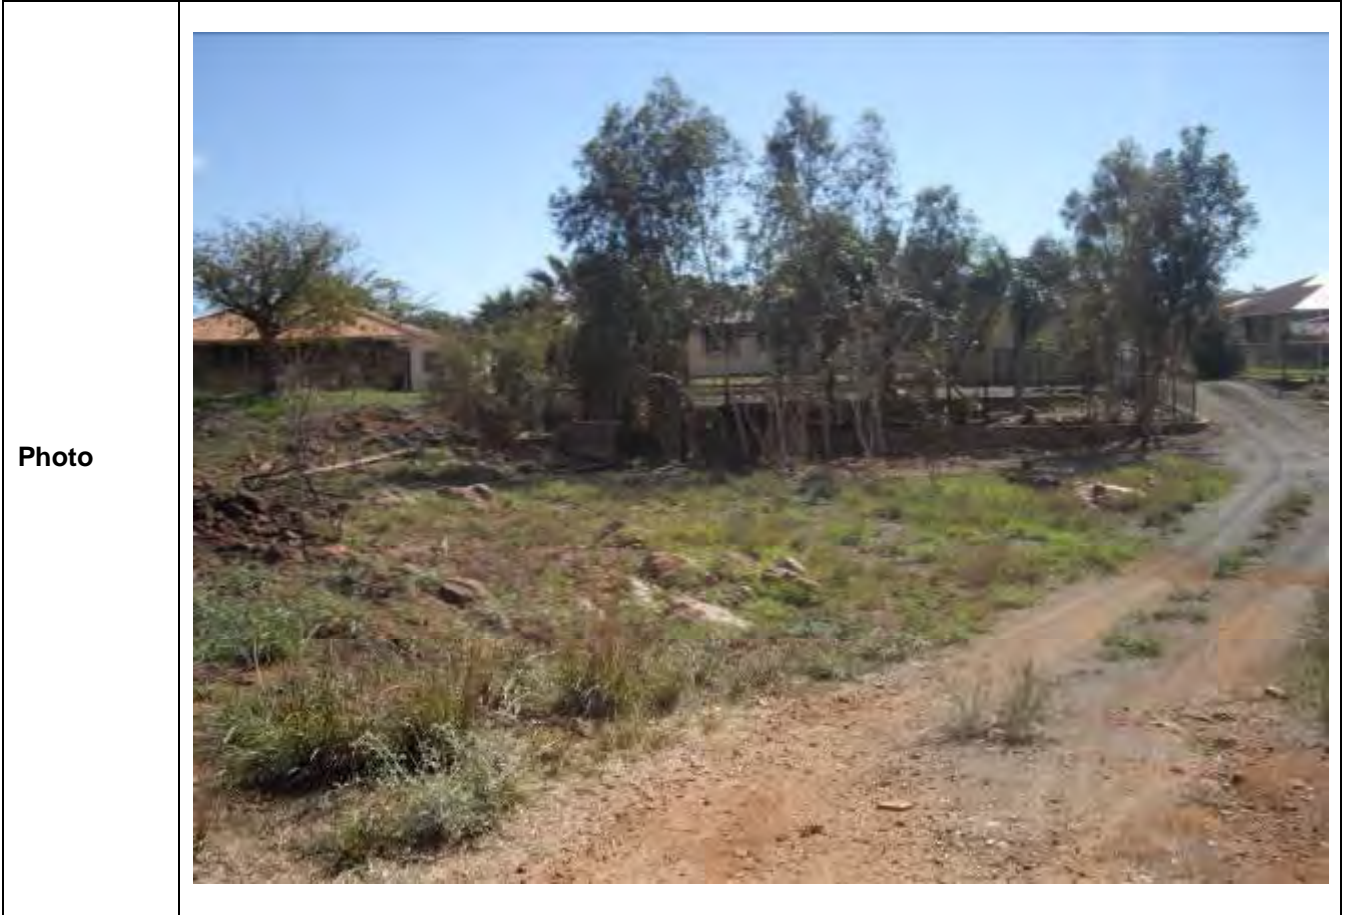
<b>Category</b>	Encroachment
<b>Type</b>	Rear access
<b>Description</b>	Rear access follows drainage contours – does not impede flow
<b>Photo ID</b>	990
<b>Scope of Works</b>	L - Rear access noted. No scope of works required.

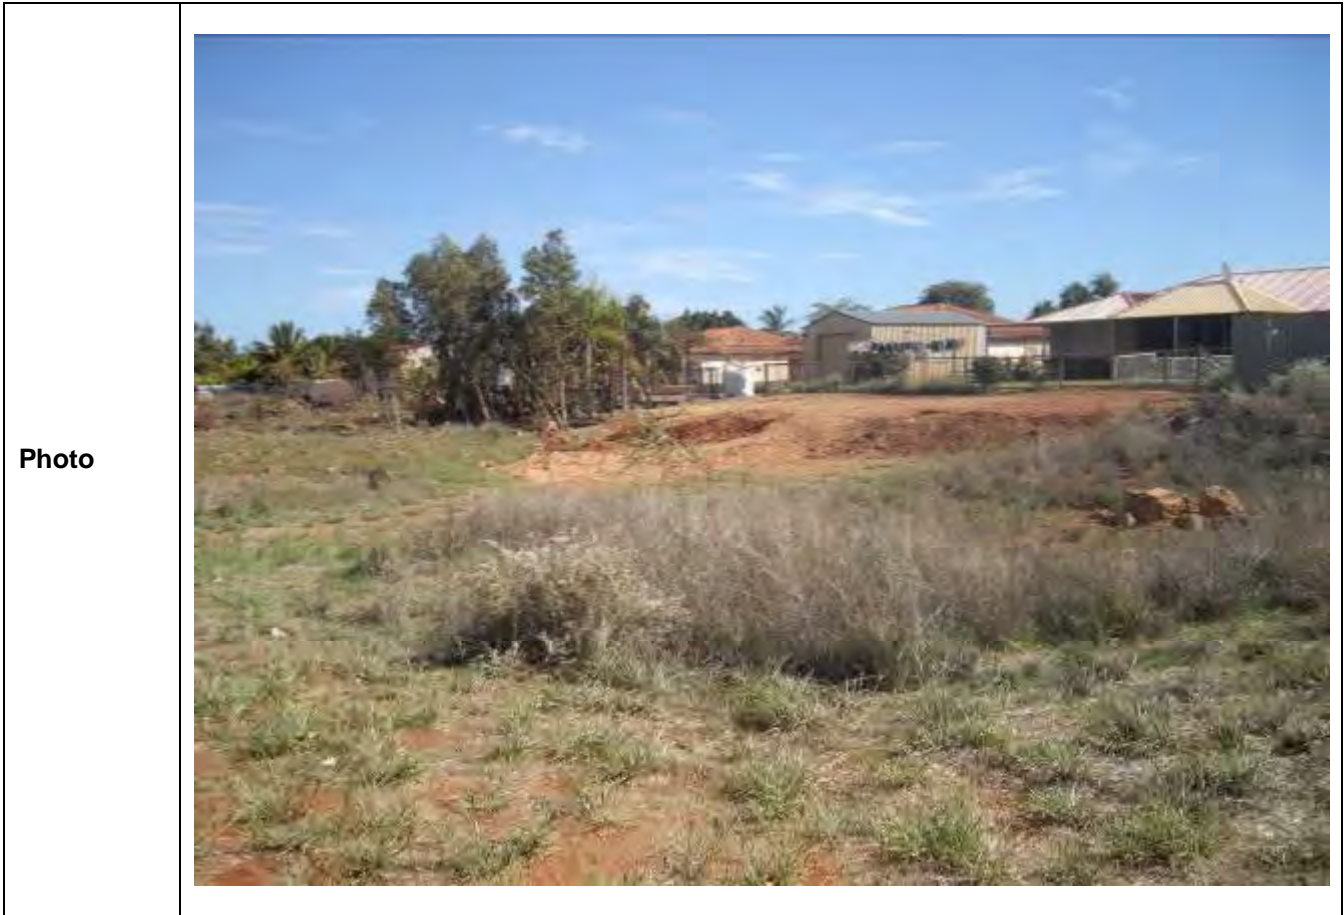
<b>Category</b>	Encroachment
<b>Type</b>	Boundary extension
<b>Description</b>	Potential extended fill having a small impact on capacity of natural channel. Fill does not appear to be compacted and may be easily eroded causing sedimentation within the drain.
<b>Photo ID</b>	989, 474
<b>Scope of Works</b>	H – Confirmation of boundary required from survey. Measures required to prevent erosion of uncompacted fill within property boundary and removal of fill outside of property boundary.

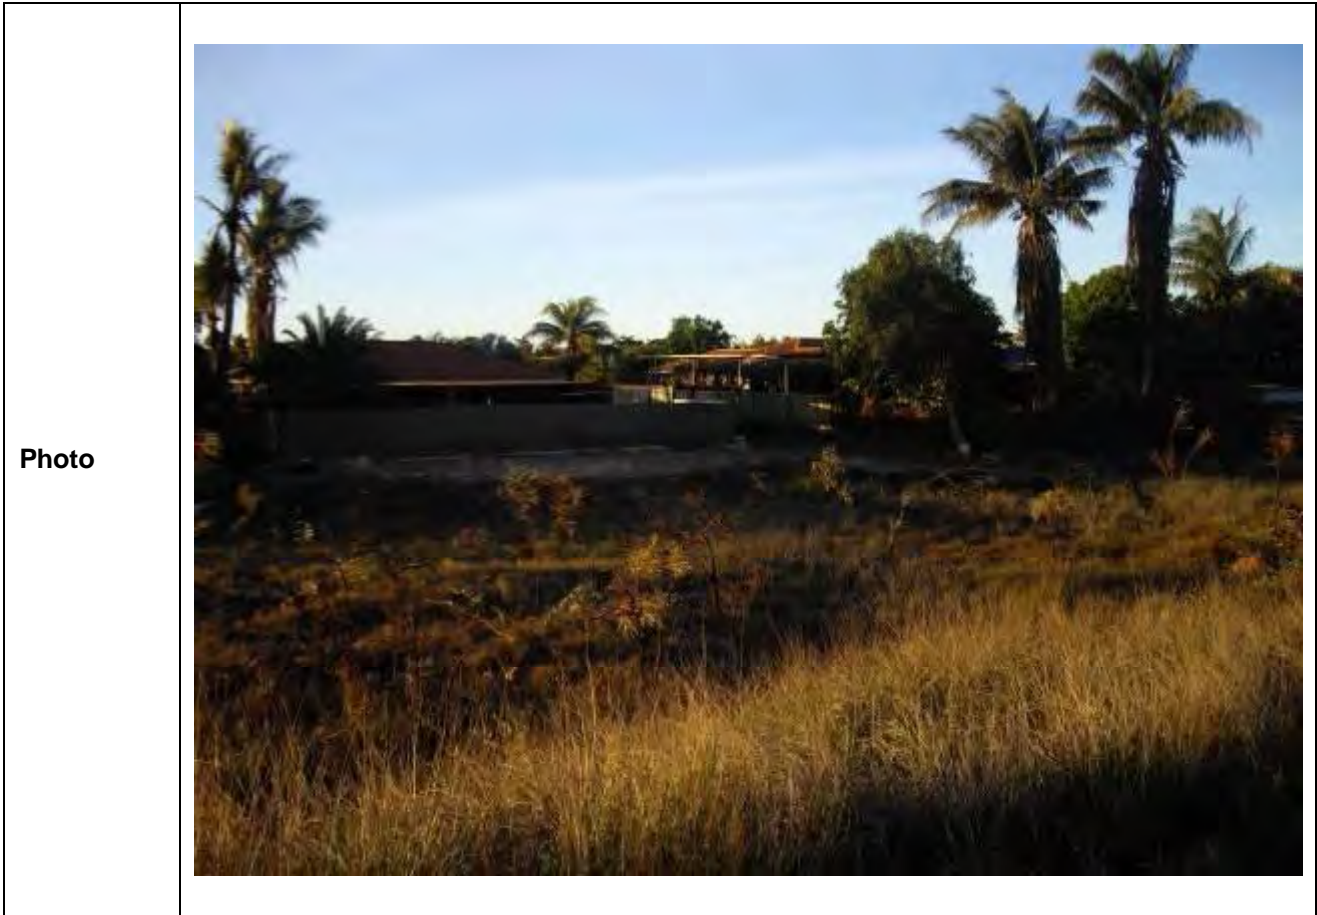
<b>Category</b>	Encroachment
<b>Type</b>	Modified drain; Rear access.
<b>Description</b>	Batter encroachment in large capacity drain in the form of a parking area which reduces cross sectional capacity; Rear access follows natural topography of drain.
<b>Photo ID</b>	682
<b>Scope of Works</b>	L - Remove batter encroachment and reinstate drainage channel to direct flow west (match to 277); L - Remove rear access noted. No major works required.

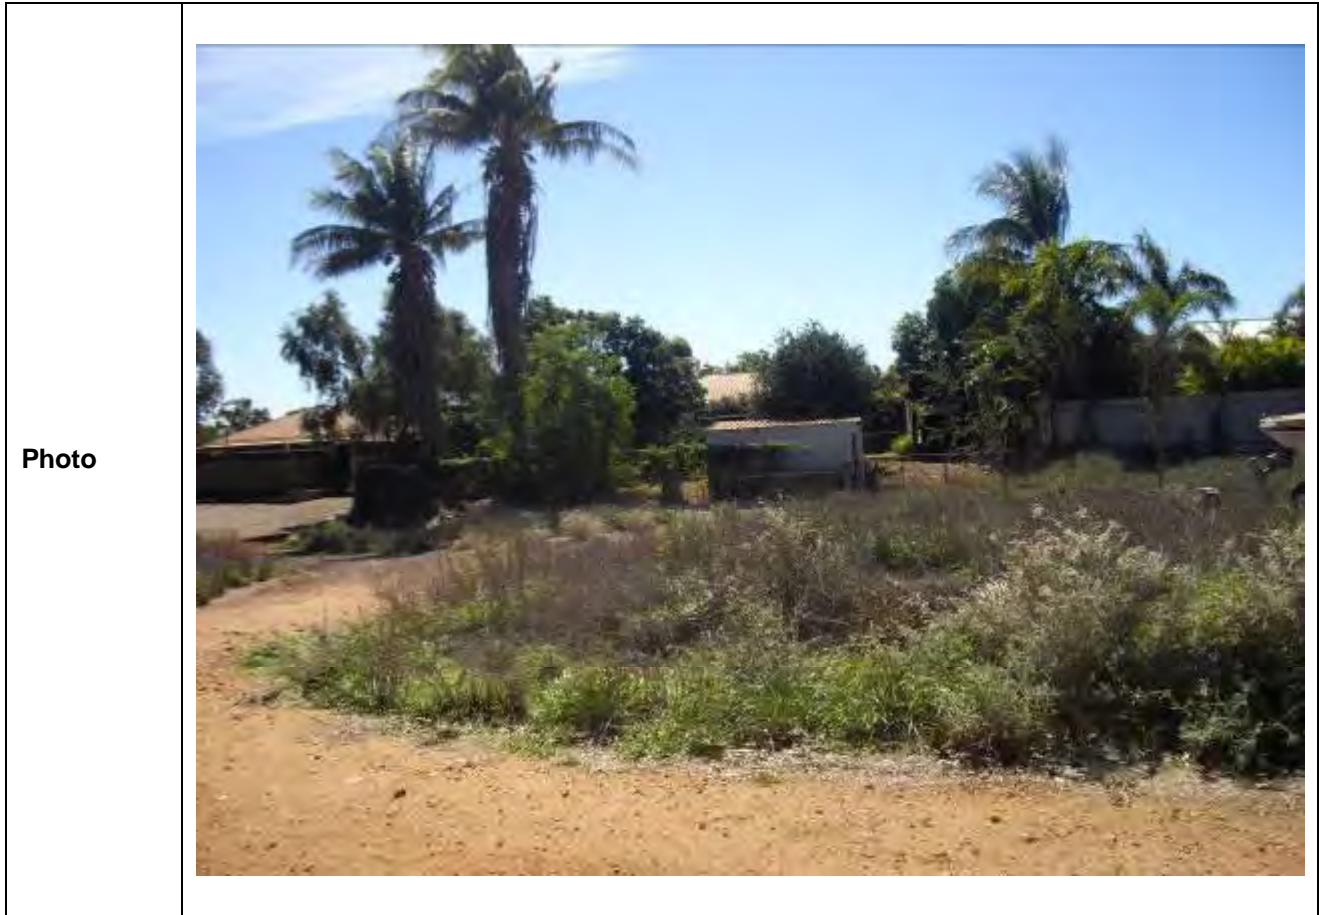
<b>Category</b>	Encroachment
<b>Type</b>	Rear access General Item
<b>Description</b>	Rear access driveway follows natural topography.
<b>Photo ID</b>	800 – photo does not show the inspection ramps
<b>Scope of Works</b>	L - Remove rear access and reinstate flow path to direct flow west (match to 276); L – Remove inspection ramps.

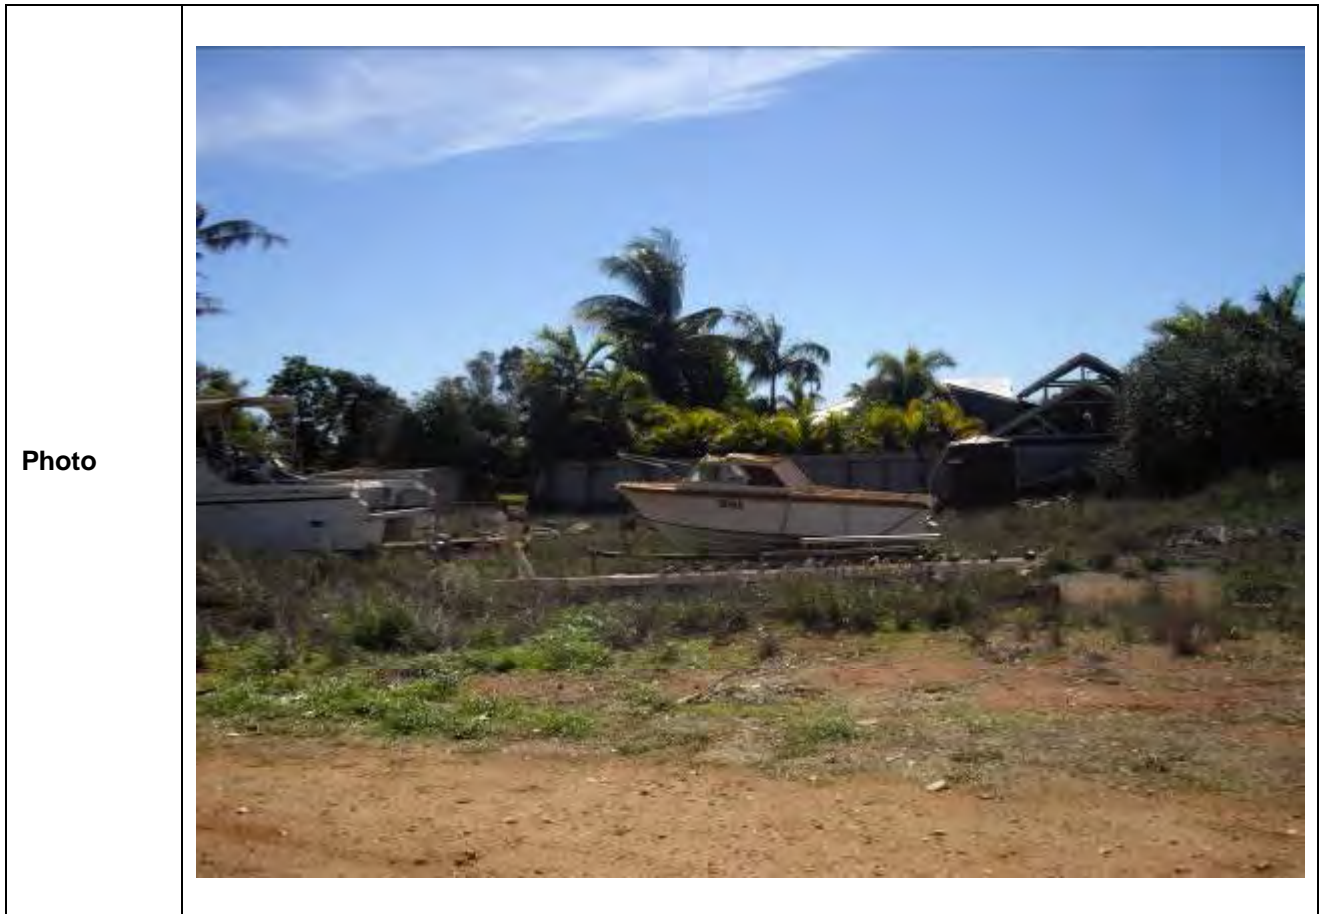
<b>Category</b>	Encroachment
<b>Type</b>	Rear access, General items
<b>Description</b>	Rear access driveway following contour of natural topography; 2 x boats, trailer and water tank.
<b>Photo ID</b>	799
<b>Scope of Works</b>	L - Remove rear access noted. No major works required. L - Remove boats, trailer and water tank.

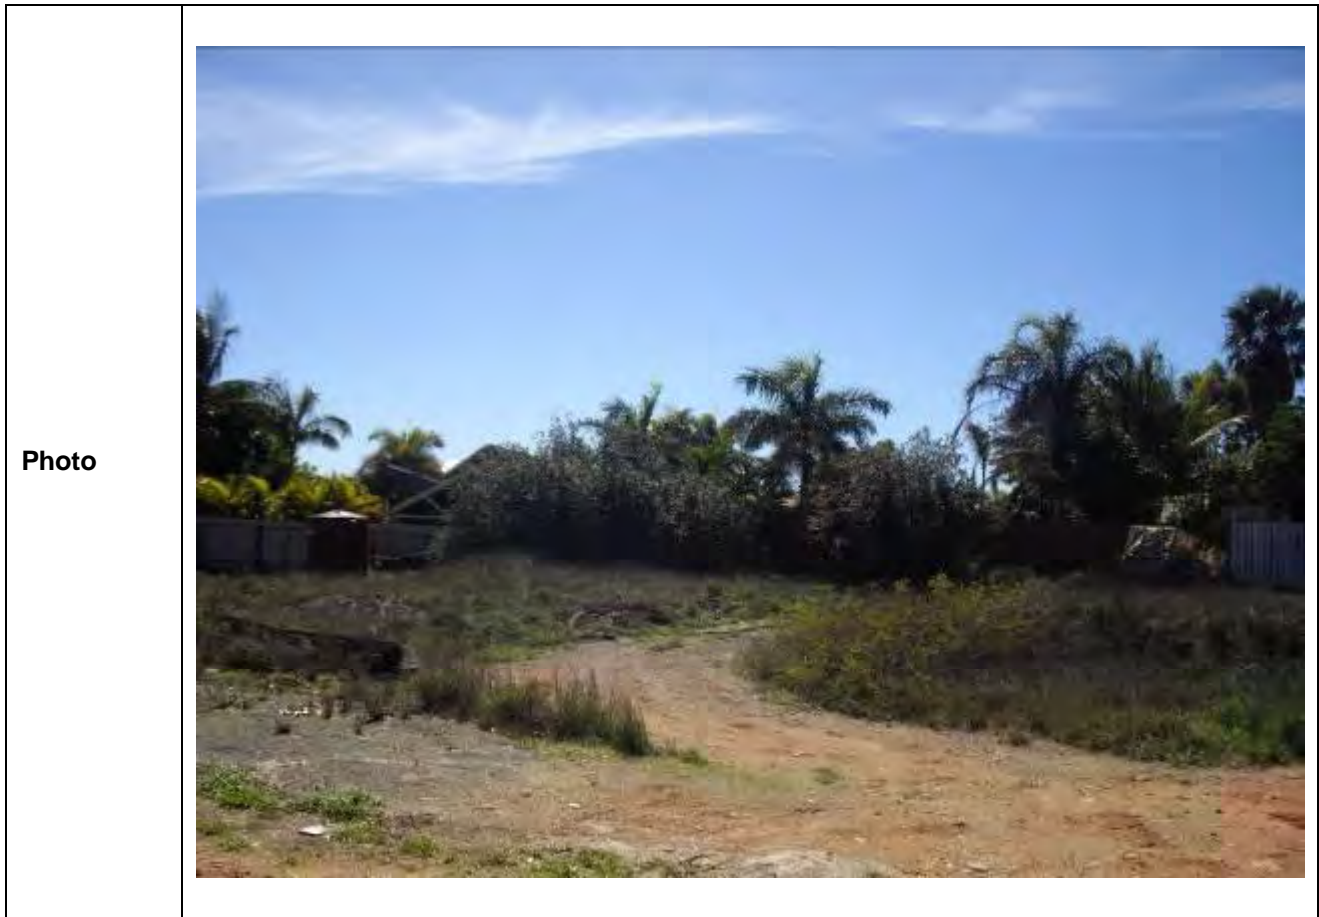
<b>Category</b>	Encroachment
<b>Type</b>	Rear access
<b>Description</b>	Rear access follows natural topography.
<b>Photo ID</b>	798 – subject property starts at tank on the right and ends at start of silver coloured fence on left.
<b>Scope of Works</b>	L - Rear access noted. No major works required.

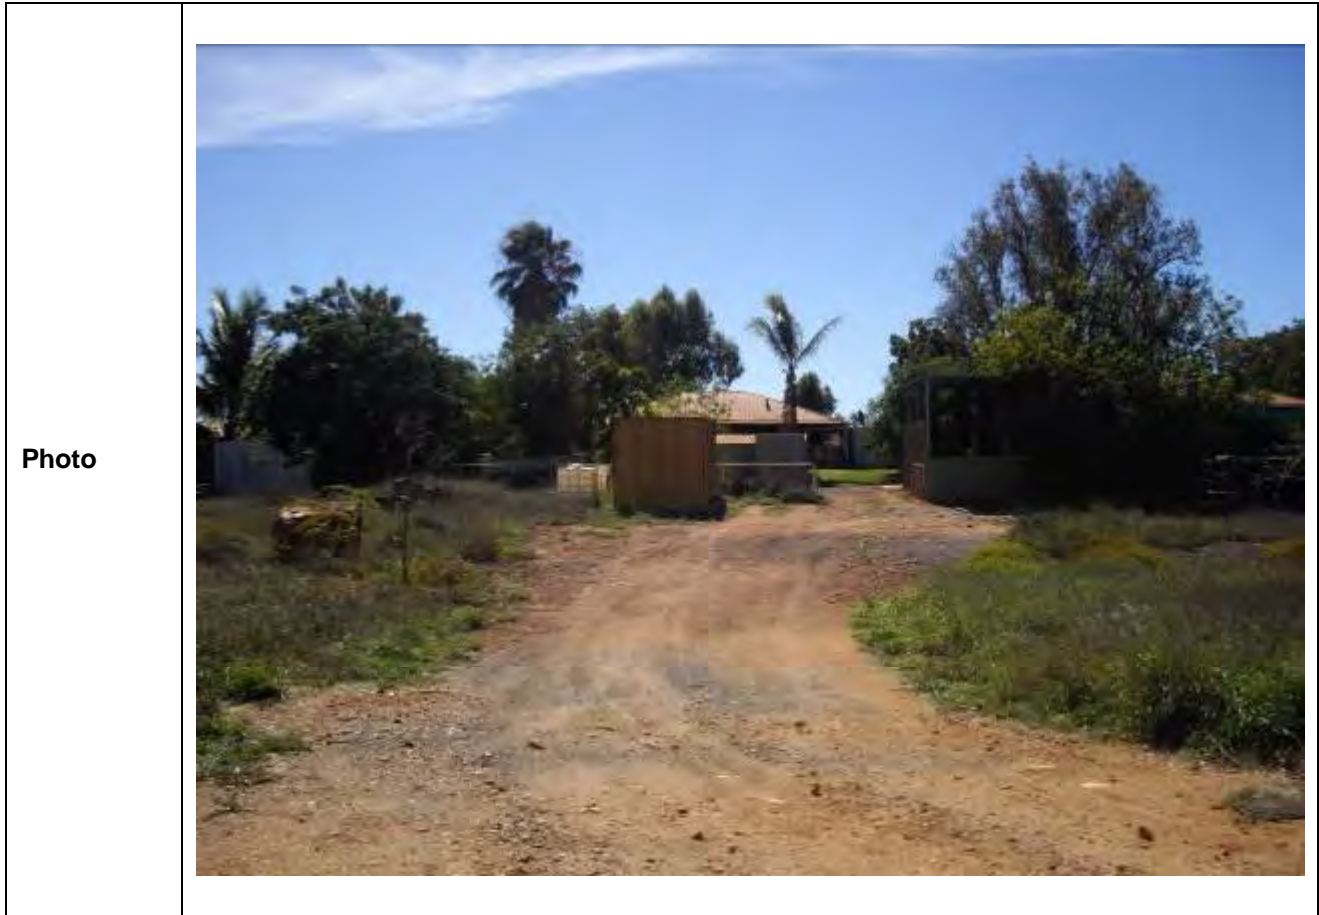
<b>Category</b>	Encroachment
<b>Type</b>	Rear access, general items
<b>Description</b>	Rear access follows natural topography having minor impact on flow; Sea container.
<b>Photo ID</b>	796
<b>Scope of Works</b>	L - Remove rear access and construct defined drainage channel to direct flow east (match to lot 281). L - Remove sea container

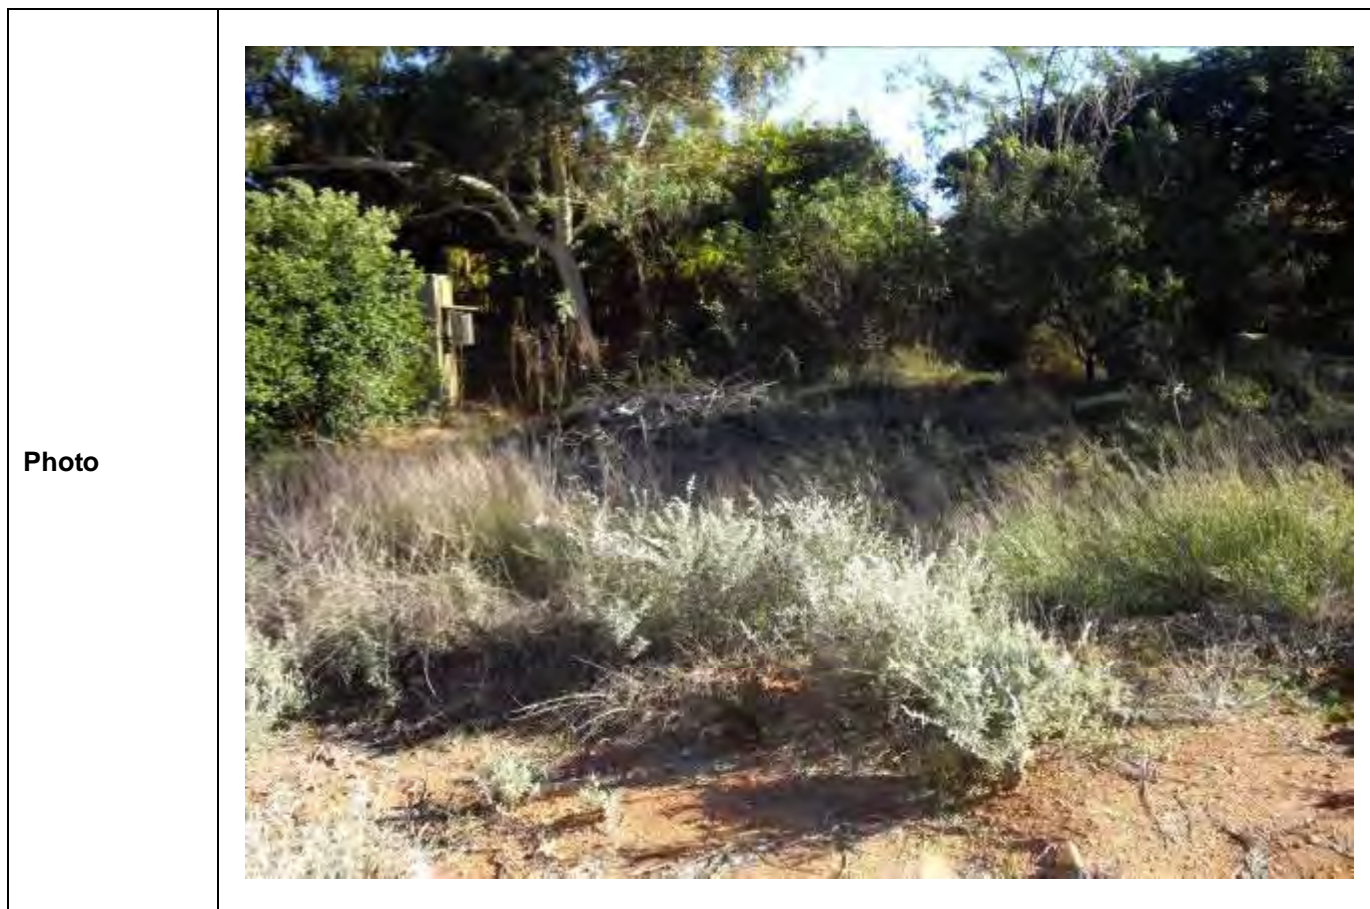
<b>Category</b>	Drain Maintenance
<b>Type</b>	Vegetation.
<b>Description</b>	Vegetation impeding flow Rocks noted, but natural channel adequate
<b>Photo ID</b>	826
<b>Scope of Works</b>	L – Remove rocks M - Vegetation is to be slashed to a nominal height of 50 mm above ground with the exception of large, established trees of height in excess of 5 m, which shall remain

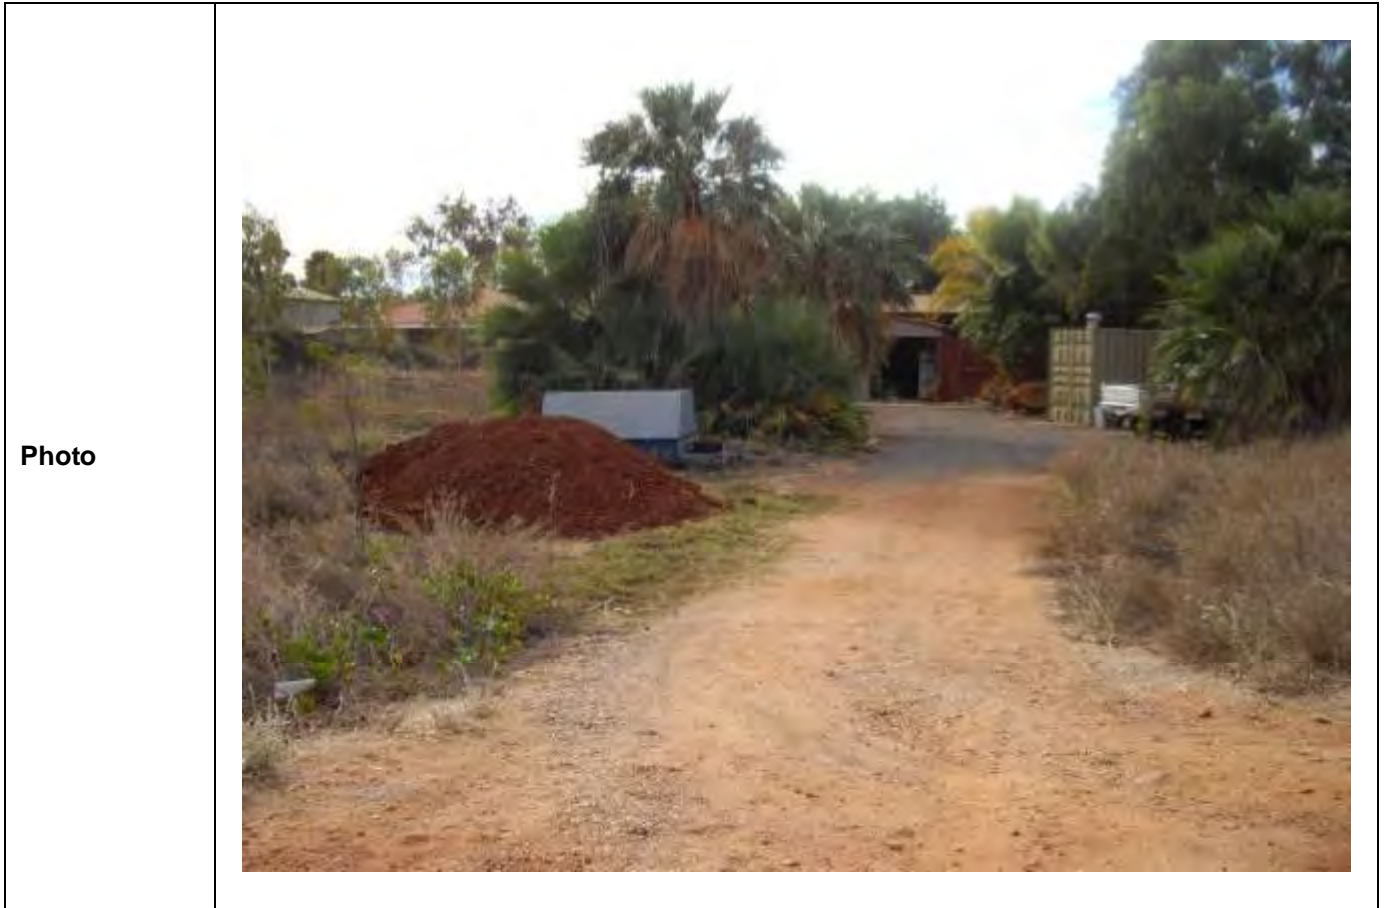
<b>Category</b>	Encroachment
<b>Type</b>	Rear access Boundary extension General items Vegetation
<b>Description</b>	Rear access with culvert Potential container encroachment Imported loose soil Semi dense vegetation
<b>Photo ID</b>	512
<b>Scope of Works</b>	H - Remove rear access and reinstate drainage flow path as defined by the natural capacity and invert of channel of downstream lot L - Remove container – confirmation required from survey; L – Remove imported loose soil L - Vegetation is to be slashed to a nominal height of 50 mm above ground with the exception of large, established trees of height in excess of 5 m, which shall remain

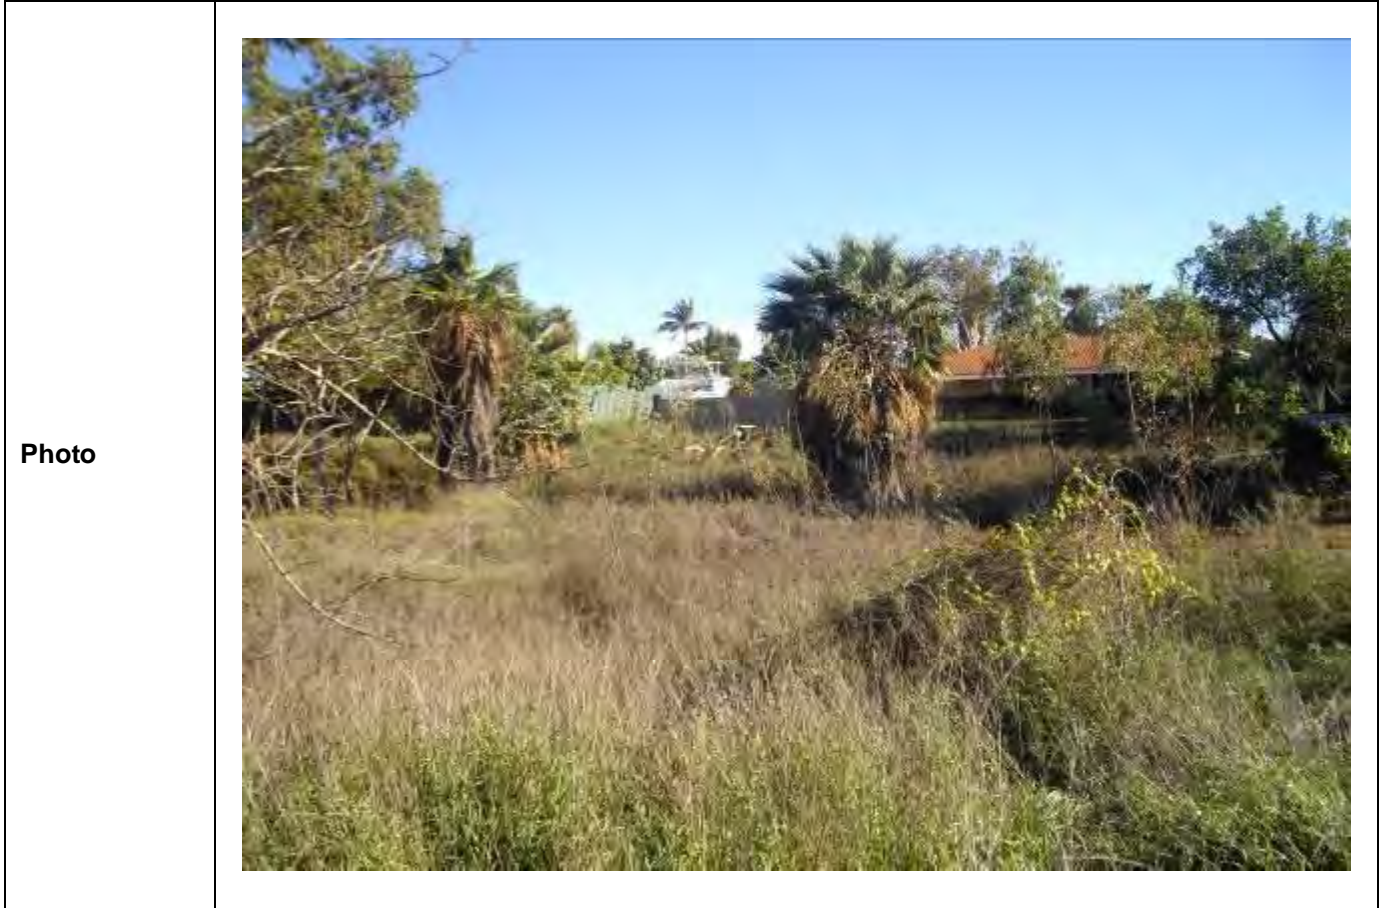
<b>Category</b>	Drain Maintenance
<b>Type</b>	Vegetation
<b>Description</b>	Semi-dense vegetation impeding flow.
<b>Photo ID</b>	827
<b>Scope of Works</b>	M - Vegetation is to be slashed to a nominal height of 50 mm above ground with the exception of large, established trees of height in excess of 5 m, which shall remain

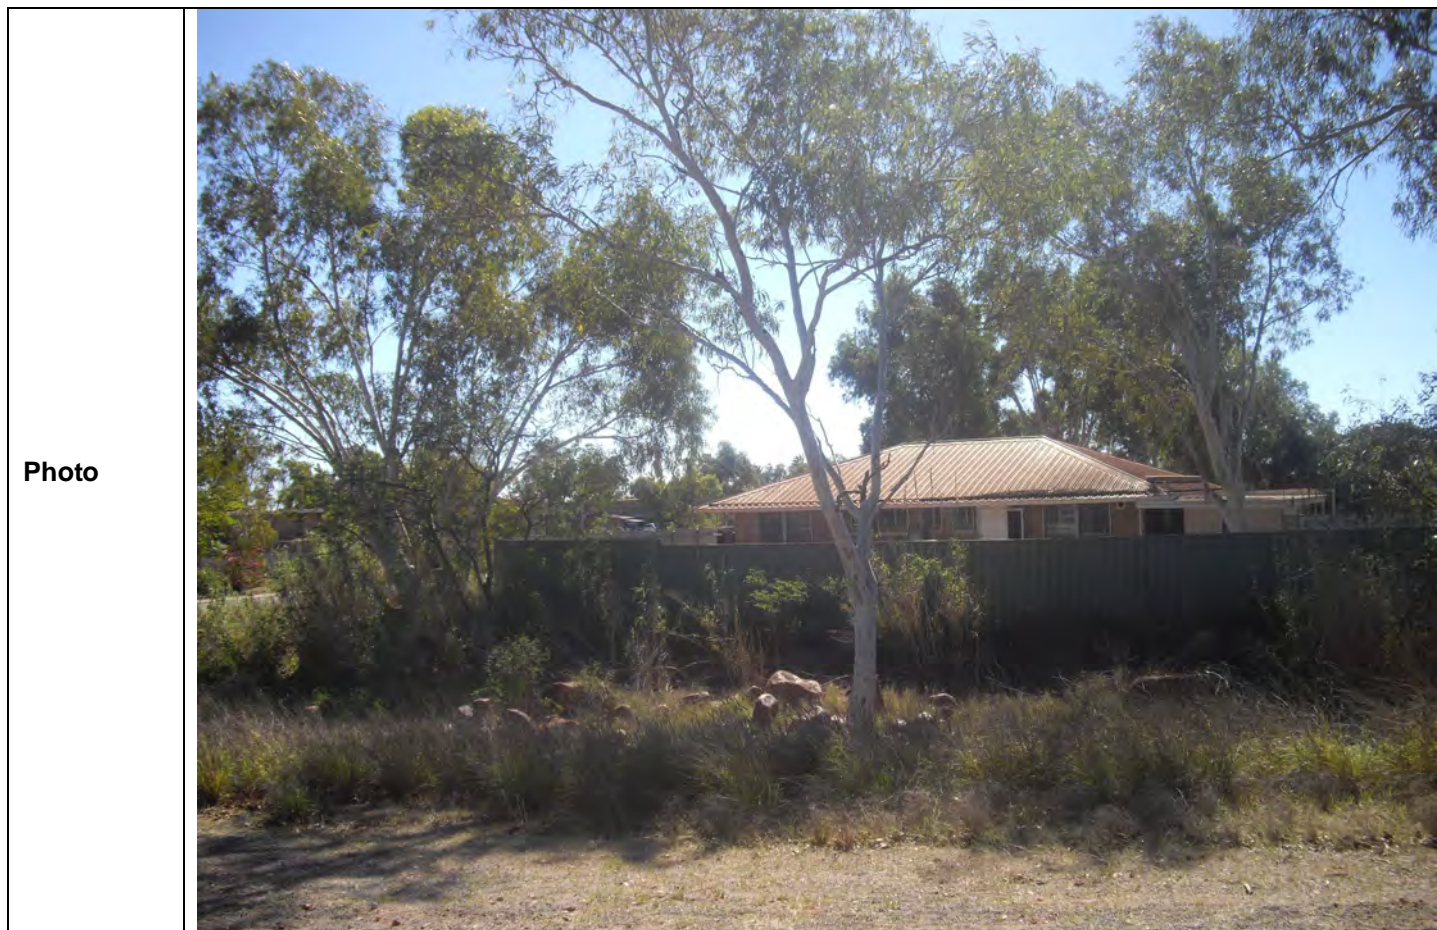
<b>Category</b>	Drain maintenance
<b>Type</b>	Rocks Vegetation
<b>Description</b>	Rocks inhibit flow, but do not impede (bottom of catchment)
<b>Photo ID</b>	1039
<b>Scope of Works</b>	M – Remove rocks M - Vegetation is to be slashed to a nominal height of 50 mm above ground with the exception of large, established trees of height in excess of 5 m, which shall remain

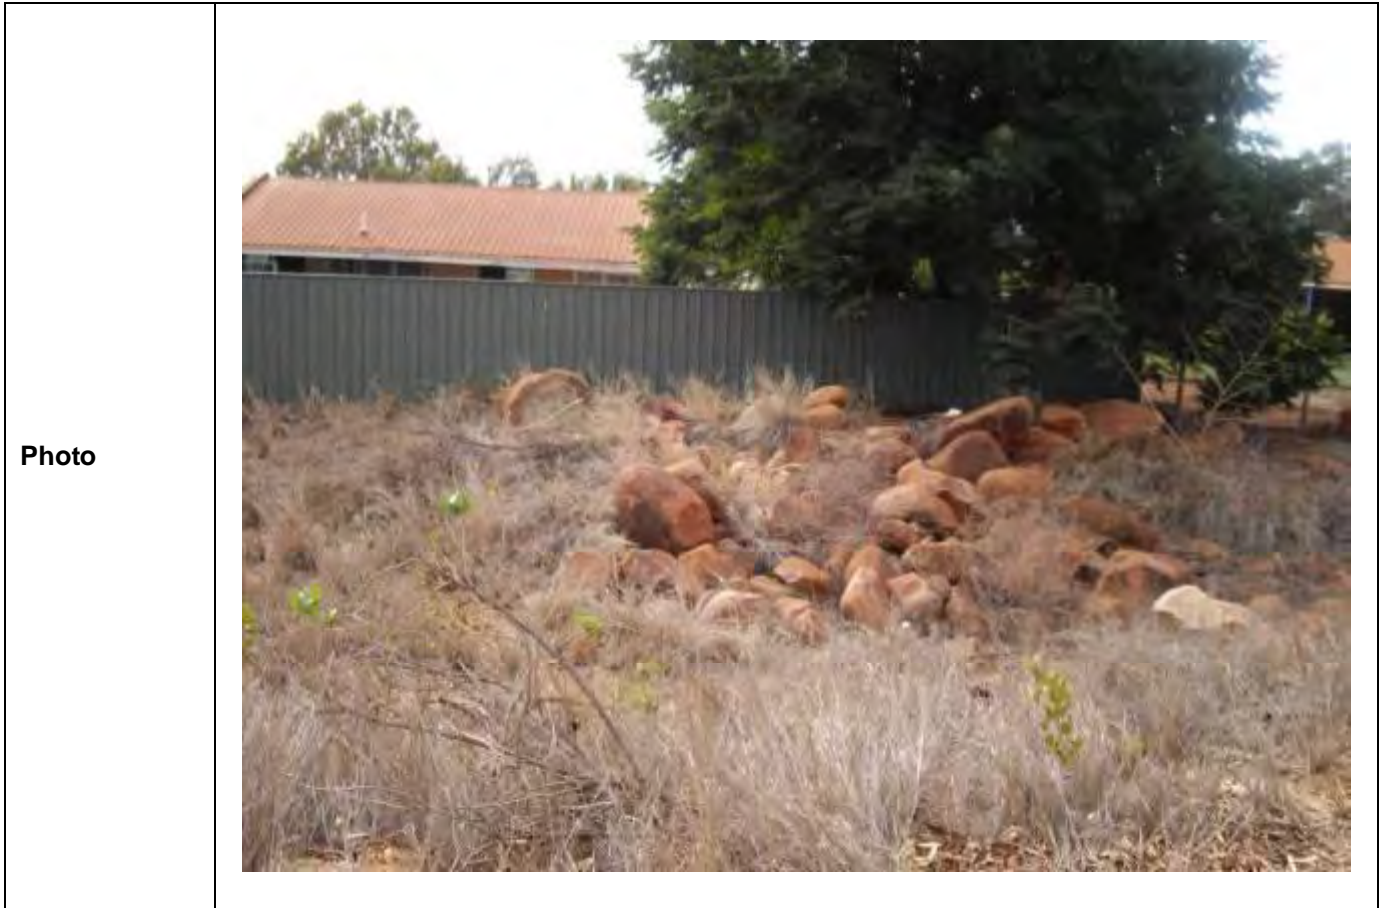
<b>Category</b>	None
<b>Type</b>	None
<b>Description</b>	Rocks noted, but don't affect flow path which is adequate
<b>Photo ID</b>	504
<b>Scope of Works</b>	None

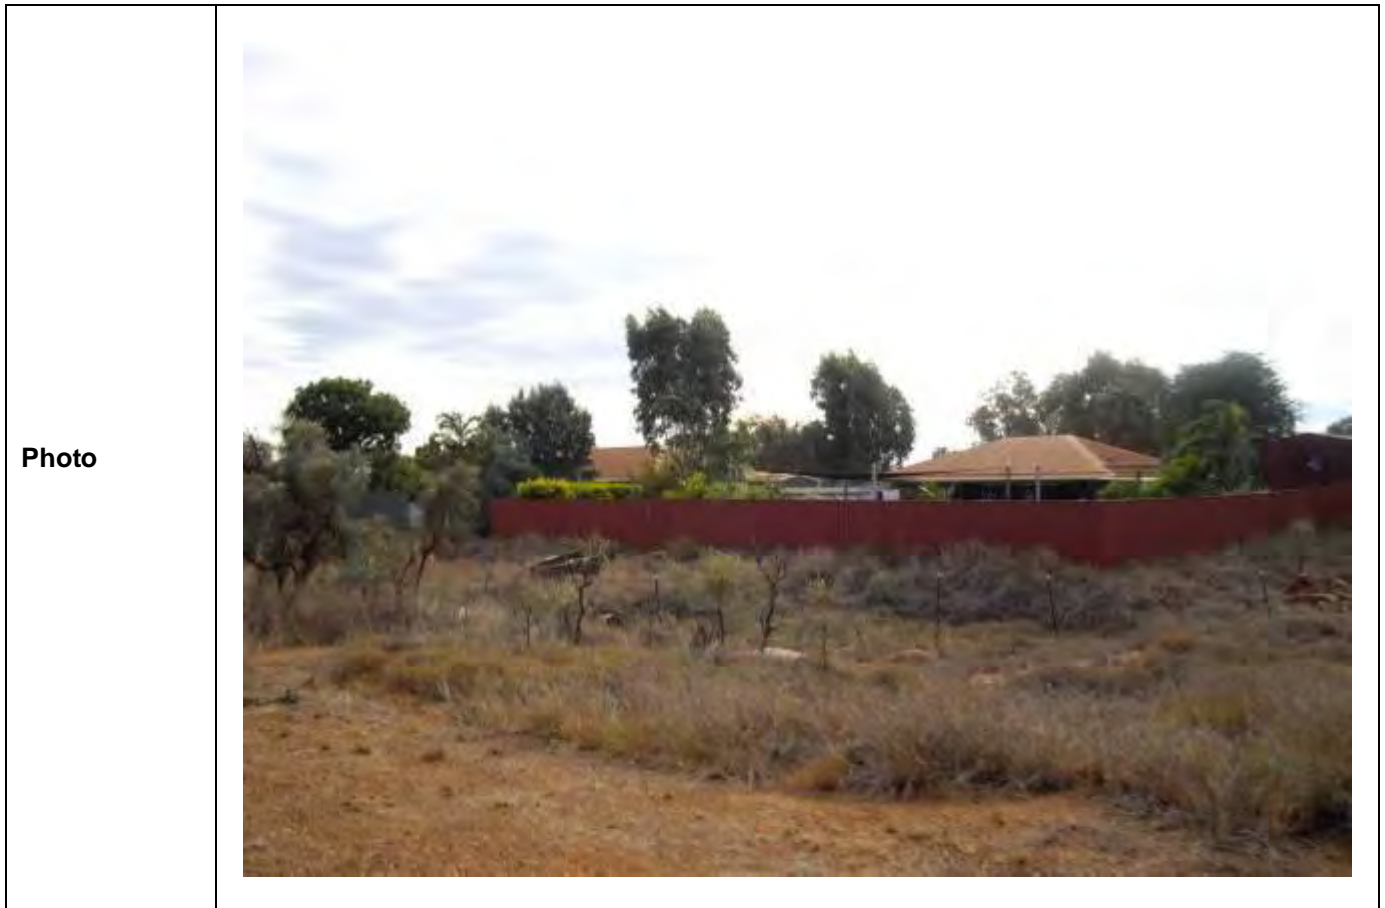
<b>Category</b>	Encroachment
<b>Type</b>	Rear access
<b>Description</b>	Rear access impedes flow. Area of concern – ponding. May be due to encroachment of lots 2,087 and 1,087 or blocked/inadequate culvert under Wooramel Crescent.
<b>Photo ID</b>	487
<b>Scope of Works</b>	M - Remove rear access way and reinstate drainage flow path as defined by the natural capacity and invert of channel of downstream lot
