City of Karratha  
Dampier Stormwater Management Study  
Report  
Part B  
June 2015

## Appendix **C** – 2010 encroachment reviews

**Rio Tinto Iron Ore**  
Report on Dampier Drainage  
Review  
Block 1 Encroachments  
June 2010

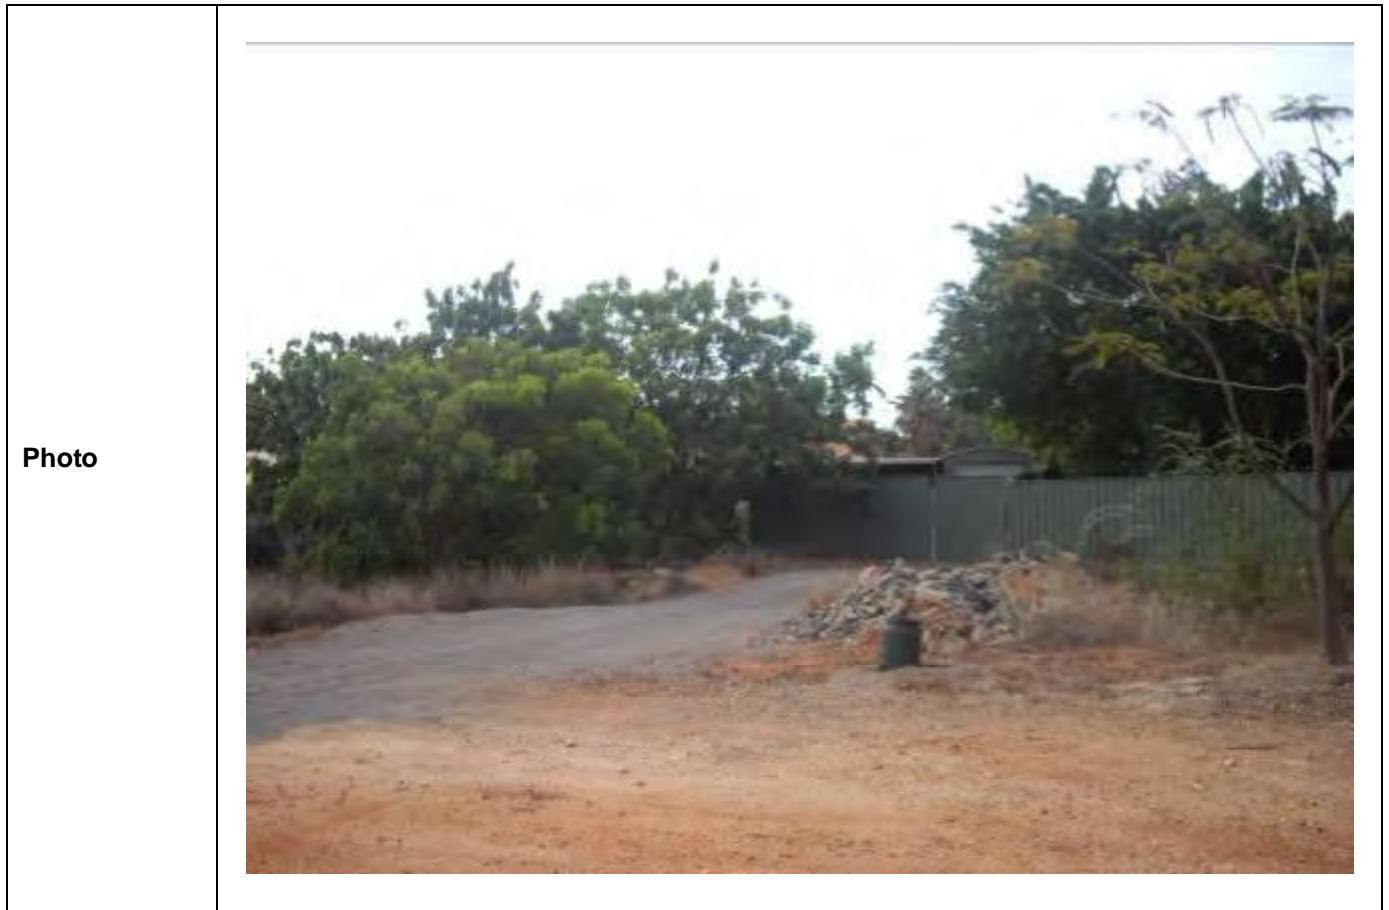
<b>Category</b>	Encroachment
<b>Type</b>	Rear access
<b>Description</b>	Rear access driveway with inadequate culverts and rock wall
<b>Photo ID</b>	610
<b>Scope of Works</b>	H - Remove access driveway and reinstate drainage flow path as defined by the natural capacity and invert of downstream lot (109) channel
