City of Karratha  
Dampier Stormwater Management Study  
Report  
Part B  
June 2015

## Appendix **C** – 2010 encroachment reviews

**Rio Tinto Iron Ore**  
Report on Dampier Drainage  
Review  
Block 1 Encroachments  
June 2010

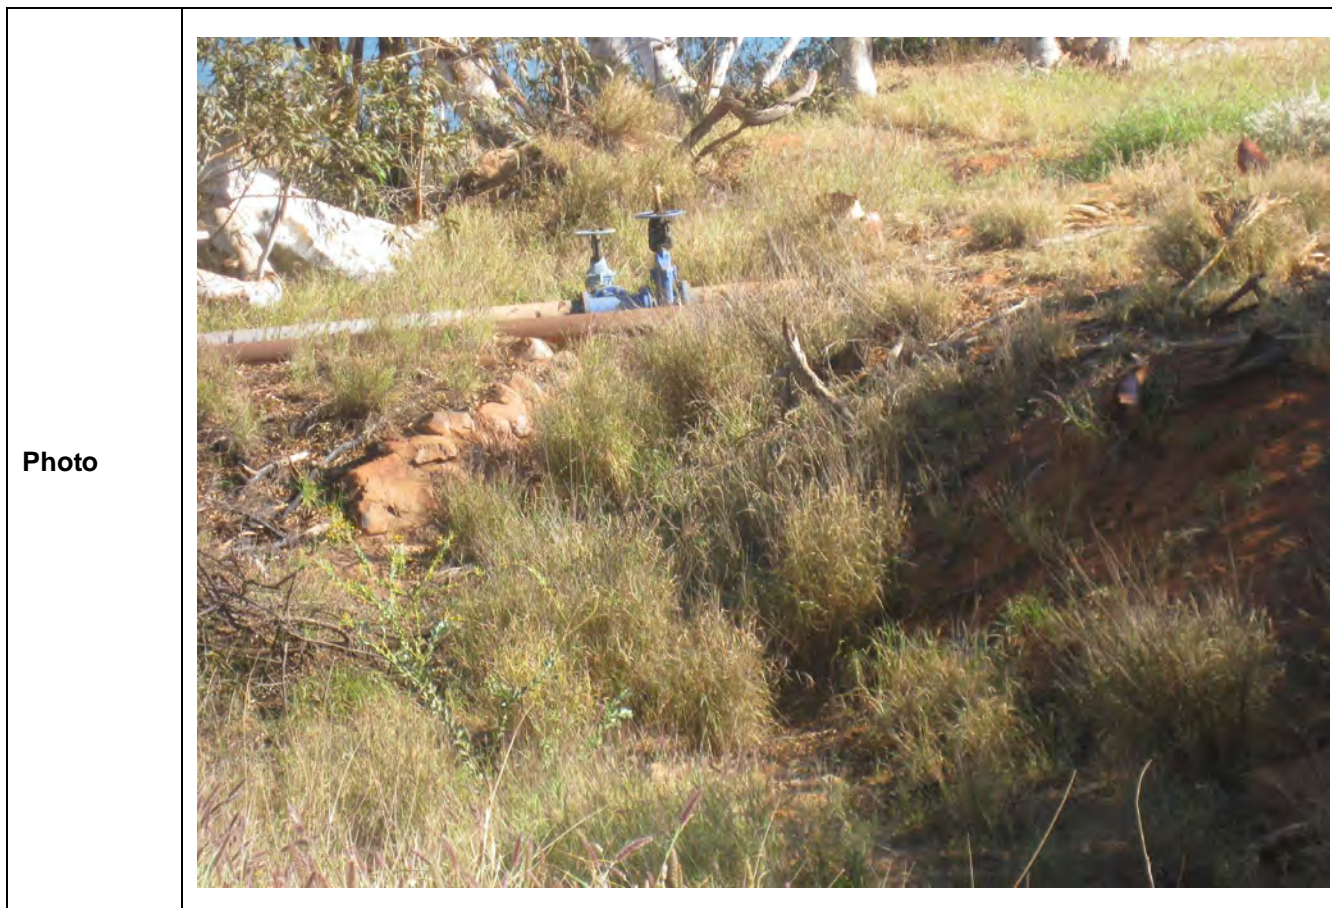
## 2.1 West of Lot No. 1 Blackwood Crescent

<b>Category</b>	Drain Maintenance
<b>Type</b>	Vegetation Pipeline Flowpath
<b>Description</b>	Dumped vegetation The water pipeline crosses the drainage reserve and significantly reduces the cross sectional capacity of the drain. Defined channel has been constructed but is blocked by vegetation (GHD has not conducted hydraulic modelling to determine if this is allowable)
<b>Photo ID</b>	
<b>Scope of Works</b>	H – Remove vegetation to clear channel blockage L - Vegetation is to be slashed to a nominal height of 50 mm above ground with the exception of large, established trees of height in excess of 5 m, which shall remain.

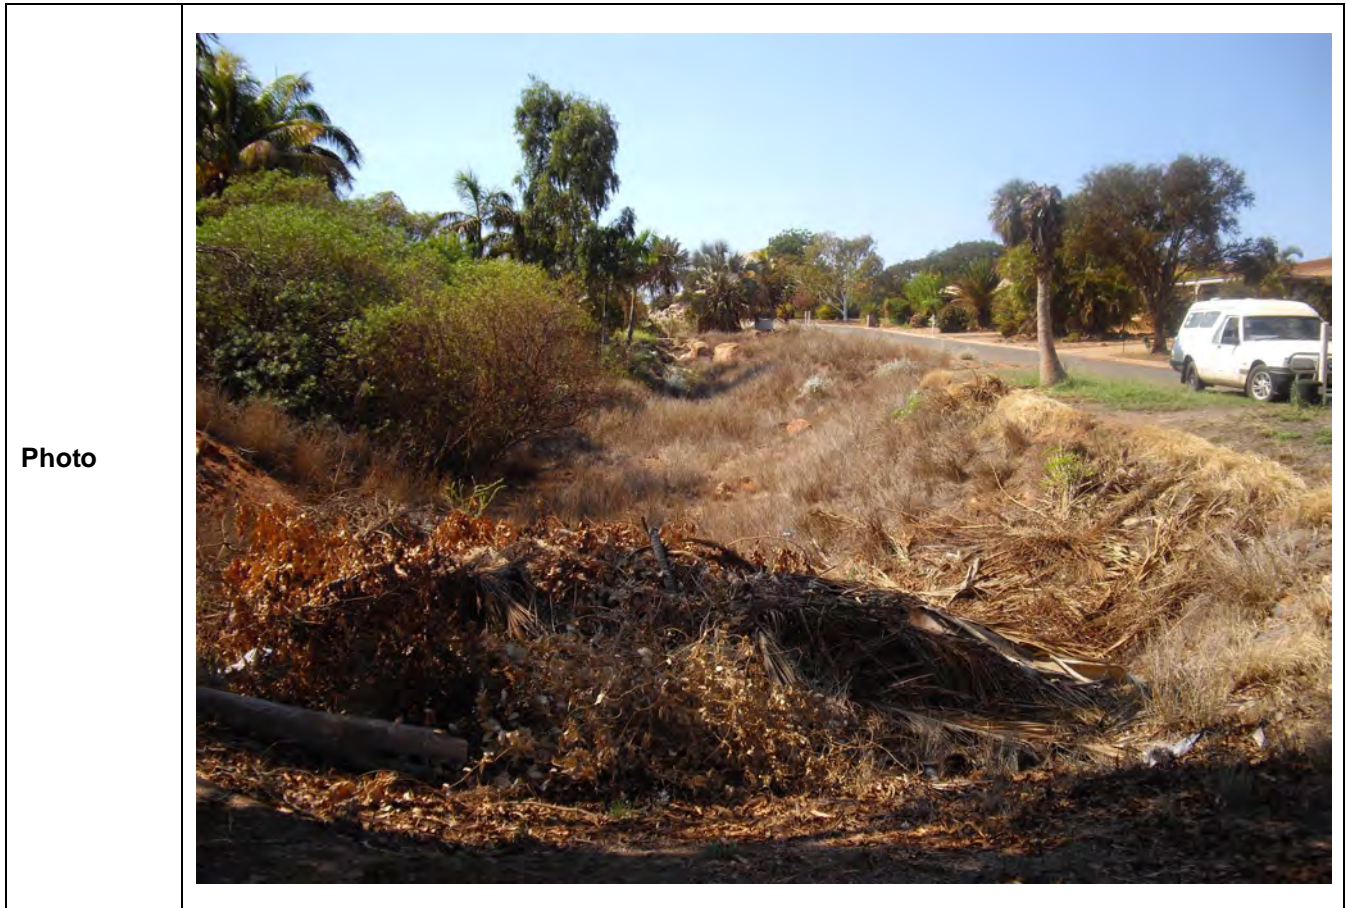
## 2.2 Lot No. 1 Blackwood Crescent

<b>Category</b>	Drain Maintenance
<b>Type</b>	Vegetation
<b>Description</b>	Semi-dense vegetation Defined channel provides adequate flow path and drainage
<b>Photo ID</b>	366
<b>Scope of Works</b>	L - Vegetation is to be slashed to a nominal height of 50 mm above ground with the exception of large, established trees of height in excess of 5 m, which shall remain; dumped vegetation is to be removed.

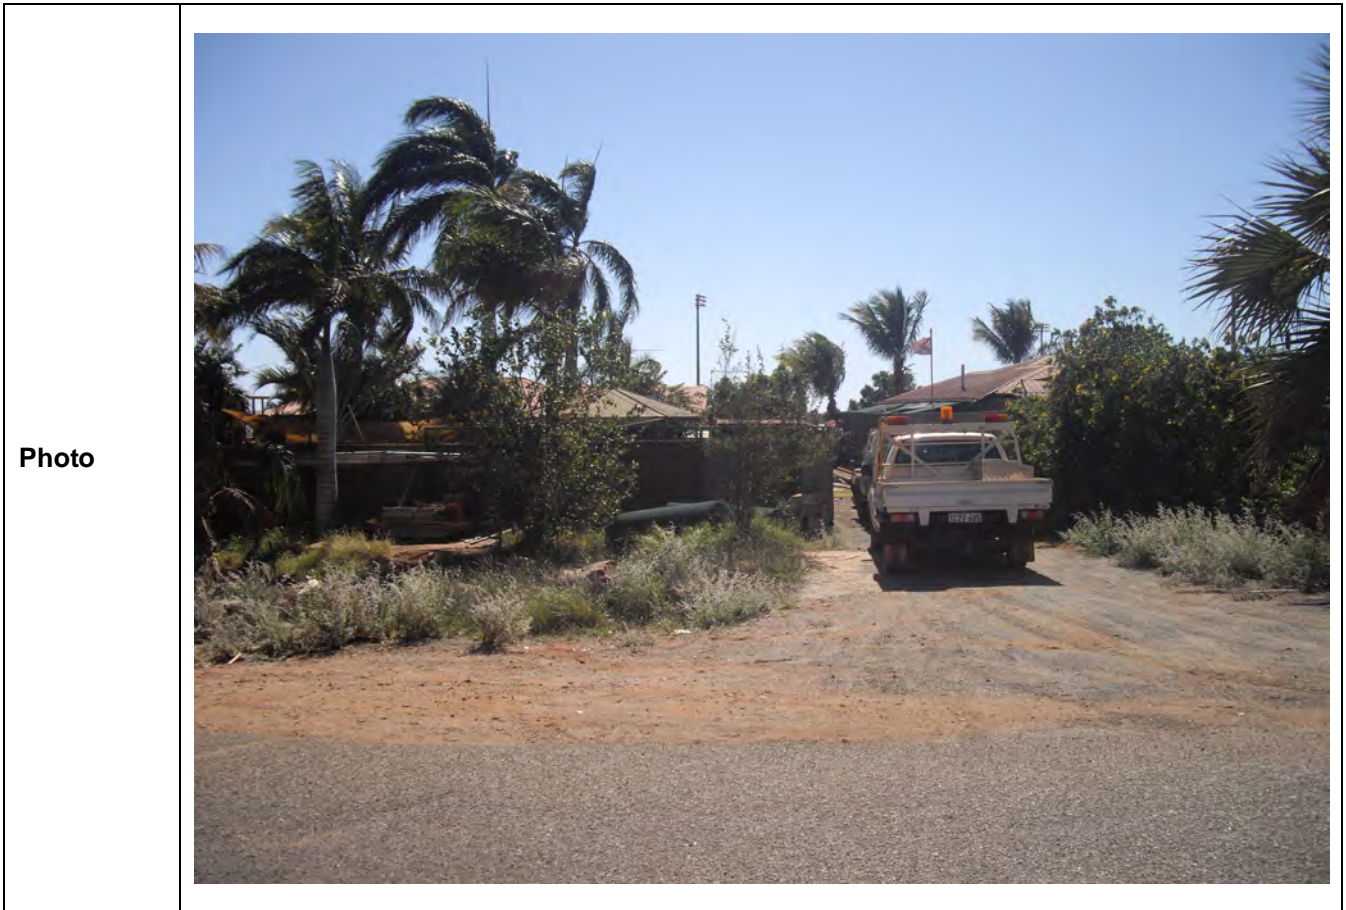
### 2.3 Lot No. 2 Blackwood Crescent

<b>Category</b>	Encroachment
<b>Type</b>	Rear access Boundary extension Vegetation Rocks
<b>Description</b>	Rear access with culvert Shed Semi – dense vegetation Large rocks impeding flow
<b>Photo ID</b>	41, 1016
<b>Scope of Works</b>	H - Remove access driveway and reinstate drainage flow path as defined by the natural channel invert of downstream lot (No. 1) L – Remove existing shed and relocate to within property boundary L - Vegetation is to be slashed to a nominal height of 50 mm above ground with the exception of large, established trees of height in excess of 5 m, which shall remain M – Remove large rocks

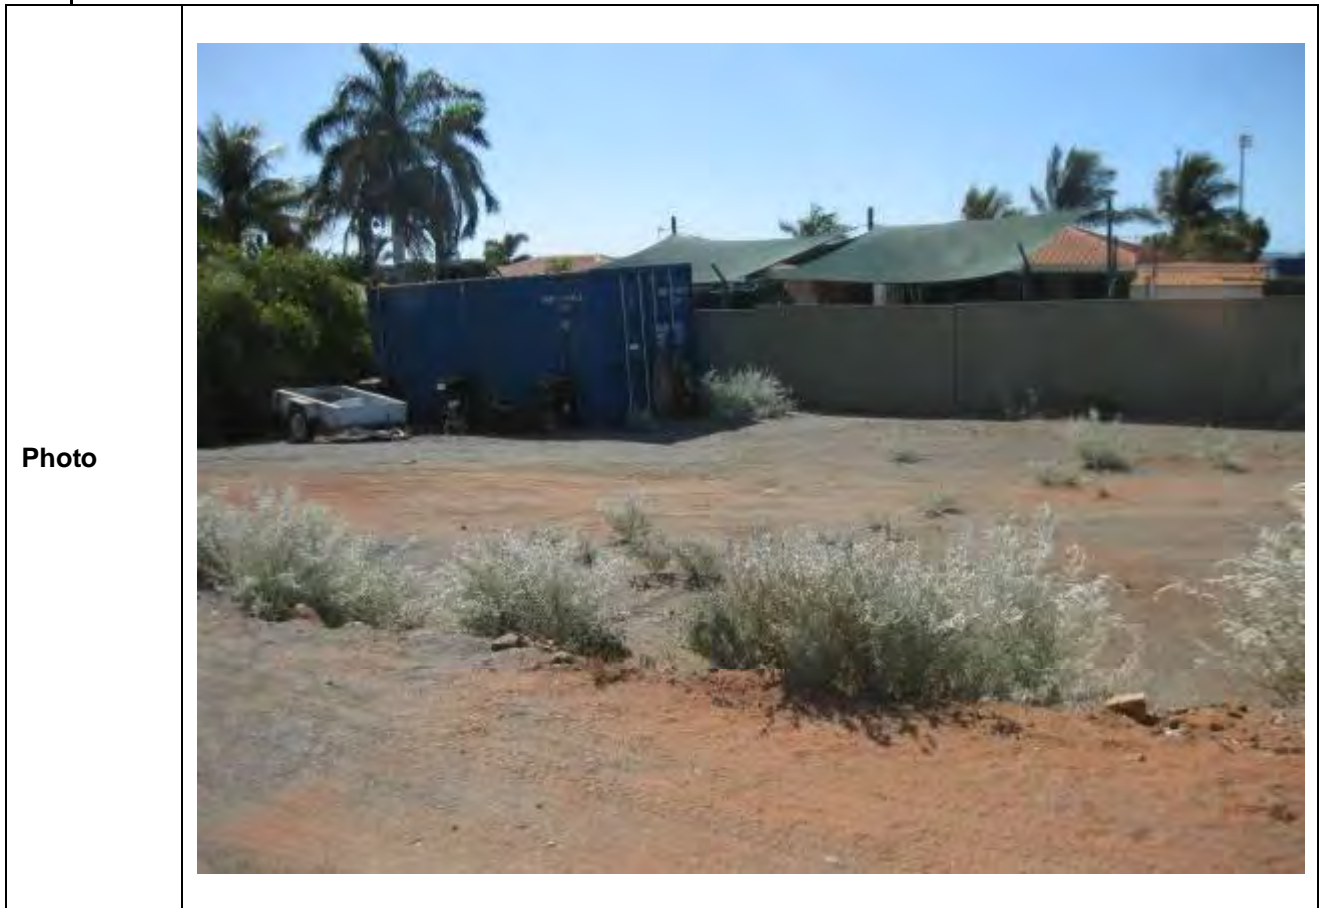
## 2.4 Lot No. 3 Blackwood Crescent

<b>Category</b>	Encroachment
<b>Type</b>	Rear access; Modified topography; General items; Boundary extension.
<b>Description</b>	Rear access with culvert; Modified topography due to imported fill material to create a hardstand/ rear access; Sea container, trailer. Fence is within drainage reserve.
<b>Photo ID</b>	41
<b>Scope of Works</b>	H - Remove access driveway and reinstate drainage flow path as defined by the natural channel invert of downstream lot (No. 2). H – Remove fill material and reinstate drainage flow path as defined by the upstream and downstream capacity; L – Remove sea container and trailer; L - Remove existing fence and relocate to within the property boundary.

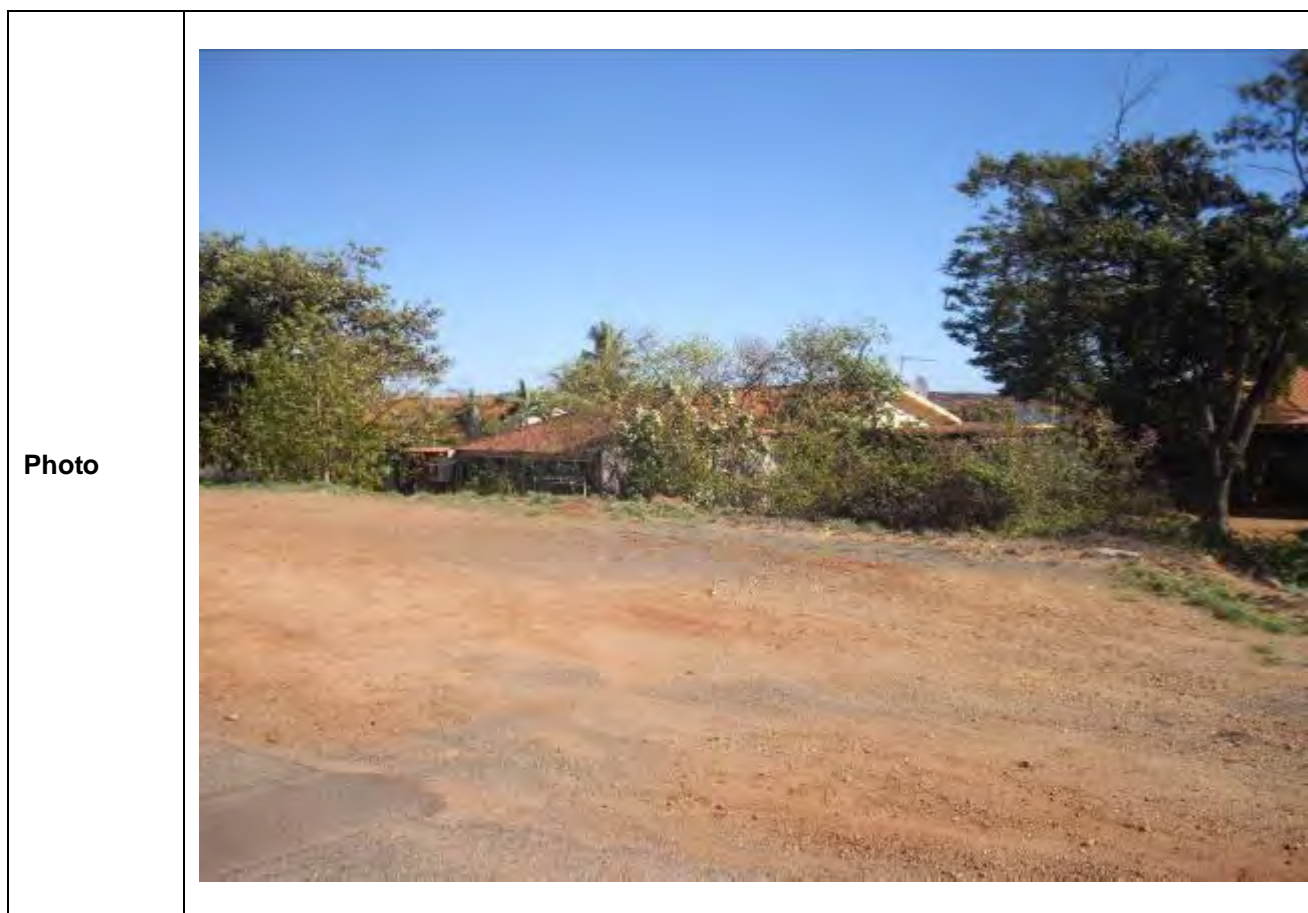
## 2.7 Lot No. 6 Blackwood Crescent

<b>Category</b>	Drain Maintenance
<b>Type</b>	Flow path
<b>Description</b>	No defined flow path. Top of catchment and flow off reserve considered to be minor.
<b>Photo ID</b>	706
<b>Scope of Works</b>	None – flow path adequate.

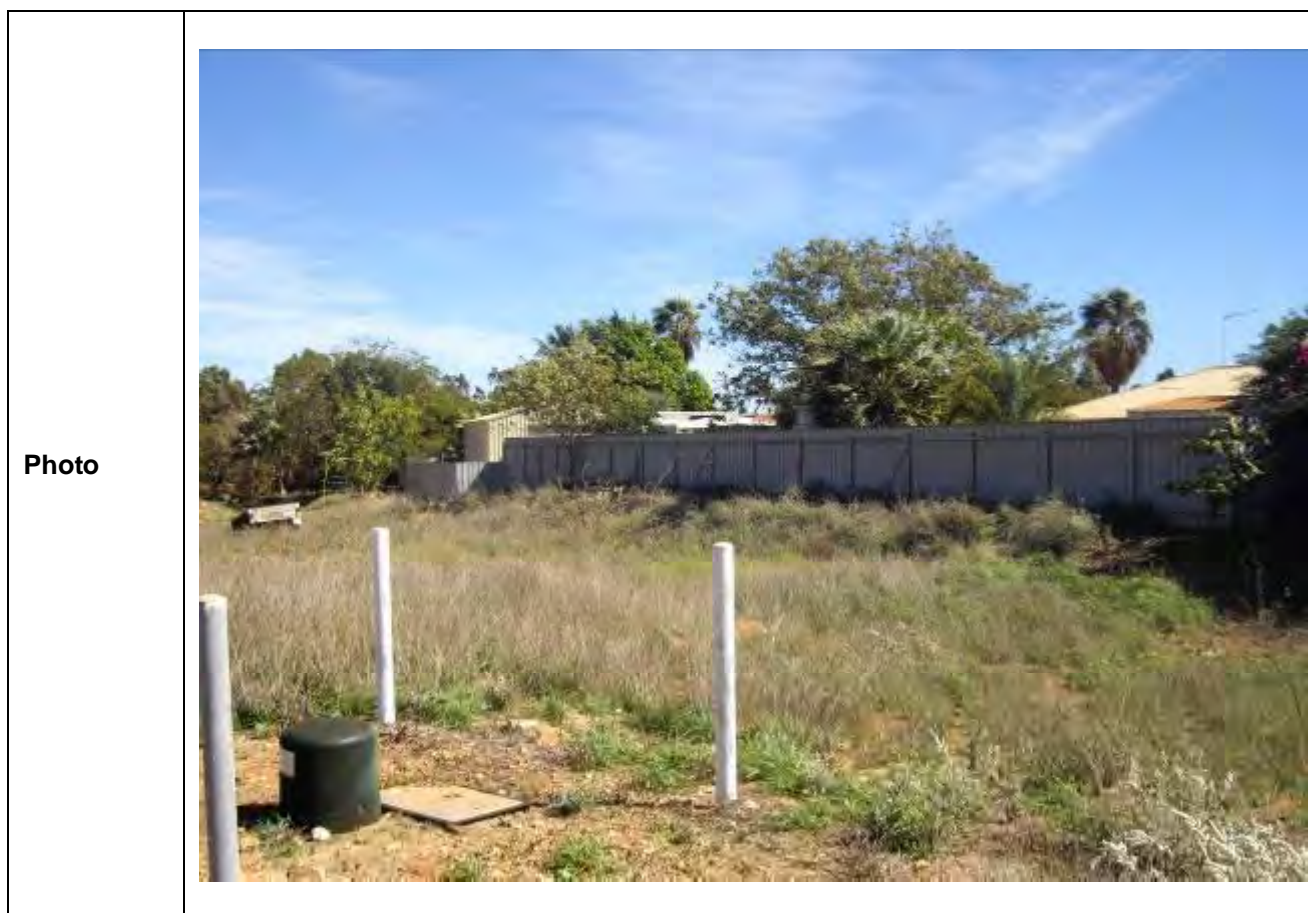
### 3.3 Lot No. 9 Durack Crescent

<b>Category</b>	Drain Maintenance
<b>Type</b>	Vegetation Rear Access
<b>Description</b>	Unmaintained vegetation Rear access follows natural topography – flow path adequate
<b>Photo ID</b>	738
<b>Scope of Works</b>	L - Vegetation is to be slashed to a nominal height of 50 mm above ground with the exception of large, established trees of height in excess of 5 m, which shall remain.

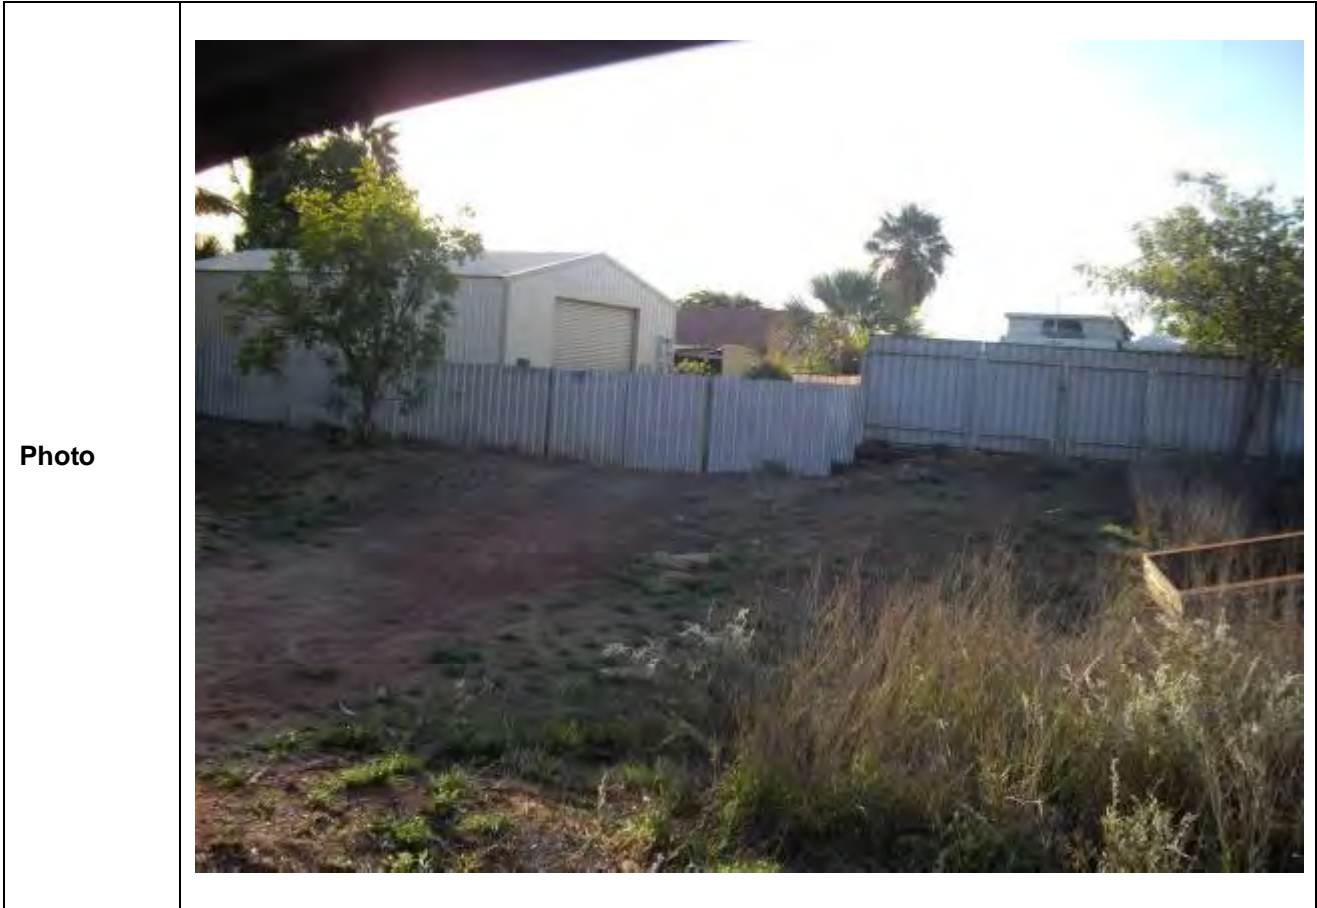
### 3.4 Lot No. 10 Durack Crescent

<b>Category</b>	Encroachment
<b>Type</b>	Rear access Boundary encroachment
<b>Description</b>	Rear access follows natural topography and has minor impedence to flow Fence and shed are within the drainage reserve
<b>Photo ID</b>	676
<b>Scope of Works</b>	M - Remove rear access driveway and reinstate drainage flow path as defined by the natural channel invert of downstream channel. L – Remove fence and relocate to within property boundary. Remove shed and relocate to within property boundary – confirmation required from survey.

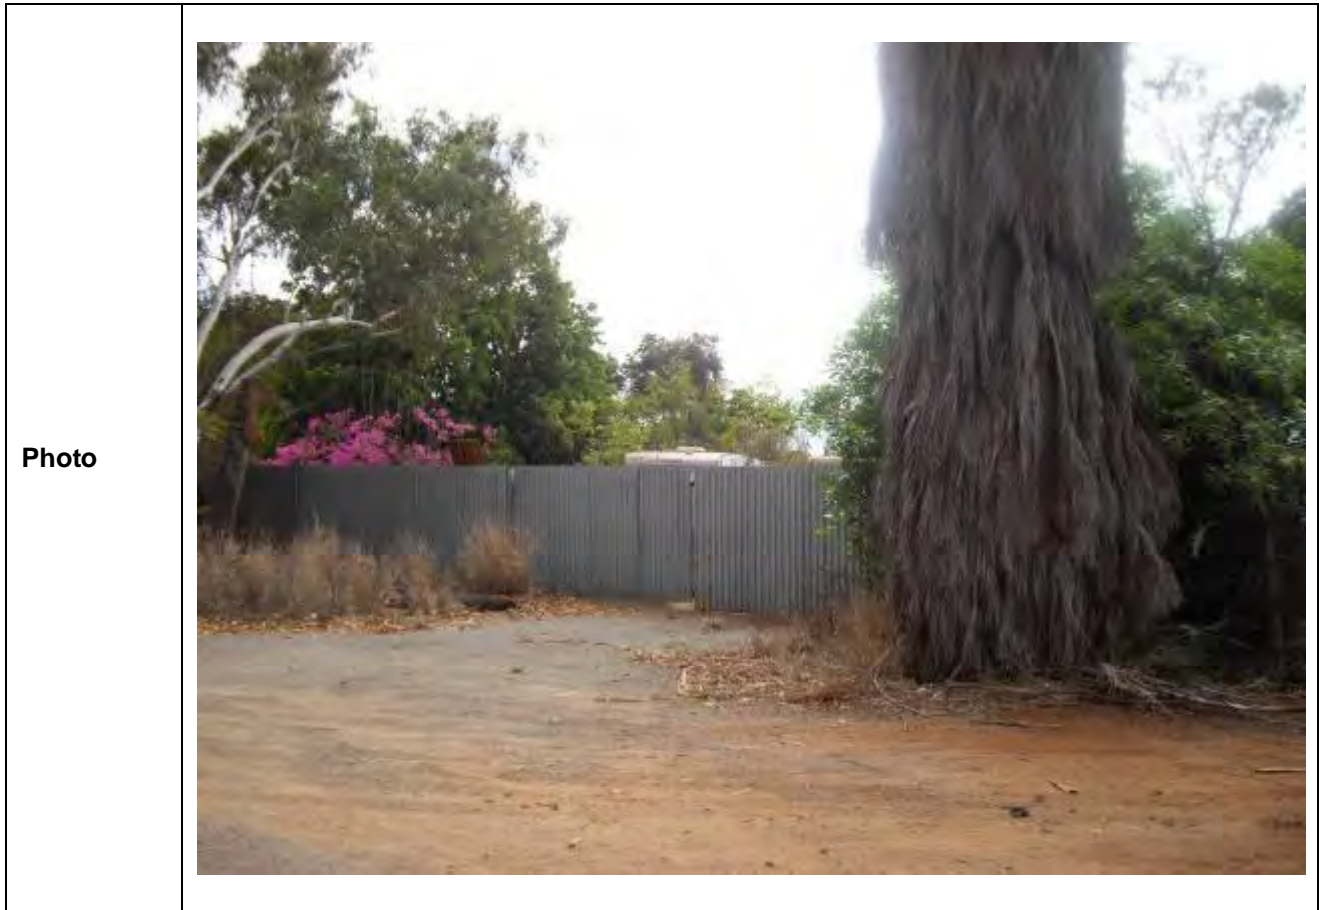
### 3.7 Lot No. 13 Durack Crescent

<b>Category</b>	Encroachment
<b>Type</b>	Boundary Extension Rear access
<b>Description</b>	Fenced area within drainage reserve. Rear access and modified topography impedes flow from Lot 12.
<b>Photo ID</b>	454
<b>Scope of Works</b>	H - Remove and relocate fenced off area and reinstate property boundary H - Remove rear access and reinstate drainage flow path as defined by the natural channel invert of downstream channel

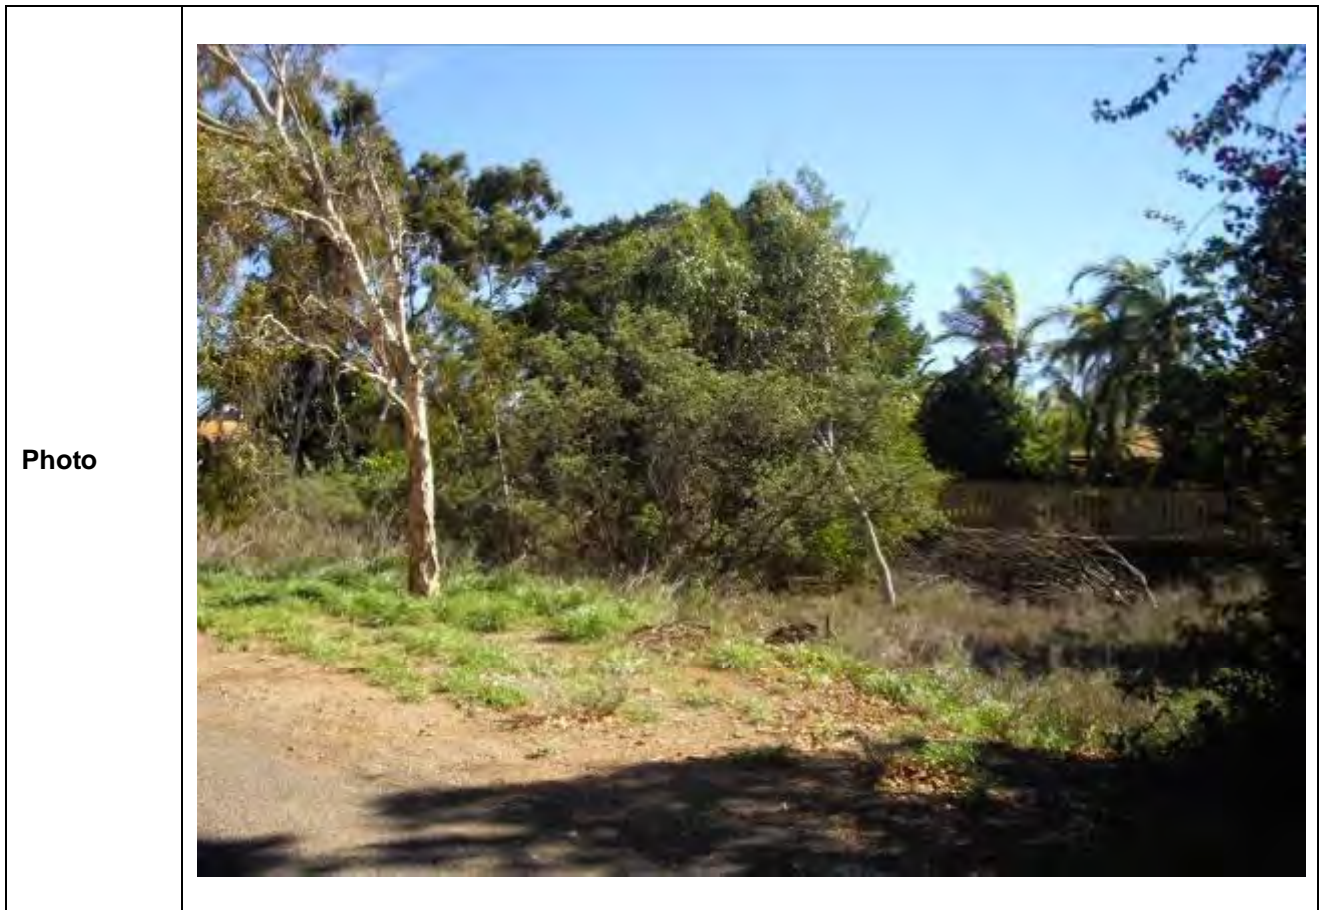
### 3.8 Lot No. 14 Durack Crescent

<b>Category</b>	Drain Maintenance
<b>Type</b>	Vegetation
<b>Description</b>	Shallow and wide drain section with dense vegetation impeding flow
<b>Photo ID</b>	739
<b>Scope of Works</b>	H - Vegetation is to be slashed to a nominal height of 50 mm above ground with the exception of large, established trees of height in excess of 5 m, which shall remain.

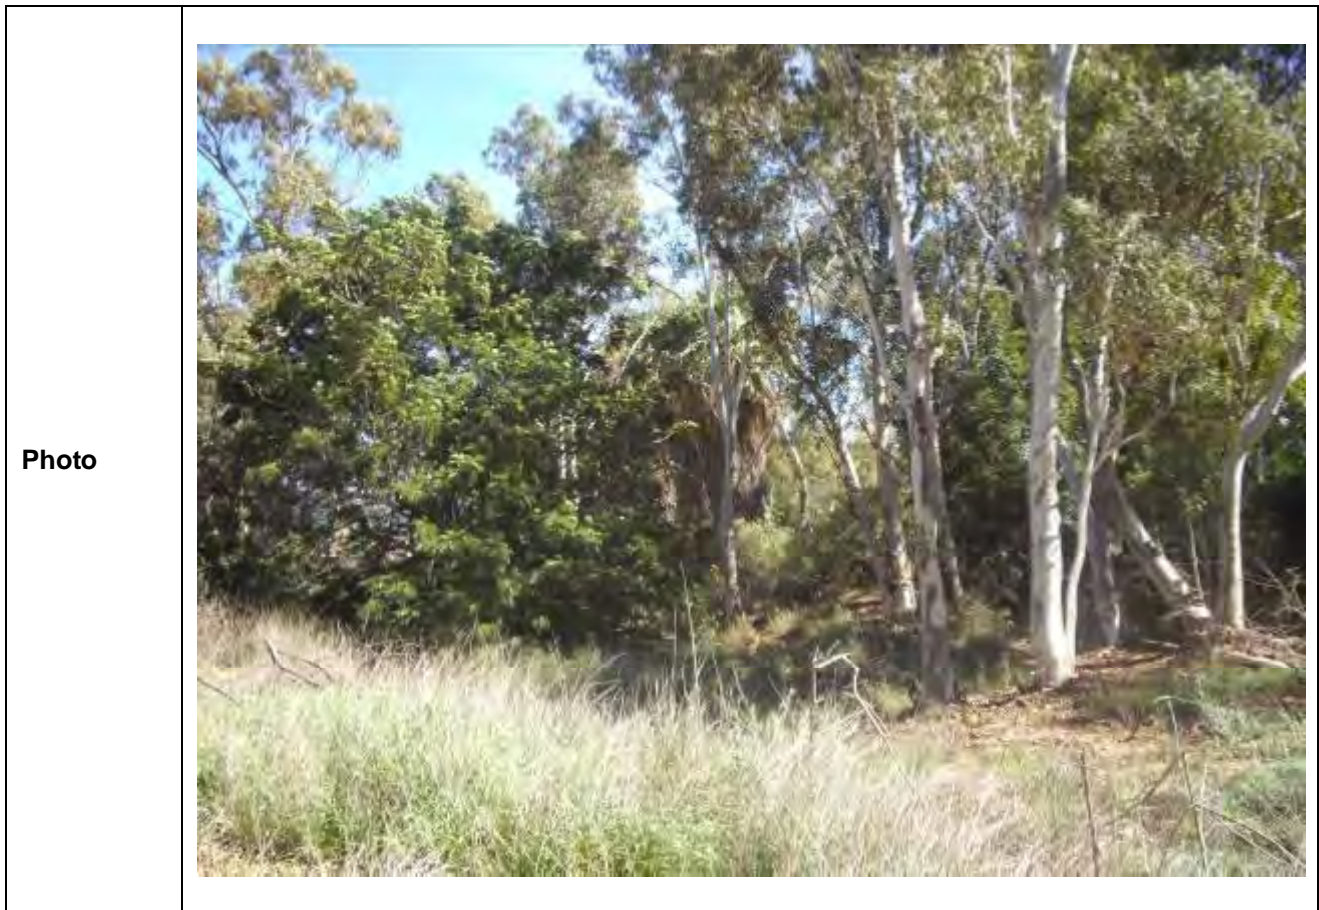
### 3.9 Lot No. 15 Durack Crescent

<b>Category</b>	Drain Maintenance
<b>Type</b>	Vegetation.
<b>Description</b>	Dense vegetation. General silting and fill required cleaning out.
<b>Photo ID</b>	740
<b>Scope of Works</b>	H - Vegetation is to be slashed to a nominal height of 50 mm above ground with the exception of large, established trees of height in excess of 5 m, which shall remain, clean out silted area.

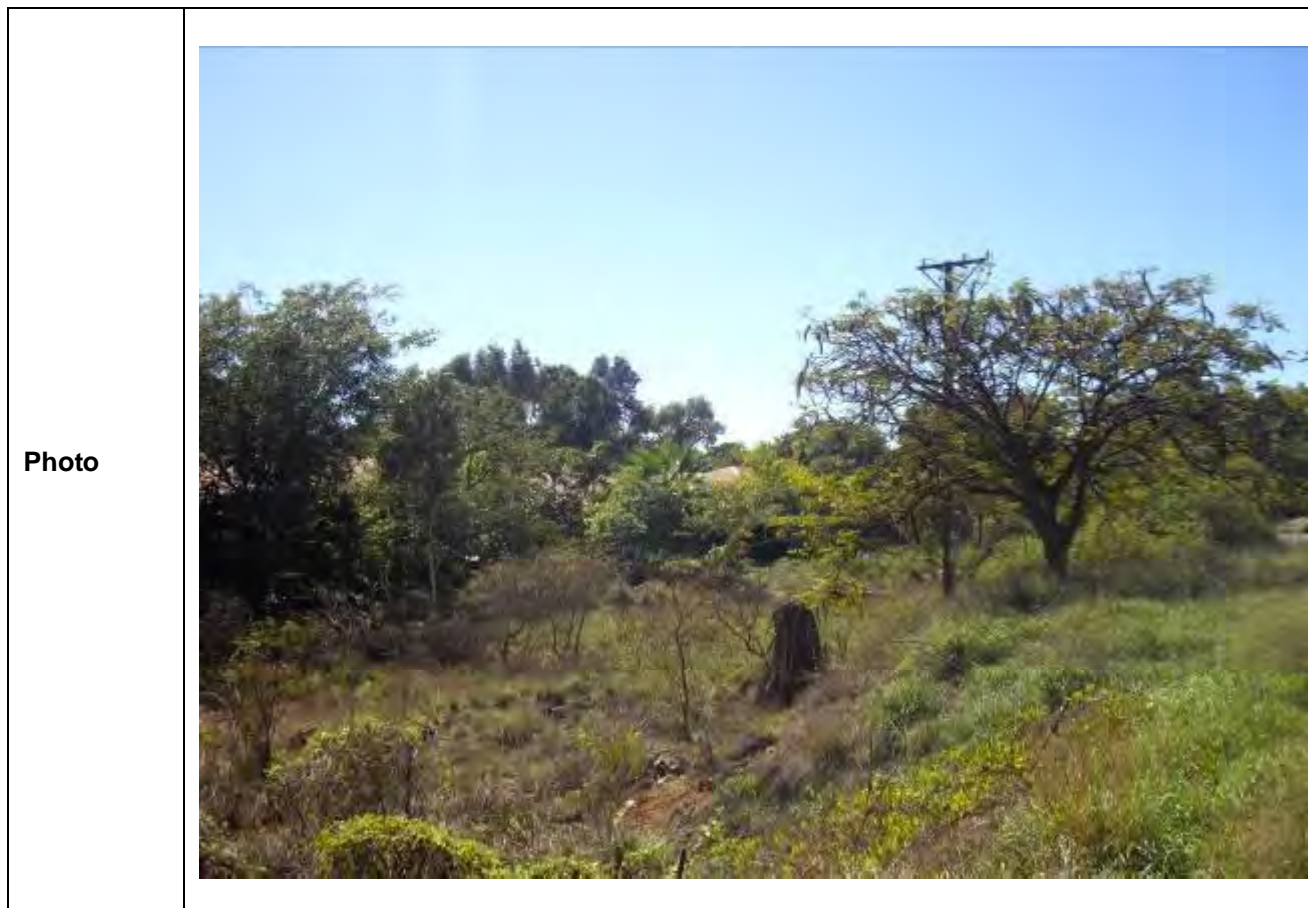
#### 4.1 Lot No. 16 Minilya Crescent

<b>Category</b>	Drain Maintenance
<b>Type</b>	Vegetation
<b>Description</b>	Good drainage reach with wide channel
<b>Photo ID</b>	737
<b>Scope of Works</b>	L - Vegetation is to be slashed to a nominal height of 50 mm above ground with the exception of large, established trees of height in excess of 5 m, which shall remain.

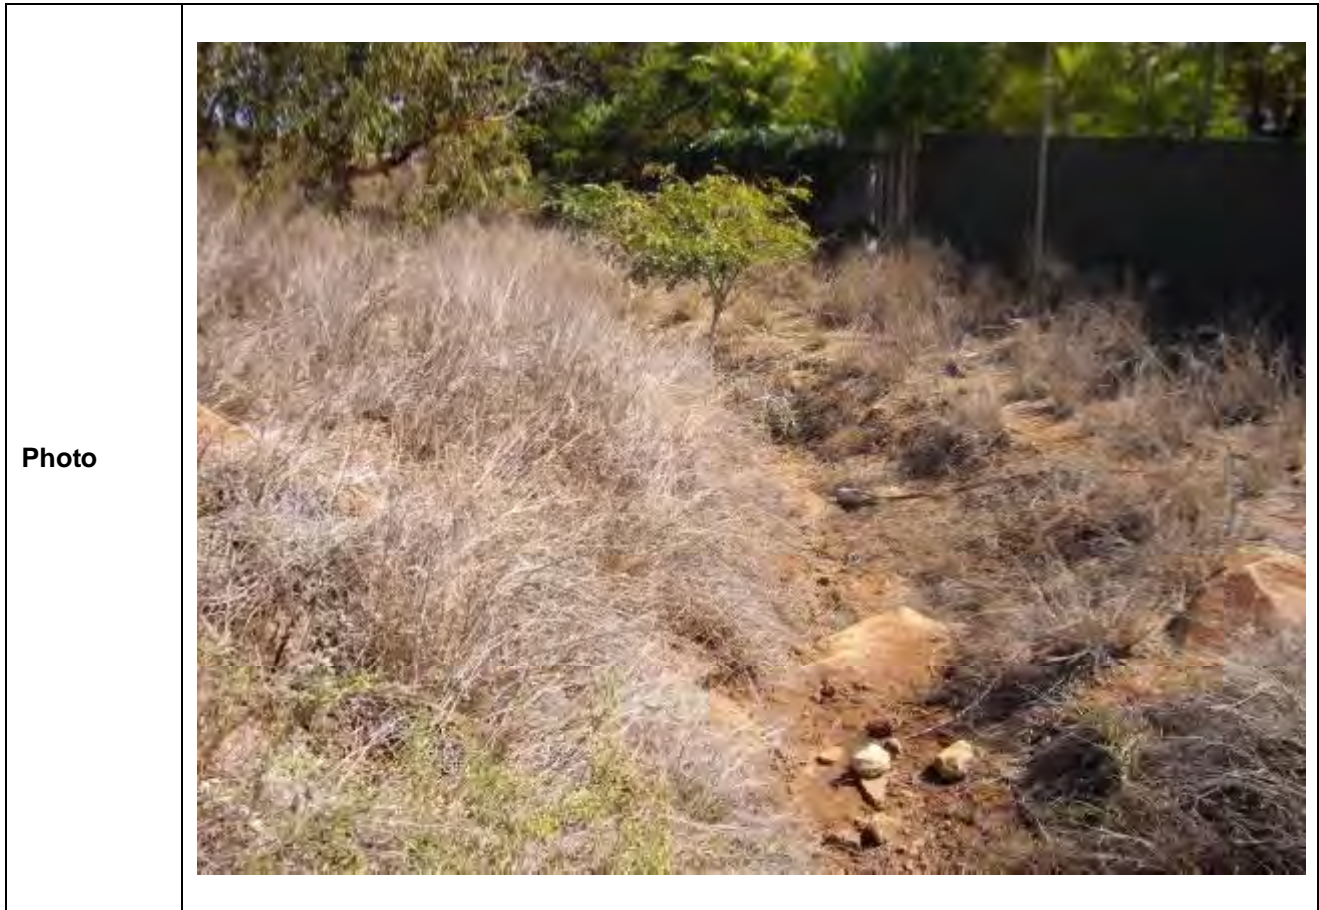
#### 4.2 Lot No. 17 Minilya Crescent

<b>Category</b>	Drain Maintenance
<b>Type</b>	Flow Path Vegetation
<b>Description</b>	Raised channel plus vegetation and rubble impede flow
<b>Photo ID</b>	371
<b>Scope of Works</b>	H – Location requires construction of reinstated drainage flow path as defined by the natural channel invert of downstream channel.

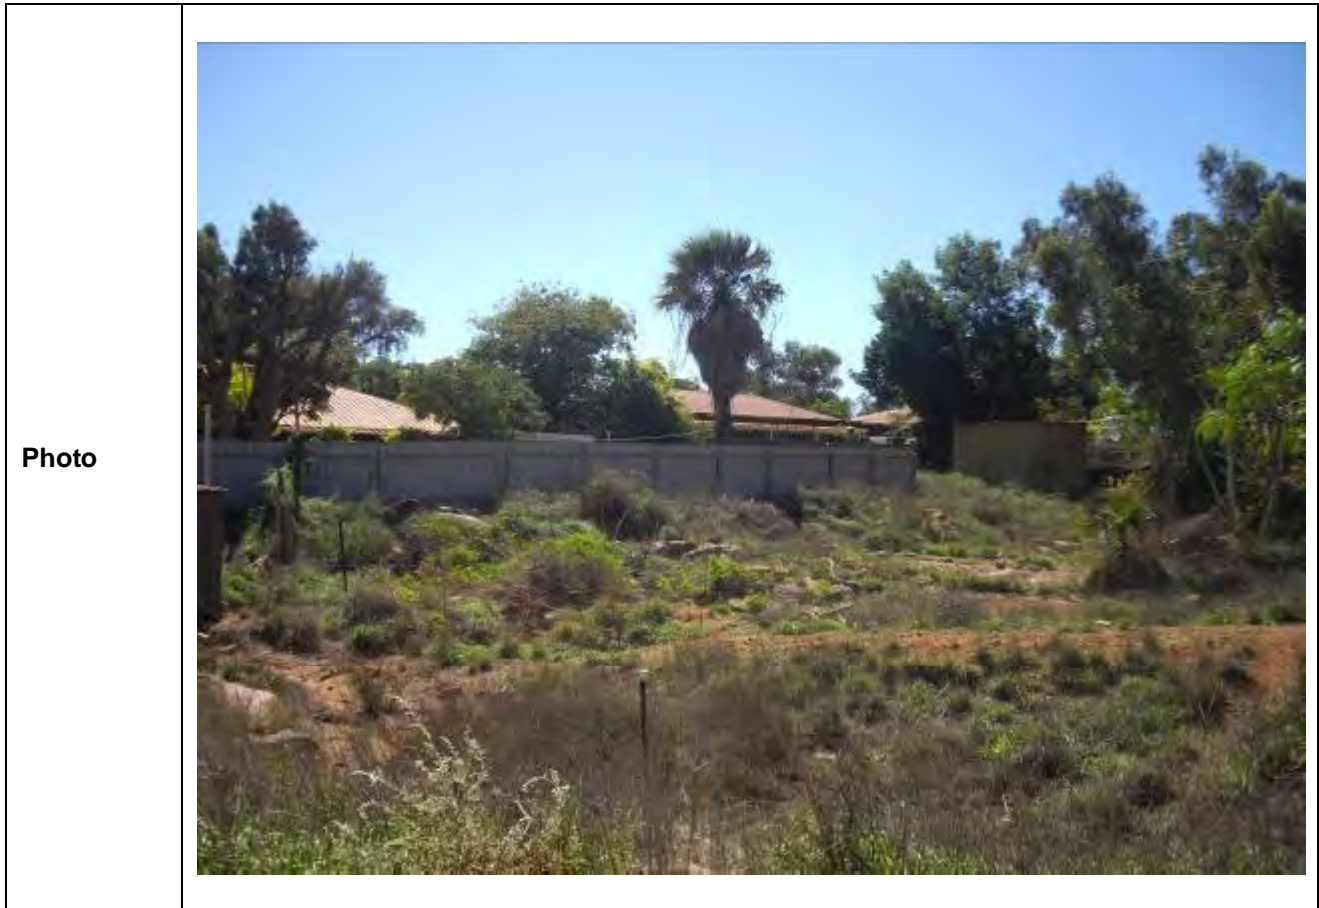
### 5.1 Lot No. 18 Minilya Crescent

<b>Category</b>	None
<b>Type</b>	None
<b>Description</b>	None
<b>Photo ID</b>	736
<b>Scope of Works</b>	None required

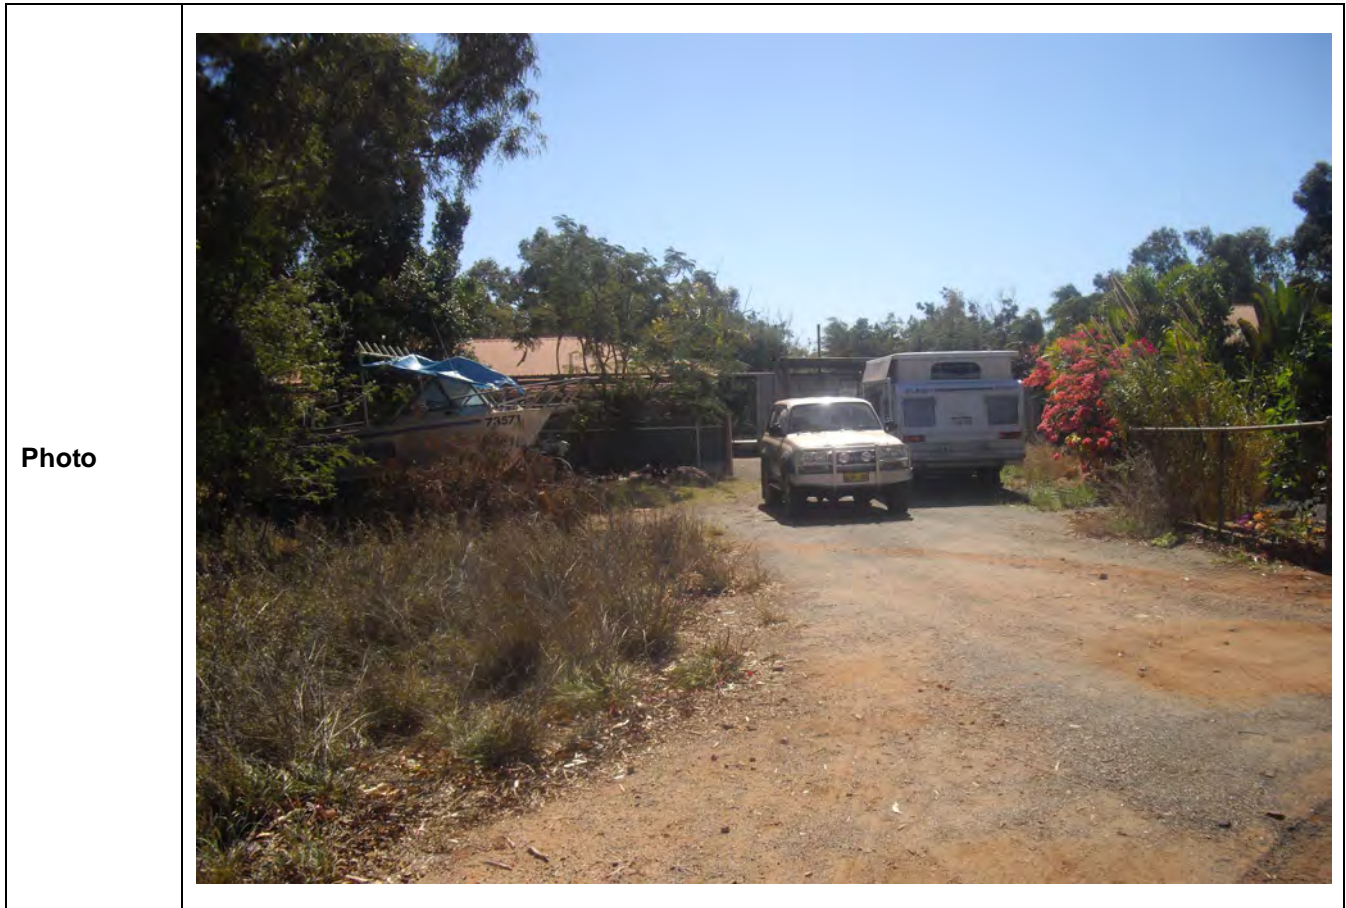
## 5.2 Lot No. 19 Minilya Crescent

<b>Category</b>	Encroachment
<b>Type</b>	Rear access
<b>Description</b>	Rear access impeding flow.
<b>Photo ID</b>	39
<b>Scope of Works</b>	H – Remove rear access and reinstate drainage flow path as defined by the natural channel invert of downstream channel.

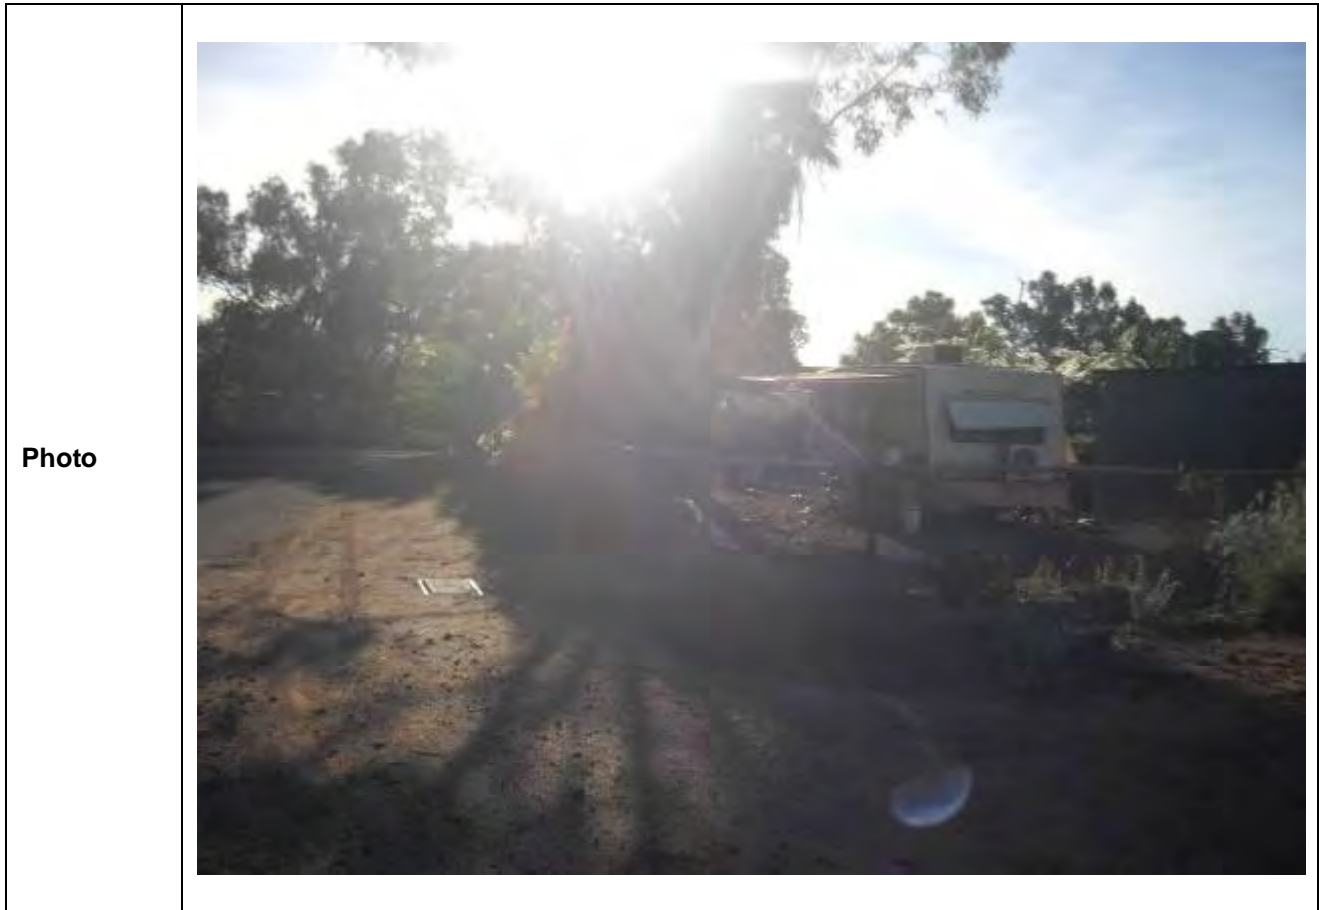
### 5.3 Lot No. 20 Minilya Crescent

<b>Category</b>	Encroachment
<b>Type</b>	Boundary extension; General item; Rear access;
<b>Description</b>	Fence and landscaping; Caravan; Rear access with culvert follows modified topography; Highly modified drainage reserve due to fill.
<b>Photo ID</b>	674
<b>Scope of Works</b>	H – Remove existing fence and landscaping relocate to within property boundary; H – Remove rear access reinstate drainage flow path as defined by the natural channel invert of downstream channel.

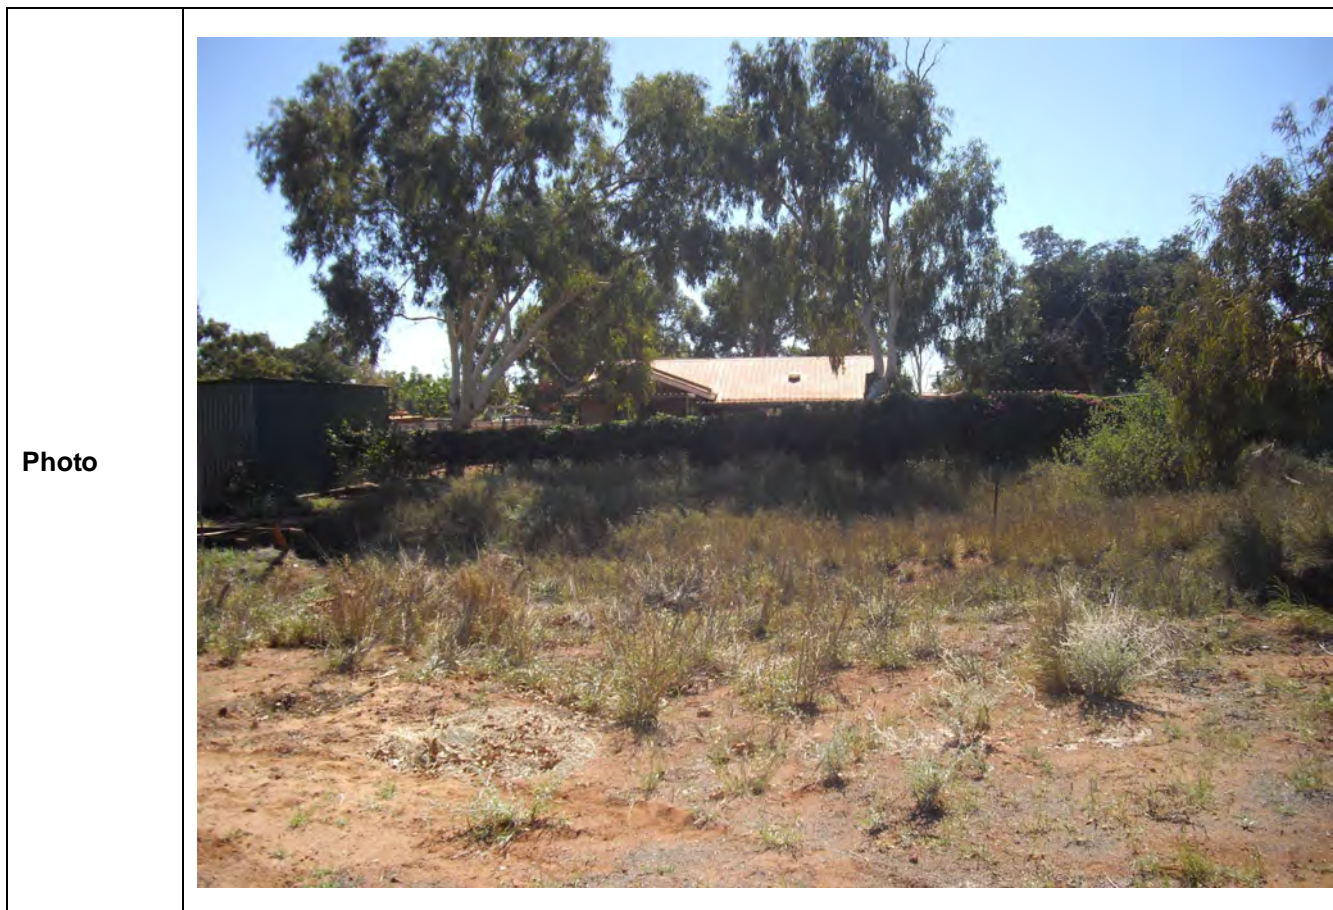
#### 5.4 Lot No. 21 Minilya Crescent

<b>Category</b>	Drain Maintenance
<b>Type</b>	Vegetation.
<b>Description</b>	Semi-dense vegetation
<b>Photo ID</b>	1023, 711
<b>Scope of Works</b>	M - Vegetation is to be slashed to a nominal height of 50 mm above ground with the exception of large, established trees of height in excess of 5 m, which shall remain

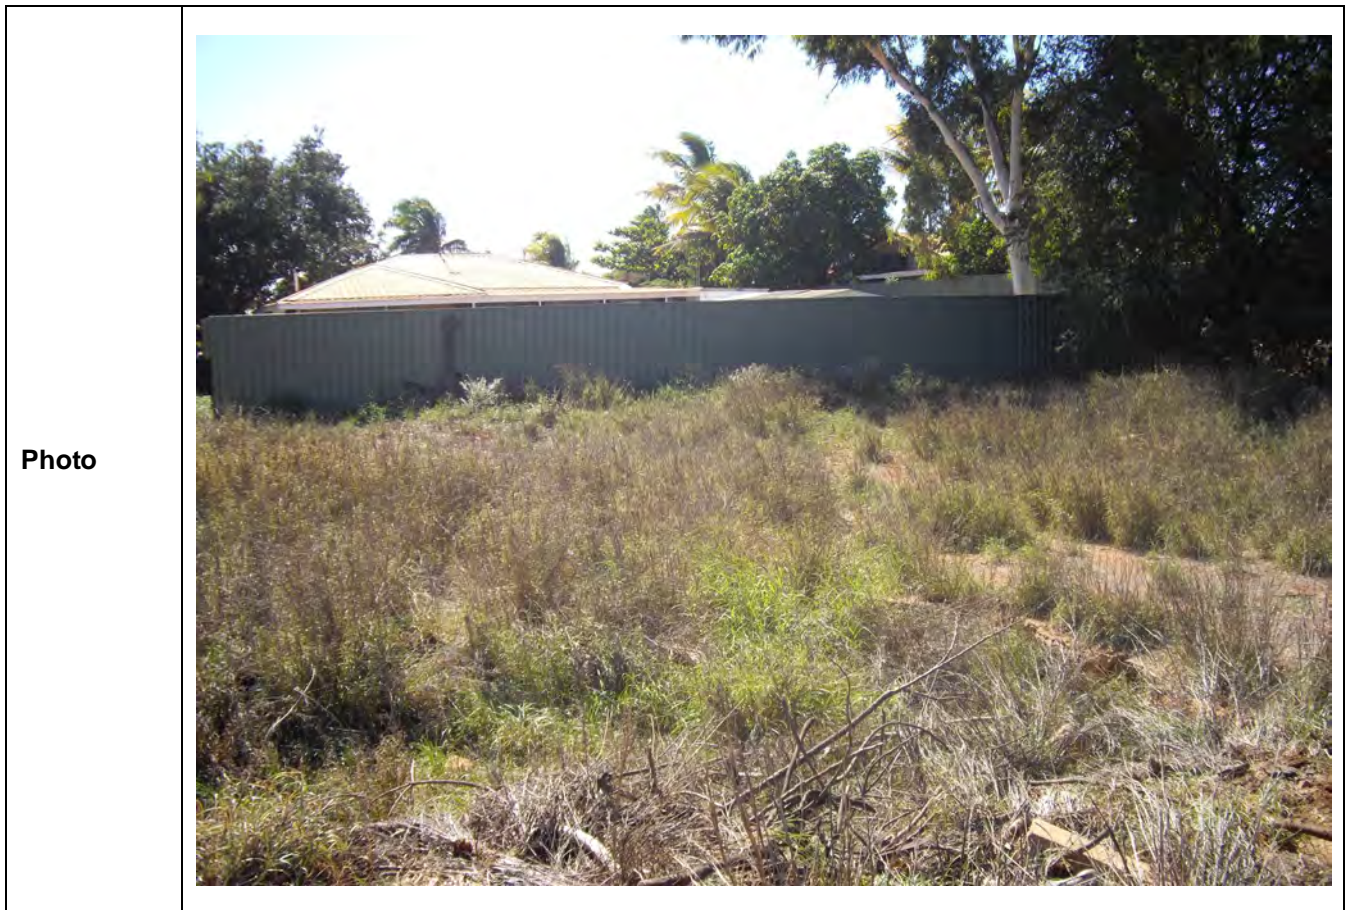
## 5.5 Lot No. 22 Minilya Crescent

<b>Category</b>	Encroachment / Drain maintenance
<b>Type</b>	Vegetation; Rear access and culvert crossing.
<b>Description</b>	Semi-dense vegetation Rear access with culvert crossing
<b>Photo ID</b>	37
<b>Scope of Works</b>	M - Vegetation is to be slashed to a nominal height of 50 mm above ground with the exception of large, established trees of height in excess of 5 m, which shall remain; M – Remove culvert crossing and reinstate drainage flow path as defined by the natural channel invert of downstream channel.
