City of Karratha  
Dampier Stormwater Management Study  
Report  
Part B  
June 2015

## Appendix **C** – 2010 encroachment reviews

**Rio Tinto Iron Ore**  
Report on Dampier Drainage  
Review  
Block 1 Encroachments  
June 2010

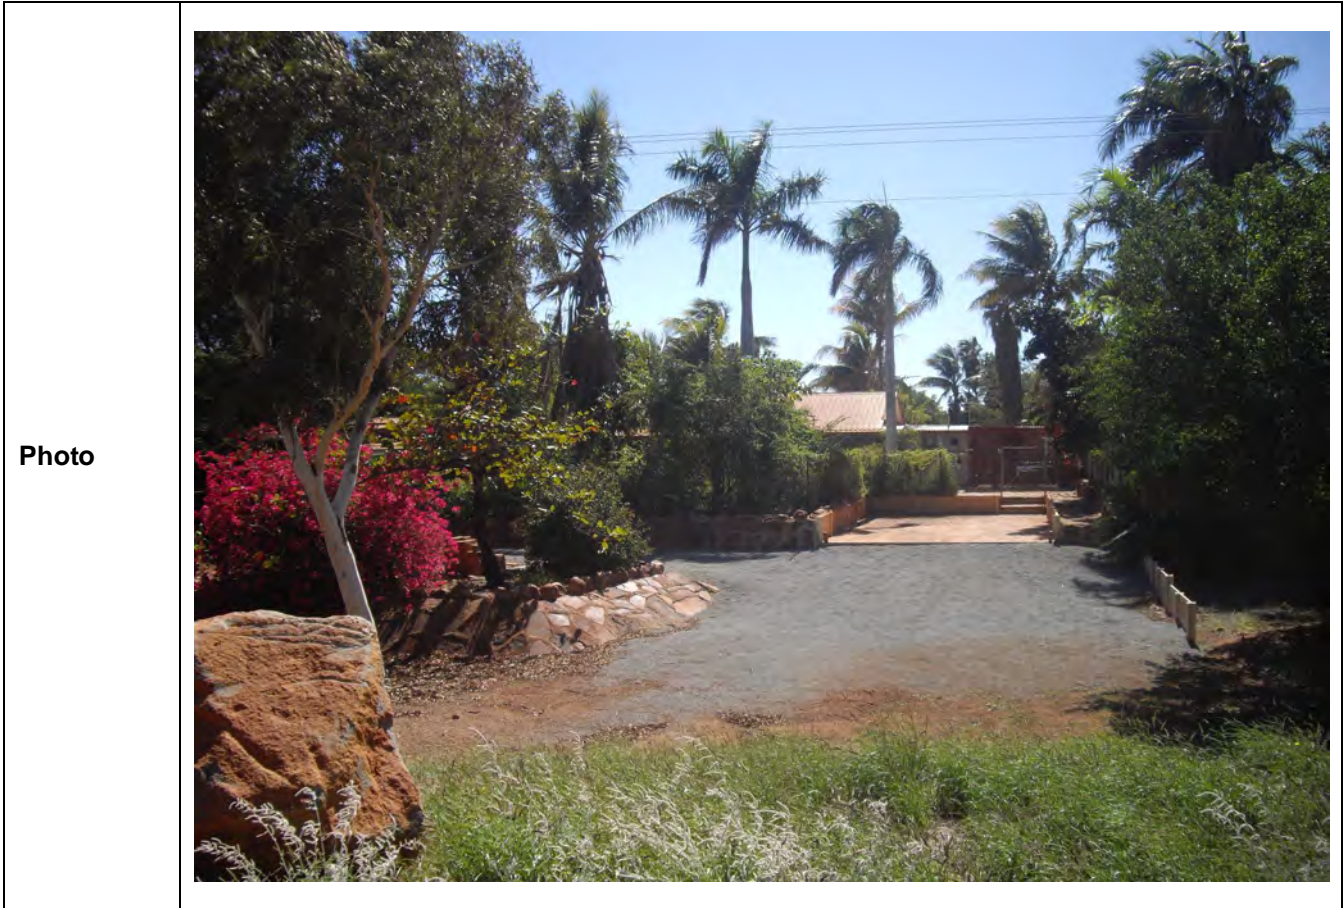
## 5.6 Lot No. 23 Minilya Crescent

<b>Category</b>	Encroachment
<b>Type</b>	Rear access; Boundary encroachment.
<b>Description</b>	Rear acces follows natural topography; Extensive landscaping including retaining walls and gardens – does not impede flow.
<b>Photo ID</b>	1019, 38
<b>Scope of Works</b>	M – Remove rear access; M – Remove landscaping.

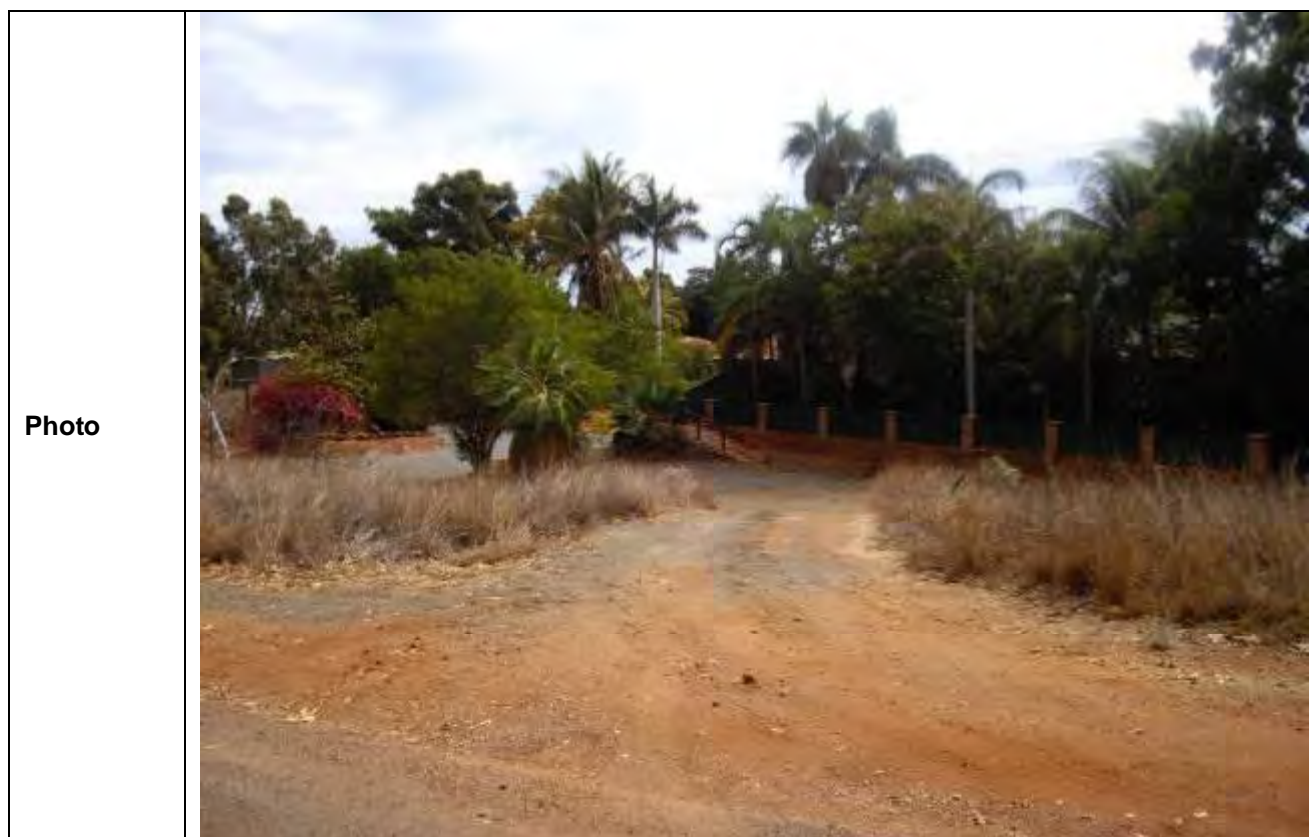
### 5.7 Lot No. 24 Minilya Crescent

<b>Category</b>	Encroachment
<b>Type</b>	Rear access
<b>Description</b>	Rear access follows natural topography
<b>Photo ID</b>	426
<b>Scope of Works</b>	M - Remove rear access and reinstate drain

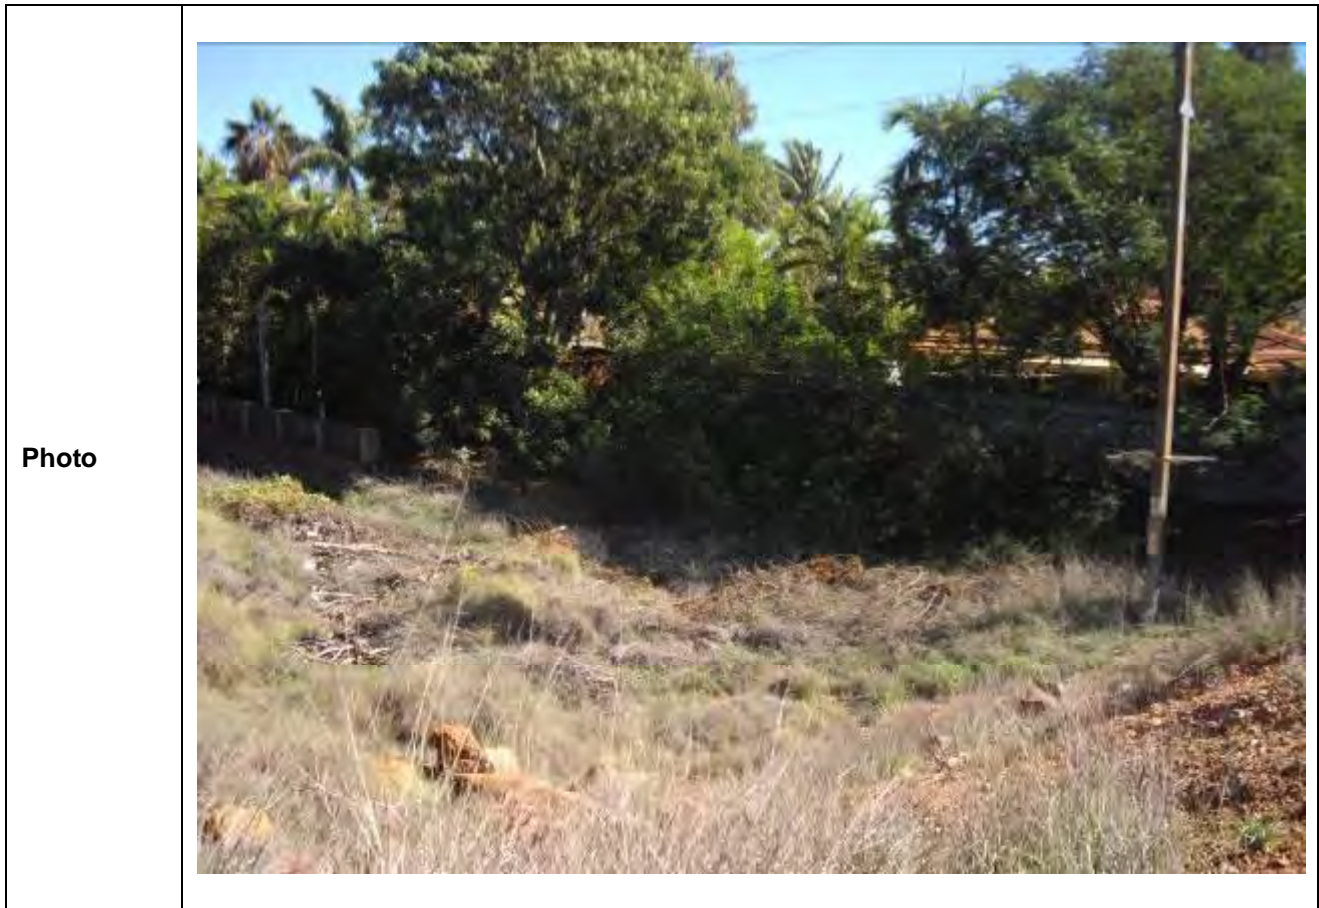
## 5.8 Lot No. 1,024 Minilya Crescent

<b>Category</b>	Encroachment
<b>Type</b>	Vegetation
<b>Description</b>	Dumped vegetation within the drainage reserve.
<b>Photo ID</b>	710
<b>Scope of Works</b>	M – Remove dumped vegetation.

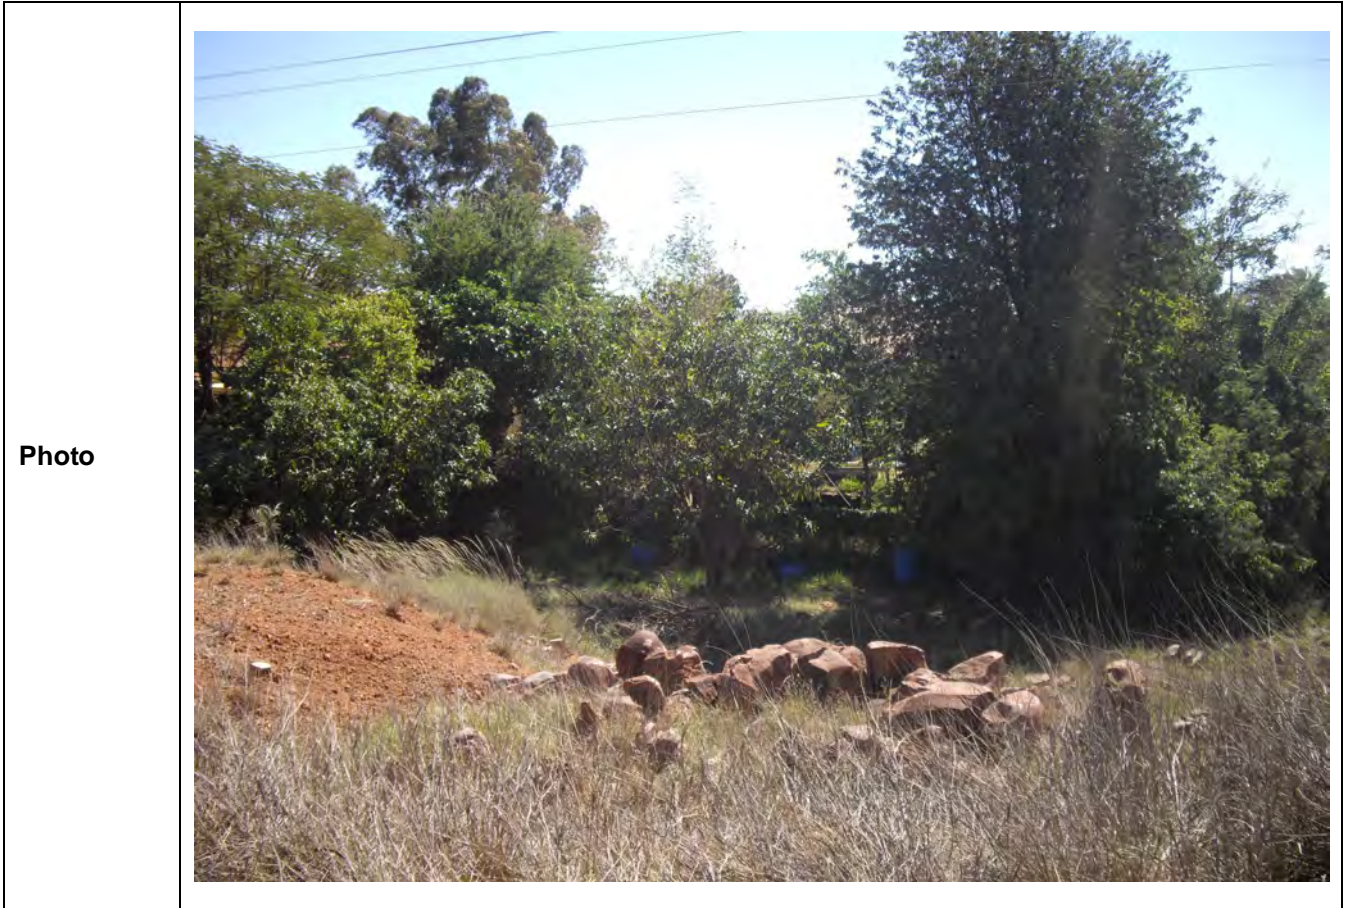
## 5.9 Lot No. 2,024 Minilya Crescent

<b>Category</b>	Encroachment / Drain maintenance
<b>Type</b>	Modified topography Rocks
<b>Description</b>	Reduced cross sectional area due to fill; Large rocks near power pole impeding flow.
<b>Photo ID</b>	709
<b>Scope of Works</b>	M – Remove fill; M – Remove rocks near power pole.

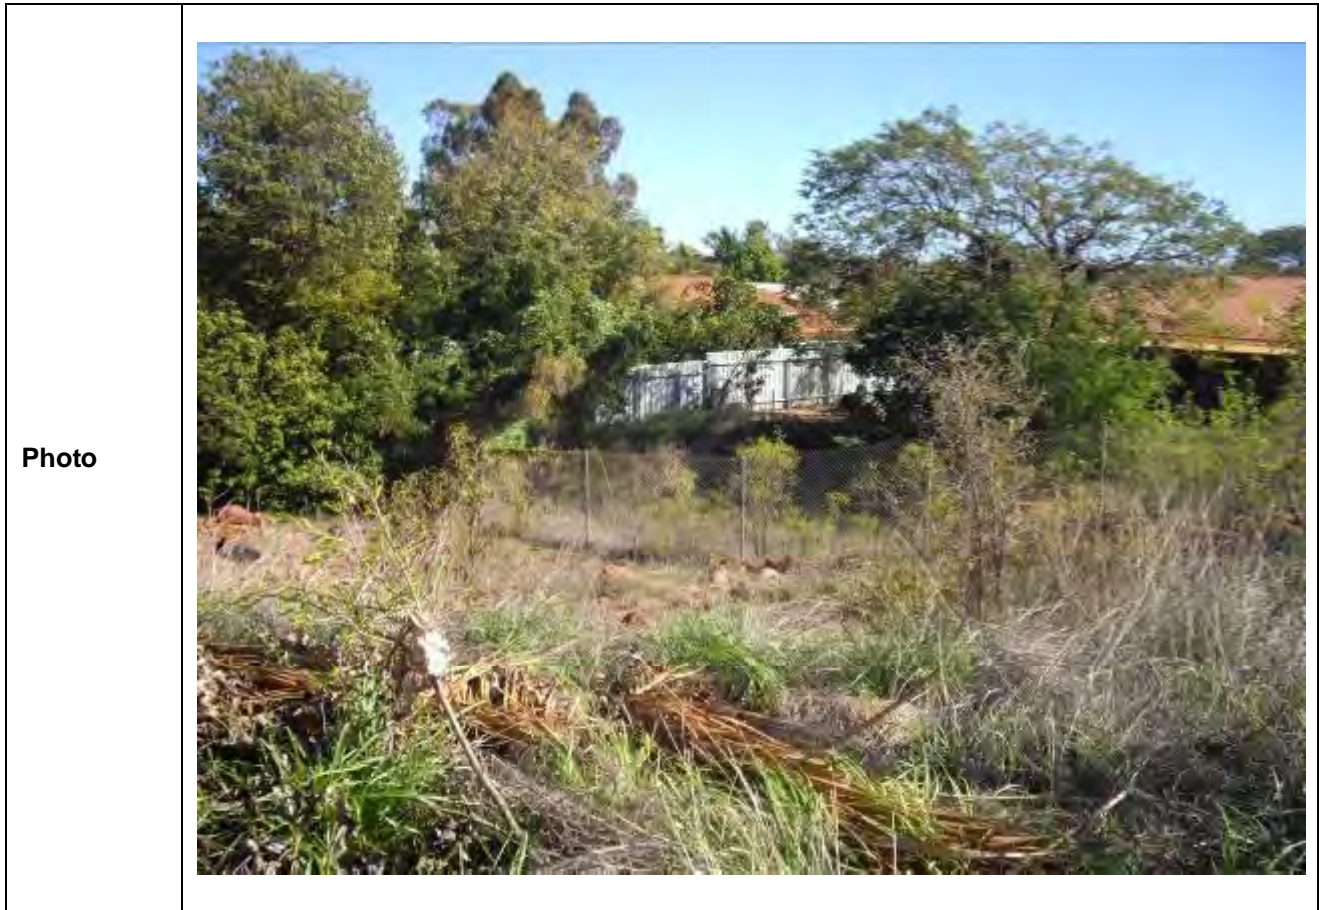
### 5.10 Lot No. 3,024 Minilya Crescent

<b>Category</b>	None
<b>Type</b>	None
<b>Description</b>	Top of catchment – natural channel adequately conveys flow downstream
<b>Photo ID</b>	708
<b>Scope of Works</b>	None

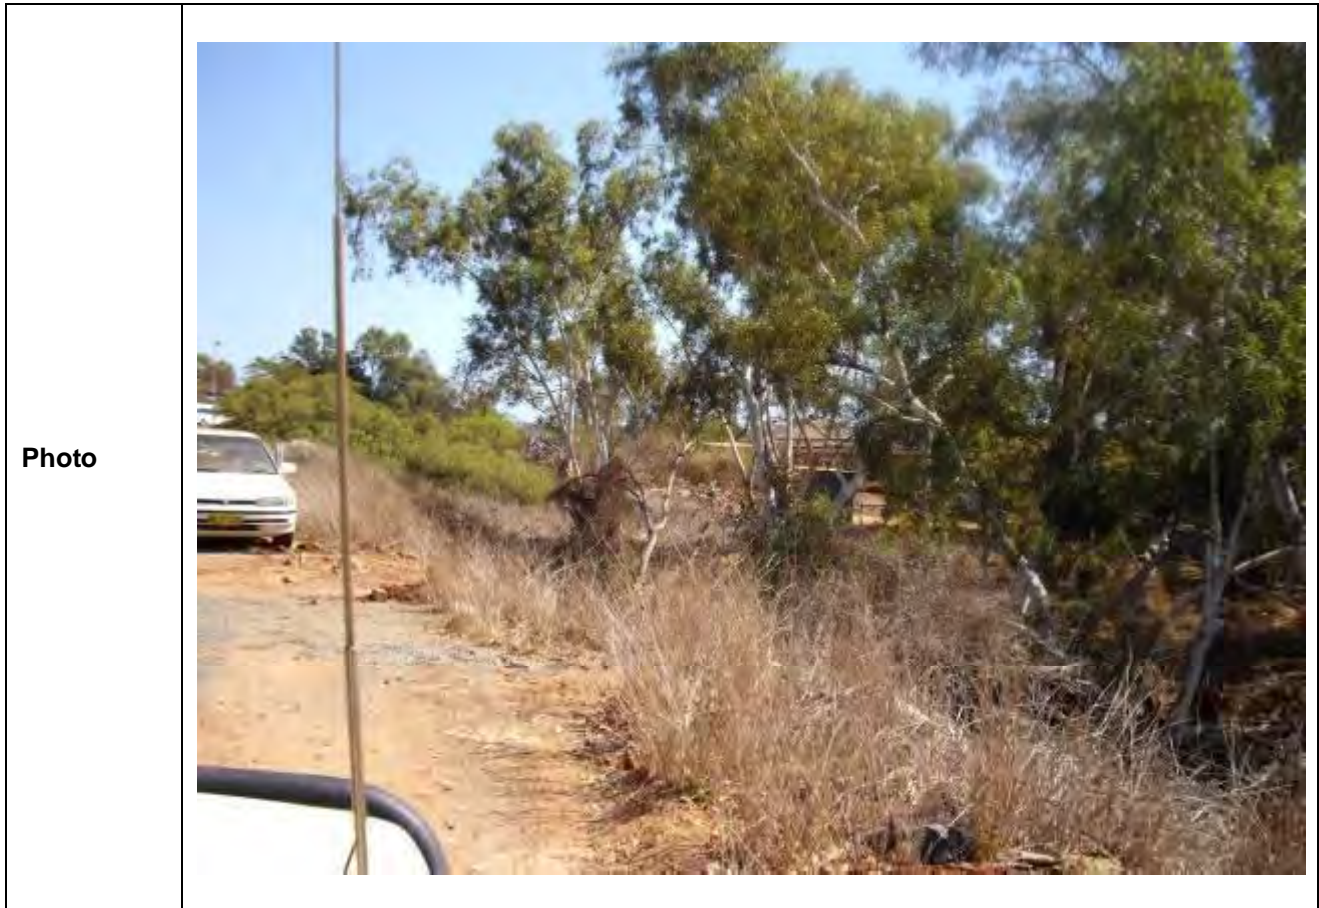
## 6.1 Lot No. 1,025 Maitland Road

<b>Category</b>	Drain Maintenance
<b>Type</b>	Vegetation
<b>Description</b>	Large trees and dense vegetation within drainage reserve.
<b>Photo ID</b>	374
<b>Scope of Works</b>	M - Vegetation is to be slashed to a nominal height of 50 mm above ground with the exception of large, established trees of height in excess of 5 m, which shall remain.

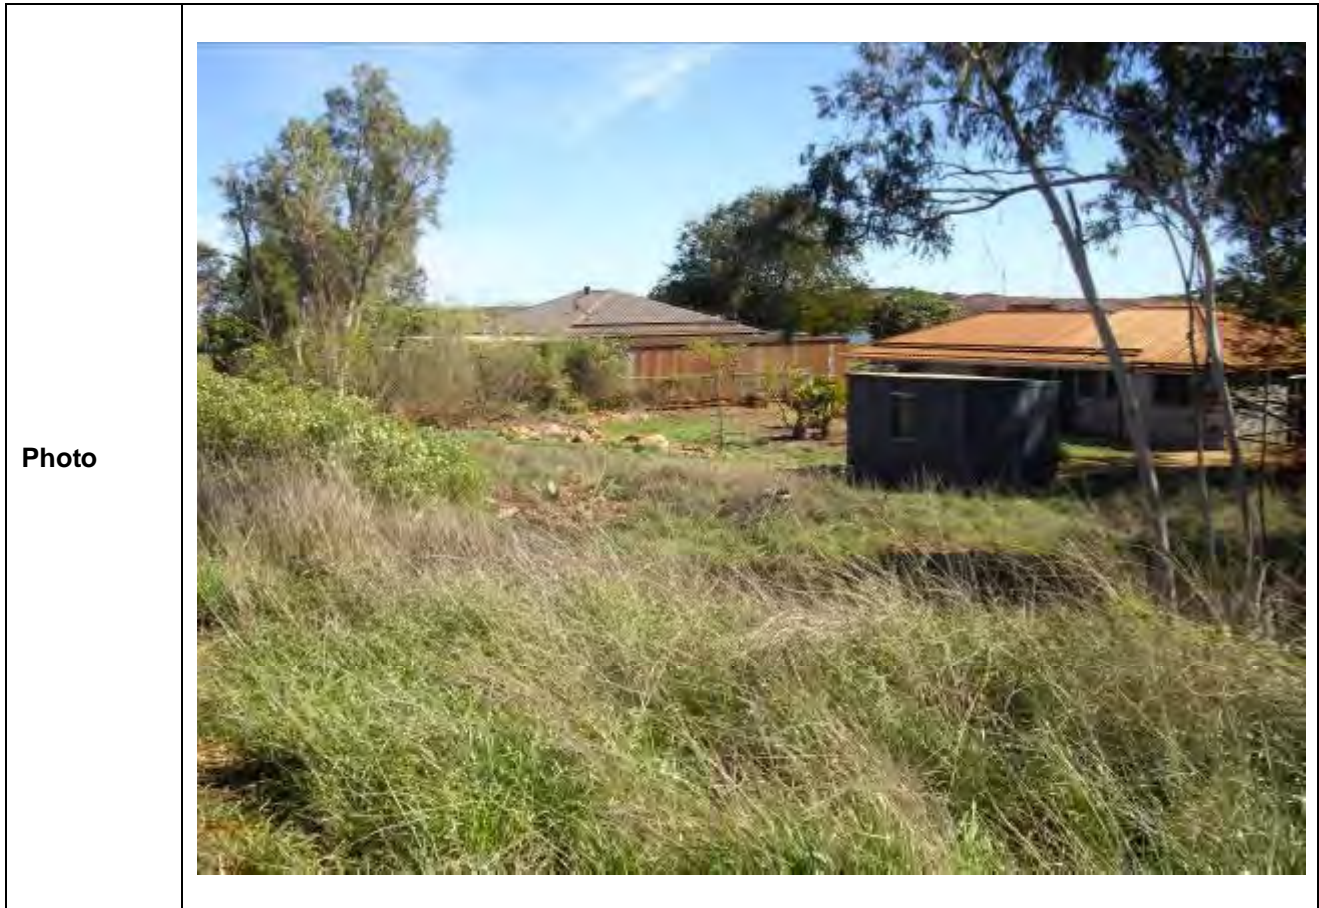
## 6.2 Lot No. 2,025 Maitland Road

<b>Category</b>	Drain Maintenance
<b>Type</b>	Undefined drain, Vegetation
<b>Description</b>	Vegetation and undefined drain impeding overland flow.
<b>Photo ID</b>	735
<b>Scope of Works</b>	M - Vegetation is to be slashed to a nominal height of 50 mm above ground with the exception of large, established trees of height in excess of 5 m, which shall remain.

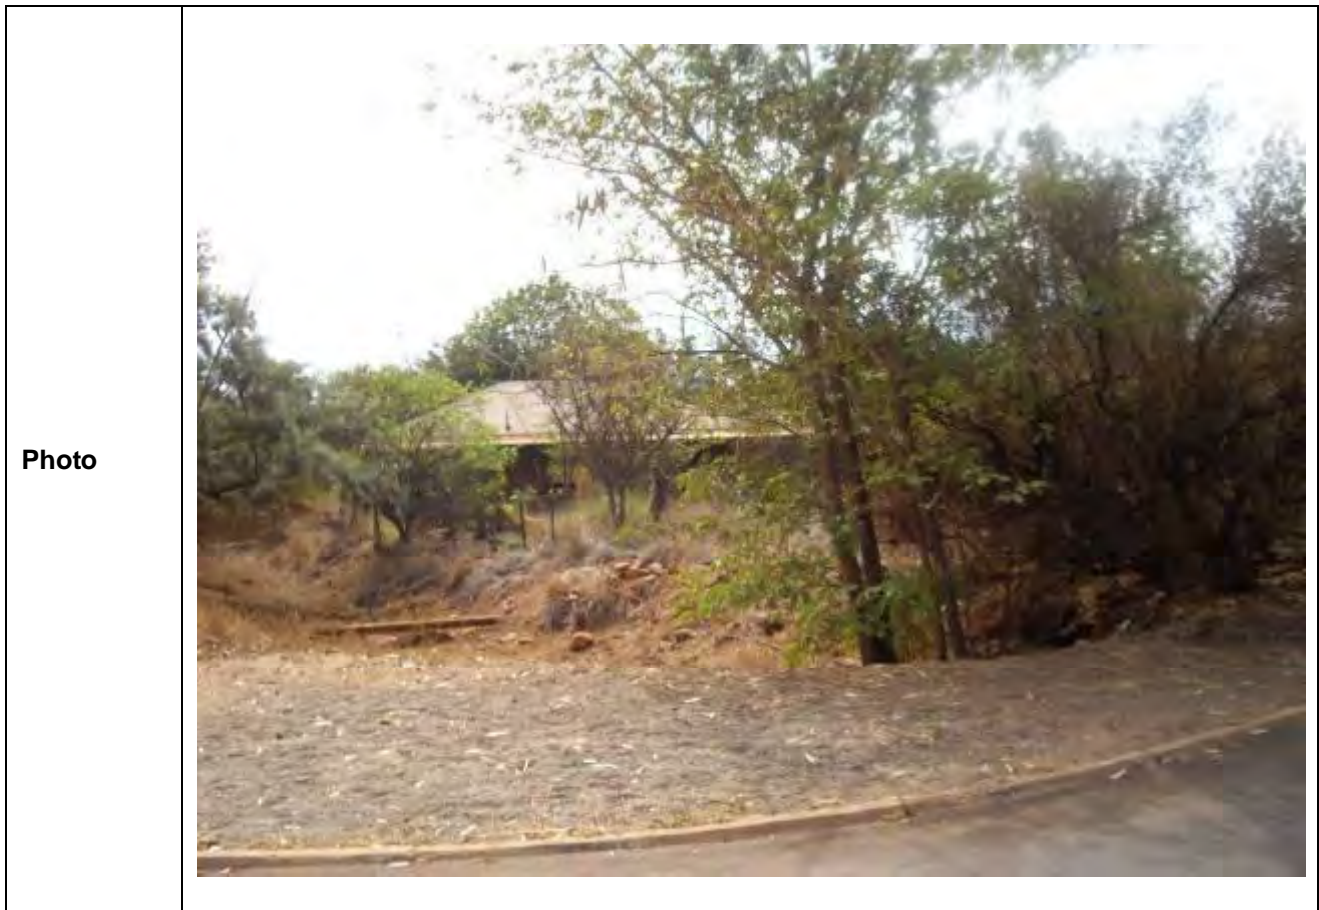
### 6.3 Lot No. 3,025 Maitland Road

<b>Category</b>	Encroachment
<b>Type</b>	Boundary extension; Vegetation; Side access.
<b>Description</b>	Fence; Unmaintained vegetation at top catchment; Side access in form of walk bridge over drain.
<b>Photo ID</b>	434 & 435
<b>Scope of Works</b>	H - Remove fence and relocate to within property boundary – confirmation required from survey. boundary; H - Vegetation is to be slashed to a nominal height of 50 mm above ground with the exception of large, established trees of height in excess of 5 m, which shall remain. M – Remove side access

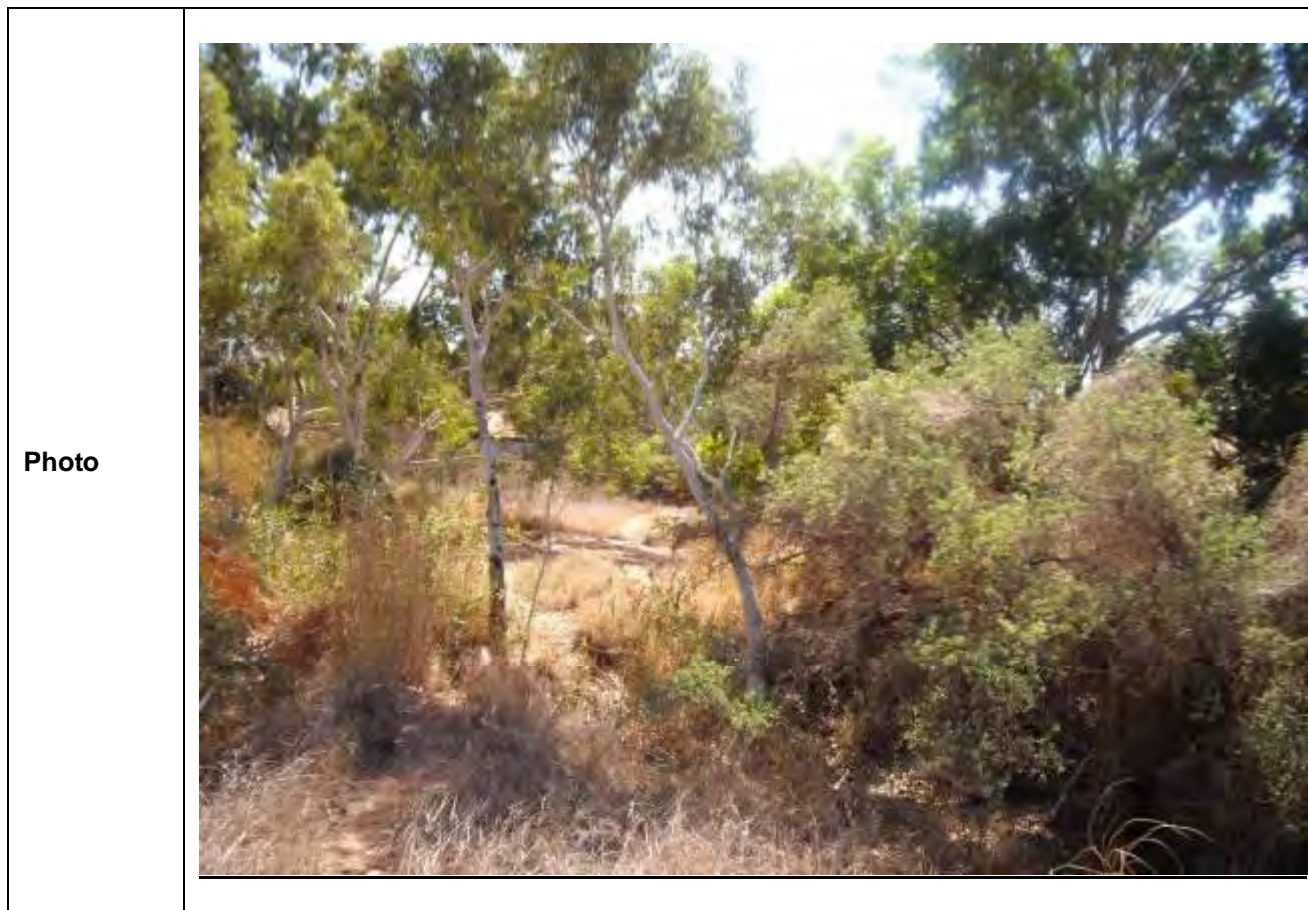
#### 6.4 Lot No. 25 De Grey Crescent

<b>Category</b>	Drain Maintenance
<b>Type</b>	Vegetation
<b>Description</b>	Dense vegetation impeding flow.
<b>Photo ID</b>	372
<b>Scope of Works</b>	H - Vegetation is to be slashed to a nominal height of 50 mm above ground with the exception of large, established trees of height in excess of 5 m, which shall remain.

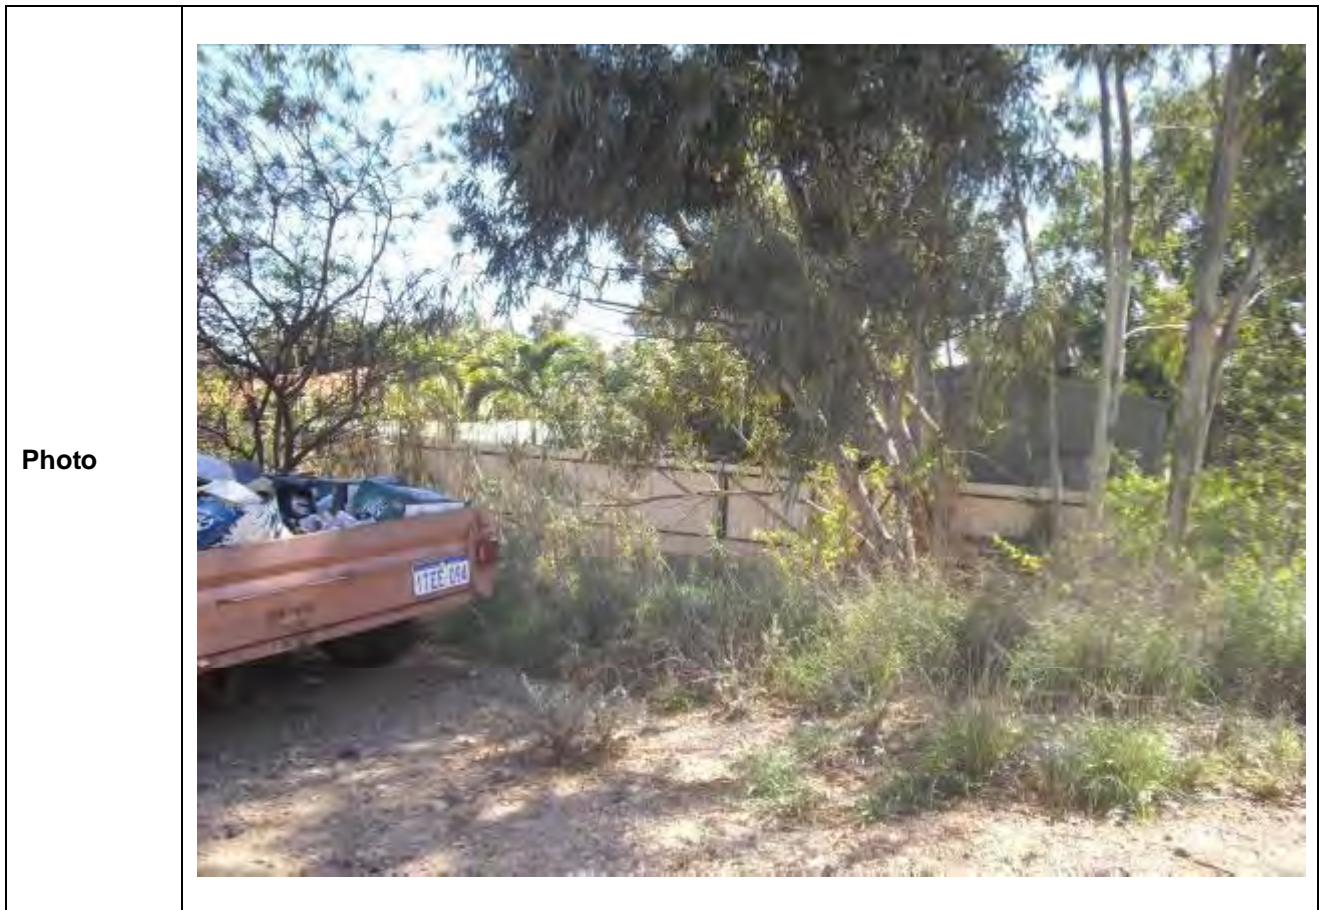
## 6.5 Lot No. 26 De Grey Crescent

<b>Category</b>	Drain Maintenance
<b>Type</b>	Flow path
<b>Description</b>	Natural flow path requires maintenance.
<b>Photo ID</b>	734
<b>Scope of Works</b>	M – Slash vegetation and reinstate drainage flow path as defined by the natural channel invert of downstream channel

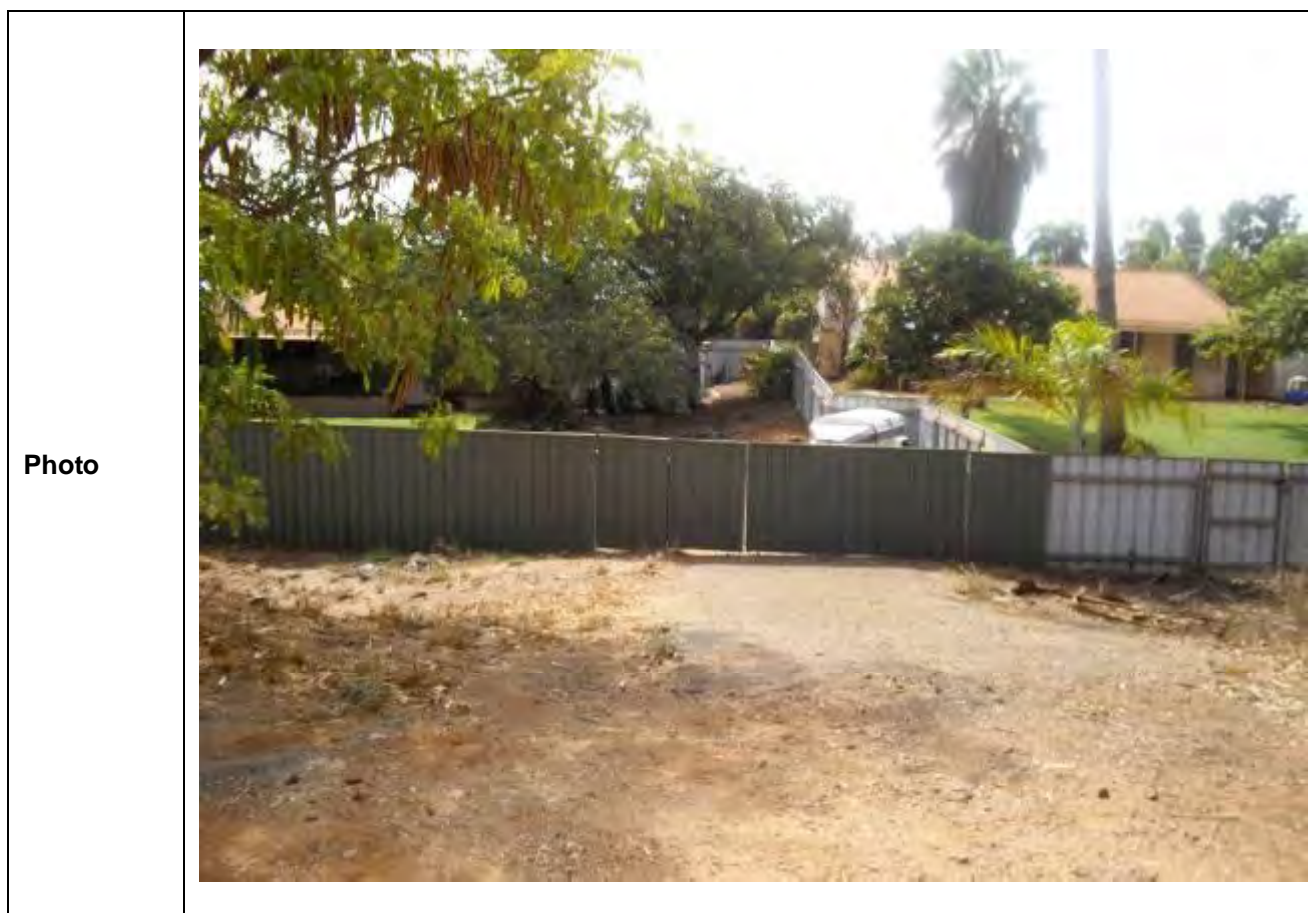
## 6.6 Lot No. 27 De Grey Crescent

<b>Category</b>	Encroachment
<b>Type</b>	Rear access.
<b>Description</b>	Rear access follows modified topography and impedes flow.
<b>Photo ID</b>	433
<b>Scope of Works</b>	H – Remove rear access reinstate drainage flow path as defined by the natural channel invert of downstream channel

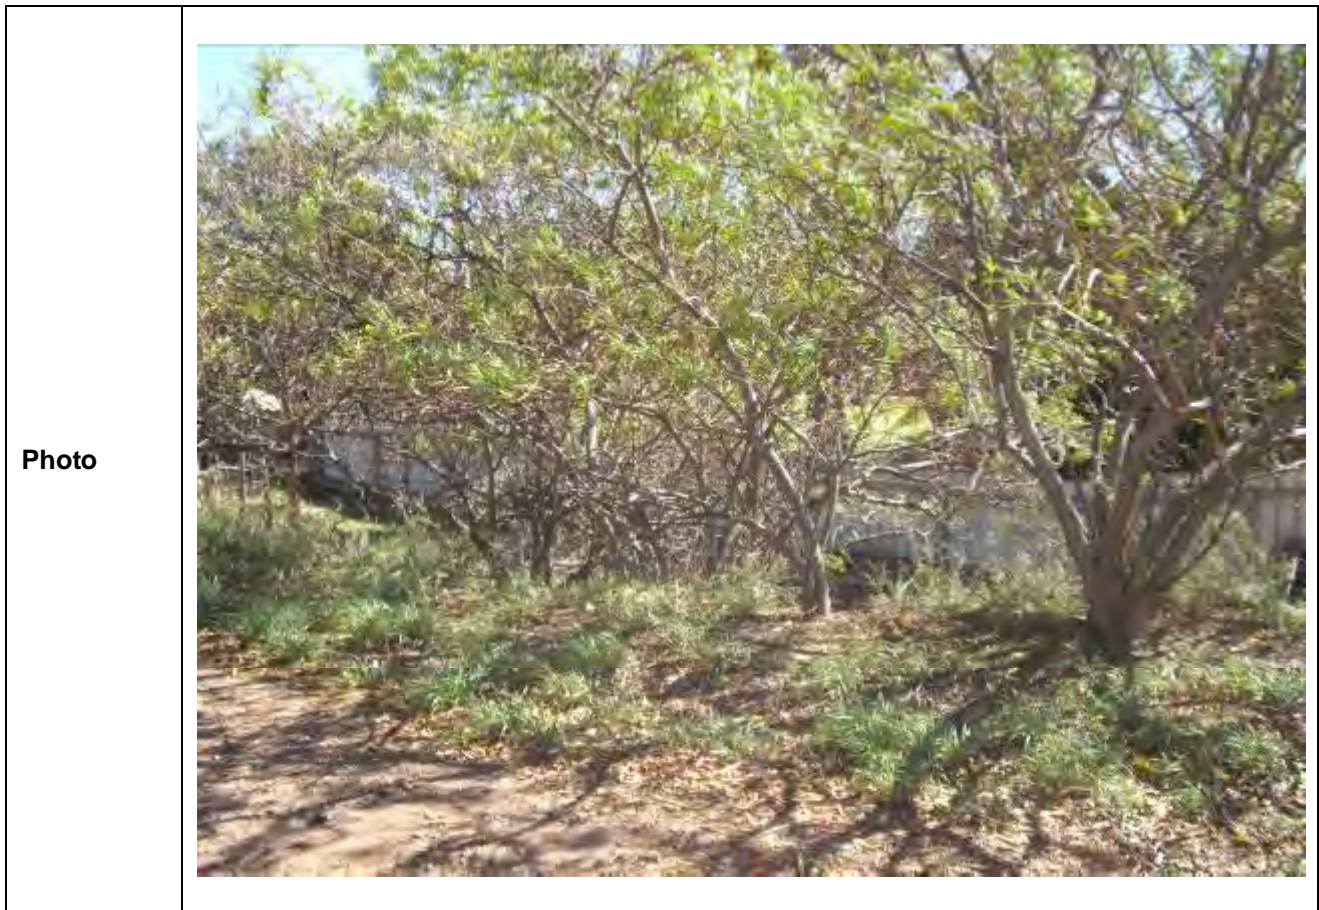
## 6.7 Lot No. 28 De Grey Crescent

<b>Category</b>	Drain Maintenance
<b>Type</b>	Flow path
<b>Description</b>	Natural flow path requires maintenance.
<b>Photo ID</b>	733
<b>Scope of Works</b>	M – Slash vegetation and reinstate drainage flow path as defined by the natural channel invert of downstream channel

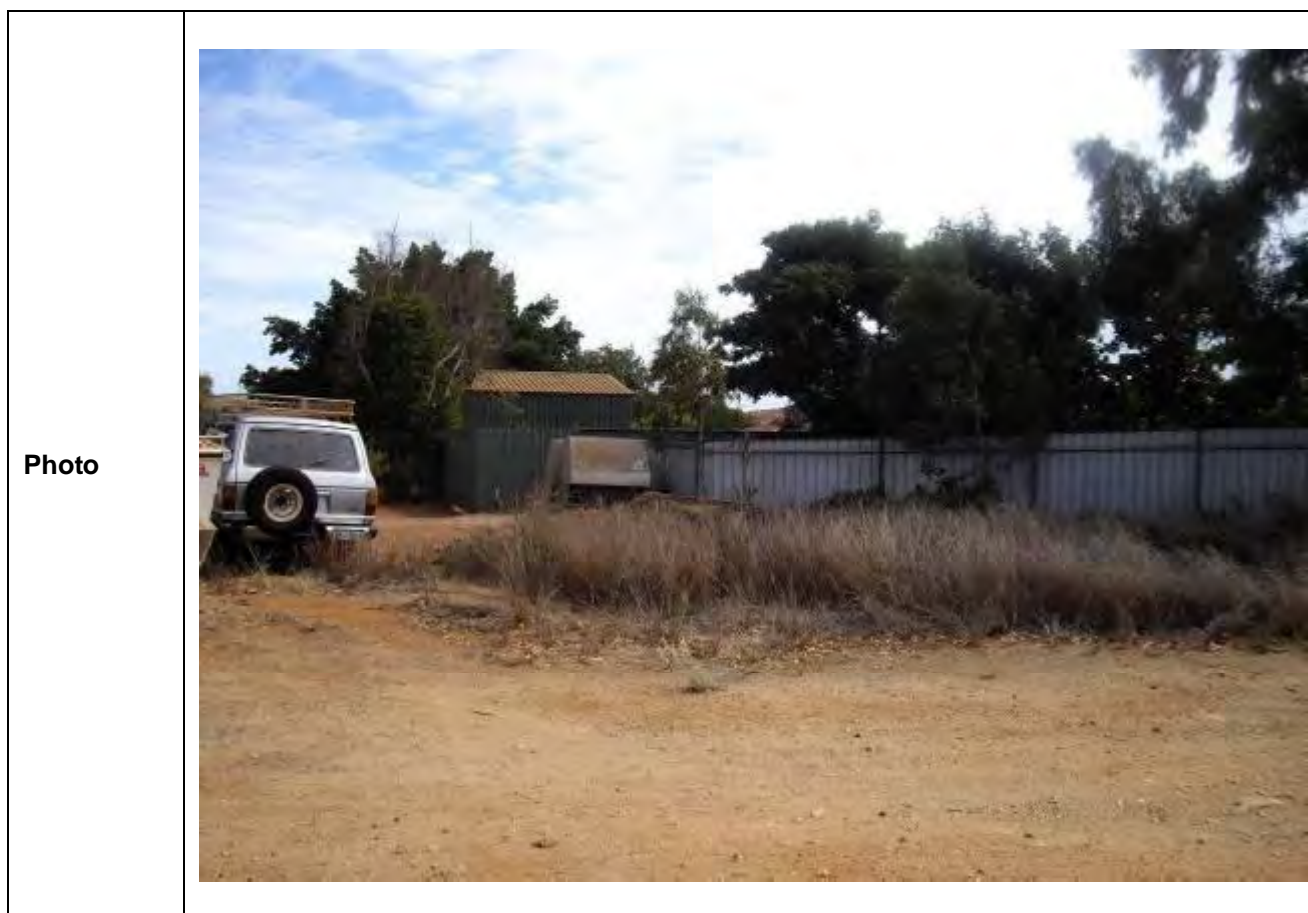
## 6.8 Lot No. 29 De Grey Crescent

<b>Category</b>	Encroachment / Drain Maintenance
<b>Type</b>	Rear access Flow path
<b>Description</b>	Rear access follows modified topography Ill defined flow path due to the modification of the drainage reserve..
<b>Photo ID</b>	432
<b>Scope of Works</b>	H - Remove rear access and reinstate drainage flow path as defined by the natural channel invert of downstream channel (lot 28); H – Design and construction of drainage flow path required.

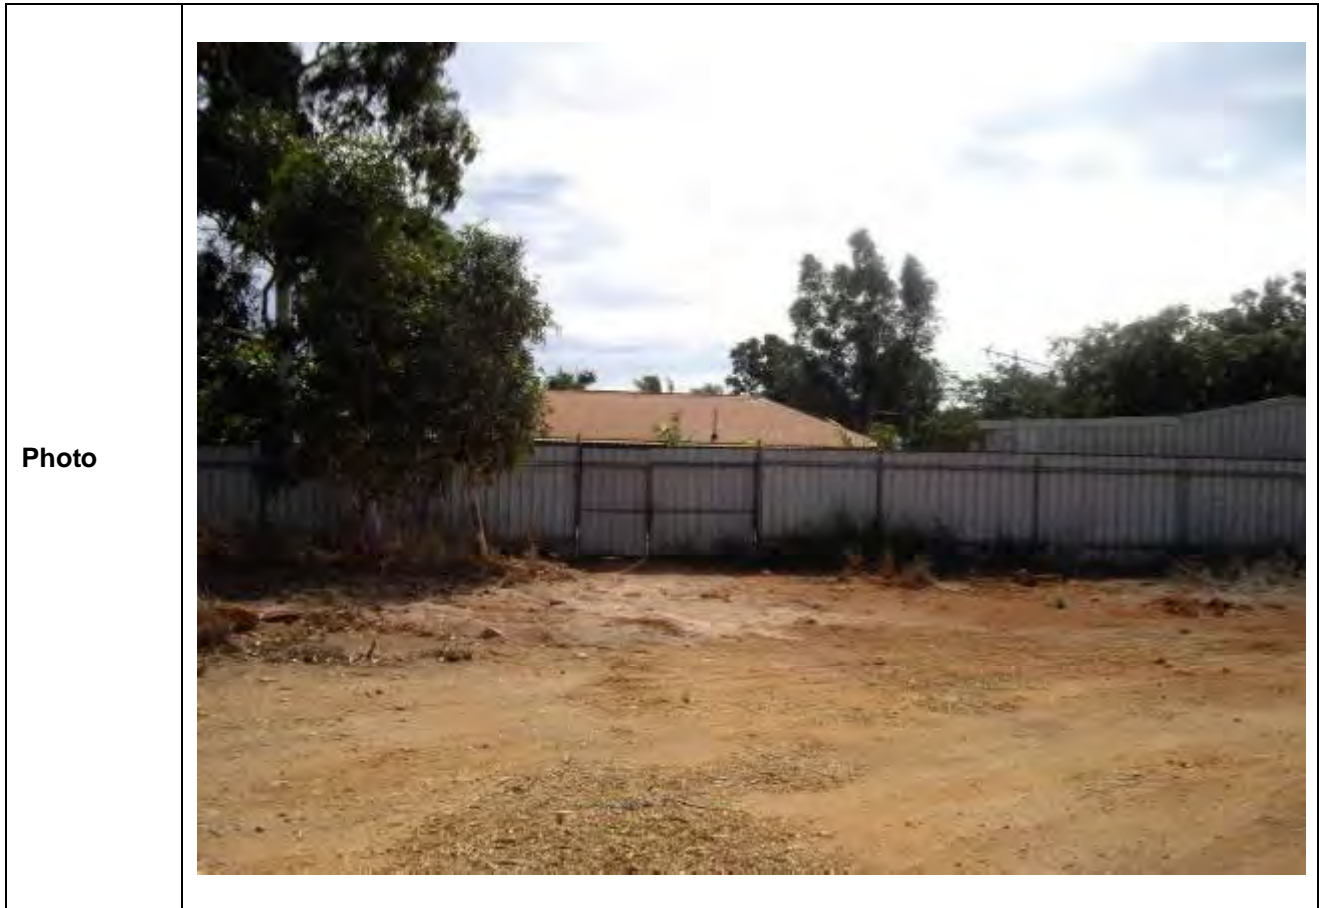
## 6.9 Lot No. 30 De Grey Crescent

<b>Category</b>	Encroachment
<b>Type</b>	Rear access Flow path
<b>Description</b>	Rear access follow modified topography Ill defined flow path due to the modification of the drainage reserve. Top of catchment
<b>Photo ID</b>	431
<b>Scope of Works</b>	L – Remove rear access (no other works required)

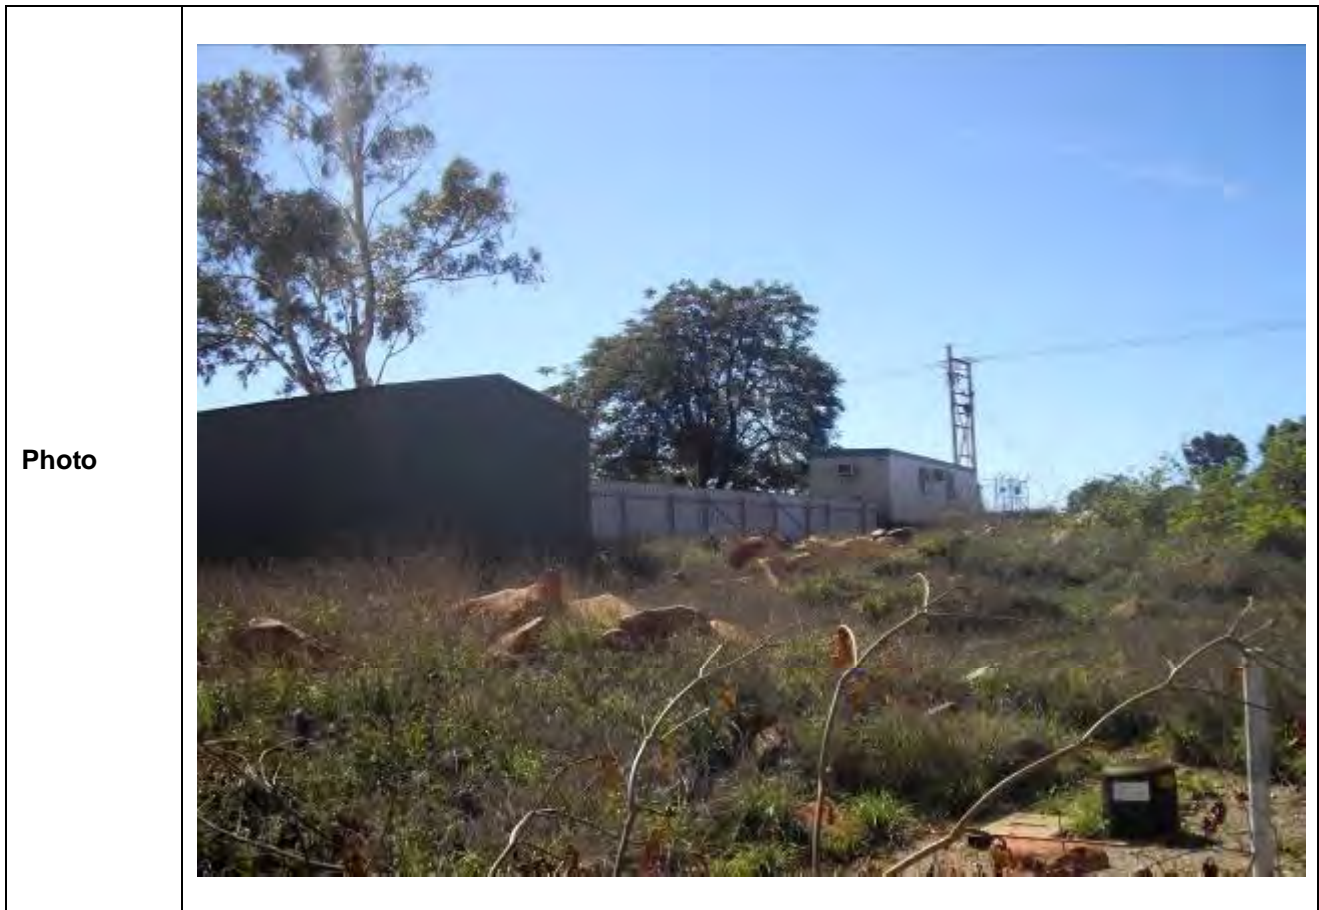
## 6.10 Lot No. 31 De Grey Crescent

<b>Category</b>	None
<b>Type</b>	Flow path
<b>Description</b>	Natural topography directs stormwater to the road reserve and the drainage reserve. No evidence of modification.
<b>Photo ID</b>	730 – photo of property with green shed.
<b>Scope of Works</b>	None required

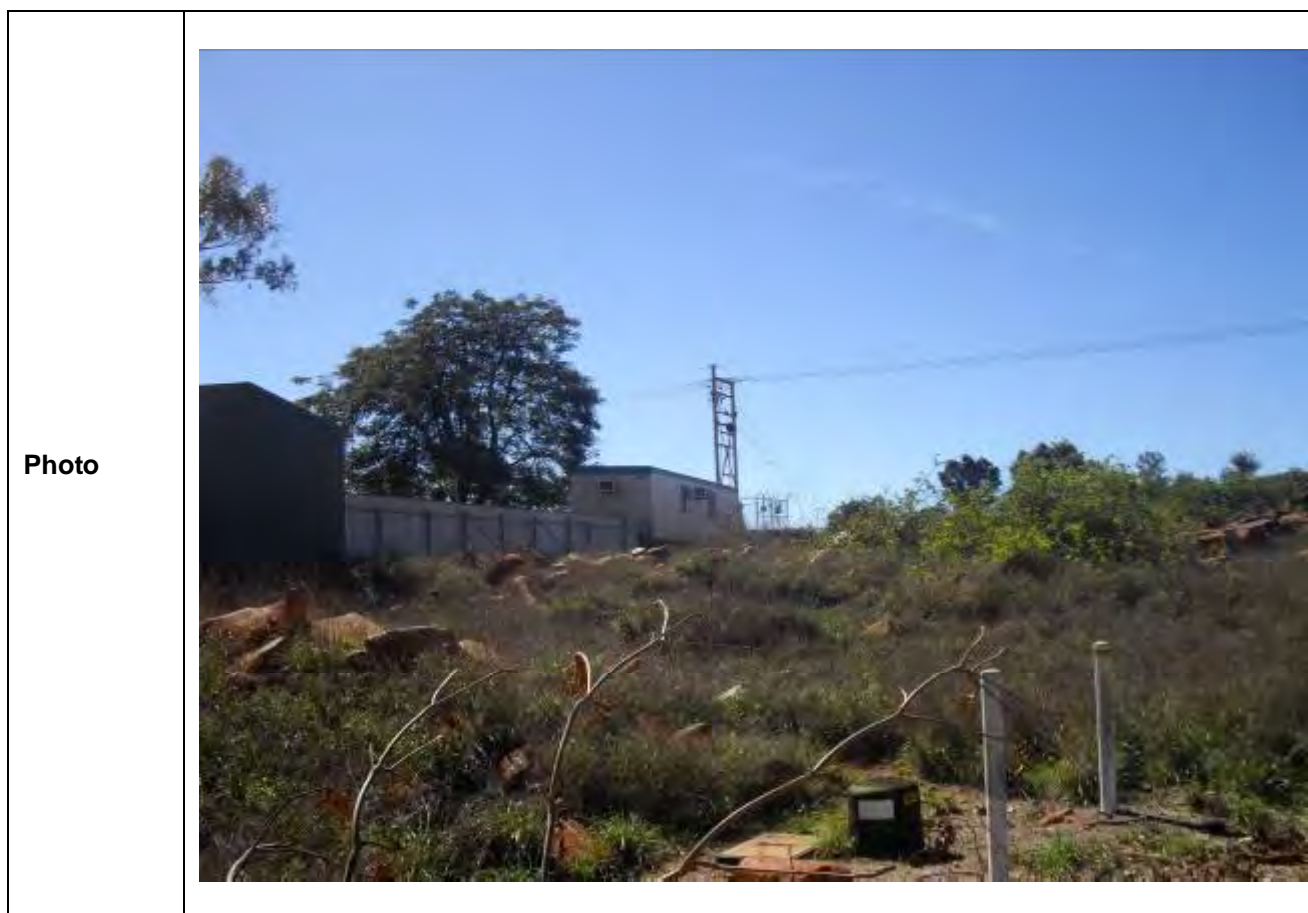
## 6.11 Lot No. 32 De Grey Crescent

<b>Category</b>	Encroachment
<b>Type</b>	Boundary extension Flow path
<b>Description</b>	'Donga' located within drainage reserve Natural topography directs stormwater to the road reserve and the drainage reserve. No evidence of modification.
<b>Photo ID</b>	731 – photo of property with 'donga'
<b>Scope of Works</b>	L – Remove 'Donga' and relocate to within property boundary.

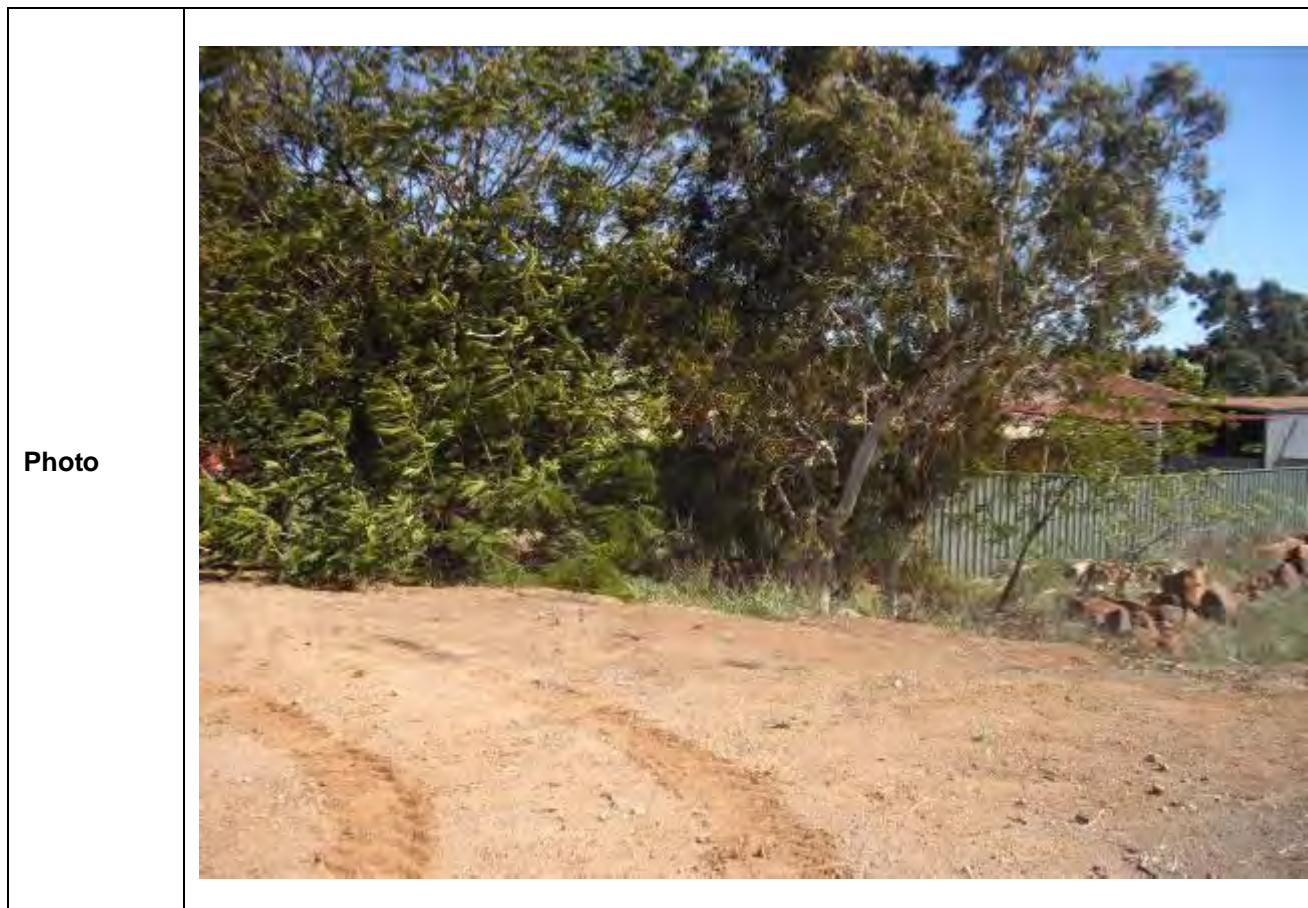
## 7.1 Lot No. 2,033 Ashburton Crescent

<b>Category</b>	Drain Maintenance/ Encroachment
<b>Type</b>	Vegetation; Ill defined flow path; Boundary extension.
<b>Description</b>	Dense vegetation impeding flow; Top of catchment - flow path adequate Fence is within drainage reserve at south-eastern corner – see aerial
<b>Photo ID</b>	712
<b>Scope of Works</b>	L - Vegetation is to be slashed to a nominal height of 50 mm above ground with the exception of large, established trees of height in excess of 5 m, which shall remain; L – Remove existing fence and relocate to within property boundary.
