City of Karratha  
Dampier Stormwater Management Study  
Report  
Part B  
June 2015

## Appendix **C** – 2010 encroachment reviews

**Rio Tinto Iron Ore**  
Report on Dampier Drainage  
Review  
Block 1 Encroachments  
June 2010

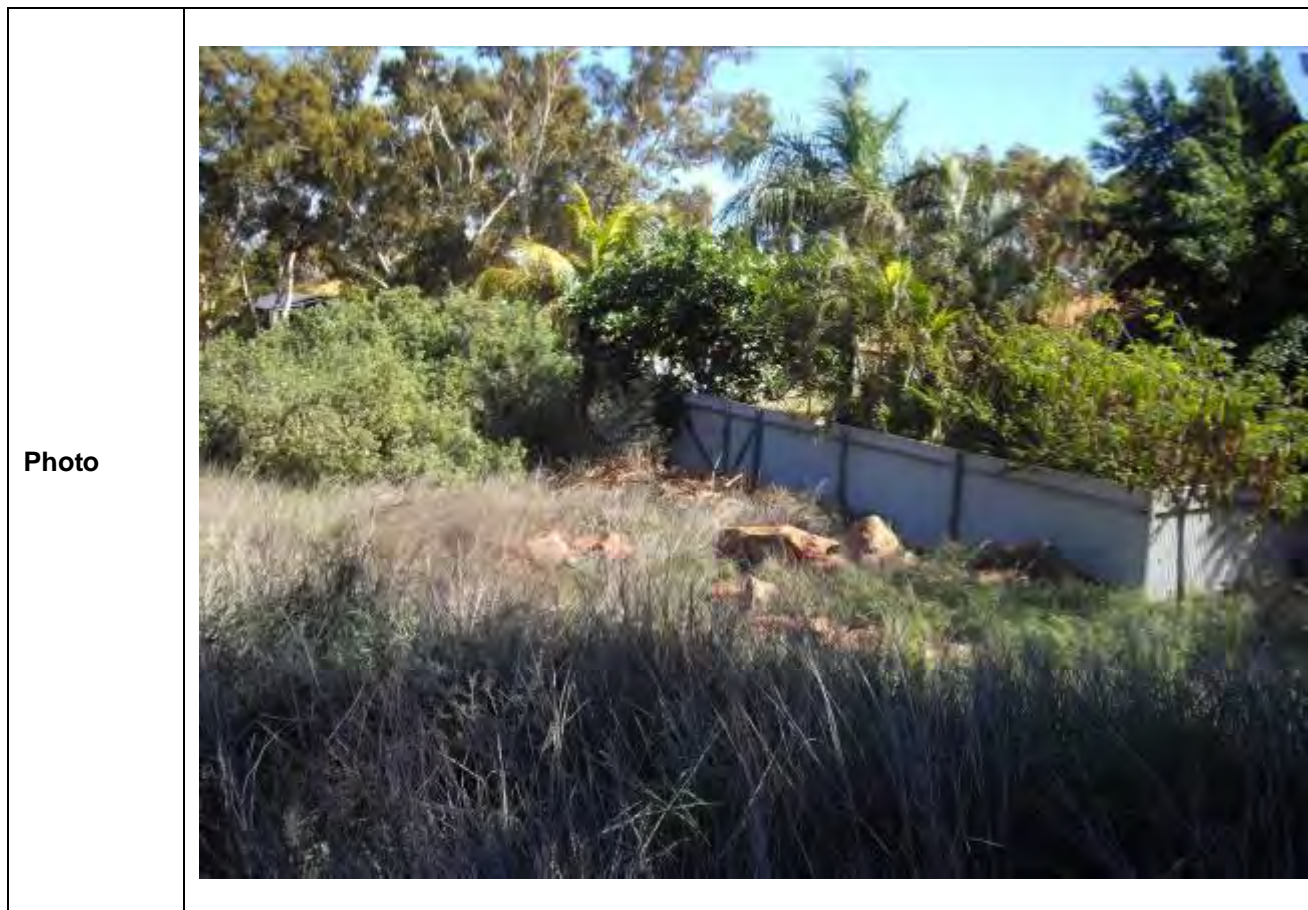
## 7.2 Lot No. 1,033 Ashburton Crescent

<b>Category</b>	Drain Maintenance
<b>Type</b>	Vegetation
<b>Description</b>	Thick low lying vegetation;
<b>Photo ID</b>	713
<b>Scope of Works</b>	H - Vegetation is to be slashed to a nominal height of 50 mm above ground with the exception of large, established trees of height in excess of 5 m, which shall remain.

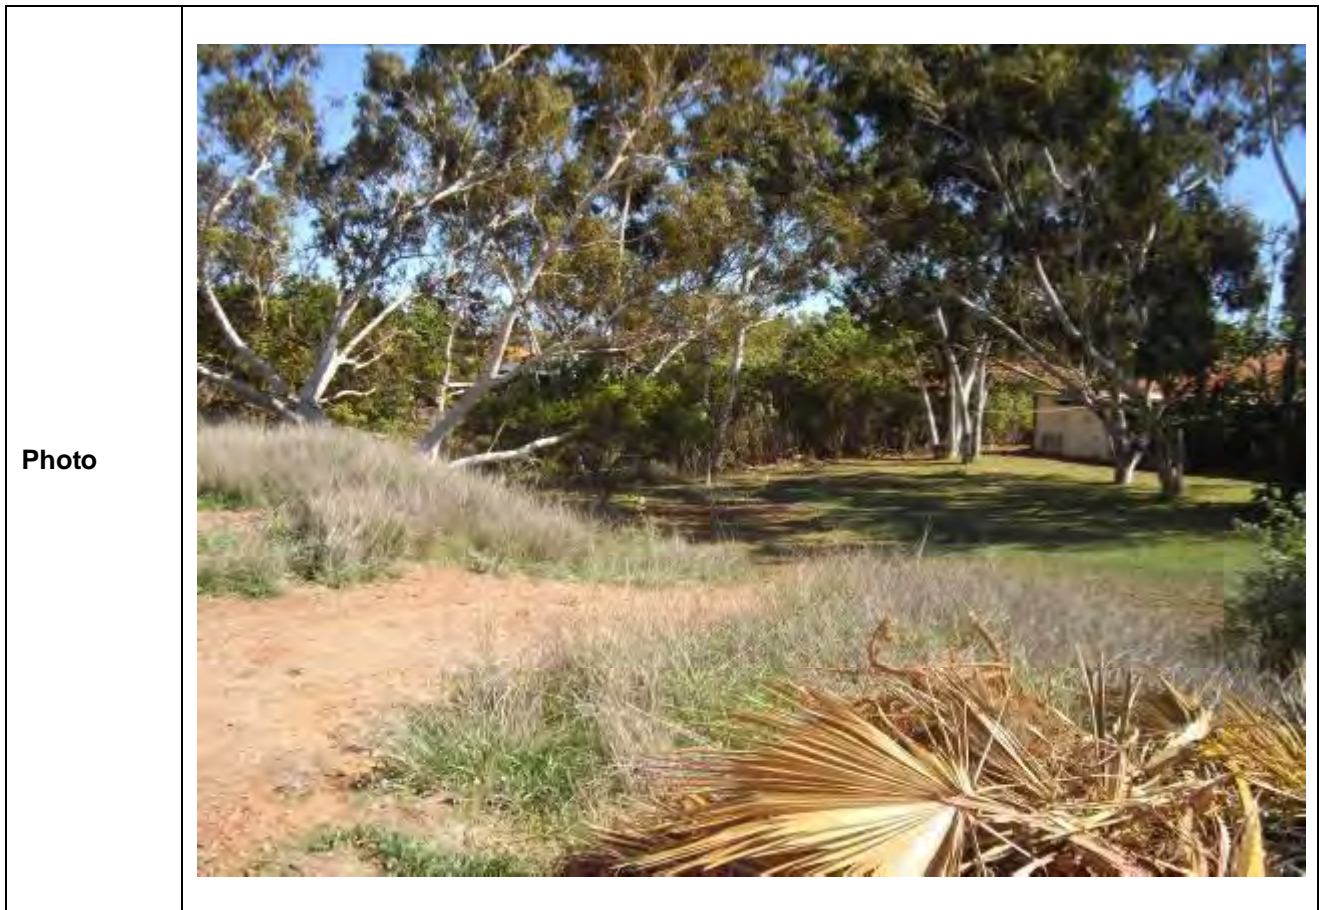
### 7.3 Lot No. 33 Ashburton Crescent

<b>Category</b>	Encroachment / Drain Maintenance
<b>Type</b>	Rear access; Vegetation;
<b>Description</b>	Rear access and modified topography. Trees and semi-dense vegetation;
<b>Photo ID</b>	714
<b>Scope of Works</b>	H - Remove rear access and reinstate drainage flow path as defined by the natural channel invert of downstream channel; L - Vegetation is to be slashed to a nominal height of 50 mm above ground with the exception of large, established trees of height in excess of 5 m, which shall remain.

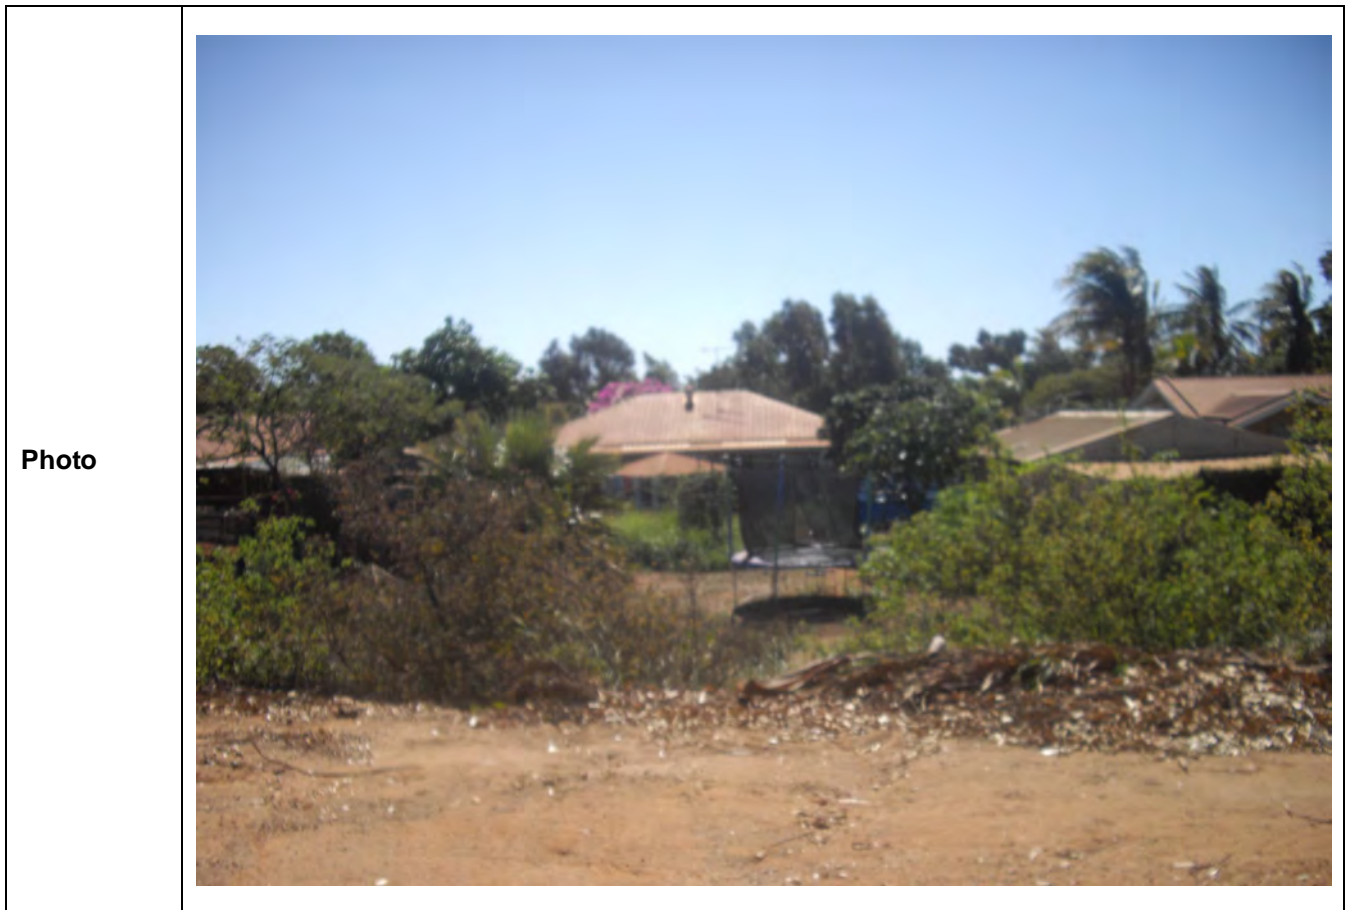
## 7.6 Lot No. 36 Ashburton Crescent

<b>Category</b>	Encroachment
<b>Type</b>	General items Flow path
<b>Description</b>	Mostly rubbish; Drainage flow path low point is within the property boundary.
<b>Photo ID</b>	1027, 444
<b>Scope of Works</b>	L - Remove rubbish; H - Reinststate drainage flow path within reserve as defined by the natural channel invert of downstream channel.

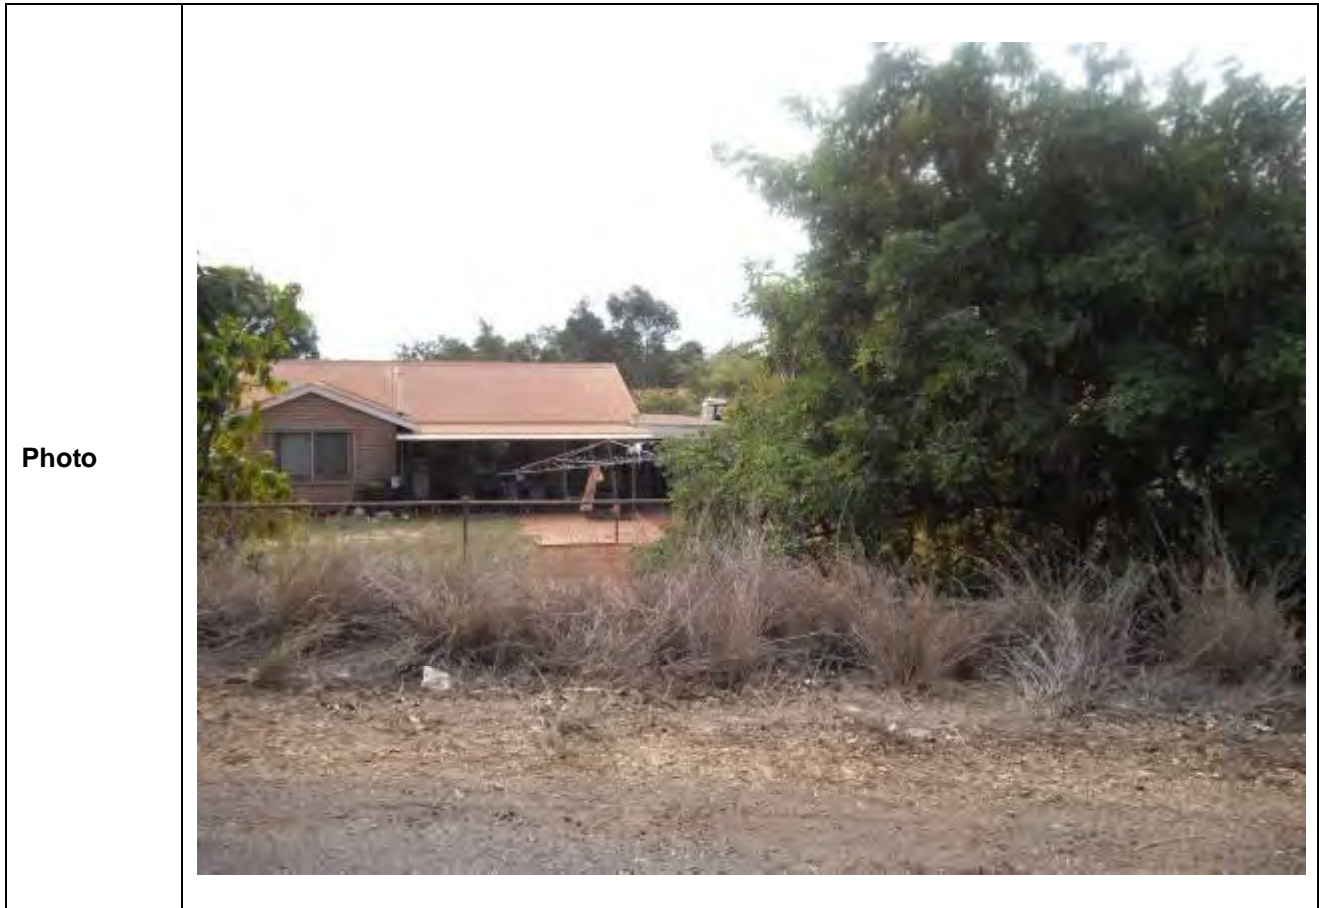
## 7.7 Lot No. 37 Ashburton Crescent

<b>Category</b>	Encroachment
<b>Type</b>	General items; Vegetation
<b>Description</b>	Rubbish Dense vegetation impedes flow
<b>Photo ID</b>	445
<b>Scope of Works</b>	L - Remove general rubbish; M - Vegetation is to be slashed to a nominal height of 50 mm above ground with the exception of large, established trees of height in excess of 5 m, which shall remain.

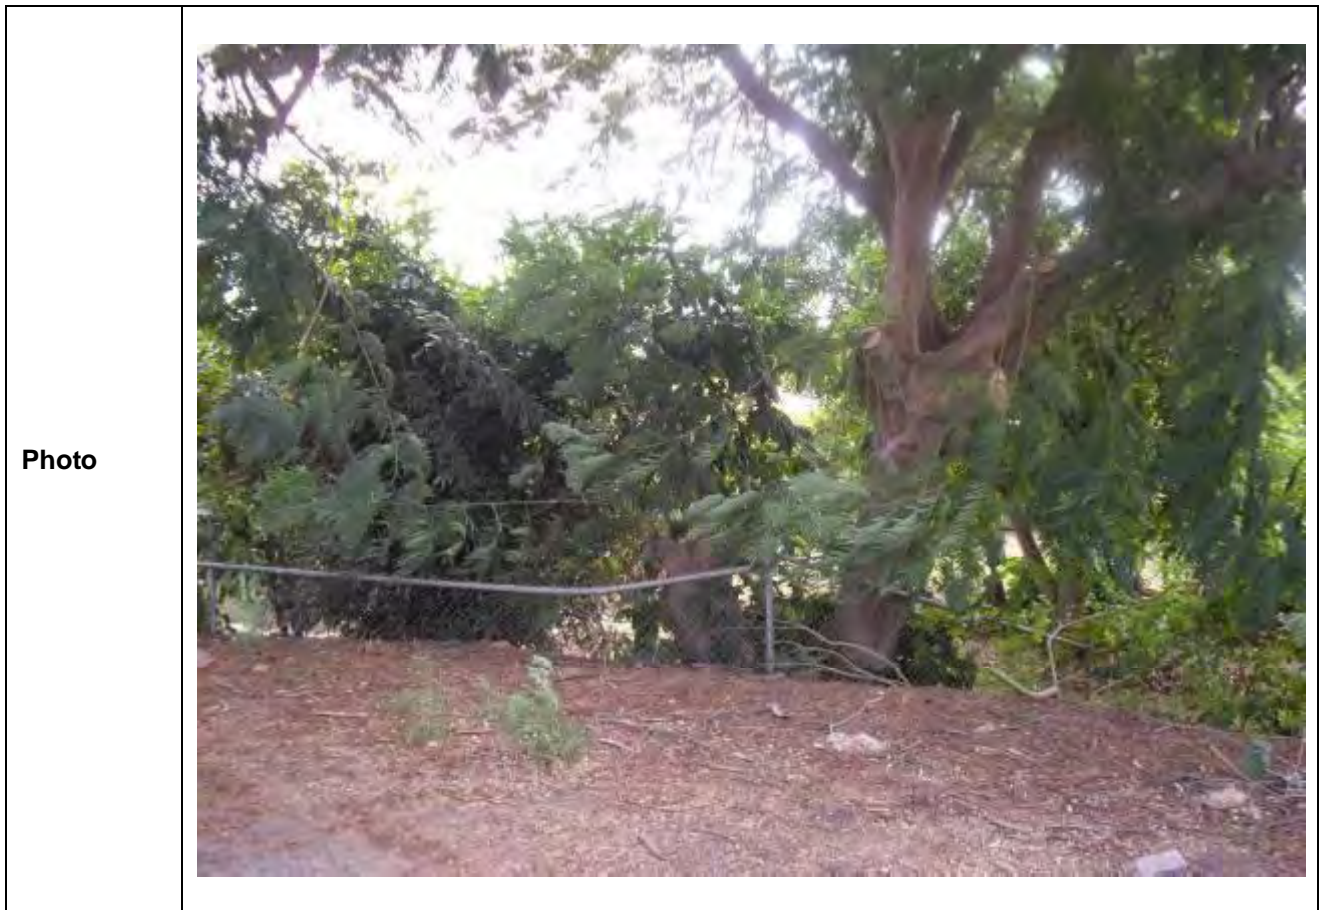
## 7.8 Lot No. 38 Ashburton Crescent

<b>Category</b>	Encroachment
<b>Type</b>	Boundary extension Flow path.
<b>Description</b>	Boundary fence is close to the road reserve; No flow path within small drainage reserve for major flow.
<b>Photo ID</b>	446
<b>Scope of Works</b>	L – Remove fence and relocate to within property boundary. H - Reinststate drainage flow path within reserve as defined by the natural channel invert of downstream channel

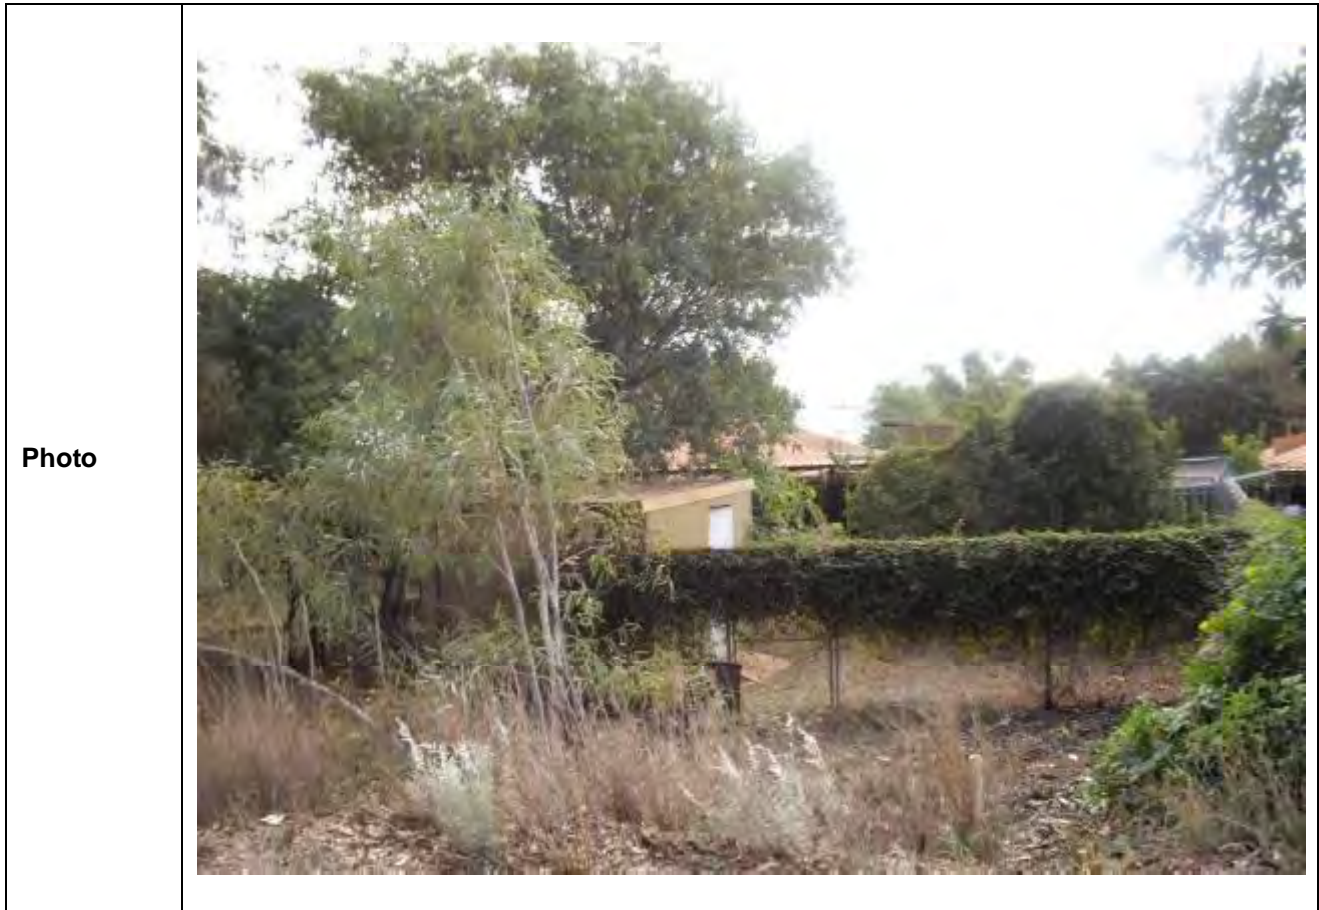
**7.9 Lot No. 39 Ashburton Crescent**

<b>Category</b>	Drain Maintenance
<b>Type</b>	Flow path
<b>Description</b>	Flow towards lots..
<b>Photo ID</b>	447
<b>Scope of Works</b>	H - Reinststate drainage flow path within reserve as defined by the natural channel invert of downstream channel

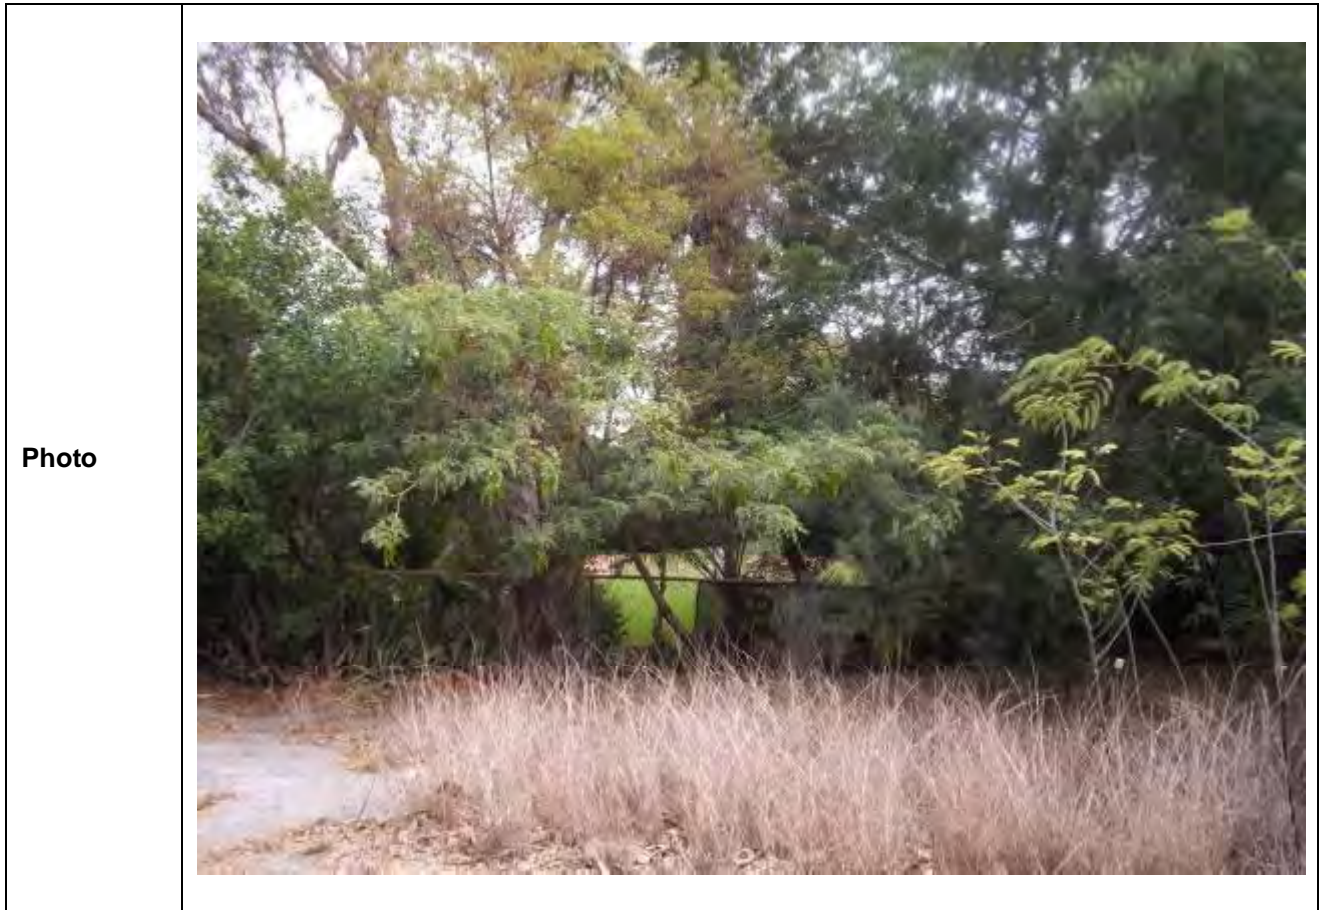
### 7.10 Lot No. 40 Ashburton Crescent

<b>Category</b>	Drain Maintenance
<b>Type</b>	Flow path
<b>Description</b>	Flow towards lots, boundary close to road.
<b>Photo ID</b>	448
<b>Scope of Works</b>	H - Reinststate drainage flow path within reserve as defined by the natural channel invert of downstream channel

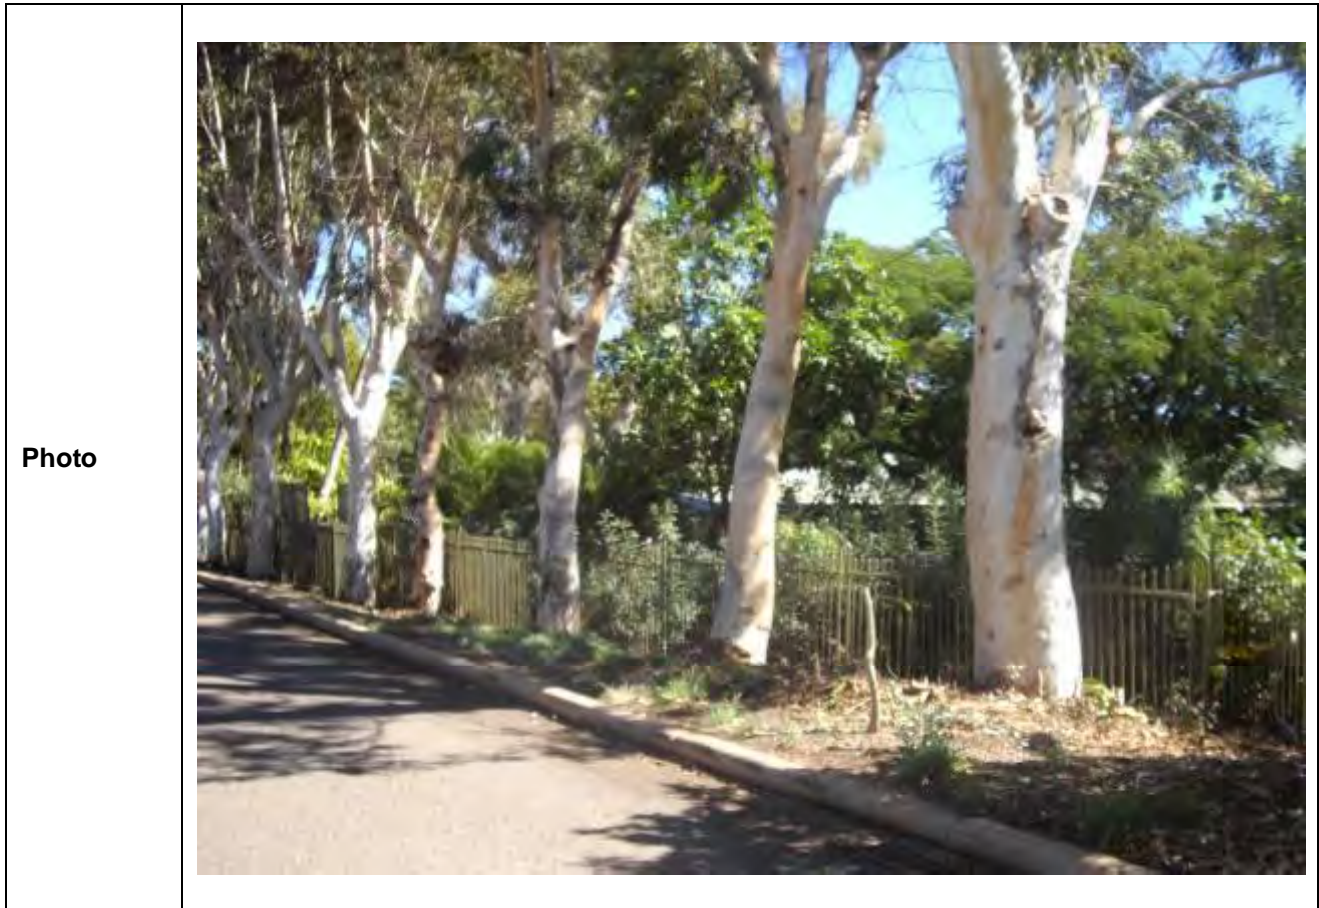
## 8.1 Lot No. 1,040 Yannarie Crescent

<b>Category</b>	Drain Maintenance/ Encroachment
<b>Type</b>	Flow path; Boundary encroachment
<b>Description</b>	Kerb and channel on both sides of road. No flow path within drainage reserve, road conveys stormwater from upslope lots Possible boundary encroachment from fence
<b>Photo ID</b>	729
<b>Scope of Works</b>	H - Remove existing fence and relocate to within property boundary – get confirmation from survey

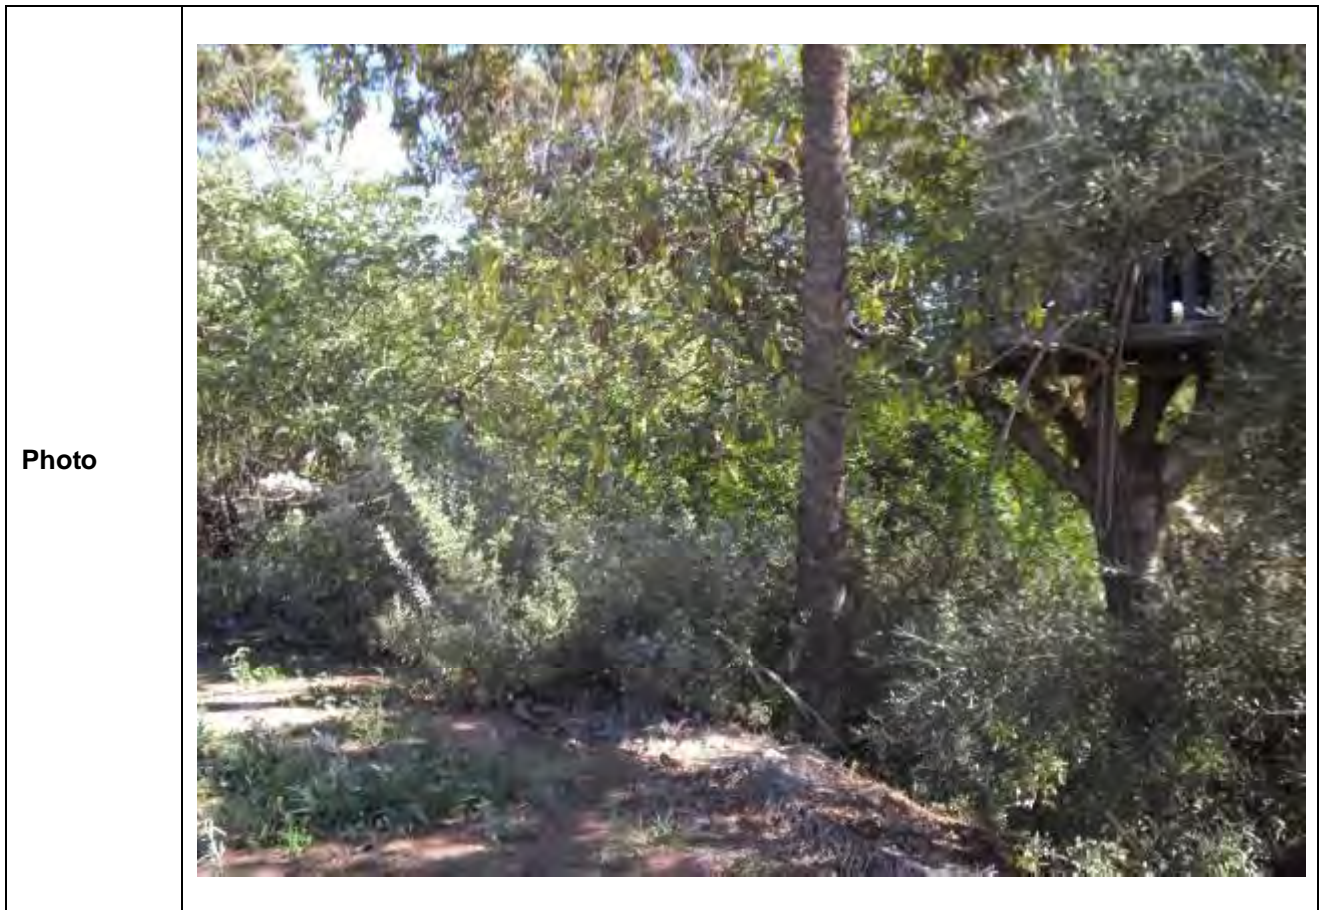
## 8.2 Lot No. 41 Yannarie Crescent

<b>Category</b>	Drain Maintenance
<b>Type</b>	Flow path Vegetation
<b>Description</b>	No East to West flow path within drainage reserve as road conveys runoff. Semi dense vegetation
<b>Photo ID</b>	728
<b>Scope of Works</b>	M - Vegetation is to be slashed to a nominal height of 50 mm above ground with the exception of large, established trees of height in excess of 5 m, which shall remain.

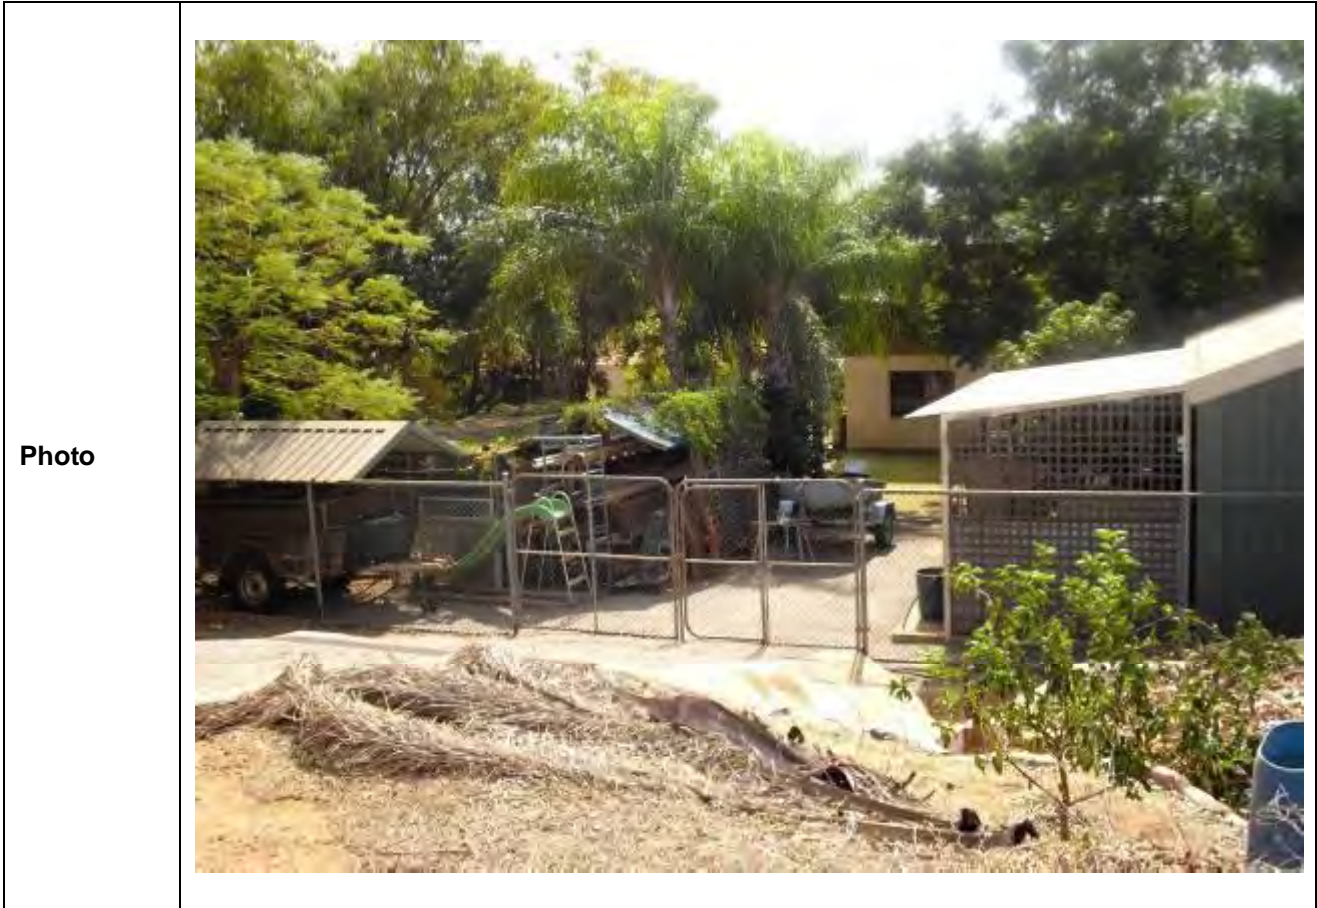
### 8.3 Lot No. 42 Yannarie Crescent

<b>Category</b>	Encroachment
<b>Type</b>	Rear access with culvert
<b>Description</b>	Rear access follows natural topography. Reconstructed channel is adequate
<b>Photo ID</b>	440
<b>Scope of Works</b>	H - Remove rear access.

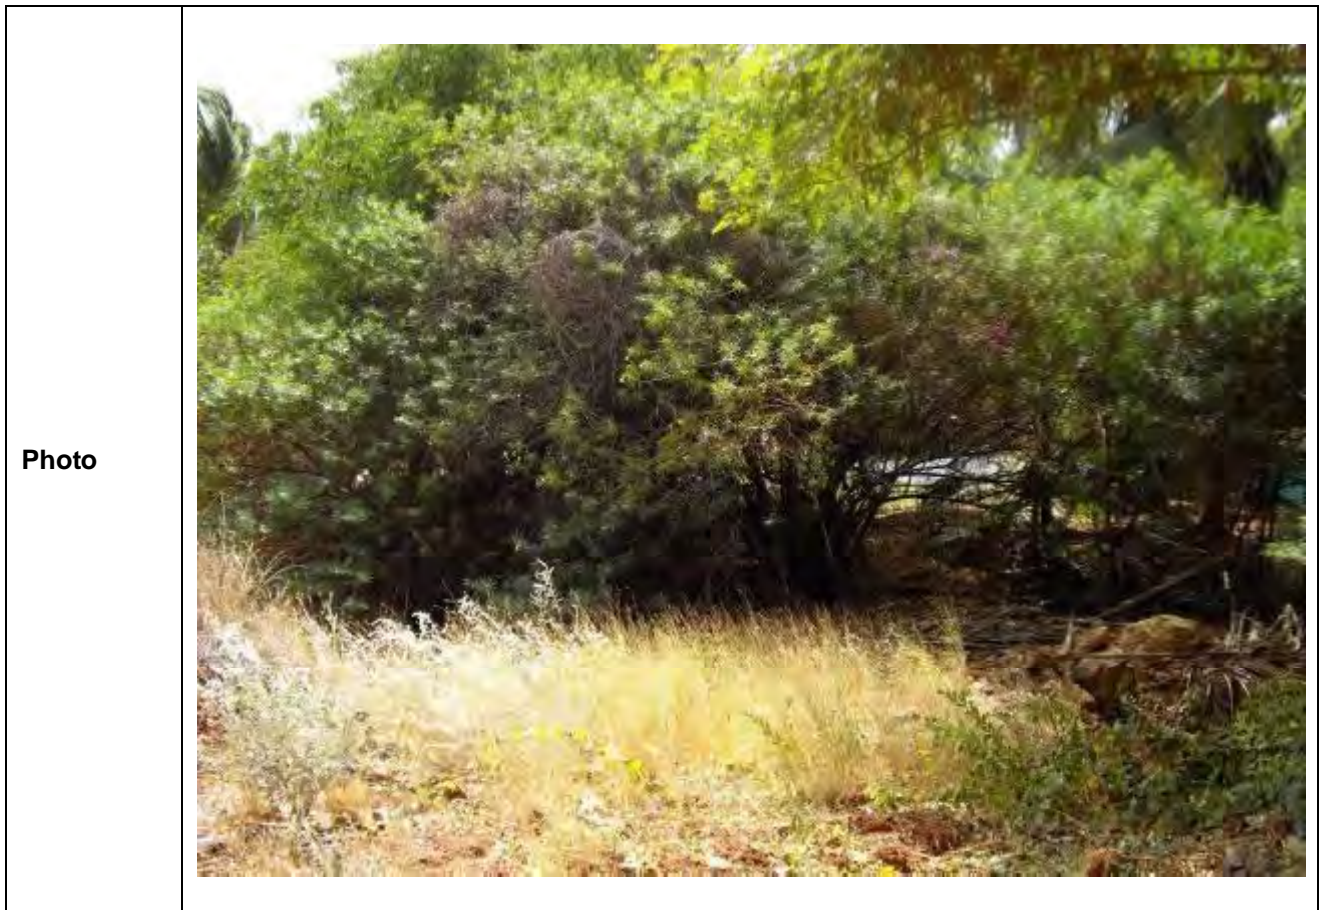
#### 8.4 Lot No. 43 Yannarie Crescent

<b>Category</b>	Encroachment
<b>Type</b>	Modified drain; Vegetation
<b>Description</b>	Drain blocked with imported fill Vegetation impeding flow
<b>Photo ID</b>	439
<b>Scope of Works</b>	M - Remove fill and reinstate drainage flow path as defined by the natural channel invert of downstream channel M - Vegetation is to be slashed to a nominal height of 50 mm above ground with the exception of large, established trees of height in excess of 5 m, which shall remain.

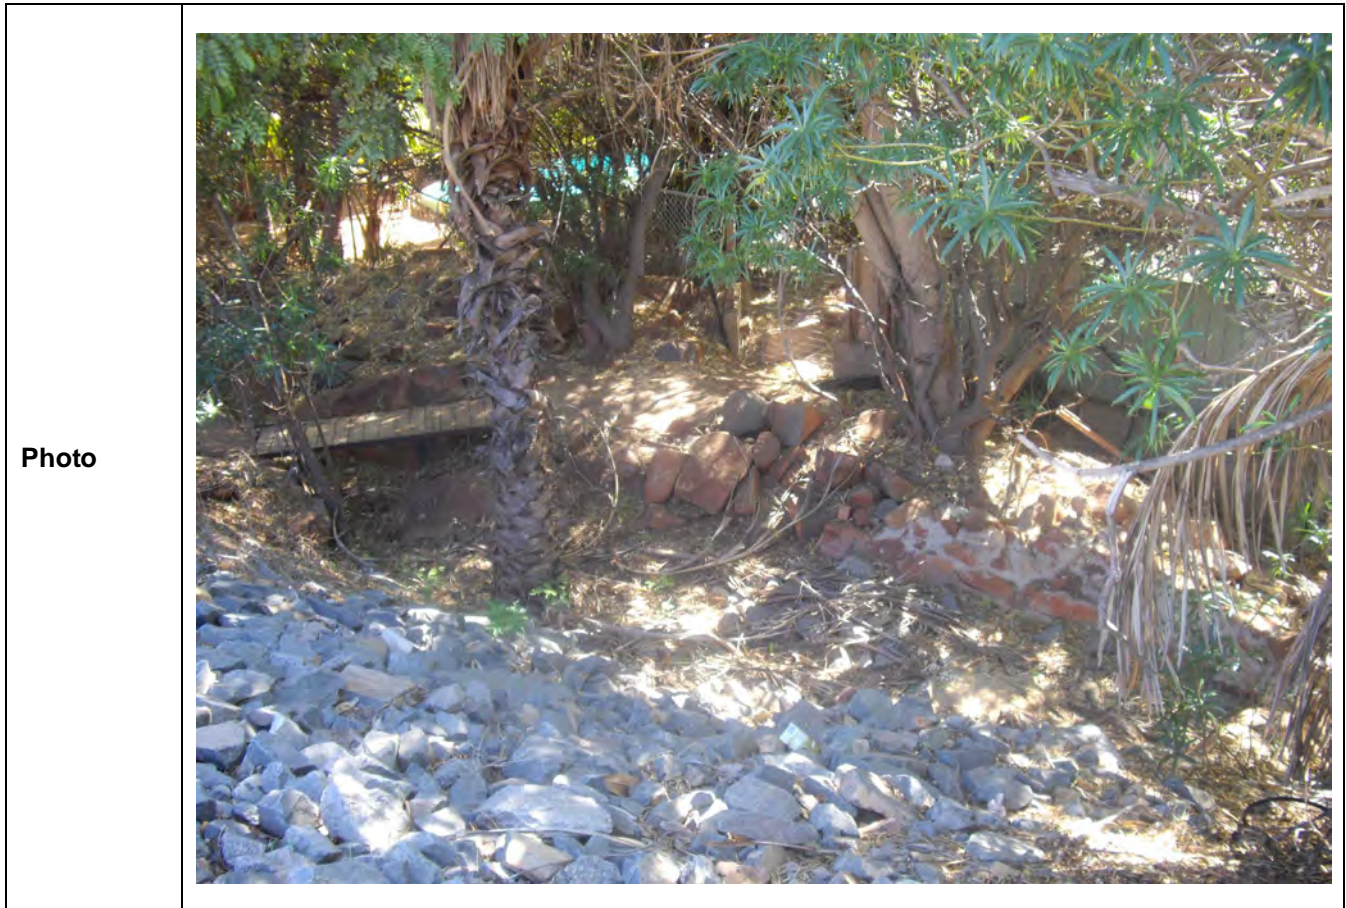
## 8.5 Lot No. 44 Yannarie Crescent

<b>Category</b>	Encroachment / Drain maintenance
<b>Type</b>	Boundary extension; Vegetation Flow Path
<b>Description</b>	Fence; Semi-dense vegetation; Unengineered culvert entry point that may encroach on property.
<b>Photo ID</b>	1028, 438
<b>Scope of Works</b>	L – Remove fence and relocate to within the property boundary; M - Vegetation is to be slashed to a nominal height of 50 mm above ground with the exception of large, established trees of height in excess of 5 m, which shall remain; H - Reinststate drainage flow path within reserve as defined by the natural channel invert of downstream channel

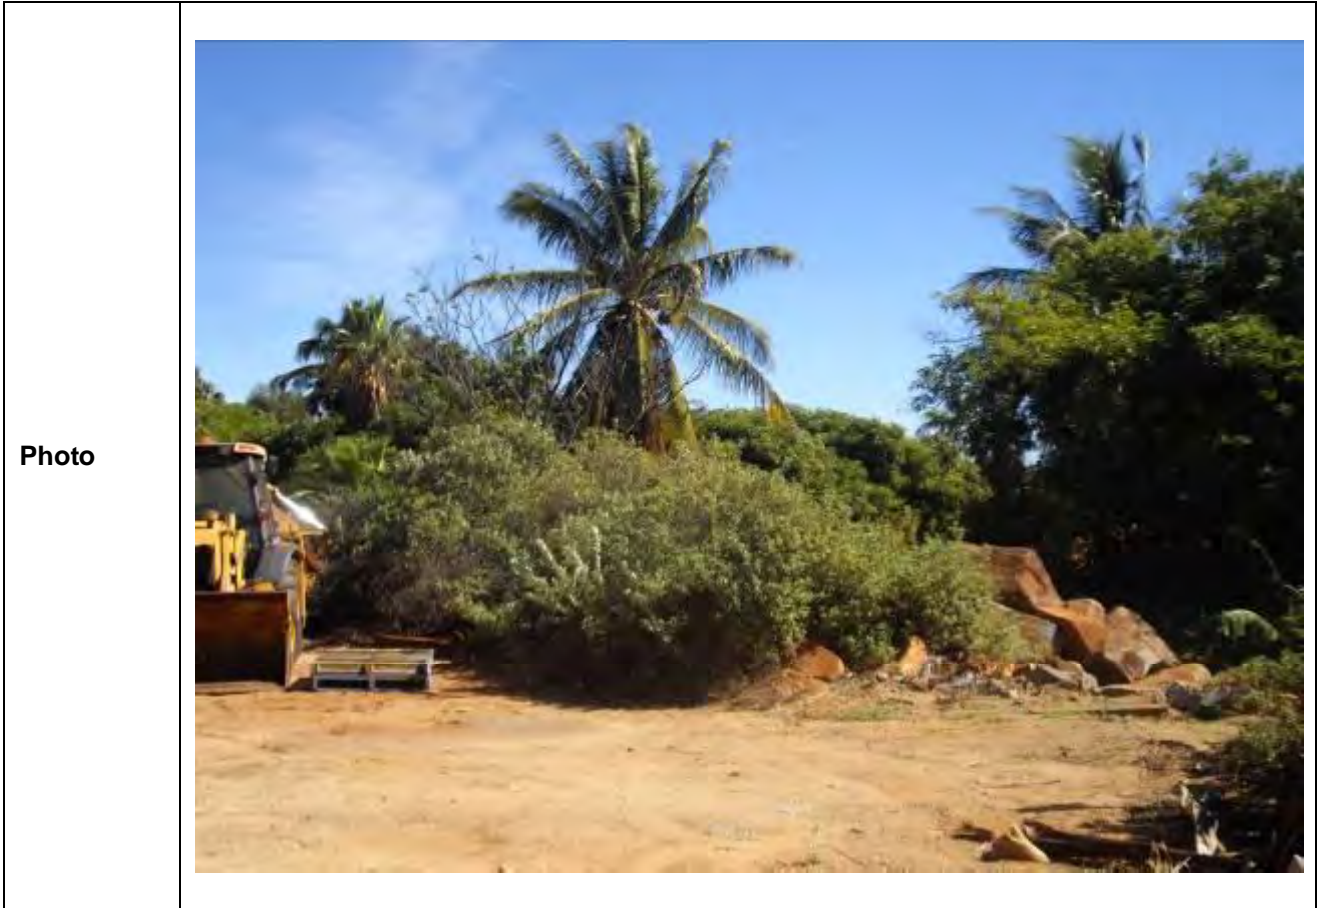
### 8.6 Lot No. 45 Yannarie Crescent

<b>Category</b>	Drain Maintenance
<b>Type</b>	Flow Path Vegetation
<b>Description</b>	No identified flow path Semi dense vegetation
<b>Rank</b>	-
<b>Photo ID</b>	727
<b>Scope of Works</b>	H - Reinststate drainage flow path as defined by the natural channel invert of downstream channel M - Vegetation is to be slashed to a nominal height of 50 mm above ground with the exception of large, established trees of height in excess of 5 m, which shall remain

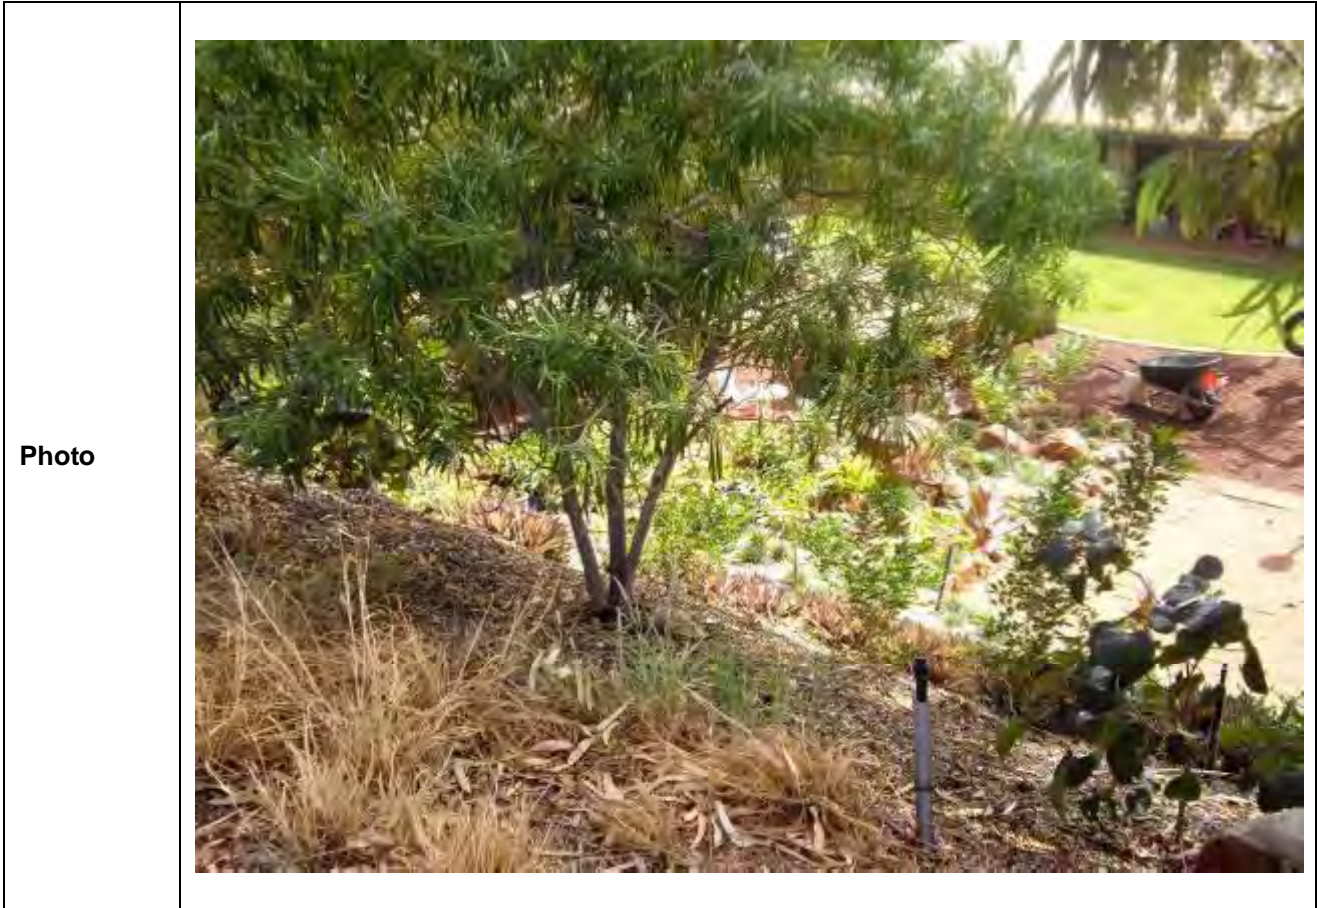
**8.7 Lot No. 46 Yannarie Crescent**

<b>Category</b>	Encroachment
<b>Type</b>	Boundary extension
<b>Description</b>	Rocks, Property gardens extend right up to road
<b>Photo ID</b>	436
<b>Scope of Works</b>	H - Remove rocks and reinstate drainage flow path as defined by the natural channel invert of downstream channel

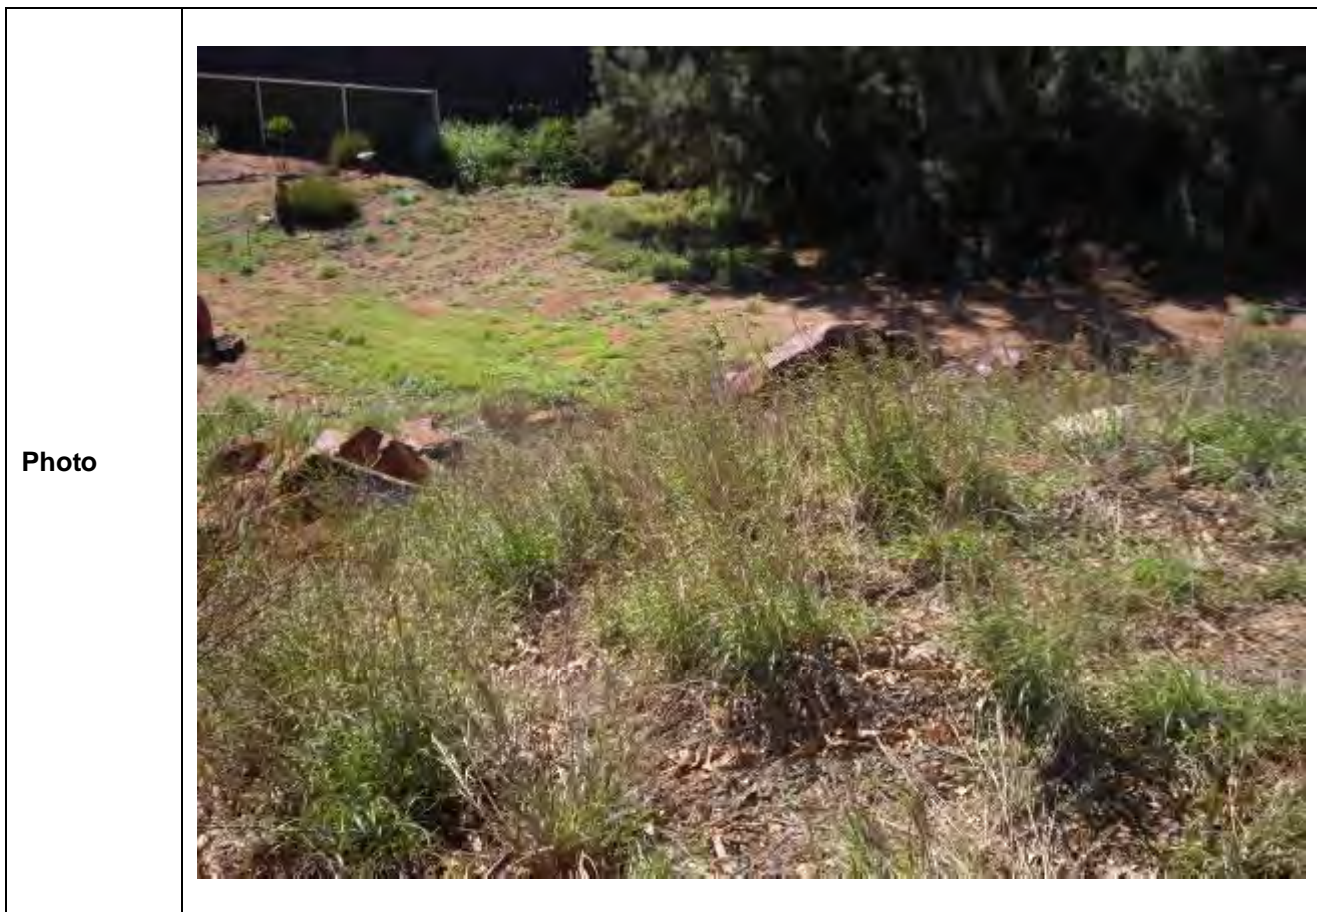
### 8.8 Lot No. 47 Yannarie Crescent

<b>Category</b>	None
<b>Type</b>	None
<b>Description</b>	Top of catchment
<b>Photo ID</b>	726
<b>Scope of Works</b>	None

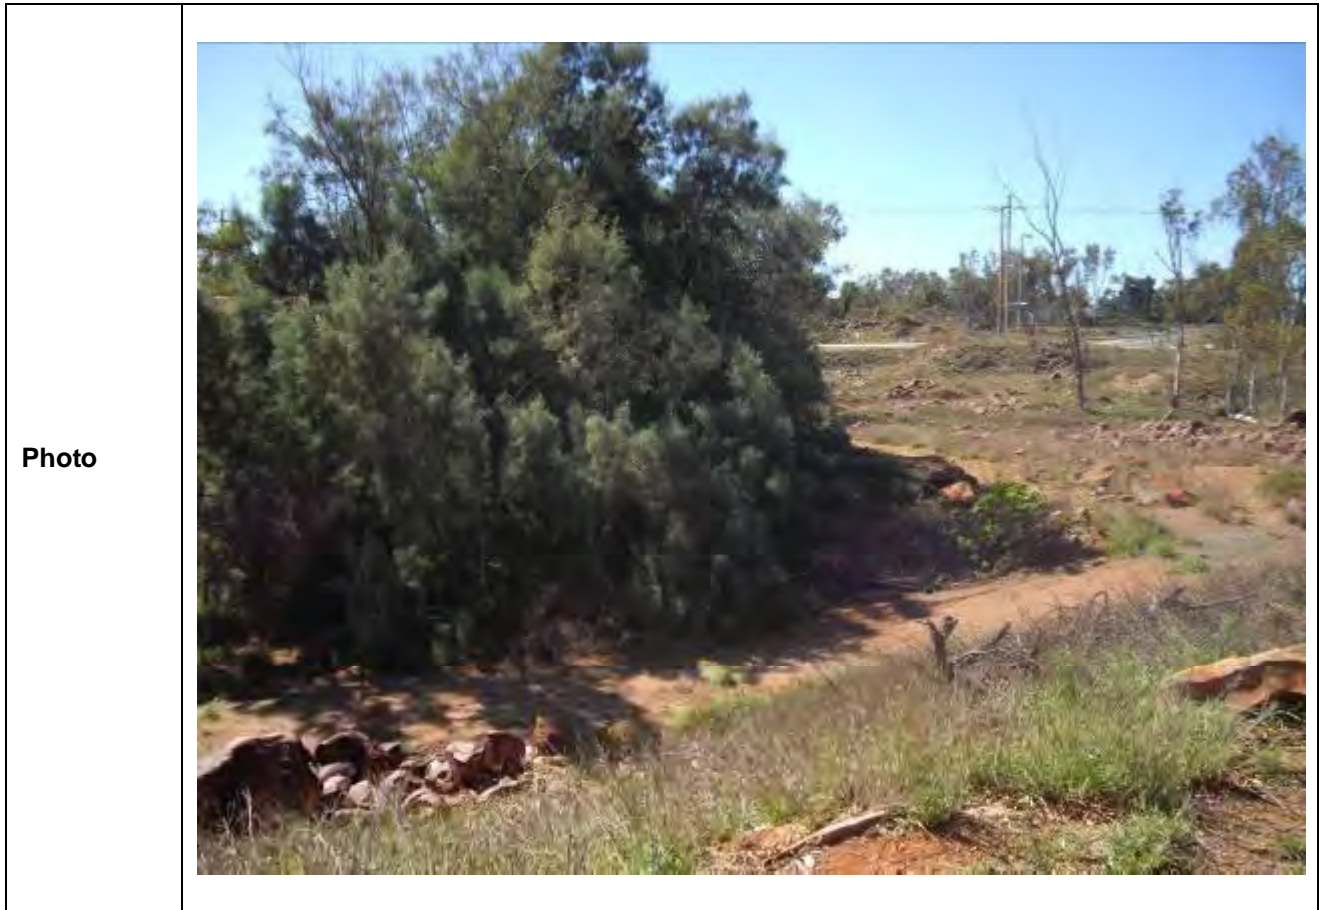
### 8.9 Lot No. 48 Yannarie Crescent

<b>Category</b>	None
<b>Type</b>	None
<b>Description</b>	Top of catchment
<b>Photo ID</b>	723
<b>Scope of Works</b>	None

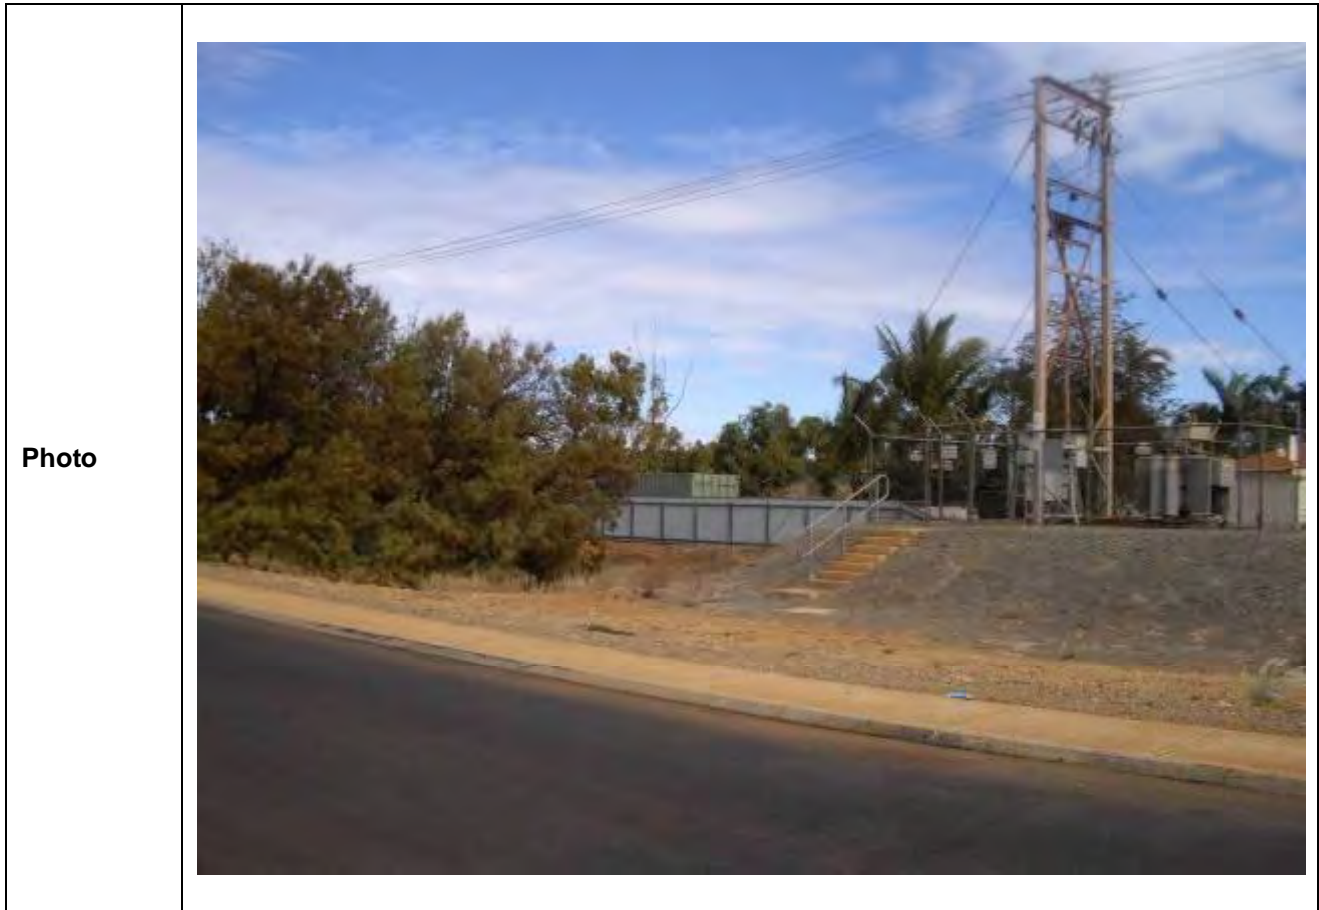
### 8.10 Lot No. 49 Yannarie Crescent

<b>Category</b>	Encroachment
<b>Type</b>	Boundary extension
<b>Description</b>	Potential extension of fence outside of property boundary
<b>Photo ID</b>	449
<b>Scope of Works</b>	L - Get confirmation from survey. Remove extension back to property boundary
