City of Karratha  
Dampier Stormwater Management Study  
Report  
Part B  
June 2015

## Appendix **C** – 2010 encroachment reviews

**Rio Tinto Iron Ore**  
Report on Dampier Drainage  
Review  
Block 1 Encroachments  
June 2010

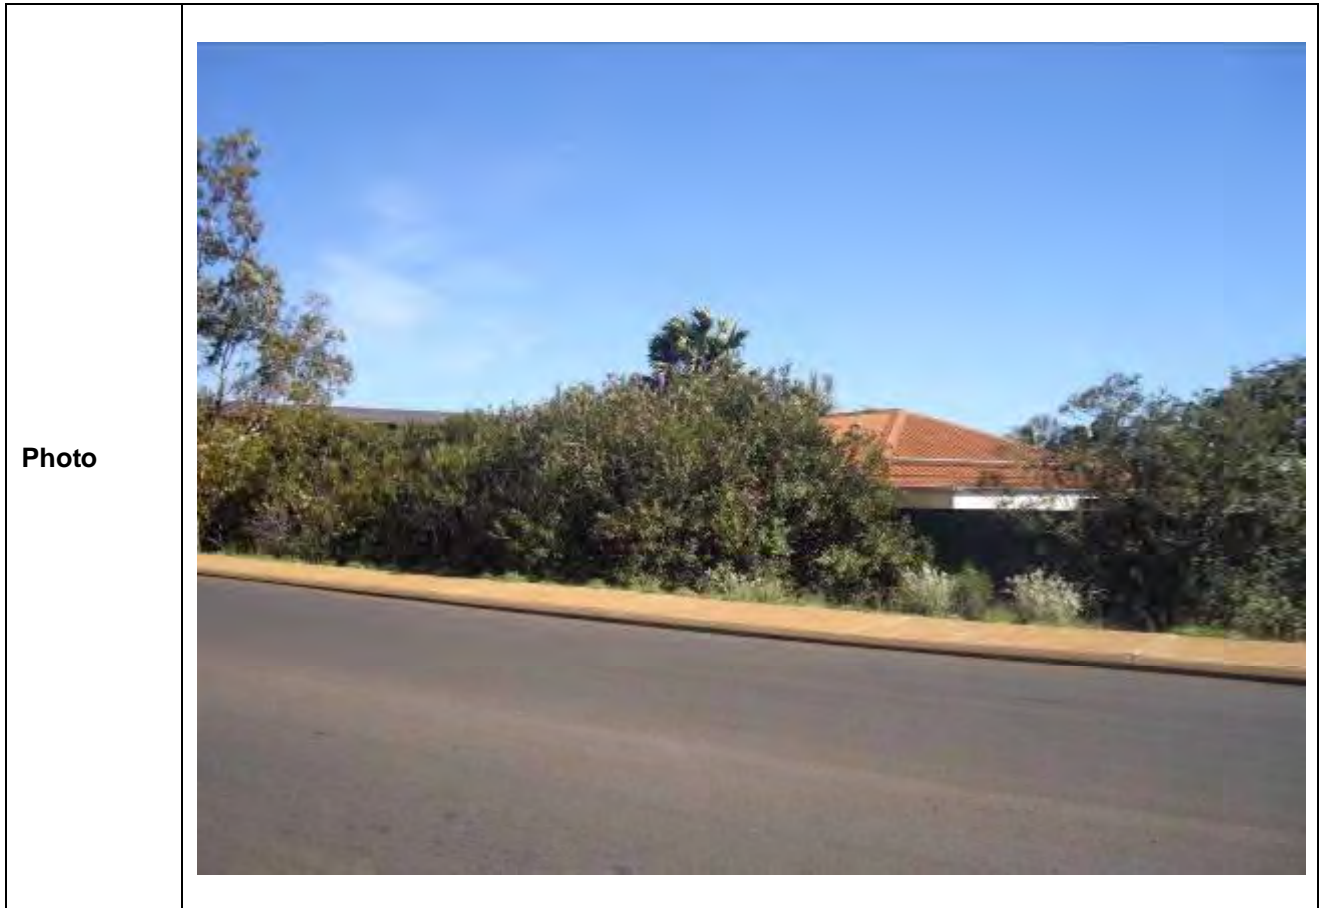
### 9.1 Lot No. 297 Fitzroy Crescent

<b>Category</b>	None
<b>Type</b>	None
<b>Description</b>	None
<b>Photo ID</b>	716
<b>Scope of Works</b>	None required

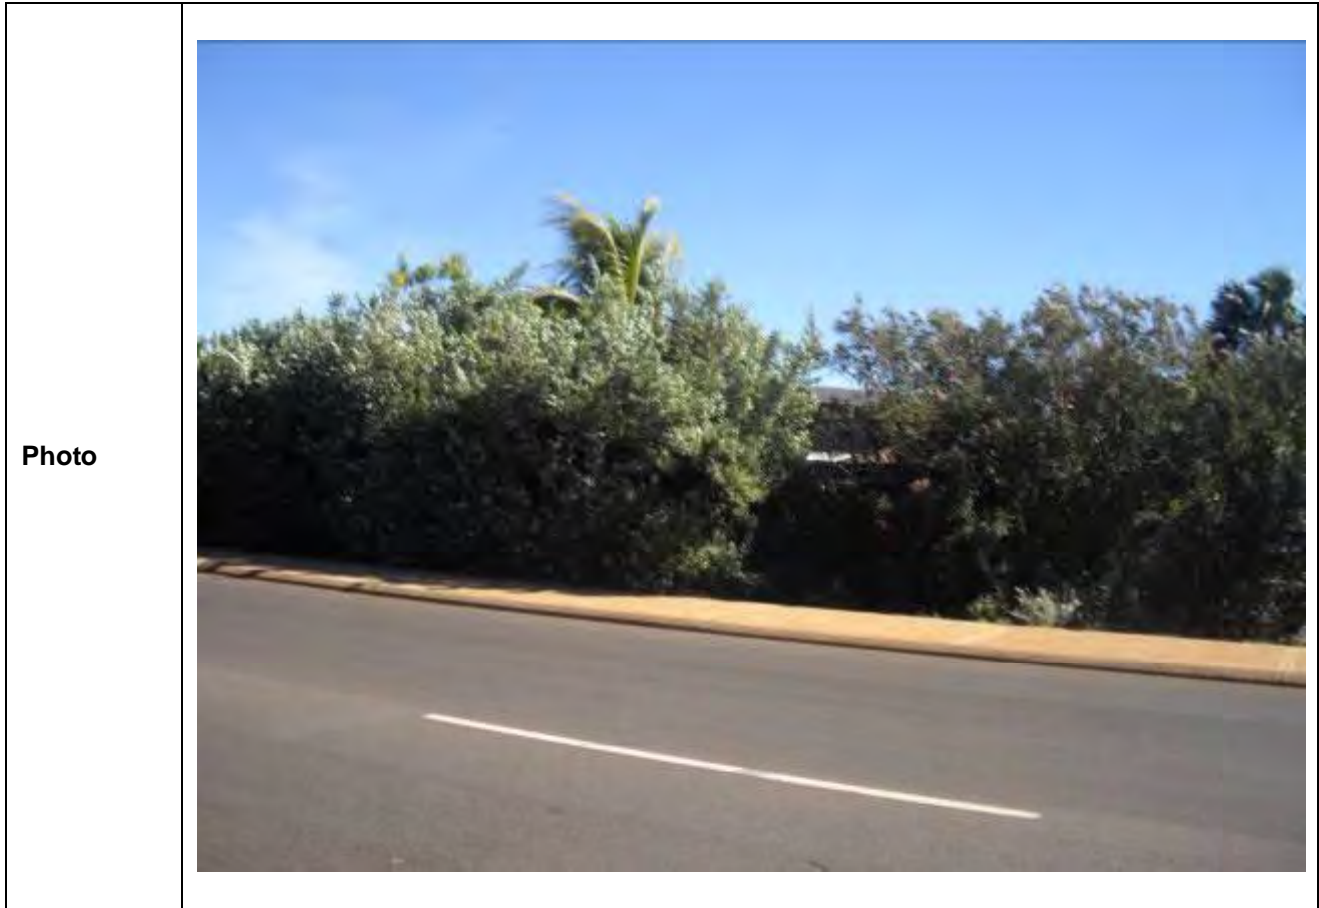
## 9.2 Lot No. 1,050 Fitzroy Crescent

<b>Category</b>	None
<b>Type</b>	None
<b>Description</b>	None
<b>Photo ID</b>	717
<b>Scope of Works</b>	None

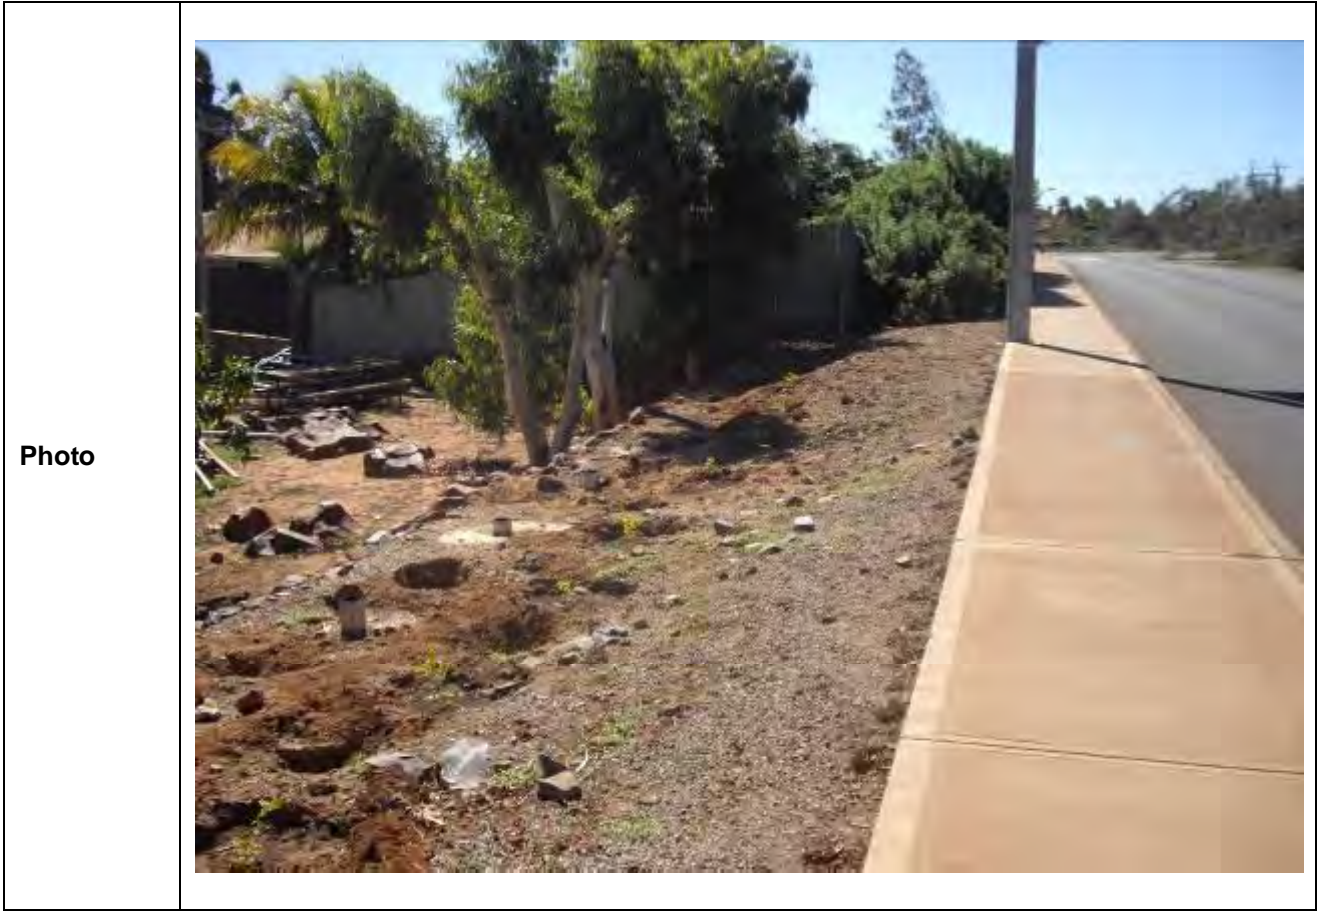
**9.3 Lot No. 50 Fitzroy Crescent**

<b>Category</b>	None
<b>Type</b>	None
<b>Description</b>	Flow path towards lots. Road reserve to function as flow path
<b>Photo ID</b>	719
<b>Scope of Works</b>	None

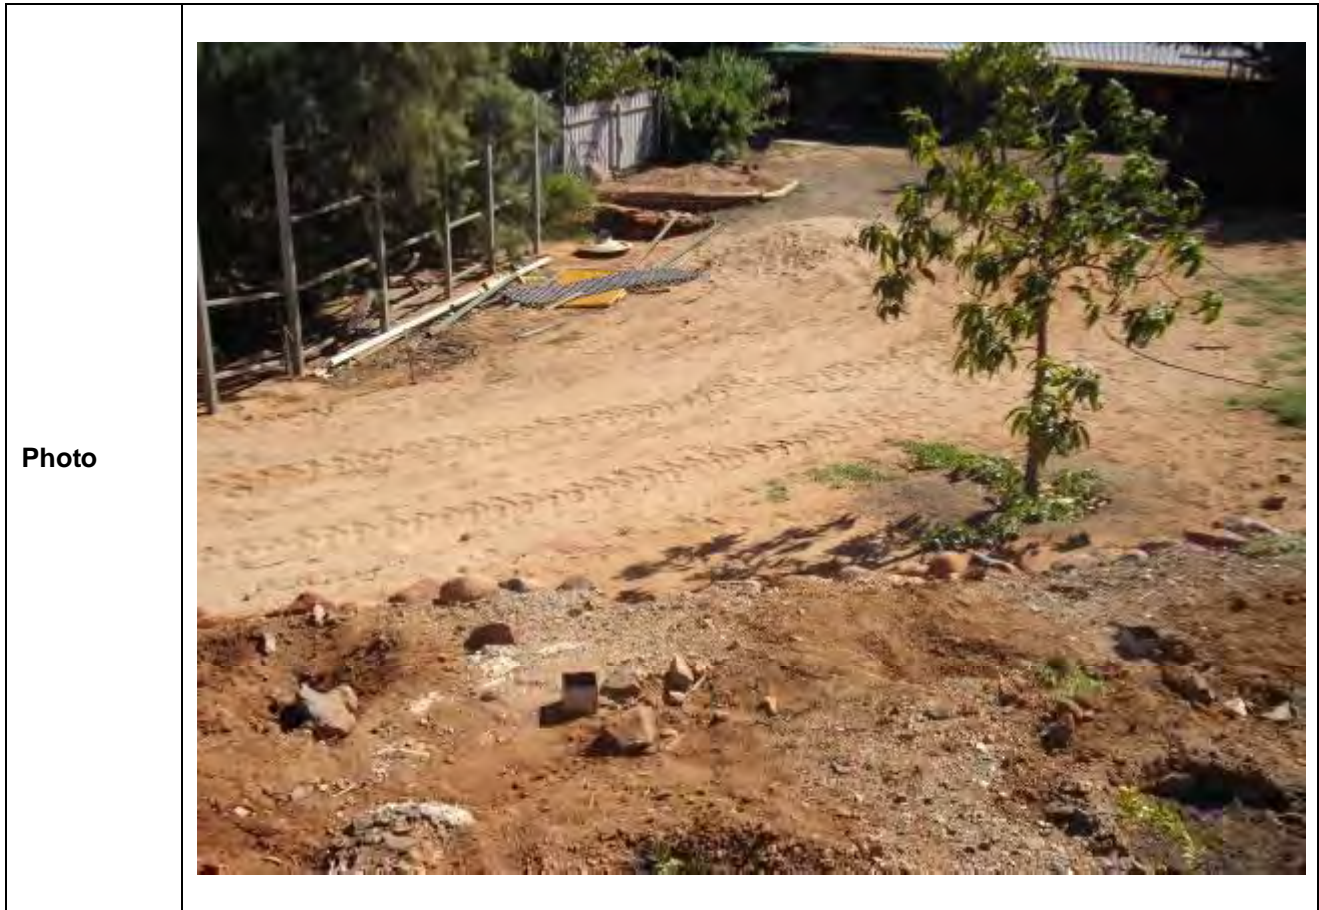
#### 9.4 Lot No. 51 Fitzroy Crescent

<b>Category</b>	None
<b>Type</b>	None
<b>Description</b>	Flow path towards lots. Road reserve functions as flow path.
<b>Photo ID</b>	720
<b>Scope of Works</b>	None required

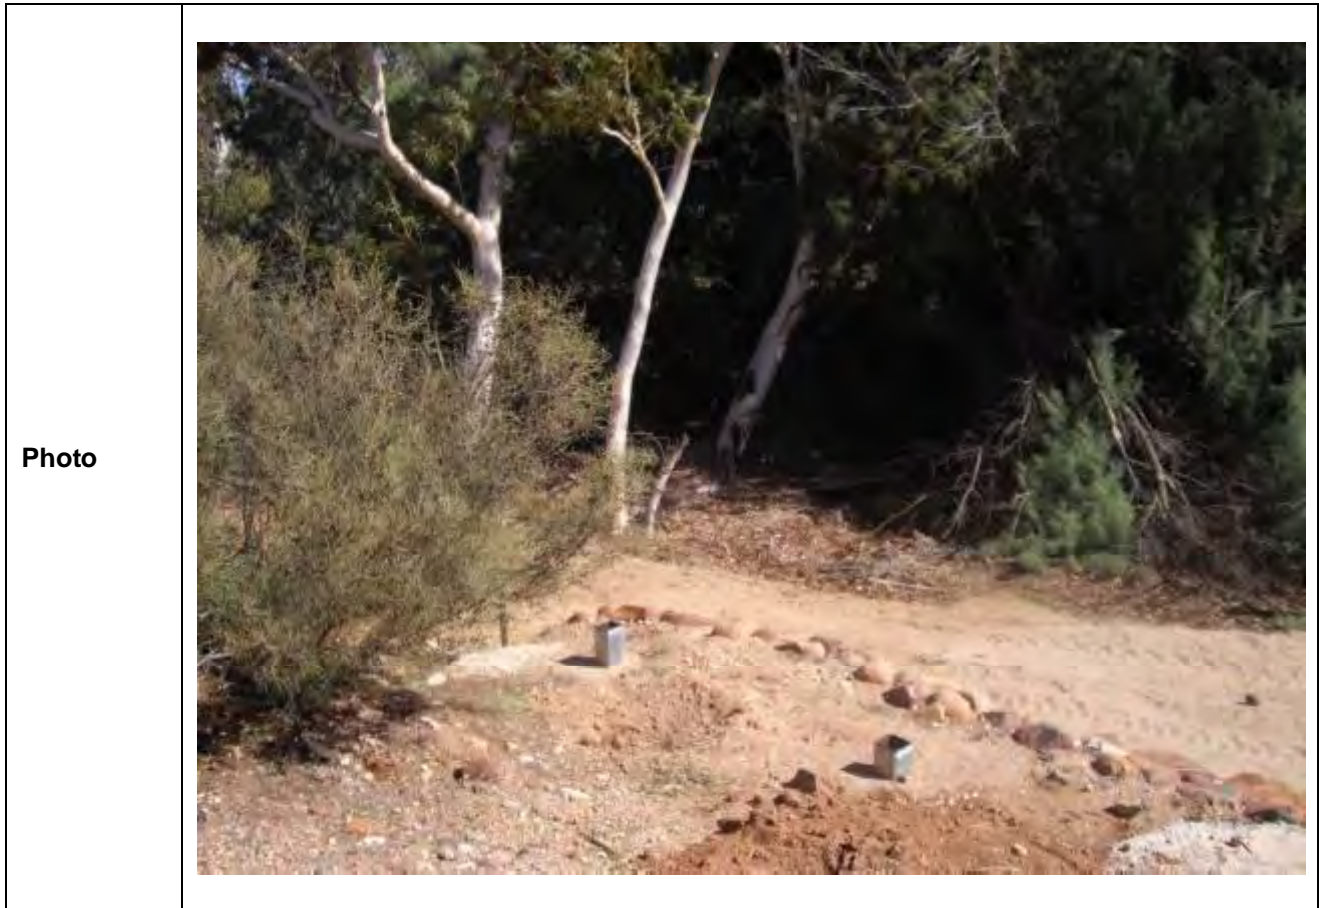
## 9.5 Lot No. 52 Fitzroy Crescent

<b>Category</b>	None
<b>Type</b>	None
<b>Description</b>	Flow path towards lots. Road reserve functions as flow path.
<b>Photo ID</b>	721
<b>Scope of Works</b>	None required

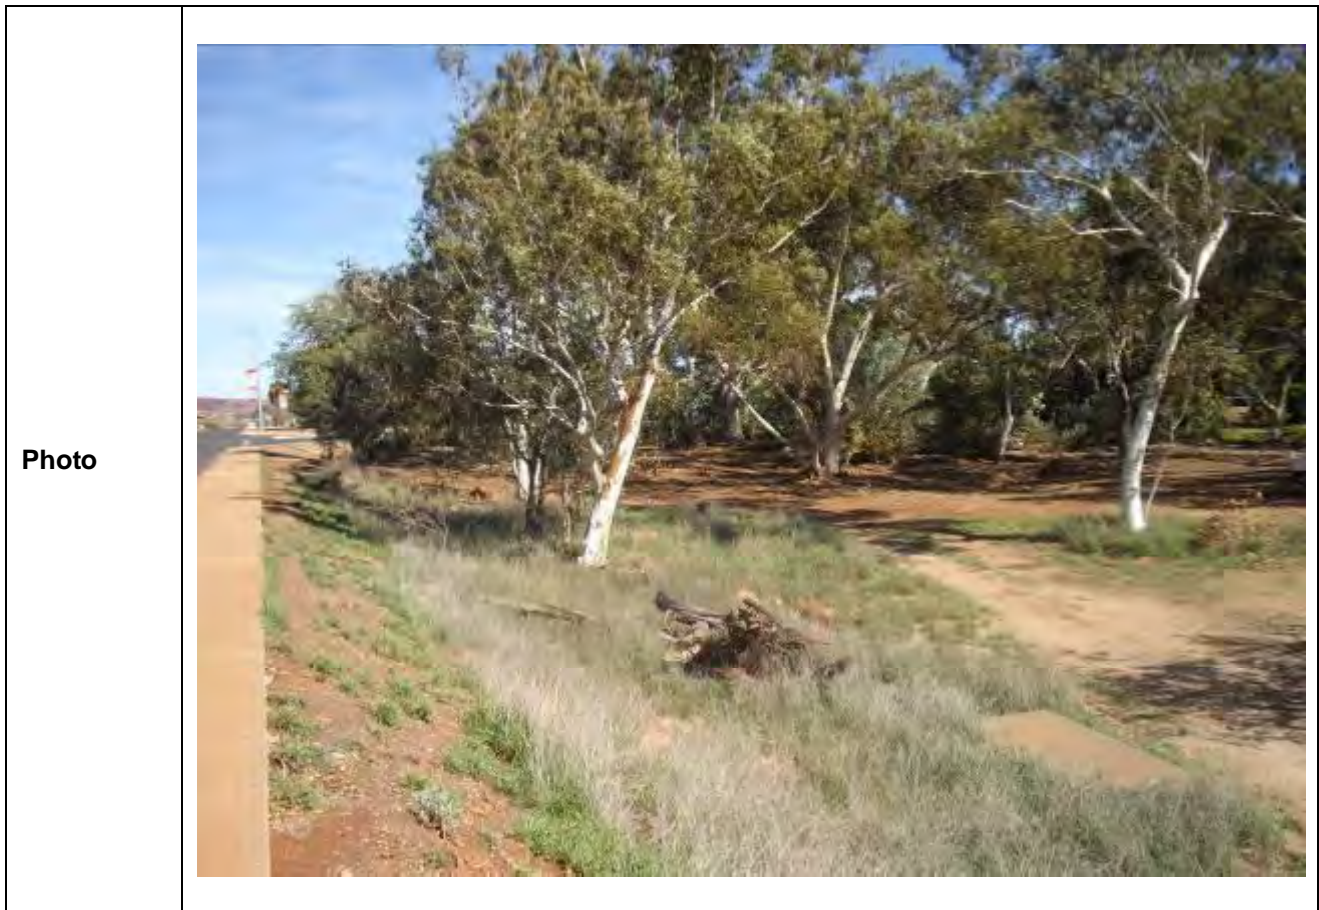
## 9.6 Lot No. 53 Fitzroy Crescent

<b>Category</b>	None
<b>Type</b>	None
<b>Description</b>	Flow path towards lots. Road reserve functions as flow path.
<b>Photo ID</b>	722
<b>Scope of Works</b>	None required

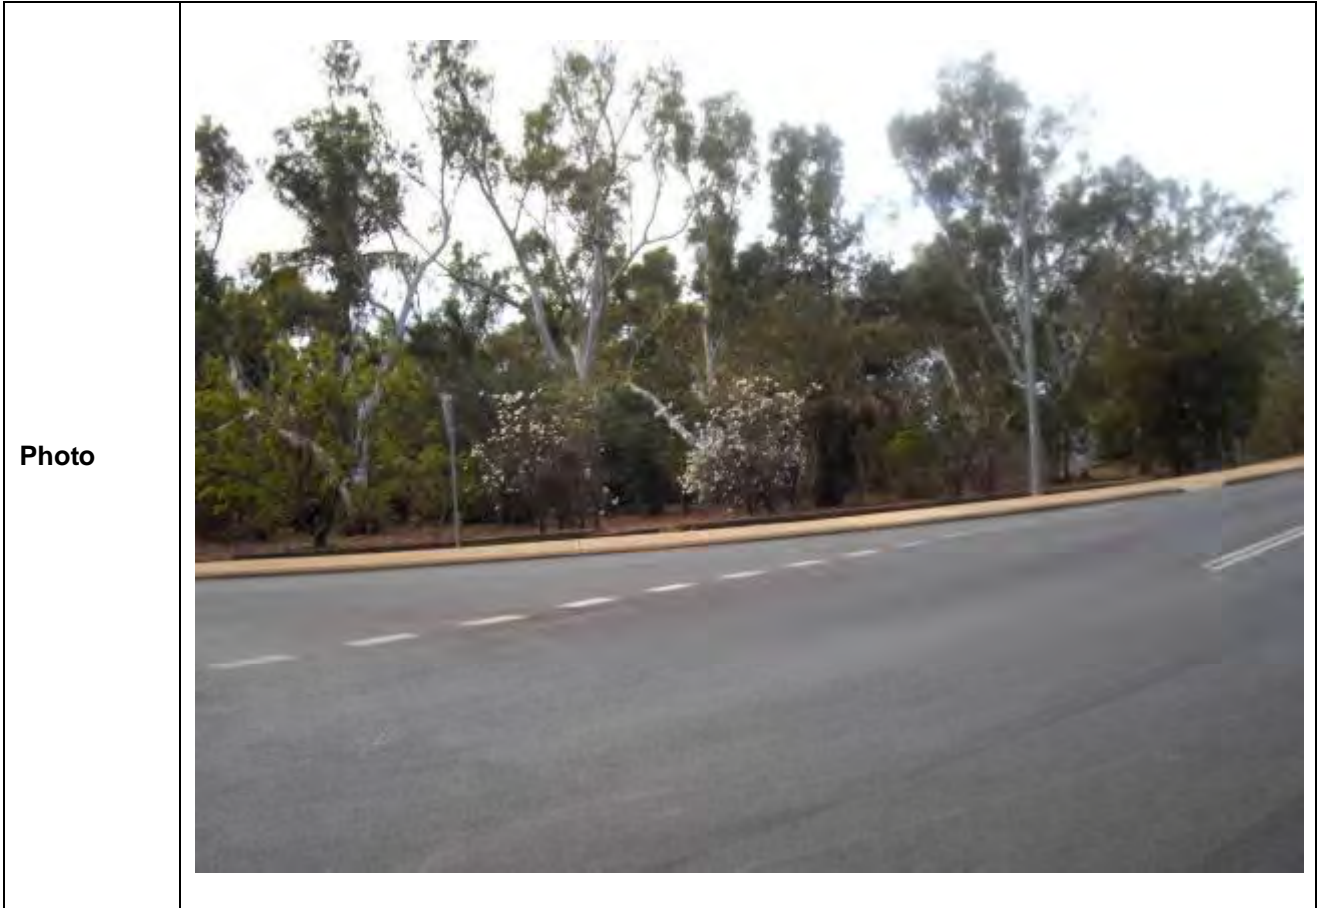
**9.7 Lot No. 54 Fitzroy Crescent**

<b>Category</b>	Encroachment
<b>Type</b>	Boundary extension, Side access with culverts
<b>Description</b>	Extended landscaping, Side access with culverts on western boundary.
<b>Photo ID</b>	451
<b>Scope of Works</b>	L - Illegal activity - remove existing landscaping up to edge of property boundary; M - Remove side access driveway and reinstate drainage defined by the natural channel

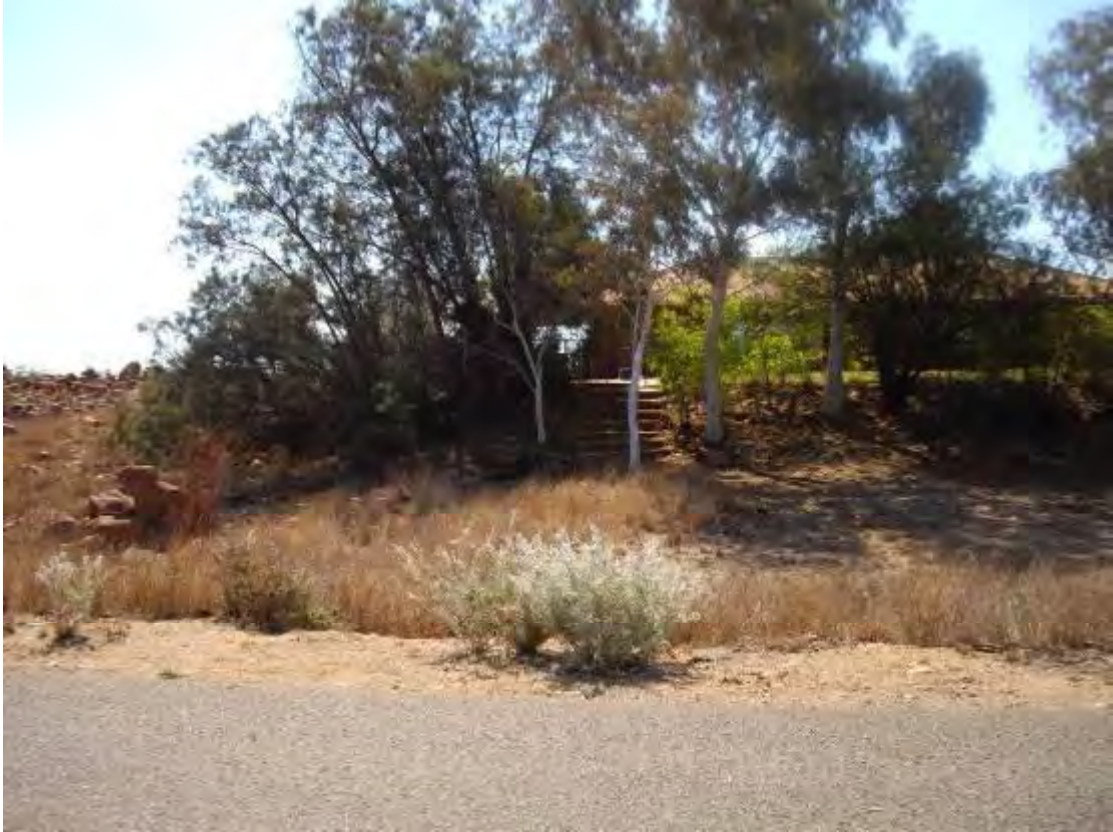
## 2.8 Lot No. 305 Pinderi Crescent

<b>Category</b>	None
<b>Type</b>	None
<b>Description</b>	Vegetation is low with defined shallow channel directing flow to open rocky space.
<b>Photo ID</b>	375
<b>Scope of Works</b>	None required

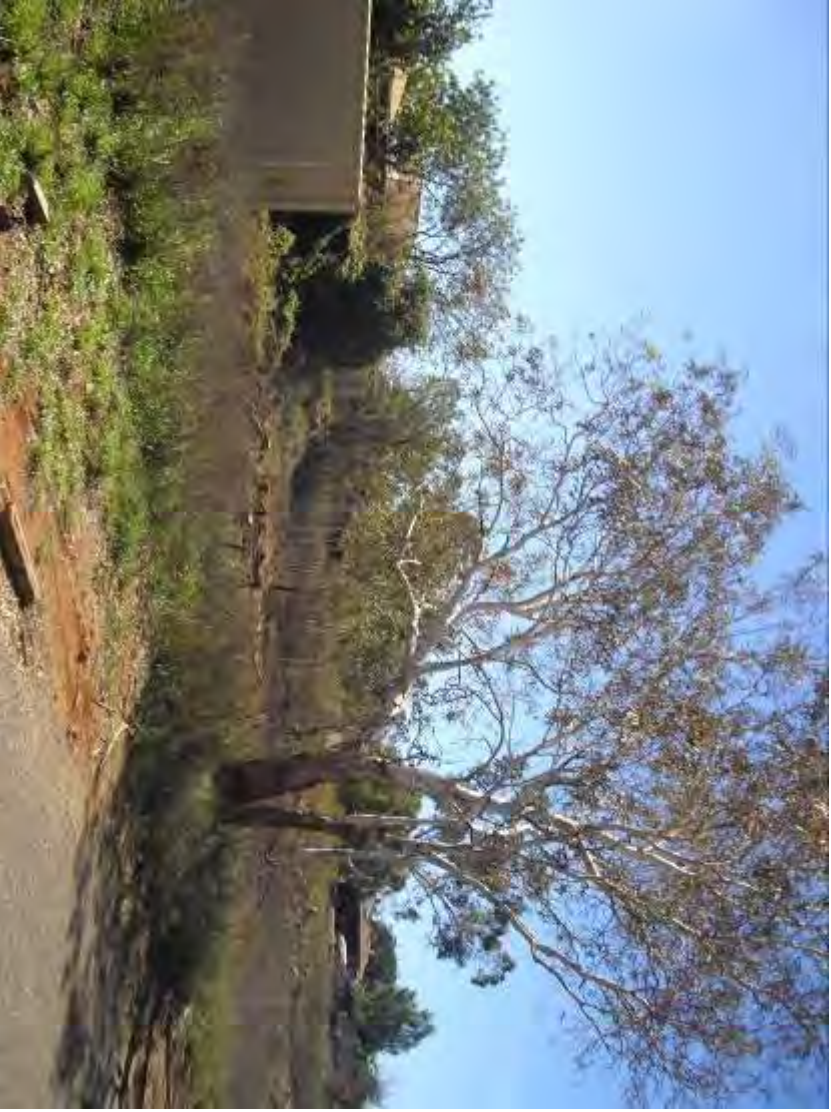
**4.1 Lot No. 227 Flynn Crescent**

<p><b>Category</b></p>	<p>Drain Maintenance</p>
<p><b>Type</b></p>	<p>Flow path</p>
<p><b>Description</b></p>	<p>Natural topography and flow path still adequate.</p>
<p><b>Photo ID</b></p>	<p>743</p>
<p><b>Scope of Works</b></p>	<p>None</p>

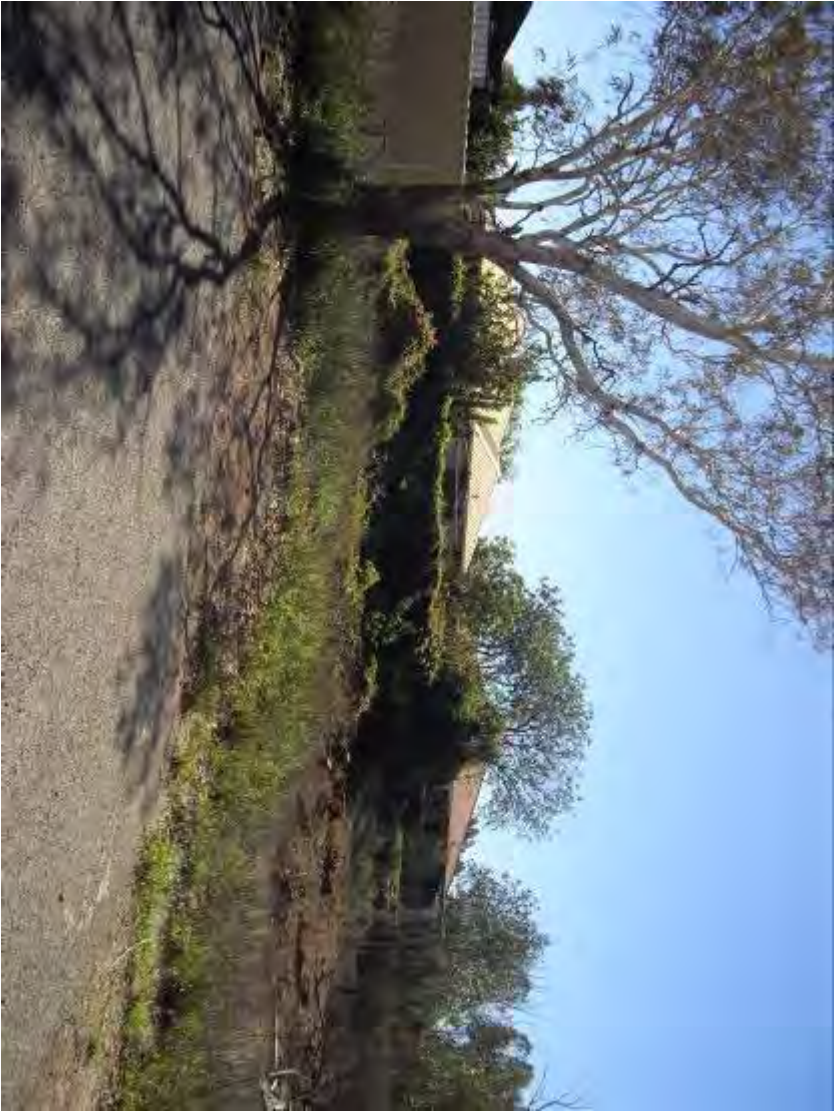
**4.2 Lot No. 228 Flynn Crescent**

<p><b>Category</b></p>	<p>Drain Maintenance</p>
<p><b>Type</b></p>	<p>Flow Path</p>
<p><b>Description</b></p>	<p>Und Natural topography and flow path still adequate.</p>
<p><b>Photo ID</b></p>	<p>744 – photo of cream coloured roof in centre of photo.</p>
<p><b>Scope of Works</b></p>	<p>None</p>

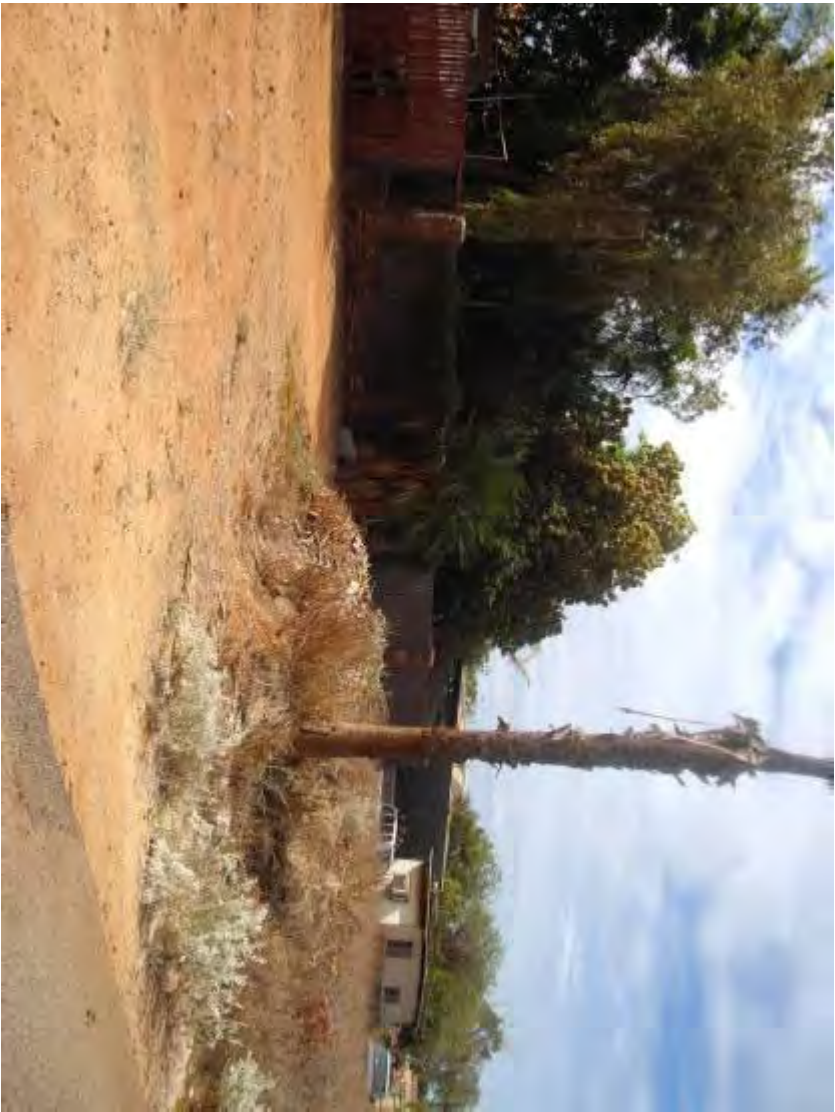
**4.4 Lot No. 230 Flynn Crescent**

<p><b>Category</b></p>	<p>Encroachment</p>
<p><b>Type</b></p>	<p>Boundary extension; Flow path.</p>
<p><b>Description</b></p>	<p>Potential encroachment from fence Modified drainage flow path Modified topography</p>
<p><b>Photo ID</b></p>	<p>458</p>
<p><b>Scope of Works</b></p>	<p>L - Remove existing and relocate boundary extension to within property boundary – get confirmation from survey; H - Reinstate drainage flow path as defined by the natural channel capacity and invert of downstream lot (from lot 234 – 230).</p>

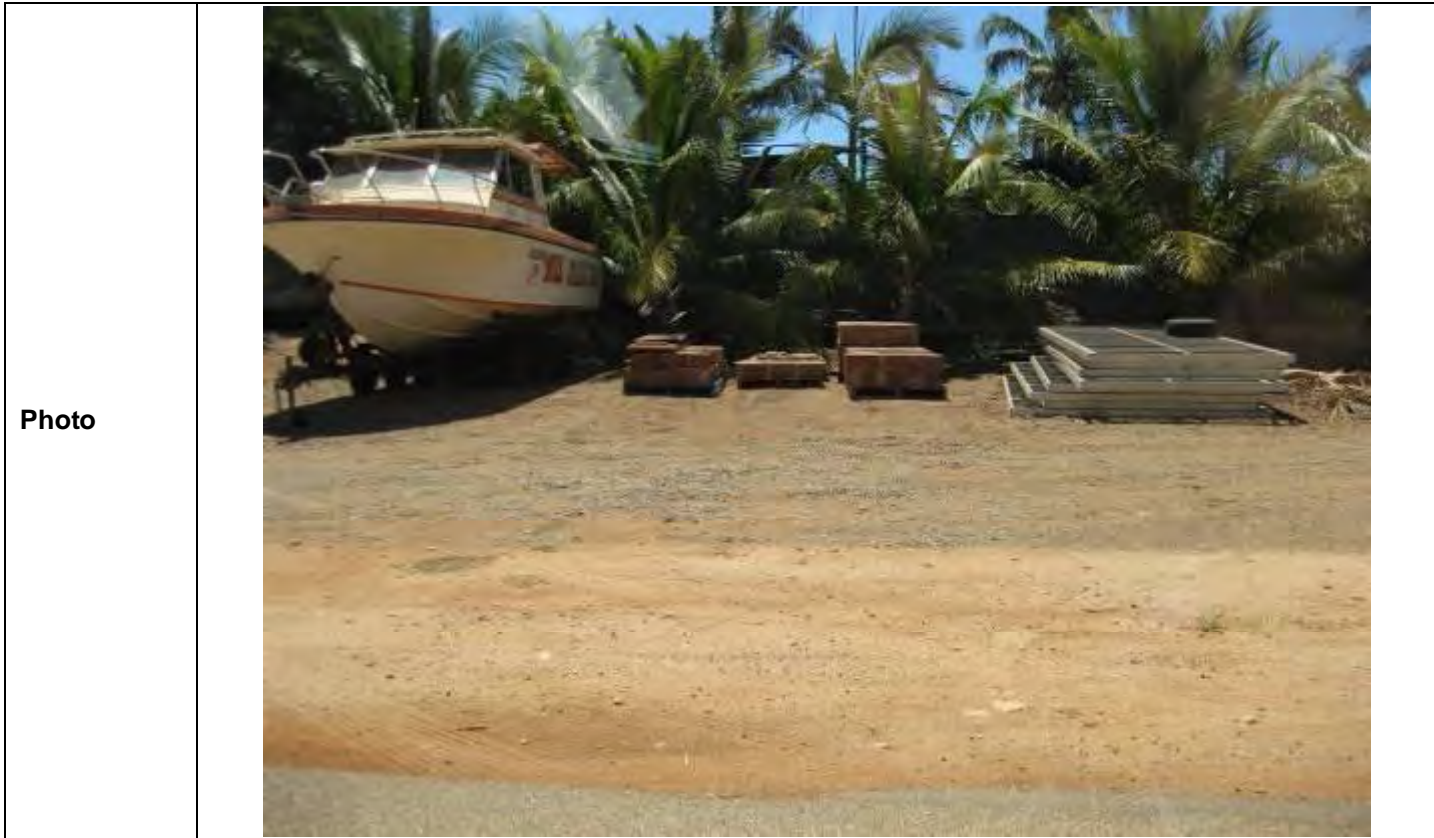
#### 4.7 Lot No. 233 Flynn Crescent

<b>Category</b>	Encroachment/Drain maintenance
<b>Type</b>	General items Flow path.
<b>Description</b>	Boat and building material Modified topography
<b>Photo ID</b>	26
<b>Scope of Works</b>	L - Remove boat and building materials H - Reinstate drainage flow path as defined by the natural channel capacity and invert of downstream lot (from lot 234 – 230).

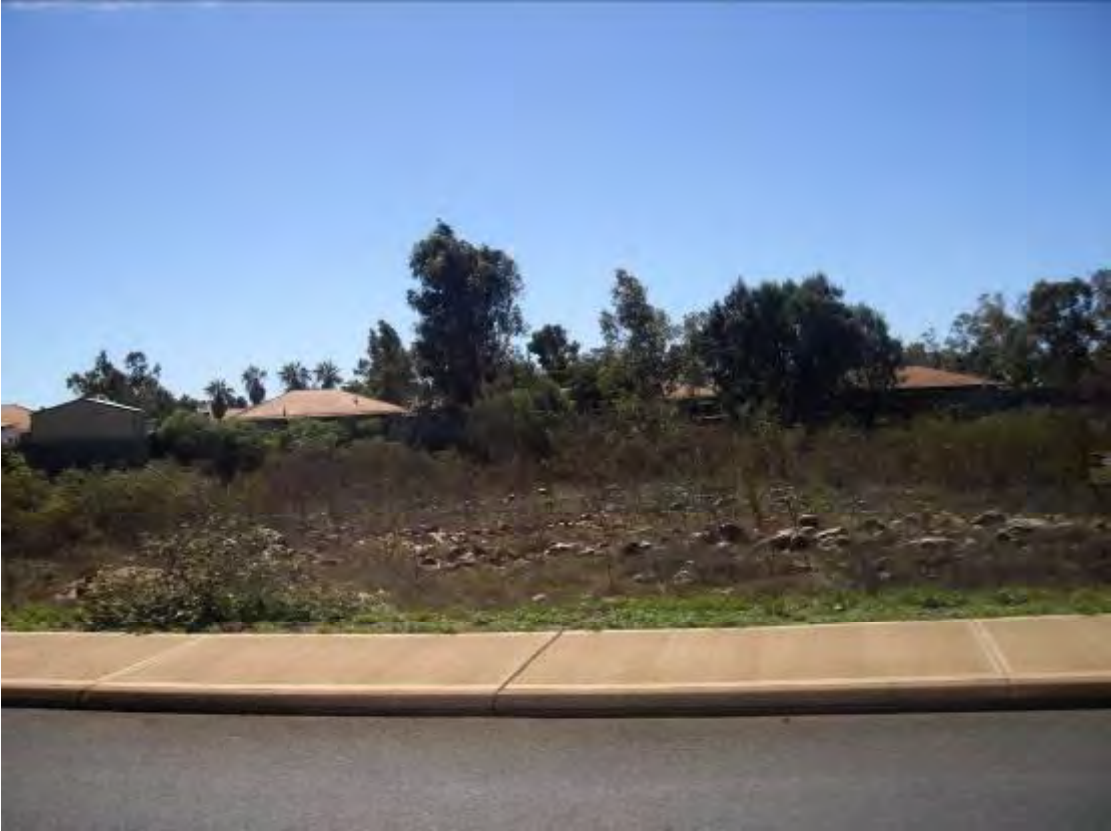
## 6.2 Lot No. 245 Hartog Crescent

<b>Category</b>	Drain Maintenance
<b>Type</b>	Vegetation.
<b>Description</b>	Vegetation impeding flow but the reserve is of a large capacity created by the raising of the road reserve and lot boundary.
<b>Photo ID</b>	766
<b>Scope of Works</b>	None required

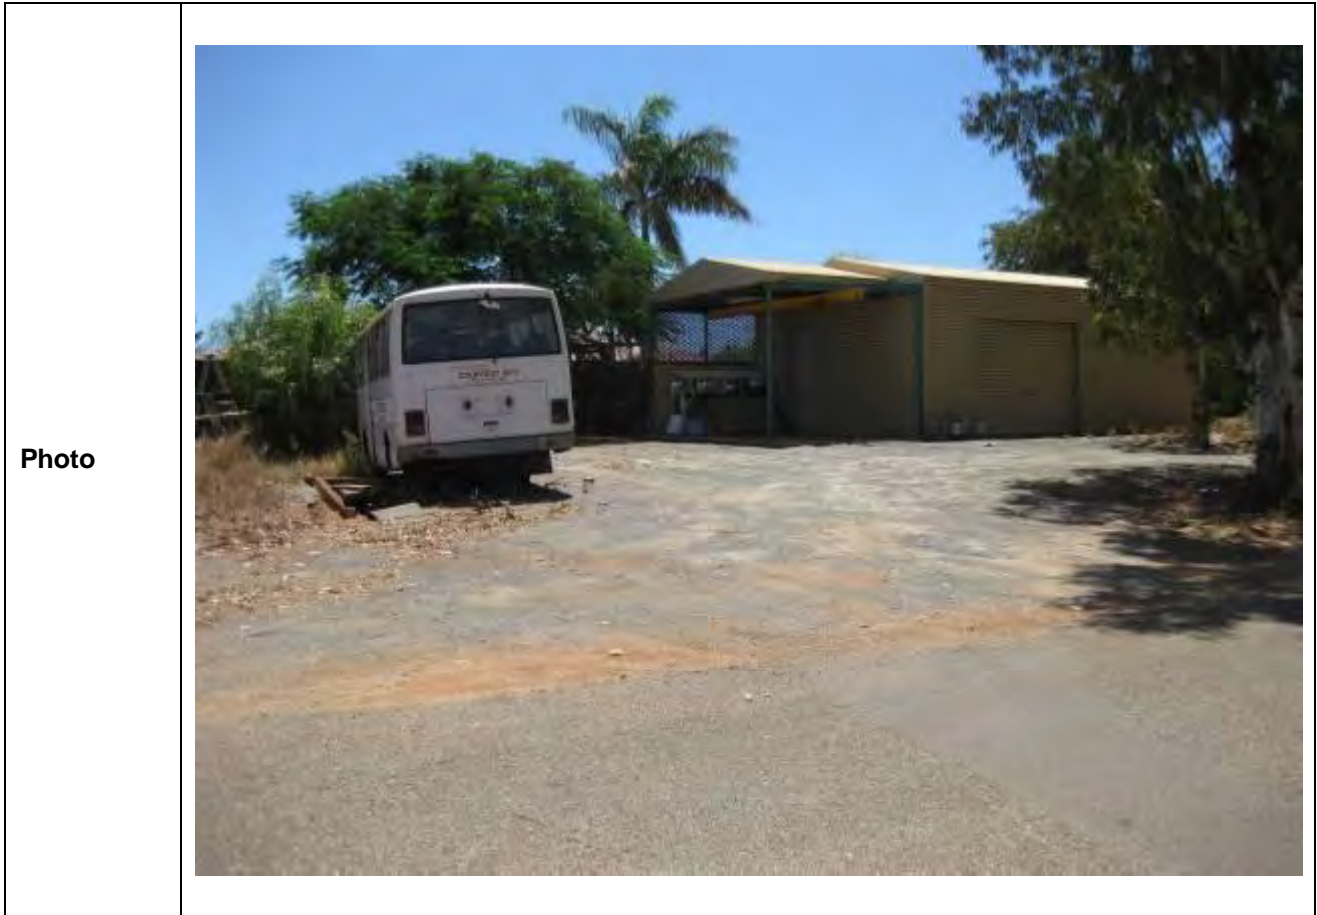
## 2.2 Lot No. 321 Patterson Crescent

<b>Category</b>	Encroachment
<b>Type</b>	Rear Access; General items.
<b>Description</b>	Rear access follows natural topography - doesn't affect flow; Bus parked in drainage reserve.
<b>Photo ID</b>	10
<b>Scope of Works</b>	L – Remove rear access L - Remove bus;

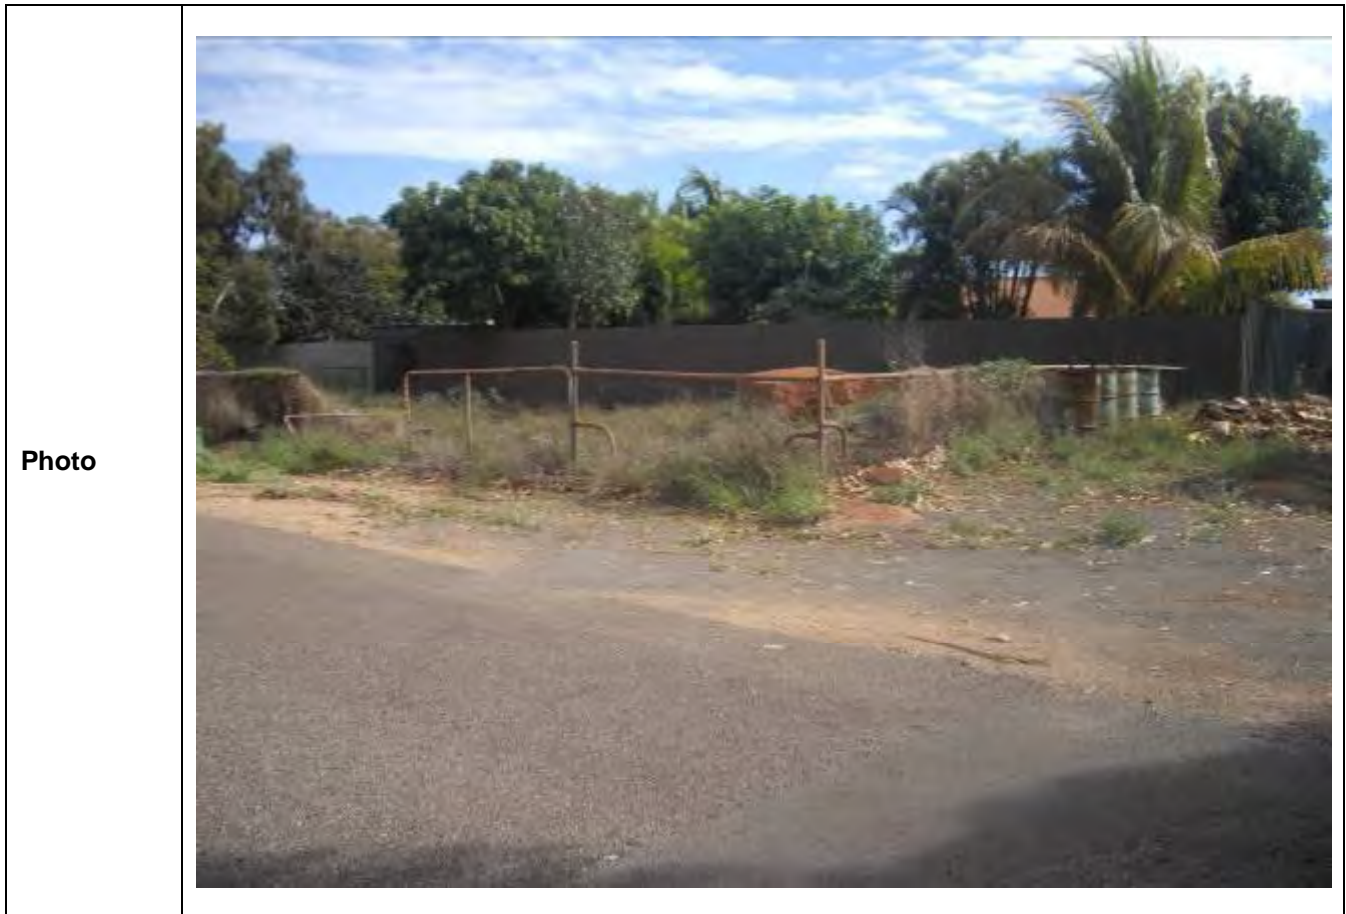
### 2.3 Lot No. 322 Patterson Crescent

<b>Category</b>	Encroachment / Drain Maintenance
<b>Type</b>	Boundary extension; General items; Topographical impedance.
<b>Description</b>	Fence located within drainage reserve; Barrels; Rocks are natural – doesn't affect flow. Flow path is directed towards the road reserve - adequate.
<b>Photo ID</b>	977 ,771
<b>Scope of Works</b>	L - Remove existing secondary fence; L – Remove barrels;

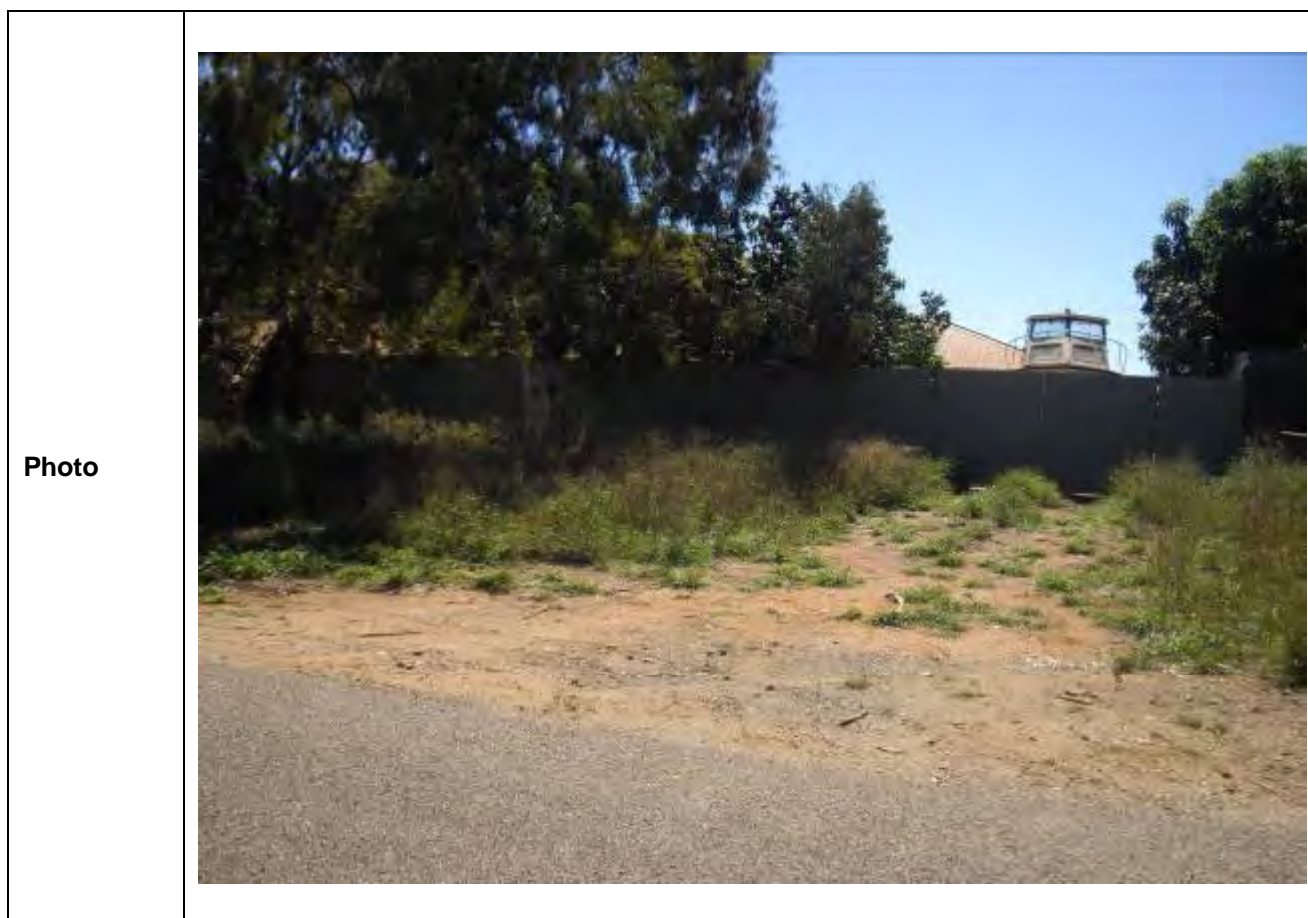
## 2.4 Lot No. 323 Patterson Crescent

<b>Category</b>	Encroachment / Drain Maintenance
<b>Type</b>	Boundary extension; Rear Access; Vegetation.
<b>Description</b>	Potential boundary encroachment from fence; Rear access follows the natural topography - doesn't affect flow; Semi-dense vegetation - impedes flow.
<b>Photo ID</b>	772
<b>Scope of Works</b>	M - Remove existing fence and relocate boundary extension to within property boundary - get confirmation from survey; L - Remove rear access and construct defined channel directing flow west to lot 324 sump; M - Vegetation is to be slashed to a nominal height of 50 mm above ground with the exception of large, established trees of height in excess of 5 m, which shall remain.

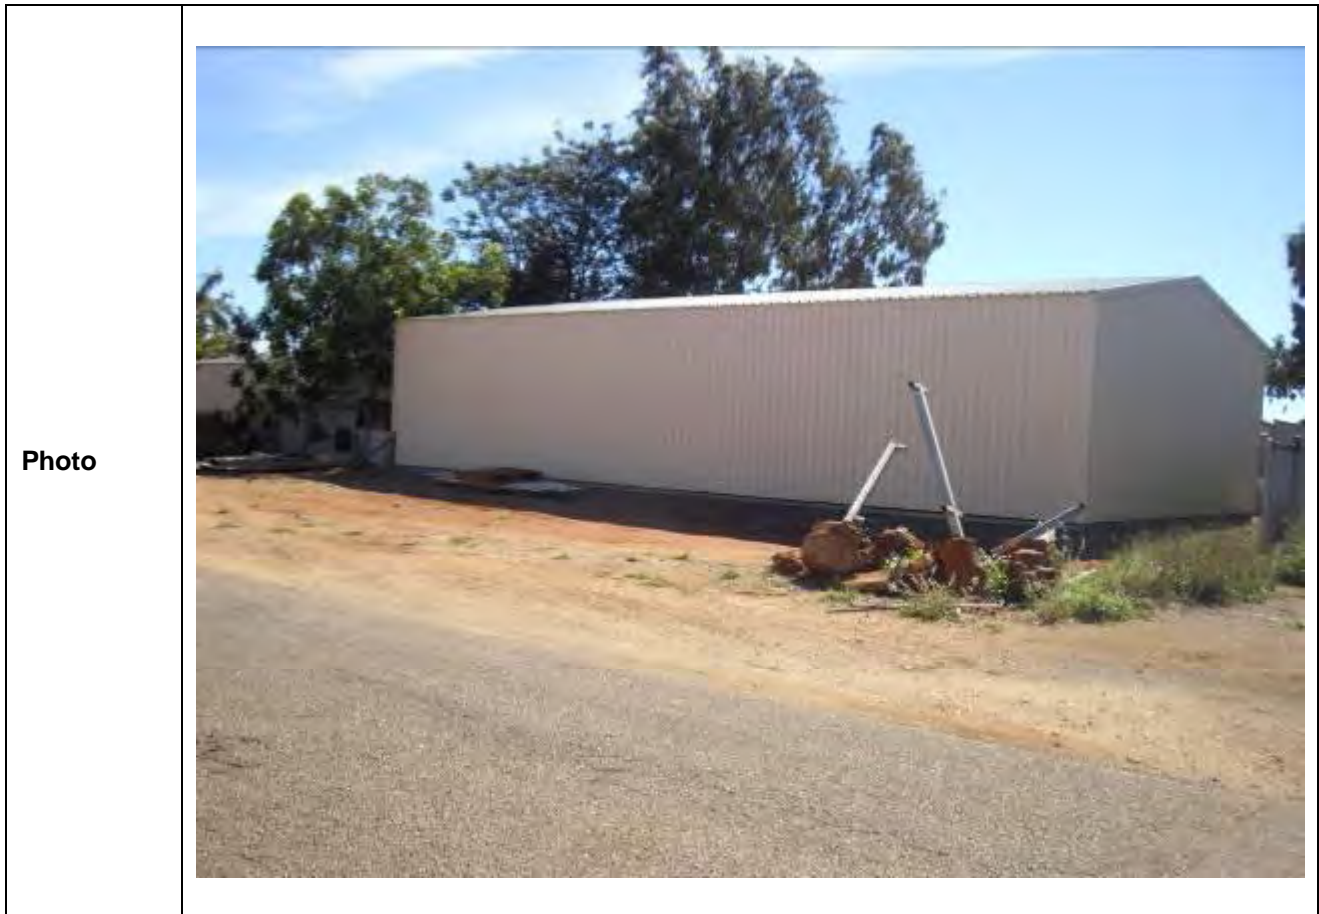
## 2.7 Lot No. 326 Patterson Crescent

<b>Category</b>	Encroachment
<b>Type</b>	General items; Boundary Encroachment Ill defined flow path
<b>Description</b>	Building/demolition material located in the drainage reserve; Shed Flat area
<b>Photo ID</b>	775
<b>Scope of Works</b>	L - Remove building/demolition materials; L – Remove existing shed and relocate to within property boundary.- get confirmation from survey; L – Construct defined channel directing flow east to lot 324.

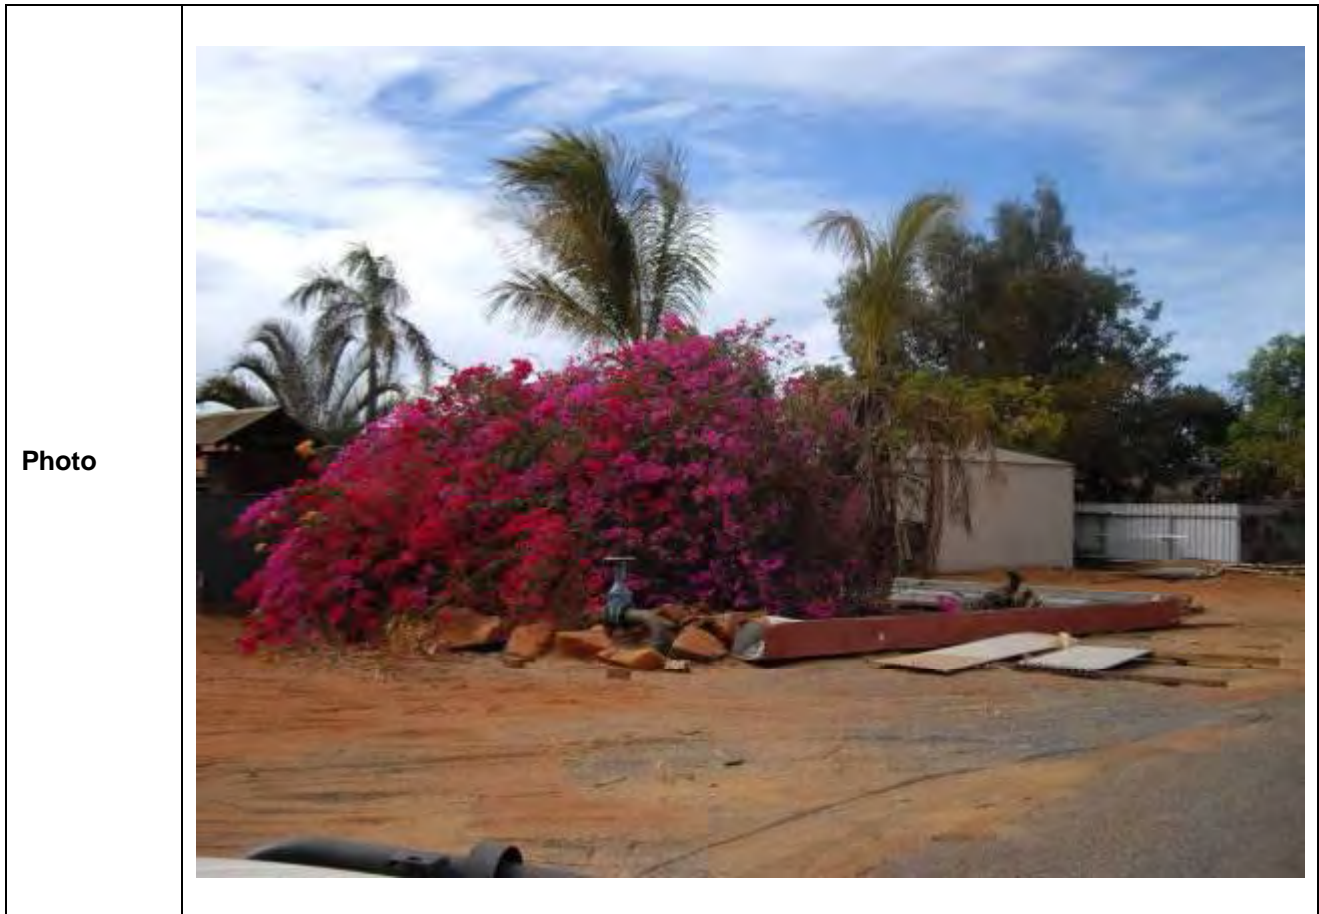
## 2.8 Lot No. 327 Patterson Crescent

<b>Category</b>	Encroachment
<b>Type</b>	Boundary extension, General items; III defined flow path.
<b>Description</b>	Rear yard landscaping; Building material; III defined flow path due to landscaping.
<b>Photo ID</b>	470
<b>Scope of Works</b>	L - Remove existing landscaping including vegetation; L – Remove building material. Construct defined channel directing flow east to lot 324.
