City of Karratha  
Dampier Stormwater Management Study  
Report  
Part B  
June 2015

## Appendix **C** – 2010 encroachment reviews

**Rio Tinto Iron Ore**  
Report on Dampier Drainage  
Review  
Block 1 Encroachments  
June 2010

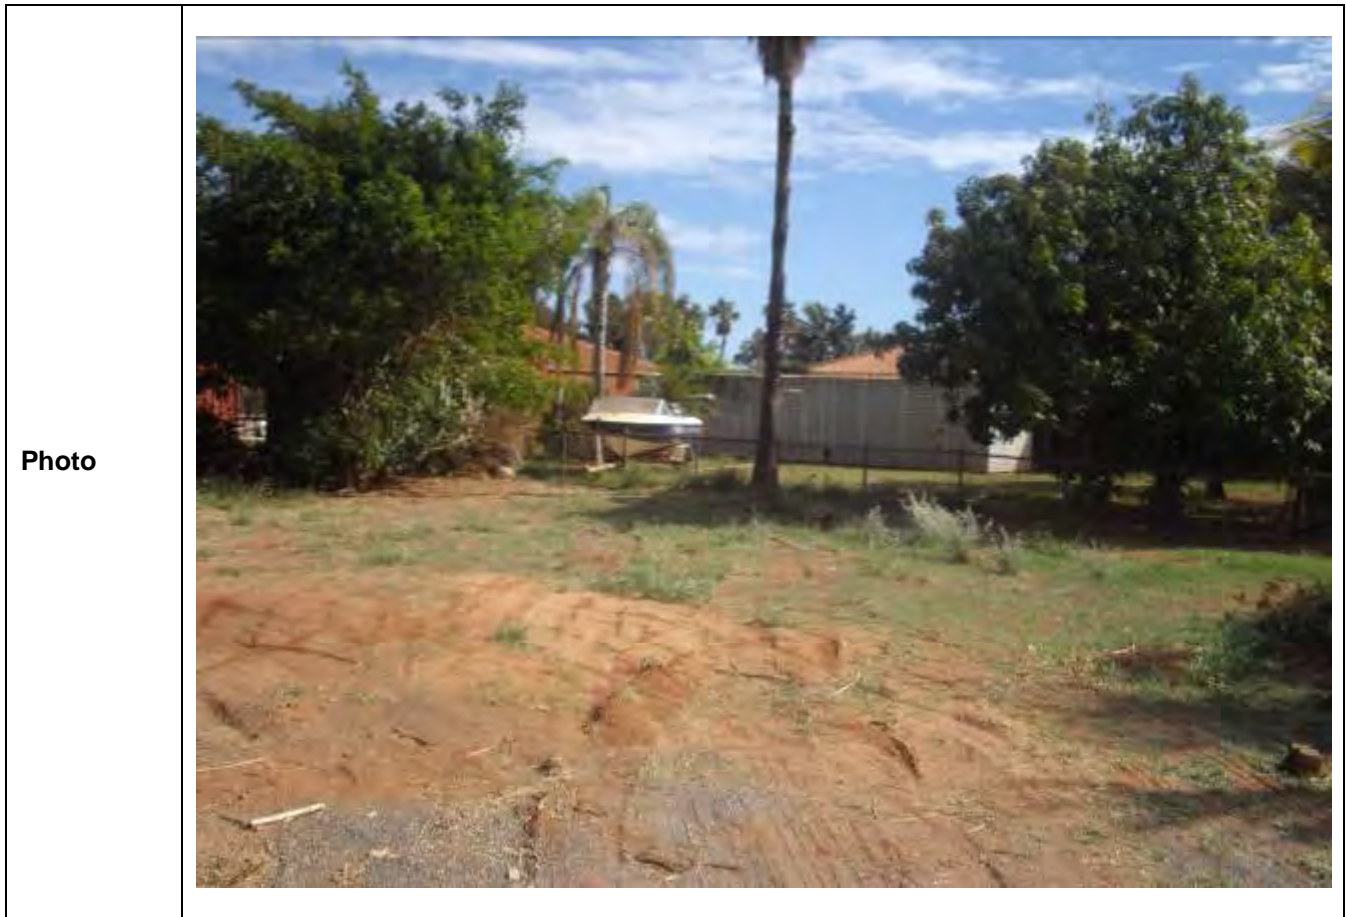
## 2.9 Lot No. 328 Patterson Crescent

<b>Category</b>	Encroachment
<b>Type</b>	Rear access, Ill defined flow path.
<b>Description</b>	Rear access follows natural topography, but has limited affect on flow. Ill defined flow path due to landscaping
<b>Photo ID</b>	980 ,776
<b>Scope of Works</b>	L - Remove rear access L - Construct defined channel directing flow east to lot 324.

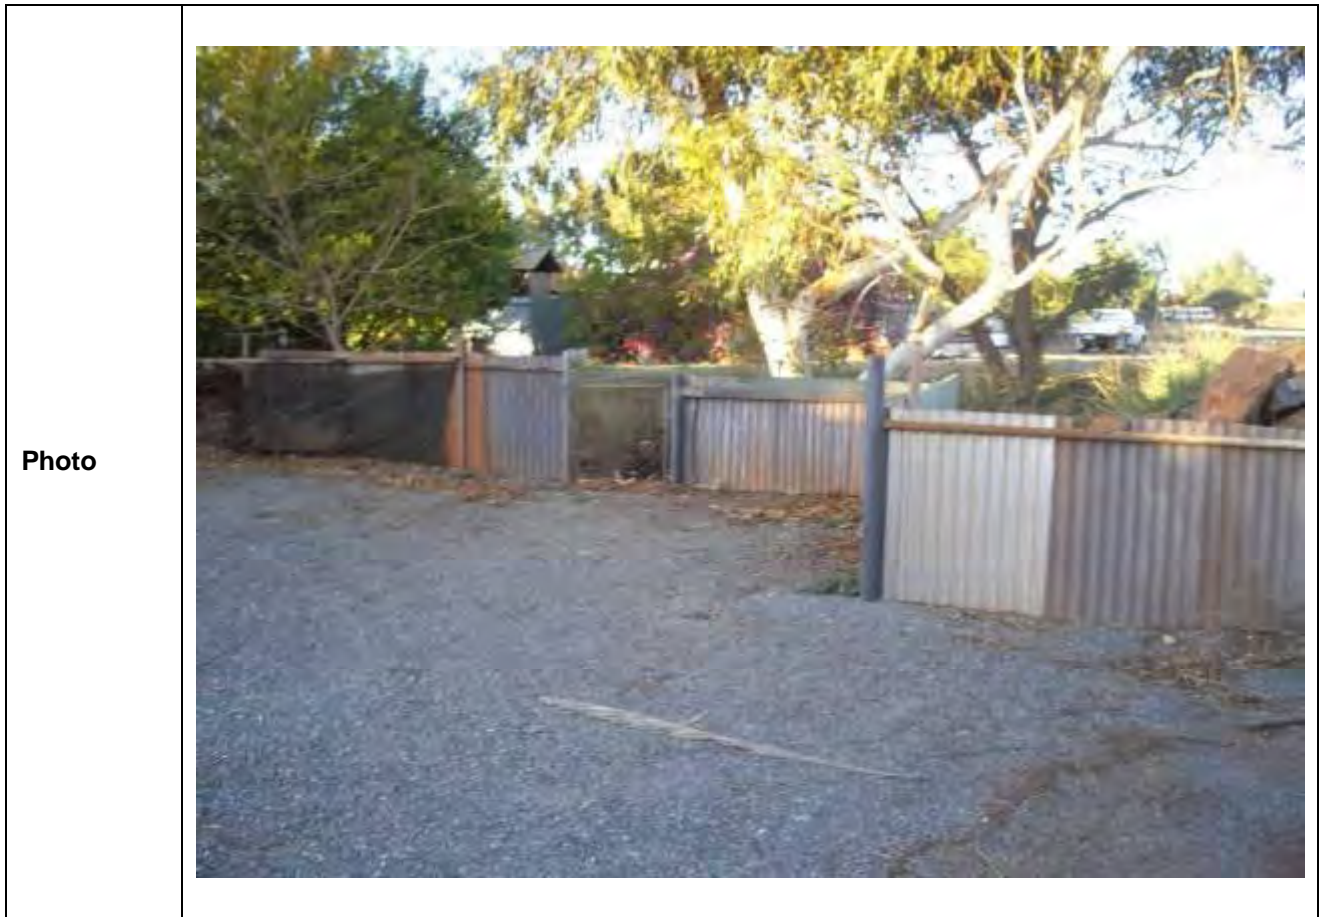
**2.10 Lot No. 329 Patterson Crescent**

<b>Category</b>	Encroachment
<b>Type</b>	Boundary extension; Rear access; Ill defined flow path.
<b>Description</b>	Fence extends perpendicular to road; Rear access follows natural topography; Ill defined flow path due to landscaping
<b>Photo ID</b>	680
<b>Scope of Works</b>	L - Remove fence; L - Remove rear access L - Construct defined channel directing flow east to lot 324.

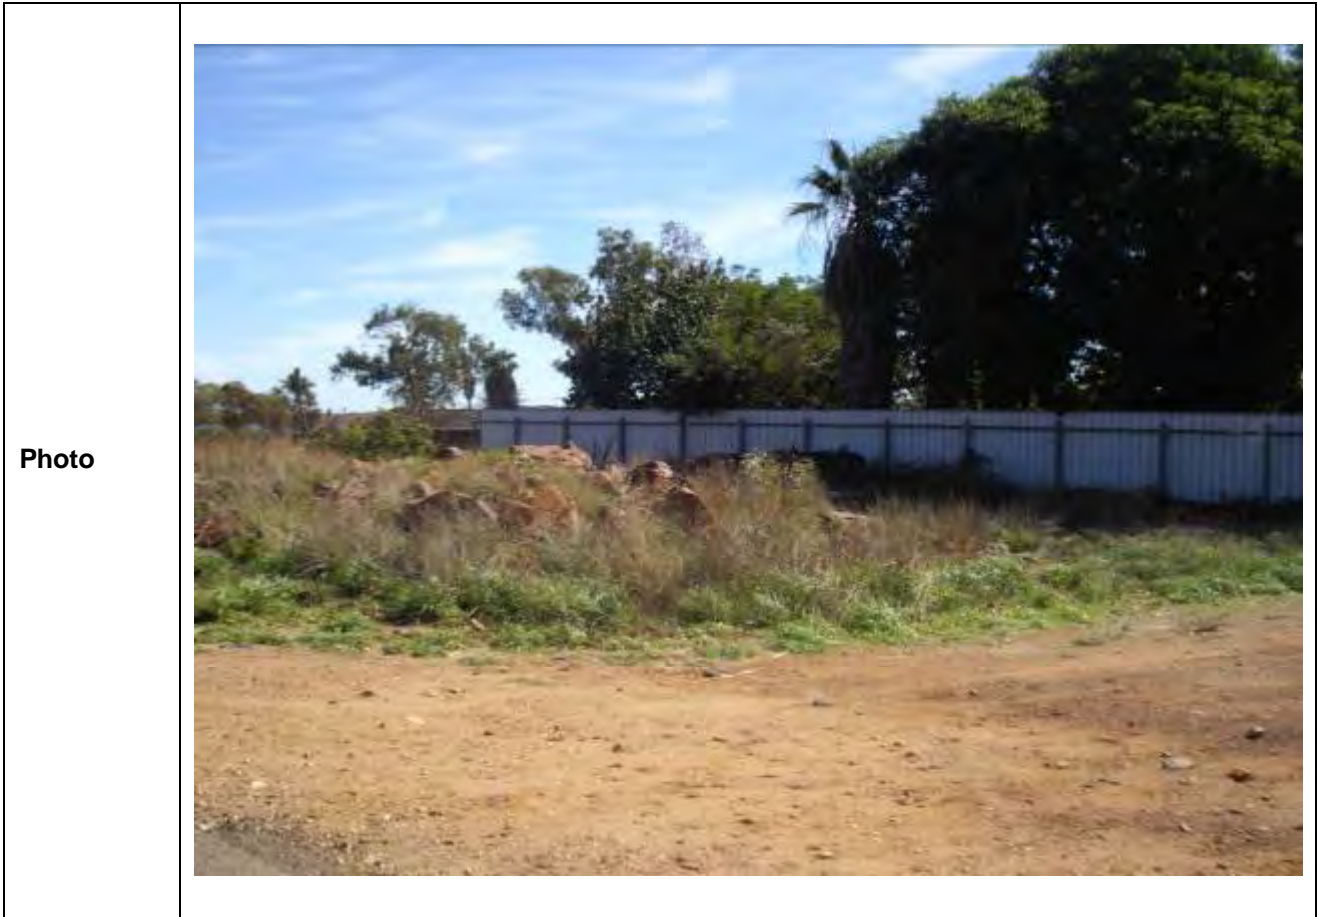
**2.11 Lot No. 330 Patterson Crescent**

<b>Category</b>	Drain Maintenance
<b>Type</b>	Ill defined flow path
<b>Description</b>	Rocks form catchment divide – do not affect flow
<b>Photo ID</b>	777
<b>Scope of Works</b>	None – rocks form catchment divide - do not affect flow.

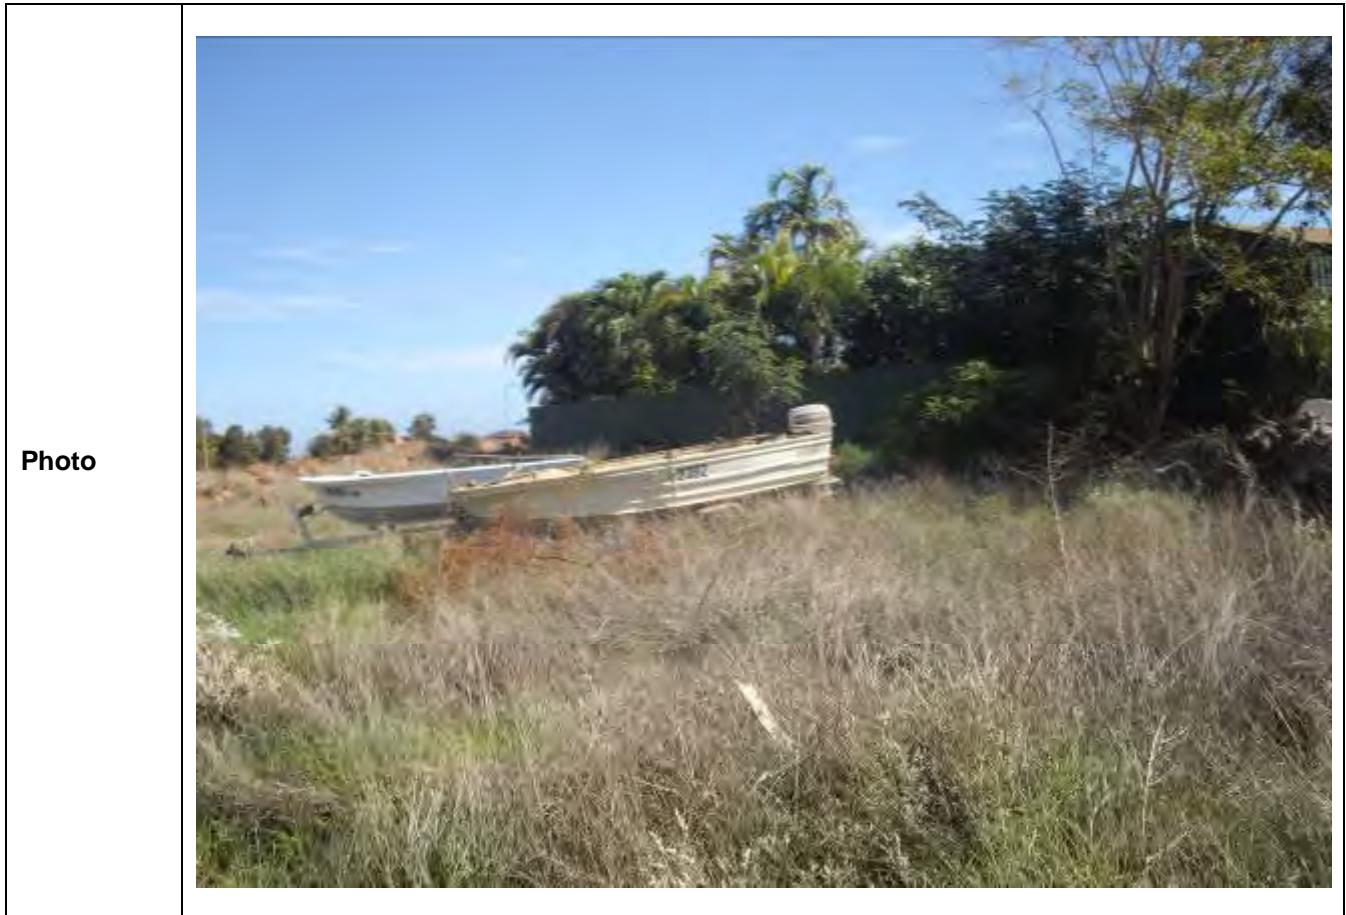
### 3.1 Lot No. 331 Elliot Crescent

<b>Category</b>	Encroachment / Drain Maintenance
<b>Type</b>	General items; Vegetation; Ill defined flow path.
<b>Description</b>	2 x boats; Dense vegetation impeding flow. No evidence of original intended design – catchment divide no works required.
<b>Photo ID</b>	988 ,8
<b>Scope of Works</b>	L - Remove boats H - Vegetation is to be slashed to a nominal height of 50 mm above ground with the exception of large, established trees of height in excess of 5 m, which shall remain L – Top of catchment no works required

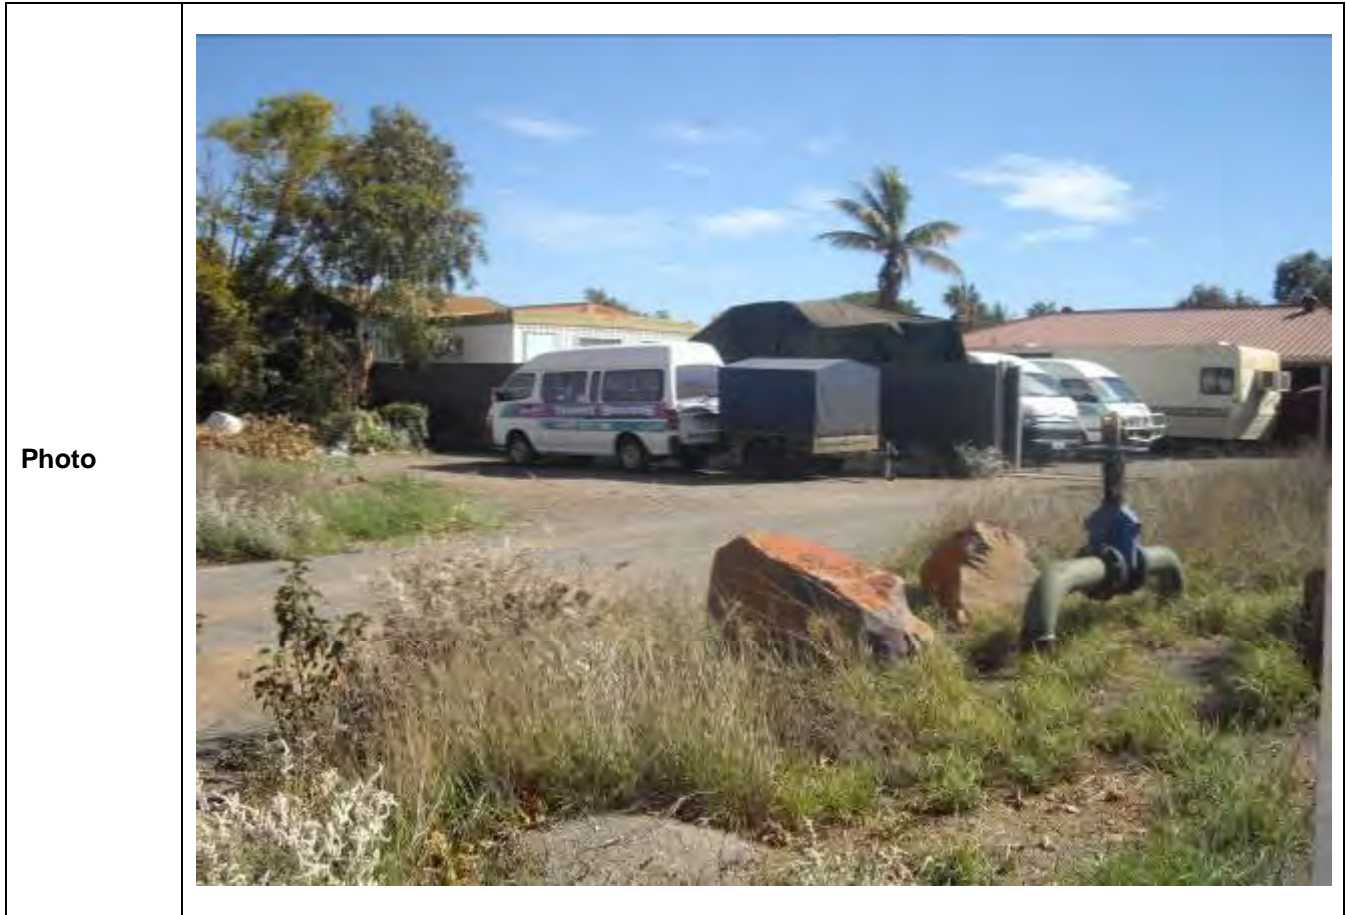
### 3.2 Lot No. 332 Elliot Crescent

<b>Category</b>	Encroachment / Drain Maintenance
<b>Type</b>	Rear access; Vegetation; General items; Ill defined flow path.
<b>Description</b>	Rear access impeding flow; Vehicle; Thick low lying vegetation that will impede flow; No evidence of original intended design.
<b>Photo ID</b>	987 – photo is of property with dark green fence with 3 mini vans and boat with cover on it.
<b>Scope of Works</b>	H - Remove rear access; L – Remove vehicle; H - Vegetation is to be slashed to a nominal height of 50 mm above ground with the exception of large, established trees of height in excess of 5 m, which shall remain; H – Construct defined channel directing flow east.

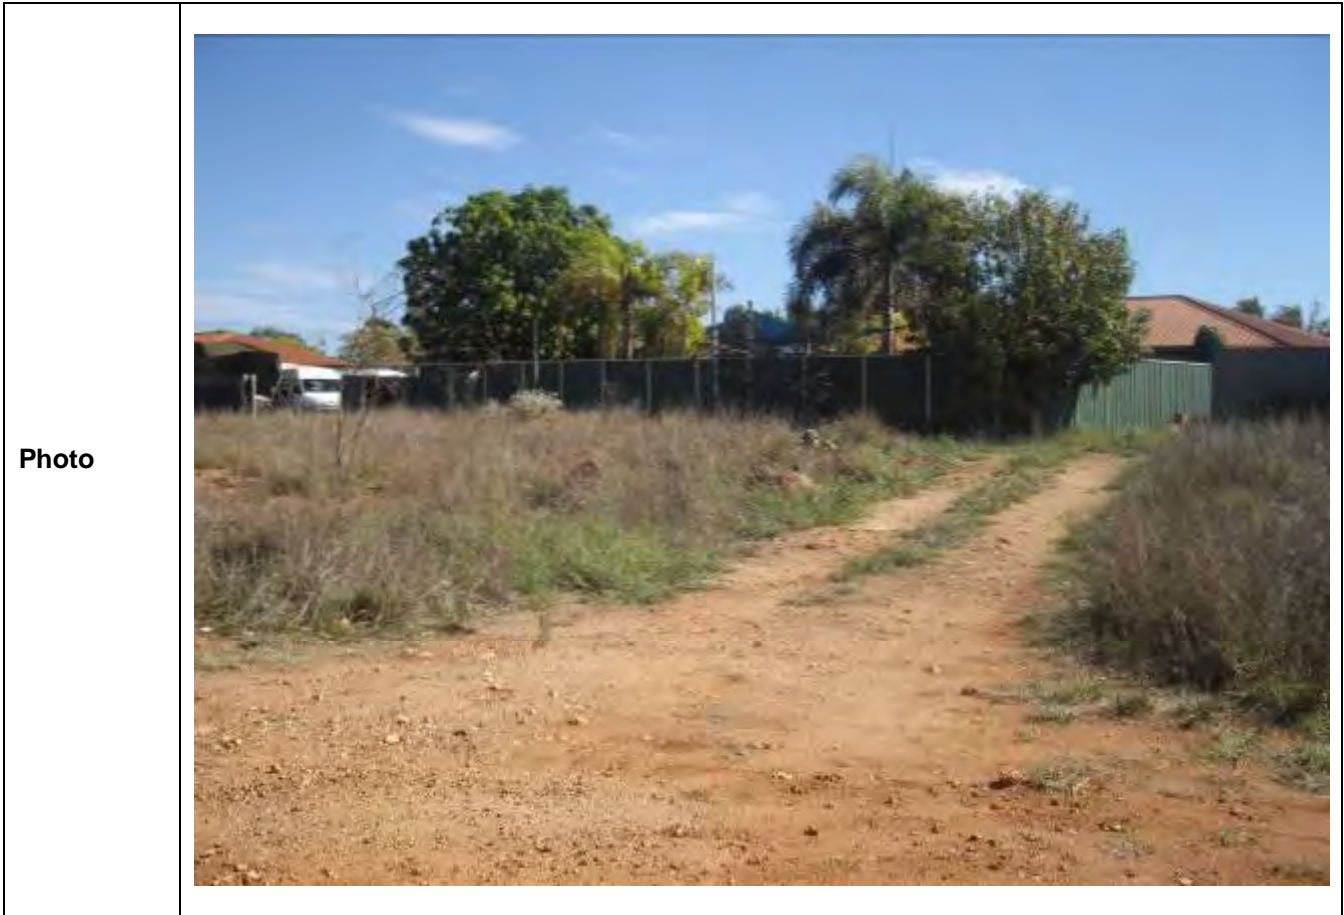
### 3.3 Lot No. 333 Elliot Crescent

<b>Category</b>	Encroachment / Drain Maintenance
<b>Type</b>	Rear access; Vegetation; Fill.
<b>Description</b>	Rear access follows contours; Thick low lying vegetation that will impede flow; Drainage reserve is above road level. Fill area potentially from excavated material from lot 333 Elliot Crescent.
<b>Photo ID</b>	986 – photo is of property with dark green fence
<b>Scope of Works</b>	L - Remove rear access and reinstate flow path H - Vegetation is to be slashed to a nominal height of 50 mm above ground with the exception of large, established trees of height in excess of 5 m, which shall remain; H – Remove fill and construct defined drainage channel directing flow east.

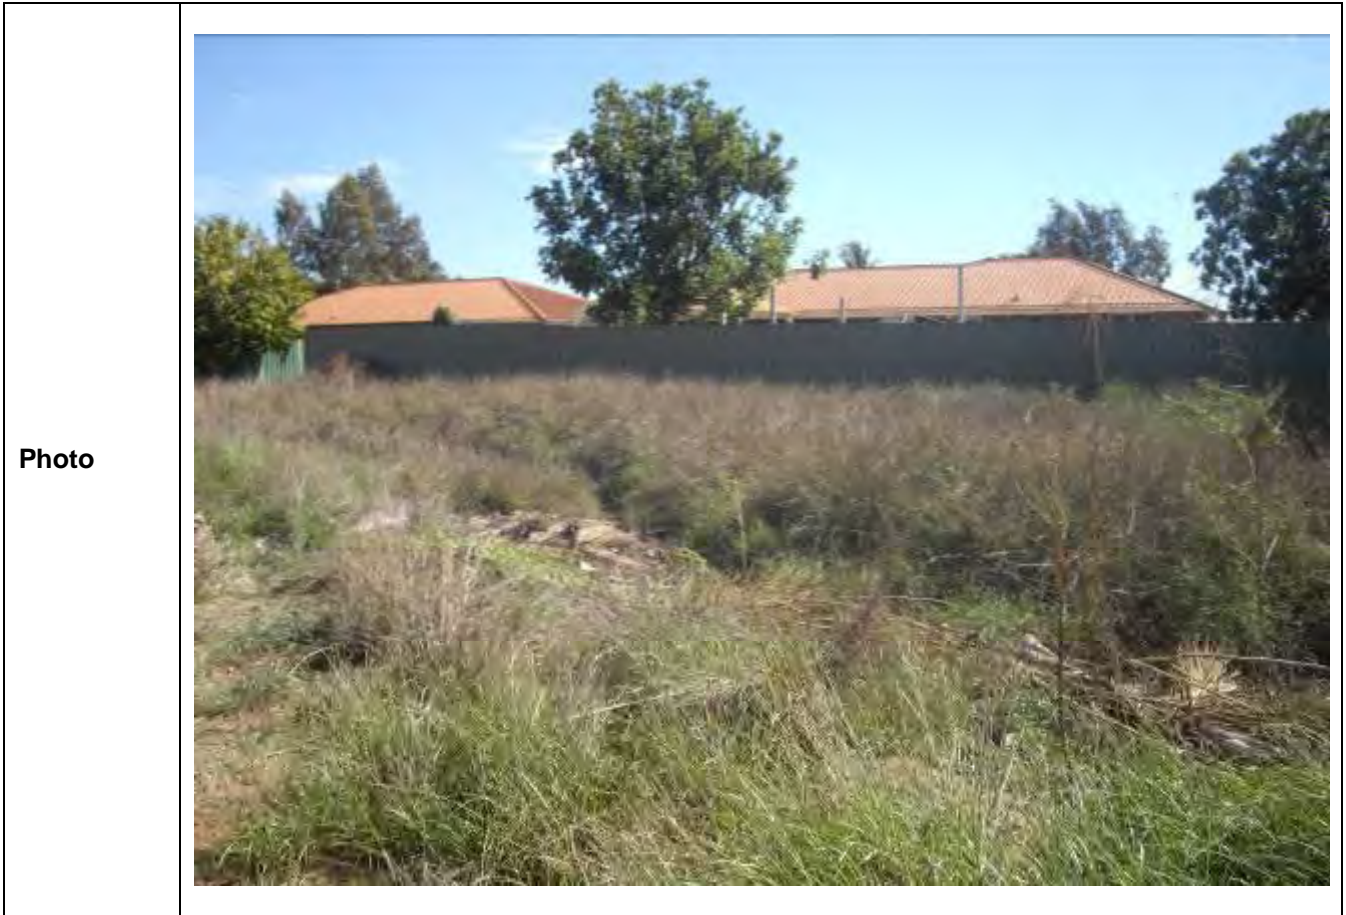
### 3.4 Lot No. 334 Elliot Crescent

<b>Category</b>	Drain Maintenance / Encroachment
<b>Type</b>	Vegetation Organic waste
<b>Description</b>	Thick low lying vegetation that will impede flow within the channel. Organic waste has been dumped within the existing drainage channel.
<b>Photo ID</b>	985
<b>Scope of Works</b>	H - Vegetation is to be slashed to a nominal height of 50 mm above ground with the exception of large, established trees of height in excess of 5 m, which shall remain; H - Organic waste to be removed from drain and returned to natural channel cross section.

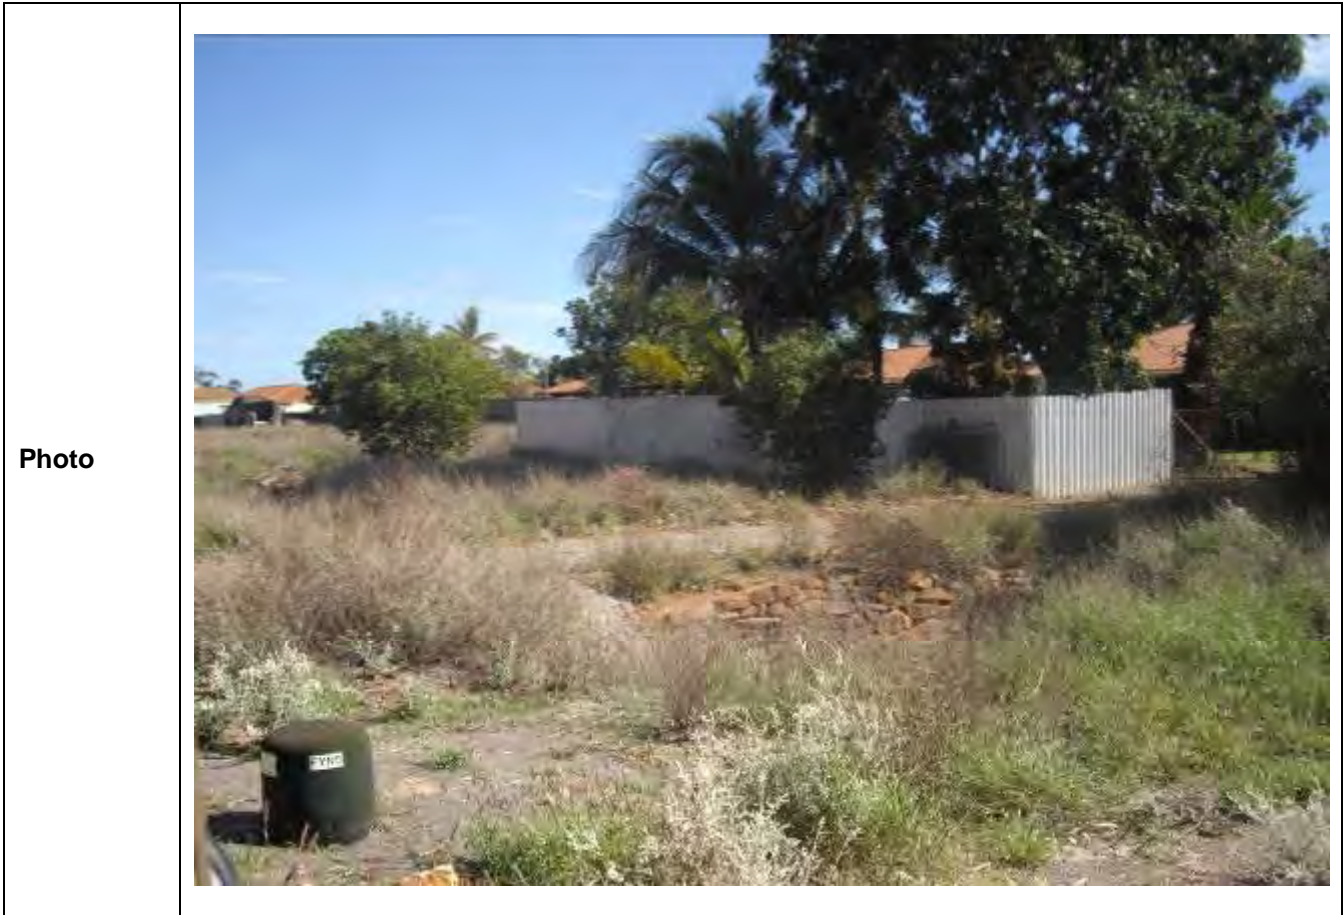
### 3.5 Lot No. 335 Elliot Crescent

<b>Category</b>	Encroachment
<b>Type</b>	Rear access with culvert; Vegetation.
<b>Description</b>	Rear access impeding flow; Semi-dense vegetation in channel and reserve.
<b>Photo ID</b>	984
<b>Scope of Works</b>	H - Remove access and reinstate drainage to downstream cross sectional capacity; H - Vegetation is to be slashed to a nominal height of 50 mm above ground with the exception of large, established trees of height in excess of 5 m, which shall remain.

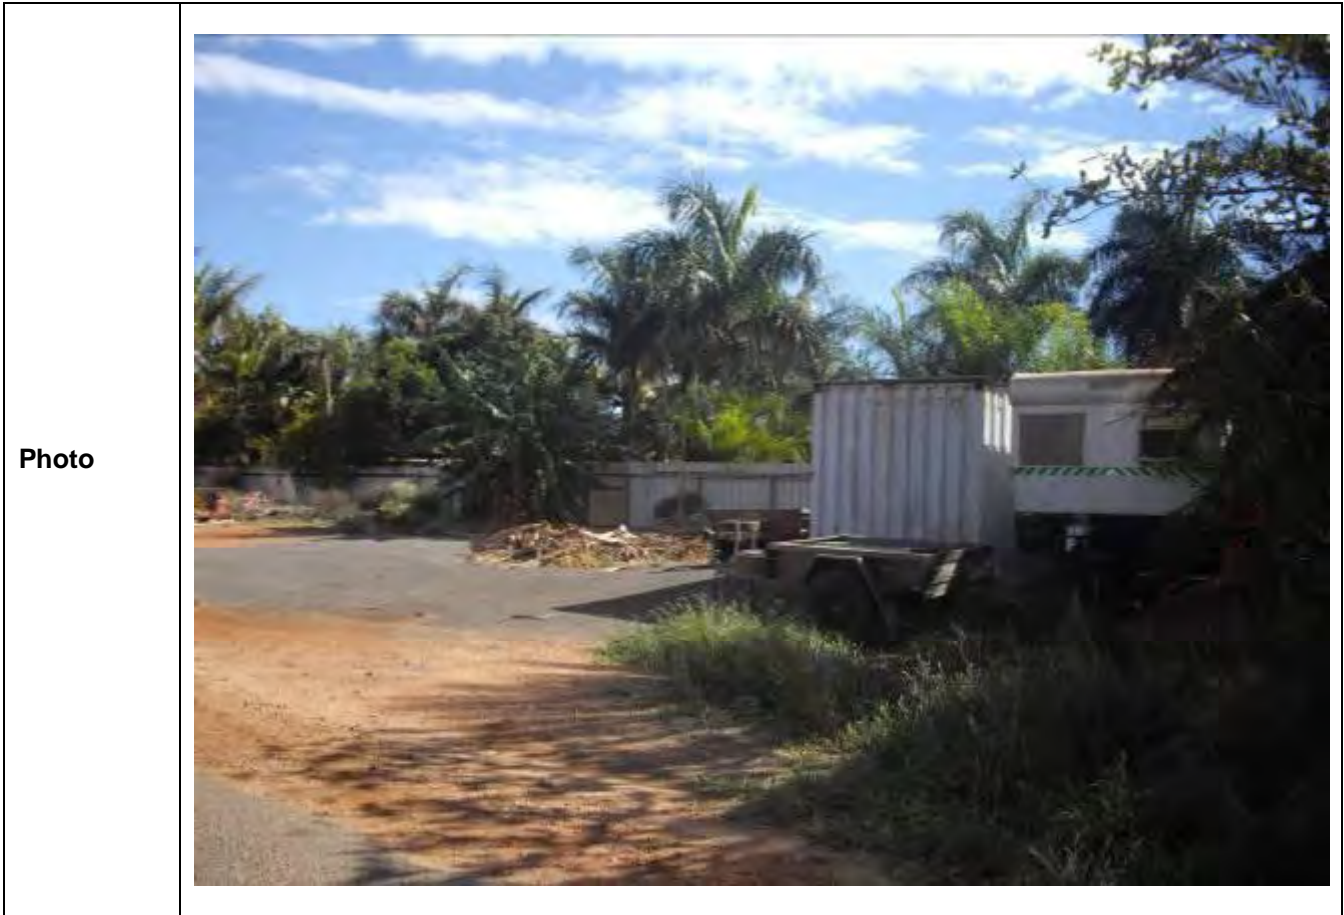
### 3.8 Lot No. 338 Elliot Crescent

<b>Category</b>	Encroachment
<b>Type</b>	Boundary extension; General items; No flow path.
<b>Description</b>	Potential backyard extension Trailer, caravan, sea container No flow path due to flat topography
<b>Photo ID</b>	981 ,472
<b>Scope of Works</b>	L - Remove existing and relocate boundary extension to within property boundary – get confirmation from survey; L - Remove trailer, caravan and sea container; L - Modify drainage reserve to redefine drainage flow path to direct east.

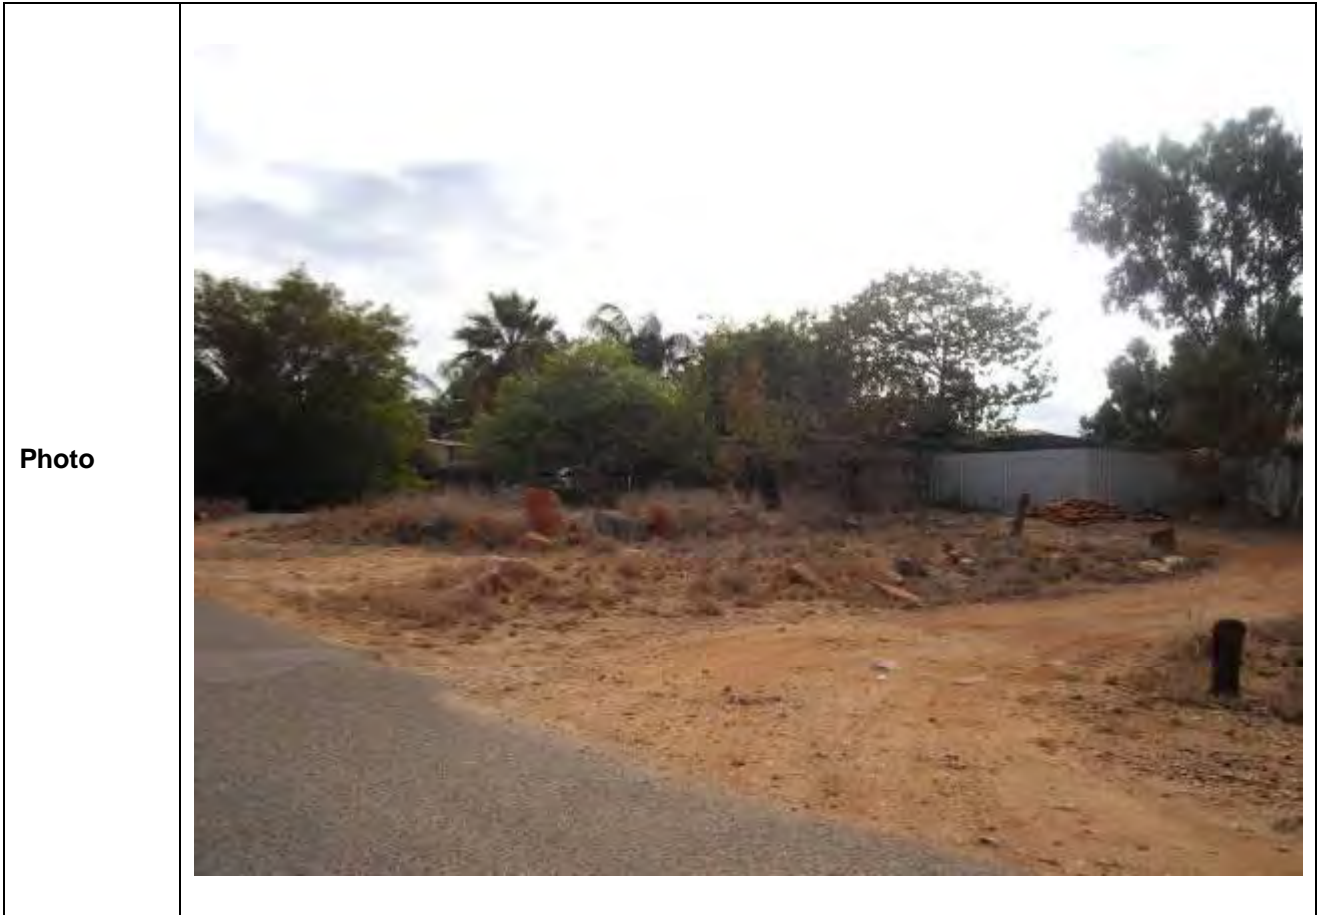
### 3.9 Lot No. 339 Elliot Crescent

<b>Category</b>	Encroachment
<b>Type</b>	Boundary extension, Rear access Modified flow path
<b>Description</b>	Fence; Rear access impeding flow; Original design intent not apparent.
<b>Photo ID</b>	471
<b>Scope of Works</b>	L - Remove existing fence and relocate to within property boundary; M - Remove rear access; L - Construct defined drainage channel directing flow east.

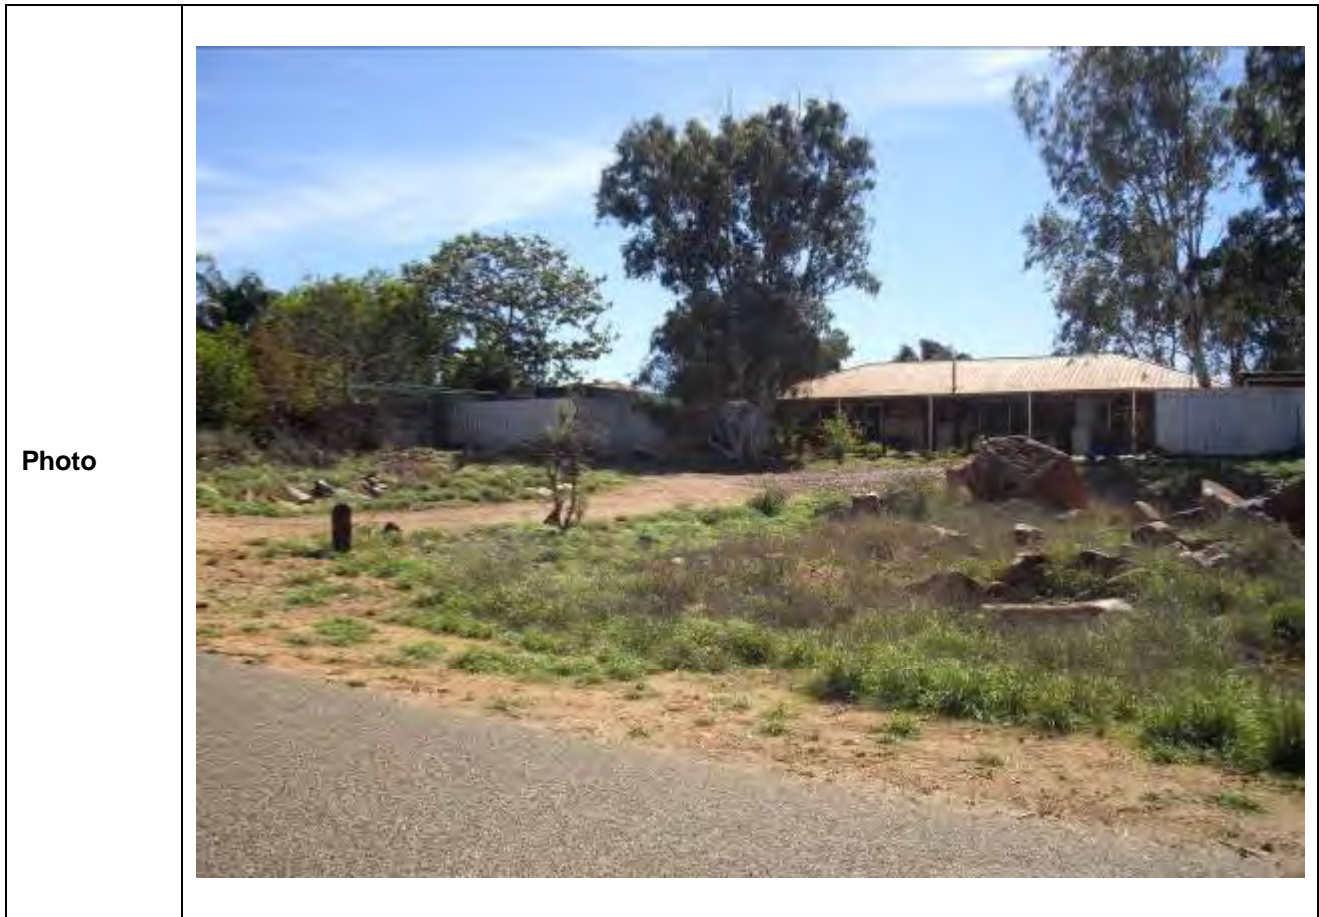
### 3.10 Lot No. 340 Elliot Crescent

<b>Category</b>	Encroachment
<b>Type</b>	Rear access Modified flow path
<b>Description</b>	Rear access follows natural topography; Original flow path appears to be an overland flow directed to the west and towards the road - adequate as kerb and road acts as main stormwater conveyer.
<b>Photo ID</b>	790
<b>Scope of Works</b>	L - Remove rear access and reinstate flow path; H - Modify drainage reserve to construct defined drainage channel directing flow east.

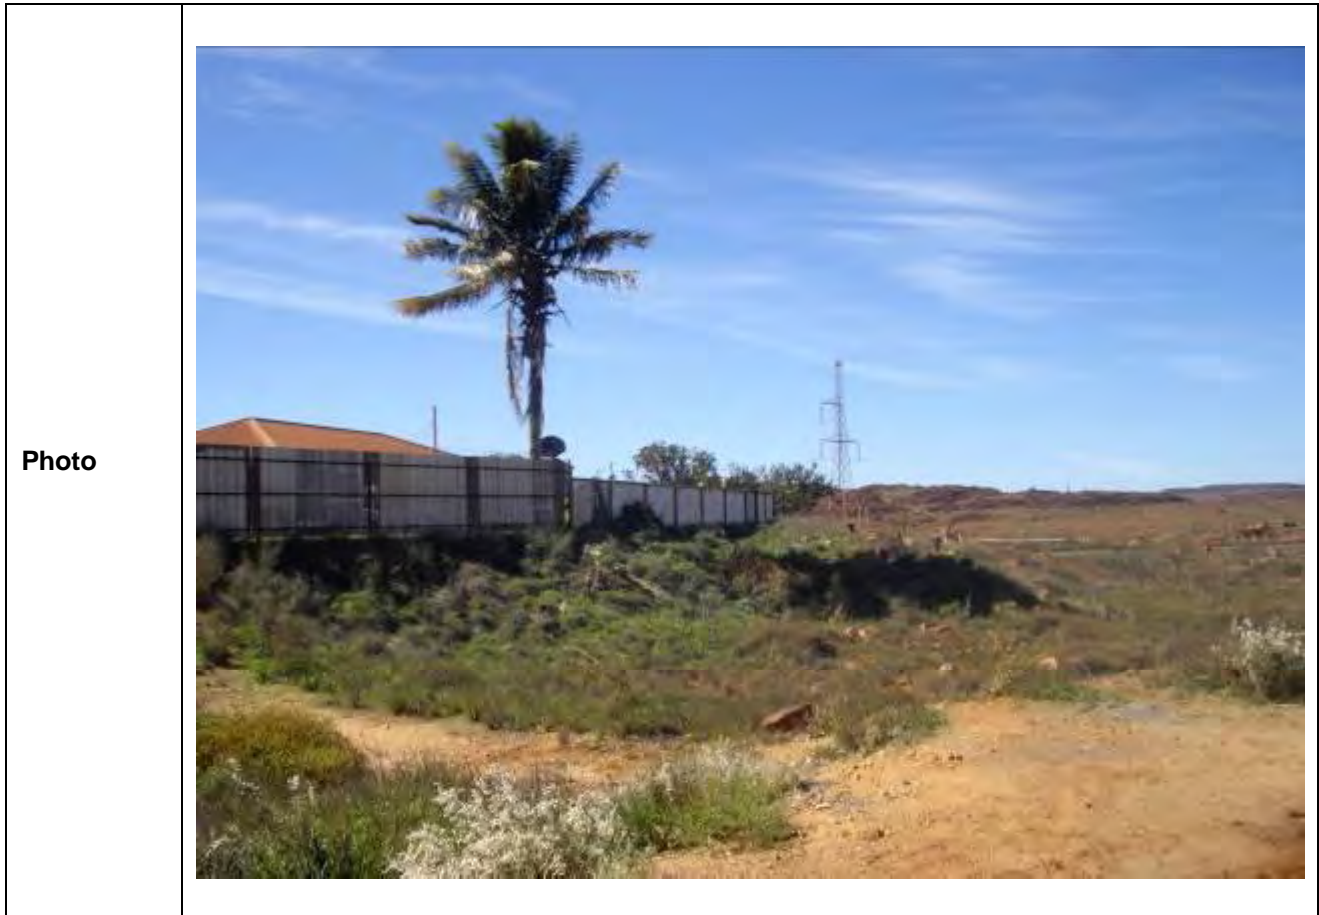
#### 4.1 Lot No. 1,251 Yule Crescent

<b>Category</b>	None
<b>Type</b>	None
<b>Description</b>	Drainage reserve is not conveying a collected body of water but is providing a slope for the stormwater to dissipate to the end of the east - west reserve. Lot drainage operates effectively.
<b>Photo ID</b>	778 – photo is of far lot
<b>Scope of Works</b>	None

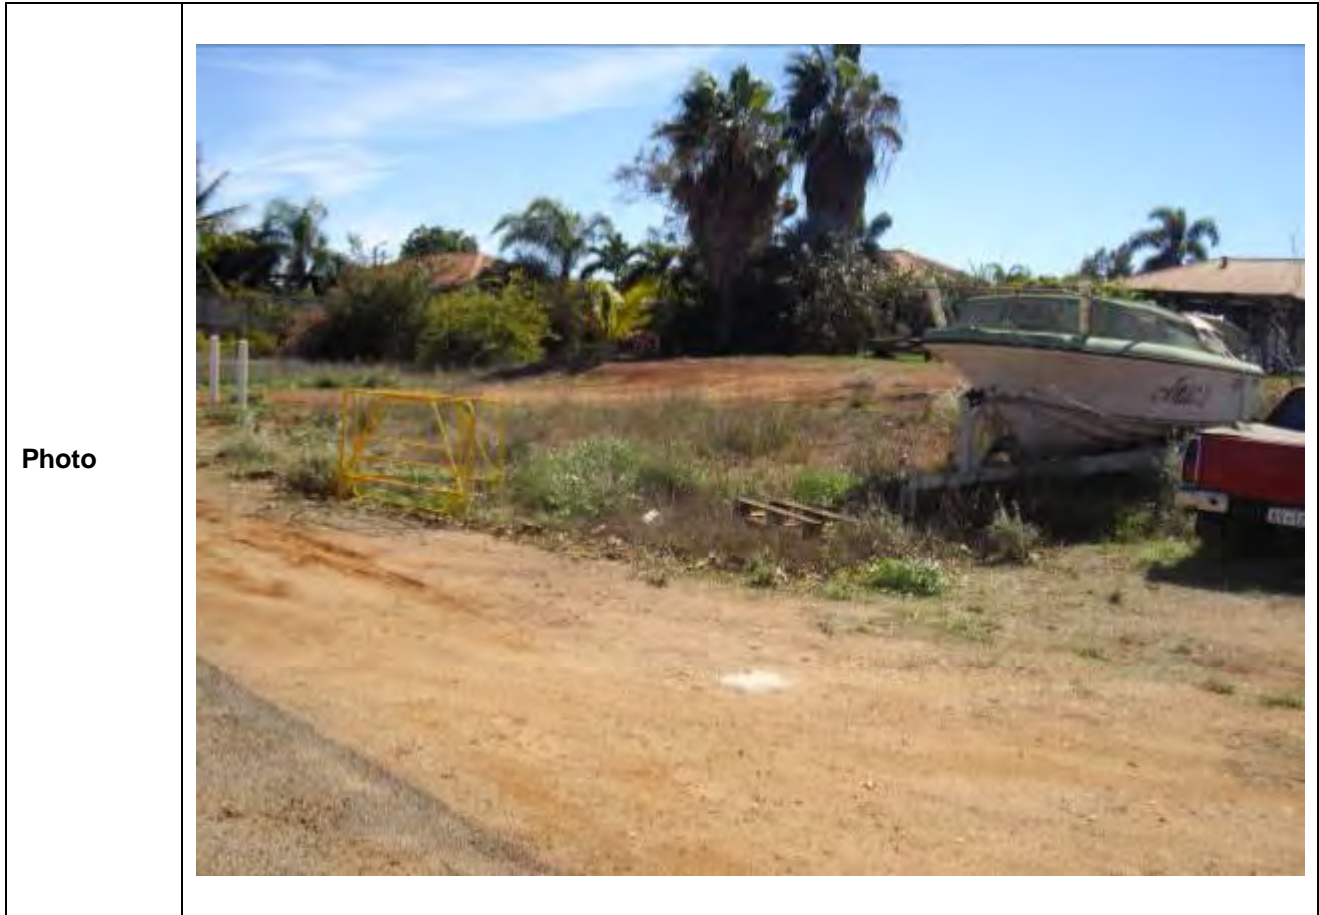
#### 4.6 Lot No. 255 Yule Crescent

<b>Category</b>	Encroachment
<b>Type</b>	Rear access; General items. Ill defined channel
<b>Description</b>	Rear access follows natural topography; Boat. Original intended drainage flow path not evident.
<b>Photo ID</b>	782
<b>Scope of Works</b>	L - Remove rear access; L - Remove boat; L – Modify drainage reserve to define drainage channel to direct flow west (match to 256).

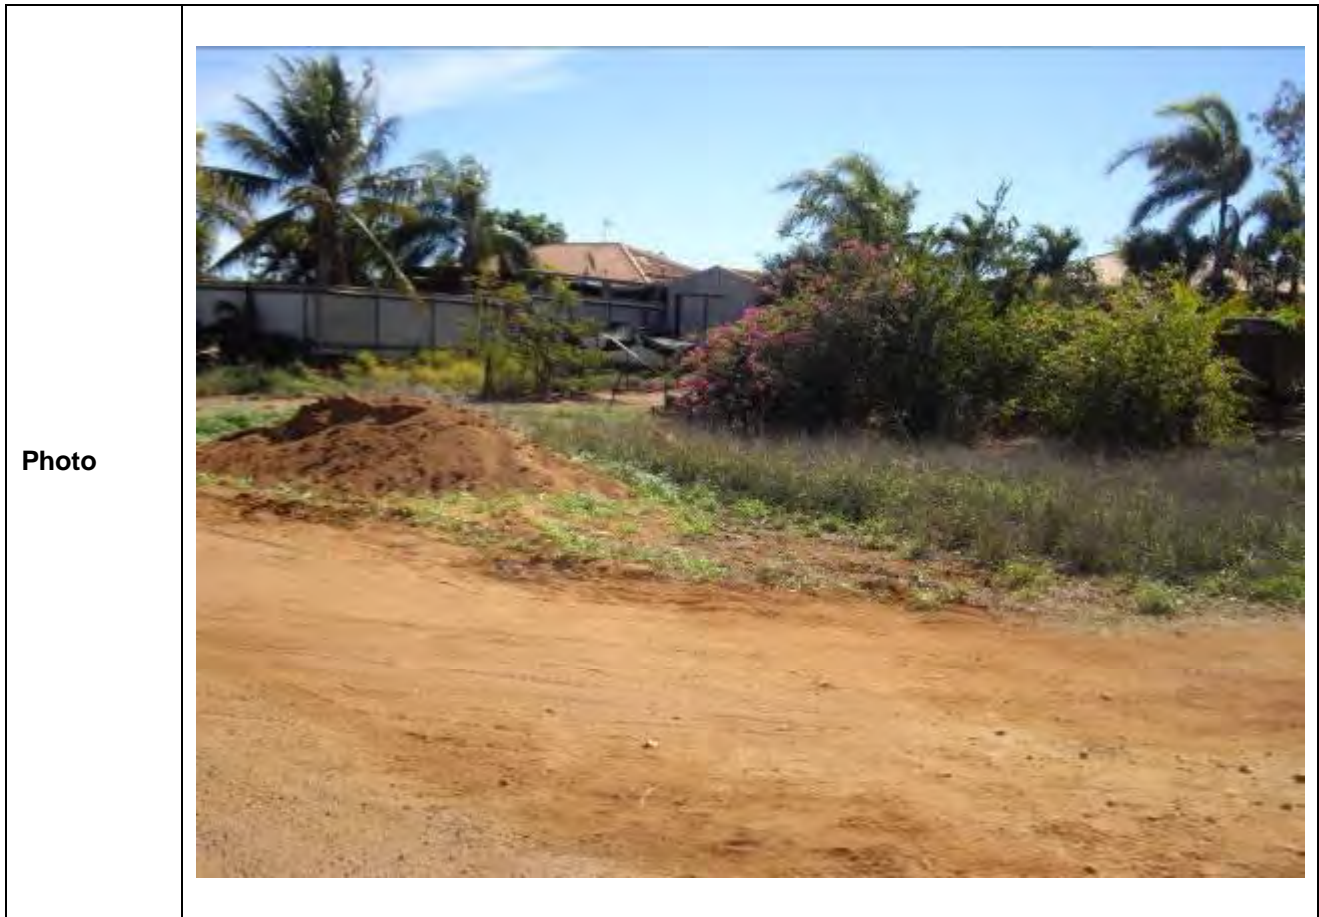
#### 4.7 Lot No. 256 Yule Crescent

<b>Category</b>	Encroachment / Drain Maintenance
<b>Type</b>	Rear access No flow path Vegetation
<b>Description</b>	Rear access follows natural topography; No drainage flow path evident; Overgrown vegetation impeding flow.
<b>Photo ID</b>	783
<b>Scope of Works</b>	L - Remove rear access; L - Modify drainage reserve to define drainage channel to direct flow west (match to 255); L - Vegetation is to be slashed to a nominal height of 50 mm above ground with the exception of large, established trees of height in excess of 5 m, which shall remain.

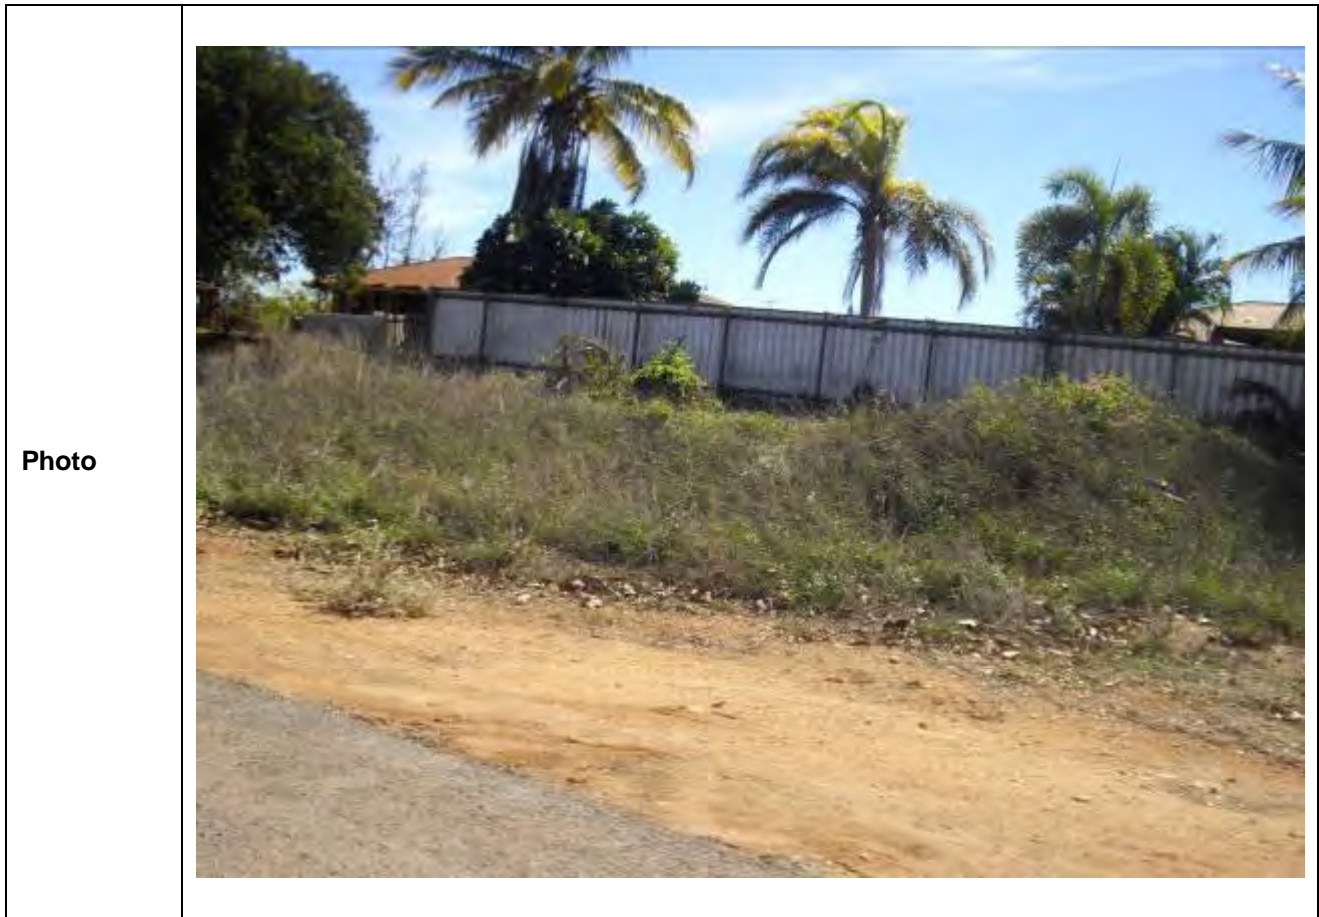
#### 4.8 Lot No. 257 Yule Crescent

<b>Category</b>	Drain Maintenance
<b>Type</b>	No flow path
<b>Description</b>	No drainage path evident within drainage reserve and no evidence of original design intent. Drainage reserve slopes towards the road - adequate.
<b>Photo ID</b>	784
<b>Scope of Works</b>	L - Modify drainage reserve to define drainage channel to direct flow west (match to 256);

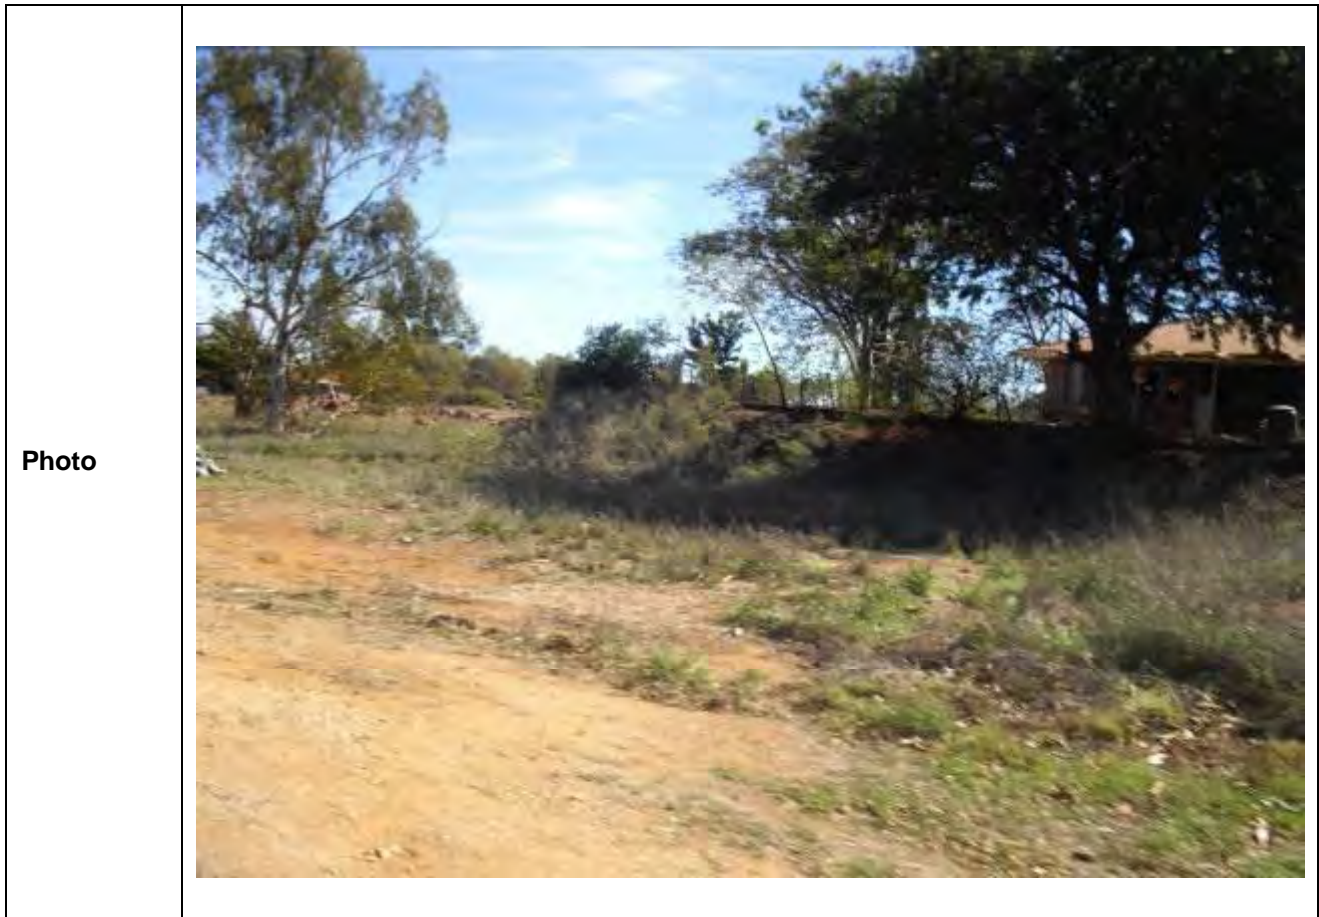
#### 4.9 Lot No. 258 Yule Crescent

<b>Category</b>	Drain Maintenance
<b>Type</b>	No flow path
<b>Description</b>	No drainage path evident within drainage reserve and no evidence of original design intent. Natural topography directs stormwater to the west.
<b>Photo ID</b>	785
<b>Scope of Works</b>	H - Construct defined drainage channel to direct flow west (match to 257);

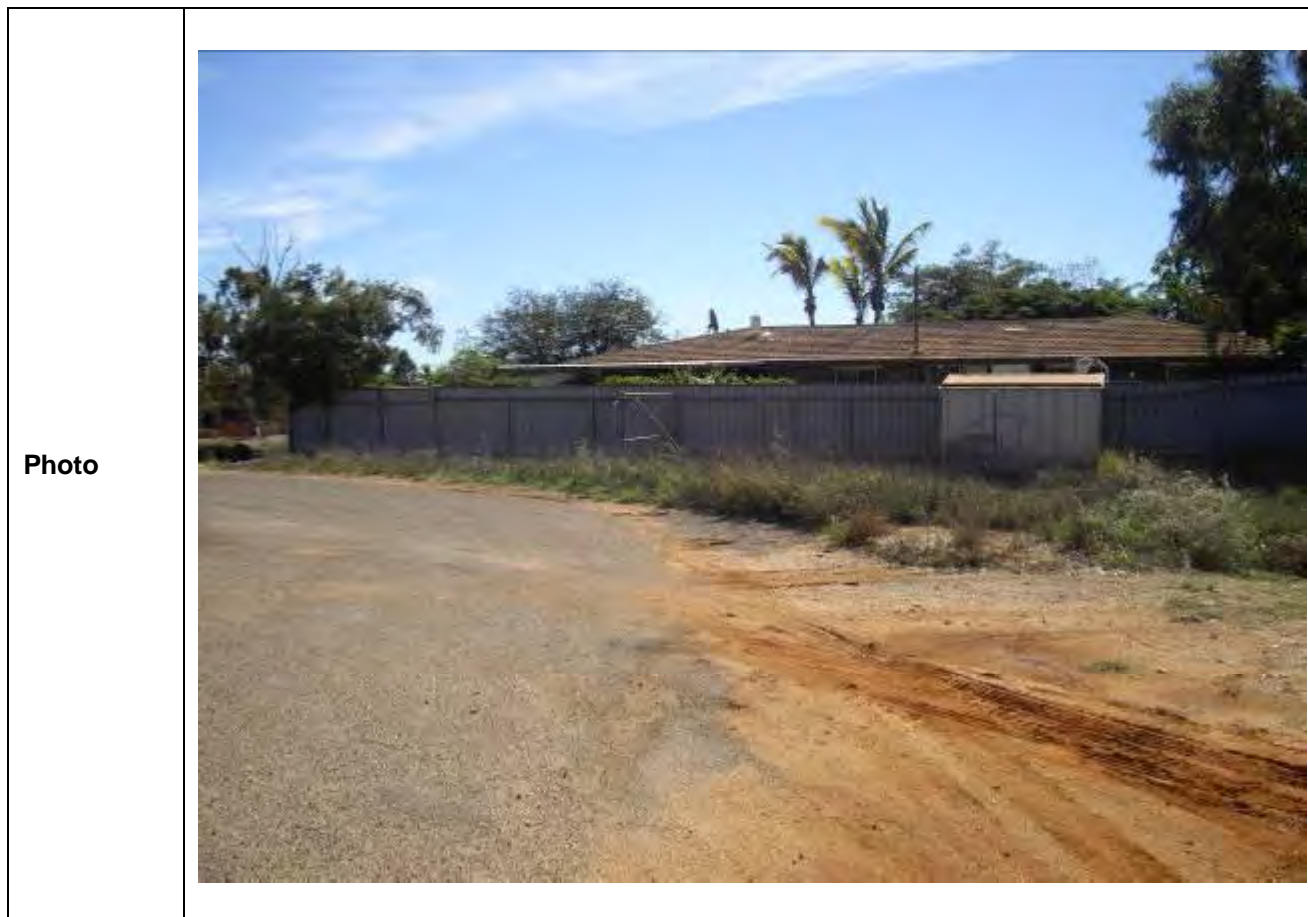
## 5.1 Lot No. 1,259 Wilkie Crescent

<b>Category</b>	Encroachment
<b>Type</b>	Rear access; Lot configuration.
<b>Description</b>	Rear access - impedes flow; Lot configuration creates 'bottle neck'.
<b>Photo ID</b>	794
<b>Scope of Works</b>	H – Remove rear access and construct defined channel to direct flow west.
