City of Karratha  
Dampier Stormwater Management Study  
Report  
Part B  
June 2015

## Appendix **C** – 2010 encroachment reviews

**Rio Tinto Iron Ore**  
Report on Dampier Drainage  
Review  
Block 1 Encroachments  
June 2010

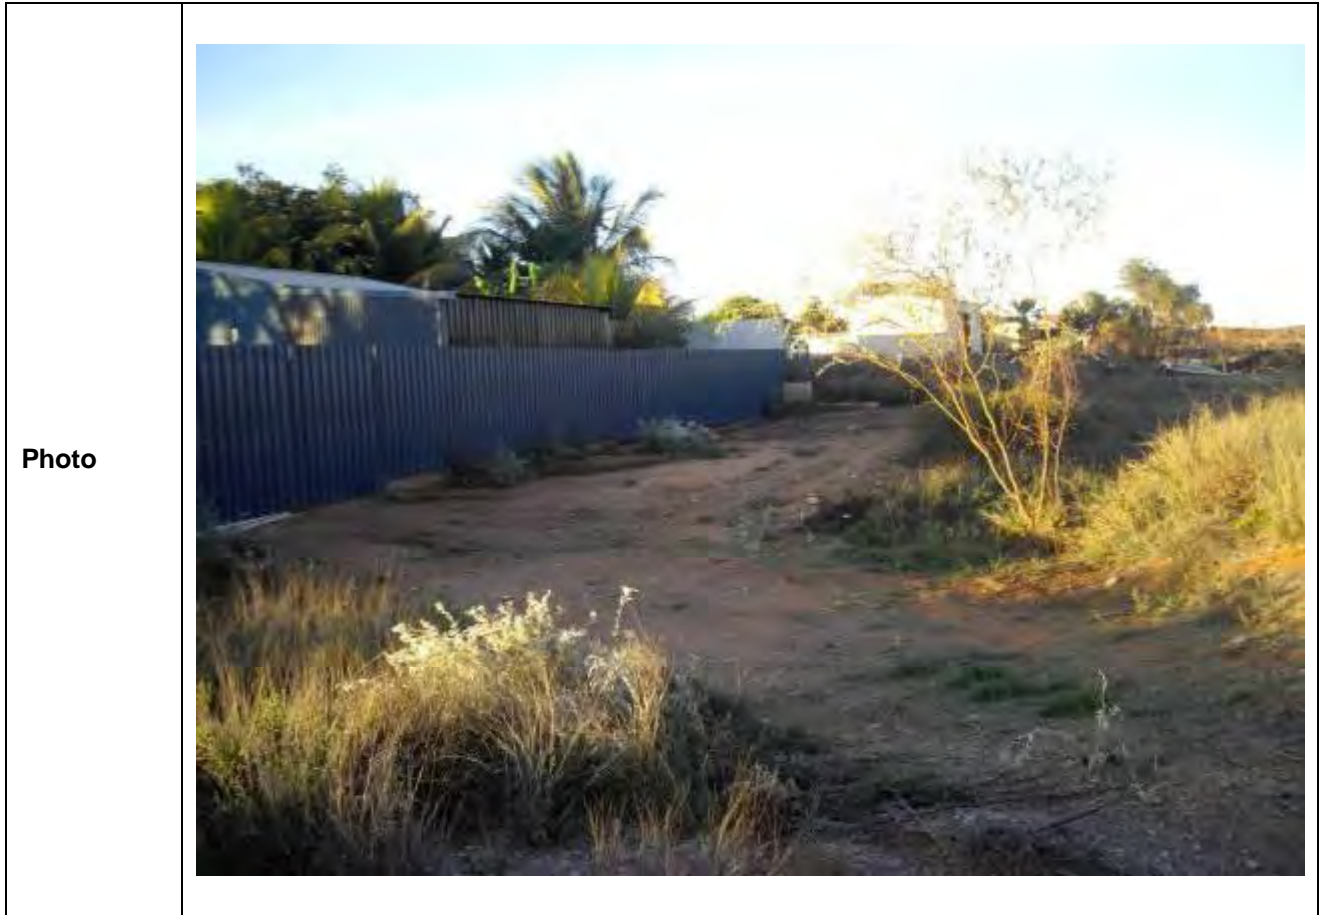
## 5.2 Lot No. 259 Wilkie Crescent

<b>Category</b>	Encroachment
<b>Type</b>	Modified drainage channel; Rear access.
<b>Description</b>	Batter encroachment in the form of a parking area; Rear access follows drainage contours with minor impedance to flow.
<b>Photo ID</b>	681
<b>Scope of Works</b>	L - Remove batter / parking area and reinstate drainage channel to upstream capacity L – Remove rear access.

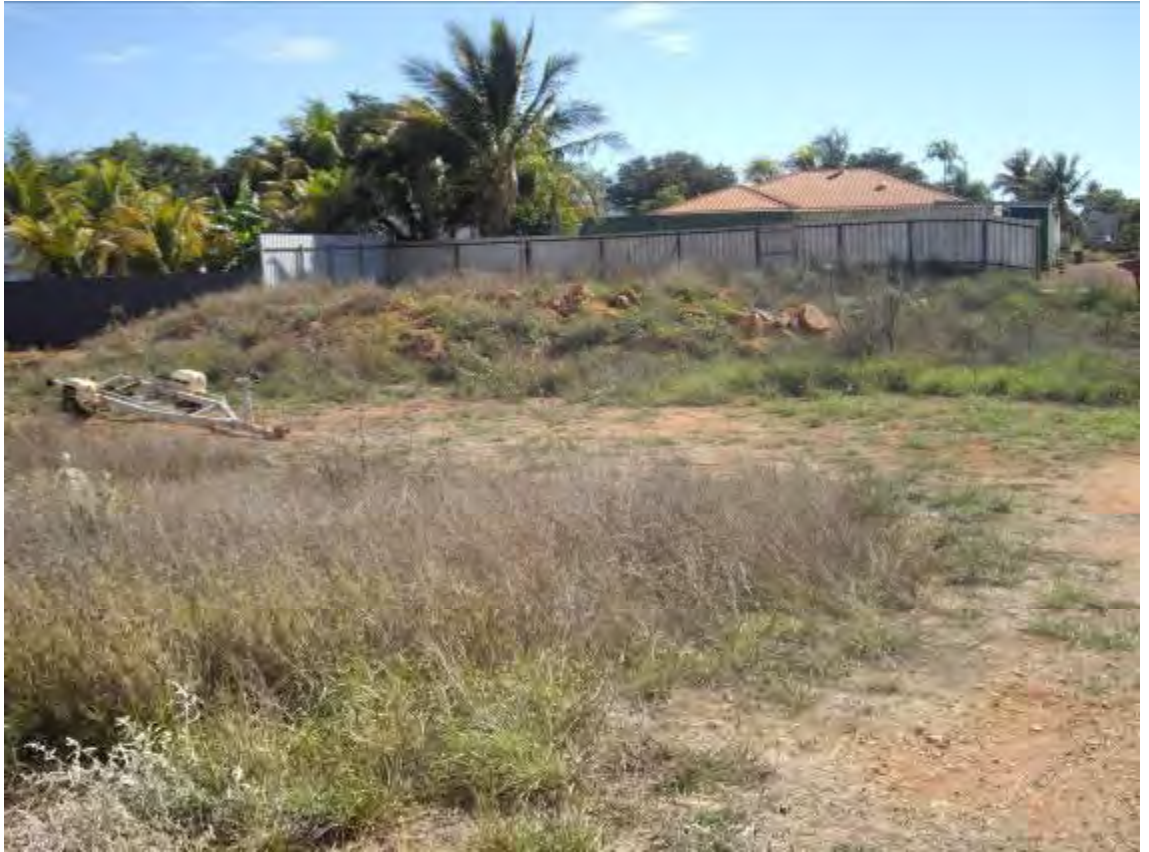
### 5.3 Lot No. 260 Wilkie Crescent

Category	Drain Maintenance / Encroachment
Type	Vegetation General item
Description	Semi-dense <u>un</u> maintained vegetation – inhibits flow Trailer
Photo ID	991
Scope of Works	L - Vegetation is to be slashed to a nominal height of 50 mm above ground with the exception of large, established trees of height in excess of 5 m, which shall remain; L – Remove trailer.

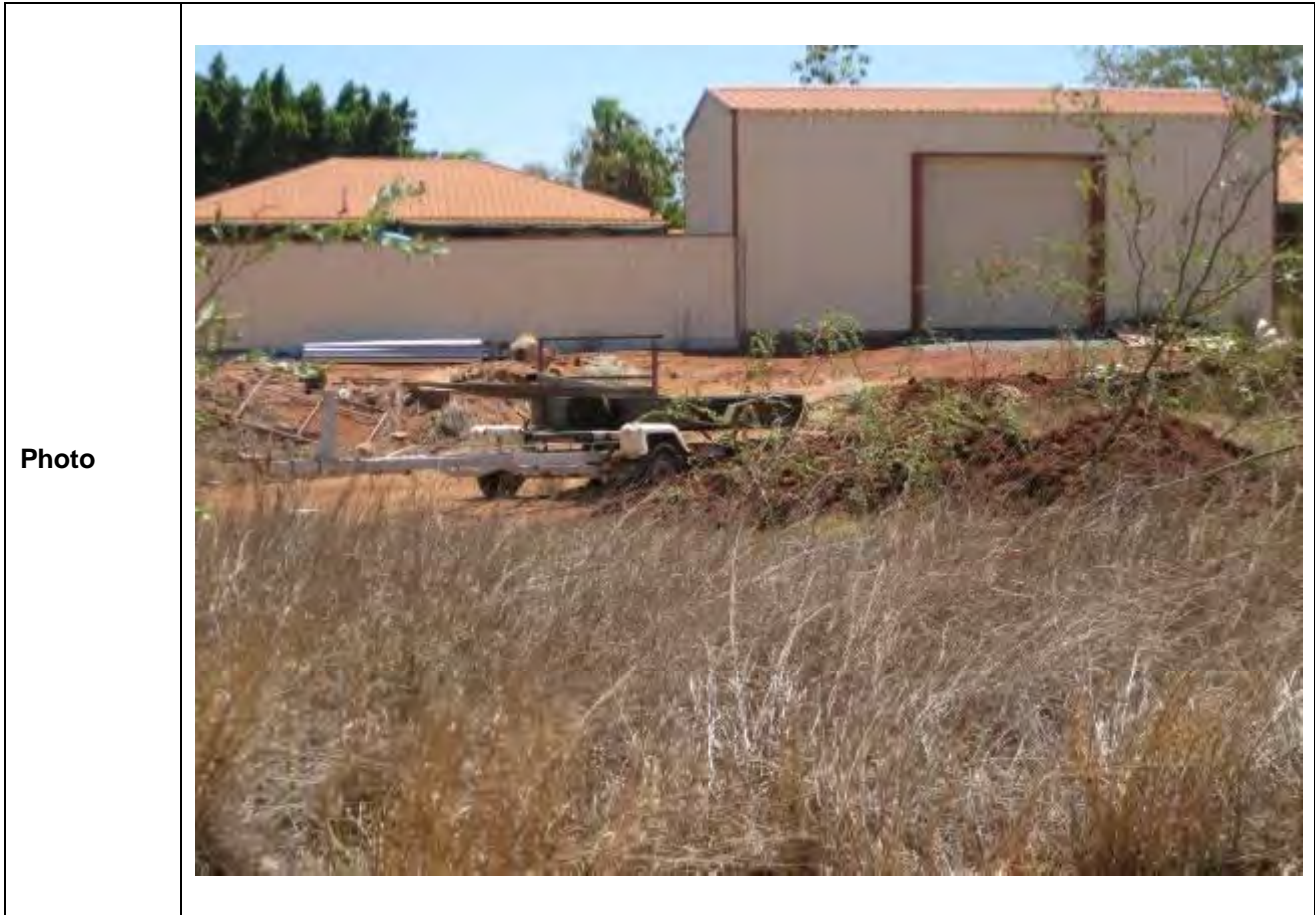
## 5.4 Lot No. 261 Wilkie Crescent

<b>Category</b>	Encroachment / Drain Maintenance
<b>Type</b>	Ill defined flow path Rear access; General items.
<b>Description</b>	Topography of reserve is relatively flat; Rear access impeding flow; Mounded fill potentially causing sedimentation within the drain. Boat trailers
<b>Photo ID</b>	4
<b>Scope of Works</b>	L - Modify drainage reserve to define drainage channel to direct flow west H - Remove rear access and reinstate drainage flow path L - Remove mounded fill and boat trailers

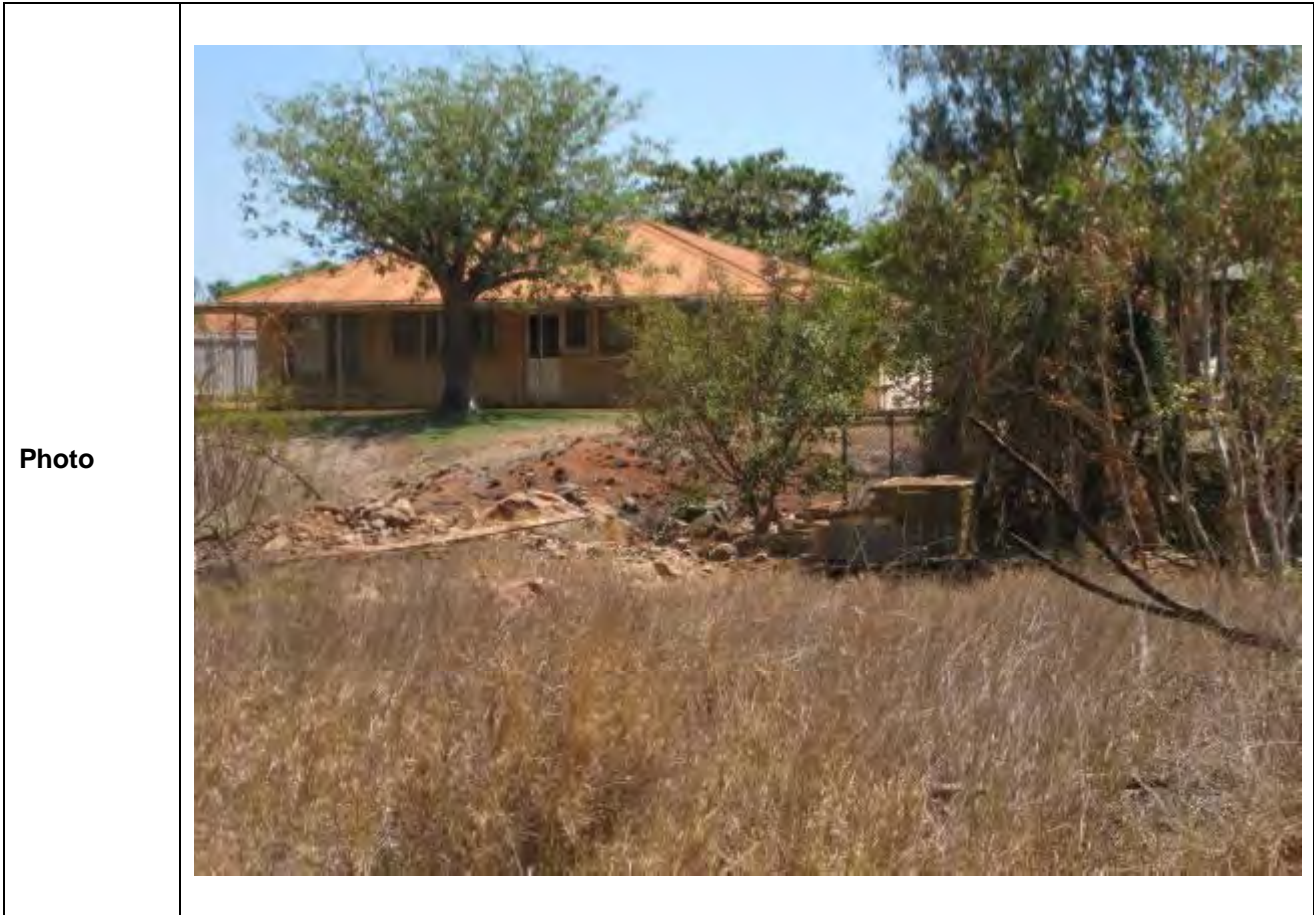
**5.5 Lot No. 262 Wilkie Crescent**

<b>Category</b>	Drain maintenance
<b>Type</b>	Vegetation
<b>Description</b>	Vegetation impeding flow
<b>Photo ID</b>	3
<b>Scope of Works</b>	H - Vegetation is to be slashed to a nominal height of 50 mm above ground with the exception of large, established trees of height in excess of 5 m, which shall remain;

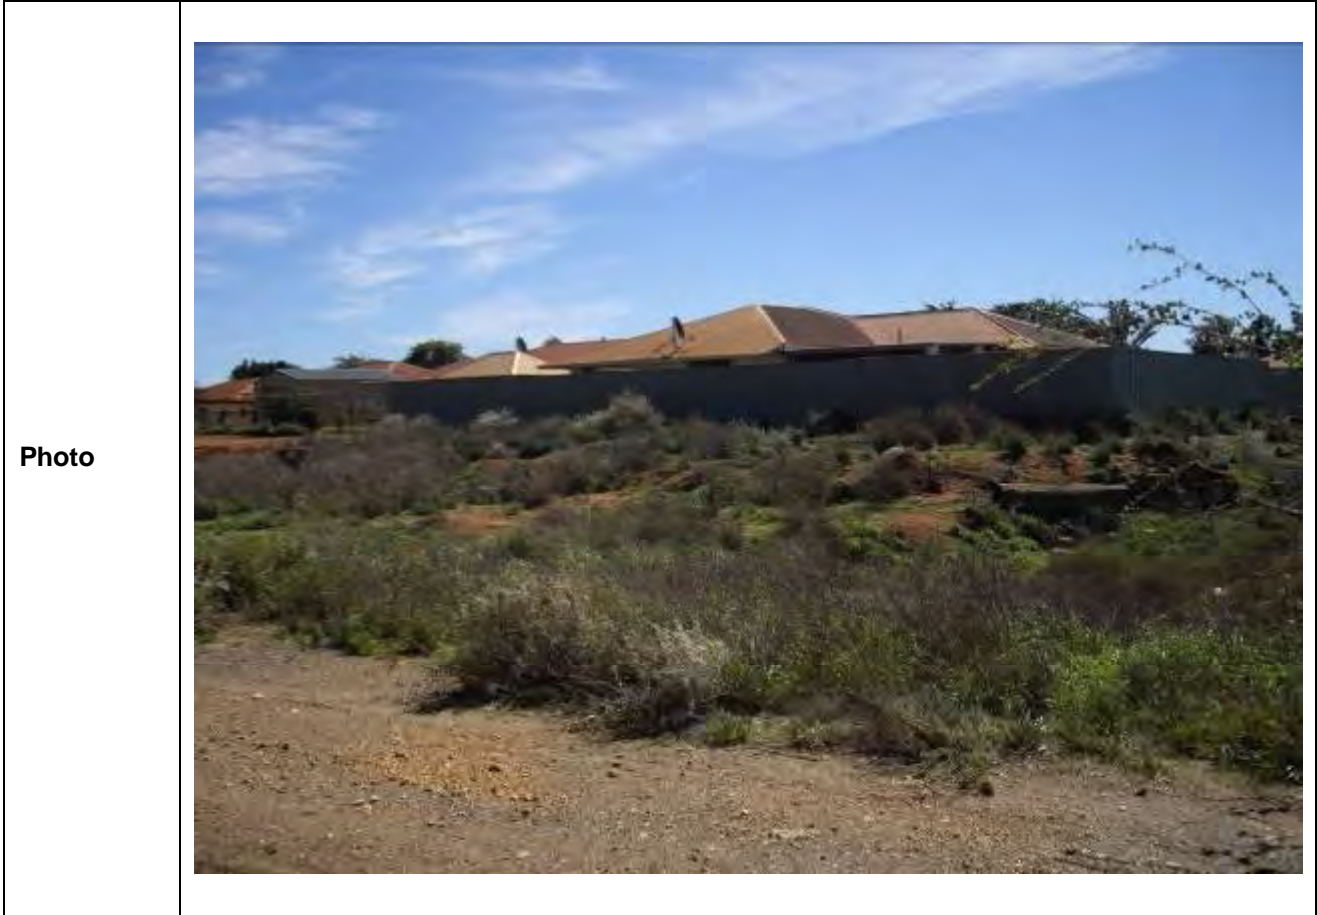
**5.8 Lot No. 265 Wilkie Crescent**

<b>Category</b>	Drain Maintenance
<b>Type</b>	Ill defined flow path
<b>Description</b>	Not defined drainage flow path due to natural topography.
<b>Photo ID</b>	793
<b>Scope of Works</b>	L - Modify drainage reserve define drainage channel to direct flow east.

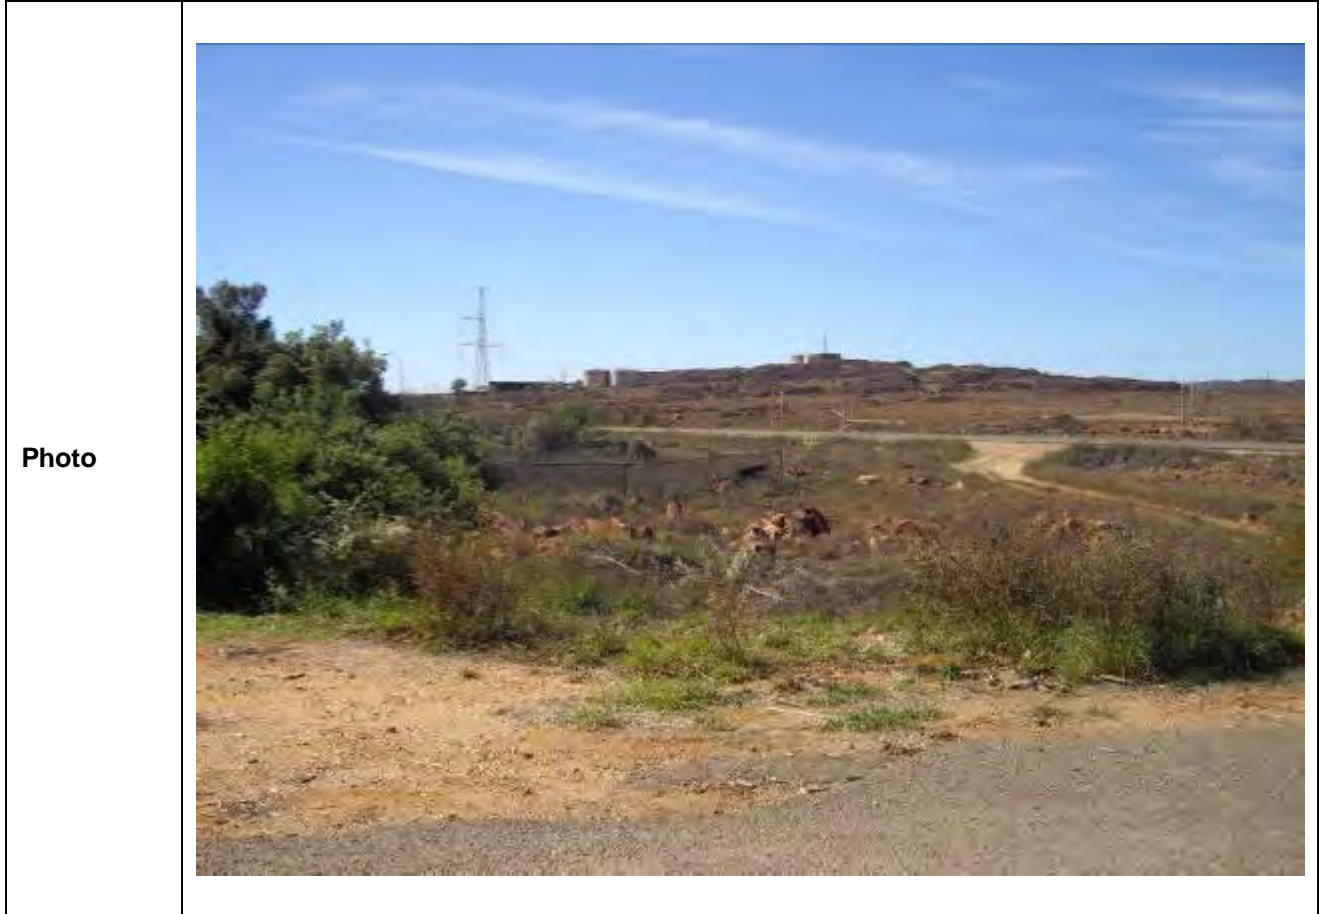
## 6.1 Lot No. 266 Pingandy Crescent

<b>Category</b>	Encroachment / Drain Maintenance
<b>Type</b>	Vegetation. Boundary Extension
<b>Description</b>	Dense overgrown vegetation but not impeding the full width of the reserve; Fence
<b>Photo ID</b>	786 – photo shows vegetation, fence in relation to the road.
<b>Scope of Works</b>	L - Vegetation is to be slashed to a nominal height of 50 mm above ground with the exception of large, established trees of height in excess of 5 m, which shall remain: L – Remove existing fence and relocate to within property boundary – get confirmation from survey.

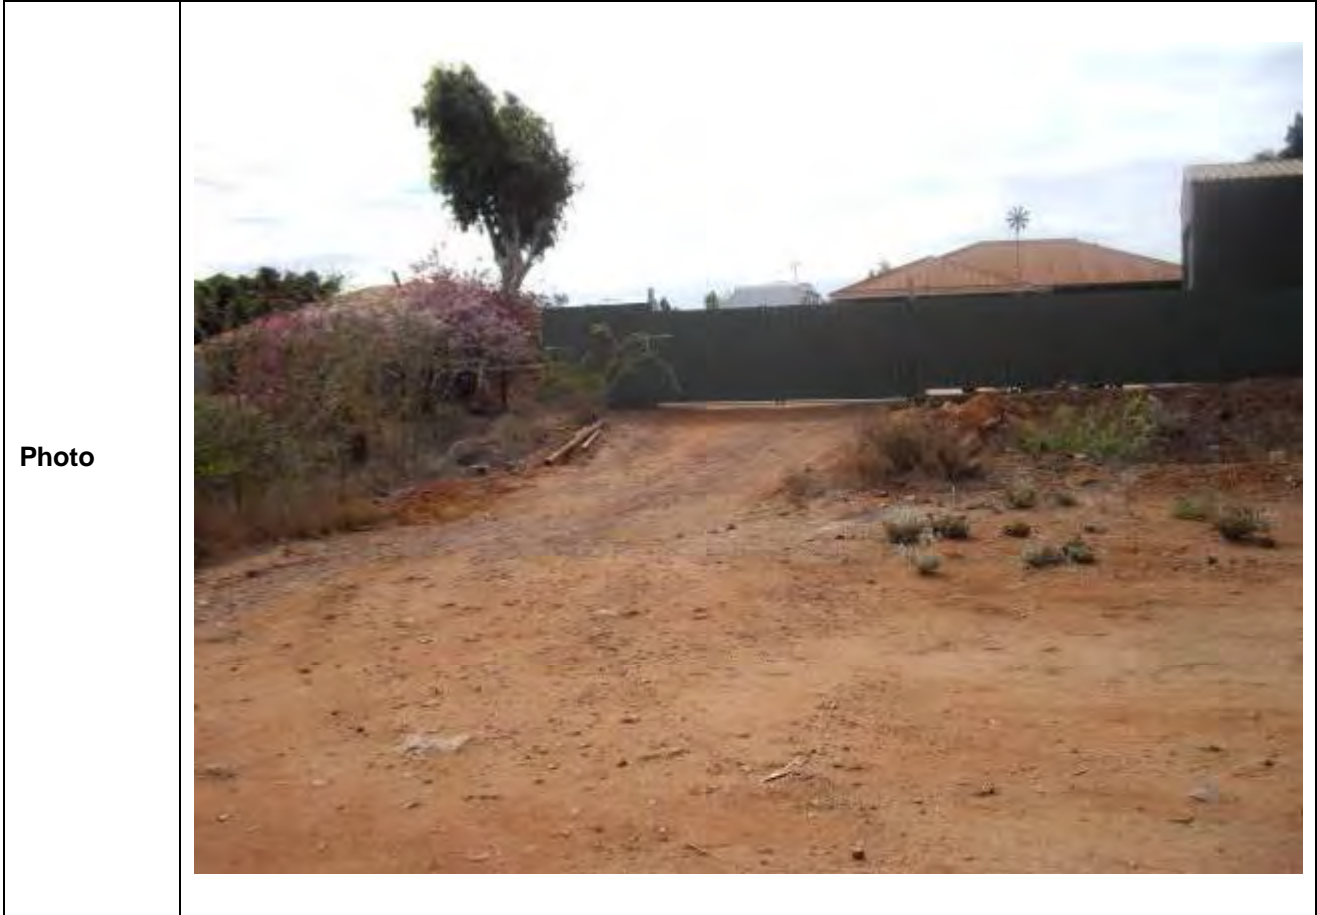
## 6.2 Lot No. 267 Pingandy Crescent

<b>Category</b>	Encroachment
<b>Type</b>	Rear access
<b>Description</b>	Rear access impeding flow
<b>Photo ID</b>	477
<b>Scope of Works</b>	H - Remove rear access and construct defined drainage channel to direct flow east.

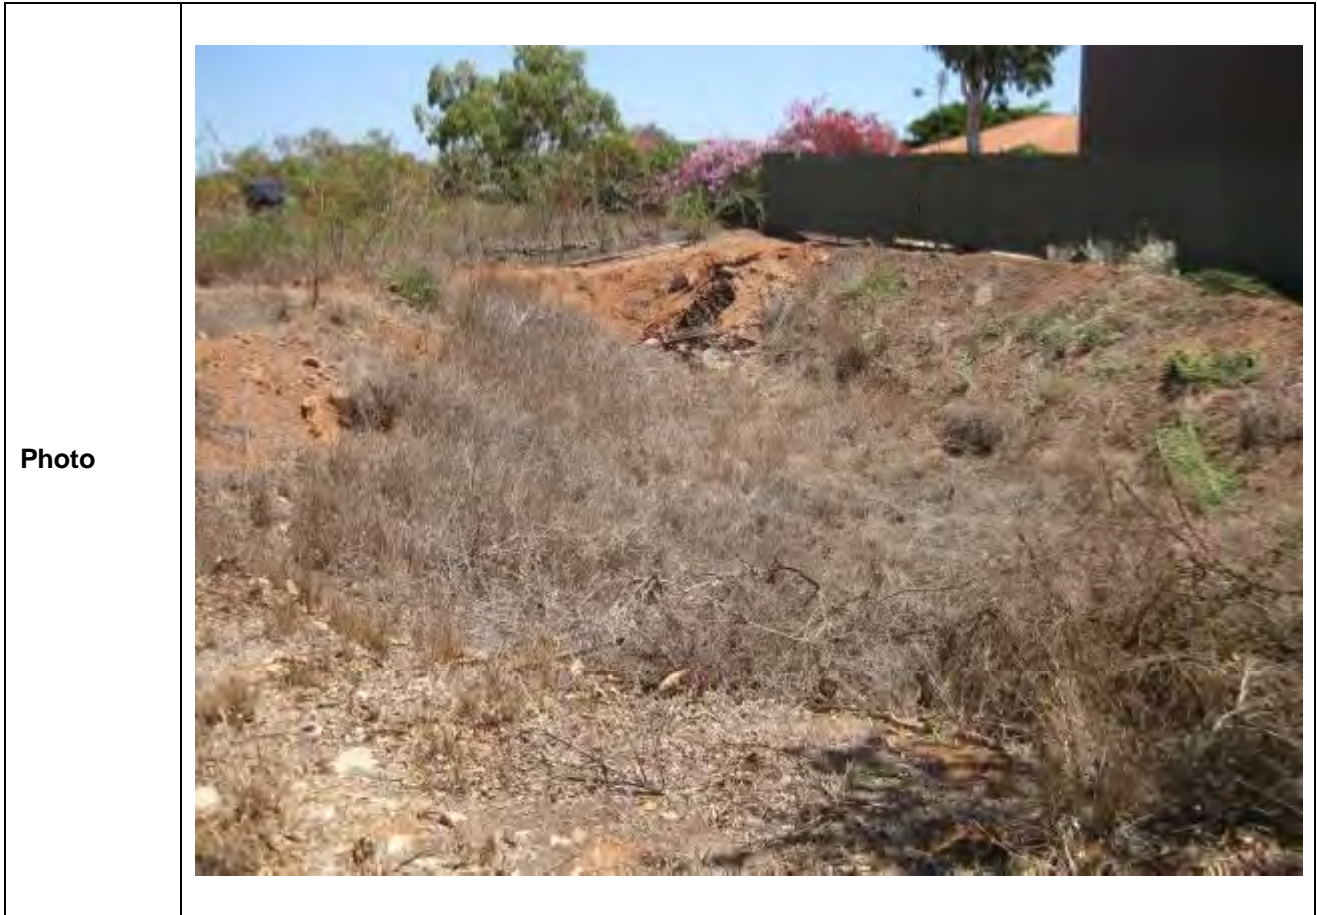
### 6.3 Lot No. 268 Pingandy Crescent

<b>Category</b>	Encroachment
<b>Type</b>	Rear access
<b>Description</b>	Rear access impeding flow (upstream is also blocked making a depression at this lot; as shown in photo)
<b>Photo ID</b>	17 – green fence is lot 268
<b>Scope of Works</b>	H - Remove rear access and construct defined drainage channel to direct flow east.

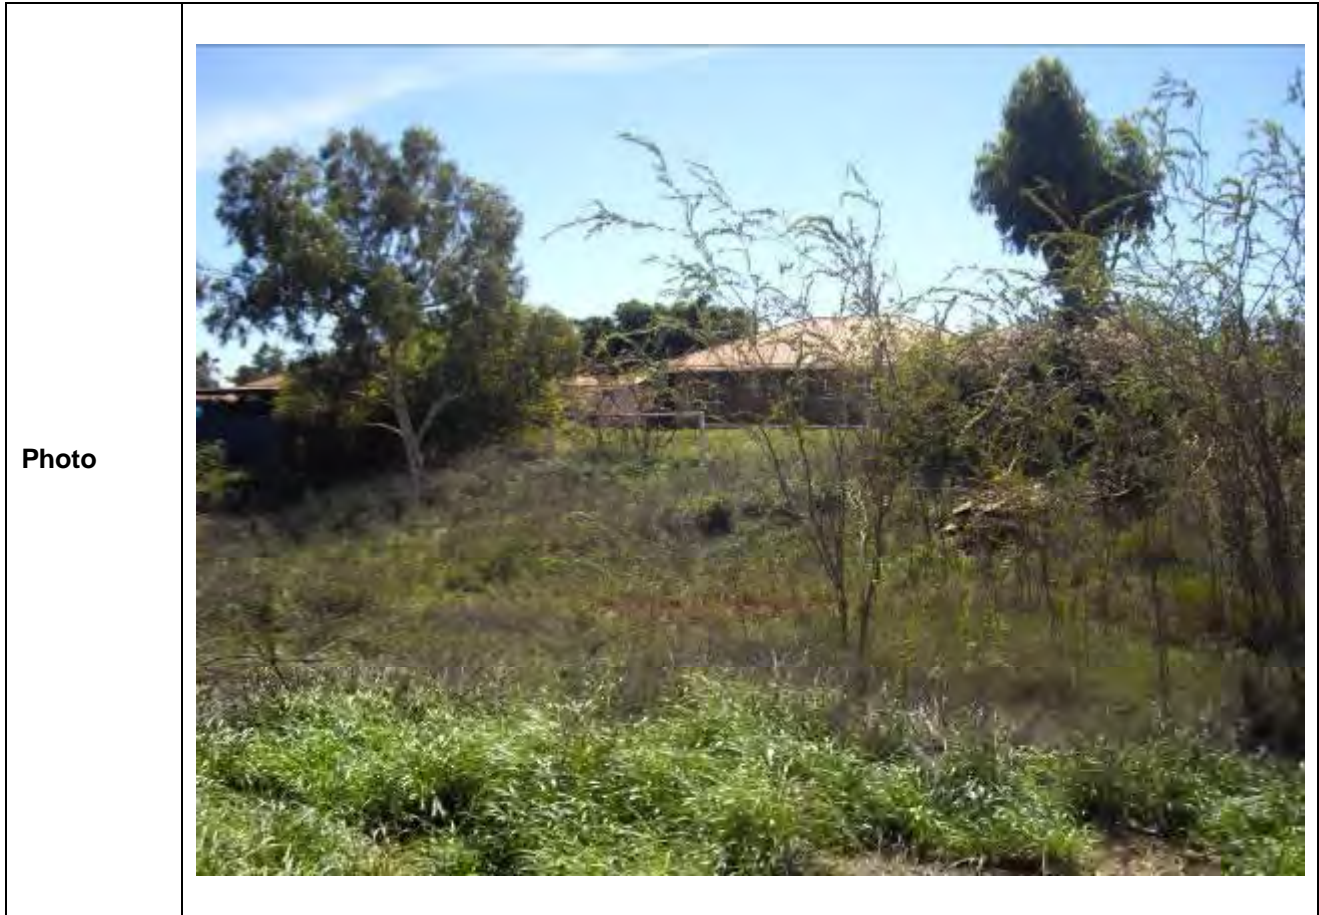
## 6.4 Lot No. 269 Pingandy Crescent

<b>Category</b>	Drain Maintenance / Encroachment
<b>Type</b>	Vegetation; Rear access.
<b>Description</b>	Dense unmaintained vegetation. Rear access follows drainage contours having a small impact on drainage.
<b>Photo ID</b>	787
<b>Scope of Works</b>	H - Vegetation is to be slashed to a nominal height of 50 mm above ground with the exception of large, established trees of height in excess of 5 m, which shall remain. L – Remove rear access and construct defined drainage channel to direct flow west.

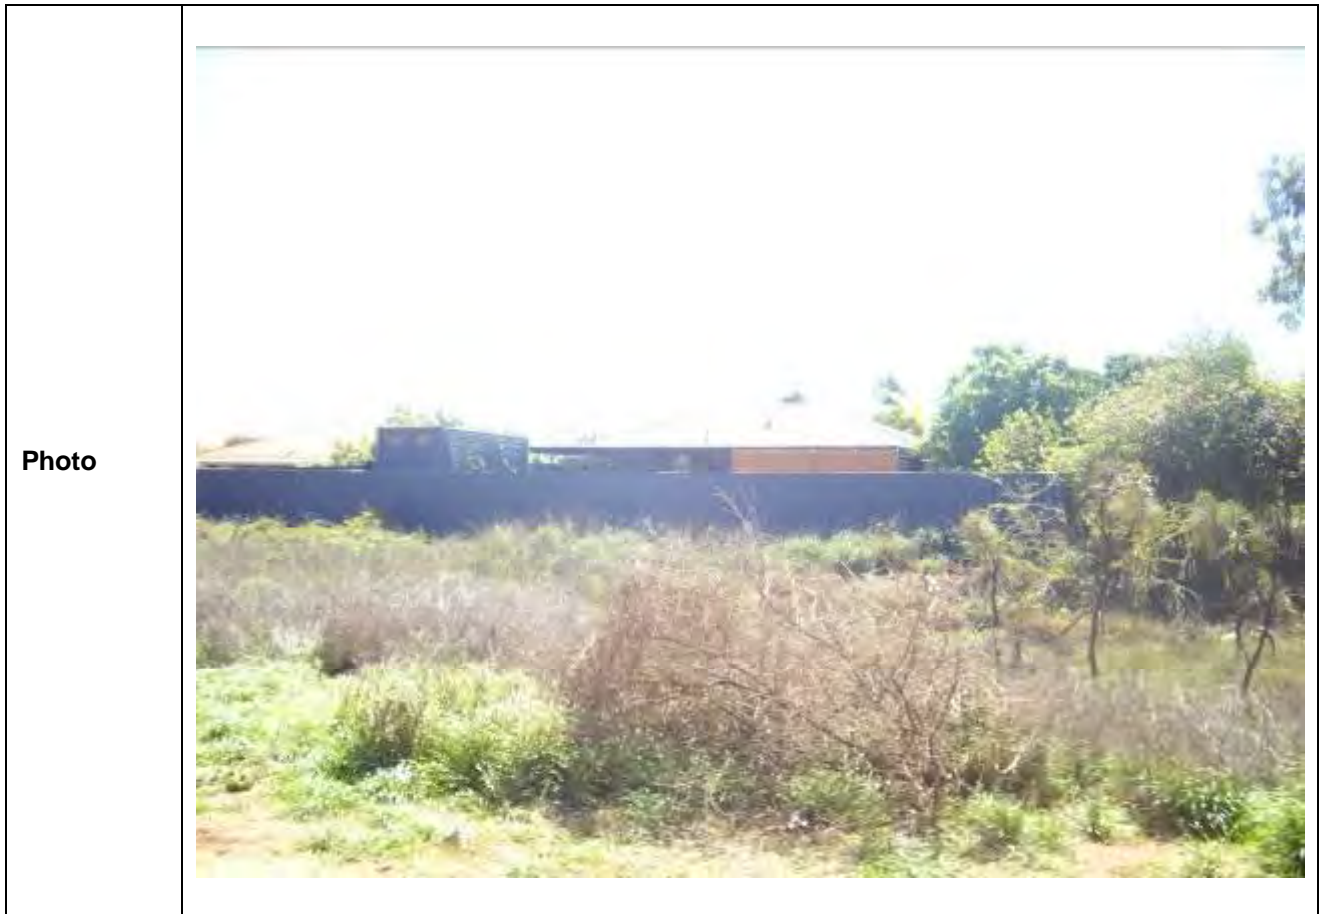
## 6.5 Lot No. 270 Pingandy Crescent

<b>Category</b>	Drain Maintenance / Encroachment
<b>Type</b>	Vegetation; Rear access.
<b>Description</b>	Dense overgrown vegetation; Rear access impedes flow.
<b>Photo ID</b>	788 – rear access is on the western edge of photo.
<b>Scope of Works</b>	H - Vegetation is to be slashed to a nominal height of 50 mm above ground with the exception of large, established trees of height in excess of 5 m, which shall remain; L – Remove rear access and construct defined drainage channel to direct flow west (match to 269).

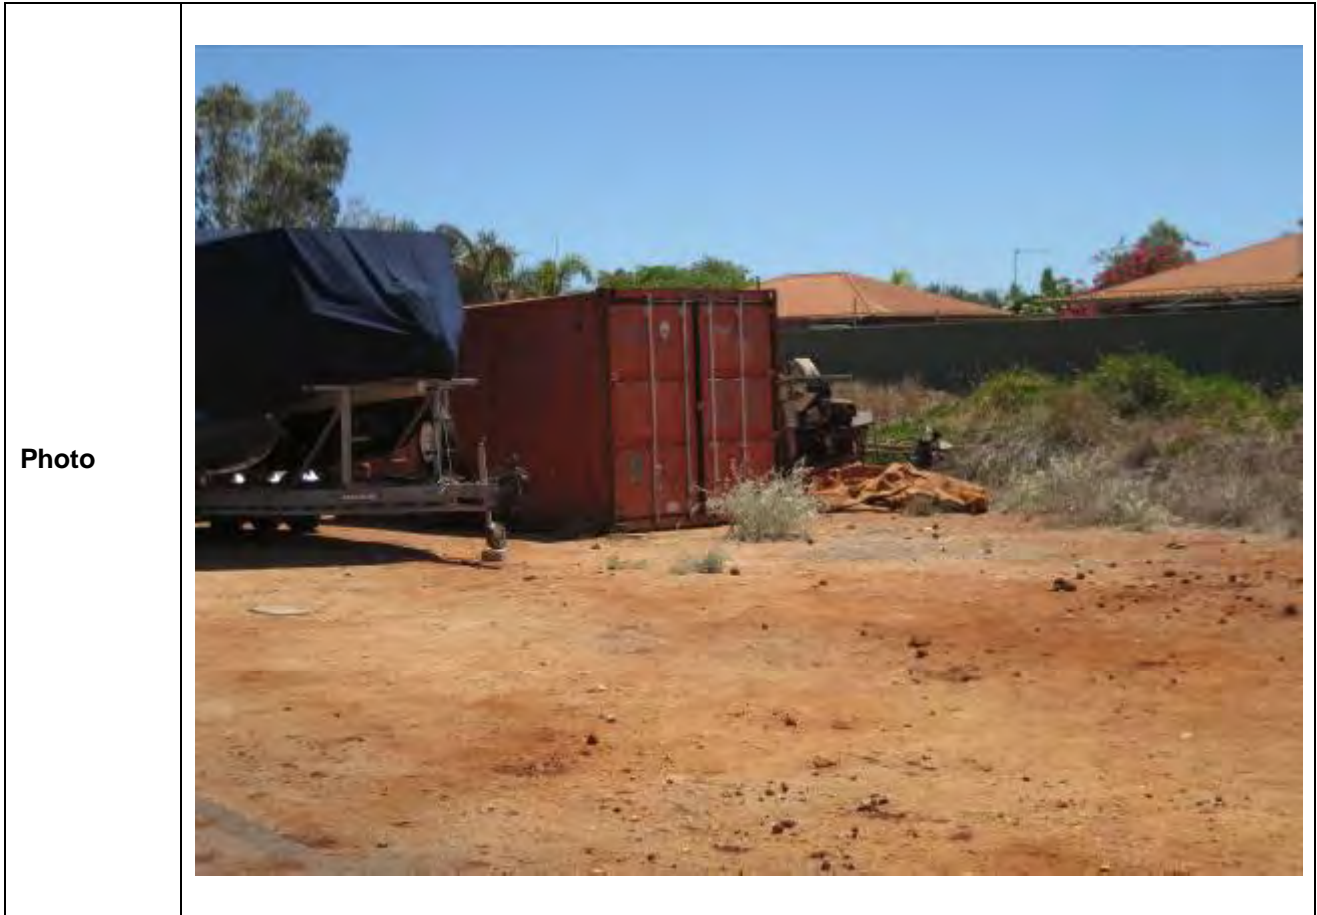
## 6.6 Lot No. 271 Pingandy Crescent

<b>Category</b>	Encroachment
<b>Type</b>	General items; Rear access
<b>Description</b>	Sea container, boat. Rear access on top of completely fill drainage reserve. Original intended drainage reserve is not evident.
<b>Photo ID</b>	18, 996
<b>Scope of Works</b>	L - Remove sea container and boats L – Remove rear access and construct defined drainage channel to direct flow west (match to 270).

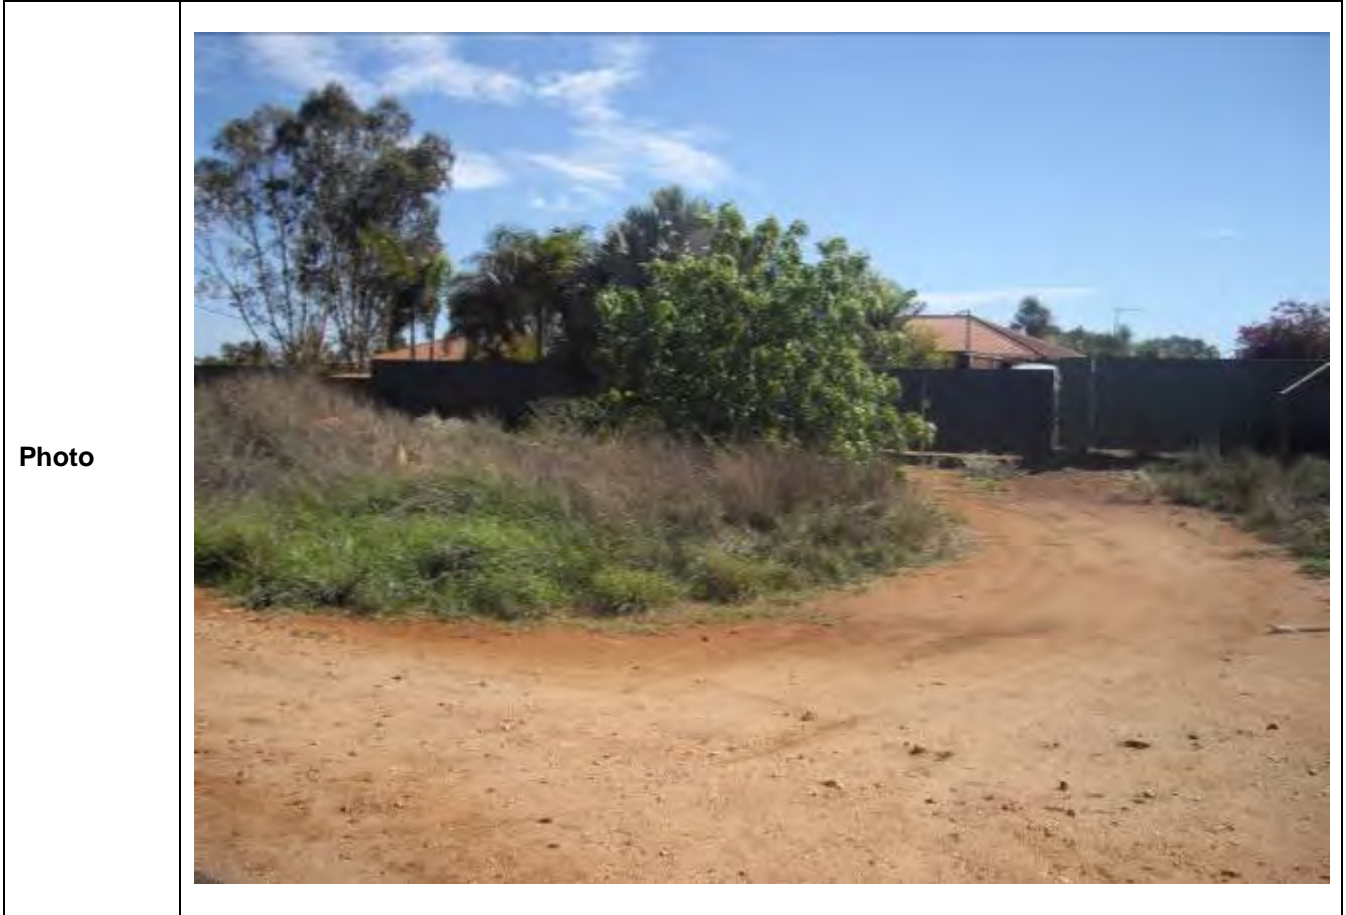
## 6.7 Lot No. 272 Pingandy Crescent

<b>Category</b>	Drain Maintenance / Encroachment
<b>Type</b>	Vegetation; Rear access.
<b>Description</b>	Dense overgrown vegetation impeding flow; Rear access follows on top of completely filled area. Original natural topography not apparent.
<b>Photo ID</b>	995, 789
<b>Scope of Works</b>	H - Vegetation is to be slashed to a nominal height of 50 mm above ground with the exception of large, established trees of height in excess of 5 m, which shall remain; L - Remove rear access and construct defined drainage channel to direct flow west (match to 271).

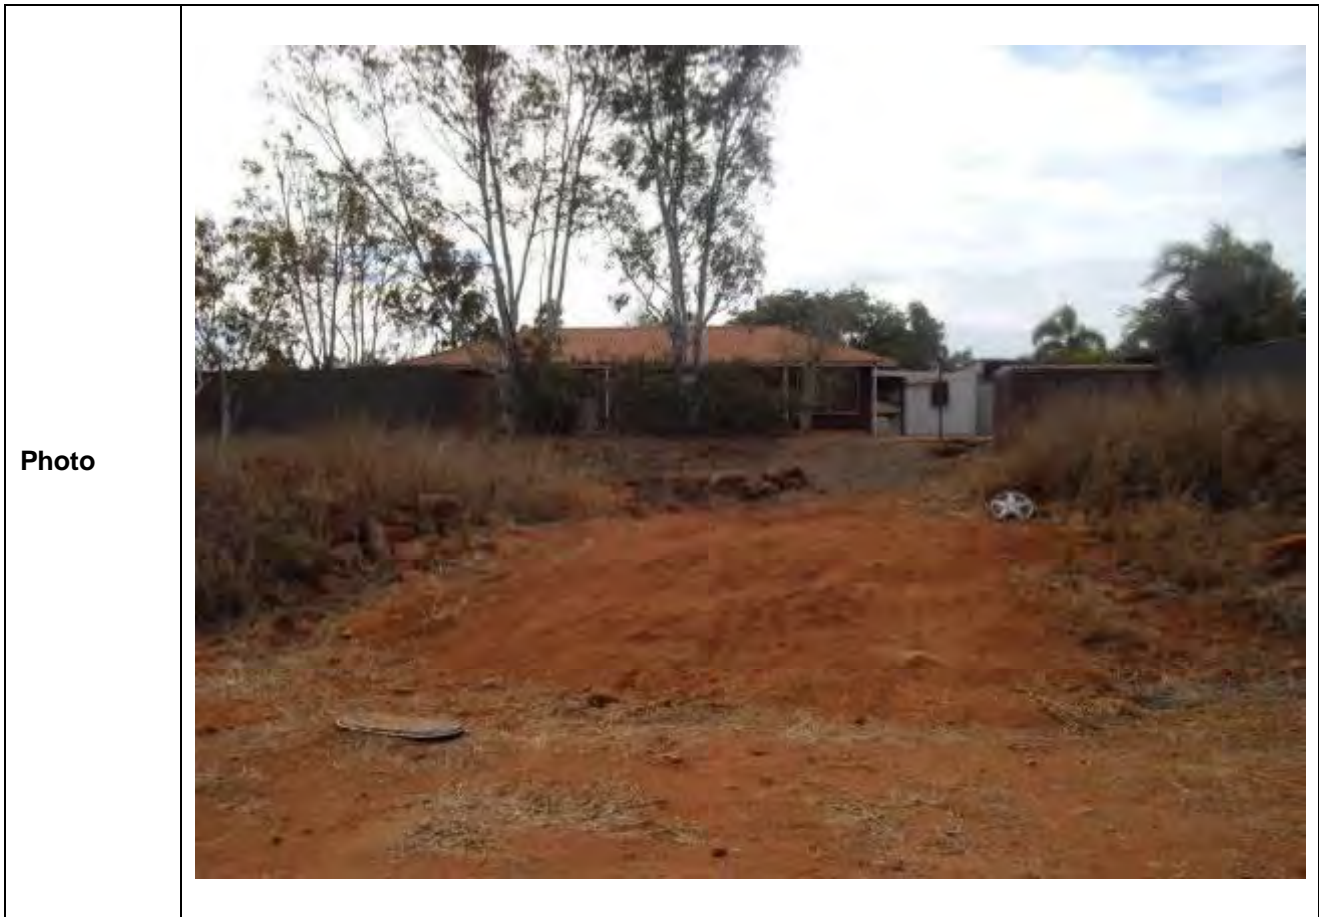
## 6.8 Lot No. 273 Pingandy Crescent

<b>Category</b>	Encroachment
<b>Type</b>	Rear access
<b>Description</b>	Rear access impeding flow. Original natural topography not apparent.
<b>Photo ID</b>	478
<b>Scope of Works</b>	H - Remove access way and construct defined drainage channel to direct flow west (match to 271).

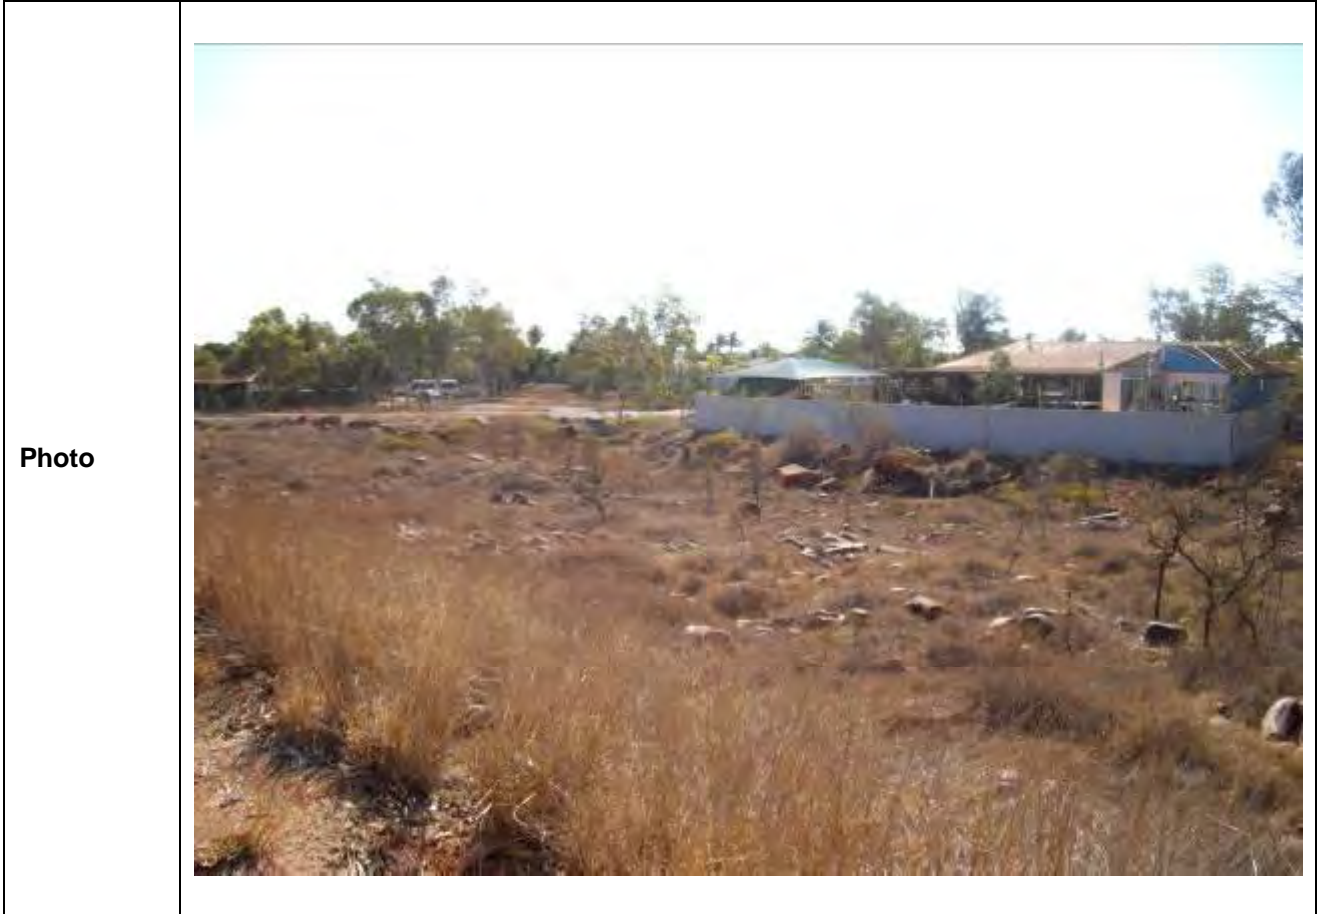
**7.1 Lot No. 274 Stuart Crescent**

<b>Category</b>	Drain Maintenance
<b>Type</b>	Vegetation
<b>Description</b>	Large capacity natural drainage channel as a result of raising of lot and road reserve.
<b>Photo ID</b>	383 – Subject property at centre-right portion of photo.
<b>Scope of Works</b>	None

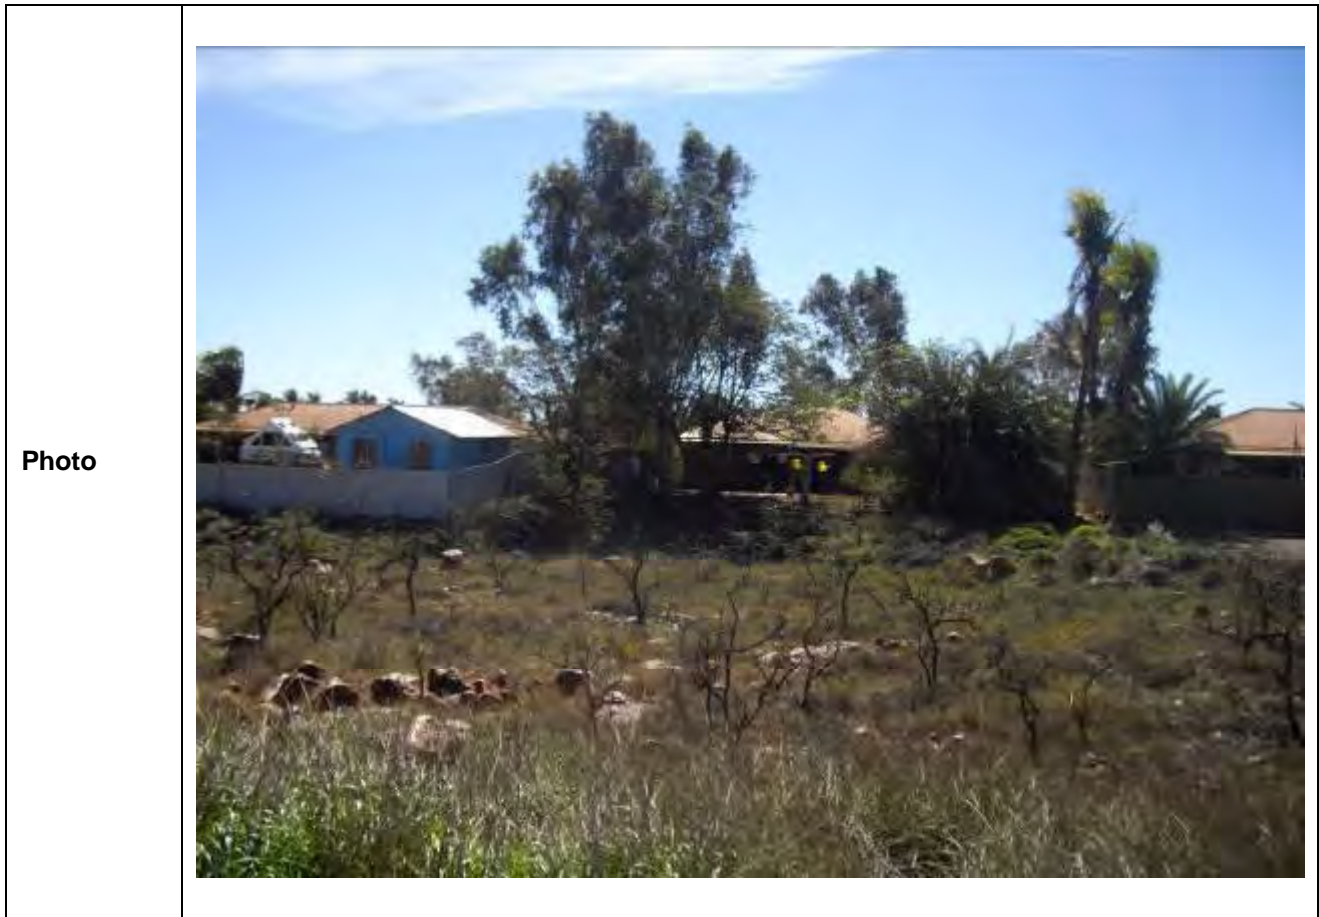
## 7.2 Lot No. 275 Stuart Crescent

<b>Category</b>	Drain Maintenance
<b>Type</b>	Vegetation.
<b>Description</b>	Large capacity natural drainage channel as a result of risen lot and road reserves.
<b>Photo ID</b>	801 – Subject lot is middle property within photo
<b>Scope of Works</b>	None

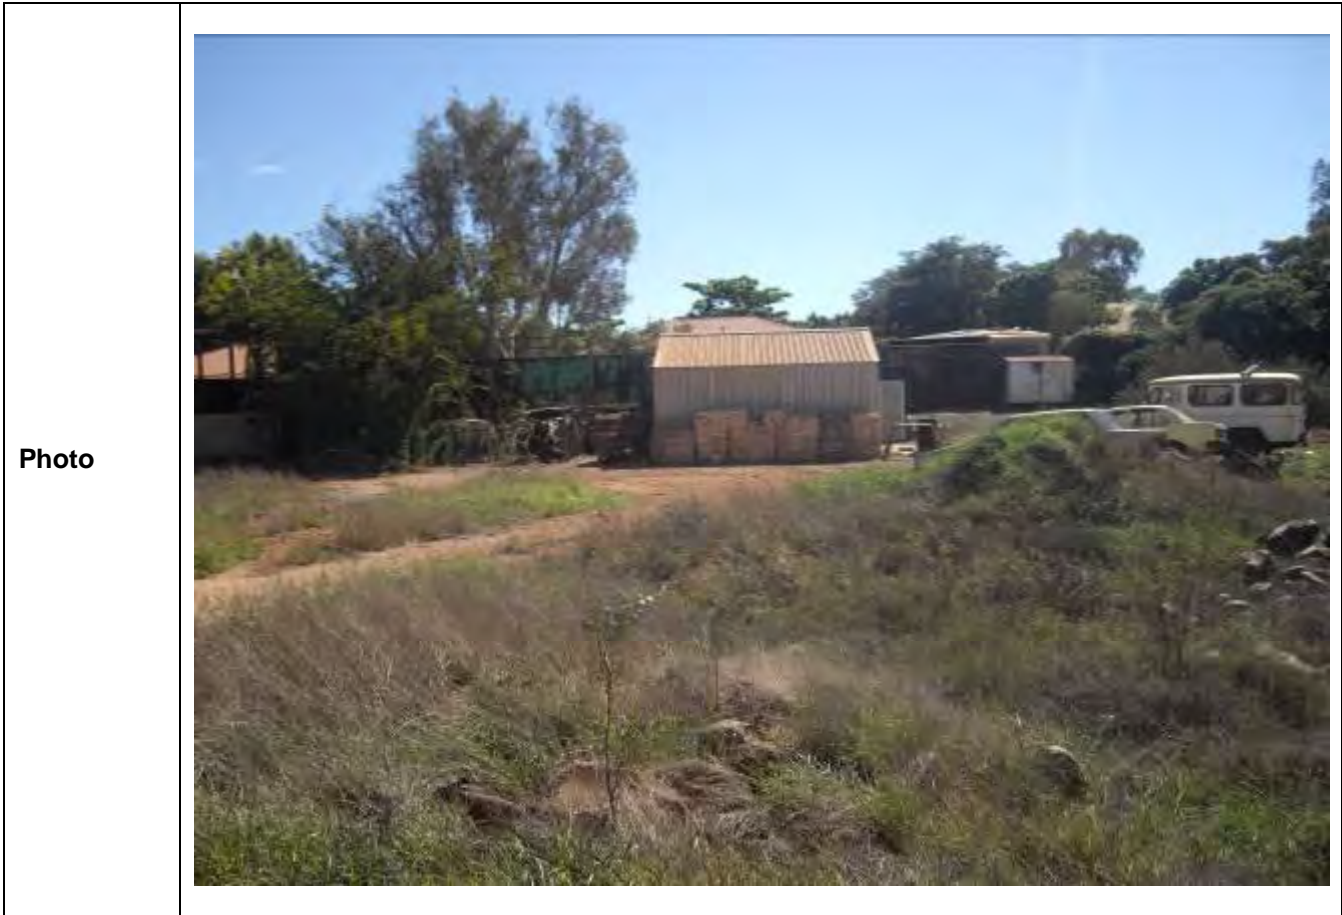
**7.8 Lot No. 281 Stuart Crescent**

<b>Category</b>	Encroachment
<b>Type</b>	Rear access; General items.
<b>Description</b>	Rear access follows natural topography having minor impact on flow path; 3 x vehicles
<b>Photo ID</b>	993
<b>Scope of Works</b>	L - Remove rear access and reinstate drainage flow path to direct flow east. L - Remove vehicles

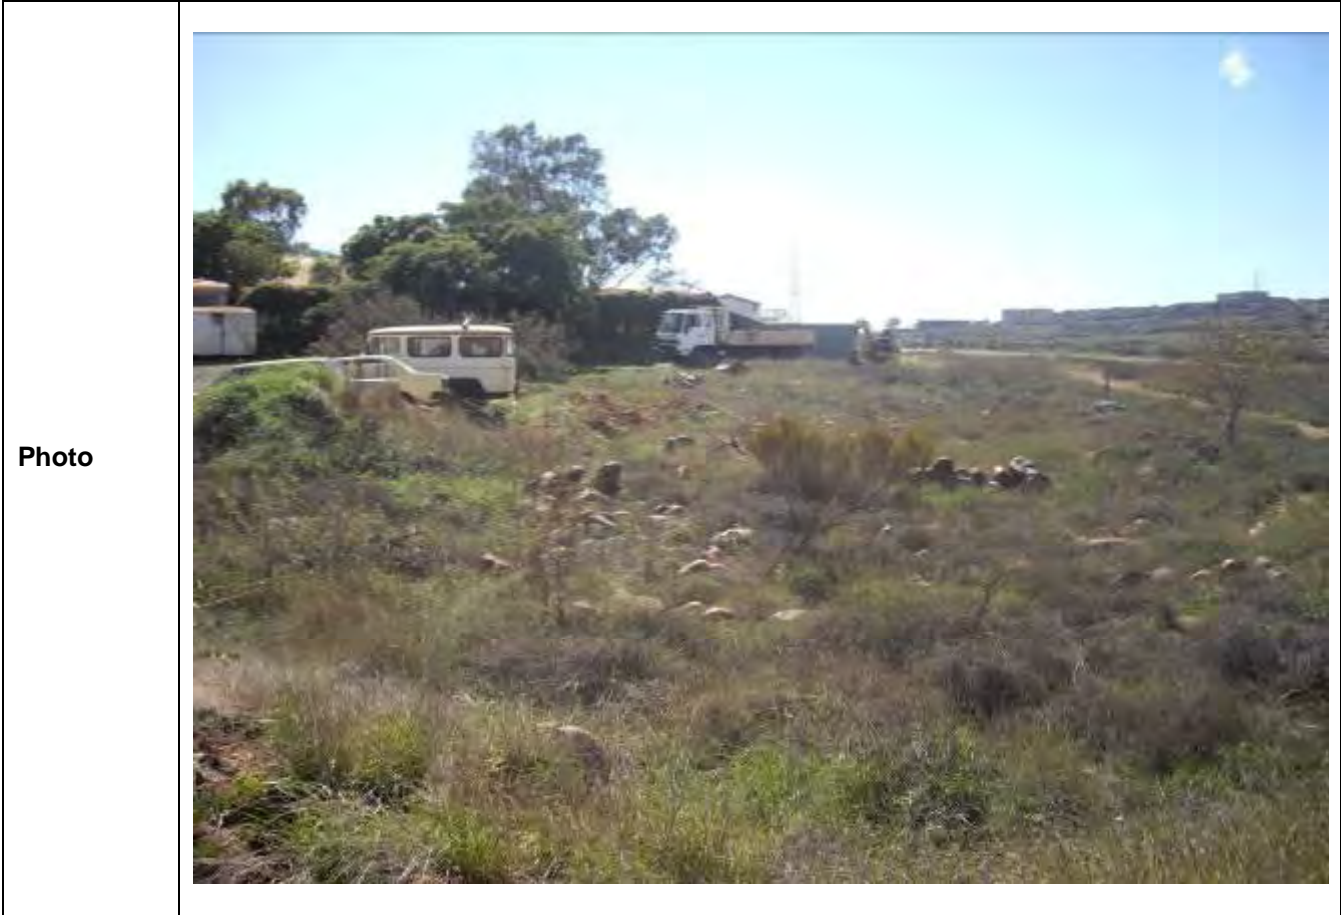
**7.9 Lot No. 282 Stuart Crescent**

<b>Category</b>	None
<b>Type</b>	None
<b>Description</b>	None
<b>Photo ID</b>	992
<b>Scope of Works</b>	None
