City of Karratha  
Dampier Stormwater Management Study  
Report  
Part B  
June 2015

## Appendix **C** – 2010 encroachment reviews

**Rio Tinto Iron Ore**  
Report on Dampier Drainage  
Review  
Block 1 Encroachments  
June 2010

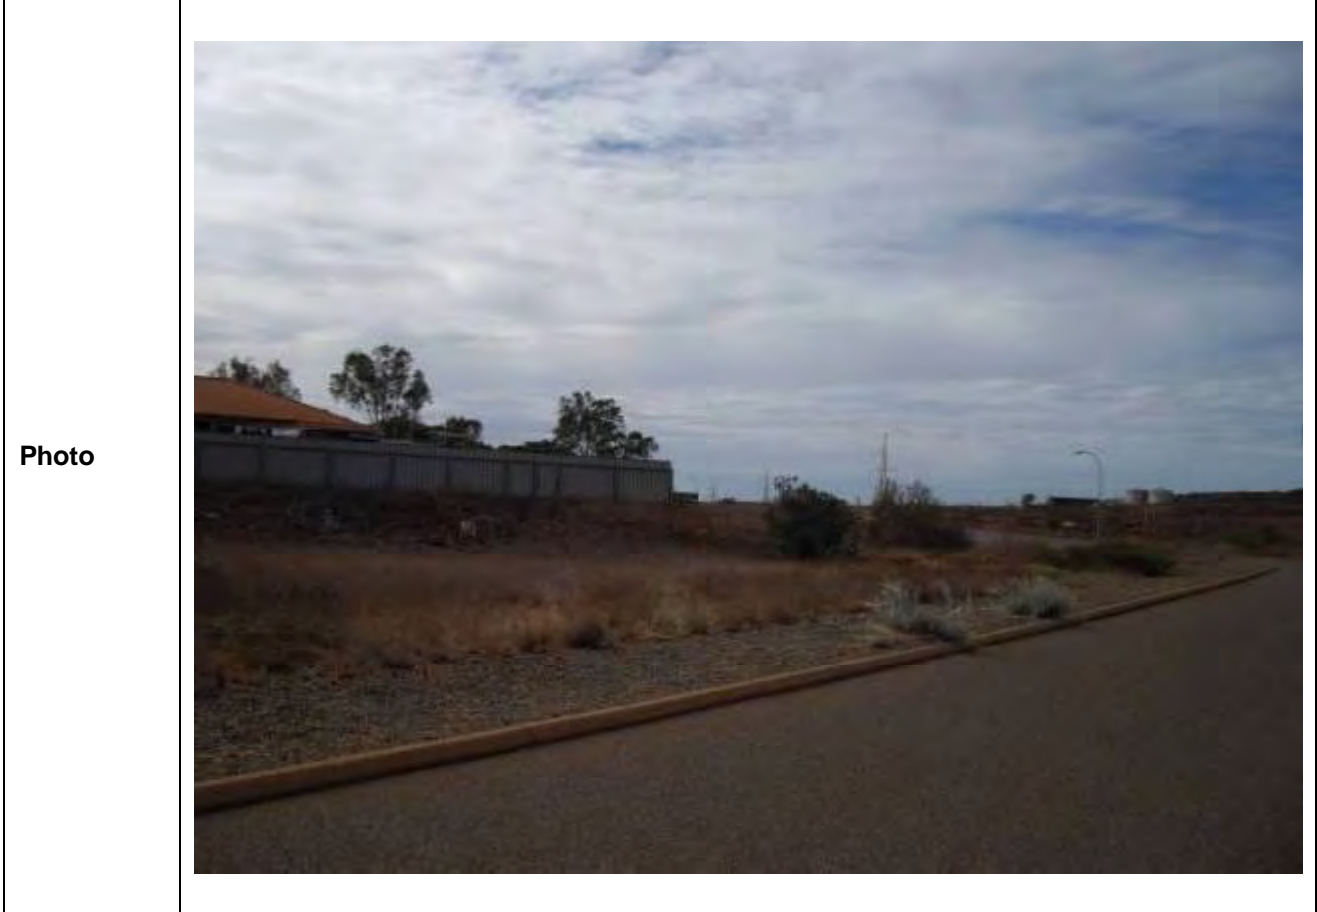
**8.1 Lot No. 283 Robe Crescent**

<b>Category</b>	Encroachment
<b>Type</b>	Boundary extension
<b>Description</b>	Potential boundary extension from fence.
<b>Photo ID</b>	476 – subject property is on the left side of property.
<b>Scope of Works</b>	L - Remove existing and relocate boundary extension to within property boundary – get confirmation from survey.

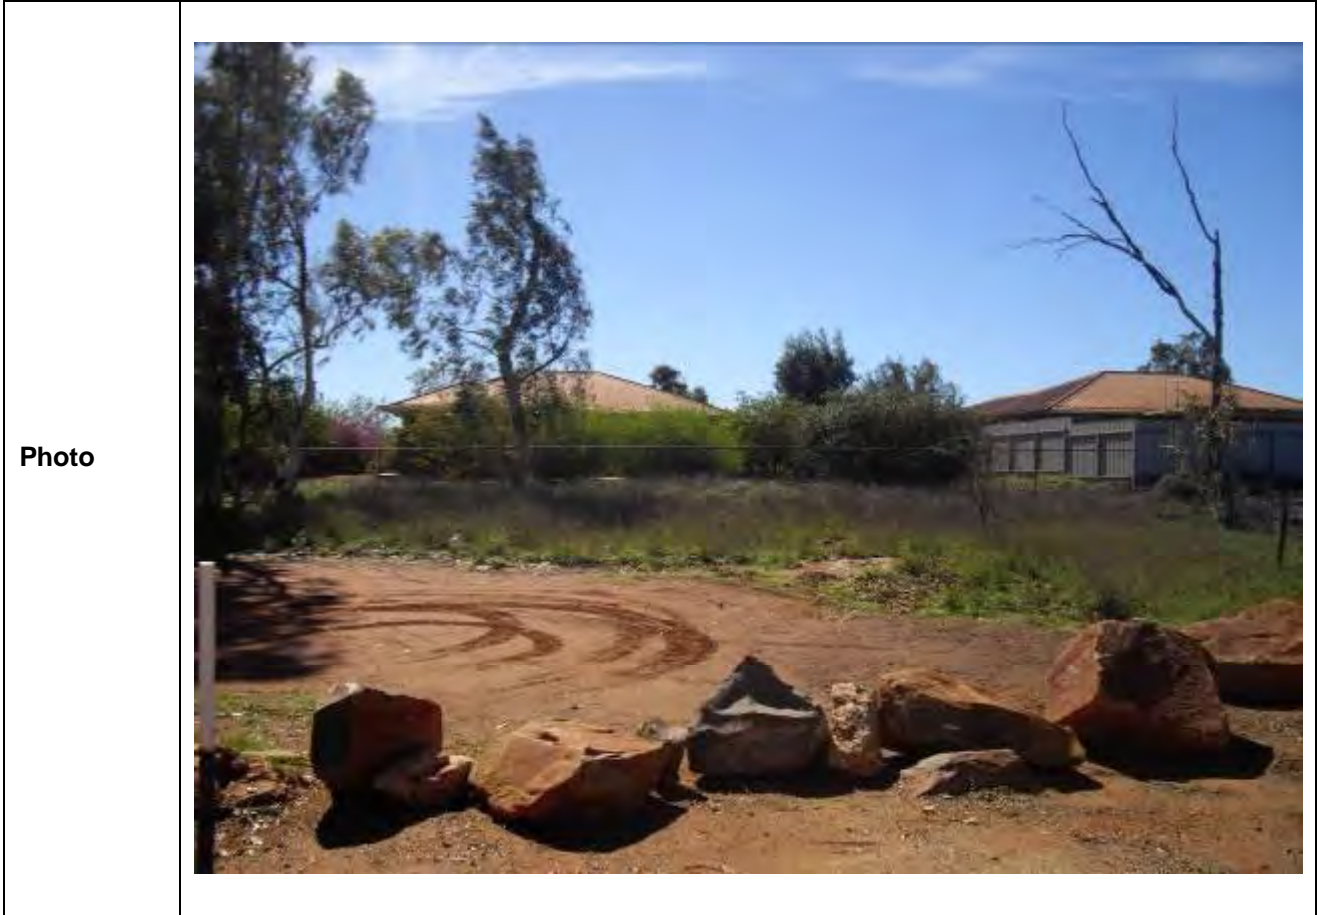
## 8.2 Lot No. 284 Robe Crescent

<b>Category</b>	None
<b>Type</b>	None
<b>Description</b>	Drains east via natural channel - adequate.
<b>Photo ID</b>	803
<b>Scope of Works</b>	None

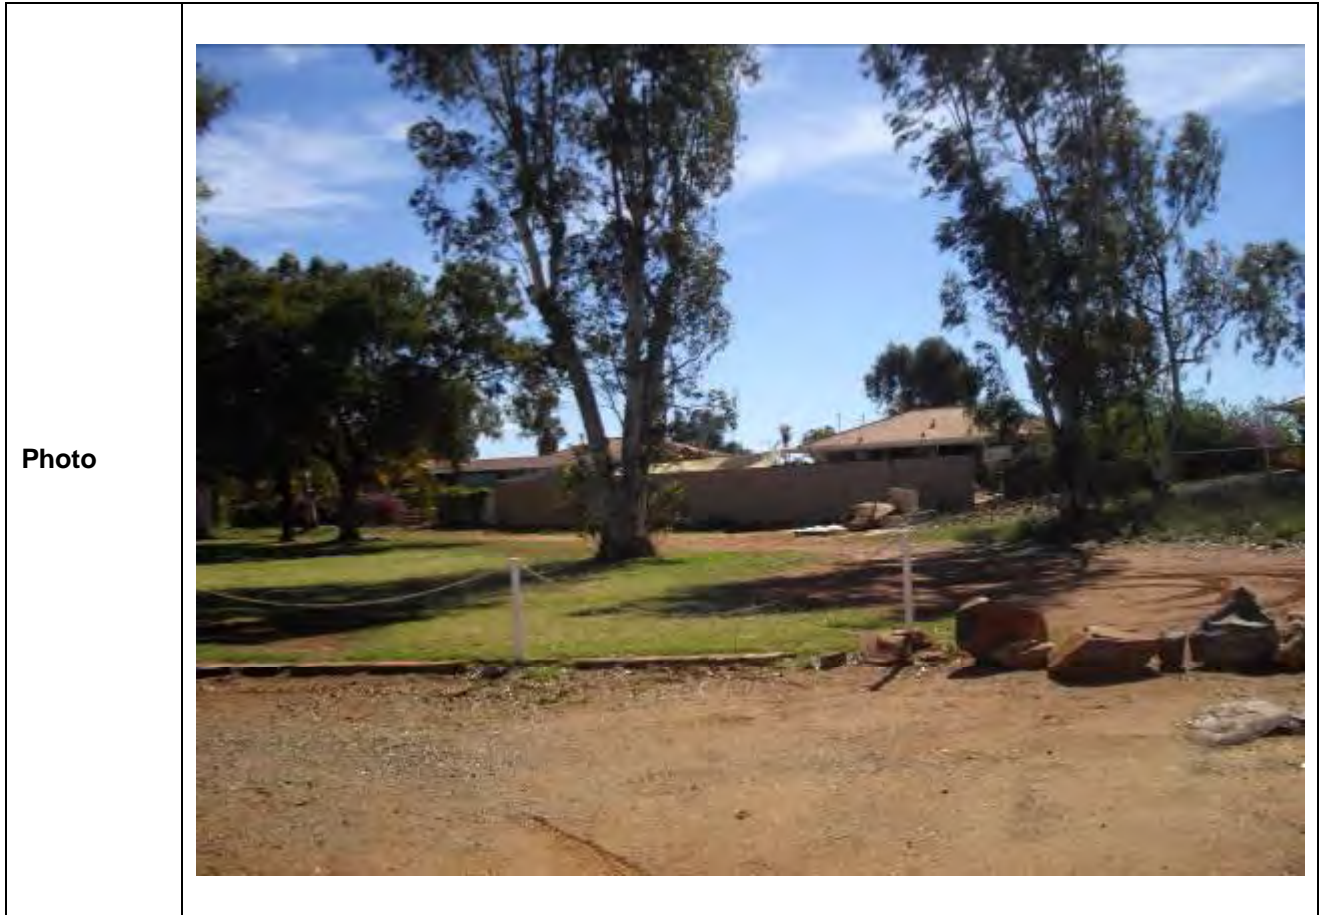
### 8.3 Lot No. 285 Robe Crescent

<b>Category</b>	None
<b>Type</b>	None
<b>Description</b>	No drainage path due to development of park.
<b>Photo ID</b>	804
<b>Scope of Works</b>	N/A

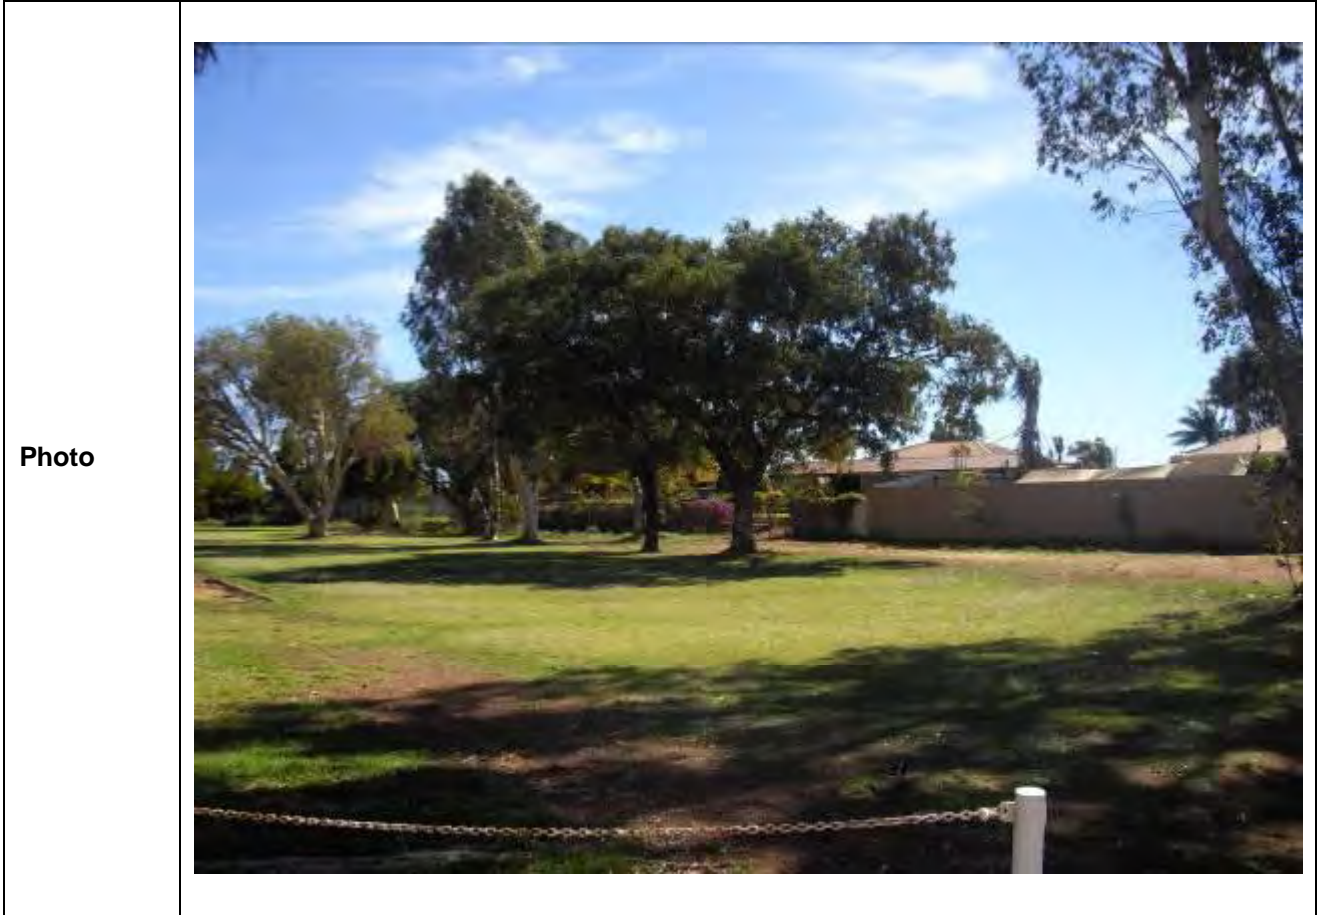
#### 8.4 Lot No. 286 Robe Crescent

<b>Category</b>	None
<b>Type</b>	None
<b>Description</b>	No drainage path due to development of park.
<b>Photo ID</b>	805
<b>Scope of Works</b>	N/A

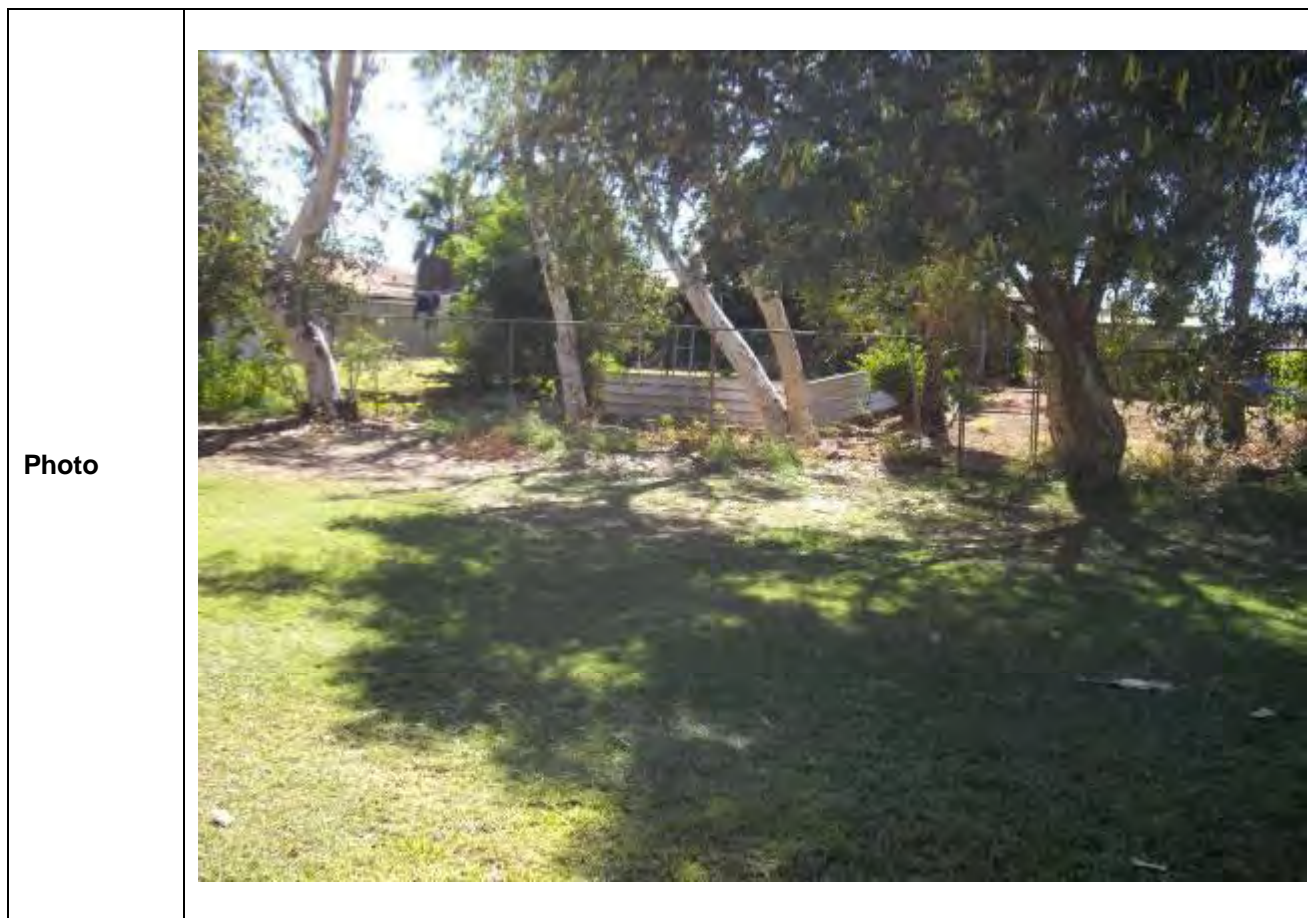
## 8.5 Lot No. 287 Robe Crescent

<b>Category</b>	None
<b>Type</b>	None
<b>Description</b>	No drainage path
<b>Photo ID</b>	806
<b>Scope of Works</b>	N/A

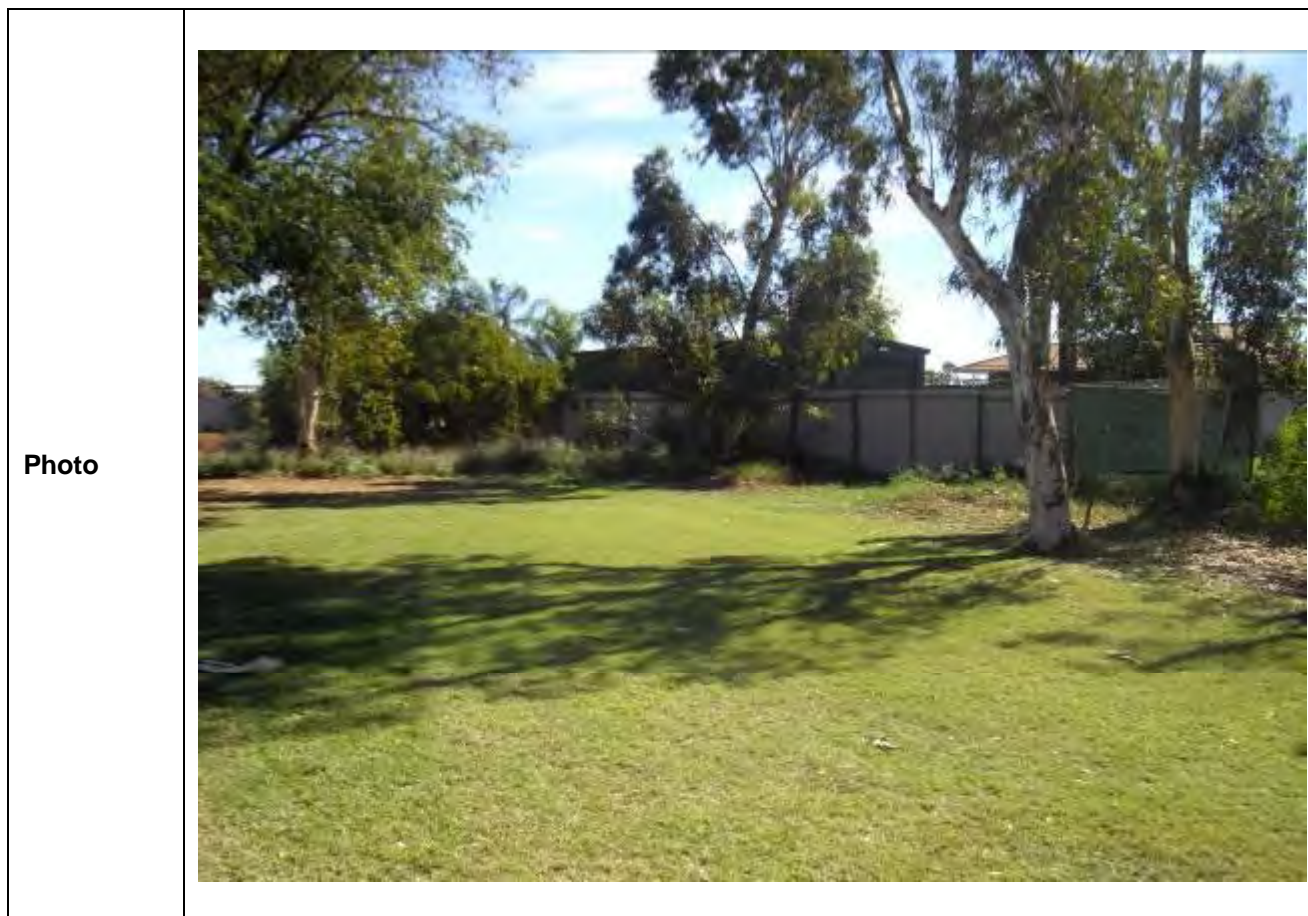
**8.6 Lot No. 288 Robe Crescent**

<b>Category</b>	None
<b>Type</b>	None
<b>Description</b>	No drainage path.
<b>Photo ID</b>	807
<b>Scope of Works</b>	N/A

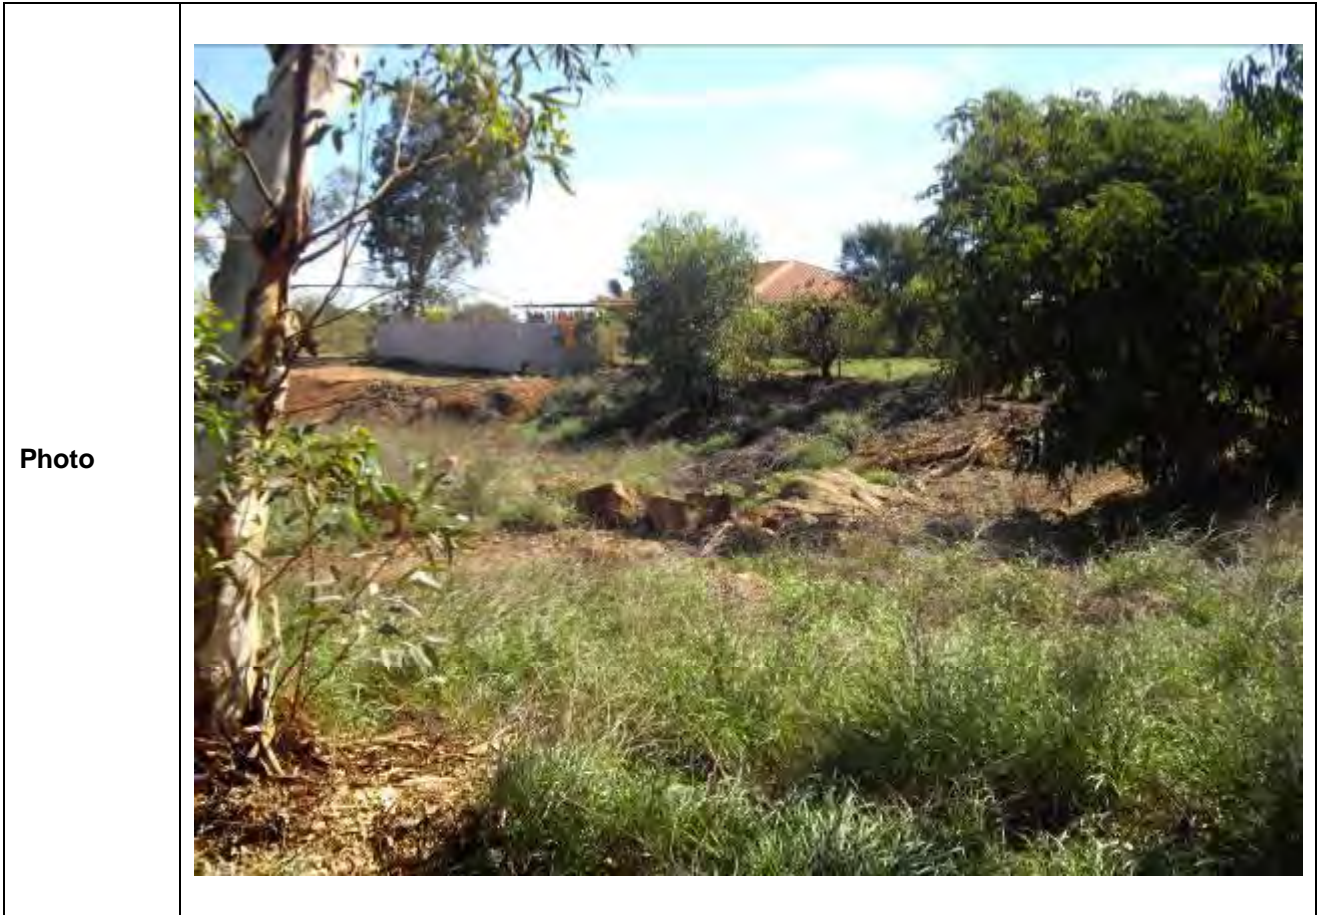
**8.7 Lot No. 289 Robe Crescent**

<b>Category</b>	Encroachment
<b>Type</b>	Organic matter
<b>Description</b>	Branches placed within the drainage reserve.
<b>Photo ID</b>	808
<b>Scope of Works</b>	L - Remove branches.

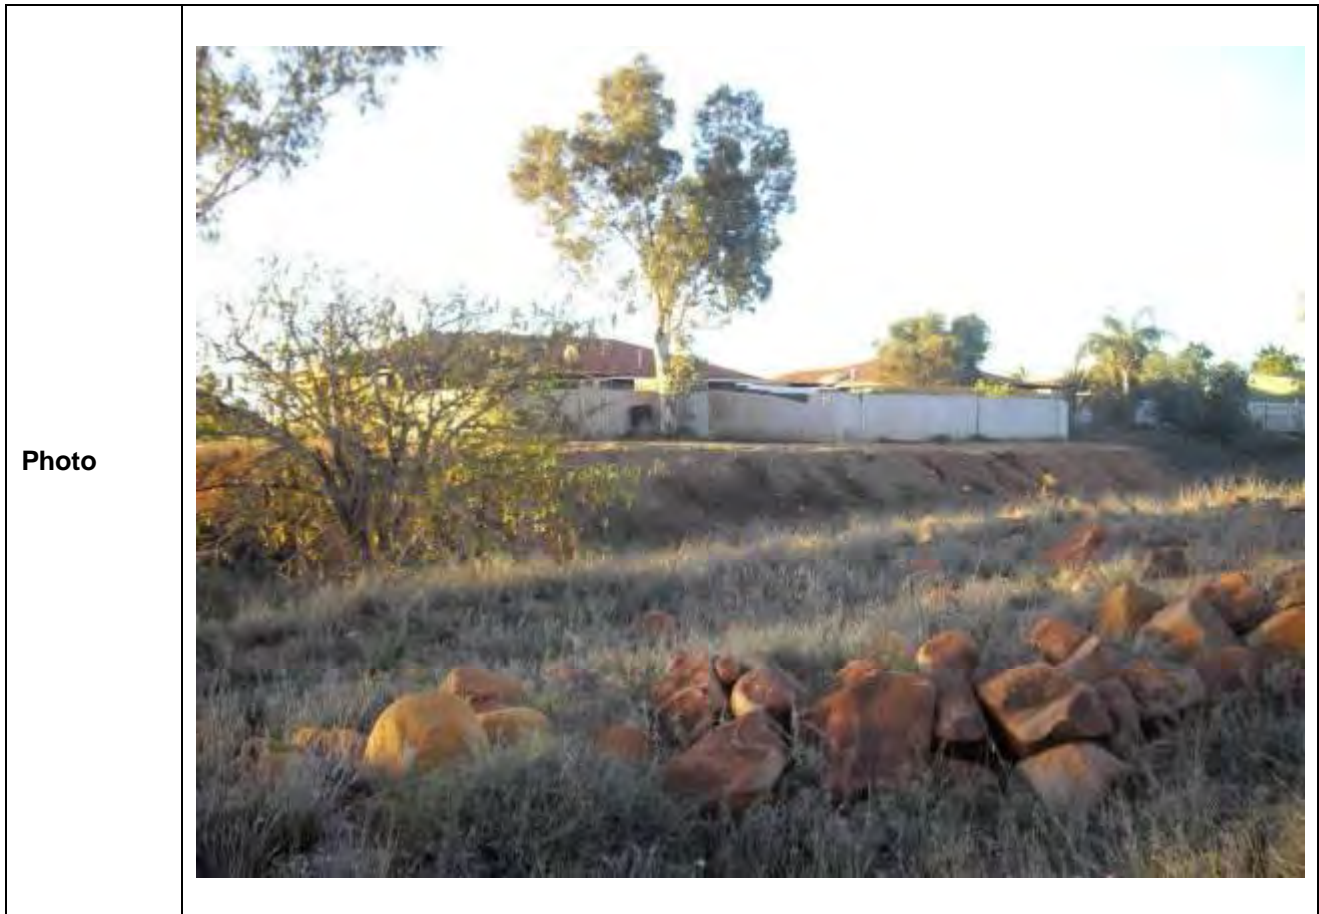
## 8.8 Lot No. 290 Robe Crescent

<b>Category</b>	Encroachment
<b>Type</b>	Modified drain
<b>Description</b>	Property has extended its flat area which has created a batter encroachment on the drainage reserve. Flat area is of uncompacted fill which will erode and create sediment into the drainage network.
<b>Photo ID</b>	683
<b>Scope of Works</b>	H - Remove batter encroachment.

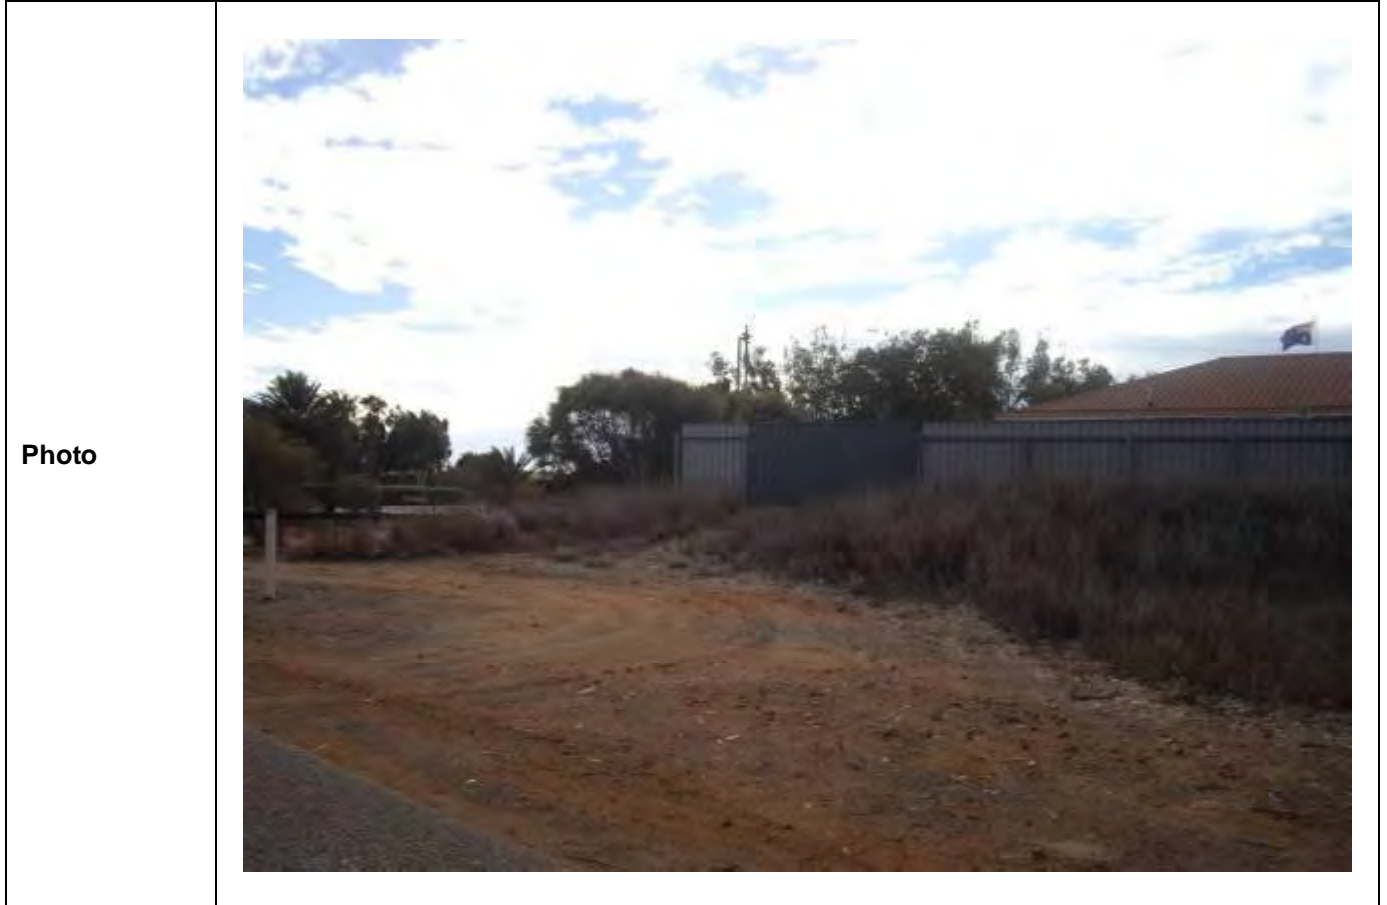
## 2.1 Lot 1,055 Gascoyne Crescent

<b>Category</b>	Encroachment
<b>Type</b>	Rear access
<b>Description</b>	Rear access impeding flow.
<b>Photo ID</b>	518
<b>Scope of Works</b>	H – Remove rear access and reinstate drainage flow path as defined by the natural capacity and invert of downstream lot channel

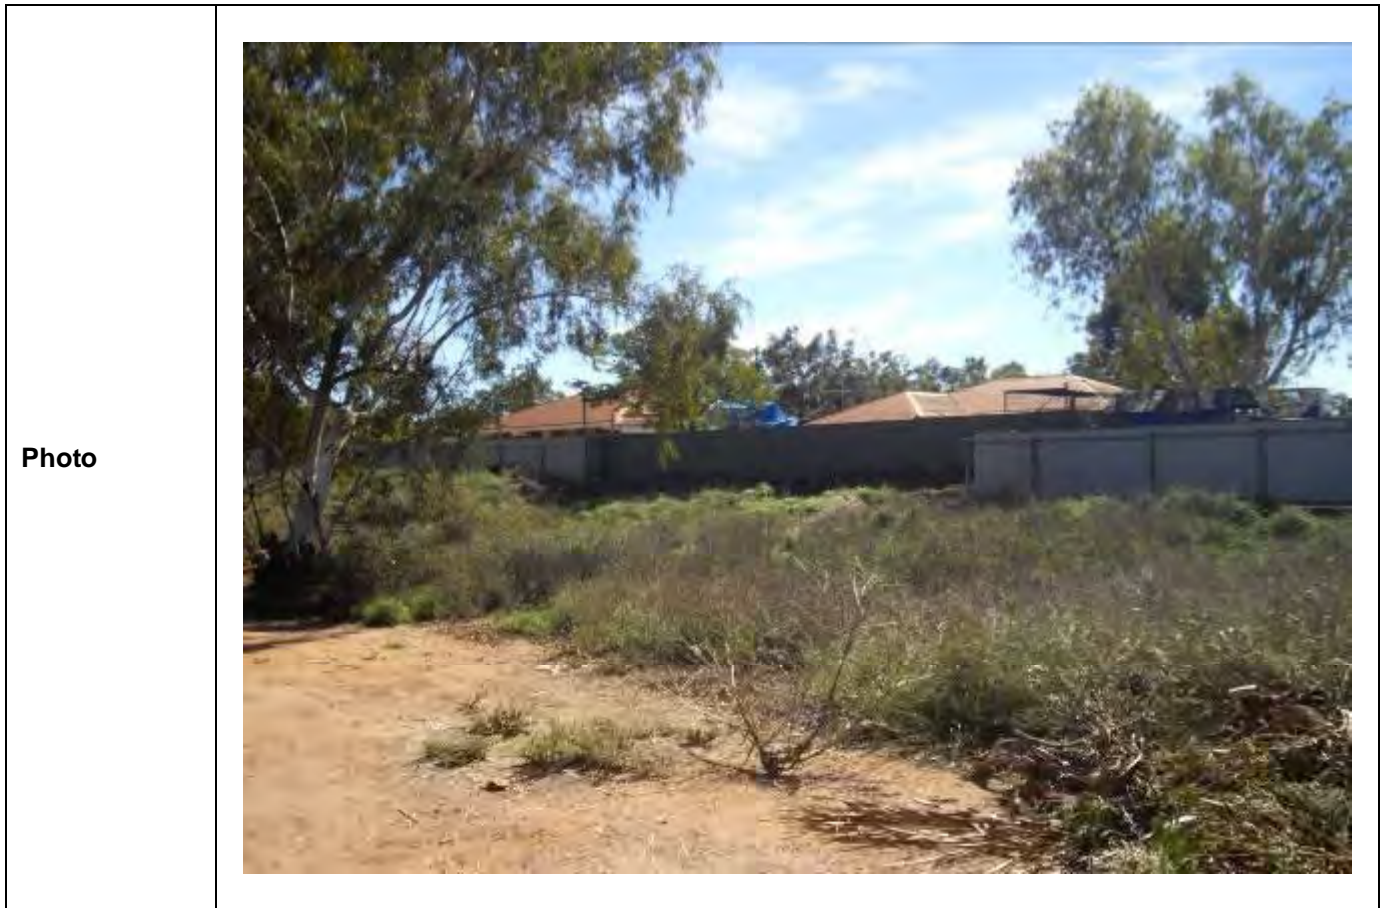
## 2.2 Lot No. 55 Gascoyne Crescent

<b>Category</b>	Drain Maintenance
<b>Type</b>	Vegetation
<b>Description</b>	Semi dense vegetation Natural flow path adequate
<b>Photo ID</b>	811 – photo of property with the darker fence.
<b>Scope of Works</b>	M - Vegetation is to be slashed to a nominal height of 50 mm above ground with the exception of large, established trees of height in excess of 5 m, which shall remain

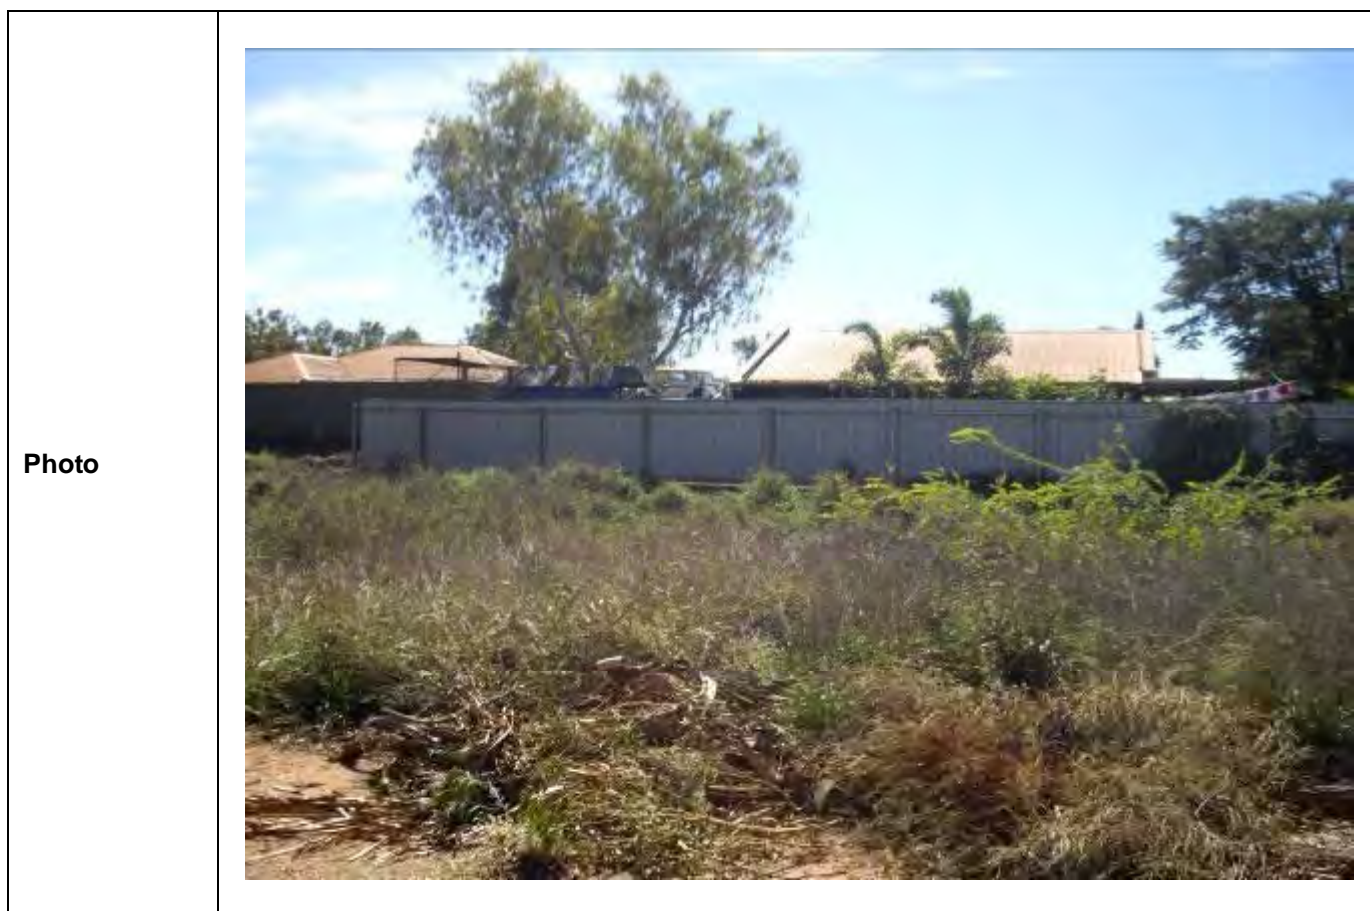
### 2.3 Lot No. 56 Gascoyne Crescent

<b>Category</b>	Drain Maintenance
<b>Type</b>	Vegetation Fill material
<b>Description</b>	Semi-dense vegetation.
<b>Photo ID</b>	810
<b>Scope of Works</b>	M - Vegetation is to be slashed to a nominal height of 50 mm above ground with the exception of large, established trees of height in excess of 5 m, which shall remain H – remove fill material and drainage flow path as defined by the natural capacity and invert of downstream (lot 55) channel

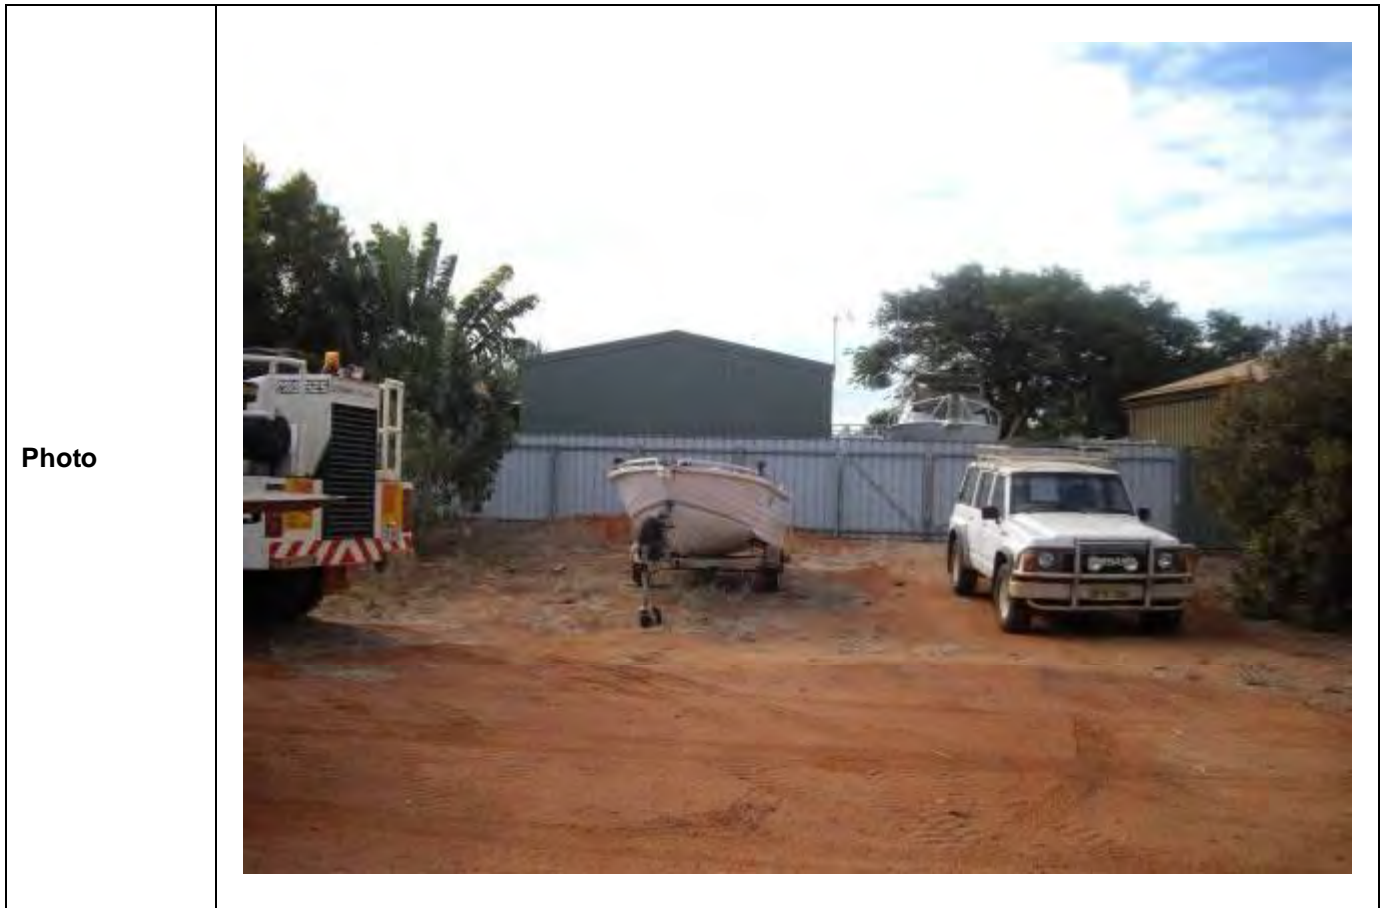
## 2.4 Lot No. 57 Gascoyne Crescent

<b>Category</b>	Encroachment
<b>Type</b>	Rear access, Boundary extension, General items
<b>Description</b>	Rear access driveway and modified topography with no defined channel, Possible boundary extension in south-eastern corner, Storage of boat and vehicles
<b>Photo ID</b>	517
<b>Scope of Works</b>	M – Remove rear access and reinstate drainage flow path as defined by the natural capacity and invert of downstream lot channel L – Remove boundary extension in the south western corner of property and relocate to within property boundary. L – Remove boat and vehicles.

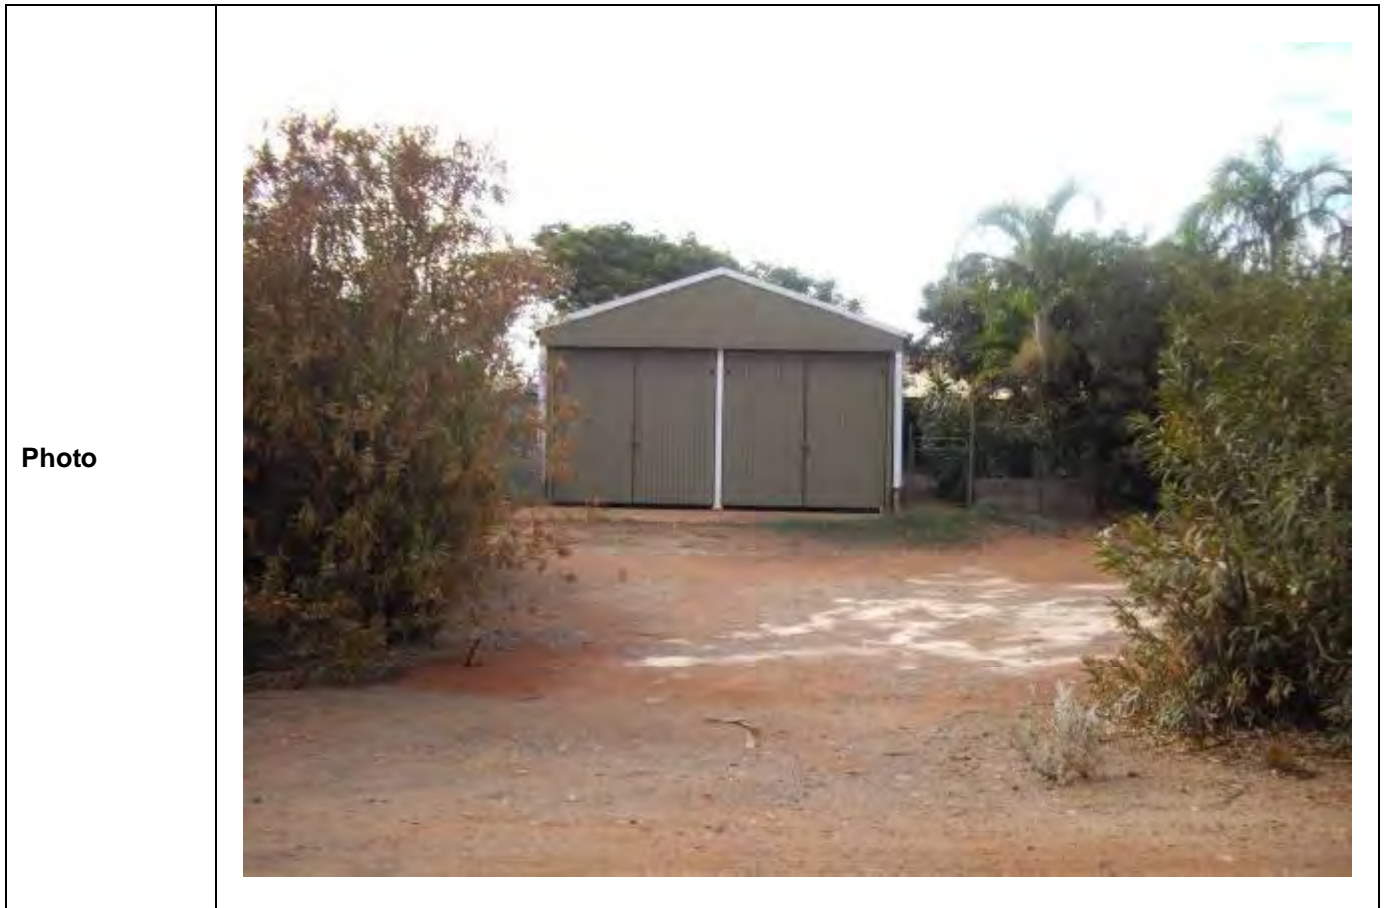
## 2.5 Lot No. 58 Gascoyne Crescent

<b>Category</b>	Encroachment / Drain Maintenance
<b>Type</b>	Boundary extension Vegetation
<b>Description</b>	Shed is well within the drainage reserve Modified topography but does not impede flow Vegetation within drainage reserve
<b>Photo ID</b>	516
<b>Scope of Works</b>	L - Remove shed to within property boundary L - Vegetation is to be slashed to a nominal height of 50 mm above ground with the exception of large, established trees of height in excess of 5 m, which shall remain

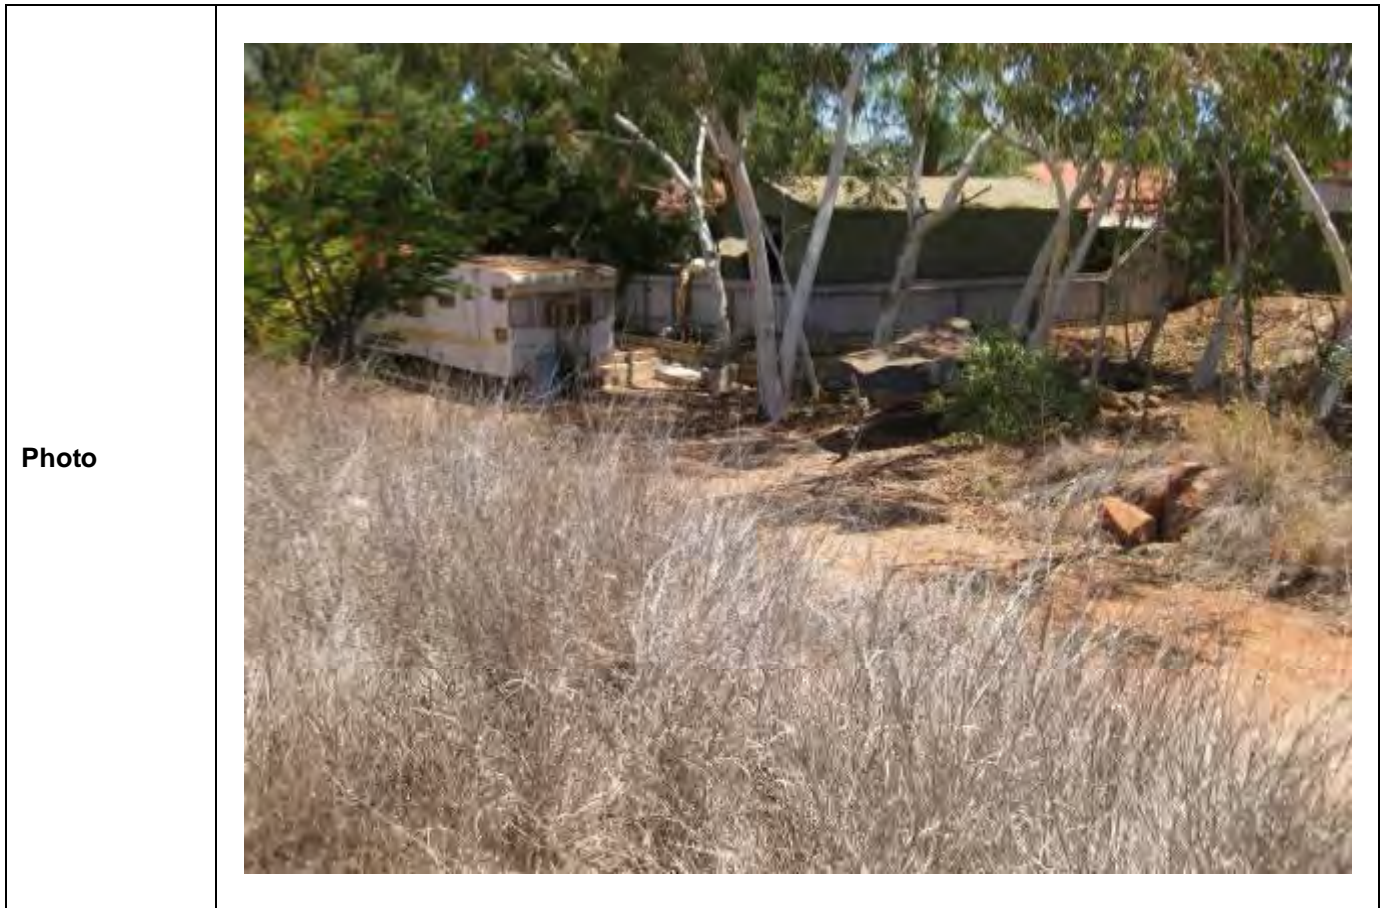
## 2.6 Lot No. 59 Gascoyne Crescent

<b>Category</b>	Encroachment
<b>Type</b>	General items
<b>Description</b>	Caravan Modified flow path – does not impede flow
<b>Photo ID</b>	7322
<b>Scope of Works</b>	L - Remove caravan

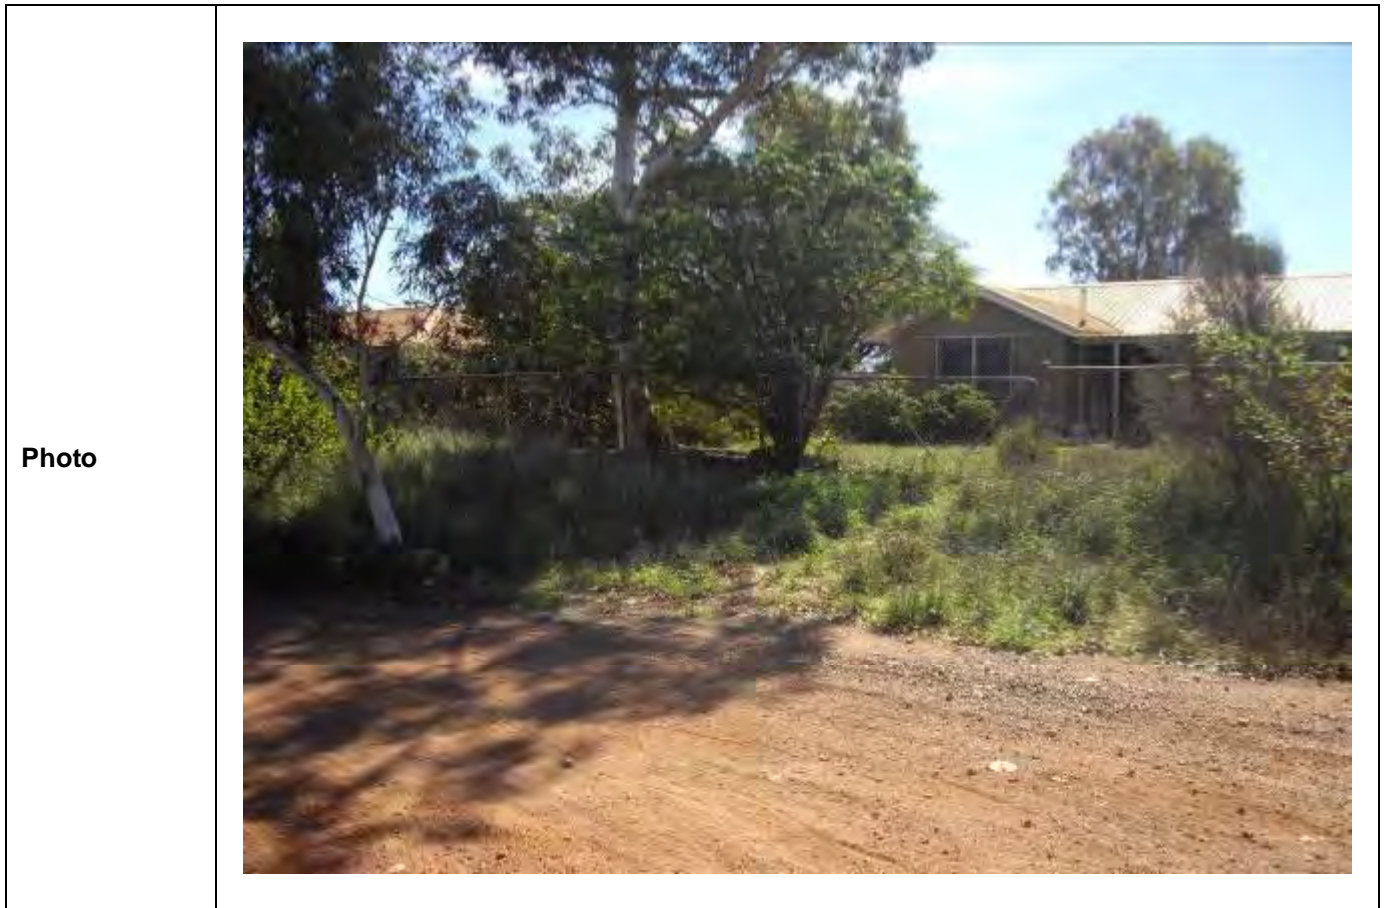
## 2.7 Lot No. 60 Gascoyne Crescent

<b>Category</b>	Drain Maintenance / Encroachment
<b>Type</b>	Rear access.
<b>Description</b>	Rear access follows modified topography directs flow to road - adequate.
<b>Photo ID</b>	809
<b>Scope of Works</b>	L – Remove rear access

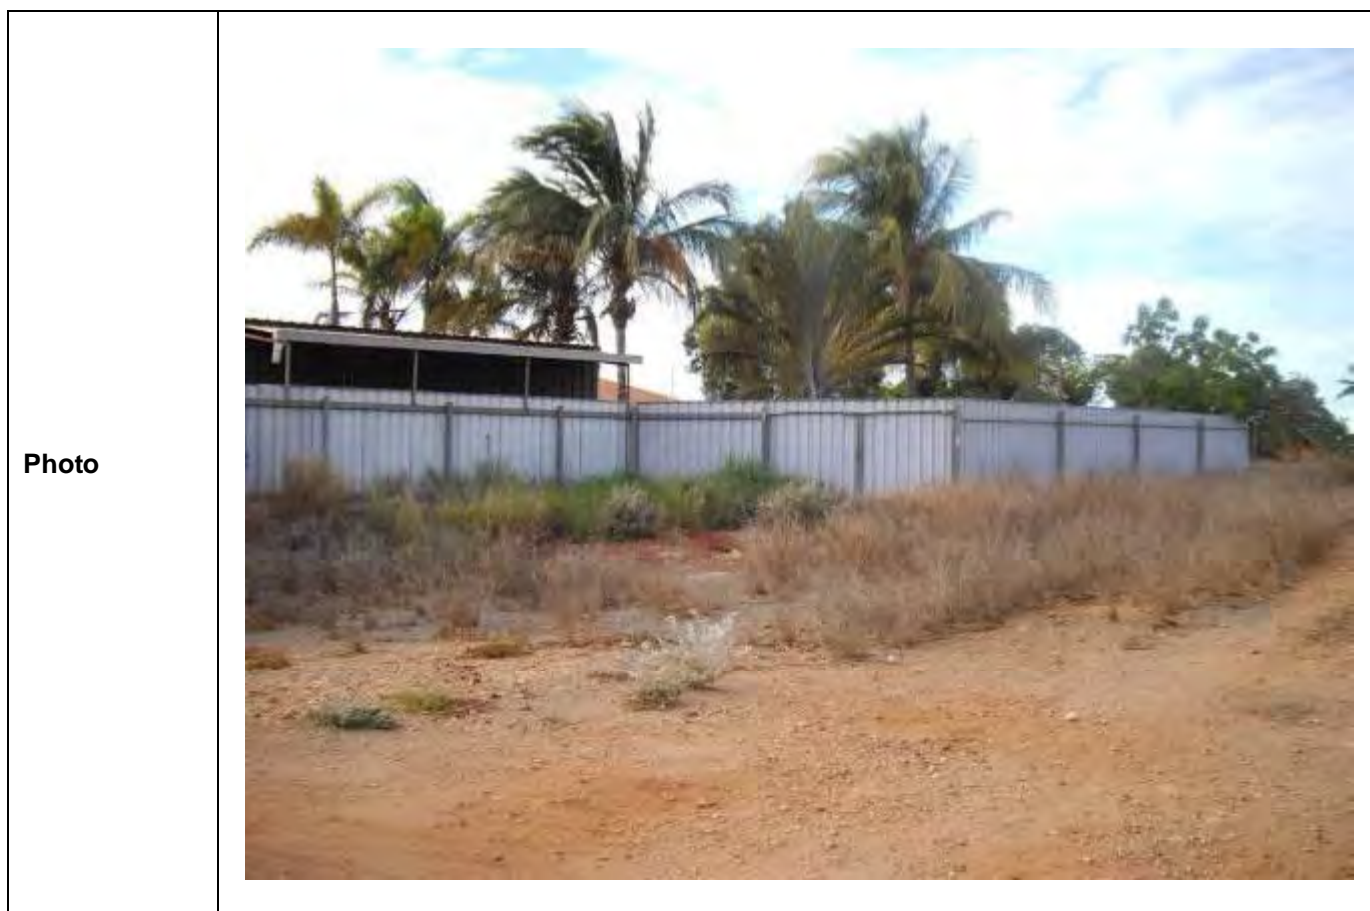
## 2.8 Lot No. 61 Gascoyne Crescent

<b>Category</b>	Encroachment
<b>Type</b>	Backyard extension Highly modified drainage reserve
<b>Description</b>	Fence extends to within drainage reserve; Natural flow path apparent and and adequate
<b>Photo ID</b>	515
<b>Scope of Works</b>	L - Remove backyard extension

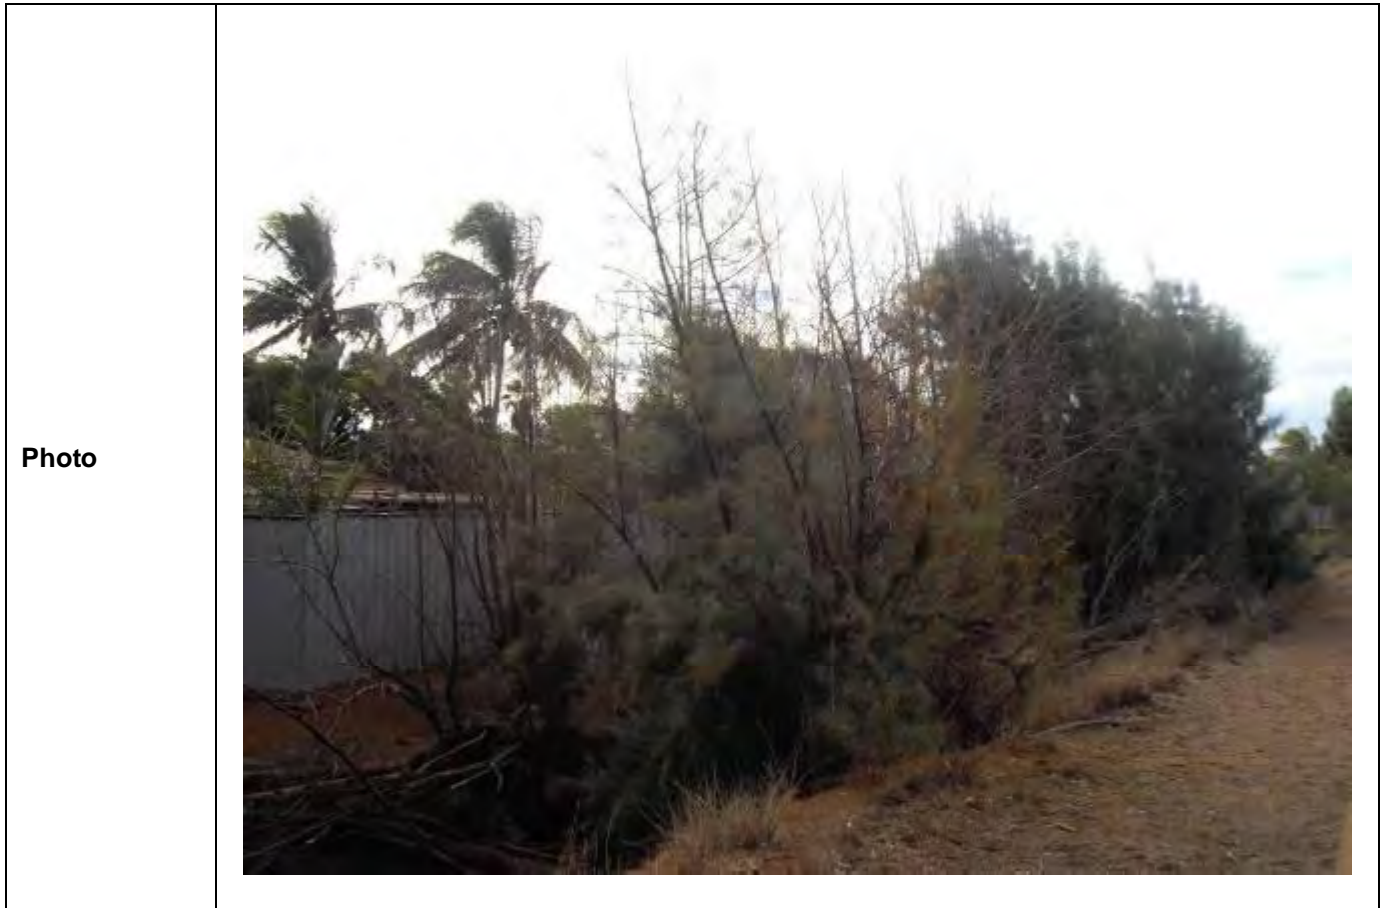
### 3.1 Lot No. 3,062 Hardey Crescent

<b>Category</b>	Encroachment / Drain Maintenance
<b>Type</b>	Boundary extension Vegetation.
<b>Description</b>	Fence on eastern and southern boundaries Semi dense vegetation impedes flow
<b>Photo ID</b>	513
<b>Scope of Works</b>	L - Remove fence and relocate to within property boundary – get confirmation from survey. H - Vegetation is to be slashed to a nominal height of 50 mm above ground with the exception of large, established trees of height in excess of 5 m, which shall remain.
