City of Karratha  
Dampier Stormwater Management Study  
Report  
Part B  
June 2015

## Appendix **C** – 2010 encroachment reviews

**Rio Tinto Iron Ore**  
Report on Dampier Drainage  
Review  
Block 1 Encroachments  
June 2010

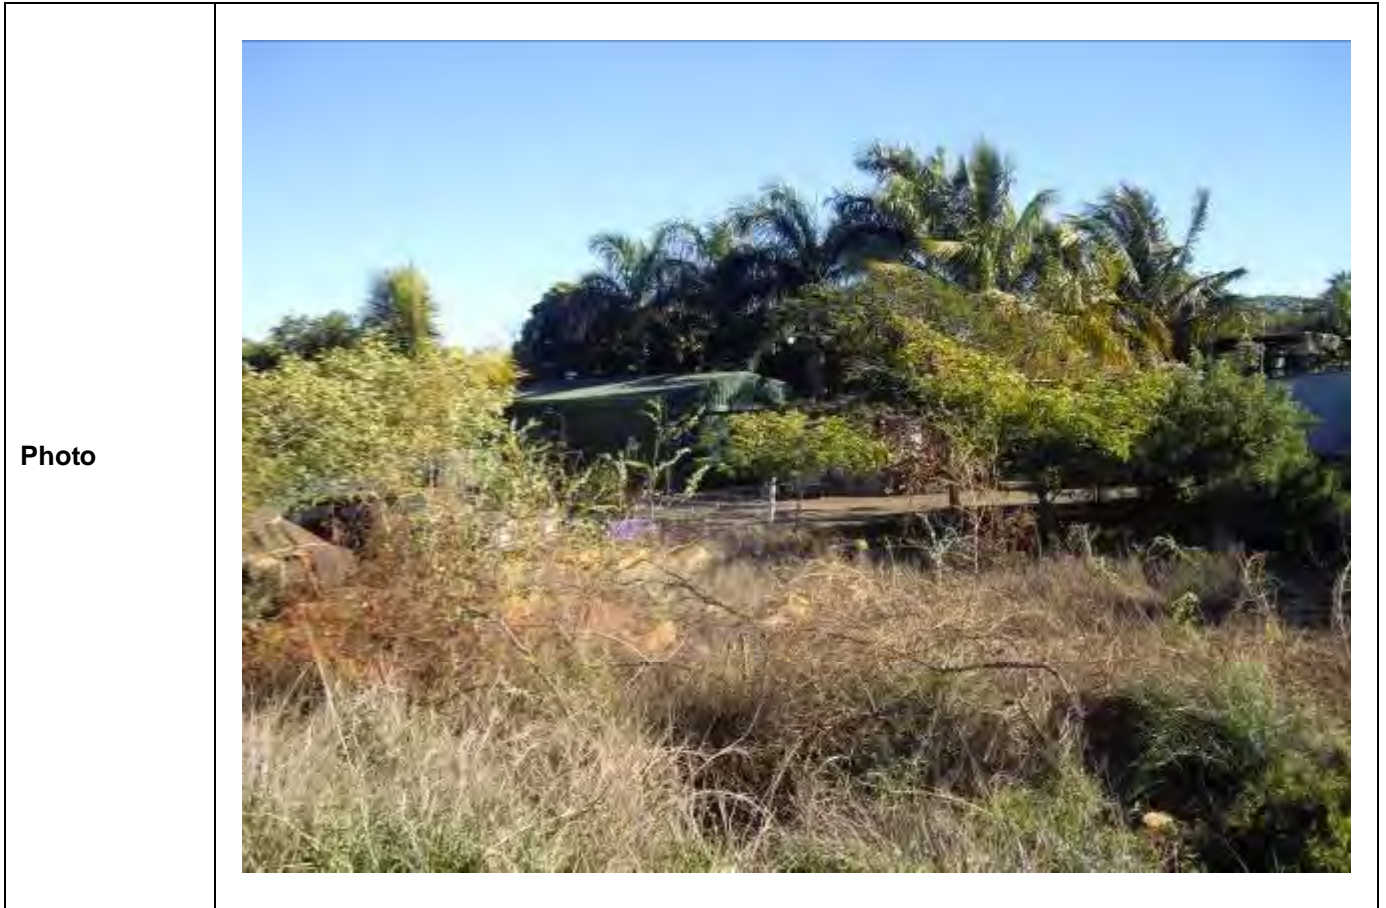
### 3.2 Lot No. 2,062 Hardey Crescent

<b>Category</b>	Encroachment
<b>Type</b>	Rear access, General items
<b>Description</b>	Rear access impeding flow. Blue metal has been imported and appears to have modified the drainage reserve considerably Cars, trailers.
<b>Photo ID</b>	823
<b>Scope of Works</b>	H - Remove rear access and reinstate drainage flow path as defined by the natural capacity and invert of channel of downstream lot (1062). L - Remove cars and trailers.

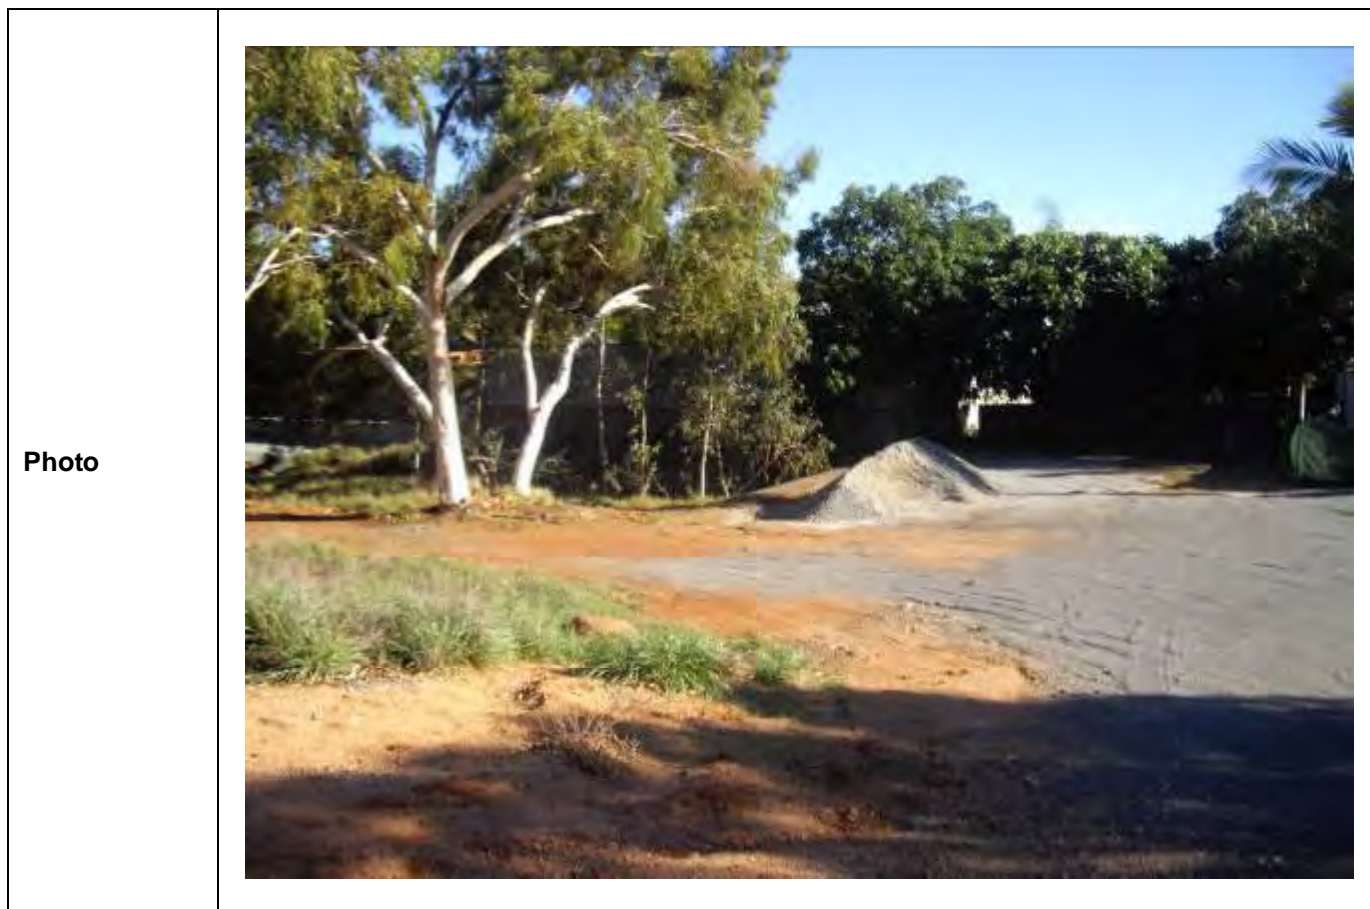
### 3.3 Lot No. 1,062 Hardey Crescent

<b>Category</b>	Encroachment
<b>Type</b>	Rear access Modified flow path Vegetation
<b>Description</b>	Rear access with culvert Imported blue metal and fill.
<b>Photo ID</b>	824
<b>Scope of Works</b>	M – Remove rear access reinstate drainage flow path as defined by the natural capacity and invert of channel of downstream lot M – Remove imported blue metal L - Vegetation is to be slashed to a nominal height of 50 mm above ground with the exception of large, established trees of height in excess of 5 m, which shall remain.

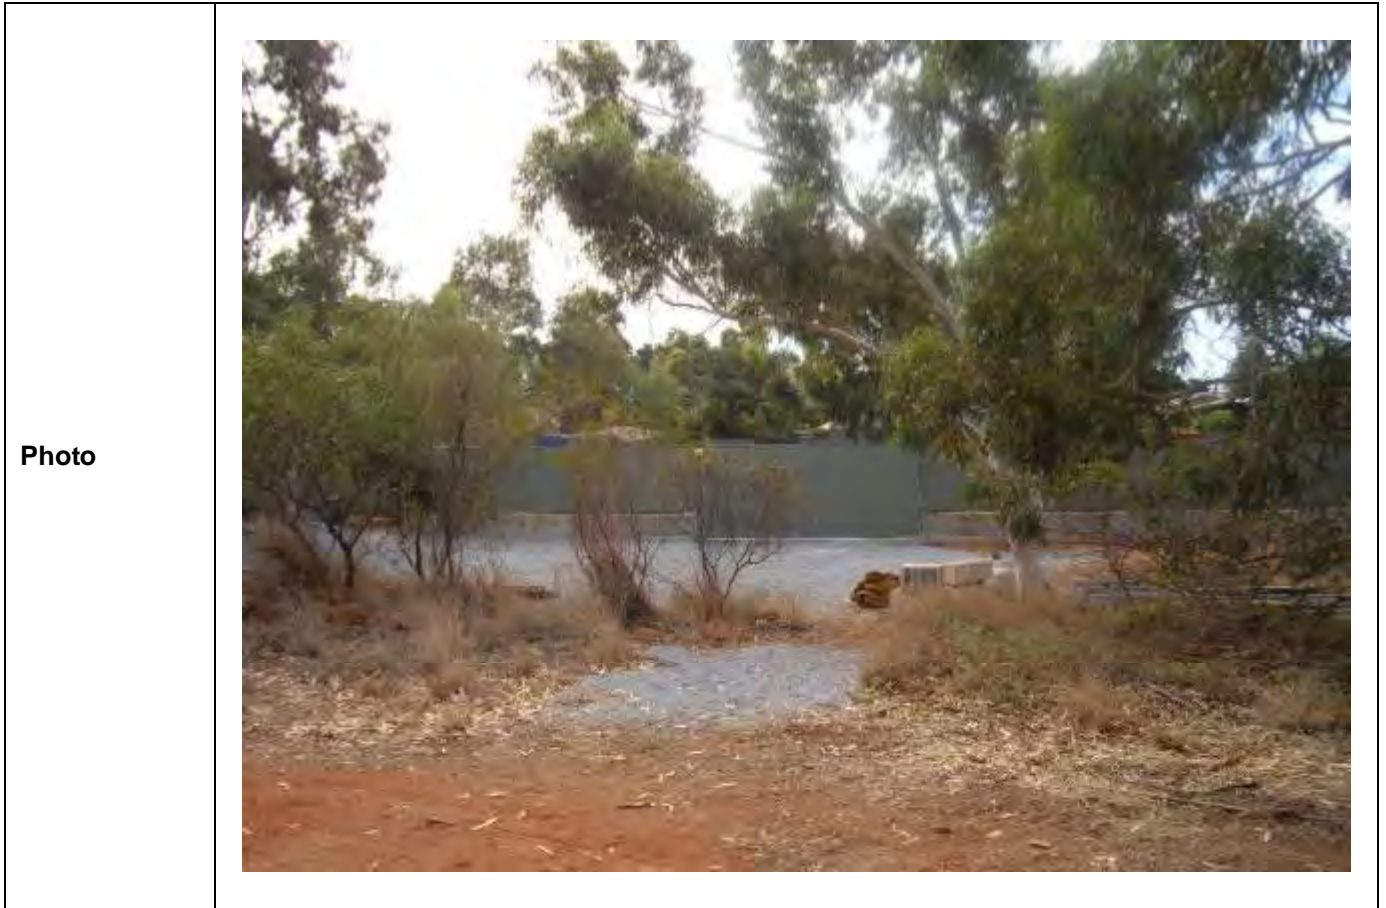
### 3.4 Lot No. 62 Hardey Crescent

<b>Category</b>	Encroachment
<b>Type</b>	Rear access Boundary extension
<b>Description</b>	Rear access with culvert including a large amount of fill created into a parking area. Note that this is historically a high risk flooding area; Minor misalignment of the boundary extension.
<b>Photo ID</b>	507
<b>Scope of Works</b>	H - Remove rear access way and reinstate drainage flow path as defined by the natural capacity and invert of channel of downstream lot (63) L – Remove fence and relocate to within the property boundary.

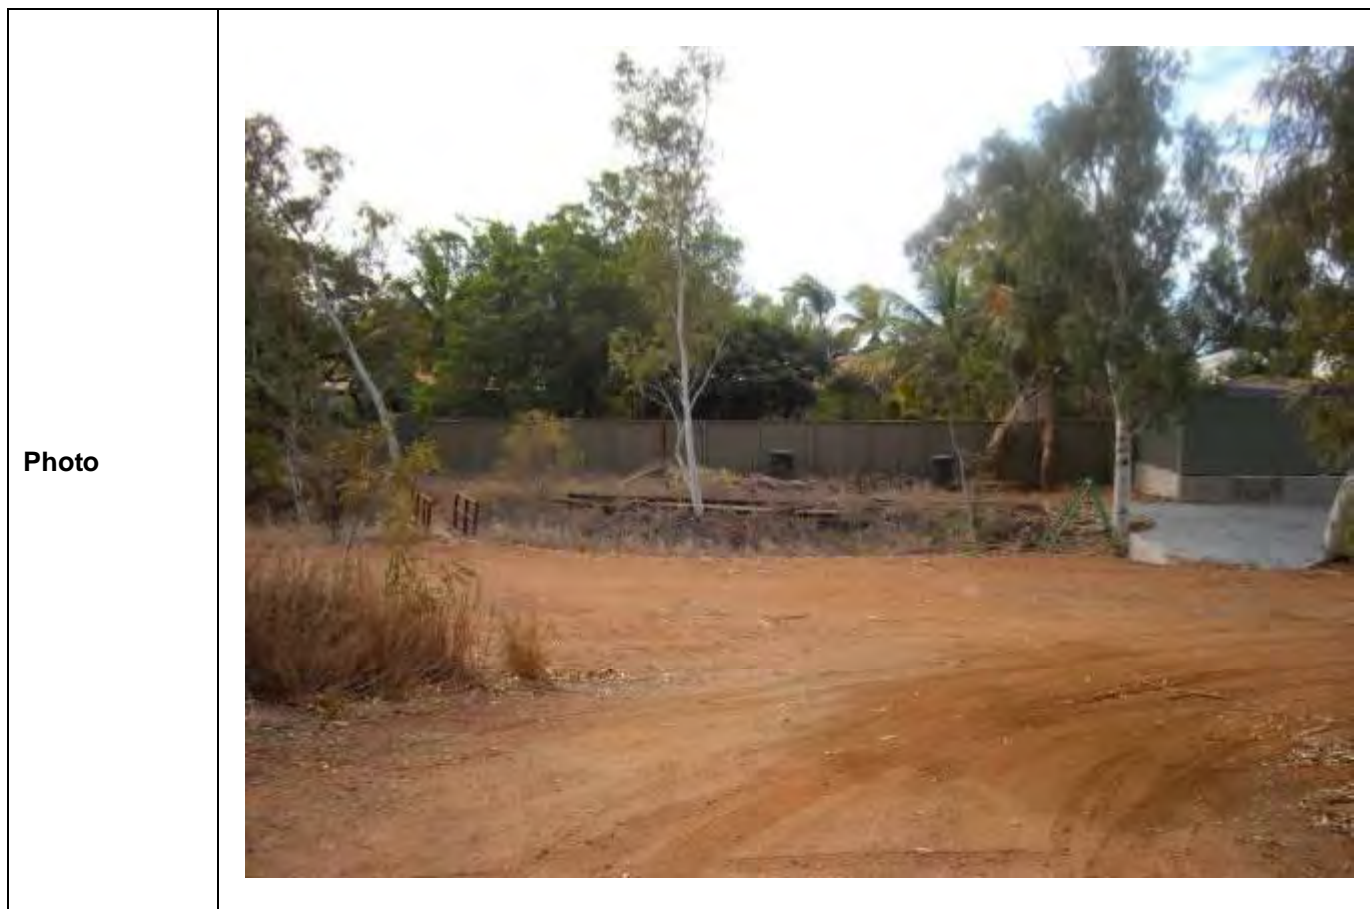
### 3.5 Lot No. 63 Hardey Crescent

<b>Category</b>	Encroachment
<b>Type</b>	General items Rear access
<b>Description</b>	General rubbish and swing set Walkway bridge
<b>Photo ID</b>	508
<b>Scope of Works</b>	L - Remove rubbish L – Remove swing set L – Remove rear access

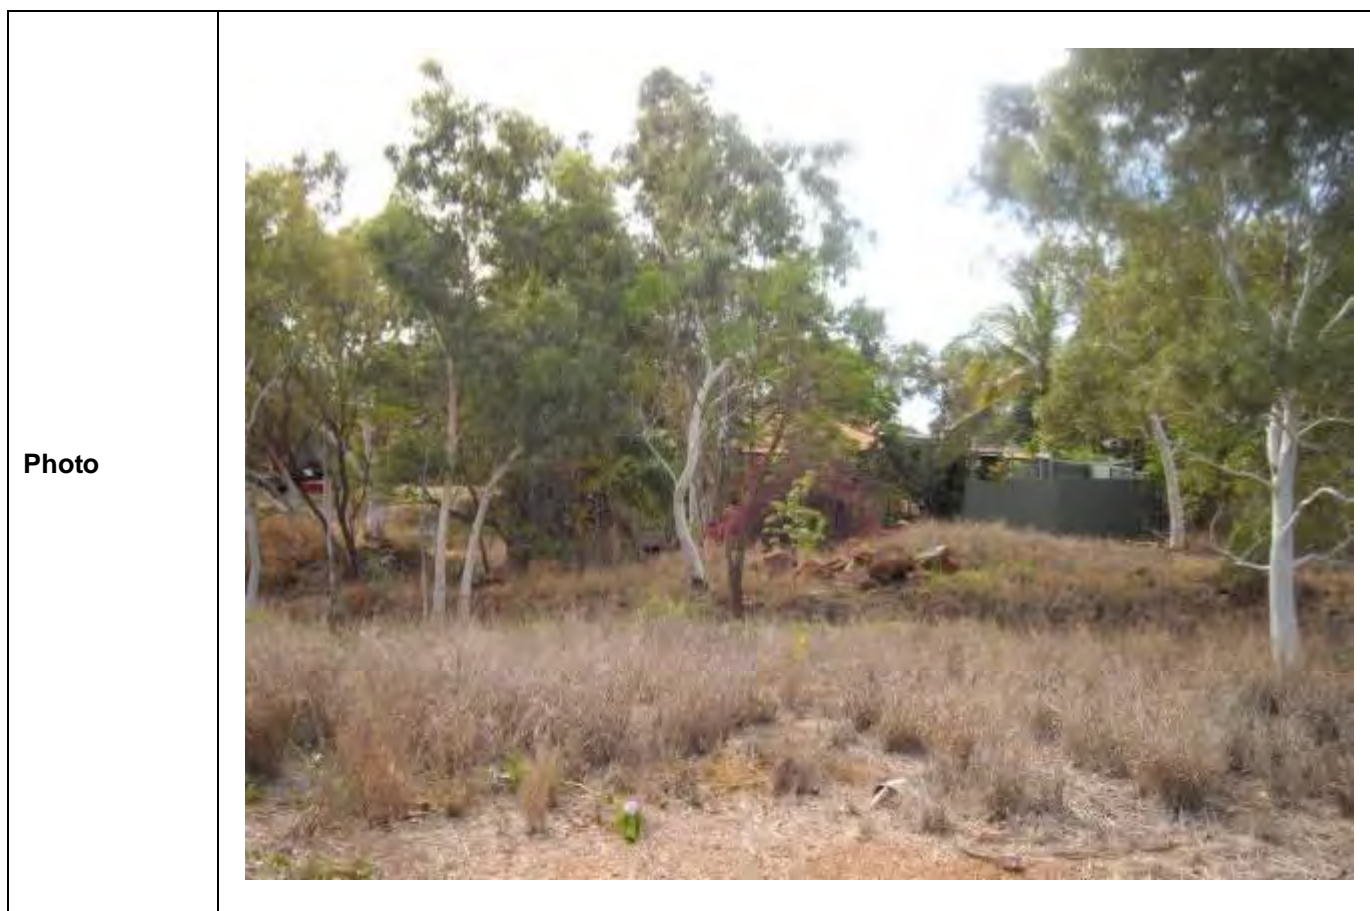
### 3.6 Lot No. 64 Hardey Crescent

<b>Category</b>	Drain Maintenance
<b>Type</b>	Vegetation
<b>Description</b>	Semi-dense vegetation Natural channel apparent and adequate
<b>Photo ID</b>	509
<b>Scope of Works</b>	M - Vegetation is to be slashed to a nominal height of 50 mm above ground with the exception of large, established trees of height in excess of 5 m, which shall remain

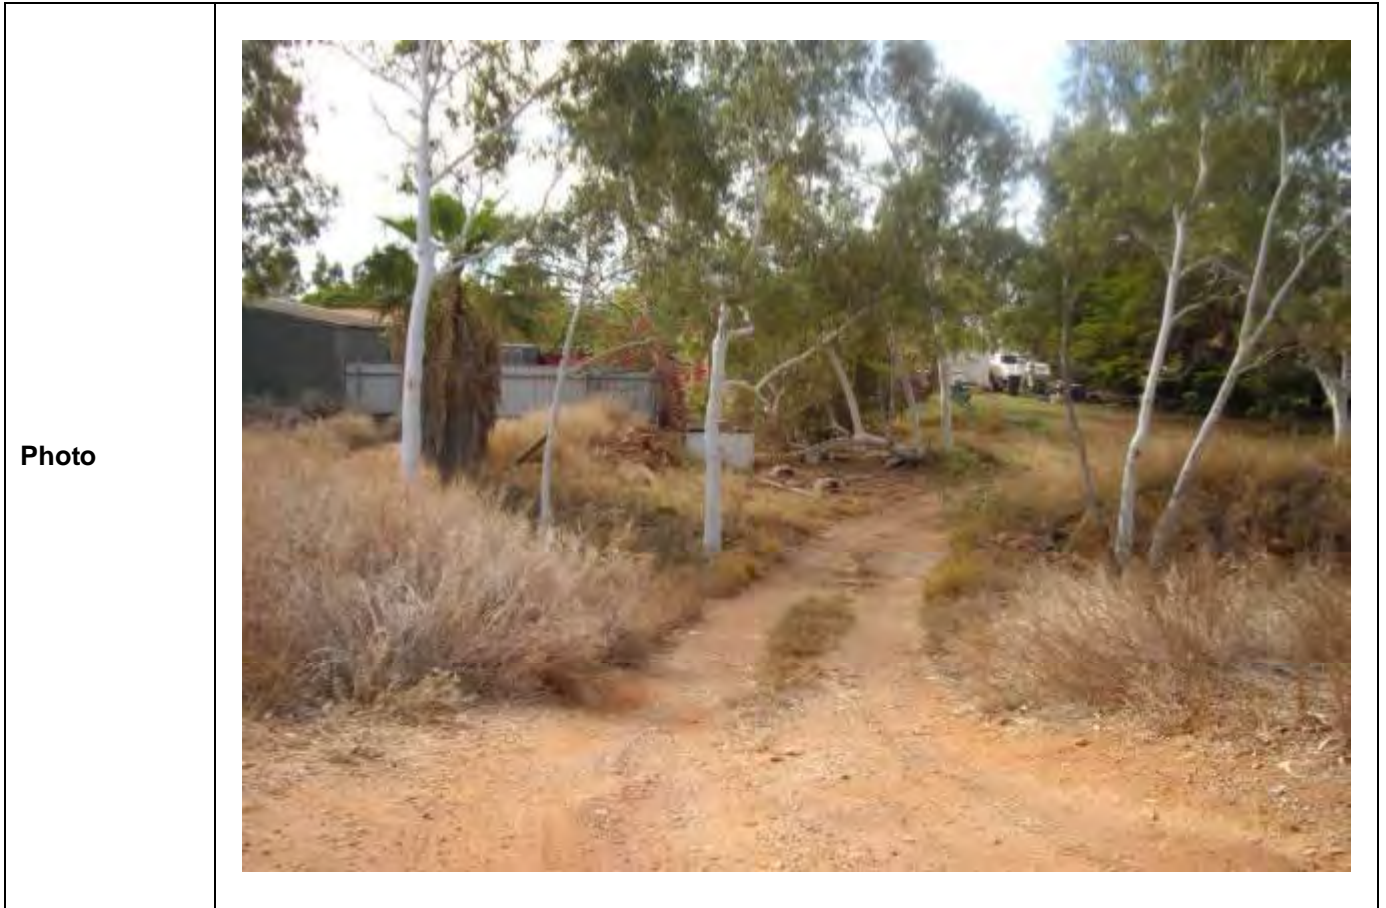
### 3.7 Lot No. 65 Hardey Crescent

<b>Category</b>	Encroachment / Drain Maintenance
<b>Type</b>	Rear access Vegetation
<b>Description</b>	Rear access follows natural topography Semi-dense vegetation
<b>Photo ID</b>	510
<b>Scope of Works</b>	L – Remove rear access and reinstate drainage flow path as defined by the natural capacity and invert of channel of downstream lot M - Vegetation is to be slashed to a nominal height of 50 mm above ground with the exception of large, established trees of height in excess of 5 m, which shall remain

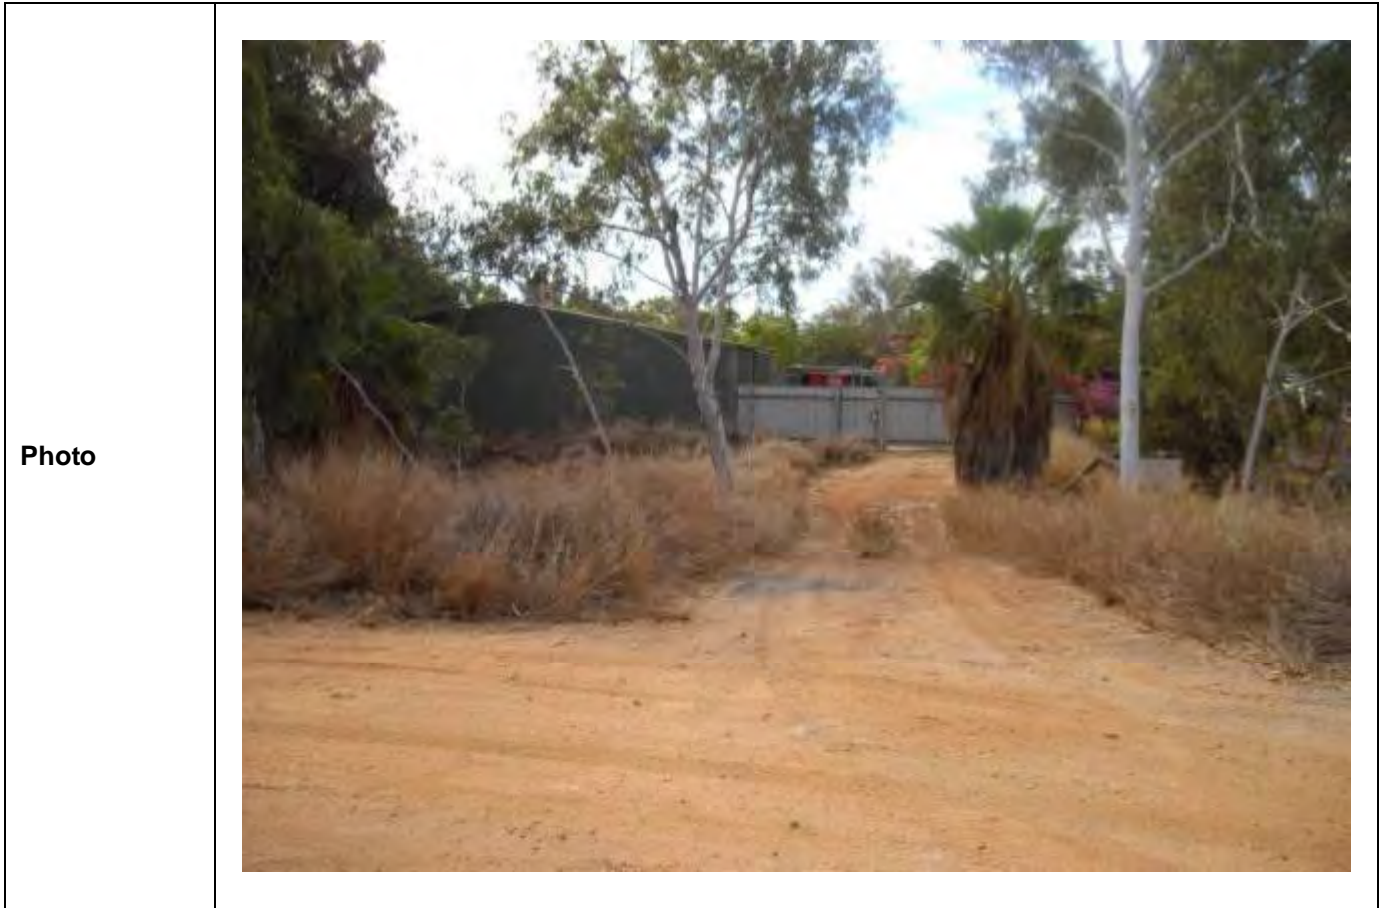
### 3.8 Lot No. 66 Hardey Crescent

<b>Category</b>	Encroachment
<b>Type</b>	Rear access; Vegetation
<b>Description</b>	Rear access with culvert impeding flow; Semi-dense vegetation.
<b>Photo ID</b>	511
<b>Scope of Works</b>	H – Remove access way and reinstate drainage flow path as defined by the natural capacity and invert of channel of downstream lot M - Vegetation is to be slashed to a nominal height of 50 mm above ground with the exception of large, established trees of height in excess of 5 m, which shall remain

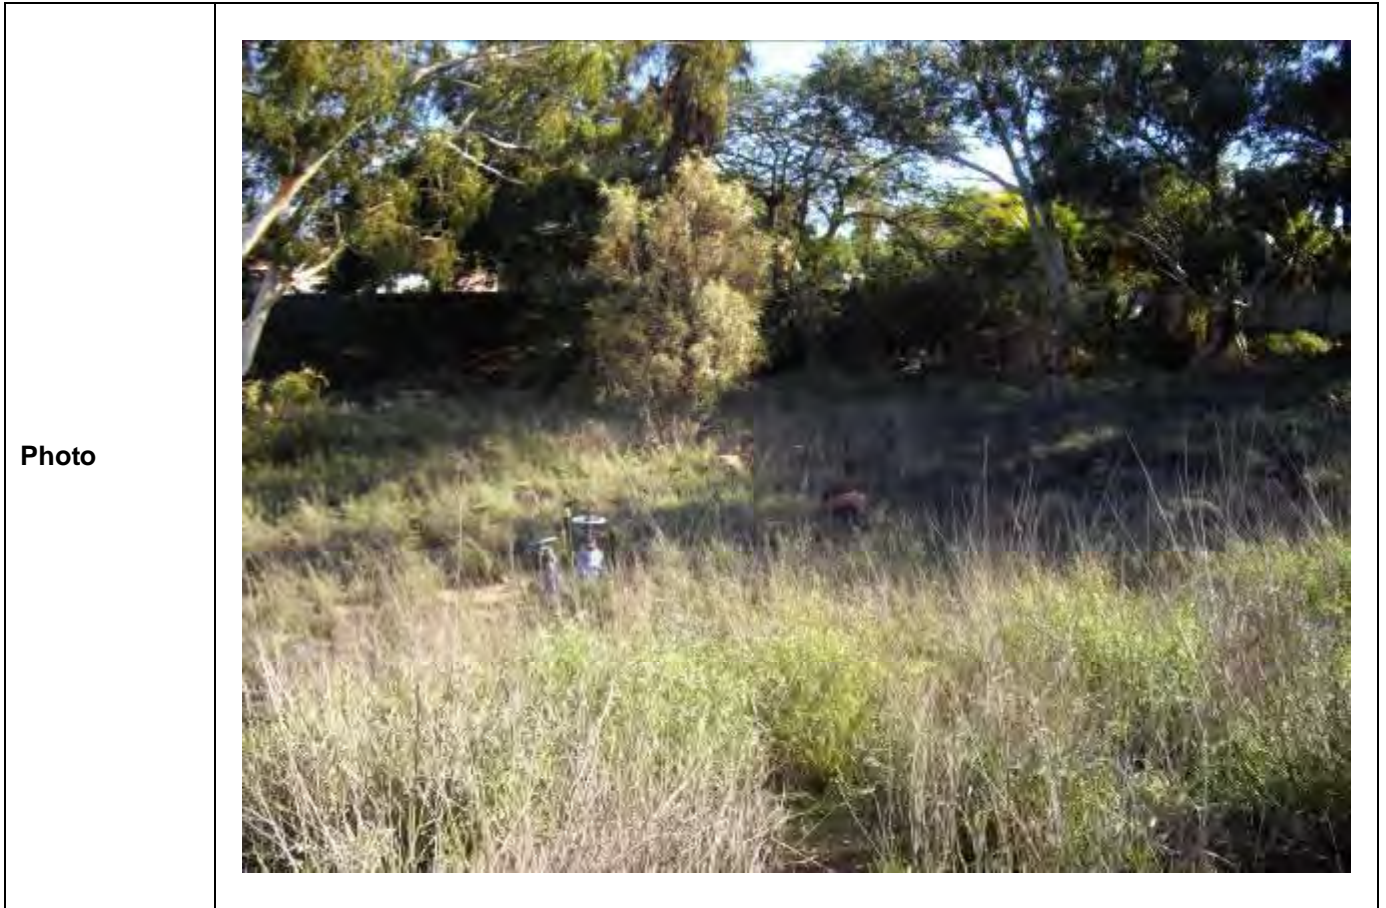
### 3.9 Lot No. 67 Hardey Crescent

<b>Category</b>	Drain Maintenance
<b>Type</b>	Rocks ; Vegetation.
<b>Description</b>	Rocks impeding flow; Vegetation impeding flow.
<b>Photo ID</b>	825
<b>Scope of Works</b>	L – Remove rocks M - Vegetation is to be slashed to a nominal height of 50 mm above ground with the exception of large, established trees of height in excess of 5 m, which shall remain

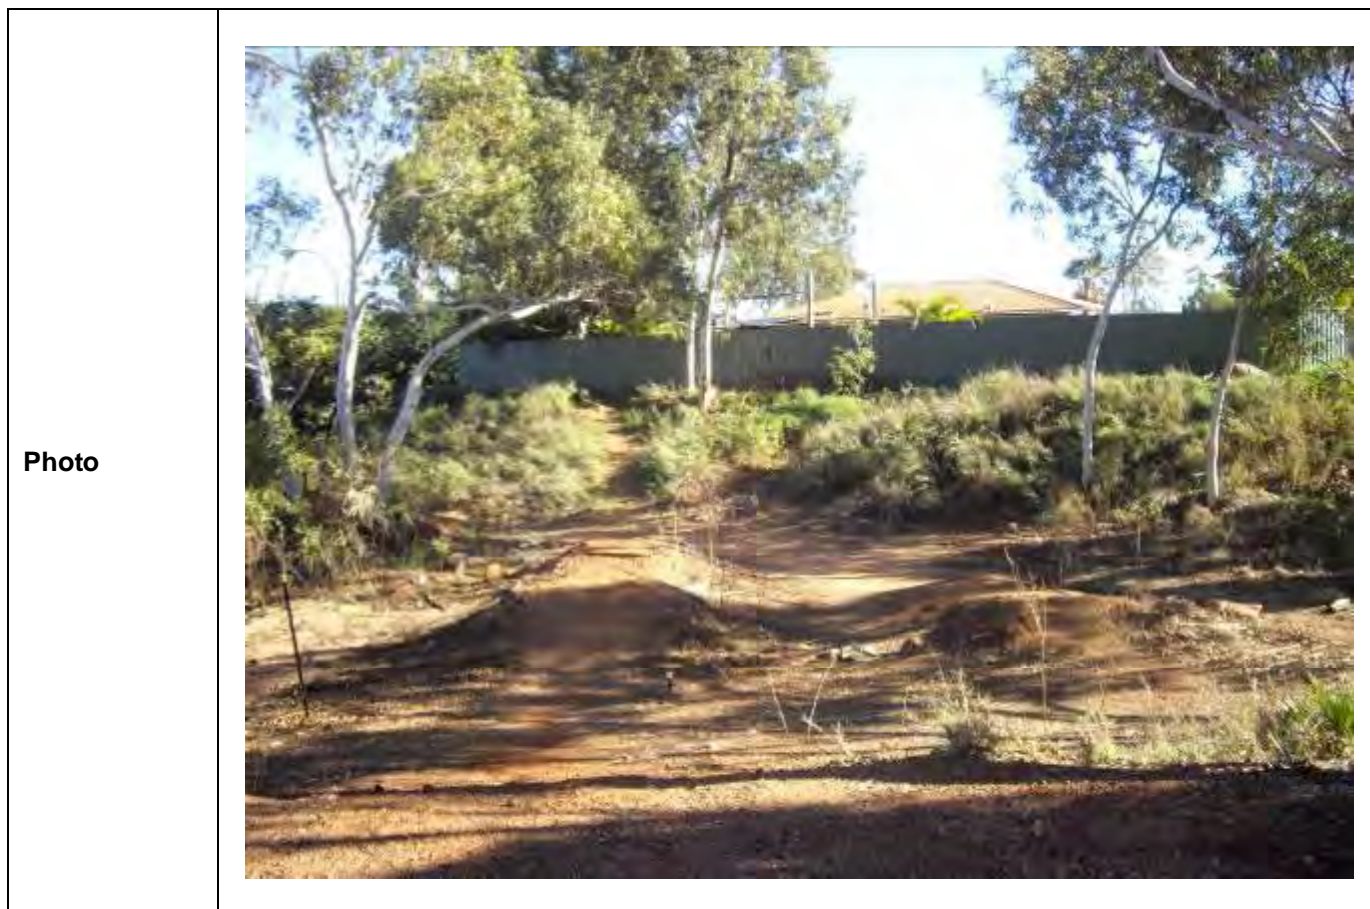
### 3.13 Lot No. 1,070 Hardey Crescent

<b>Category</b>	Drain Maintenance
<b>Type</b>	Modified drainage reserve
<b>Description</b>	Mounded fill created into bike jumps – flow path adequate
<b>Photo ID</b>	828
<b>Scope of Works</b>	L - Remove bike jumps

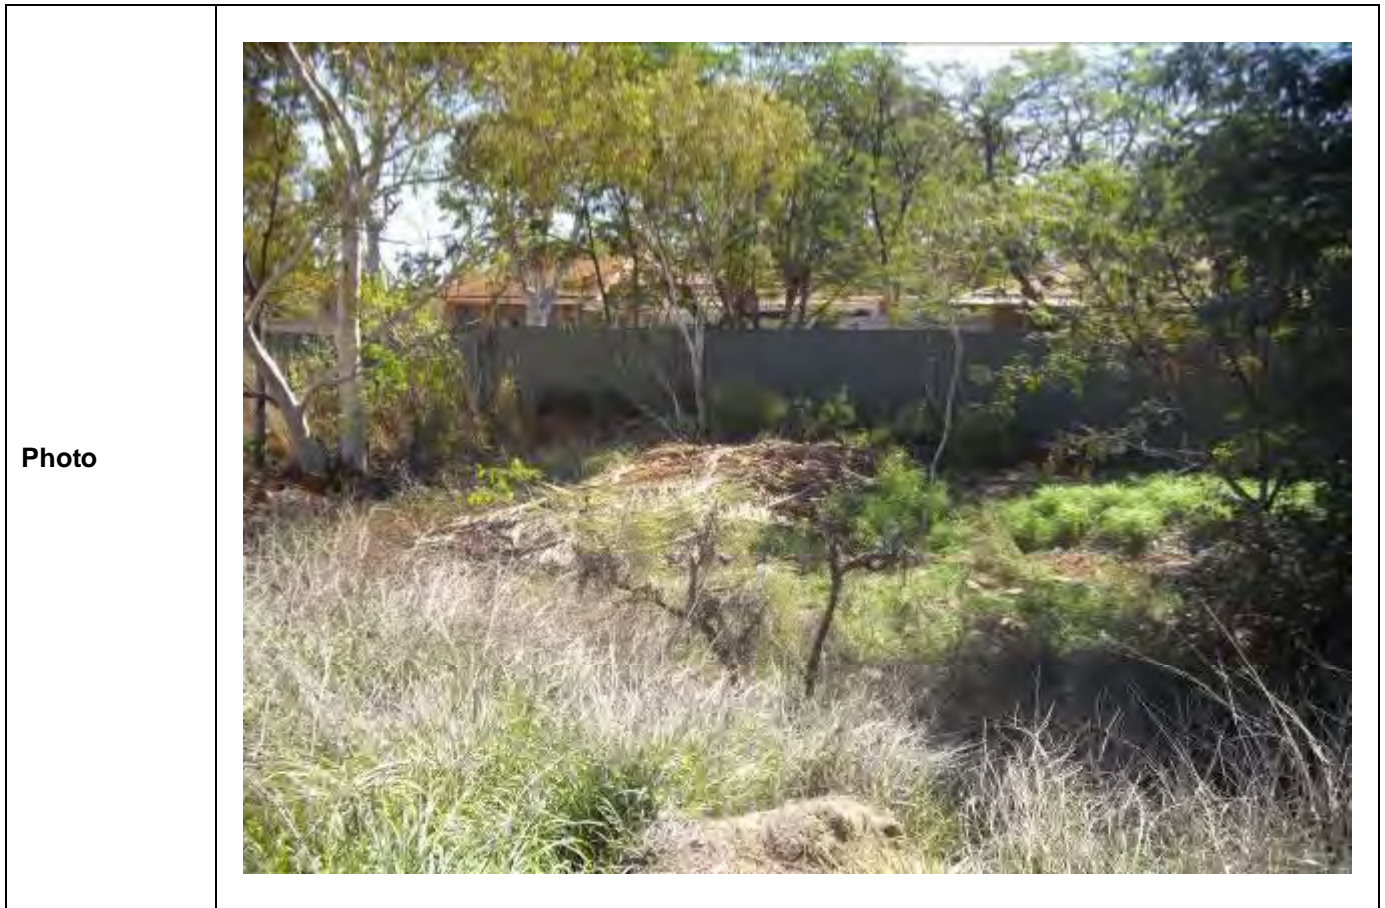
## 4.2 Lot No. 3,071 Fortesque Crescent

<b>Category</b>	Drain Maintenance
<b>Type</b>	Vegetation Fill
<b>Description</b>	Semi-dense vegetation impeding flow; Cut branches disposed of within drainage reserve.
<b>Photo ID</b>	814
<b>Scope of Works</b>	M - Vegetation is to be slashed to a nominal height of 50 mm above ground with the exception of large, established trees of height in excess of 5 m, which shall remain M – Remove fill and reinstate drainage flow path as defined by the natural capacity and invert of channel of downstream lot

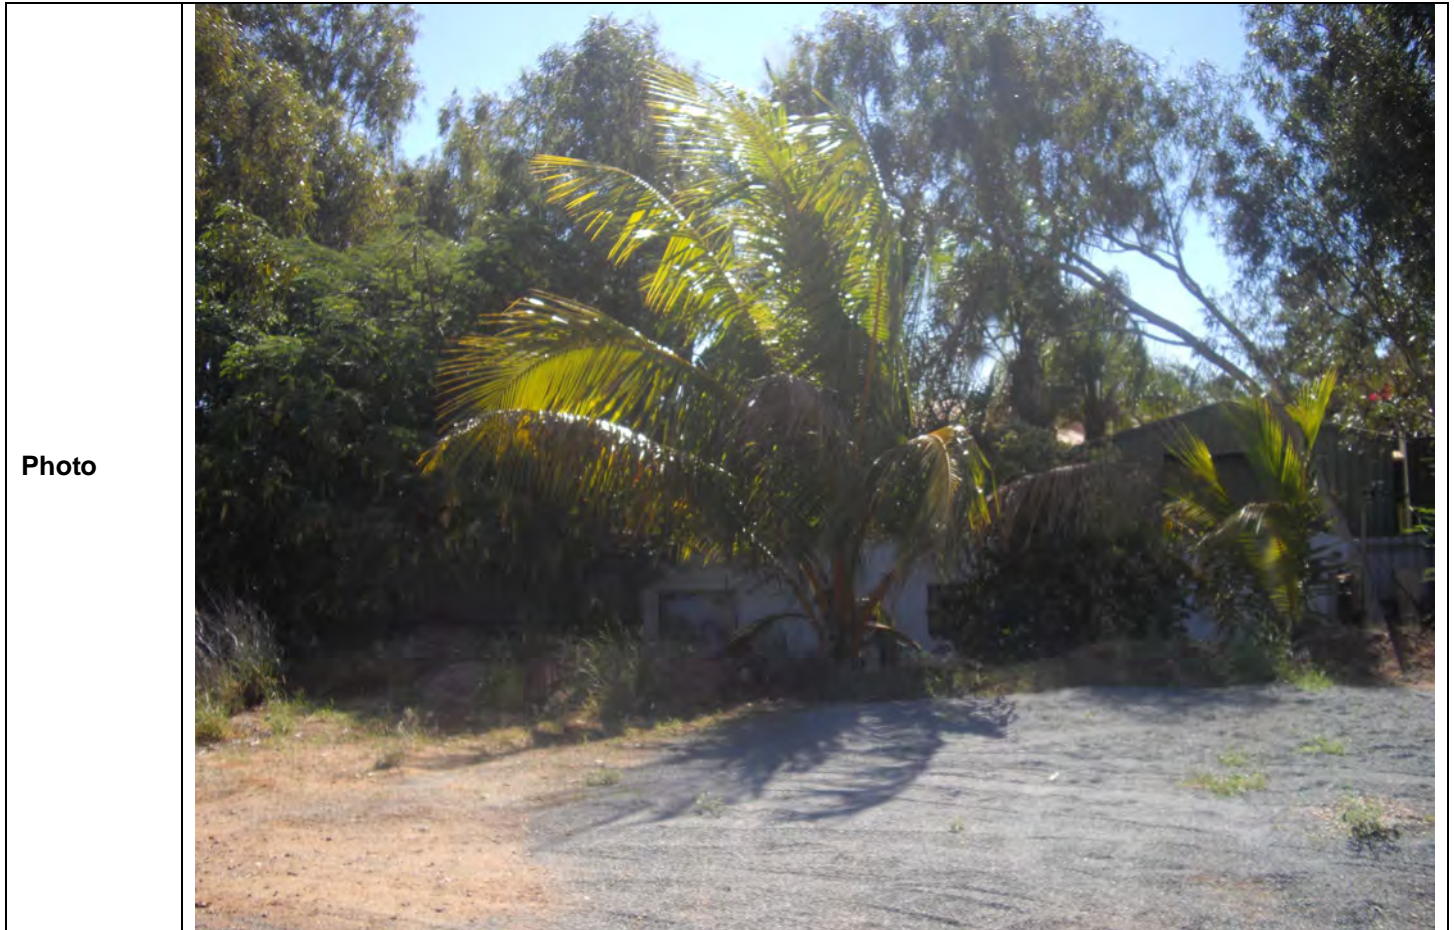
### 4.3 Lot No. 2,071 Fortesque Crescent

<b>Category</b>	Encroachment
<b>Type</b>	General item
<b>Description</b>	Caravan
<b>Photo ID</b>	1038
<b>Scope of Works</b>	M – Remove caravan.

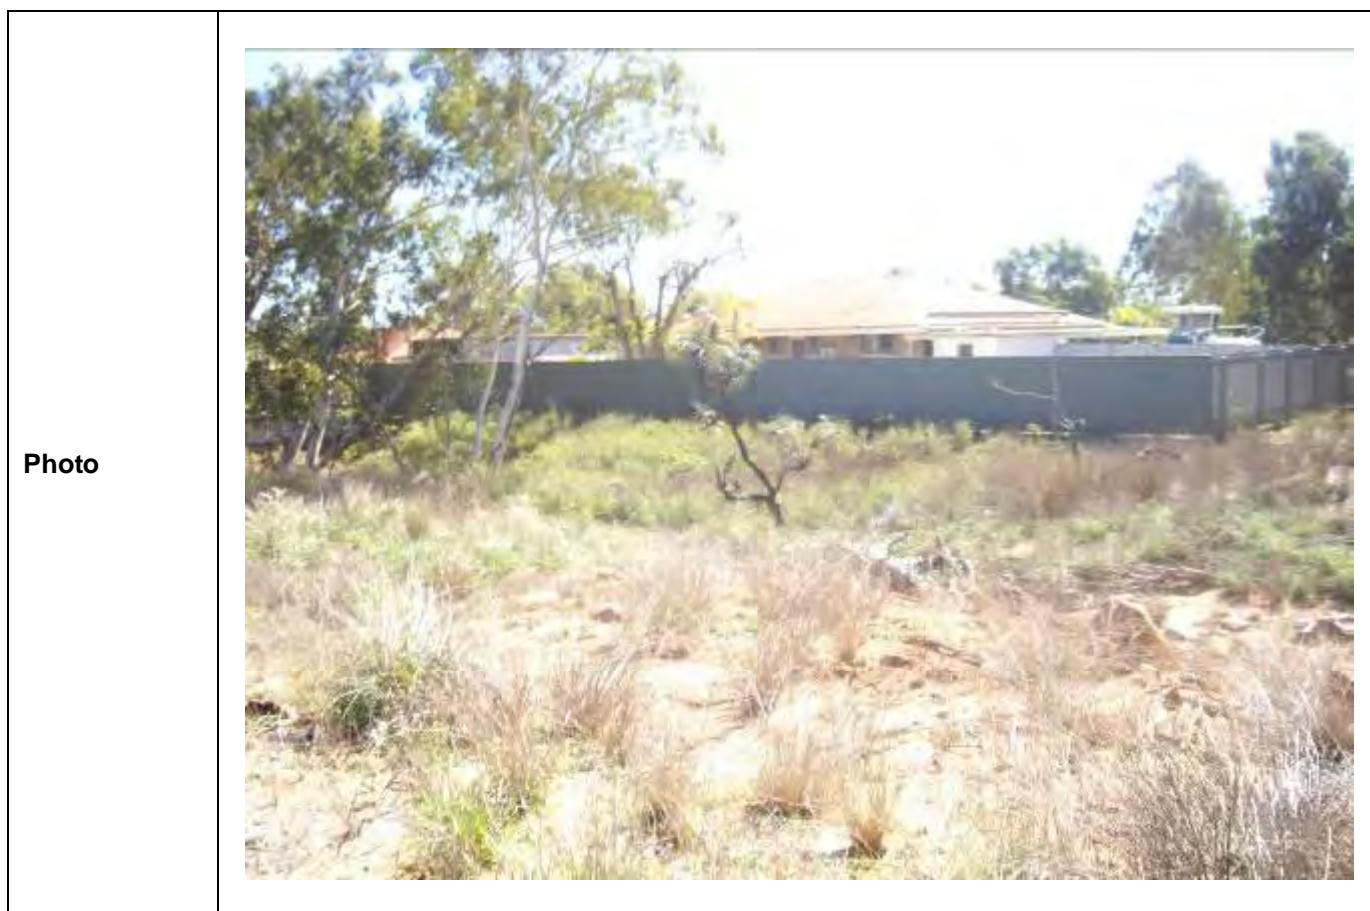
#### 4.4 Lot No. 1,071 Fortesque Crescent

<b>Category</b>	Drain Maintenance / Encroachment
<b>Type</b>	Vegetation Rear access
<b>Description</b>	Semi-dense vegetation Rear access follows natural topography
<b>Photo ID</b>	813
<b>Scope of Works</b>	M - Vegetation is to be slashed to a nominal height of 50 mm above ground with the exception of large, established trees of height in excess of 5 m, which shall remain L – Remove rear access

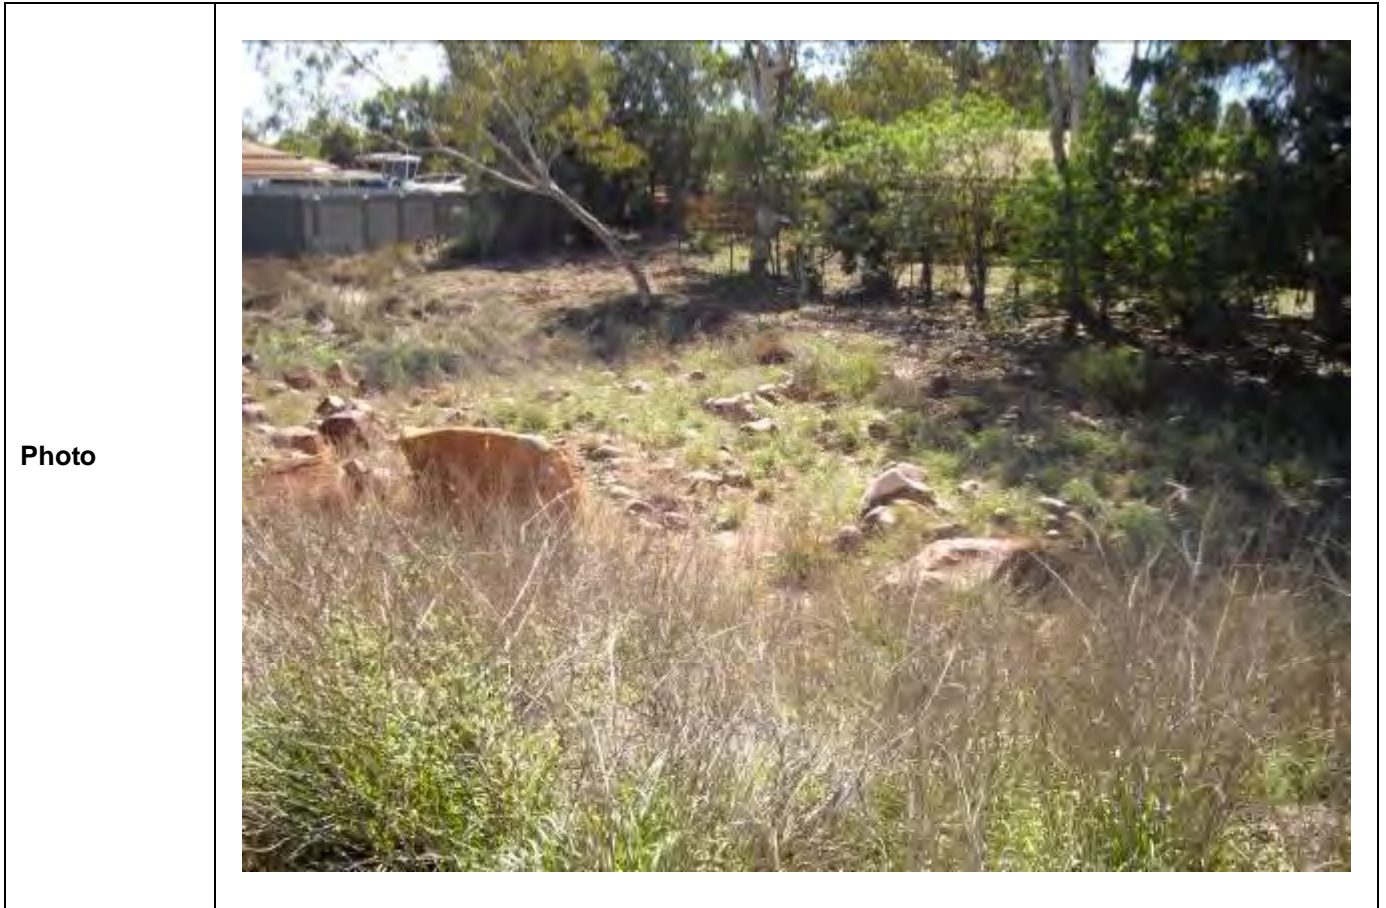
#### 4.5 Lot No. 71 Fortesque Crescent

<b>Category</b>	Drain Maintenance / Encroachment
<b>Type</b>	Vegetation Rocks Rear access
<b>Description</b>	Low lying vegetation impeding flow Rocks impeding flow Rear access follows natural topography
<b>Photo ID</b>	812
<b>Scope of Works</b>	M - Vegetation is to be slashed to a nominal height of 50 mm above ground with the exception of large, established trees of height in excess of 5 m, which shall remain M – Remove rocks from within the “channel” and reinstate drainage flow path as defined by the natural capacity and invert of channel of downstream lot

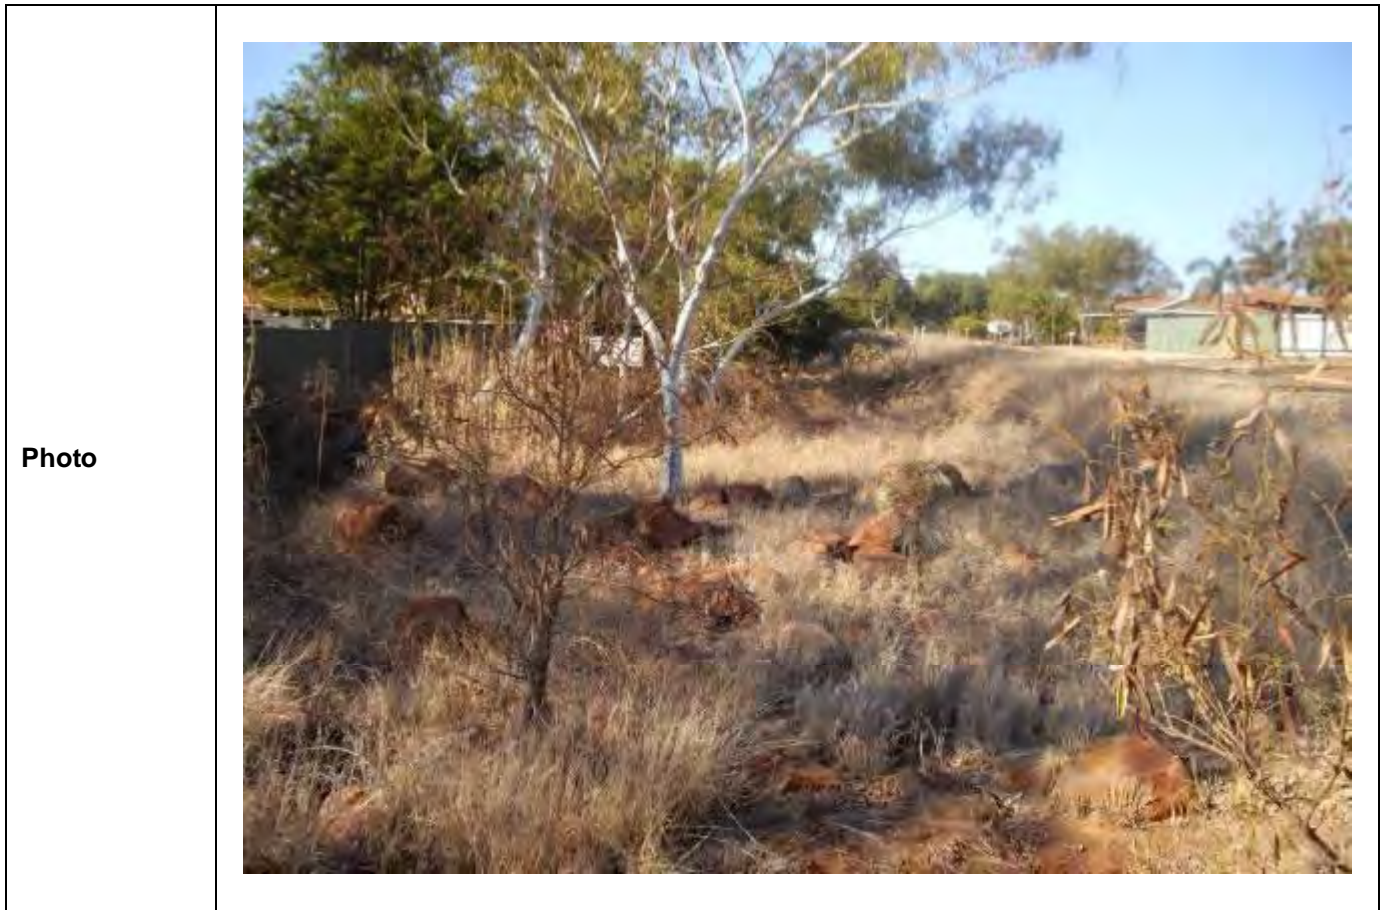
#### 4.6 Lot No. 72 Fortesque Crescent

<b>Category</b>	Drain Maintenance
<b>Type</b>	Vegetation
<b>Description</b>	Semi dense vegetation Natural flow path adequate
<b>Photo ID</b>	384
<b>Scope of Works</b>	L - Vegetation is to be slashed to a nominal height of 50 mm above ground with the exception of large, established trees of height in excess of 5 m, which shall remain

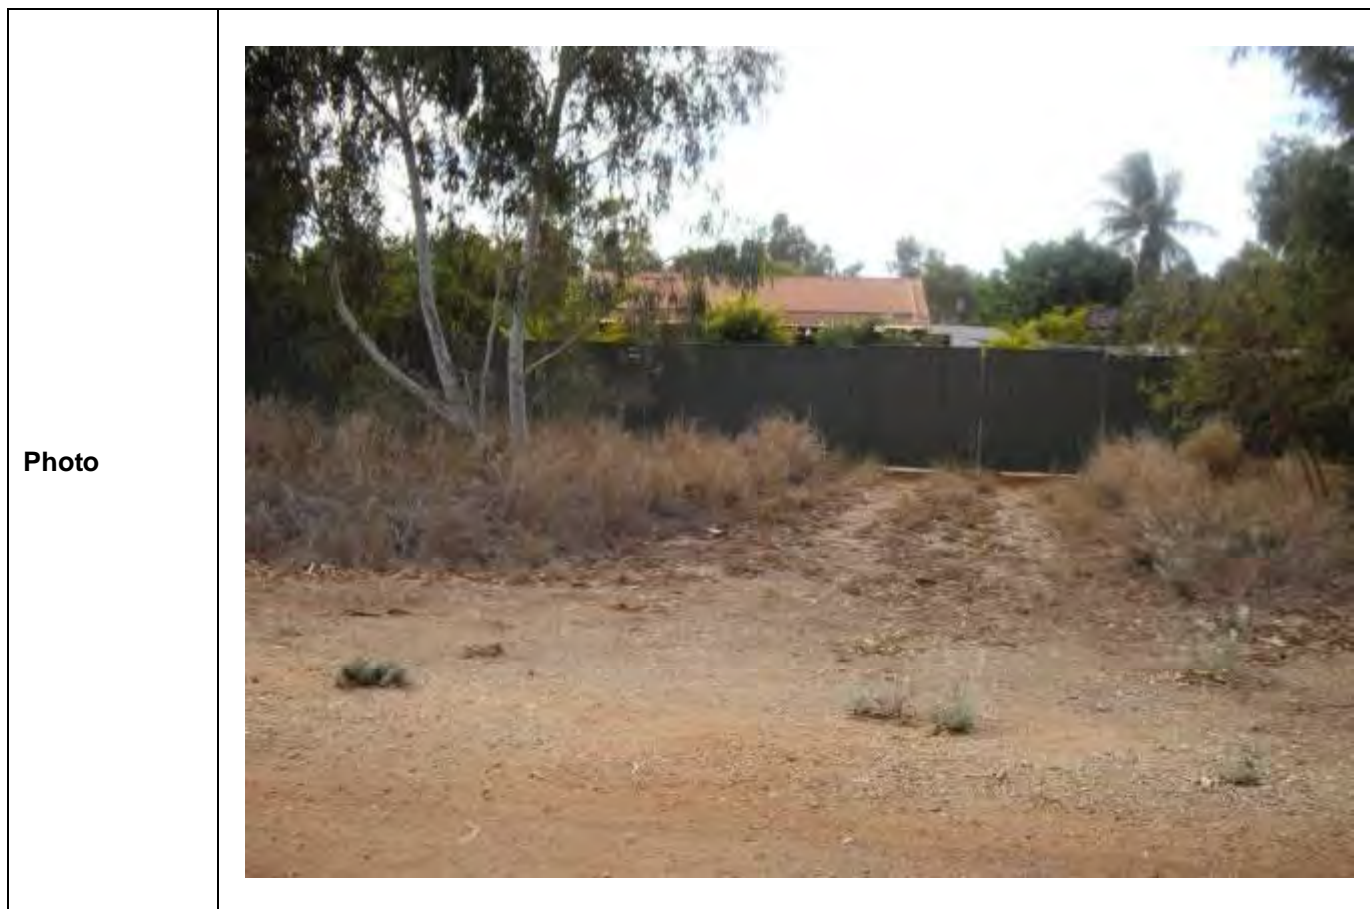
#### 4.7 Lot No. 73 Fortesque Crescent

<b>Category</b>	Encroachment
<b>Type</b>	Rear access
<b>Description</b>	Rear access impeding flow
<b>Photo ID</b>	482
<b>Scope of Works</b>	H – Remove rear access and reinstate drainage flow path as defined by the natural capacity and invert of channel of downstream lot (72)

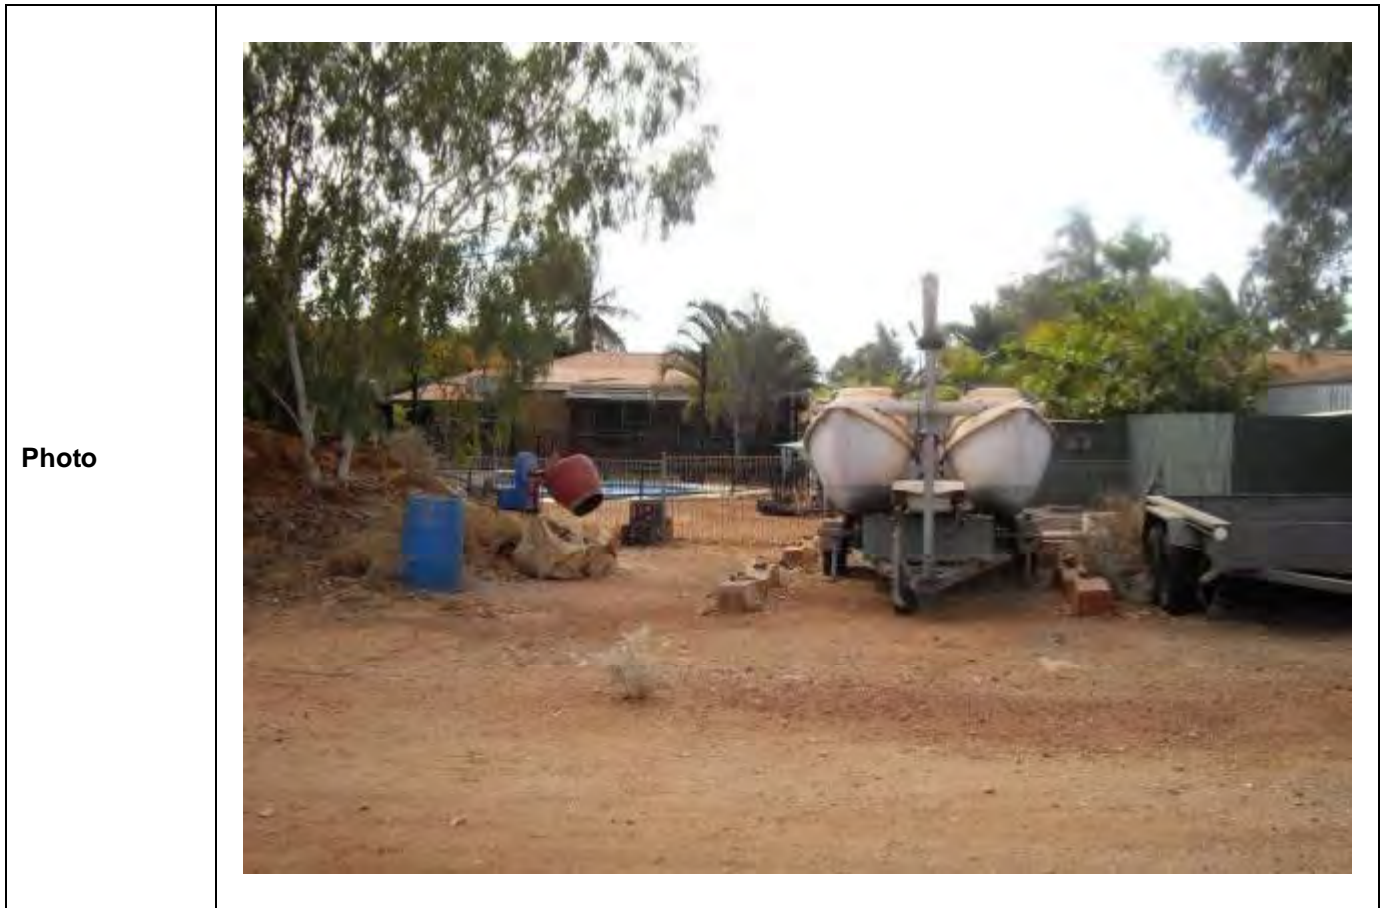
#### 4.8 Lot No. 74 Fortesque Crescent

<b>Category</b>	Encroachment
<b>Type</b>	Rear access; Modified reserve; General items.
<b>Description</b>	Rear access and modified topography Fill material potentially due to the excavation of the pool in the subject lot Boat, trailer, barrels, concrete mixer
<b>Photo ID</b>	481
<b>Scope of Works</b>	H – Remove rear access and reinstate drainage flow path as defined by the natural capacity and invert of channel of downstream lot (72) H – Remove fill material L – Remove boat, trailer, barrels and concrete mixer.
