City of Karratha  
Dampier Stormwater Management Study  
Report  
Part B  
June 2015

## Appendix **C** – 2010 encroachment reviews

**Rio Tinto Iron Ore**  
Report on Dampier Drainage  
Review  
Block 1 Encroachments  
June 2010

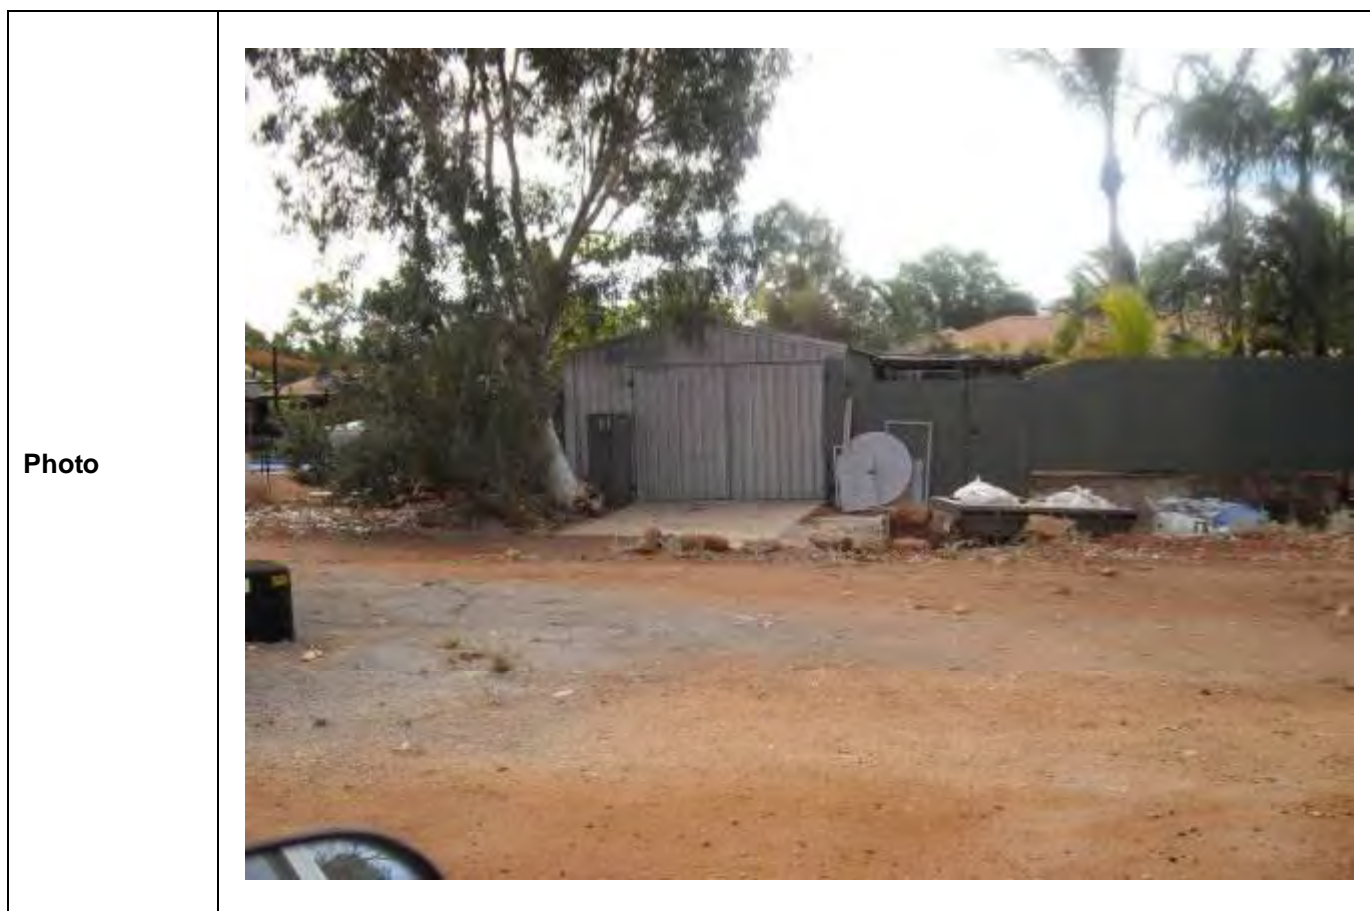
#### 4.9 Lot No. 75 Fortesque Crescent

<b>Category</b>	Encroachment
<b>Type</b>	Rear access General items
<b>Description</b>	Rear access with culvert and modified topography (Culvert outlet unknown) "Rubbish skip" and general rubbish in the low point of drainage reserve.
<b>Photo ID</b>	480
<b>Scope of Works</b>	H – Remove rear access and reinstate drainage flow path as defined by the natural capacity and invert of channel of downstream lot (72) M – Remove rubbish skip and general rubbish.

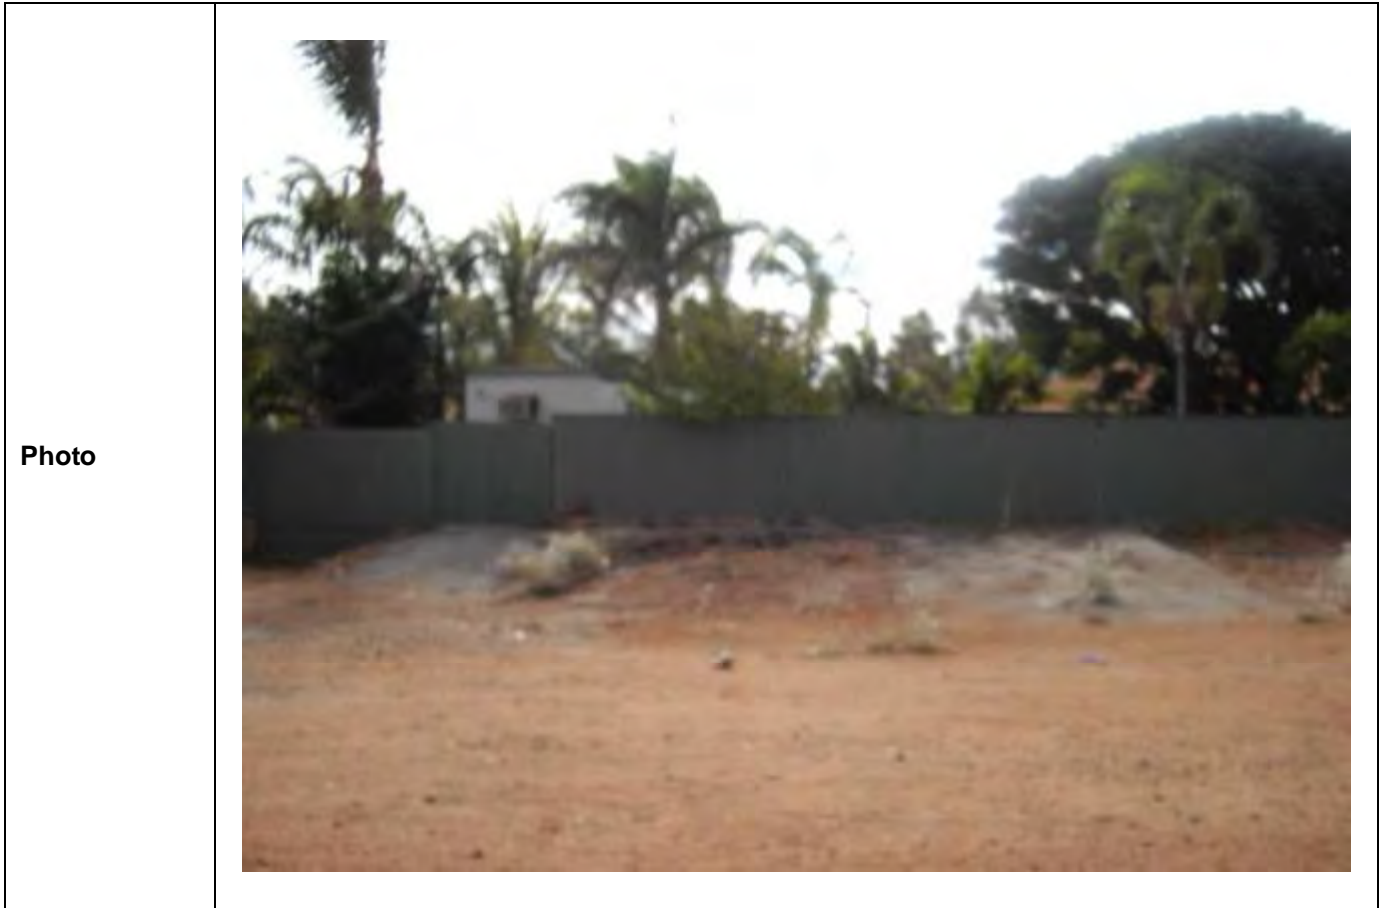
#### 4.10 Lot No. 76 Fortesque Crescent

<b>Category</b>	Encroachment
<b>Type</b>	Rear access Flow path
<b>Description</b>	Rear access and modified topography from the fill material; Extensive modification of the drainage reserve due to fill.
<b>Photo ID</b>	479
<b>Scope of Works</b>	H – Remove rear access and reinstate drainage flow path as defined by the natural capacity and invert of channel of downstream lot (72) L – Remove fill

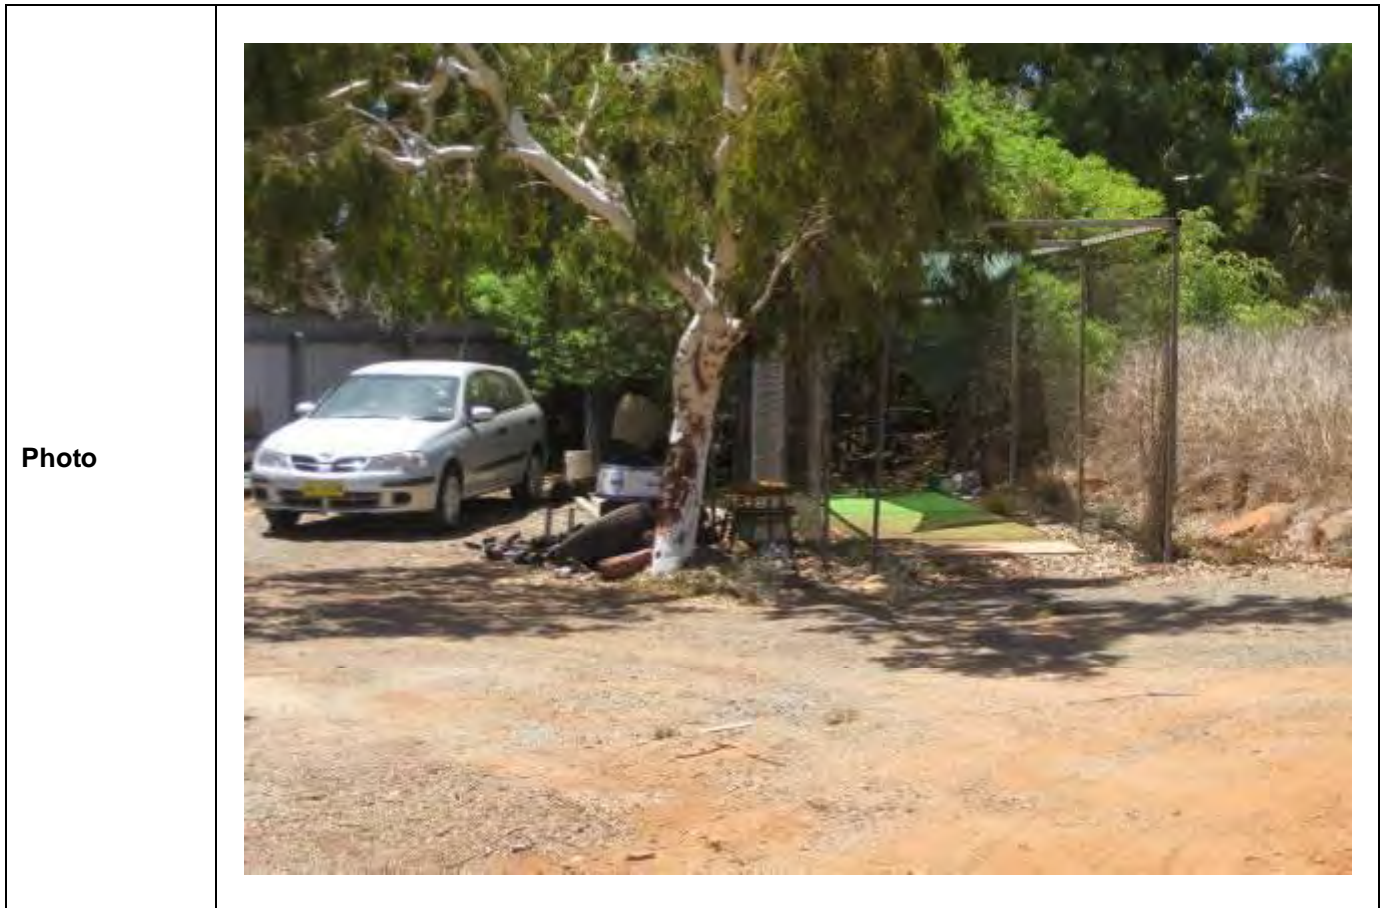
#### 4.11 Lot No. 77 Fortesque Crescent

<b>Category</b>	Encroachment
<b>Type</b>	Rear access; General items; Flow path.
<b>Description</b>	Rear access and modified topography; Cricket pitch, car, general rubbish; No flow path evident due to extensive fill.
<b>Photo ID</b>	7324
<b>Scope of Works</b>	H – Remove rear access and reinstate drainage flow path as defined by the natural capacity and invert of channel of downstream lot (72) H - Remove cricket pitch, car and general rubbish;

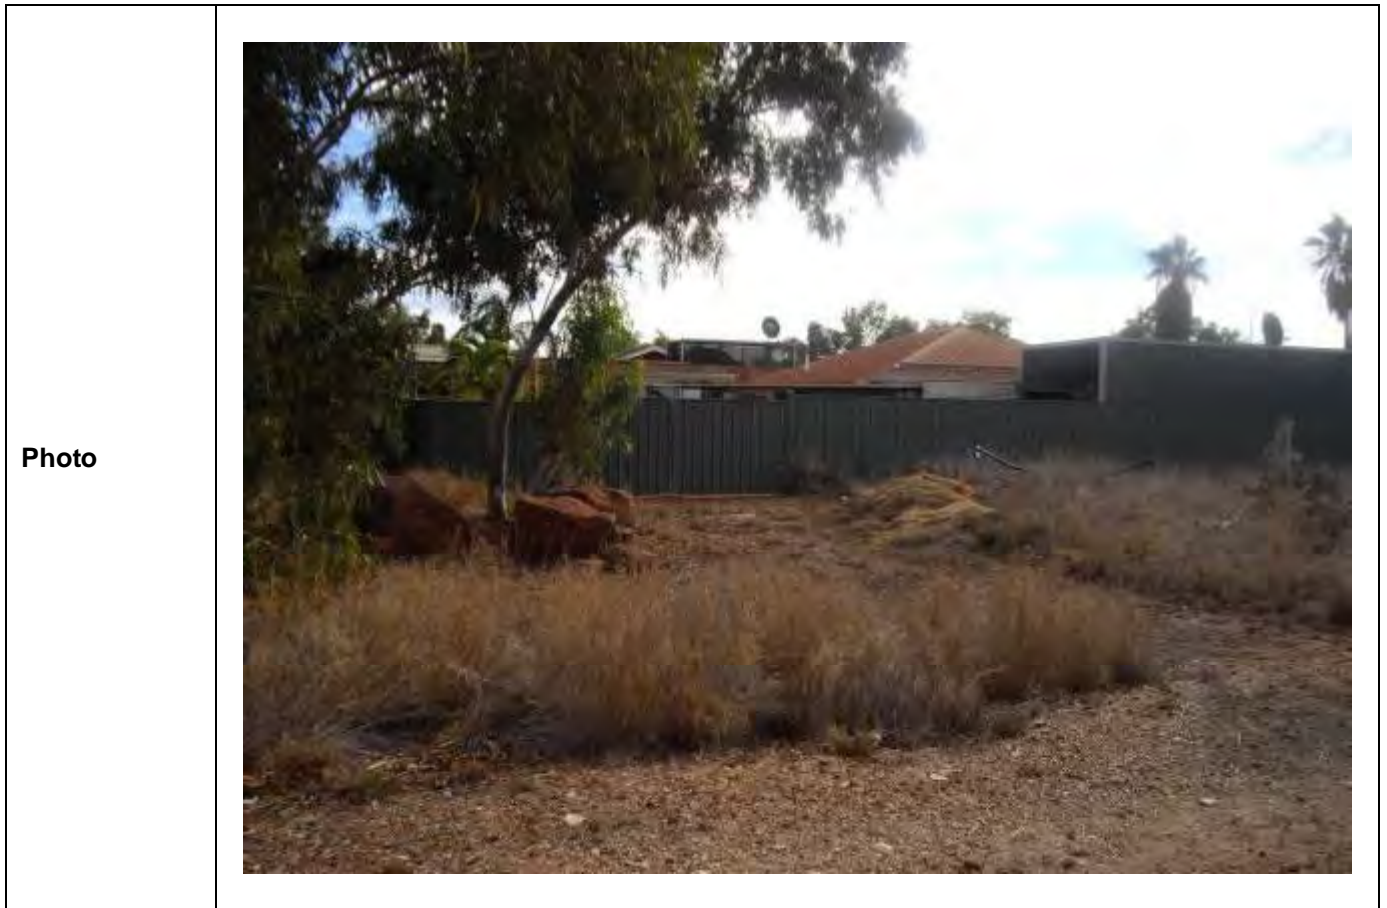
#### 4.12 Lot No. 78 Fortesque Crescent

<b>Category</b>	Encroachment
<b>Type</b>	Side access
<b>Description</b>	Side access follows natural topography
<b>Photo ID</b>	514
<b>Scope of Works</b>	L - Remove side access way

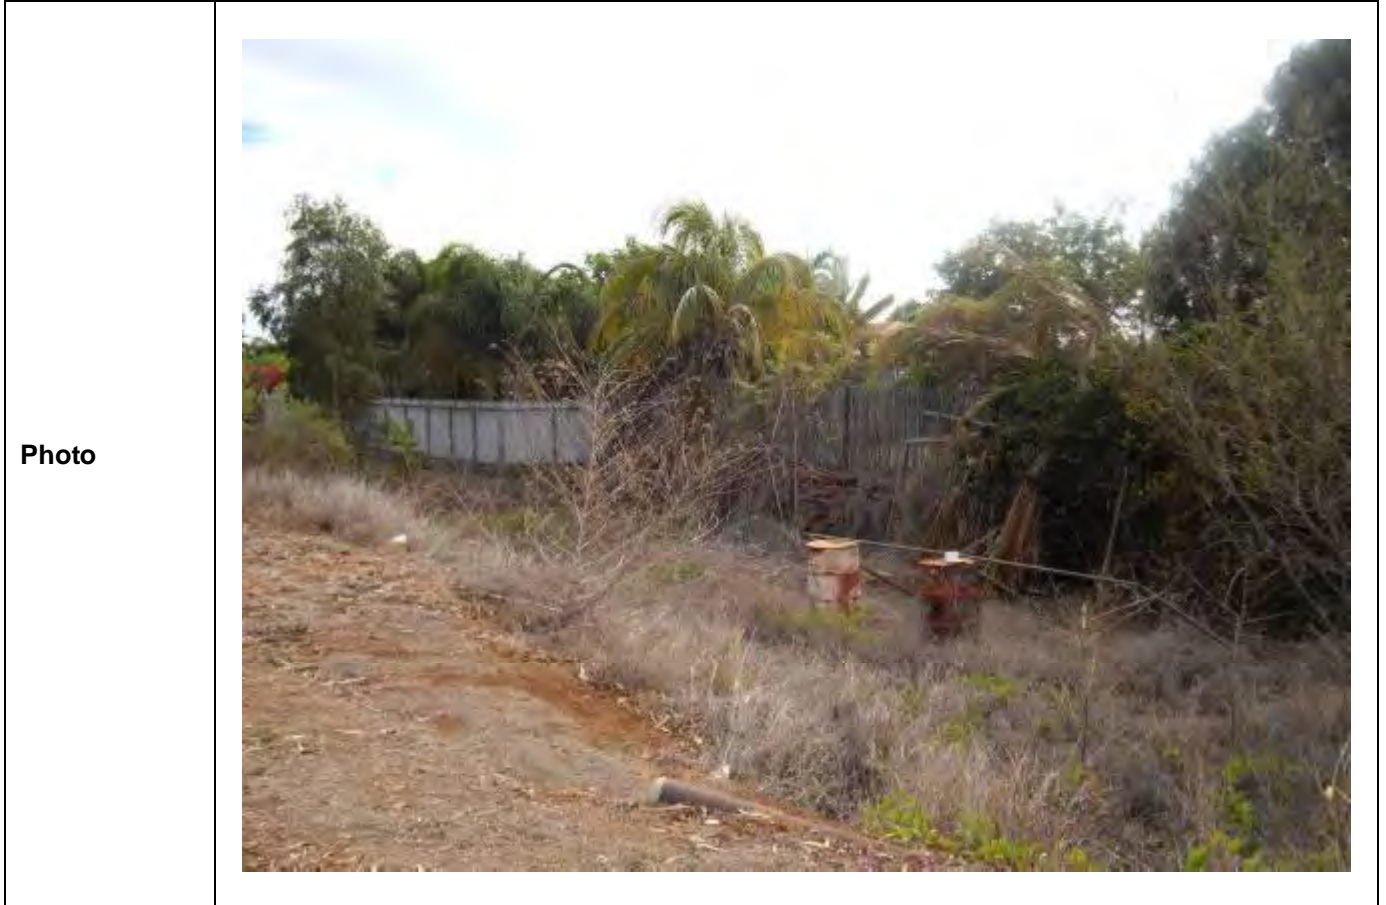
### 5.1 Lot No. 3,079 Berkeley Crescent

<b>Category</b>	Encroachment / Drain Maintenance
<b>Type</b>	General items Vegetation
<b>Description</b>	Rubbish, Barrels Semi dense vegetation
<b>Photo ID</b>	497
<b>Scope of Works</b>	L - Remove rubbish and barrels L - Vegetation is to be slashed to a nominal height of 50 mm above ground with the exception of large, established trees of height in excess of 5 m, which shall remain

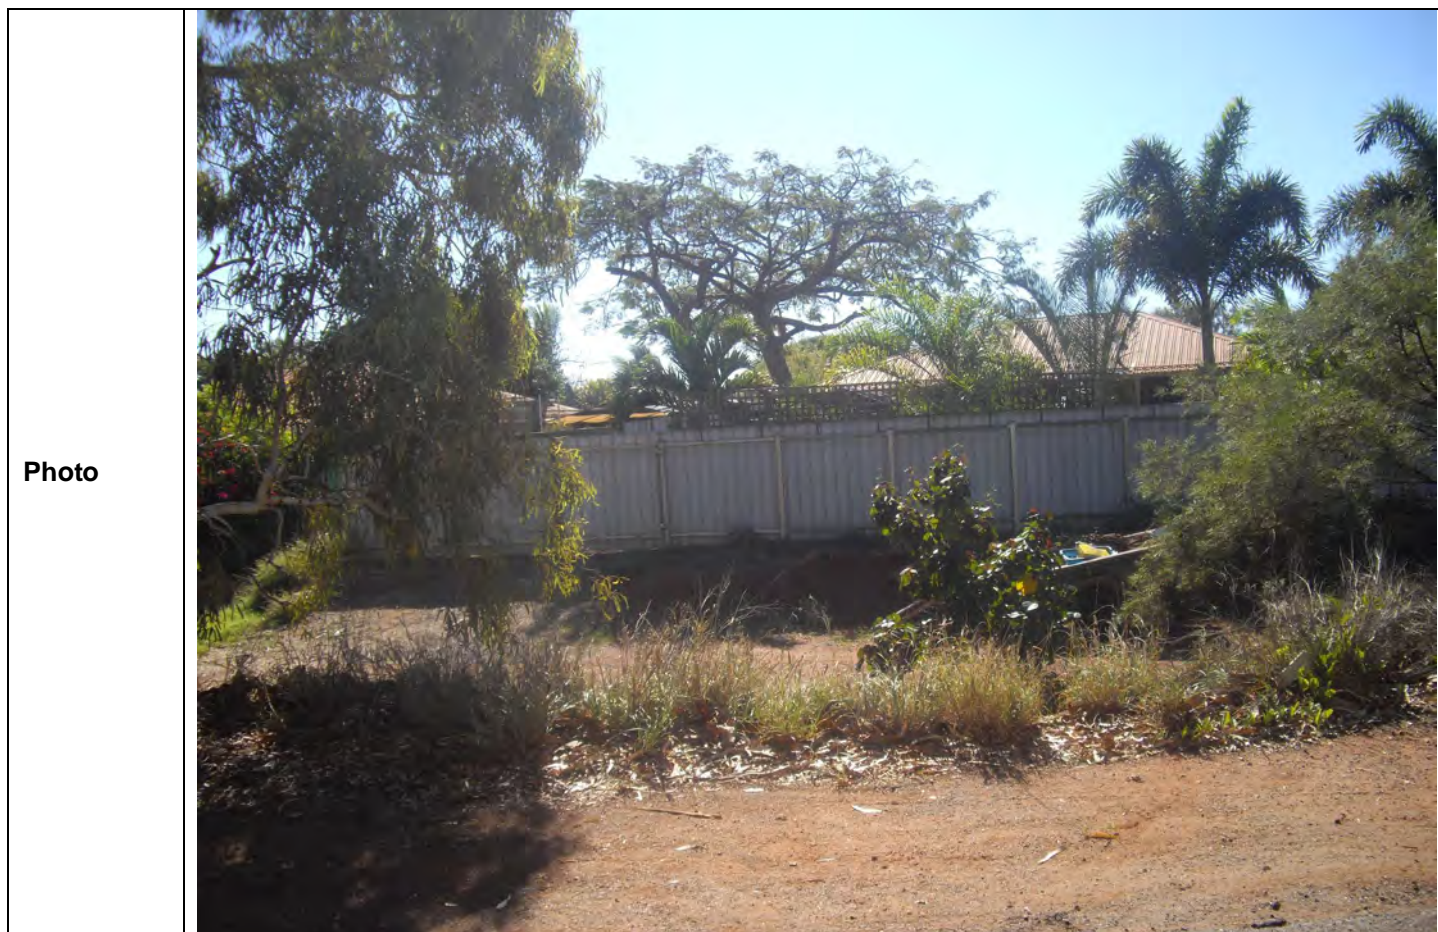
## 5.2 Lot No. 2,079 Berkeley Crescent

<b>Category</b>	Encroachment
<b>Type</b>	Rear access, General items.
<b>Description</b>	Rear access driveway follows natural topography (top of catchment – doesn't affect flow) Boat and trailer within reserve
<b>Photo ID</b>	1041, 498 – boat not within the photo
<b>Scope of Works</b>	L - Remove access driveway L - Remove boat and trailer

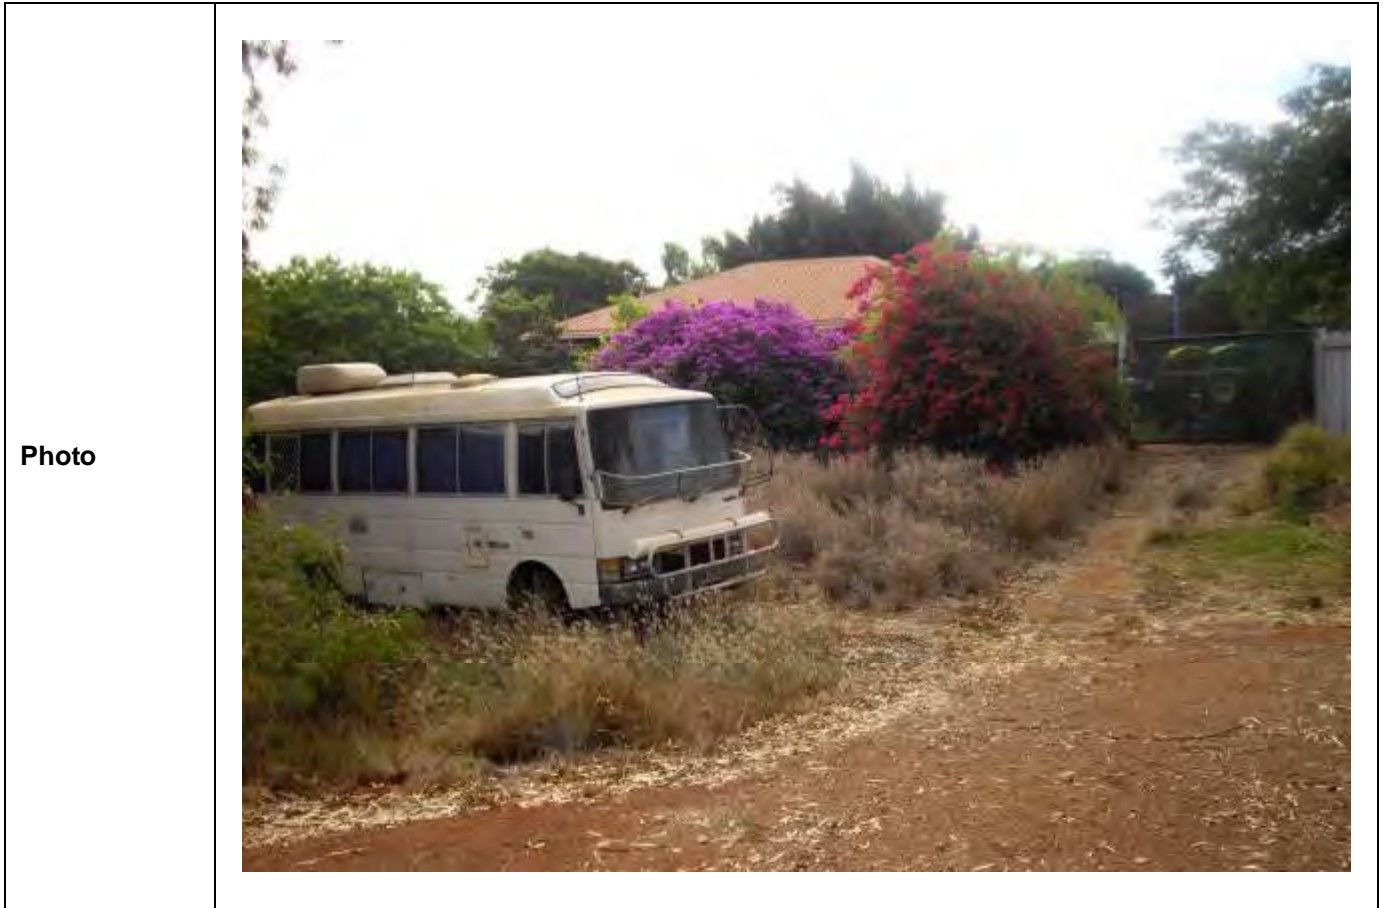
### 5.3 Lot No. 1,079 Berkeley Crescent

<b>Category</b>	Encroachment
<b>Type</b>	Rear access; Vegetation.
<b>Description</b>	Rear access impeding flow Semi-dense vegetation
<b>Photo ID</b>	499
<b>Scope of Works</b>	H - Remove rear access way and reinstate drainage flow path as defined by the natural capacity and invert of channel of downstream lot H - Vegetation is to be slashed to a nominal height of 50 mm above ground with the exception of large, established trees of height in excess of 5 m, which shall remain.

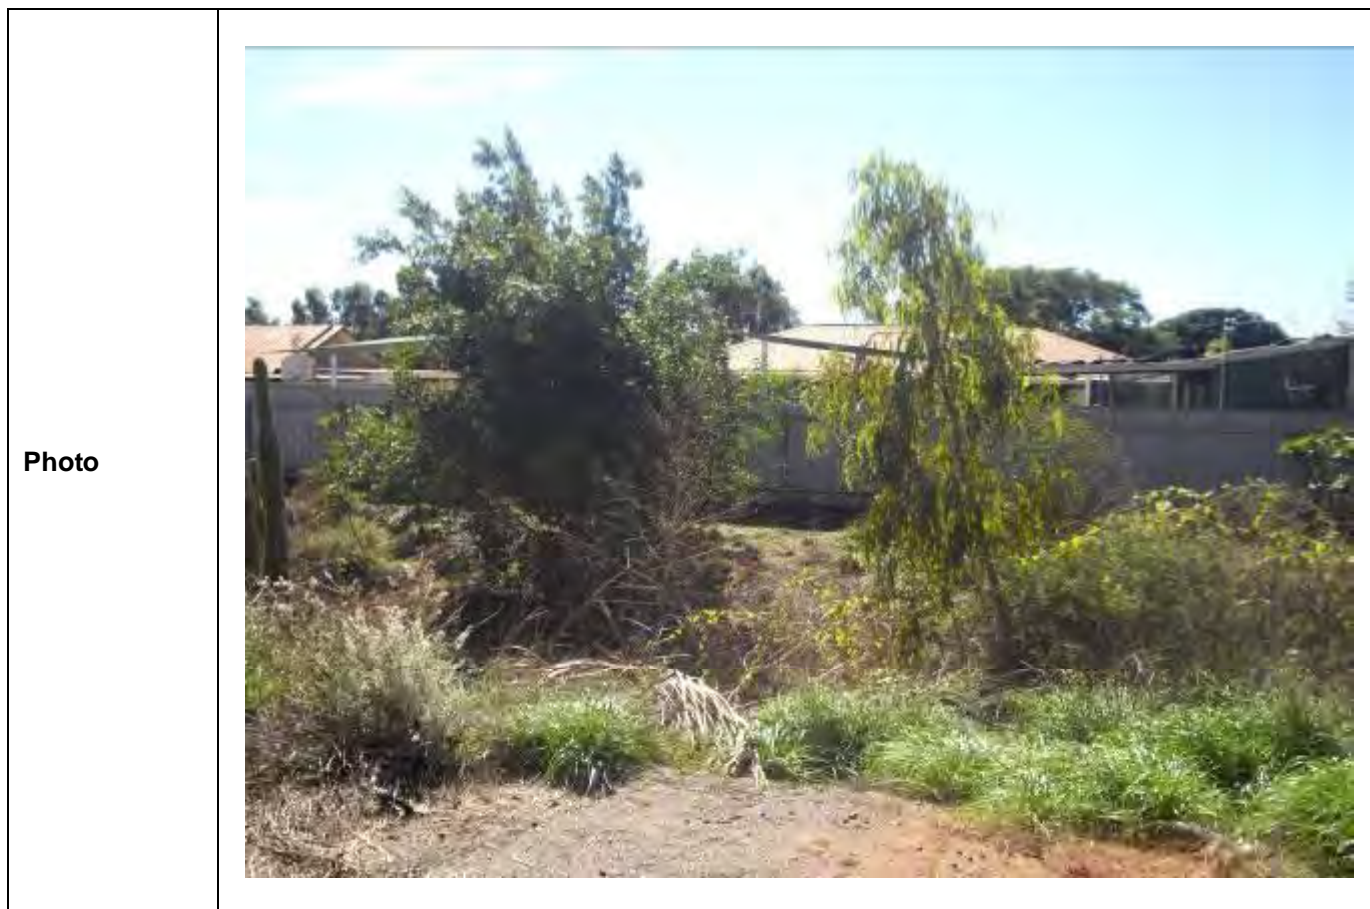
## 5.4 Lot No. 79 Berkeley Crescent

<b>Category</b>	Drain Maintenance
<b>Type</b>	Vegetation Rocks
<b>Description</b>	Unmaintained, semi-dense vegetation Rocks note, but do not impede flow
<b>Photo ID</b>	815
<b>Scope of Works</b>	M - Vegetation is to be slashed to a nominal height of 50 mm above ground with the exception of large, established trees of height in excess of 5 m, which shall remain.

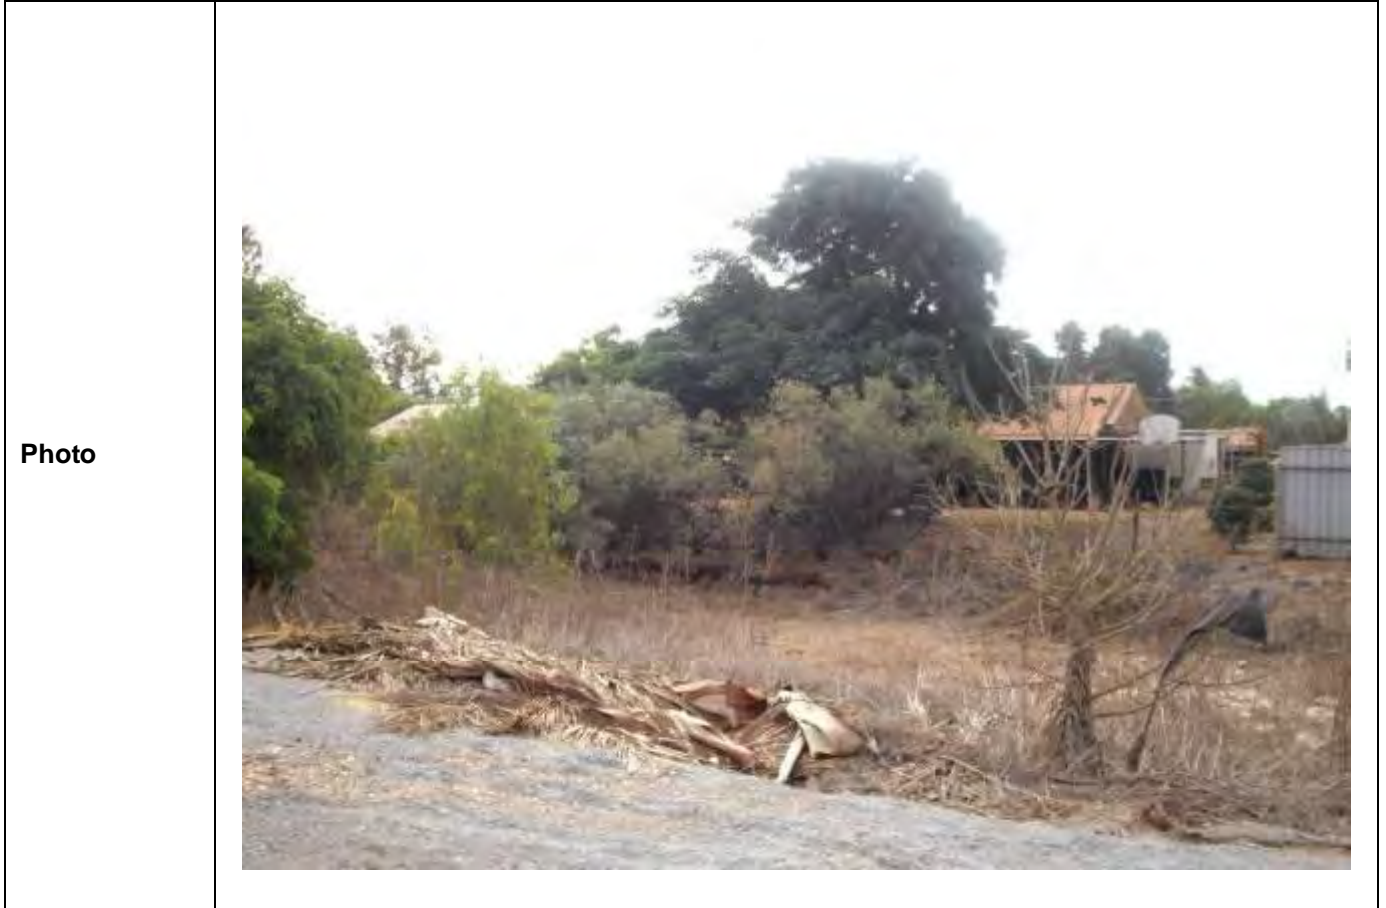
## 5.5 Lot No. 80 Berkeley Crescent

<b>Category</b>	Drain Maintenance
<b>Type</b>	Vegetation
<b>Description</b>	Semi dense vegetation
<b>Photo ID</b>	501
<b>Scope of Works</b>	L - Vegetation is to be slashed to a nominal height of 50 mm above ground with the exception of large, established trees of height in excess of 5 m, which shall remain

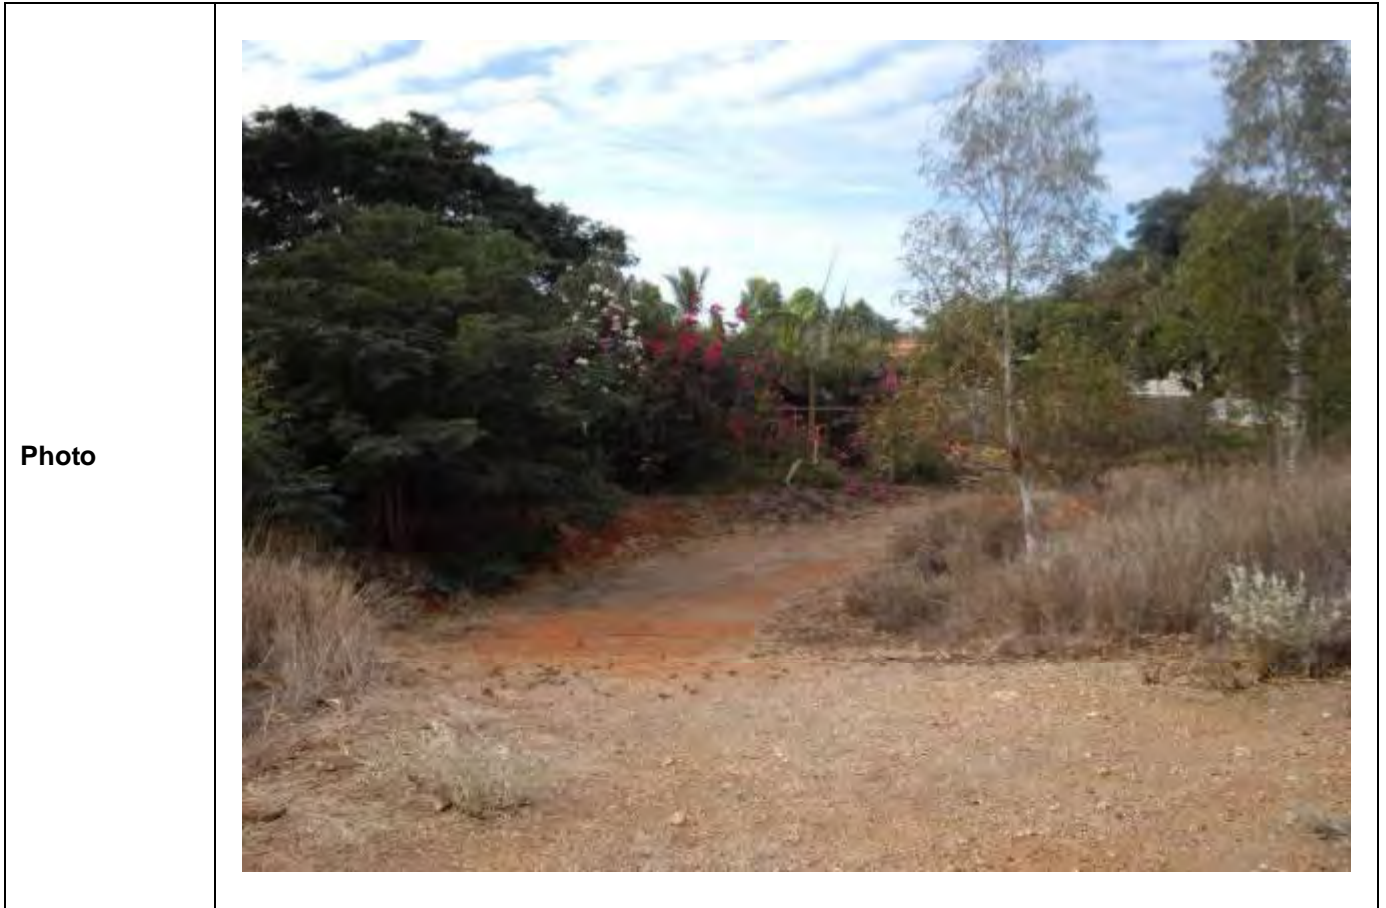
## 5.6 Lot No. 81 Berkeley Crescent

<b>Category</b>	Encroachment / Drain Maintenance
<b>Type</b>	Rear access Vegetation
<b>Description</b>	Extended driveway (stops partway over reserve) follows natural topography – channel defined and adequate Semi-dense vegetation
<b>Photo ID</b>	502
<b>Scope of Works</b>	L - Remove access way M - Vegetation is to be slashed to a nominal height of 50 mm above ground with the exception of large, established trees of height in excess of 5 m, which shall remain.

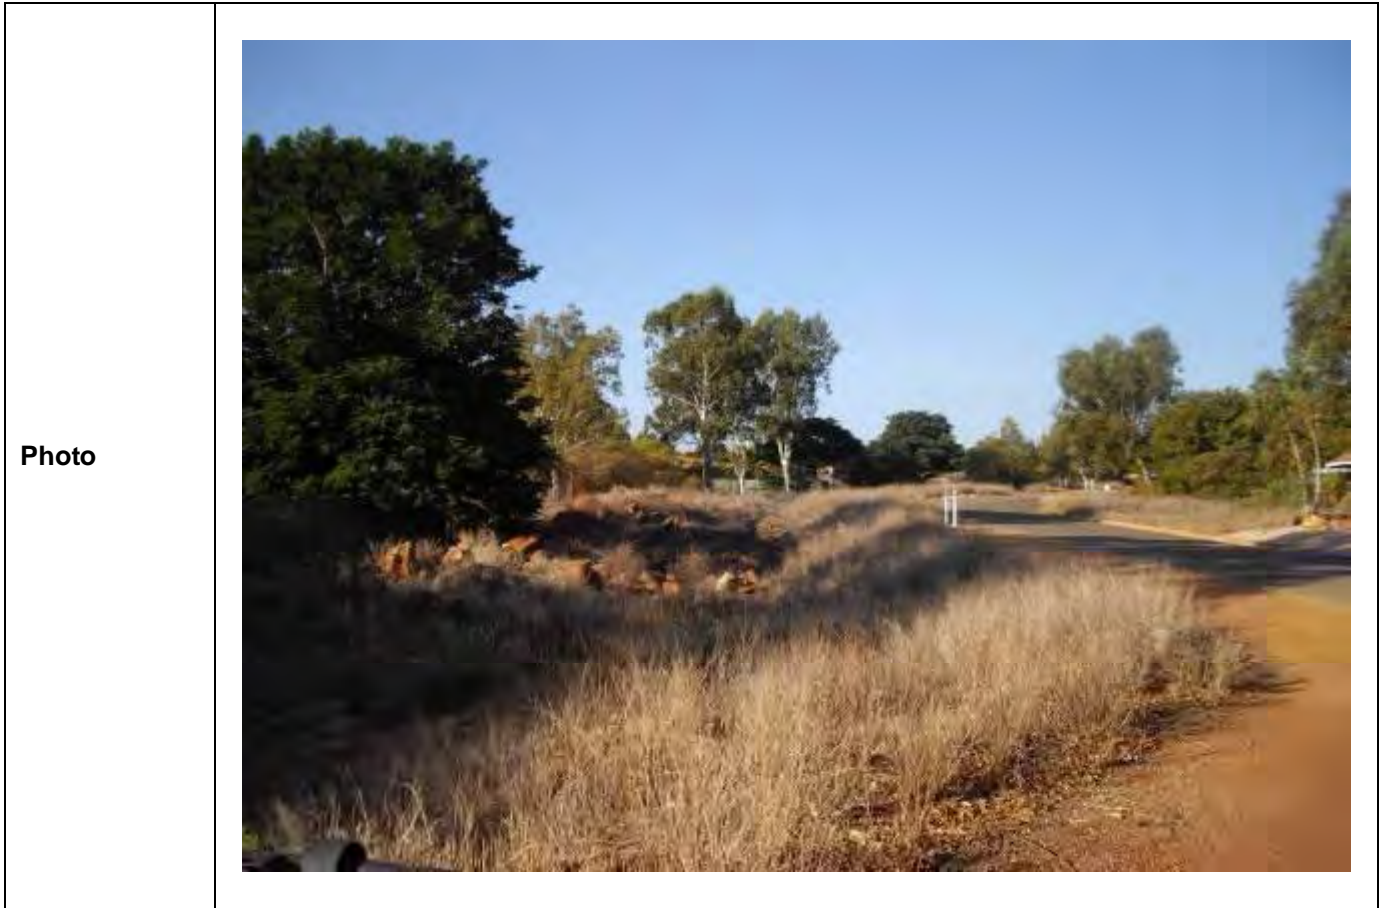
## 5.8 Lot No. 83 Berkeley Crescent

<b>Category</b>	Drain Maintenance
<b>Type</b>	Vegetation
<b>Description</b>	Semi dense vegetation
<b>Photo ID</b>	387
<b>Scope of Works</b>	L - Vegetation is to be slashed to a nominal height of 50 mm above ground with the exception of large, established trees of height in excess of 5 m, which shall remain

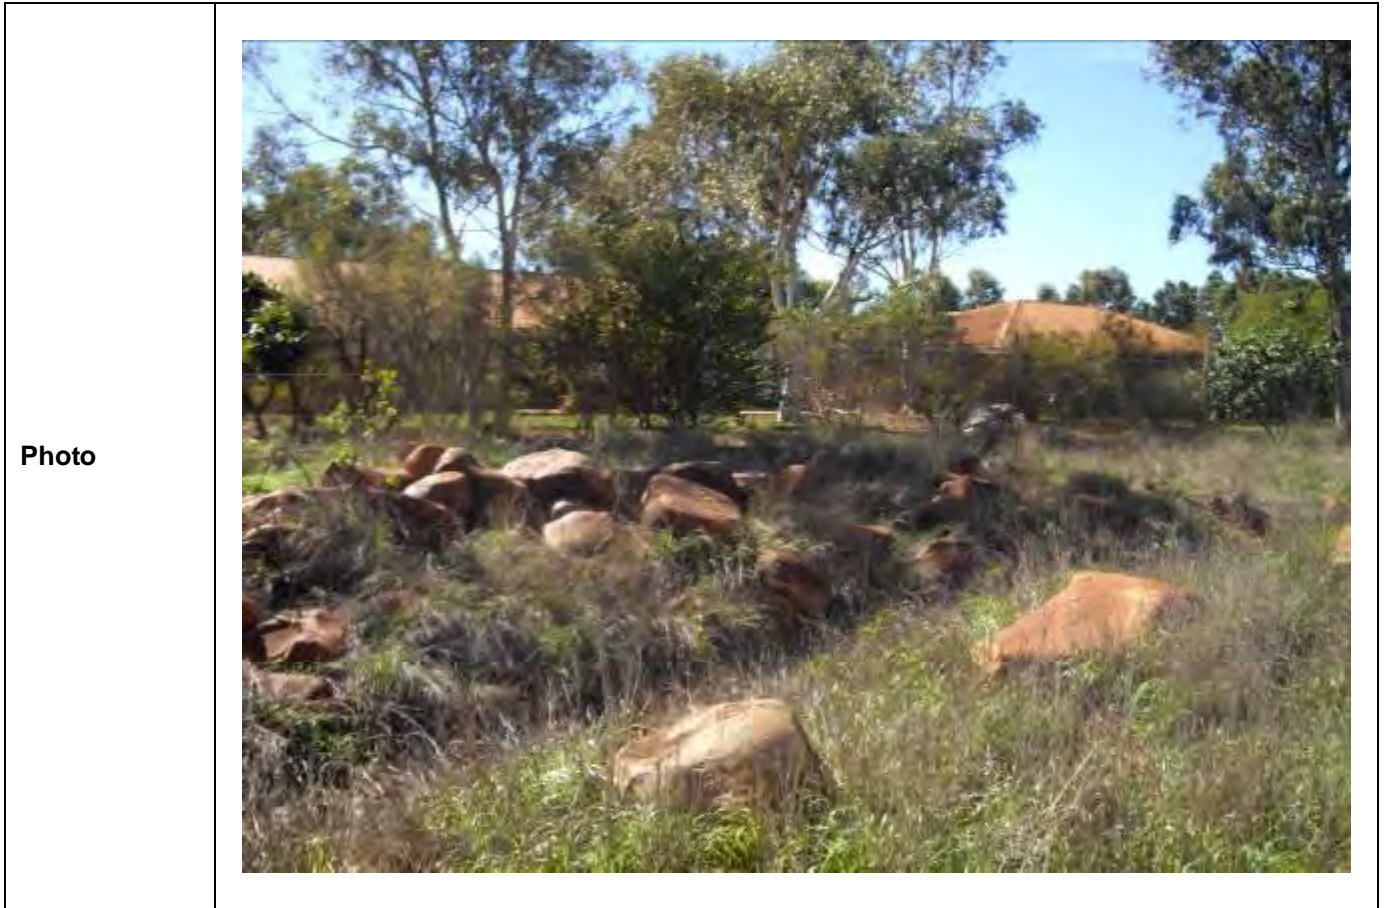
## 5.9 Lot No. 84 Berkeley Crescent

<b>Category</b>	Drain Maintenance
<b>Type</b>	Vegetation
<b>Description</b>	Semi dense vegetation Rocks present, but flow adequate
<b>Photo ID</b>	816
<b>Scope of Works</b>	L - Vegetation is to be slashed to a nominal height of 50 mm above ground with the exception of large, established trees of height in excess of 5 m, which shall remain

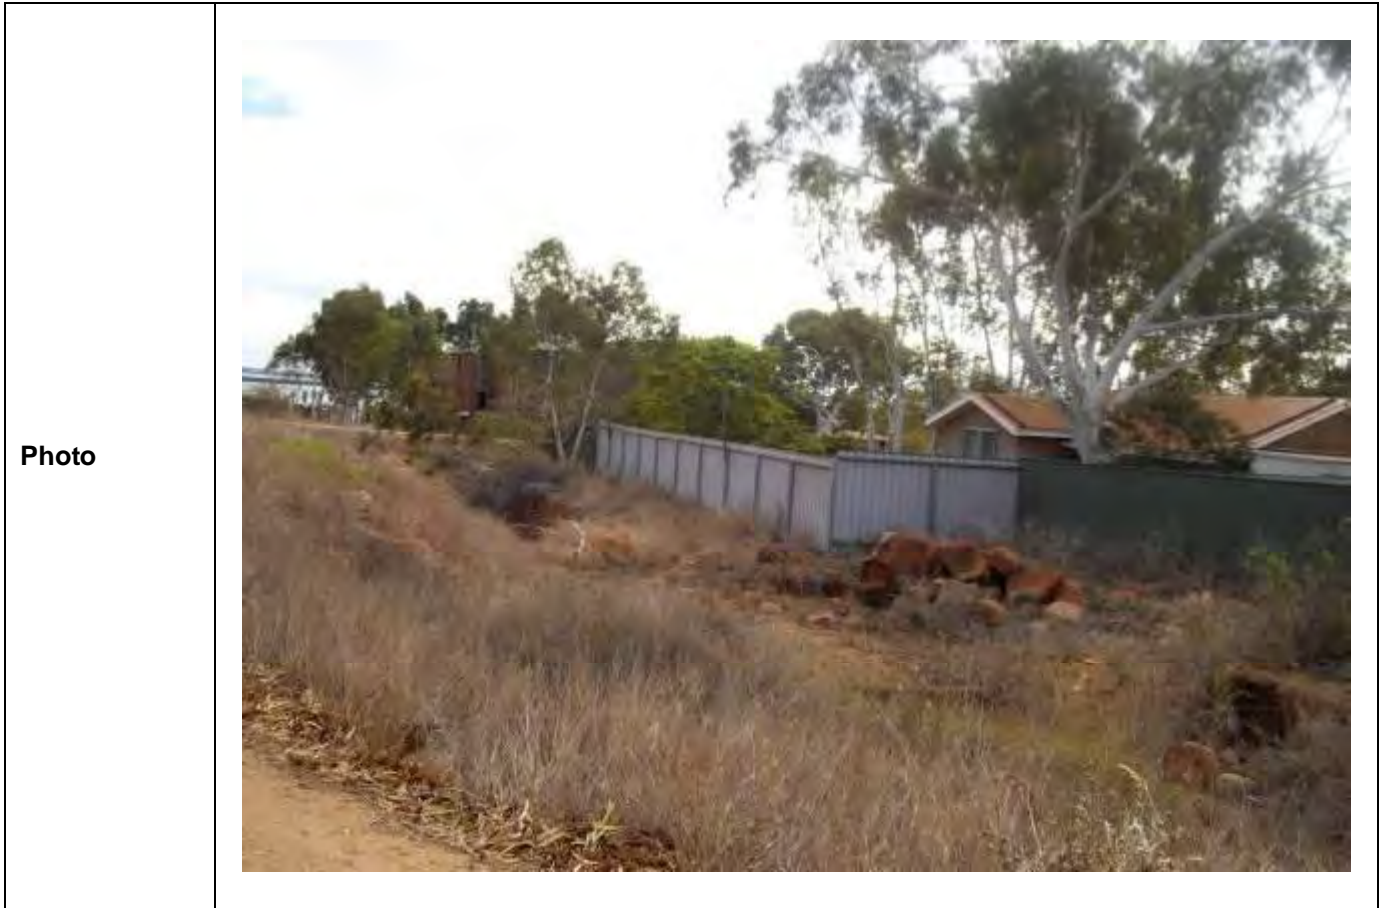
### 5.11 Lot No. 86 Berkeley Crescent

<b>Category</b>	Encroachment
<b>Type</b>	Boundary extension
<b>Description</b>	Retaining wall within drainage reserve. Slightly reducing the cross sectional capacity but also structurally required to 'retain' the raised lot. Flow path adequate
<b>Photo ID</b>	505
<b>Scope of Works</b>	L – Remove retaining wall and reinstate the property boundary.

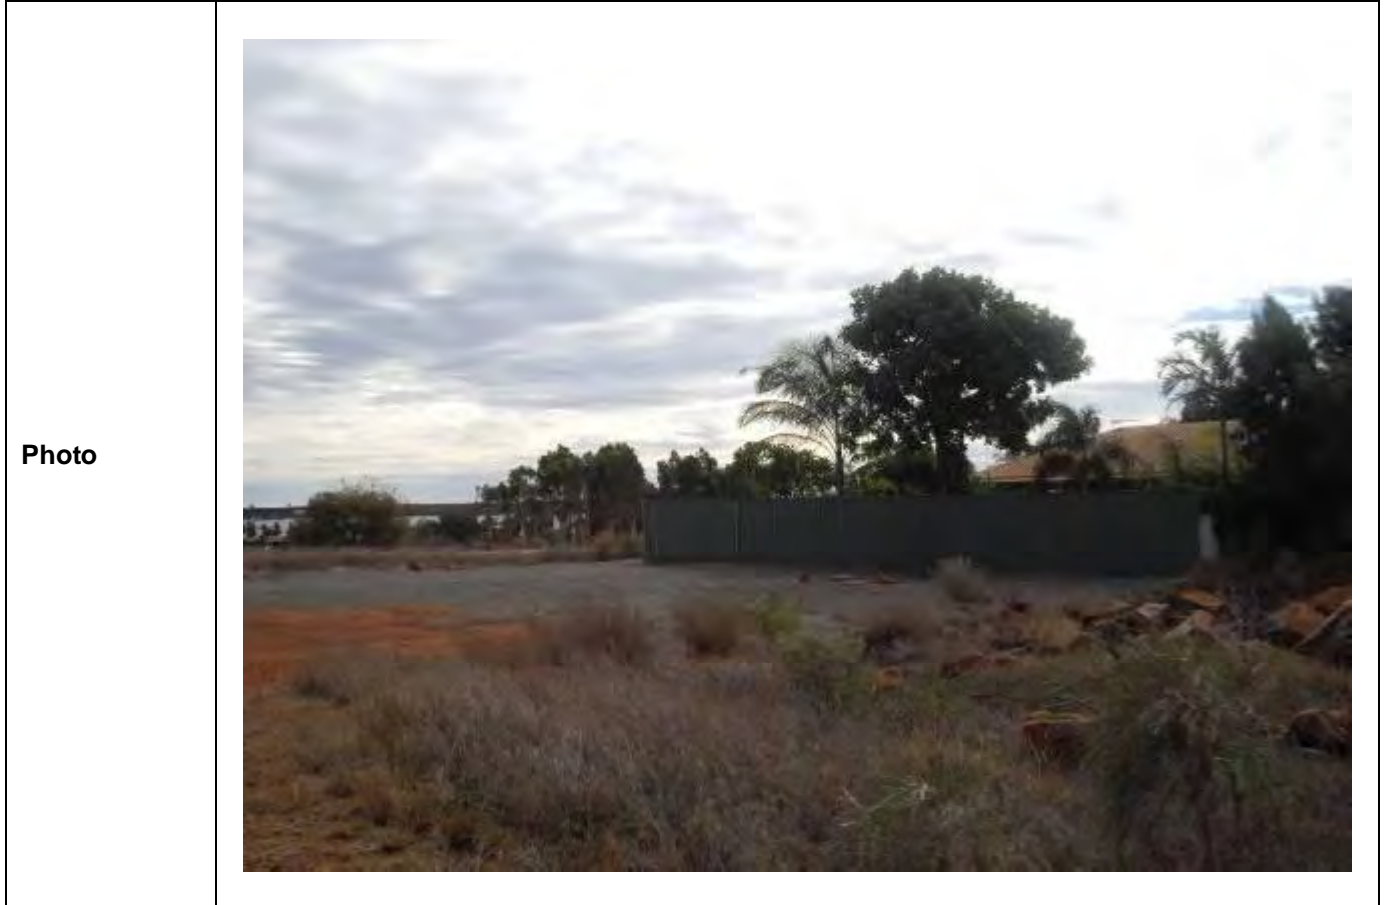
## 6.1 Lot No. 2,087 Wooramel Crescent

<b>Category</b>	Encroachment
<b>Type</b>	Rear access
<b>Description</b>	Filled rear access driveway may not be interfering with drainage - specify intended path. Drainage flow path not clear. Flow West will meet with trunk 'South to North' drainage or flow East then North through drainage reserve then culvert will direct flow under Wooramel Crescent.
<b>Photo ID</b>	488
<b>Scope of Works</b>	L - Remove rear access way and reinstate drainage flow path as defined by the natural capacity and invert of channel of downstream

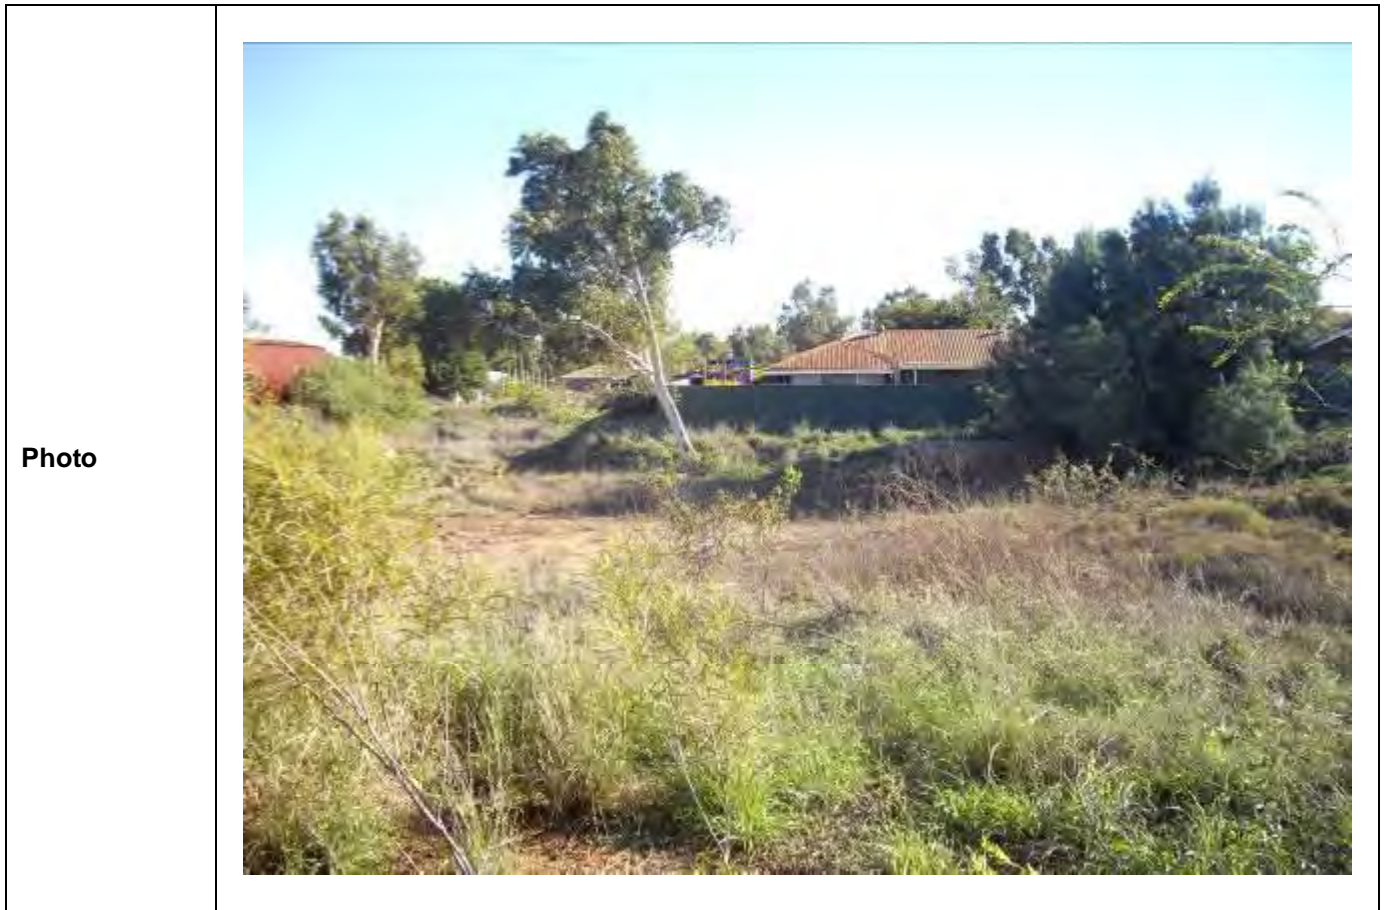
### 6.3 Lot No. 87 Wooramel Crescent

<b>Category</b>	None
<b>Type</b>	None
<b>Description</b>	Natural drainage path evident and adequate
<b>Photo ID</b>	821
<b>Scope of Works</b>	None required.

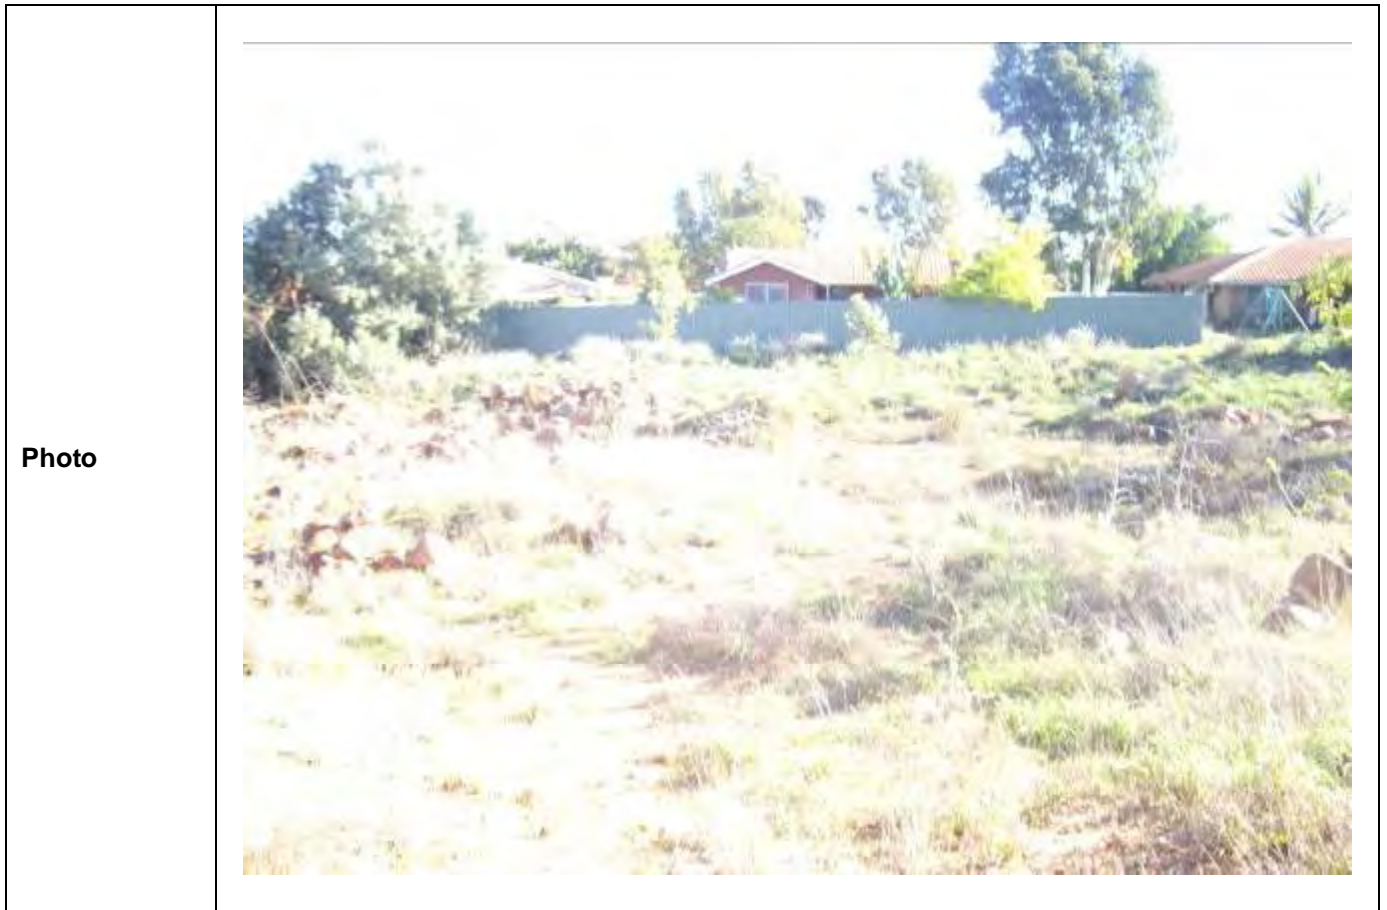
## 6.4 Lot No. 88 Wooramel Crescent

<b>Category</b>	None
<b>Type</b>	None
<b>Description</b>	Natural drainage path evident and adequate
<b>Photo ID</b>	820
<b>Scope of Works</b>	None required
