City of Karratha  
Dampier Stormwater Management Study  
Report  
Part B  
June 2015

## Appendix **C** – 2010 encroachment reviews

**Rio Tinto Iron Ore**  
Report on Dampier Drainage  
Review  
Block 1 Encroachments  
June 2010

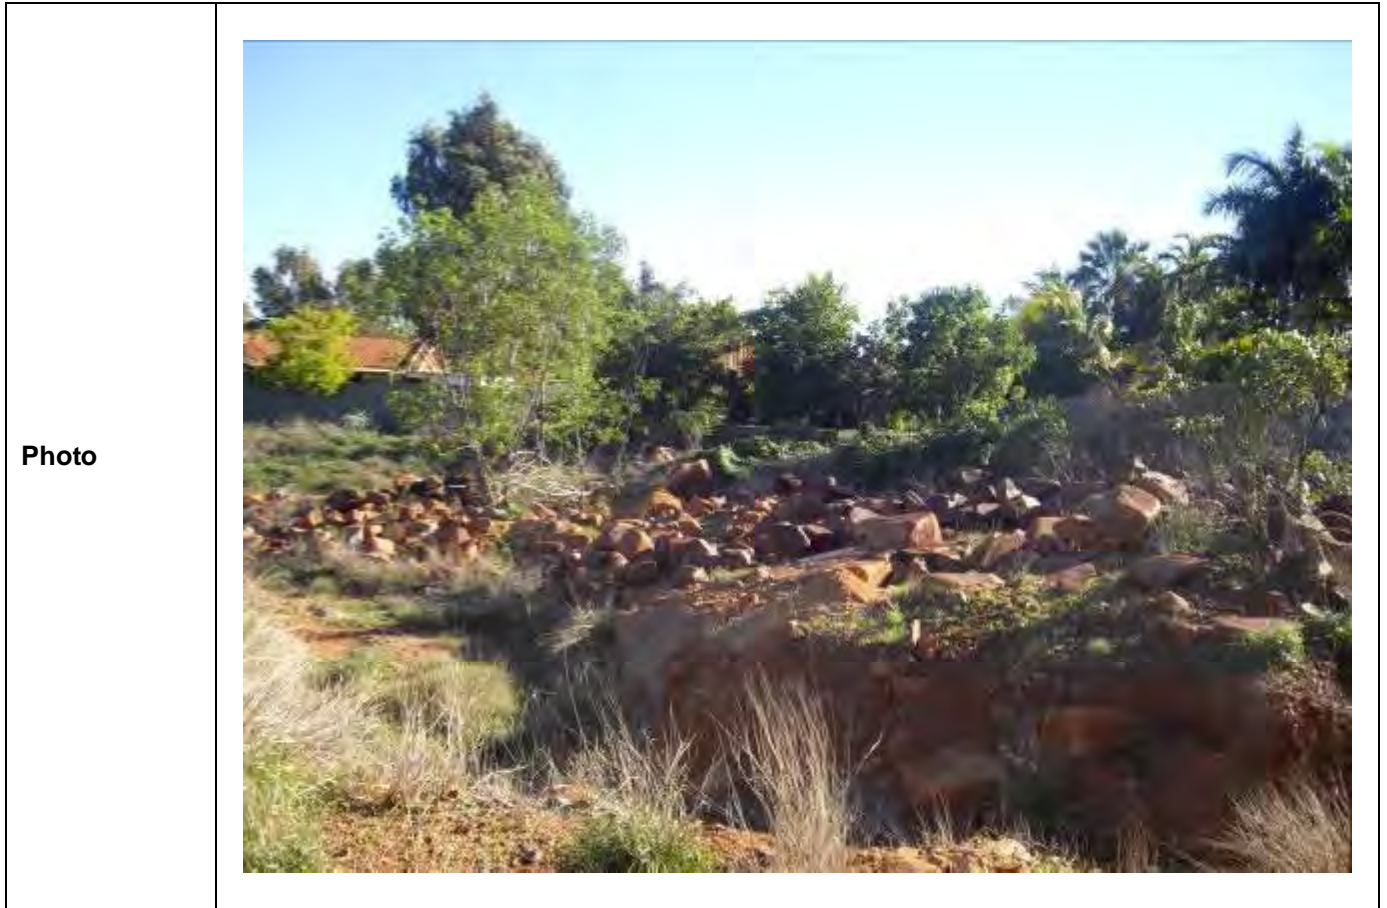
## 6.5 Lot No. 89 Wooramel Crescent

<b>Category</b>	Drain Maintenance
<b>Type</b>	Flow path
<b>Description</b>	Small channel constructed to improve flow - adequate
<b>Photo ID</b>	819
<b>Scope of Works</b>	None required.

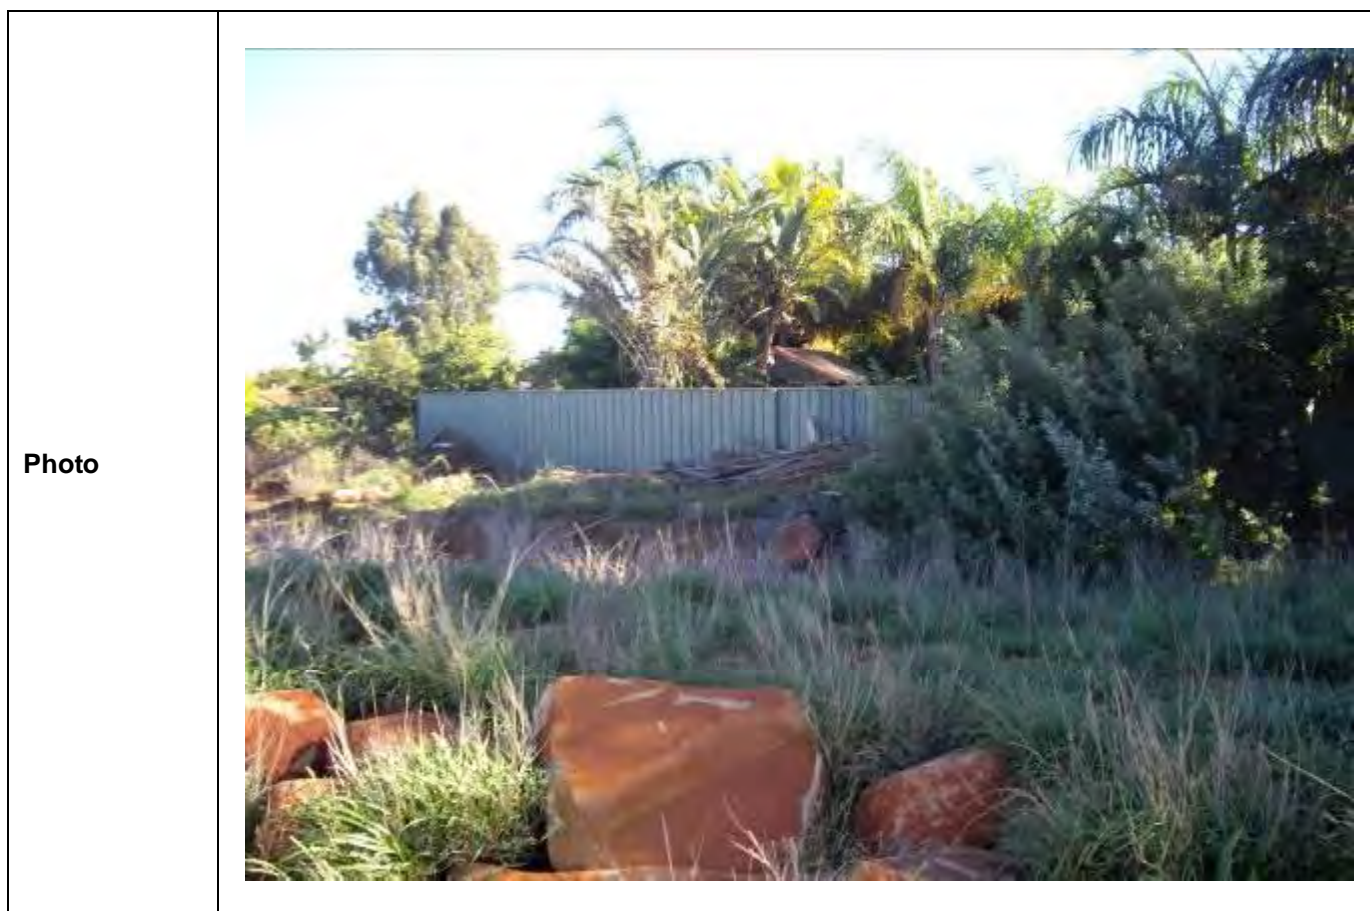
## 6.6 Lot No. 90 Wooramel Crescent

<b>Category</b>	Drain Maintenance
<b>Type</b>	Vegetation
<b>Description</b>	Semi dense vegetation Small channel defines flow path - adequate
<b>Photo ID</b>	822
<b>Scope of Works</b>	L - Vegetation is to be slashed to a nominal height of 50 mm above ground with the exception of large, established trees of height in excess of 5 m, which shall remain

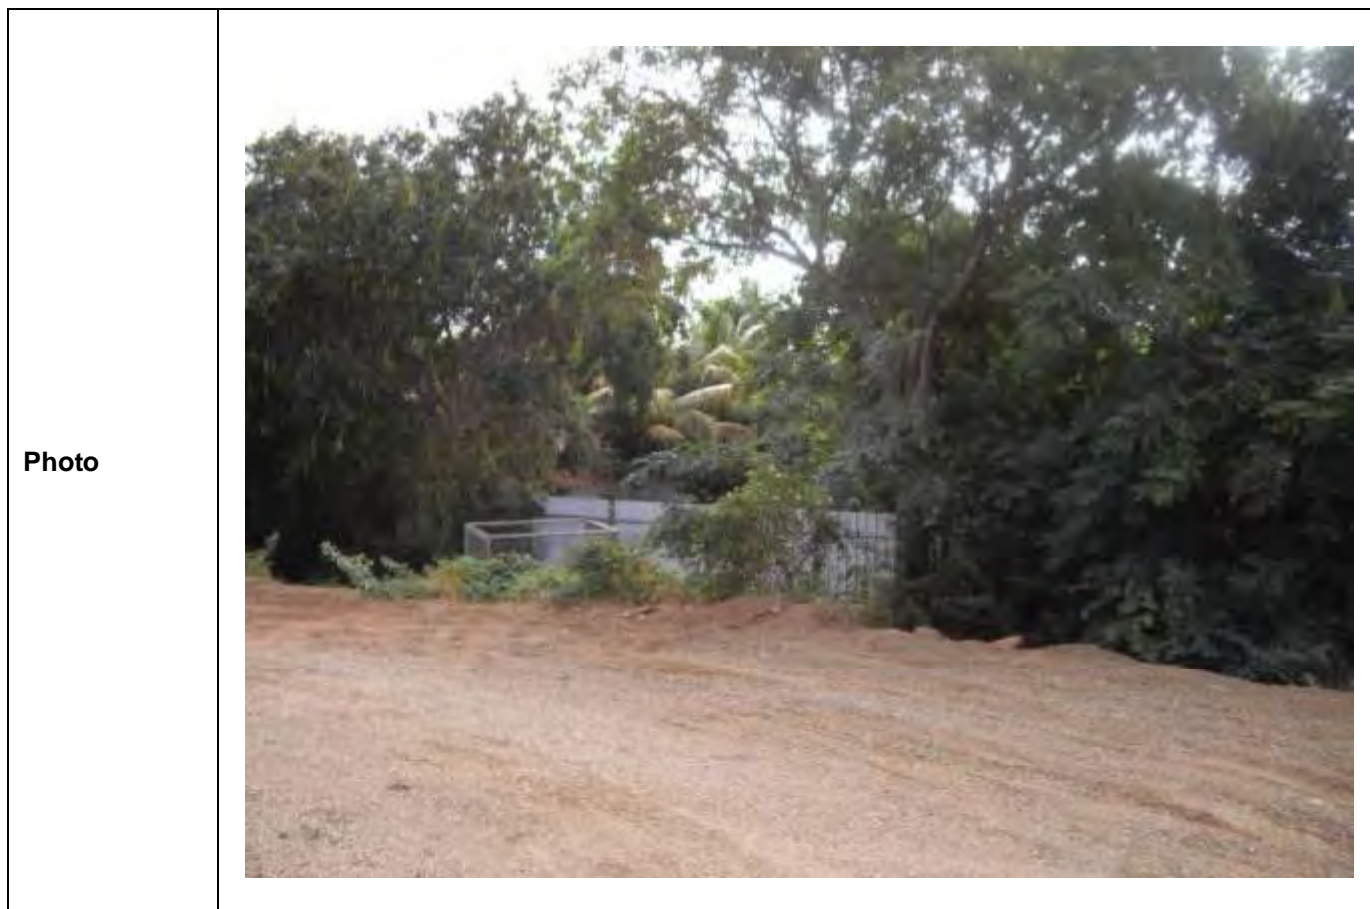
## 6.7 Lot No. 91 Wooramel Crescent

Note: Lots 91 - 95 impede upstream flow that is received from upstream lots Crescent. A define flow path is required along these lots that matches into the natural channel capacity and invert of lot 92.

<b>Category</b>	Encroachment
<b>Type</b>	Rear access
<b>Description</b>	Rear access and parking area impeding flow.
<b>Photo ID</b>	486
<b>Scope of Works</b>	H - Remove rear access way and reinstate drainage flow path as defined by the natural capacity and invert of channel of downstream lot

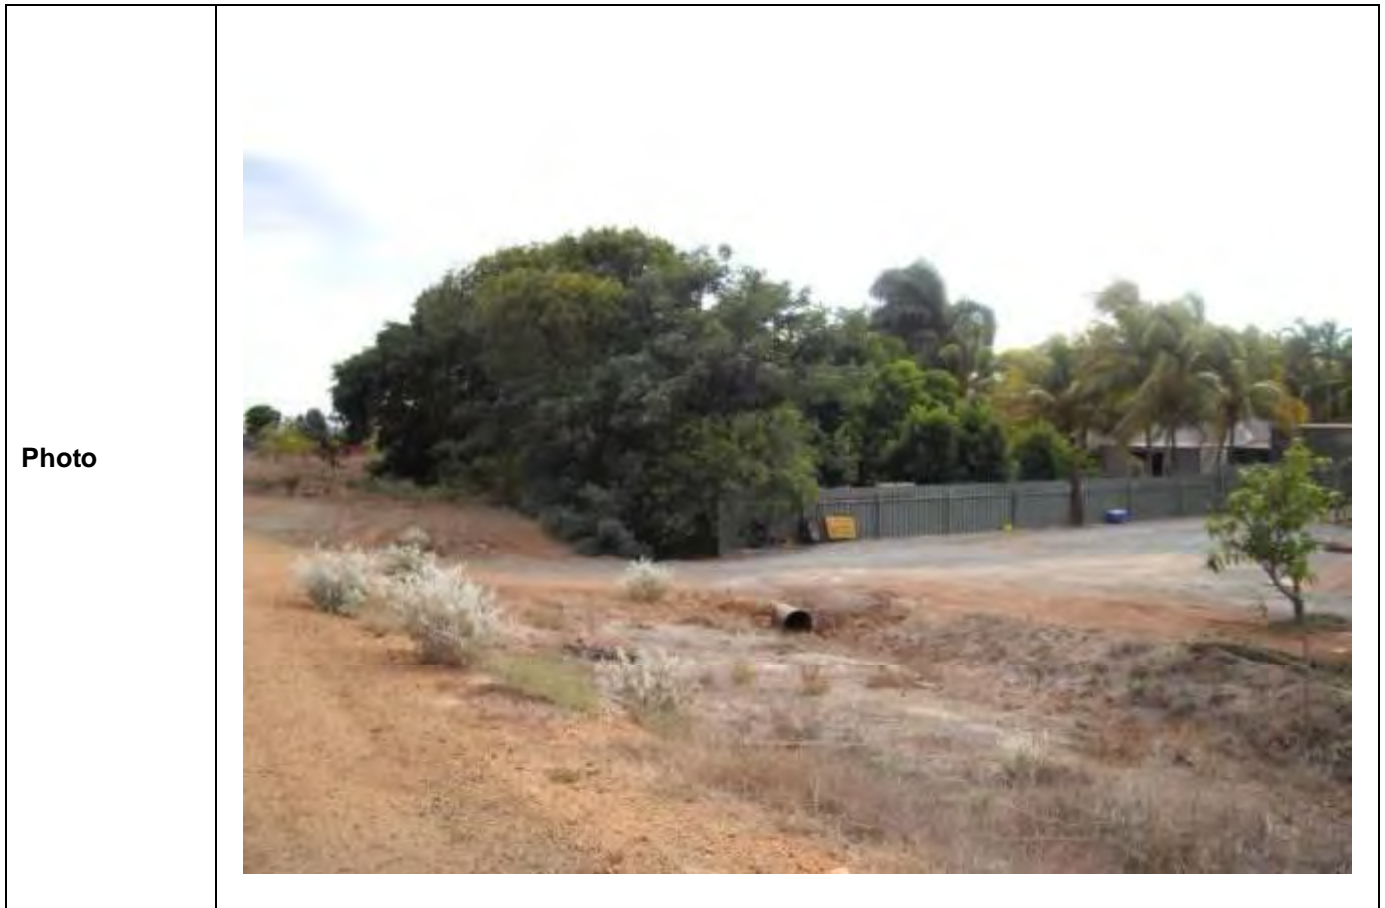
## 6.8 Lot No. 92 Wooramel Crescent

<b>Category</b>	Encroachment
<b>Type</b>	Rear access
<b>Description</b>	Rear access with culvert
<b>Photo ID</b>	485
<b>Scope of Works</b>	H - Remove rear access way and reinstate drainage flow path as defined by the natural capacity and invert of channel of downstream lot

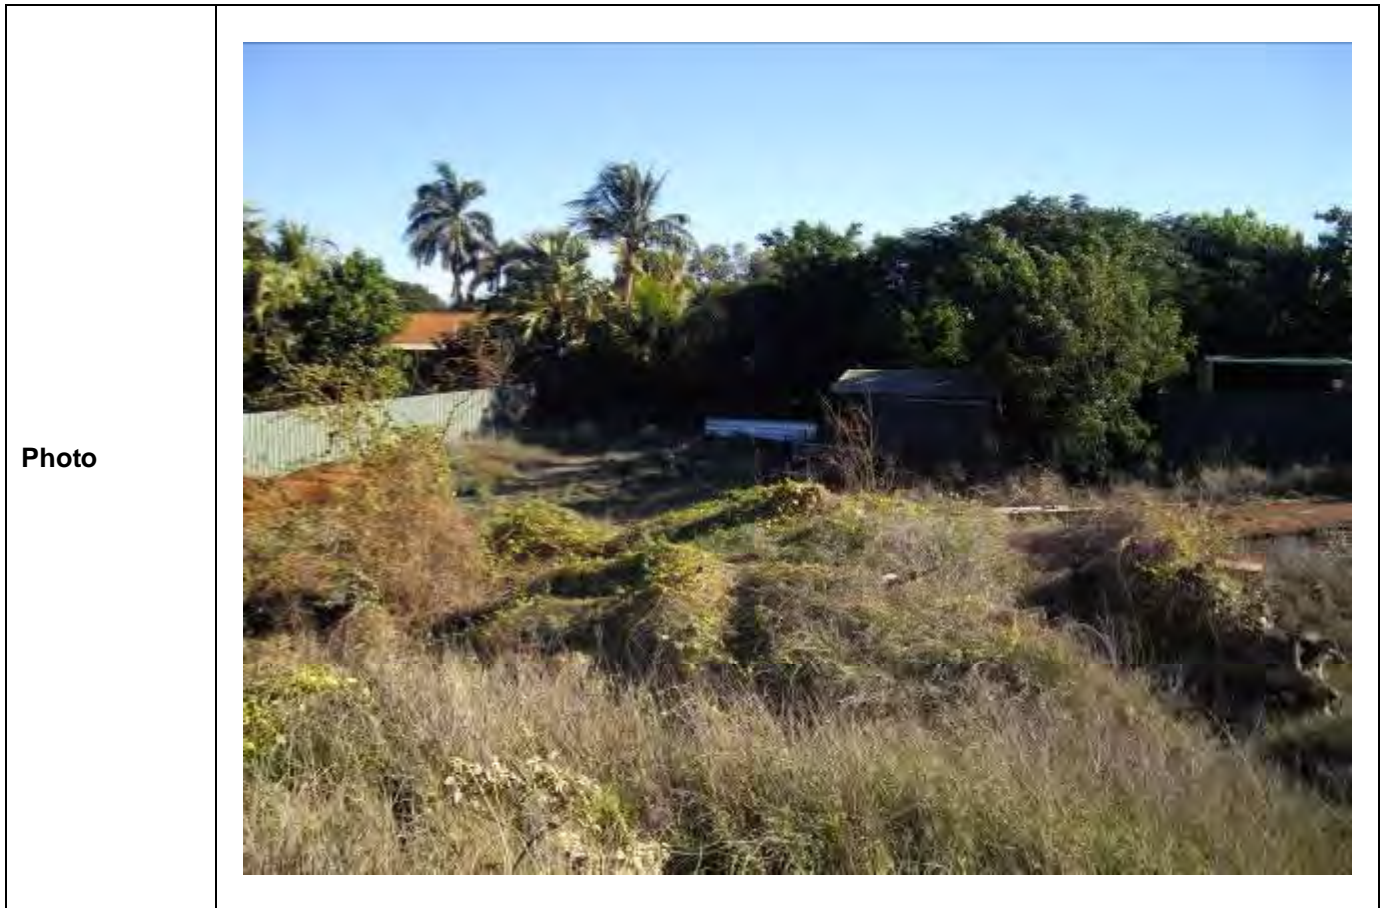
## 6.9 Lot No. 93 Wooramel Crescent

<b>Category</b>	Drain Maintenance / Encroachment
<b>Type</b>	Vegetation Rear access driveway
<b>Description</b>	Highly modified drain. Rear access follows the natural topography
<b>Photo ID</b>	818
<b>Scope of Works</b>	M - Vegetation is to be slashed to a nominal height of 50 mm above ground with the exception of large, established trees of height in excess of 5 m, which shall remain H - Remove rear access way and reinstate drainage flow path as defined by the natural capacity and invert of channel of downstream lot

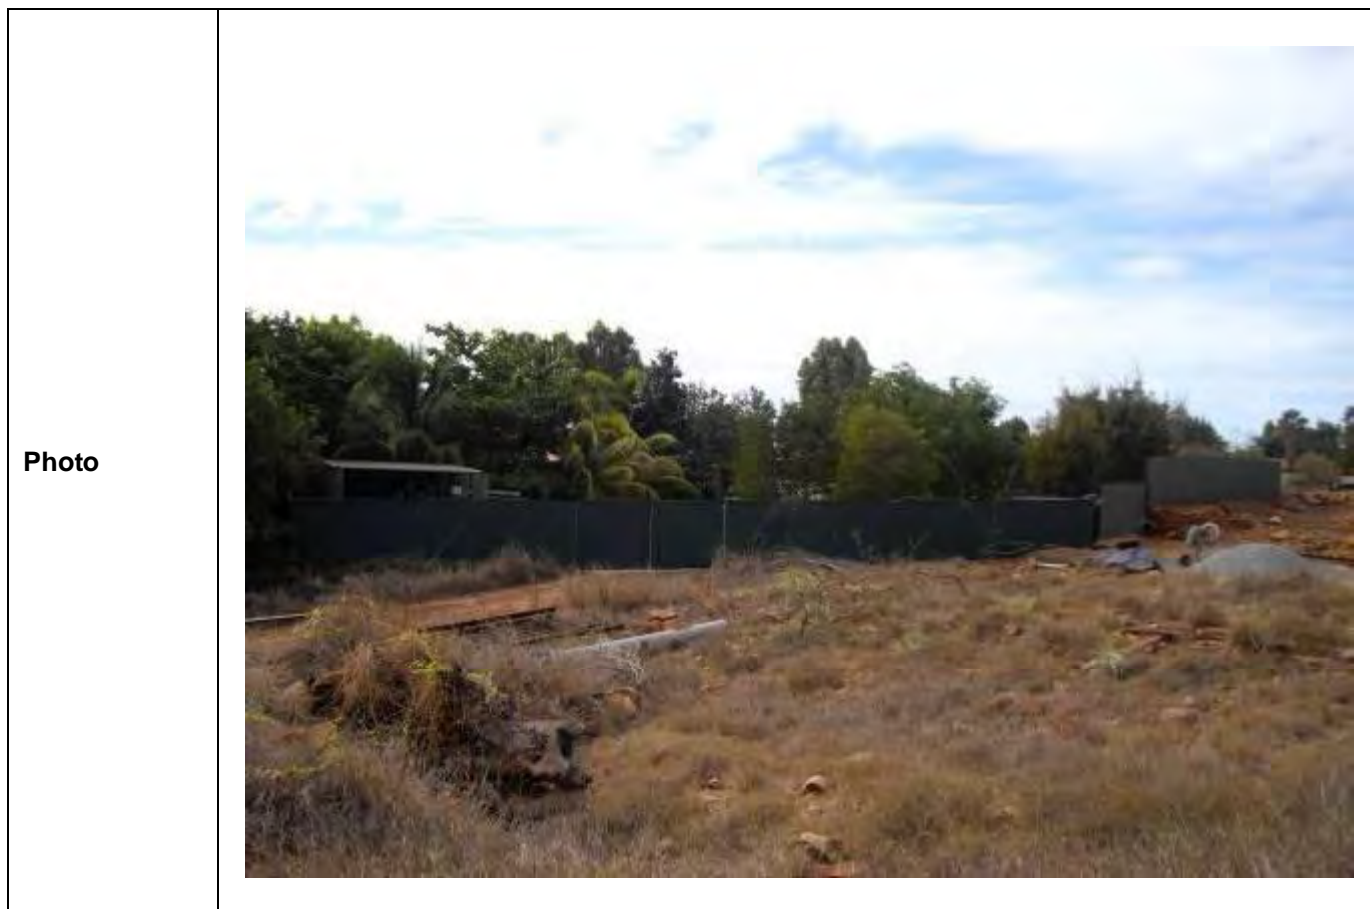
### 6.10 Lot No. 94 Wooramel Crescent

<b>Category</b>	Encroachment / Drain Management
<b>Type</b>	Rear access General items Vegetation
<b>Description</b>	Rear access follows natural topography Building material
<b>Photo ID</b>	484
<b>Scope of Works</b>	L - Remove rear access way and reinstate drainage flow path as defined by the natural capacity and invert of channel of downstream lot L - Remove building materials L - Vegetation is to be slashed to a nominal height of 50 mm above ground with the exception of large, established trees of height in excess of 5 m, which shall remain

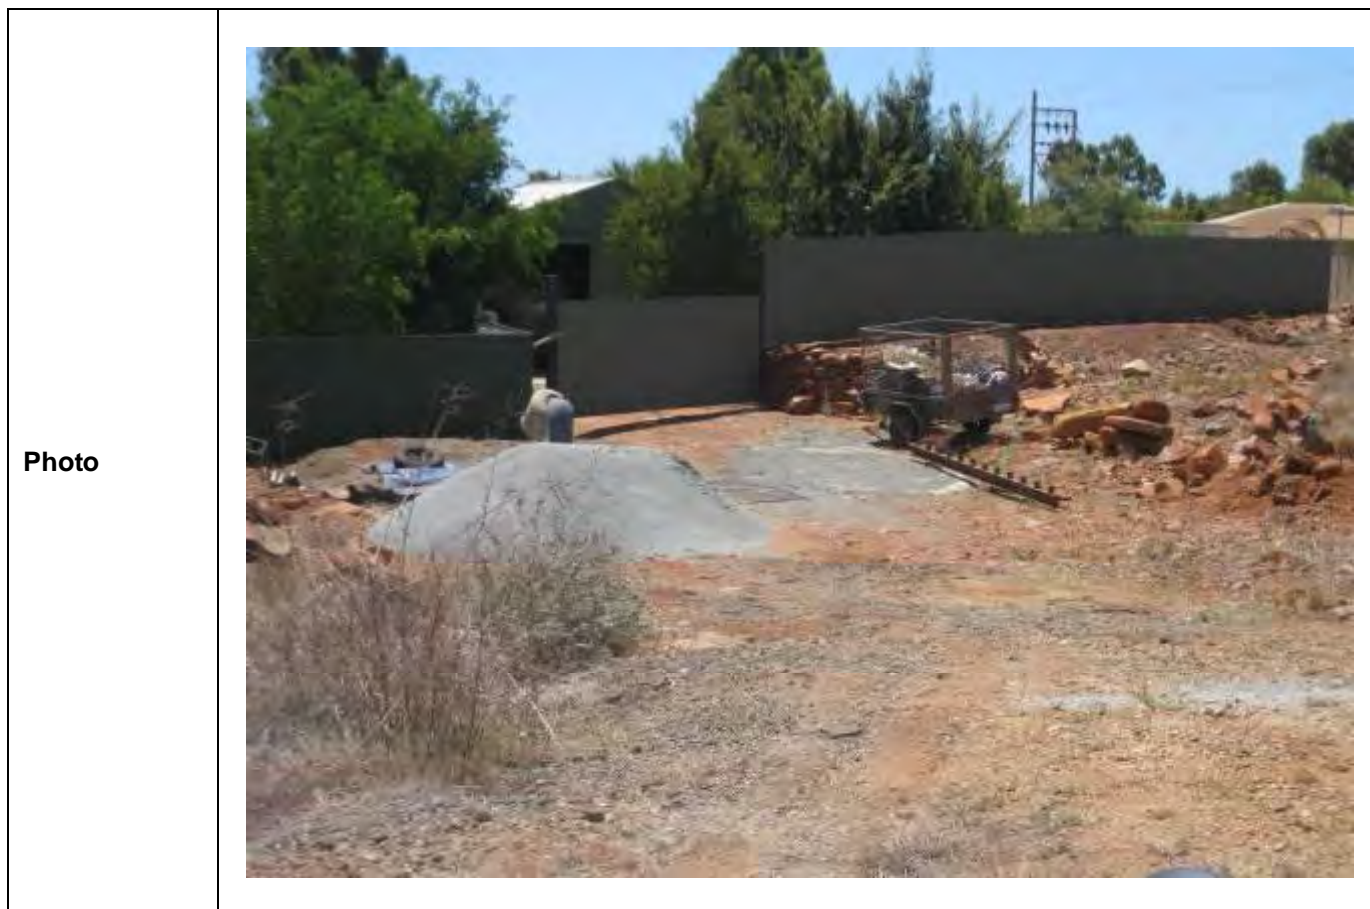
**6.11 Lot No. 95 Wooramel Crescent**

<b>Category</b>	Encroachment
<b>Type</b>	Rear access Modified reserve
<b>Description</b>	Rear access driveway Blue metal pile
<b>Photo ID</b>	7325
<b>Scope of Works</b>	L - Remove rear access way and reinstate drainage flow path as defined by the natural capacity and invert of channel of downstream lot L - Remove blue metal pile

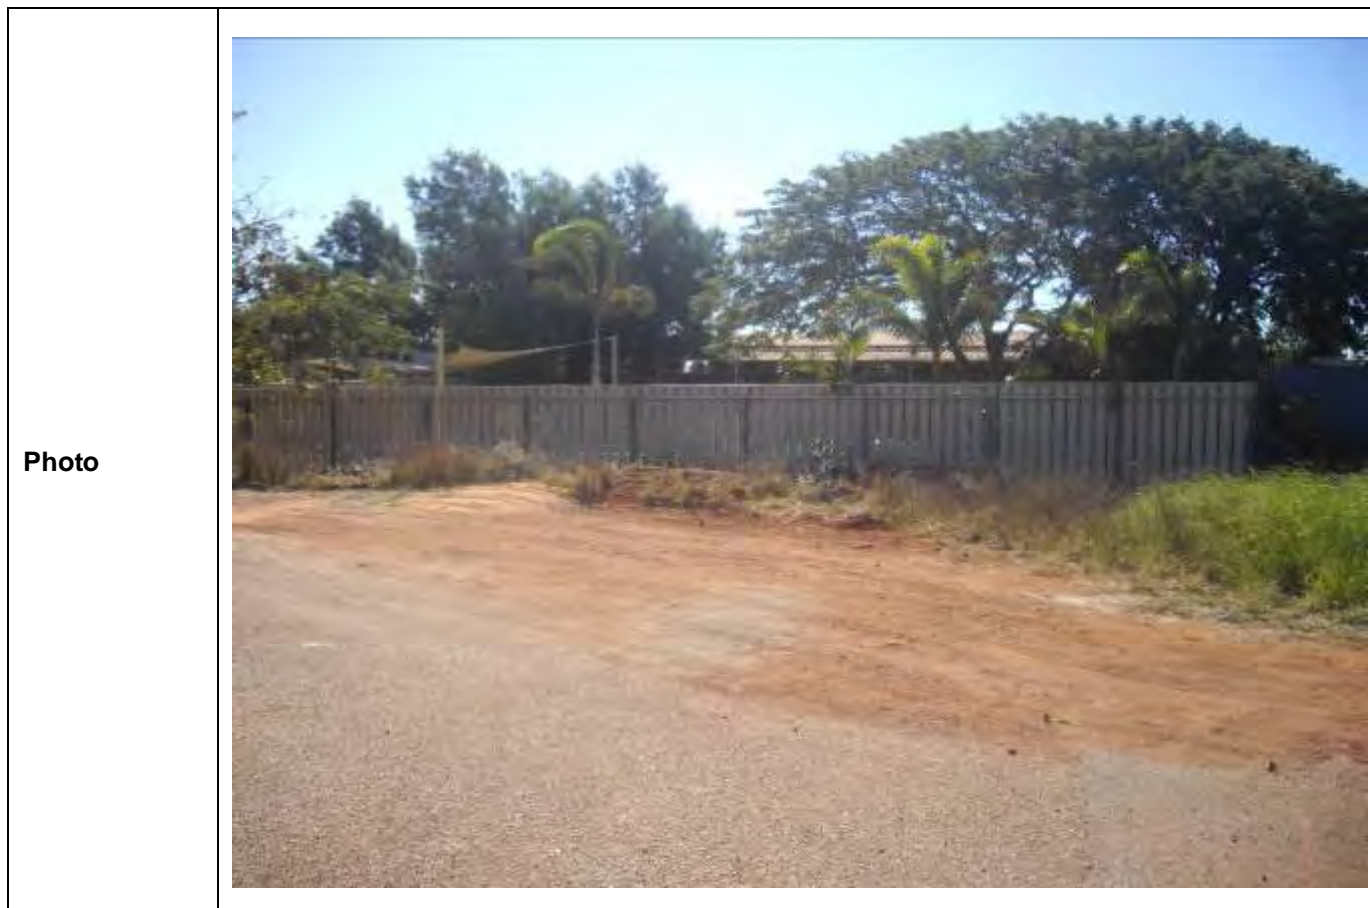
## 2.1 Lot No. 182 Lockyer Crescent

<b>Category</b>	Encroachment
<b>Type</b>	Rocks; Boundary extension
<b>Description</b>	Large rocks but flow adequate Fence
<b>Photo ID</b>	602
<b>Scope of Works</b>	L – Remove large rocks M – Remove fence and relocate to within property boundary

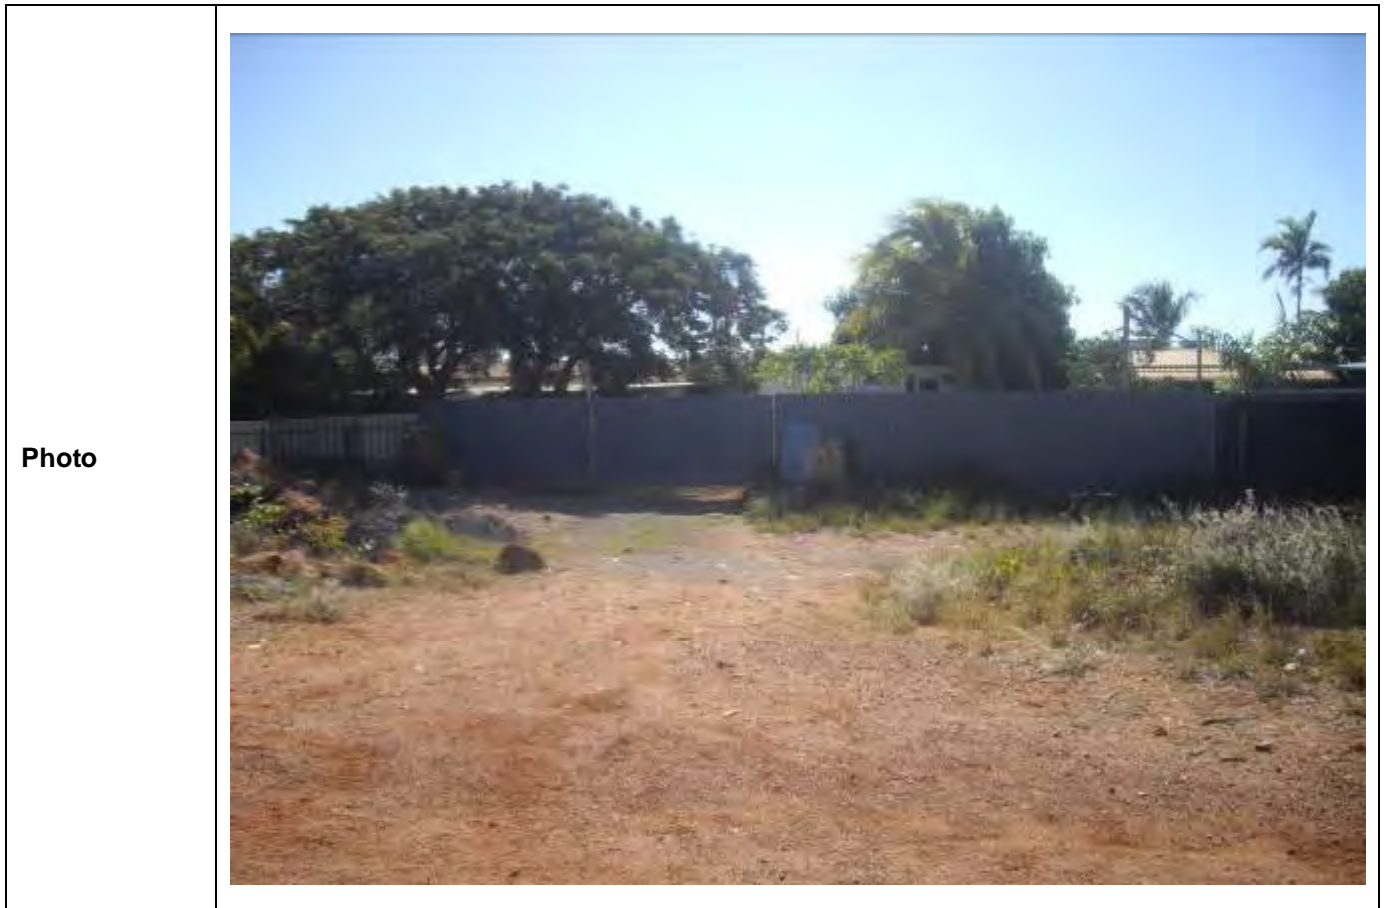
## 2.2 Lot No. 183 Lockyer Crescent

<b>Category</b>	Encroachment
<b>Type</b>	Rear access Rocks.
<b>Description</b>	Rear access and modified topography impede flow Large rocks and fill
<b>Photo ID</b>	1047, 601
<b>Scope of Works</b>	L – Remove rear access way and reinstate drainage flow path as defined by the natural capacity and invert of channel of downstream lot M – Remove rocks

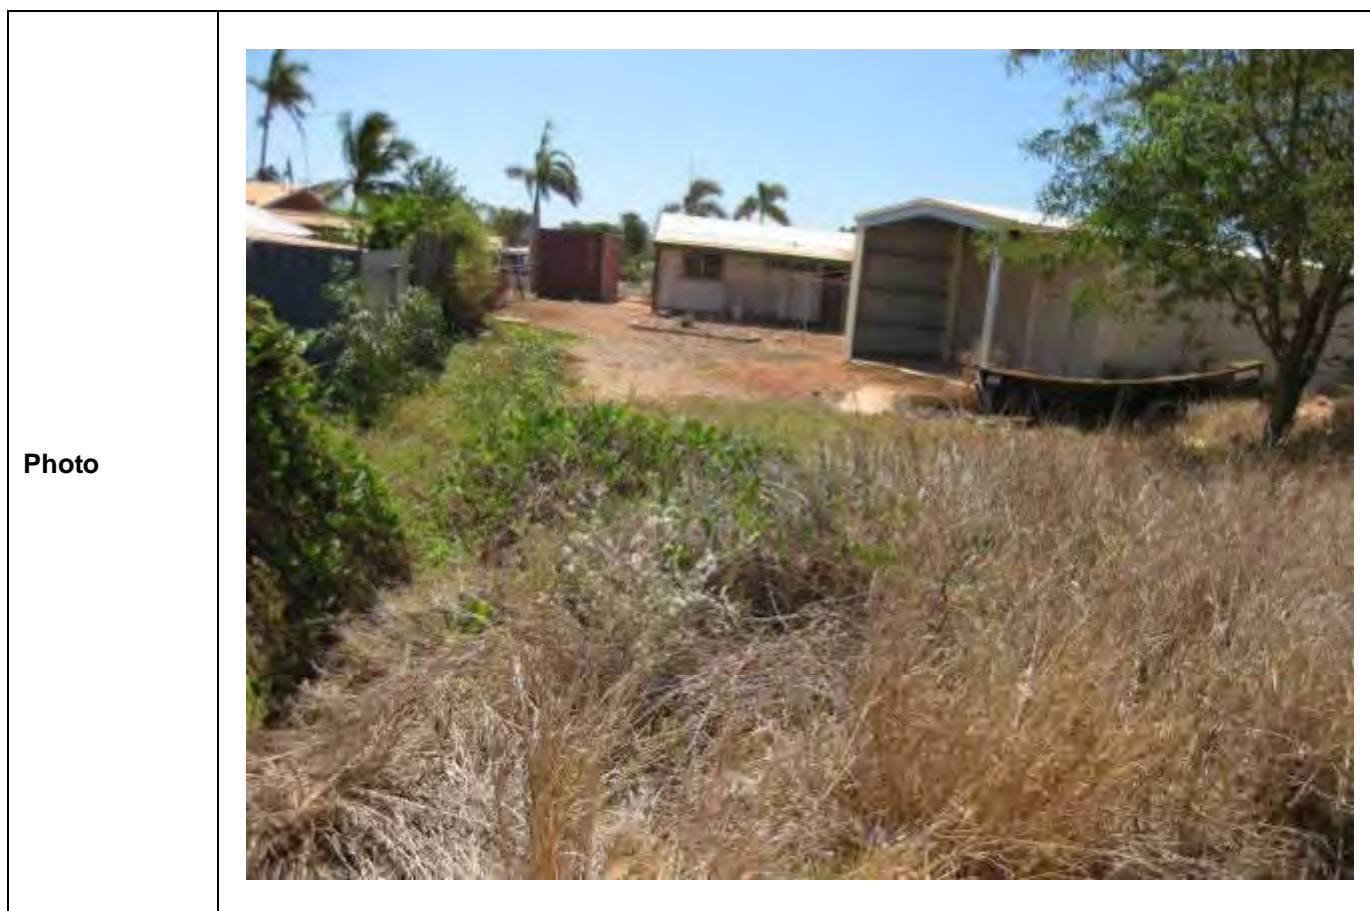
## 2.3 Lot No. 184 Lockyer Crescent

<b>Category</b>	Encroachment/ Drain Maintenance
<b>Type</b>	Rear access; General items; Boundary extension; Vegetation
<b>Description</b>	Rear access and modified topography; Boat; Shed. Semi-dense low lying vegetation.
<b>Photo ID</b>	7334
<b>Scope of Works</b>	L - Remove rear access way and reinstate drainage flow path as defined by the natural capacity and invert of channel of downstream lot L - Remove boat; L - Remove shed and relocate to within property boundary – confirmation required from survey. M - Vegetation is to be slashed to a nominal height of 50 mm above ground with the exception of large, established trees of height in excess of 5 m, which shall remain

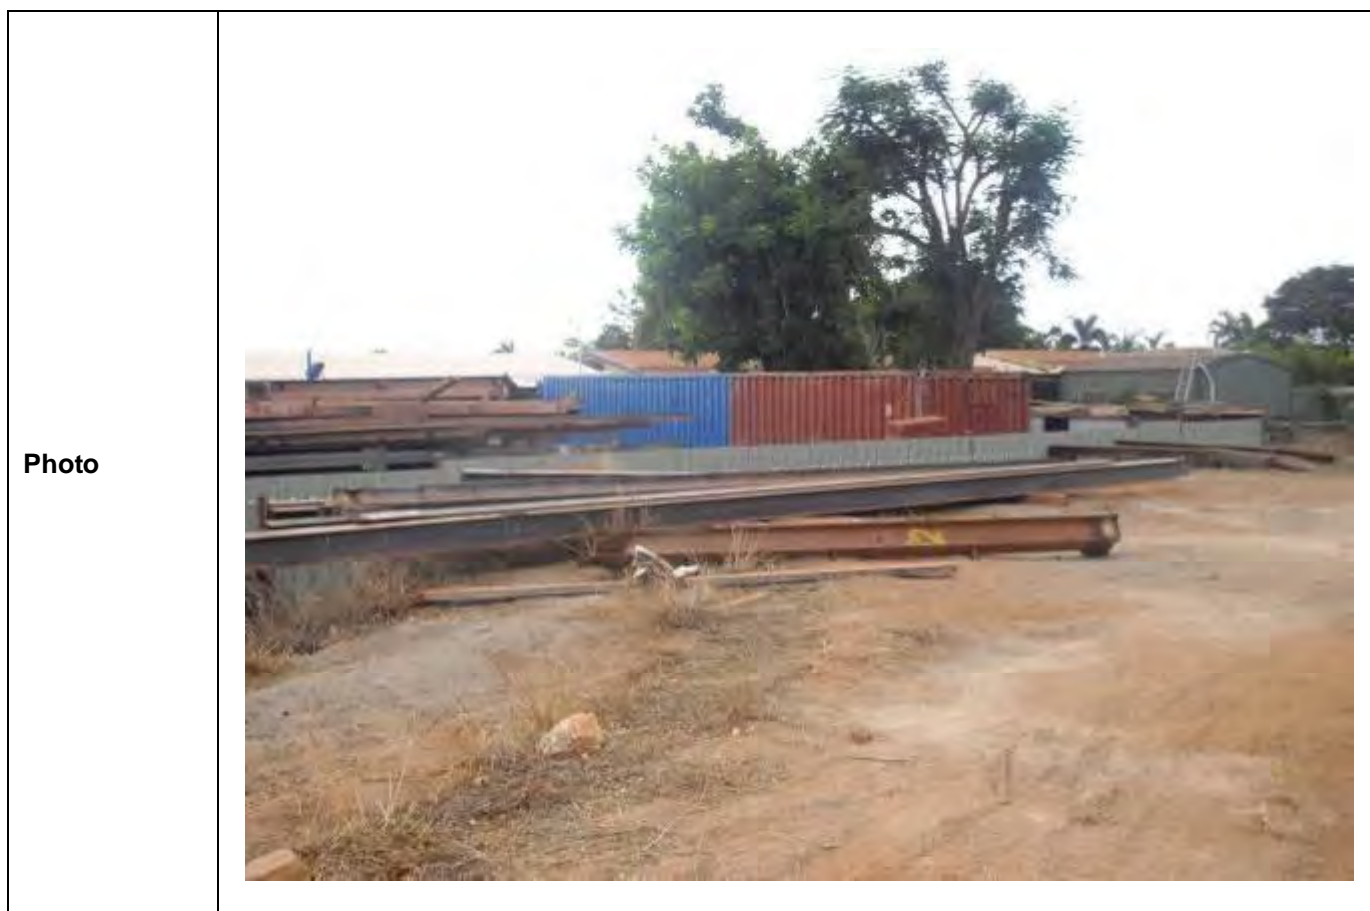
## 2.4 Lot No. 185 Lockyer Crescent

<b>Category</b>	Encroachment
<b>Type</b>	Hardstand area General items Boundary extension
<b>Description</b>	Road level has been extended towards property boundary to form a parking area. Original cross-sectional capacity has been dramatically reduced Building materials Fence is within the drainage reserve
<b>Photo ID</b>	600
<b>Scope of Works</b>	H - Remove extended parking area and reinstate drainage flow path as defined by the natural capacity and invert of channel of downstream lot L – Remove building materials; M – Remove fence and relocate surveyed boundary

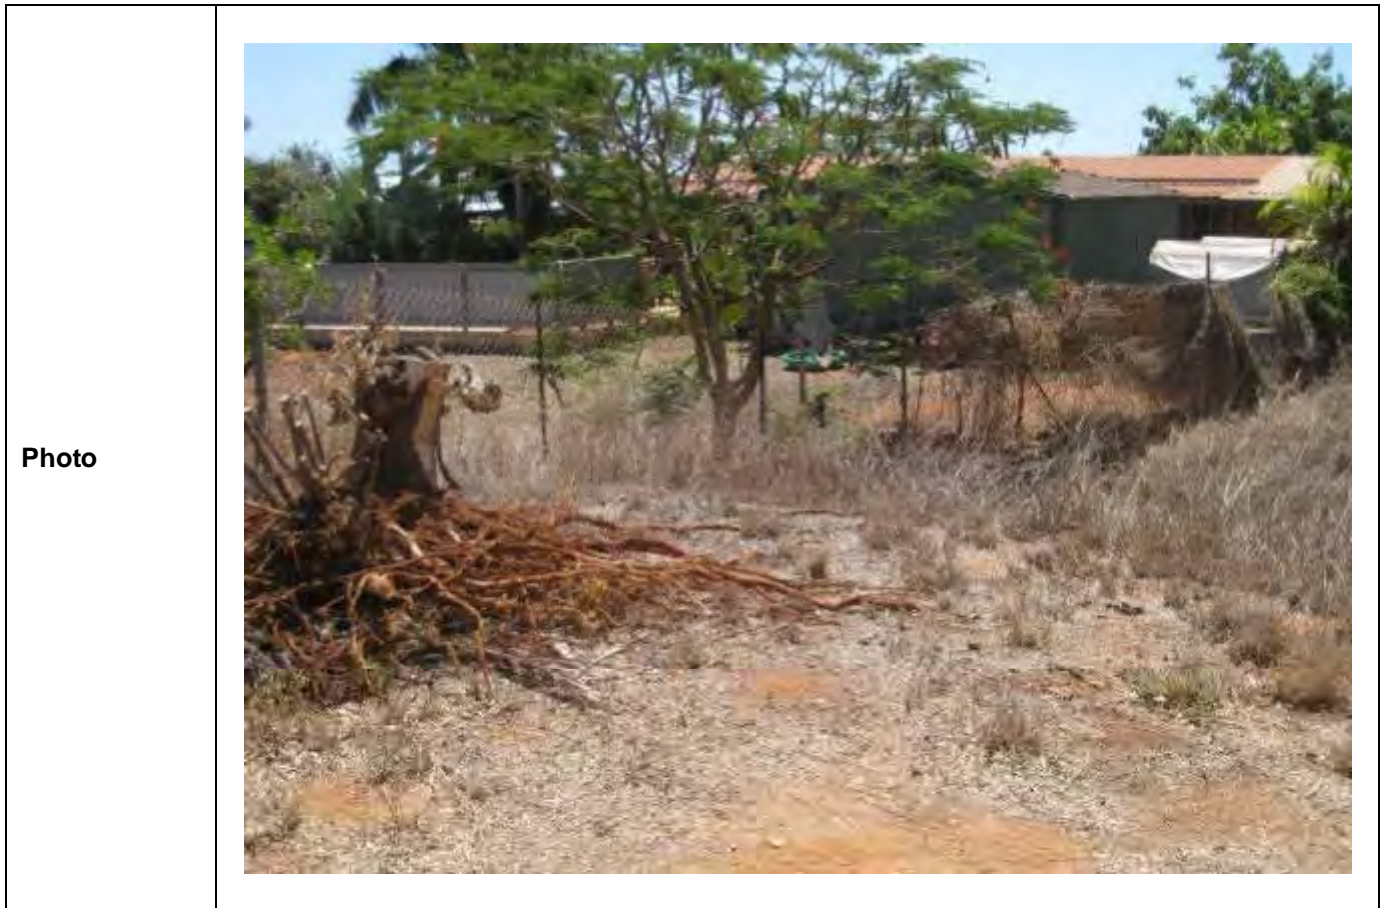
## 2.5 Lot No. 186 Lockyer Crescent

<b>Category</b>	Encroachment / Drain Maintenance
<b>Type</b>	Boundary extension Vegetation
<b>Description</b>	Mesh fence is perpendicular to road and extends the width of the drainage reserve. Low lying vegetation
<b>Photo ID</b>	7332
<b>Scope of Works</b>	H - Remove fence M - Vegetation is to be slashed to a nominal height of 50 mm above ground with the exception of large, established trees of height in excess of 5 m, which shall remain.

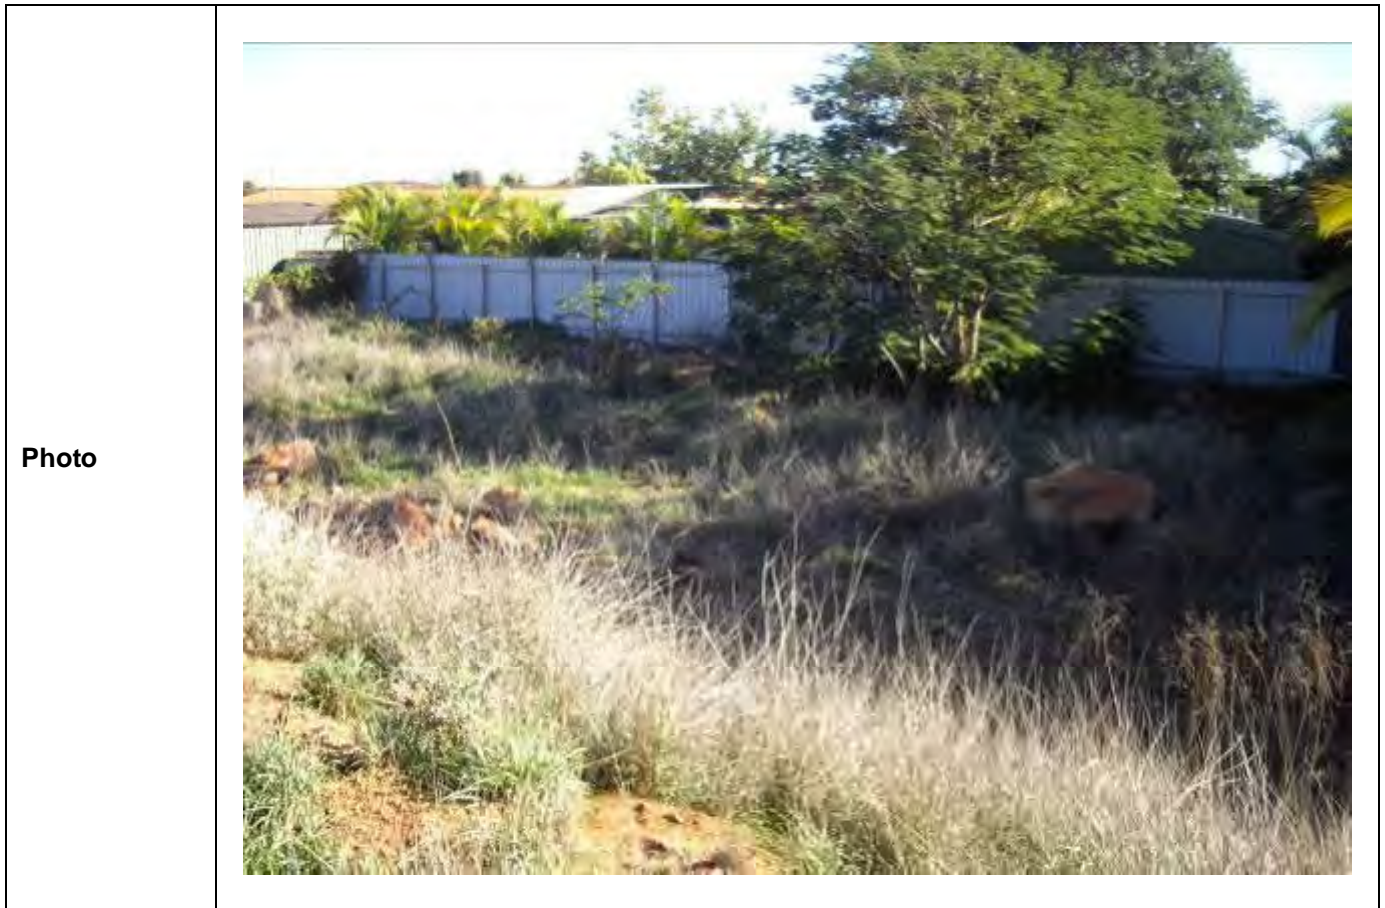
## 2.6 Lot No. 187 Lockyer Crescent

<b>Category</b>	Drain Maintenance
<b>Type</b>	Vegetation
<b>Description</b>	Semi dense vegetation
<b>Photo ID</b>	832
<b>Scope of Works</b>	L - Vegetation is to be slashed to a nominal height of 50 mm above ground with the exception of large, established trees of height in excess of 5 m, which shall remain.

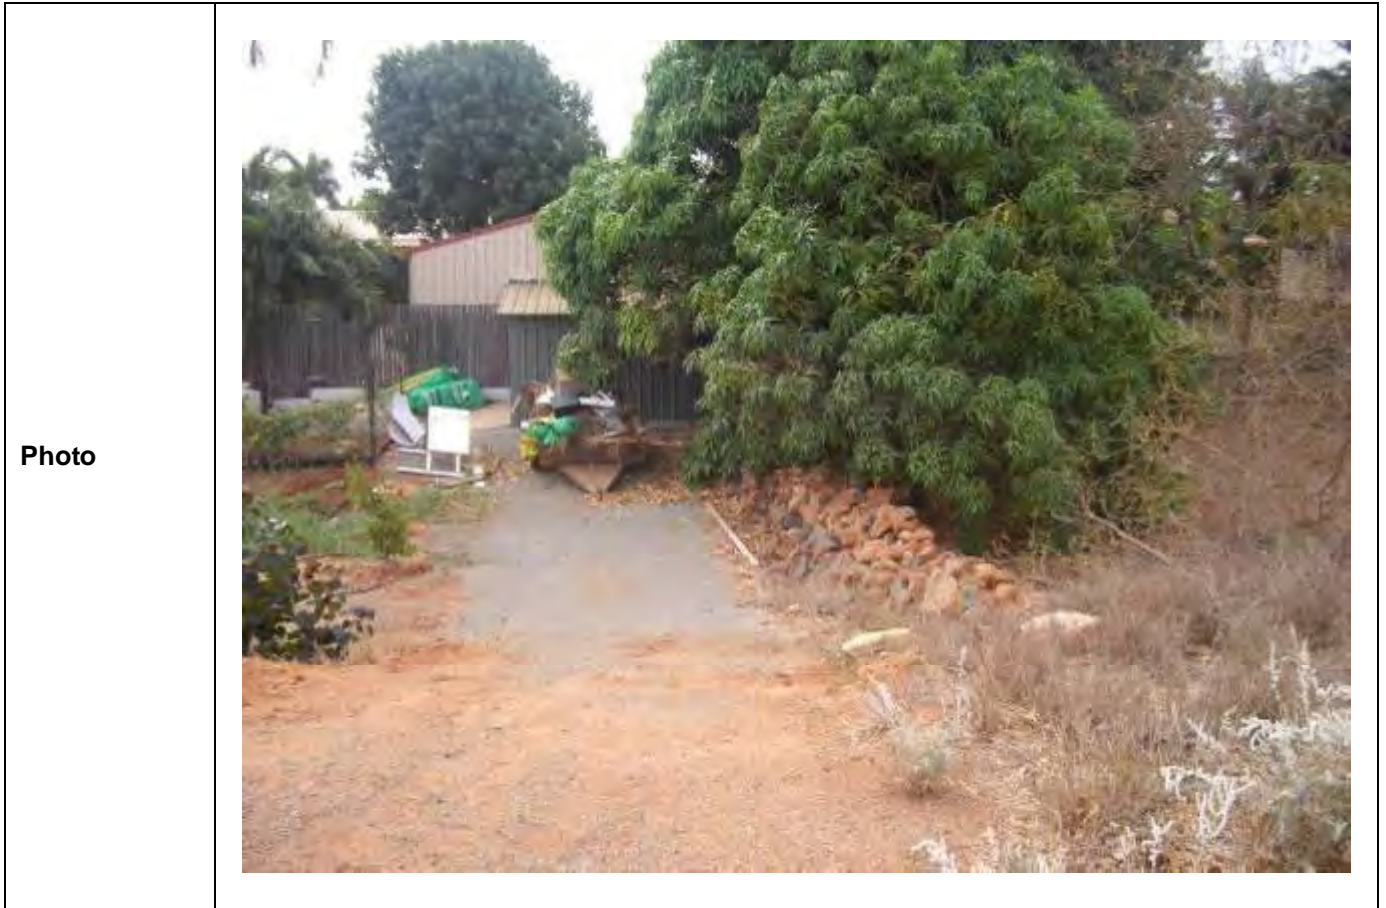
## 2.7 Lot No. 188 Lockyer Crescent

<b>Category</b>	Encroachment
<b>Type</b>	Boundary extension – fence; Boundary extension – shed; Rear access; Vegetation.
<b>Description</b>	Rock retaining wall is perpendicular to road and extends the width of the drainage reserve; Garden shed is within the drainage reserve; Rear access is impeding flow; Semi-dense low lying vegetation.
<b>Photo ID</b>	598
<b>Scope of Works</b>	H - Remove rock retaining wall. L – Remove garden shed – confirmation required from survey. H – Remove rear access and reinstate drainage flow path as defined by the natural capacity and invert of channel of downstream lot M - Vegetation is to be slashed to a nominal height of 50 mm above ground with the exception of large, established trees of height in excess of 5 m, which shall remain

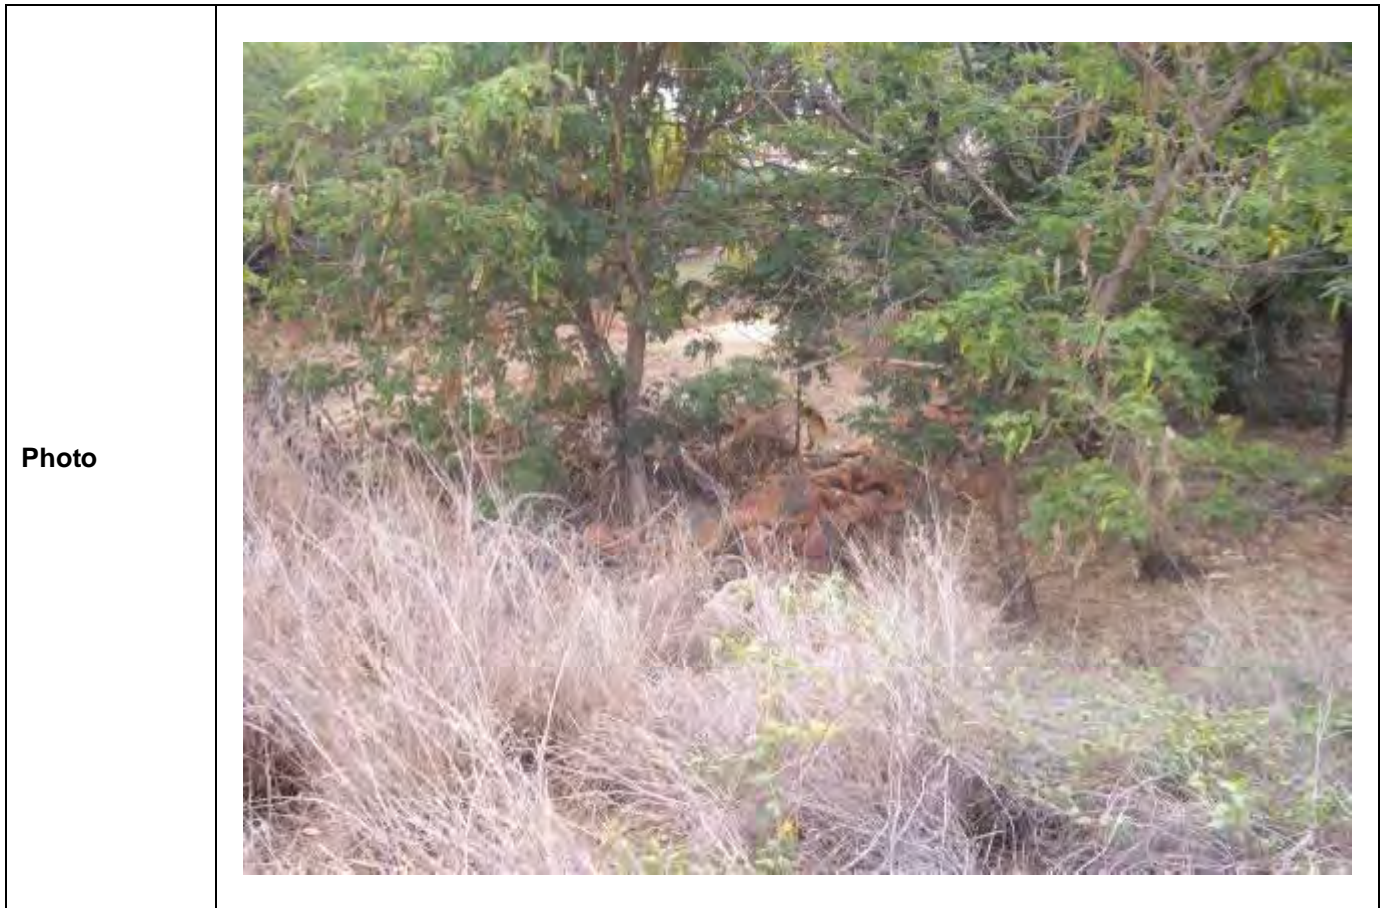
## 2.8 Lot No. 189 Lockyer Crescent

<b>Category</b>	Encroachment
<b>Type</b>	Boundary extension – mulch area; Boundary extension – retaining wall; Boundary extension – shed; Vegetation.
<b>Description</b>	Fenced off mulch area; Rock retaining wall; Shed on boundary; Semi-dense low lying vegetation
<b>Photo ID</b>	604
<b>Scope of Works</b>	H - Remove fenced off mulch area; H – Remove rock wall. L – Remove shed and relocate to within property boundary – confirmation required from survey. M - Vegetation is to be slashed to a nominal height of 50 mm above ground with the exception of large, established trees of height in excess of 5 m, which shall remain

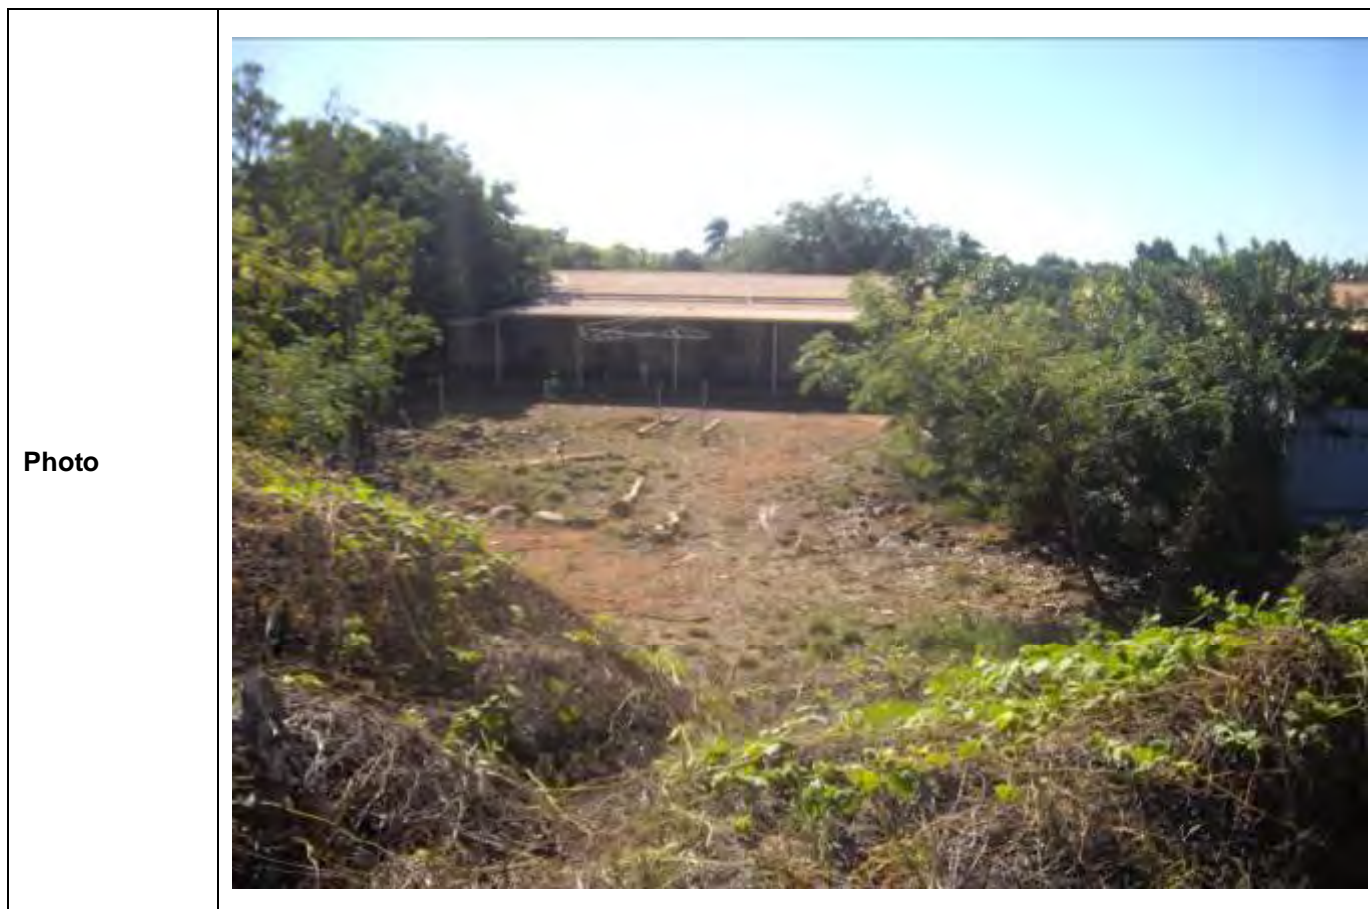
## 2.9 Lot No. 190 Lockyer Crescent

<b>Category</b>	Drain Maintenance
<b>Type</b>	Vegetation
<b>Description</b>	Semi dense vegetation Flow path adequate
<b>Photo ID</b>	7331
<b>Scope of Works</b>	L - Vegetation is to be slashed to a nominal height of 50 mm above ground with the exception of large, established trees of height in excess of 5 m, which shall remain
