City of Karratha  
Dampier Stormwater Management Study  
Report  
Part B  
June 2015

## Appendix **C** – 2010 encroachment reviews

**Rio Tinto Iron Ore**  
Report on Dampier Drainage  
Review  
Block 1 Encroachments  
June 2010

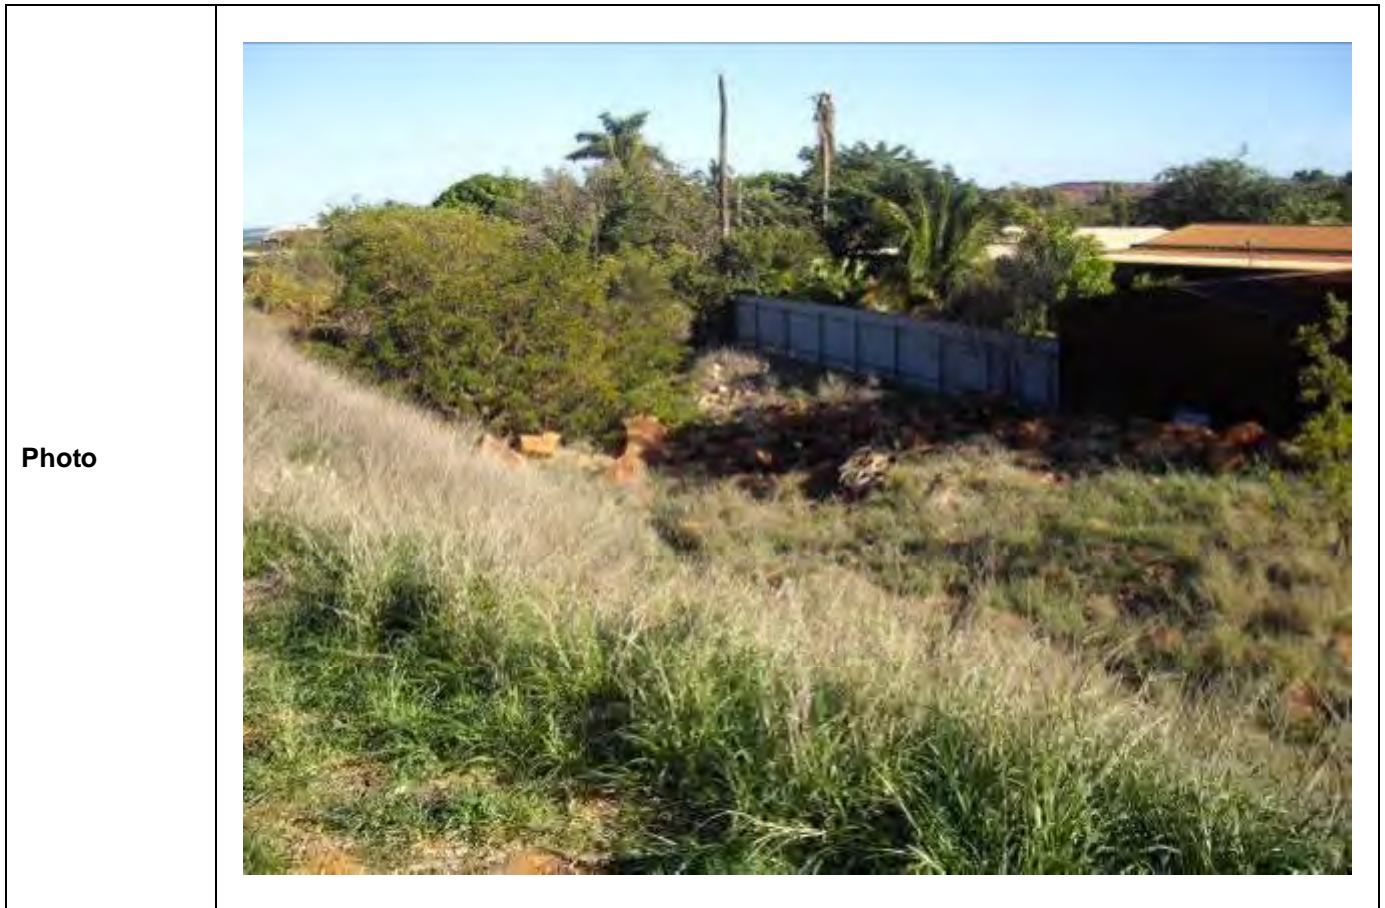
## 2.10 Lot No. 191 Lockyer Crescent

<b>Category</b>	Drain Maintenance
<b>Type</b>	Vegetation Rocks
<b>Description</b>	Semi-dense low lying vegetation Very rocky – flow not impeded
<b>Photo ID</b>	831
<b>Scope of Works</b>	M - Vegetation is to be slashed to a nominal height of 50 mm above ground with the exception of large, established trees of height in excess of 5 m, which shall remain; M – Remove rocks impeding low point of drainage flow path.

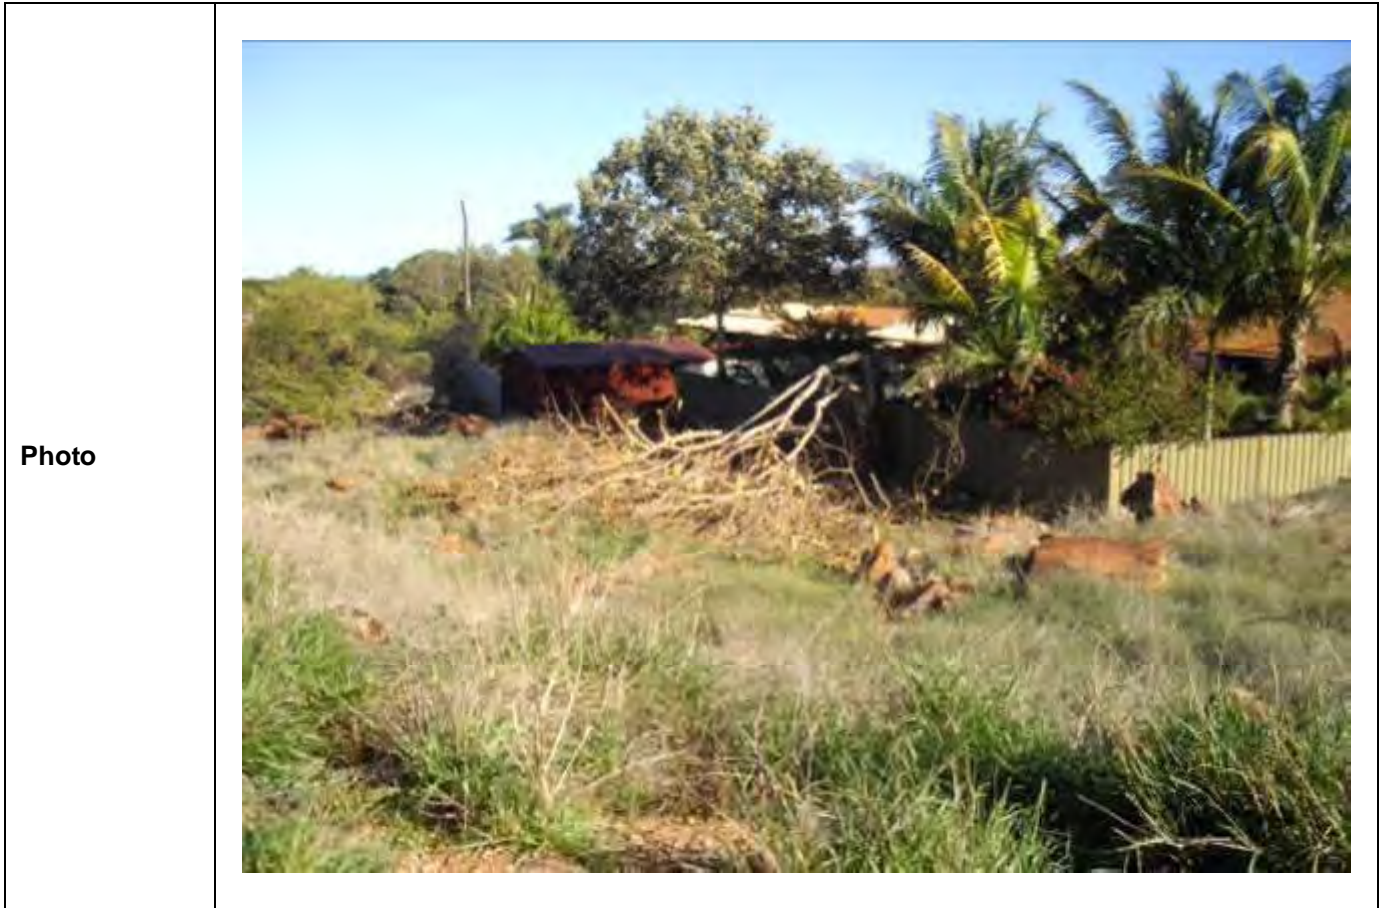
## 2.11 Lot No. 1,191 Lockyer Crescent

<b>Category</b>	Drain Maintenance
<b>Type</b>	Vegetation Rocks
<b>Description</b>	Semi-dense low lying vegetation Very rocky but flow path ok (top of catchment)
<b>Photo ID</b>	830
<b>Scope of Works</b>	M - Vegetation is to be slashed to a nominal height of 50 mm above ground with the exception of large, established trees of height in excess of 5 m, which shall remain L – Remove rocks from drainage flow path

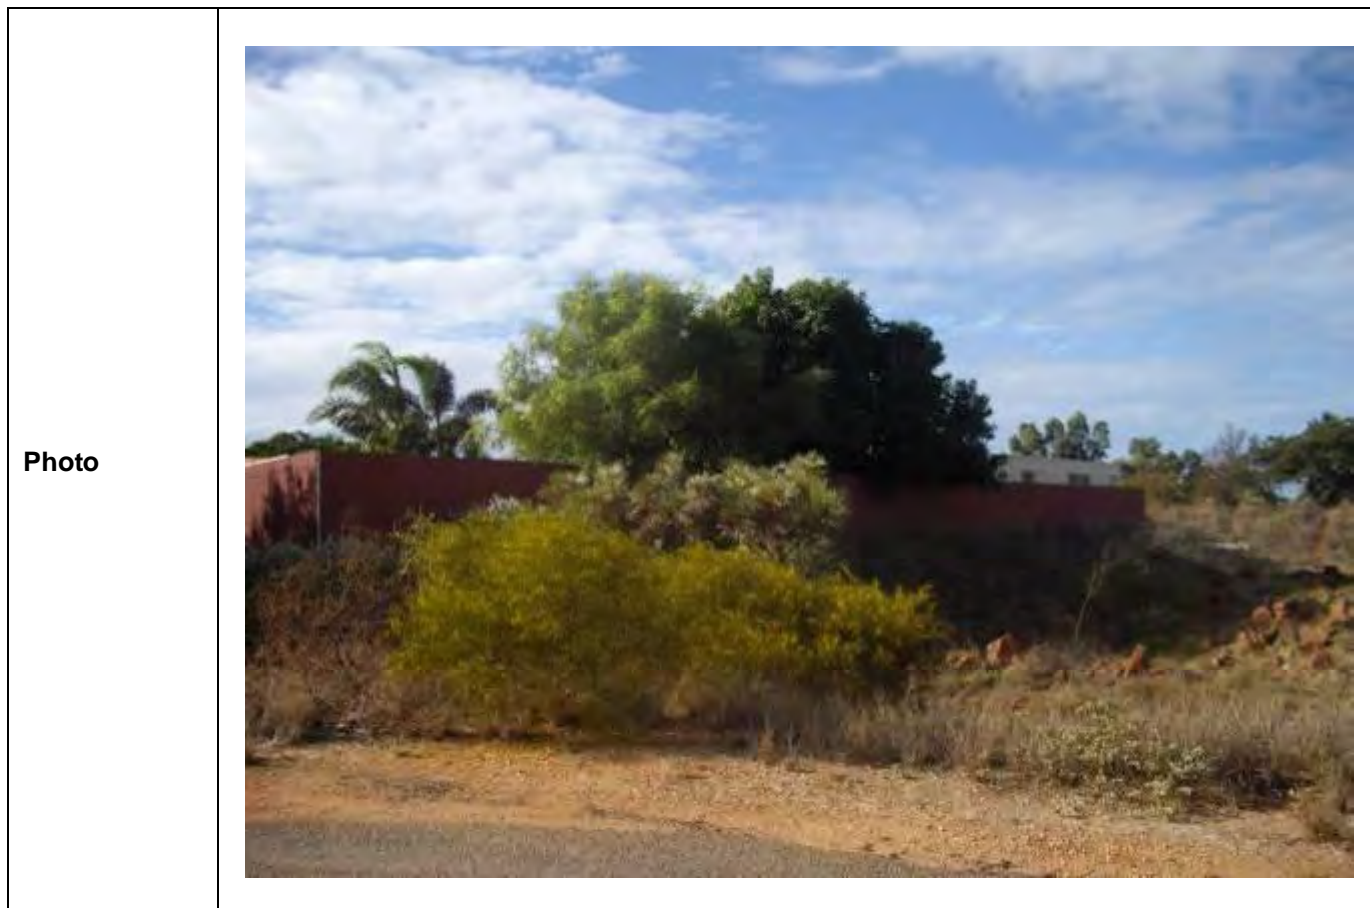
### 3.1 Lot No. 192 Forrest Crescent

<b>Category</b>	Encroachment / Drain Maintenance
<b>Type</b>	Boundary extension Vegetation
<b>Description</b>	Extended boundary on southern and eastern sides of lots; Semi-dense low lying vegetation.
<b>Photo ID</b>	519
<b>Scope of Works</b>	L – Remove extensions and relocate to within the property boundary. M - Vegetation is to be slashed to a nominal height of 50 mm above ground with the exception of large, established trees of height in excess of 5 m, which shall remain;

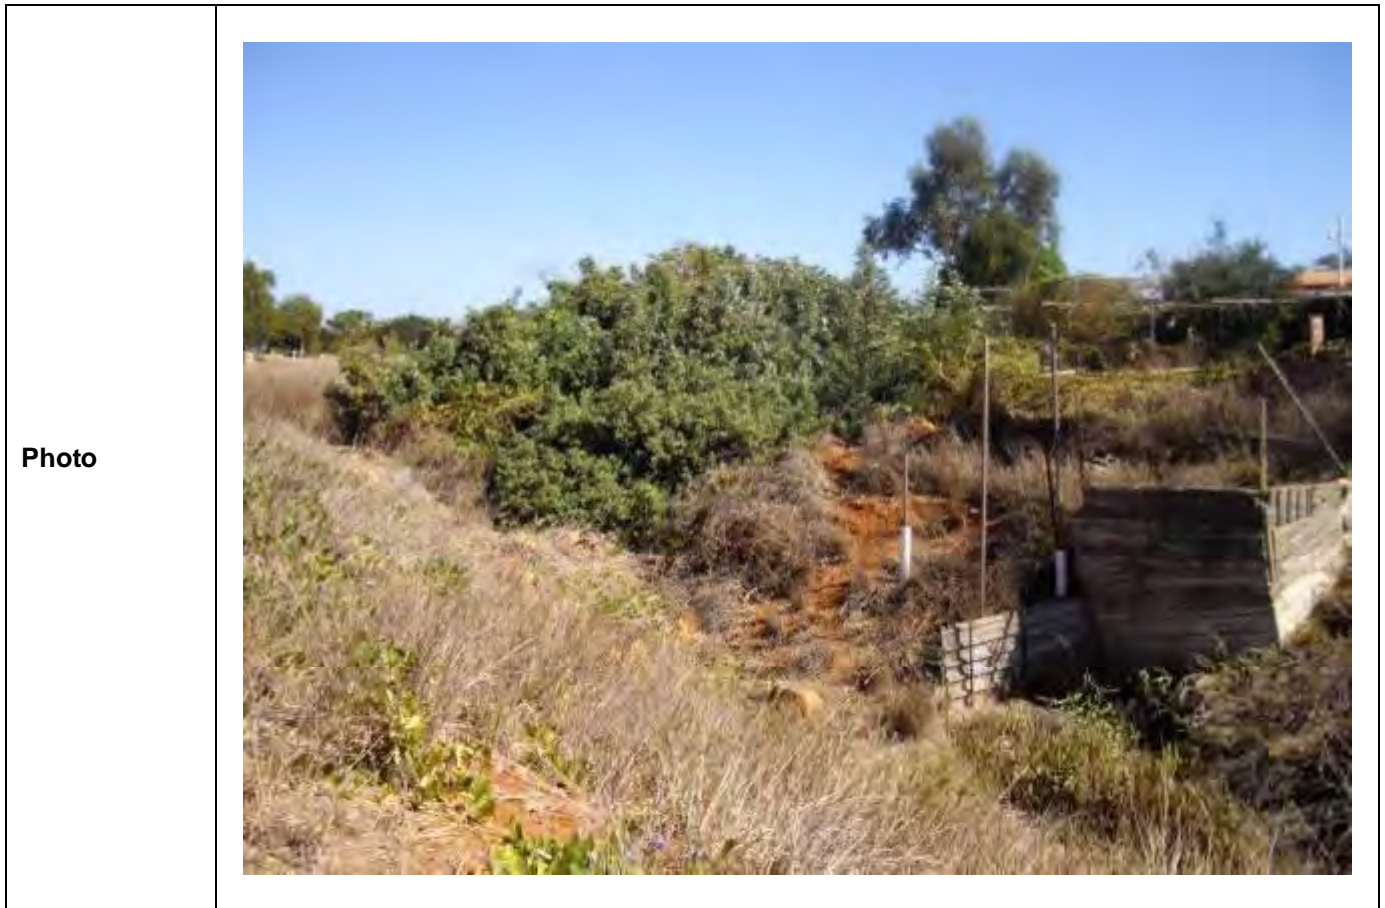
### 3.2 Lot No. 193 Forrest Crescent

<b>Category</b>	Drain Maintenance / Encroachment
<b>Type</b>	Vegetation; Flow path
<b>Description</b>	Dense vegetation impeding flow. Flow path modified, but adequate
<b>Photo ID</b>	390
<b>Scope of Works</b>	H - Vegetation is to be slashed to a nominal height of 50 mm above ground with the exception of large, established trees of height in excess of 5 m, which shall remain

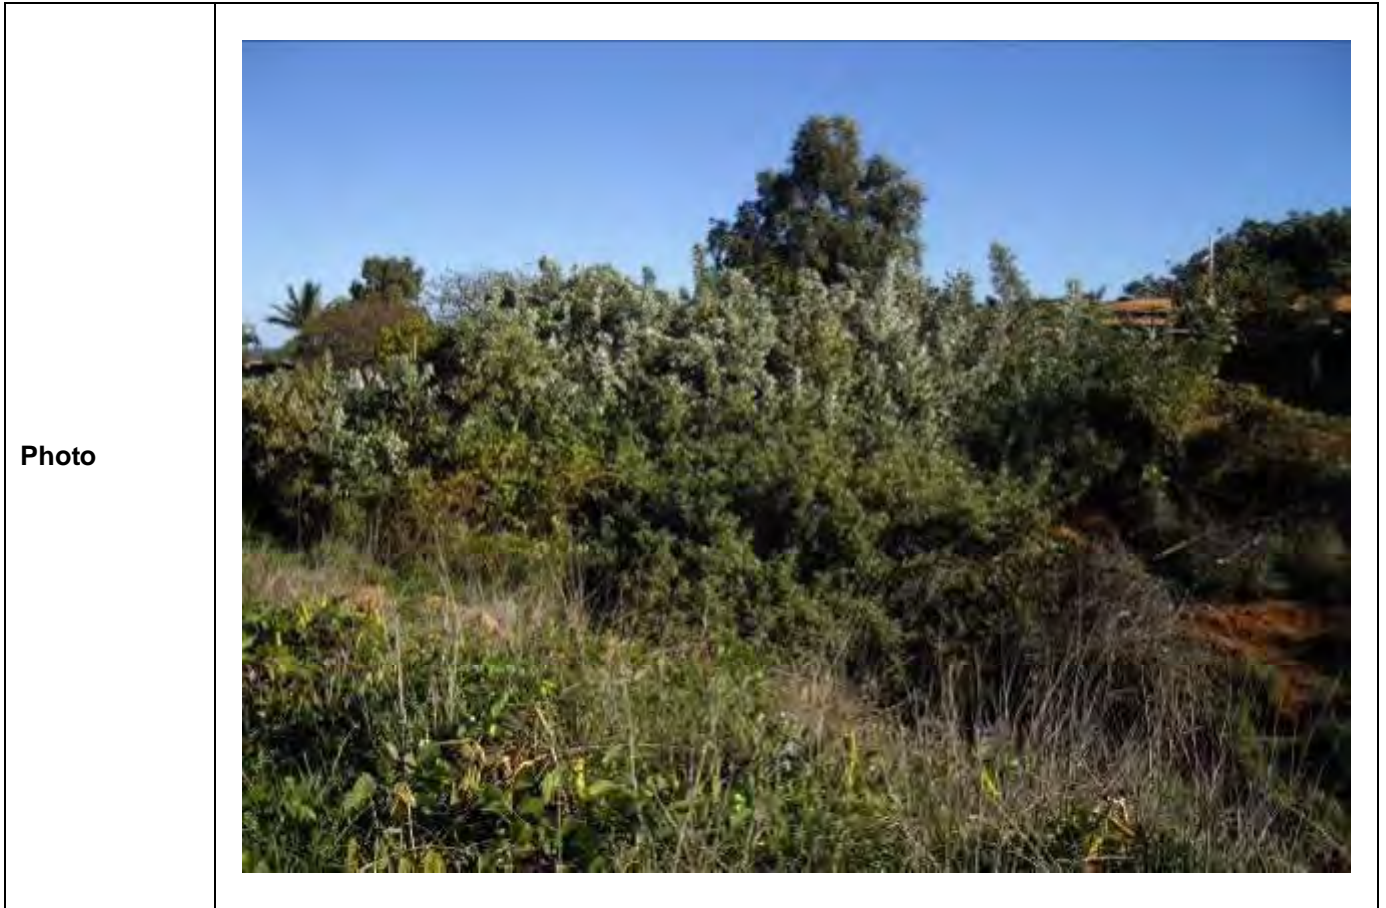
### 3.3 Lot No. 194 Forrest Crescent

<b>Category</b>	Drain Maintenance
<b>Type</b>	Vegetation; Flow path
<b>Description</b>	Dense vegetation impeding flow; Drain modified from fill. Cross sectional capacity is adequate
<b>Photo ID</b>	843
<b>Scope of Works</b>	H - Vegetation is to be slashed to a nominal height of 50 mm above ground with the exception of large, established trees of height in excess of 5 m, which shall remain; H – Remove fill and reinstate drainage flowpath

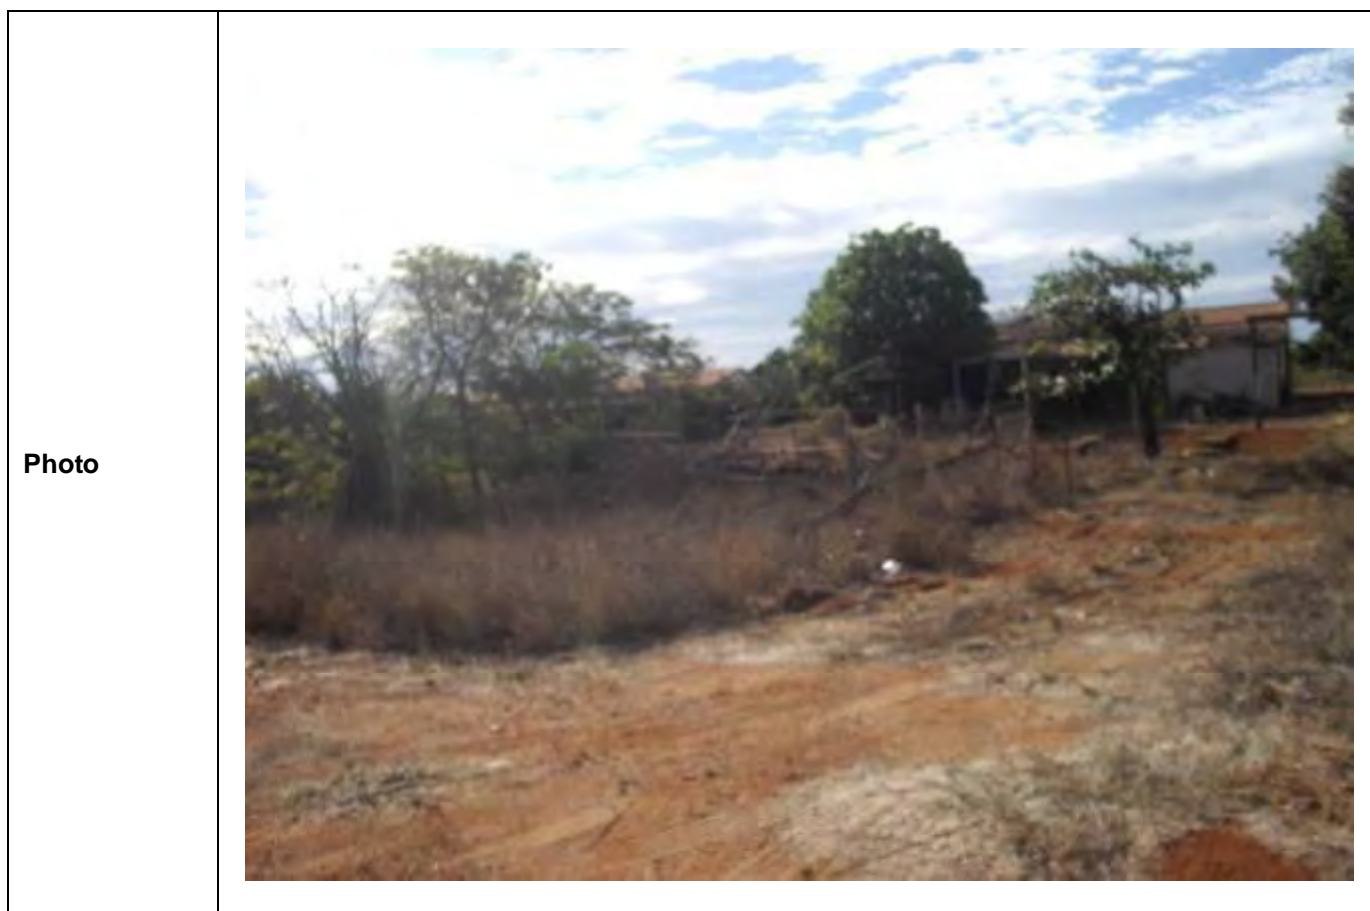
### 3.4 Lot No. 195 Forrest Crescent

<b>Category</b>	Encroachment / Drain Maintenance
<b>Type</b>	Boundary extension Rear access Vegetation
<b>Description</b>	Fence Rear access and modified topography. Semi-dense low lying vegetation
<b>Photo ID</b>	520
<b>Scope of Works</b>	L – Remove fence and relocate to within the drainage reserve; H – Remove rear access and reinstate drainage flow path as defined by the downstream cross-sectional capacity and uniform grade; M – Vegetation is to be slashed to a nominal height of 50 mm above ground with the exception of large, established trees of height in excess of 5 m, which shall remain

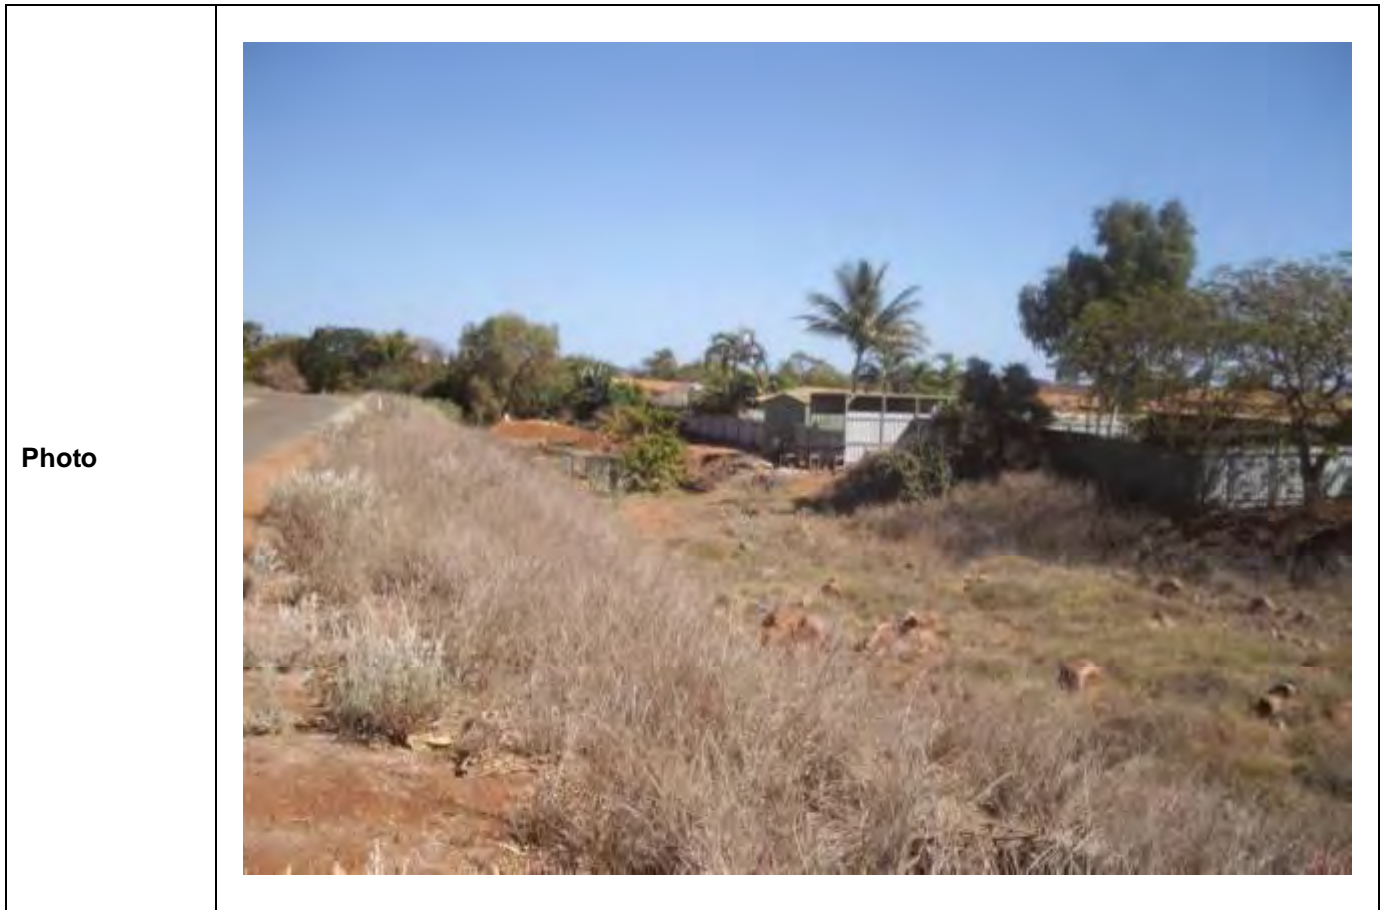
### 3.5 Lot No. 196 Forrest Crescent

<b>Category</b>	None
<b>Type</b>	None
<b>Description</b>	-
<b>Photo ID</b>	391
<b>Scope of Works</b>	None required.

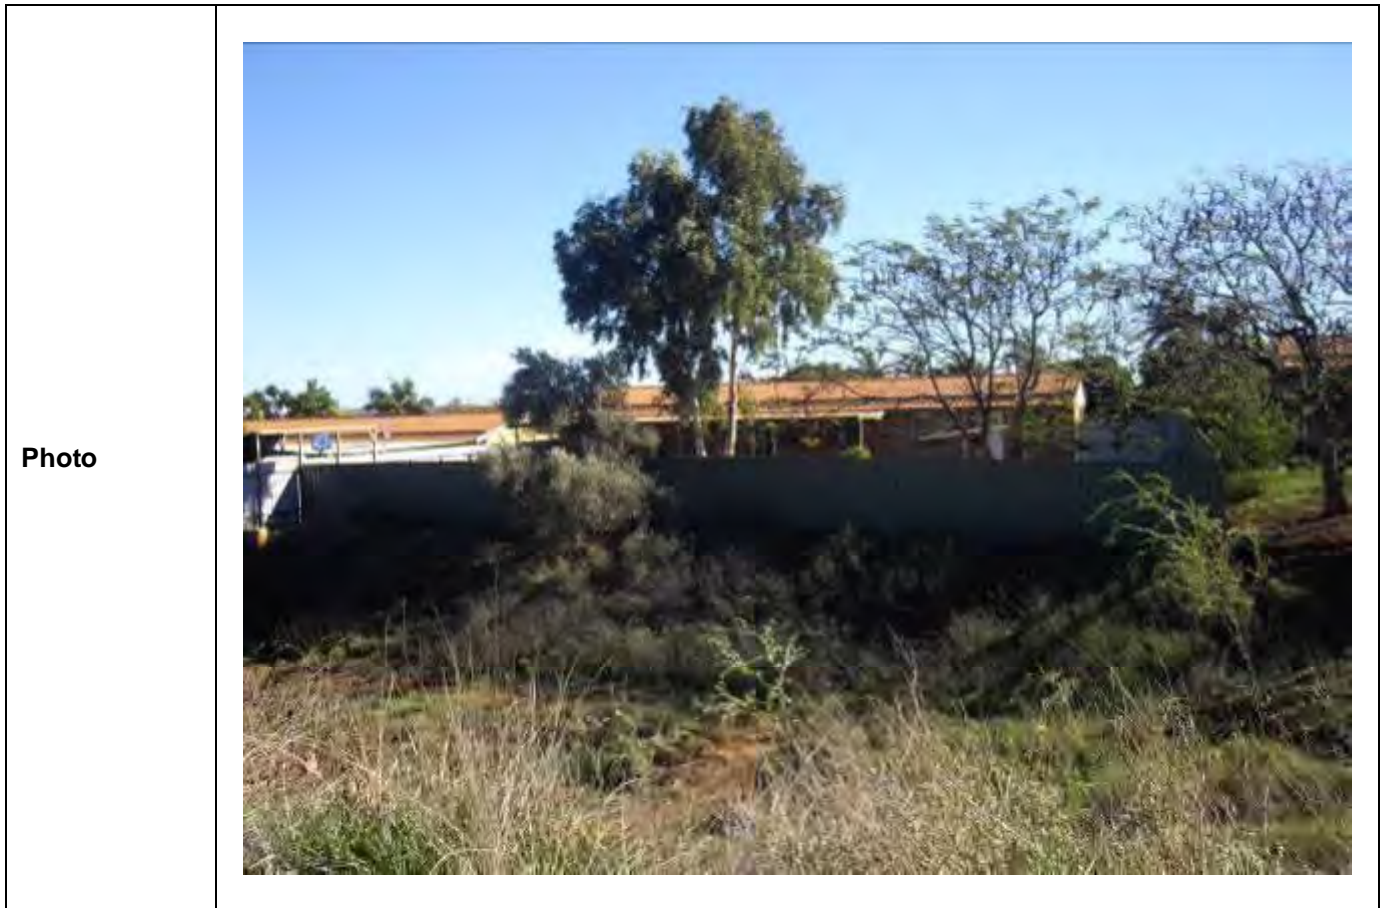
### 3.6 Lot No. 197 Forrest Crescent

<b>Category</b>	None
<b>Type</b>	None
<b>Description</b>	-
<b>Photo ID</b>	844
<b>Scope of Works</b>	None required.

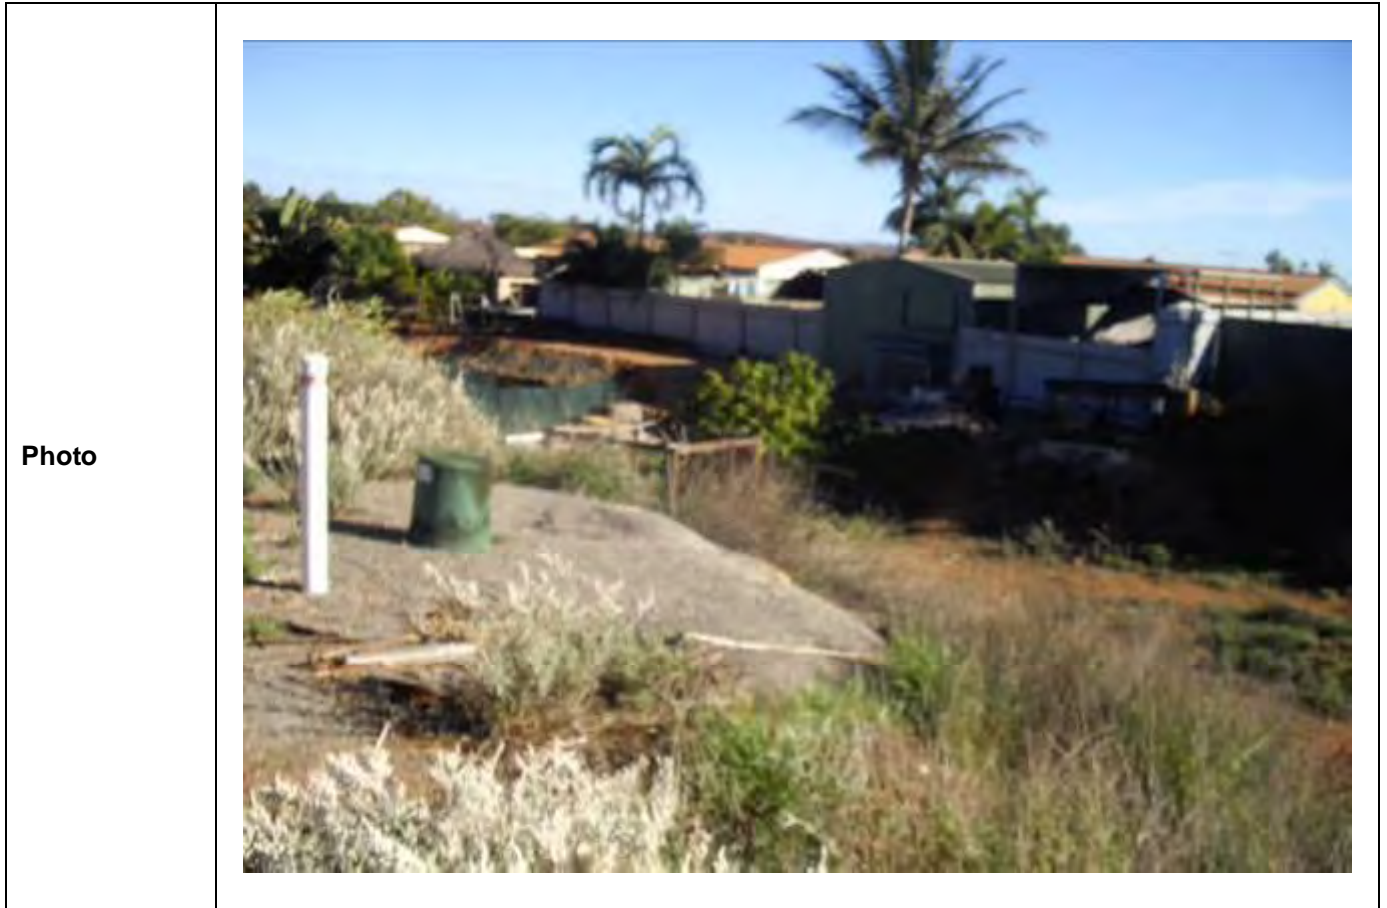
### 3.7 Lot No. 198 Forrest Crescent

<b>Category</b>	Encroachment
<b>Type</b>	General item
<b>Description</b>	Fenced off garden within drainage reserve.
<b>Photo ID</b>	845
<b>Scope of Works</b>	L - Remove garden and fence.

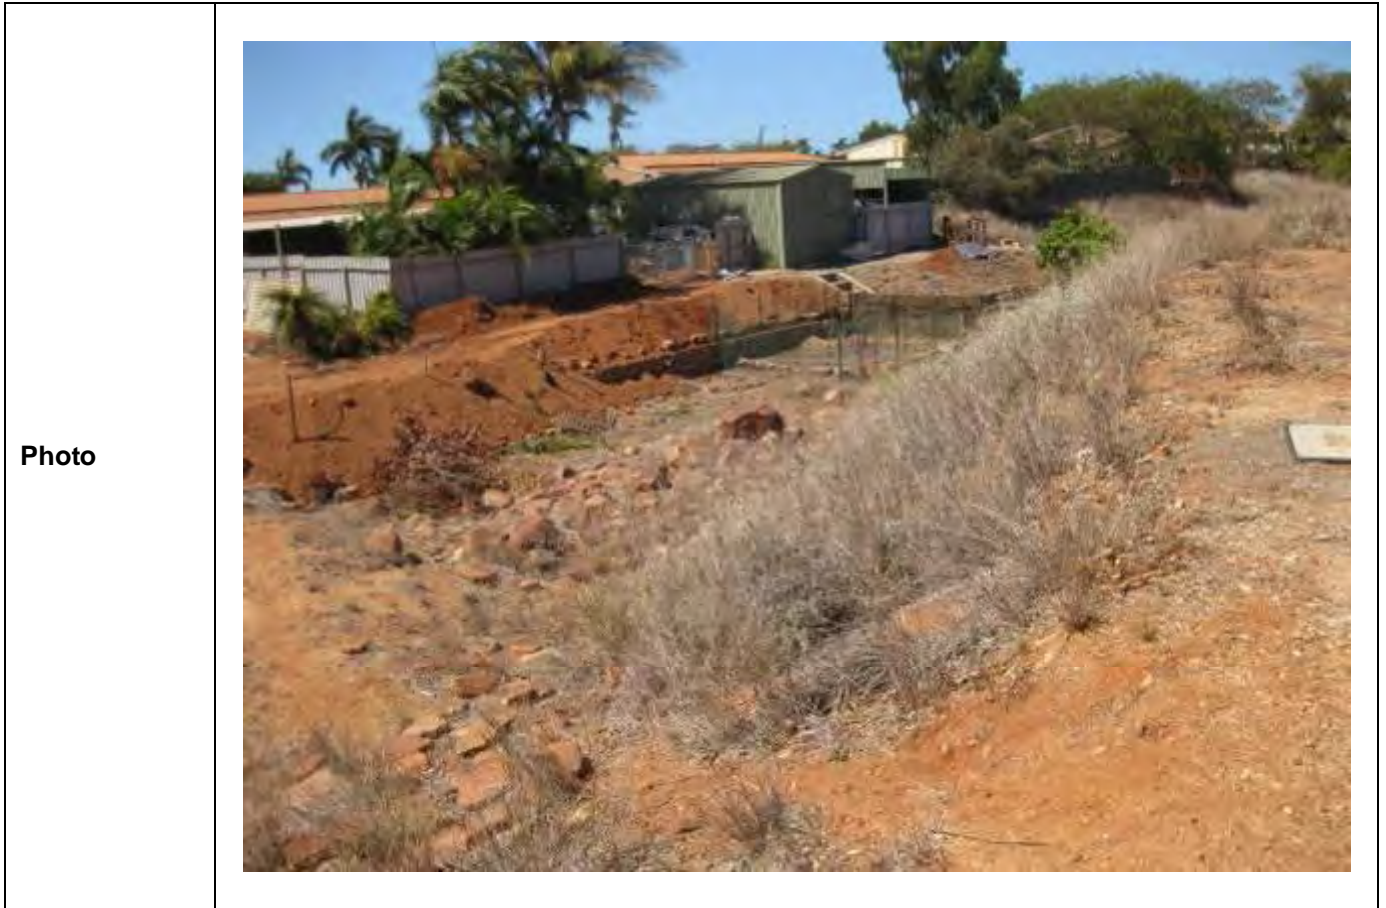
### 3.8 Lot No. 199 Forrest Crescent

<b>Category</b>	Encroachment
<b>Type</b>	Modified reserve.
<b>Description</b>	Batter encroachment in the form of uncompacted fill extending within the drainage reserve. Rocks impede flow
<b>Photo ID</b>	7343
<b>Scope of Works</b>	M – Reshape batter to stay within the property boundary and compact fill to prevent easy erosion. H – remove rocks and reinstate drainage flow path as defined by the natural capacity and invert of channel of downstream lot

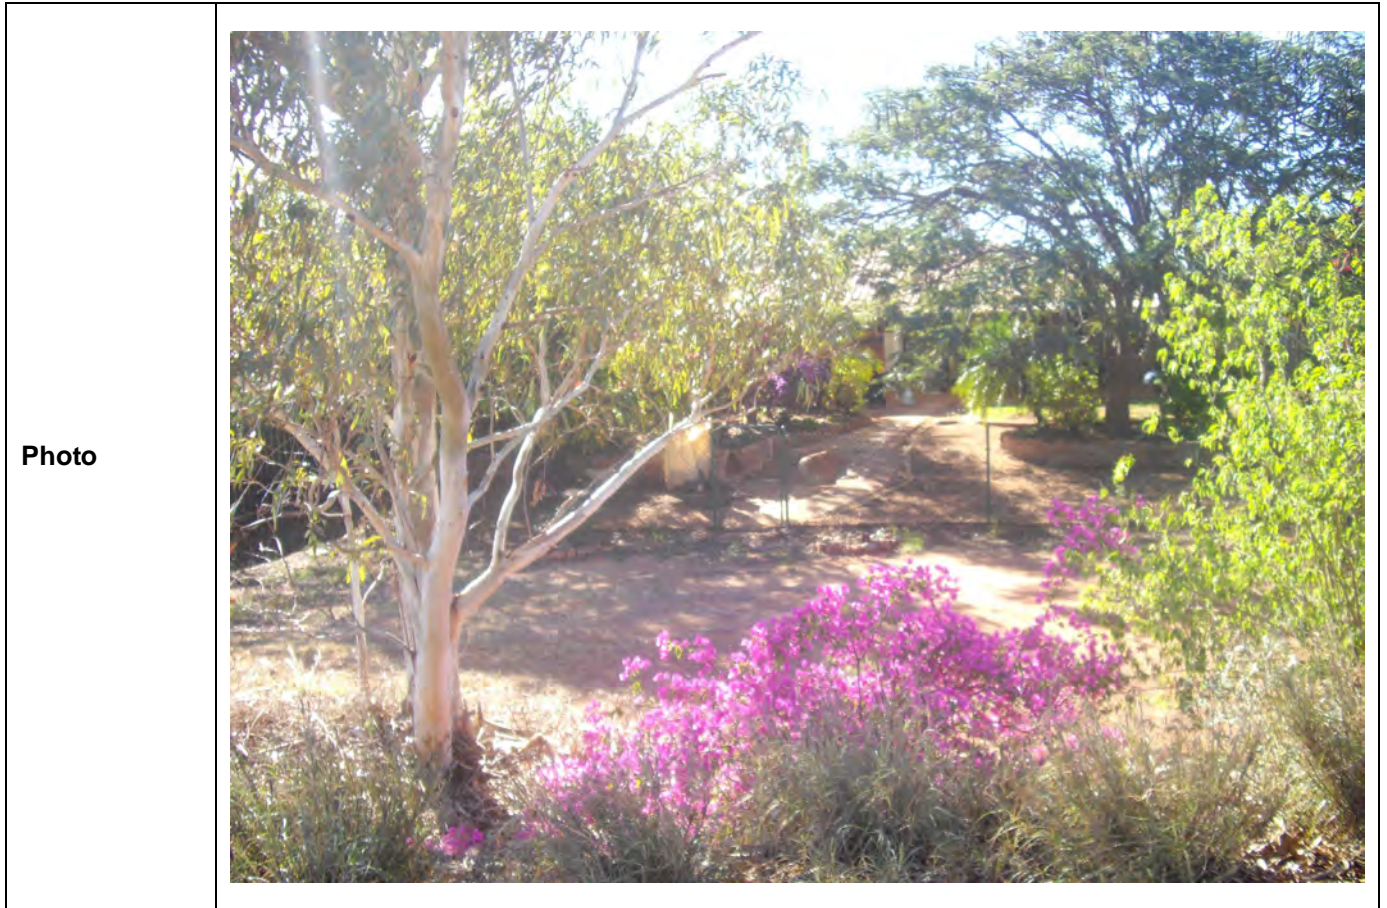
### 3.10 Lot No. 1,200 Forrest Crescent

<b>Category</b>	Drain Maintenance
<b>Type</b>	Flow path
<b>Description</b>	Flow path adequate
<b>Photo ID</b>	846
<b>Scope of Works</b>	None

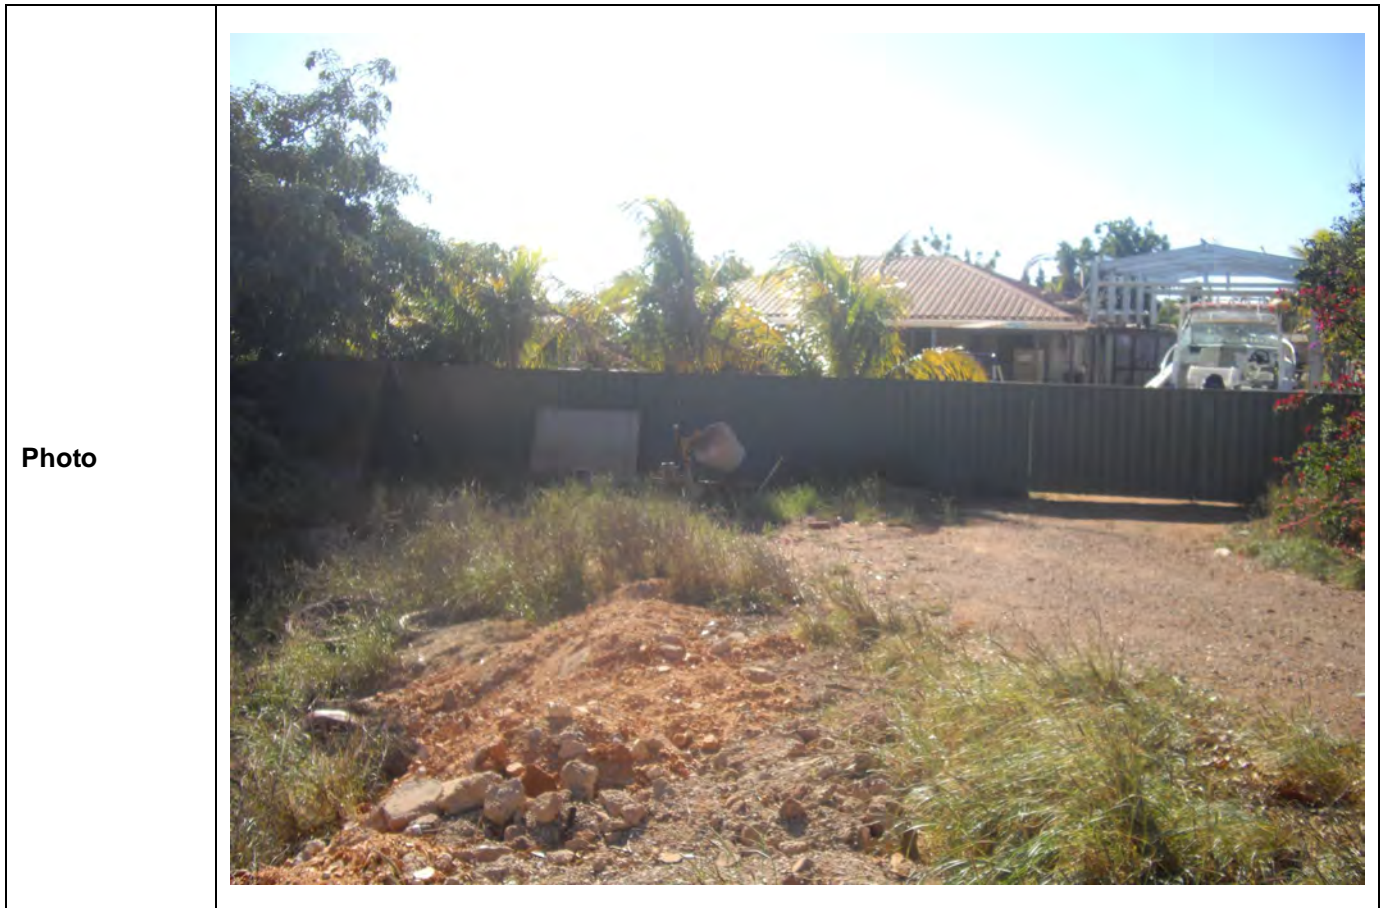
### 3.11 Lot No. 2,200 Forrest Crescent

<b>Category</b>	Encroachment
<b>Type</b>	Rear access
<b>Description</b>	Rear access impeding flow
<b>Photo ID</b>	521
<b>Scope of Works</b>	H - Remove access way and reinstate drainage flow path as defined by the natural capacity and invert of channel of downstream lot

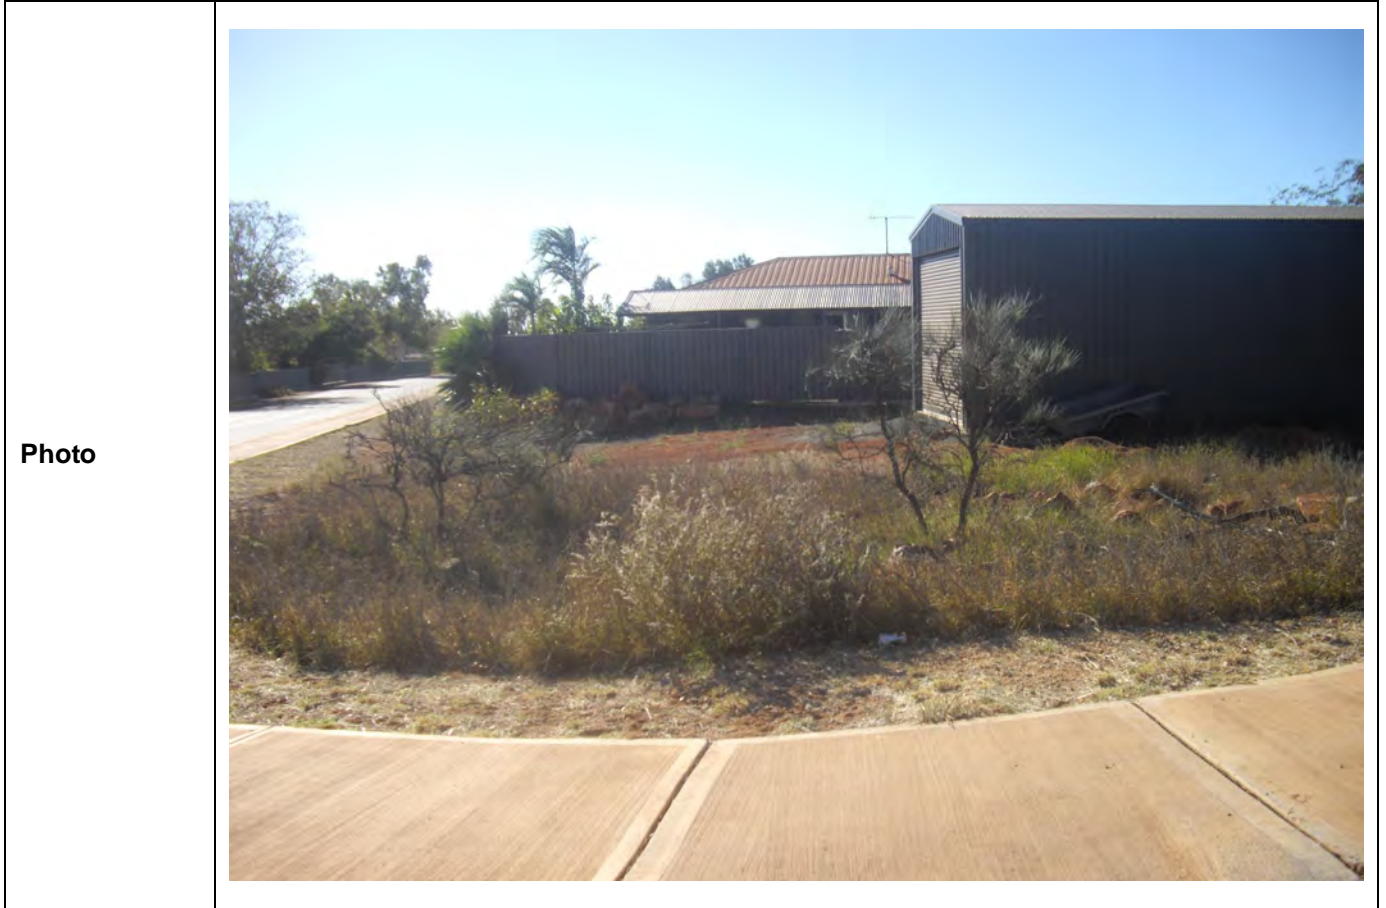
**3.12 Lot No. 3,200 Forrest Crescent**

<b>Category</b>	None
<b>Type</b>	None
<b>Description</b>	Flow path and capacity adequate
<b>Photo ID</b>	522
<b>Scope of Works</b>	None

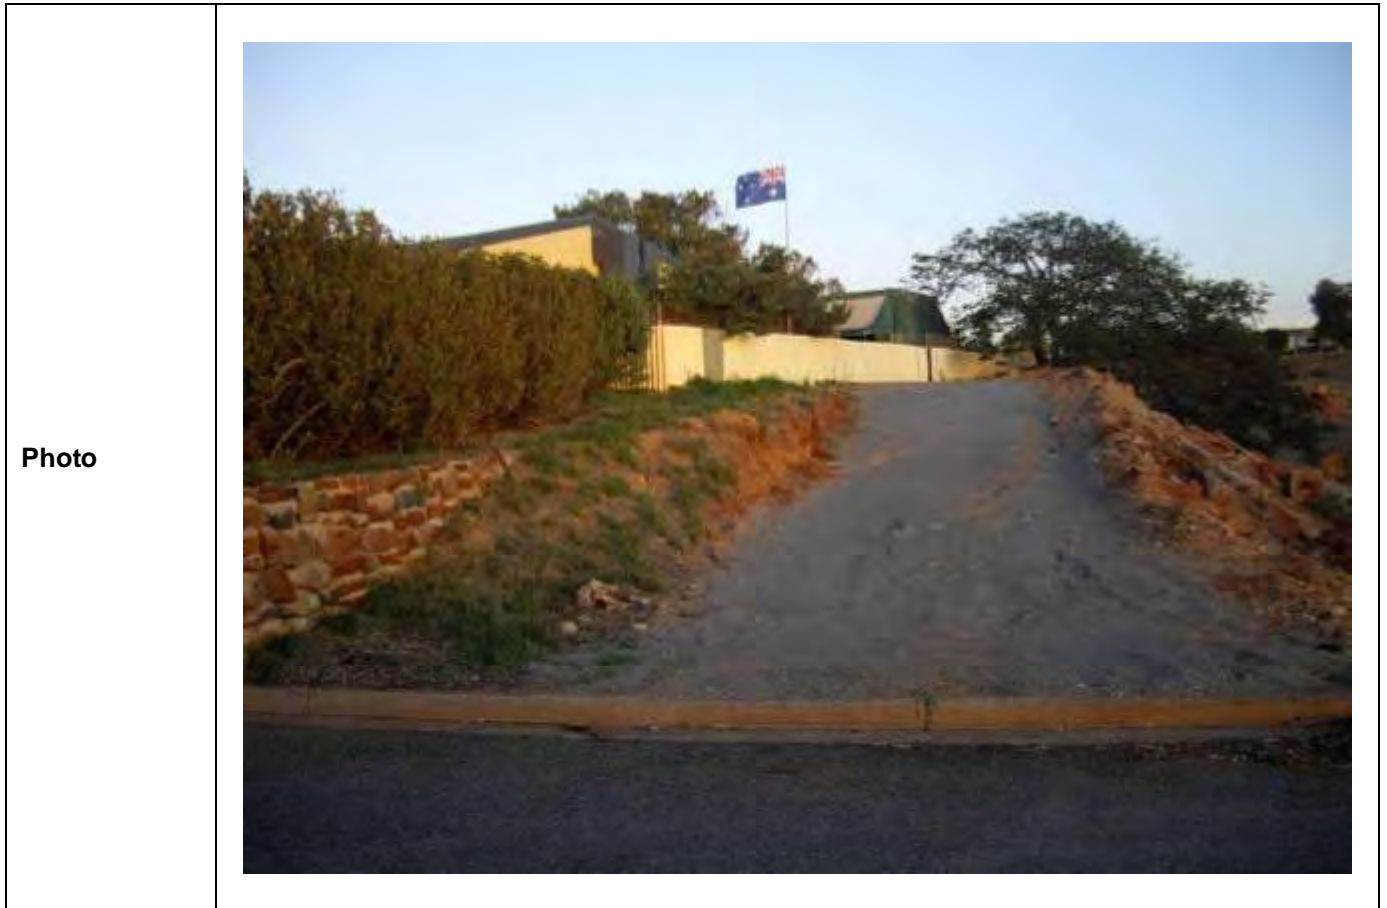
#### 4.1 Lot No. 201 Gregory Crescent

<b>Category</b>	Encroachment
<b>Type</b>	Rear access
<b>Description</b>	Side access within drainage reserve
<b>Photo ID</b>	687
<b>Scope of Works</b>	L - Remove access

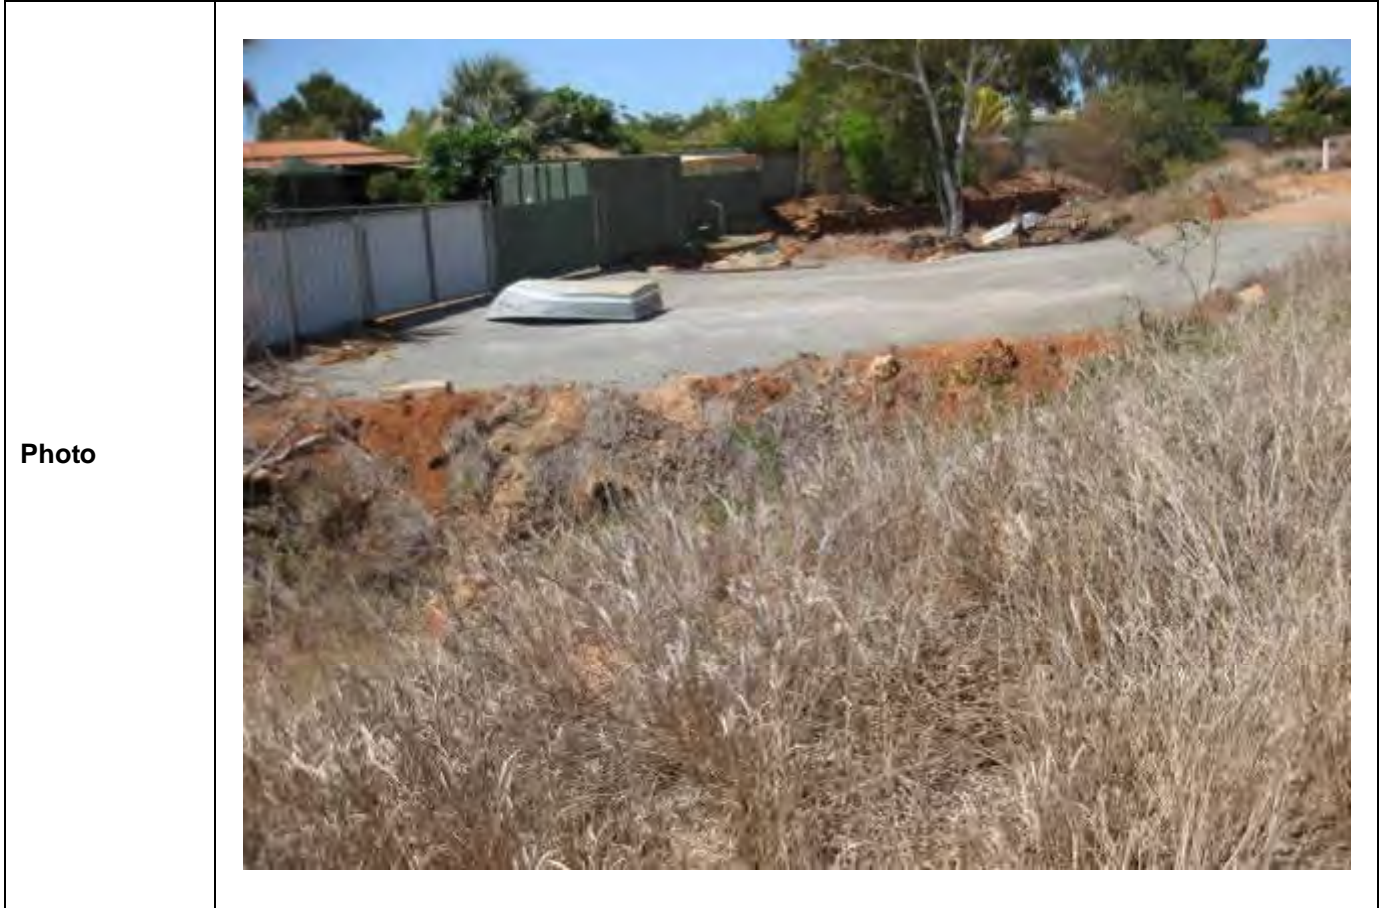
## 4.2 Lot No. 202 Gregory Crescent

<b>Category</b>	Encroachment
<b>Type</b>	Rear access General item
<b>Description</b>	Rear access with culvert impeding flow. Culvert is blocked Boat
<b>Photo ID</b>	7338 – silver fence
<b>Scope of Works</b>	H - Remove access way and reinstate drainage flow path as defined by the natural capacity and invert of channel of downstream lot L – Remove boat.

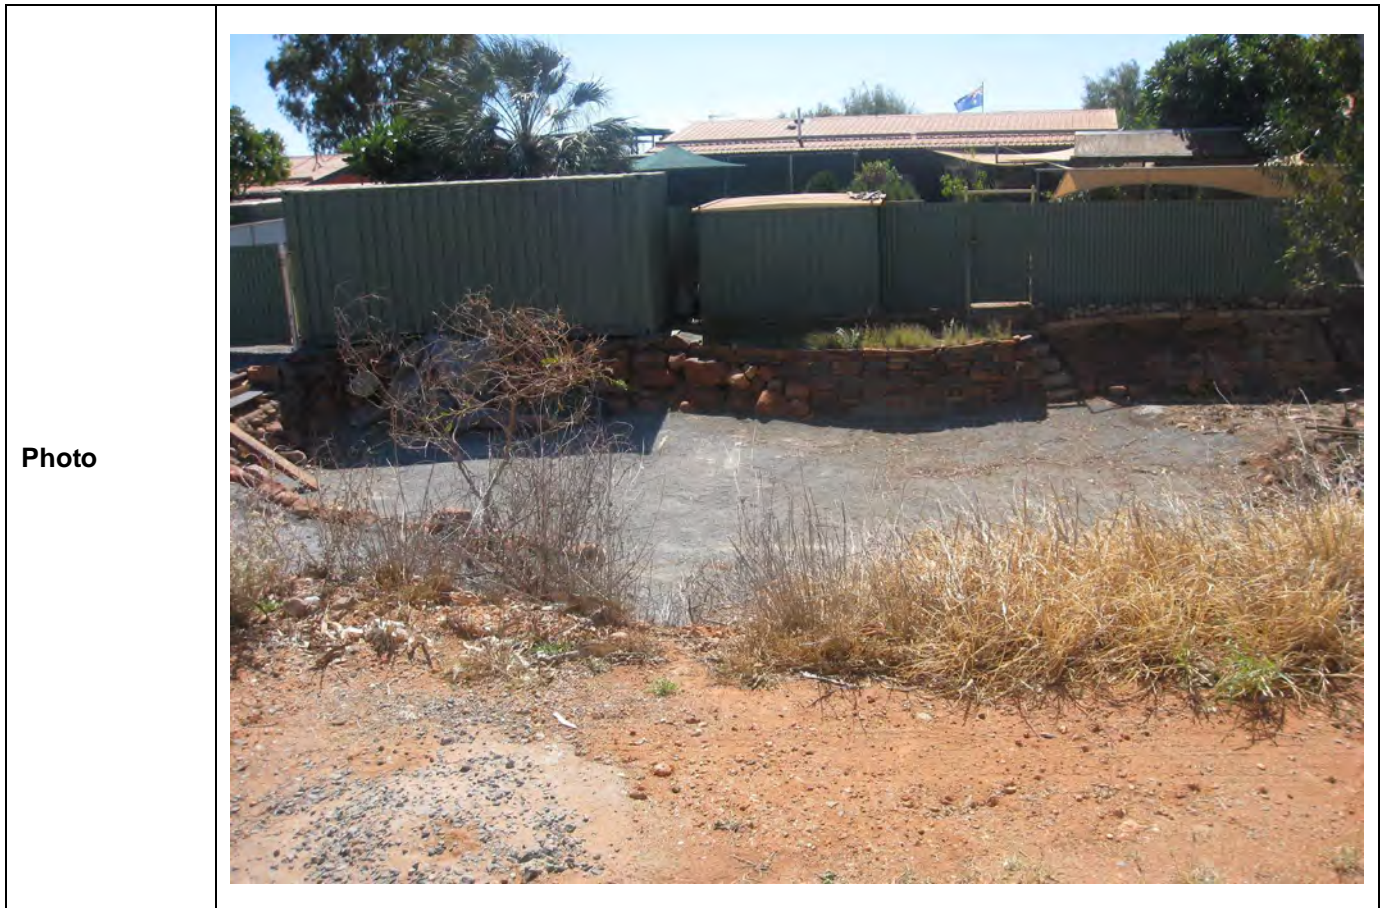
### 4.3 Lot No. 203 Gregory Crescent

<b>Category</b>	Encroachment
<b>Type</b>	Rear access
<b>Description</b>	Rear access with culvert impeding flow. Culvert is blocked;
<b>Photo ID</b>	7338 – green fence
<b>Scope of Works</b>	H - Remove access way and reinstate drainage flow path as defined by the natural capacity and invert of channel of downstream lot

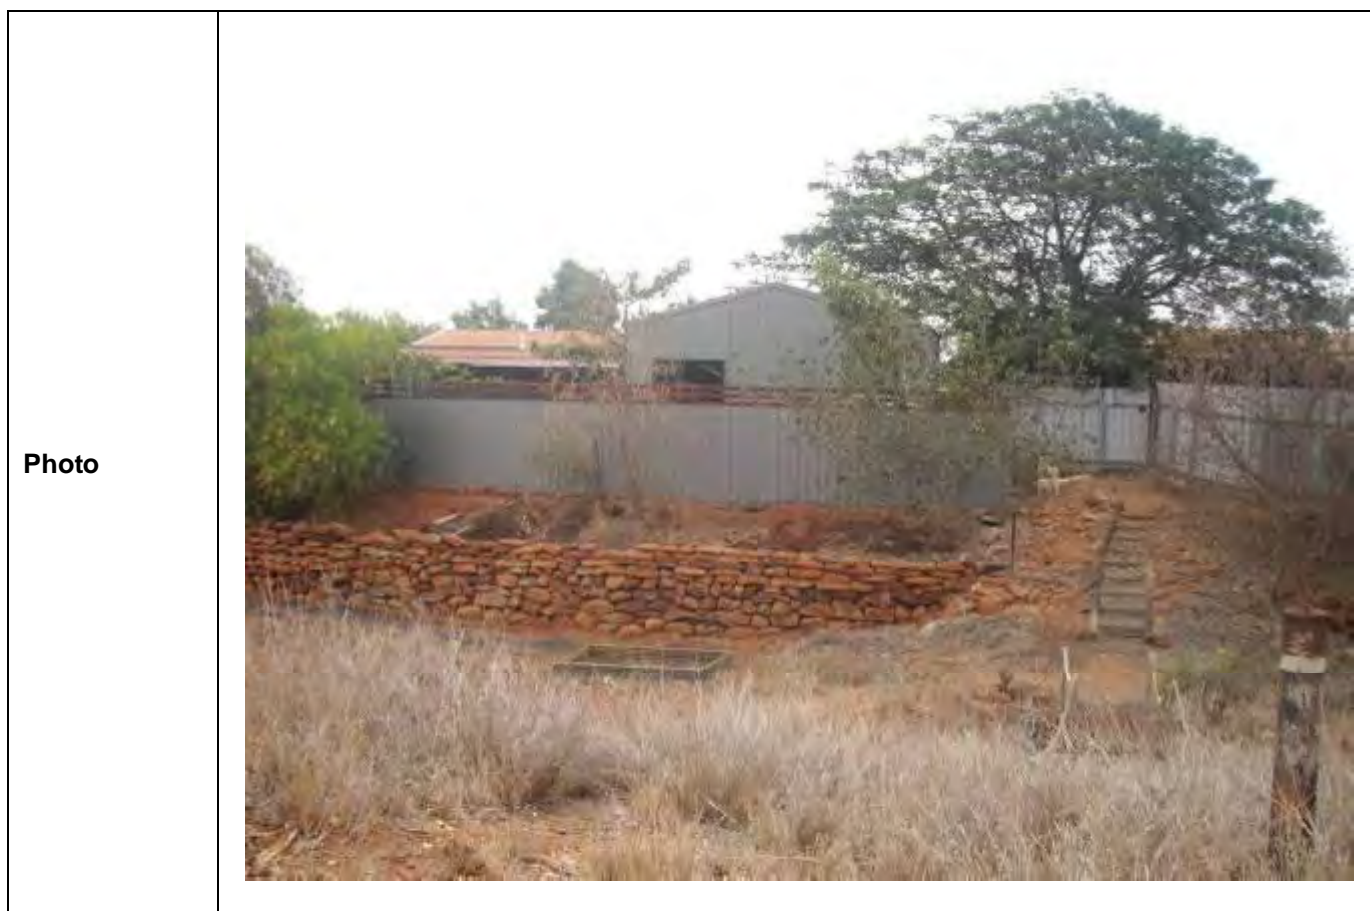
#### 4.4 Lot No. 204 Gregory Crescent

<b>Category</b>	Encroachment
<b>Type</b>	General item – pipe General item - garden
<b>Description</b>	Pipe bridge creating a reduced drainage cross section; Garden within base of drainage reserve.
<b>Photo ID</b>	594
<b>Scope of Works</b>	L – Remove bridge and reinstate drainage flow path as defined by the natural capacity and invert of channel of downstream lot L – Remove garden.
