City of Karratha  
Dampier Stormwater Management Study  
Report  
Part B  
June 2015

## Appendix **C** – 2010 encroachment reviews

**Rio Tinto Iron Ore**  
Report on Dampier Drainage  
Review  
Block 1 Encroachments  
June 2010

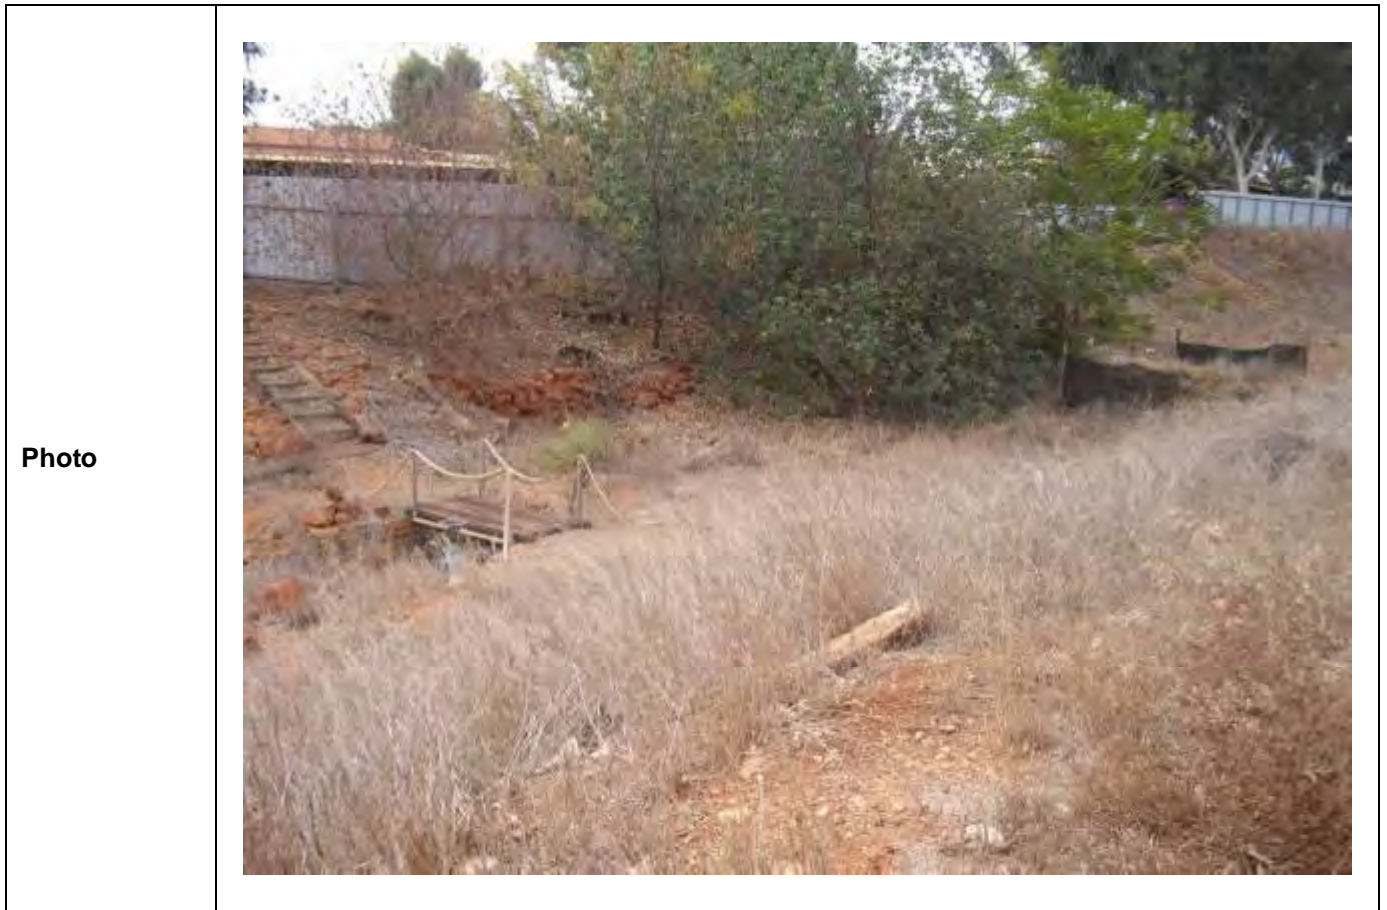
#### 4.5 Lot No. 205 Gregory Crescent

<b>Category</b>	Encroachment
<b>Type</b>	General items
<b>Description</b>	Constructed fenced garden in drain base
<b>Photo ID</b>	595
<b>Scope of Works</b>	M - Remove garden

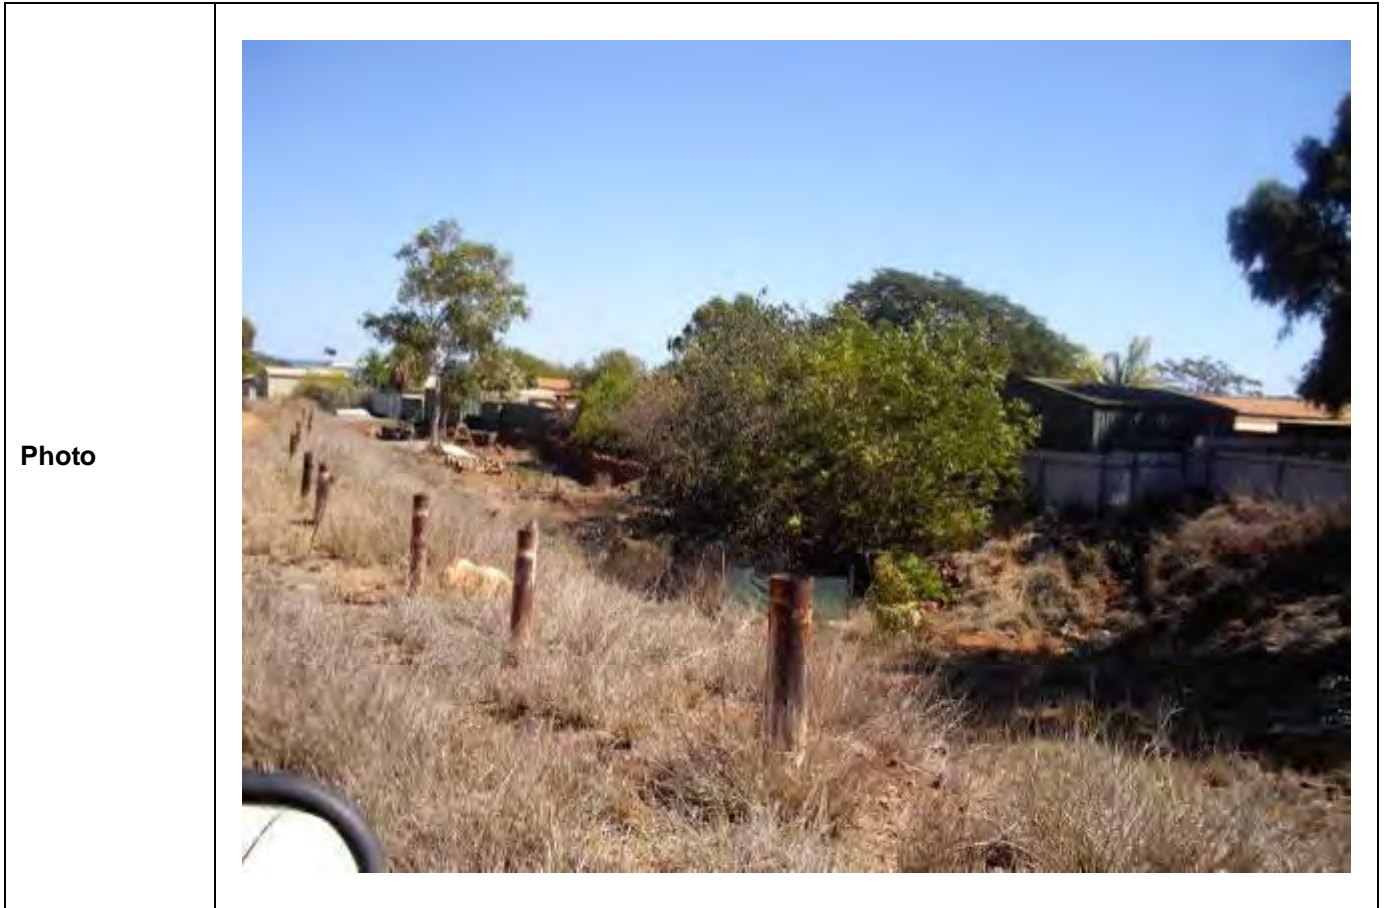
#### 4.6 Lot No. 206 Gregory Crescent

<b>Category</b>	None
<b>Type</b>	None
<b>Description</b>	None – flow path and capacity adequate
<b>Photo ID</b>	398
<b>Scope of Works</b>	None required

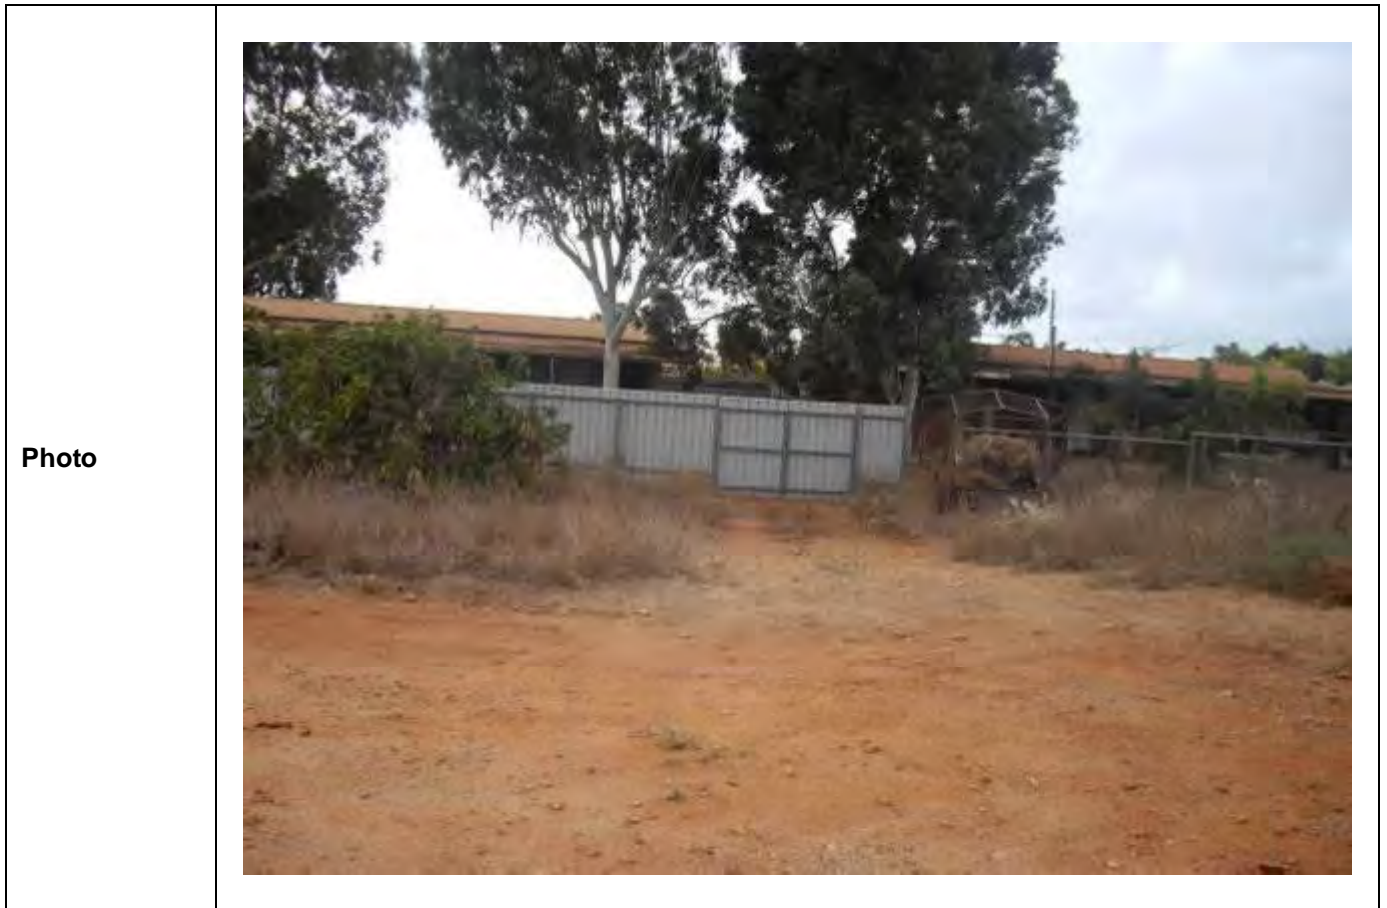
#### 4.7 Lot No. 207 Gregory Crescent

<b>Category</b>	Encroachment
<b>Type</b>	Rear access
<b>Description</b>	Rear access and modified topography impede flow Modified reserve due to fill
<b>Photo ID</b>	593
<b>Scope of Works</b>	H - Remove access way and reinstate drainage flow path as defined by the natural capacity and invert of channel of downstream lot

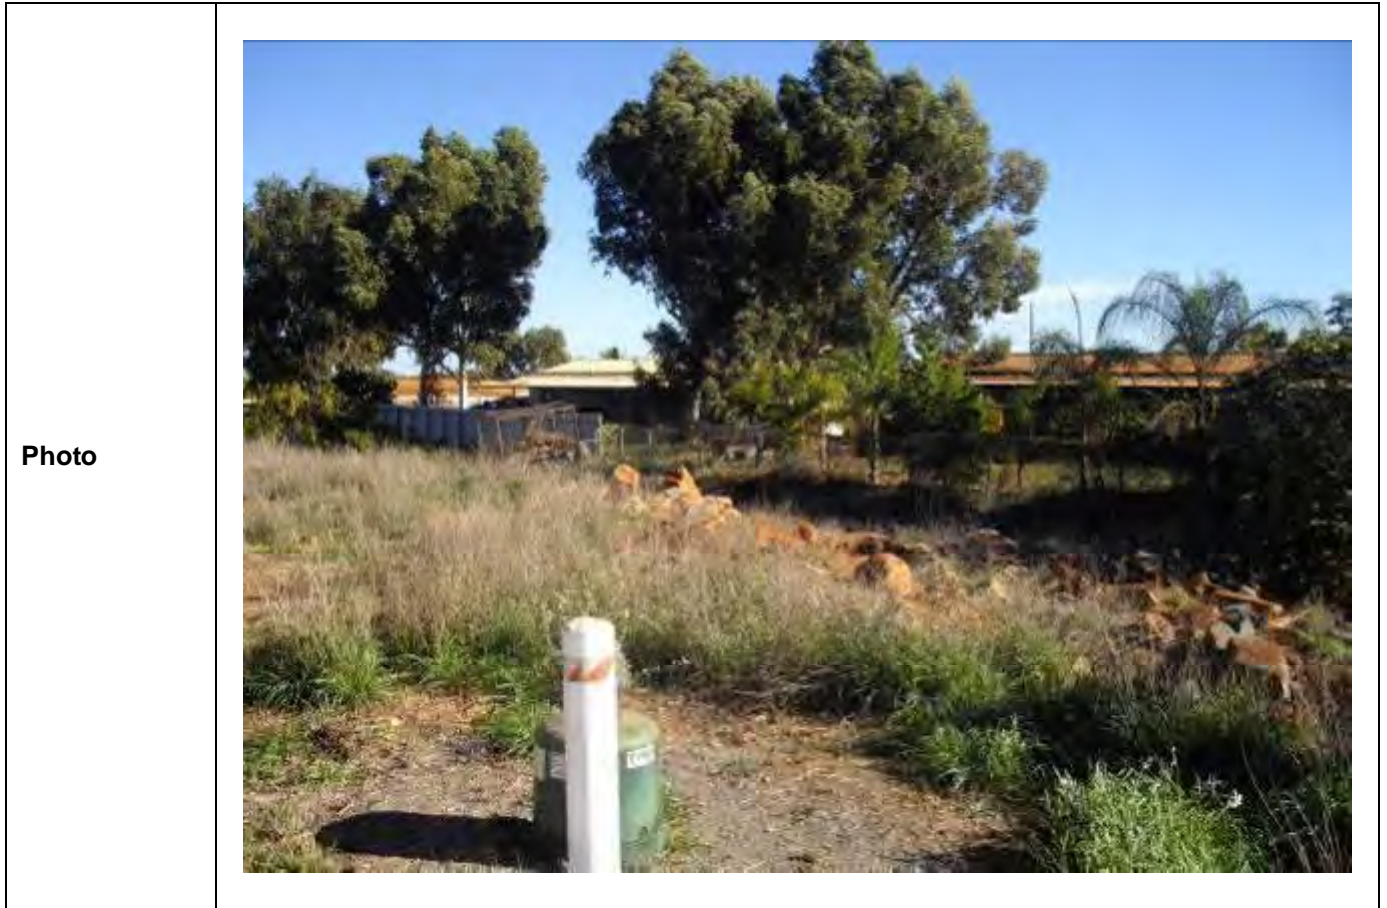
#### 4.8 Lot No. 208 Gregory Crescent

<b>Category</b>	None
<b>Type</b>	
<b>Description</b>	Rock mound between lots 208 and 1208 is catchment divide
<b>Photo ID</b>	833
<b>Scope of Works</b>	None

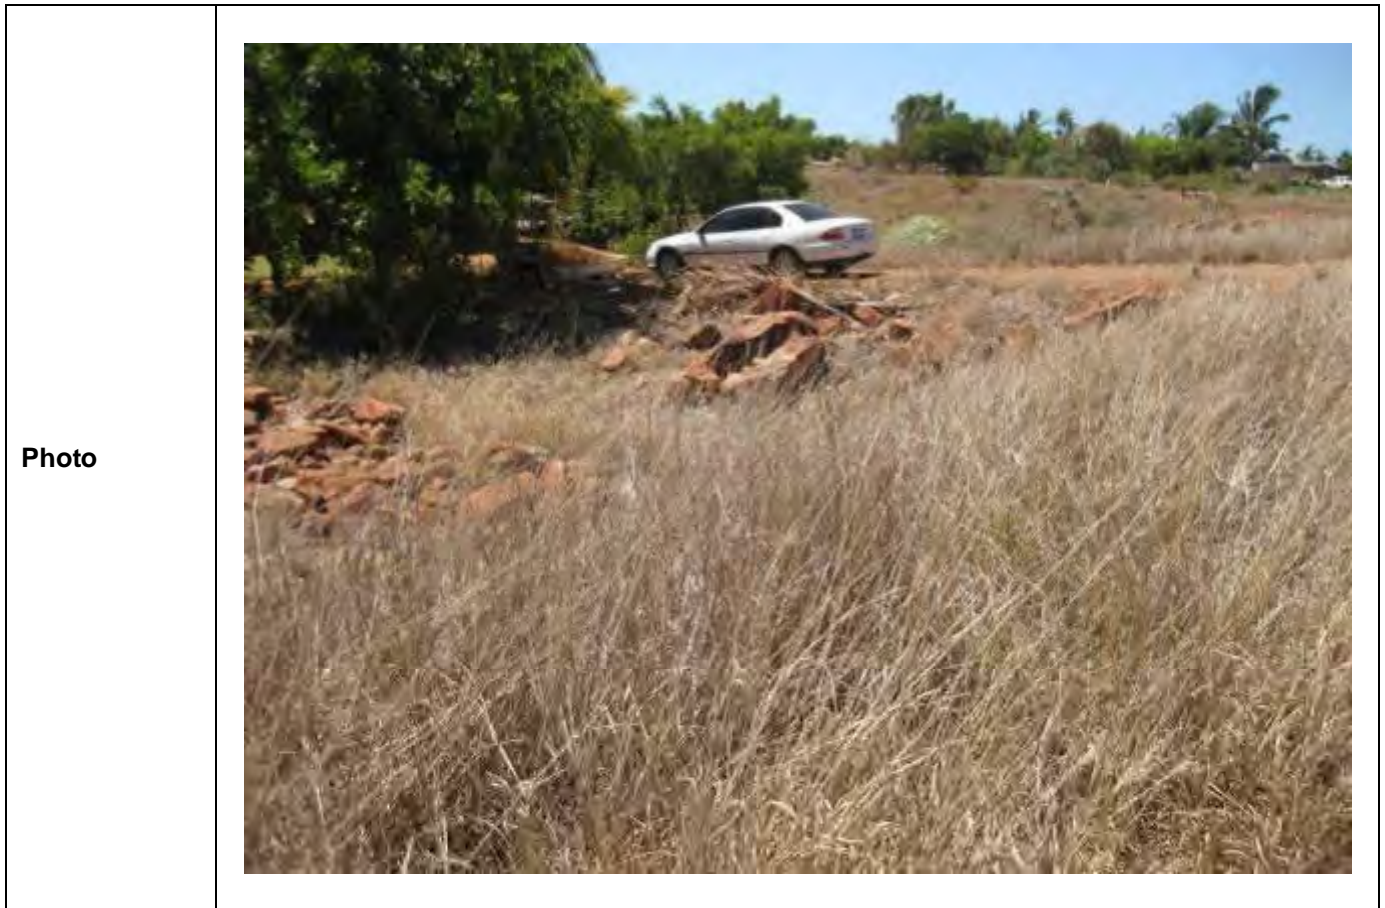
#### 4.9 Lot No. 1,208 Gregory Crescent

<b>Category</b>	Encroachment
<b>Type</b>	Rear access
<b>Description</b>	Rear access impeding flow impedes flow
<b>Photo ID</b>	7335
<b>Scope of Works</b>	H - Remove access way and reinstate drainage flow path as defined by the natural capacity and invert of channel of downstream lot

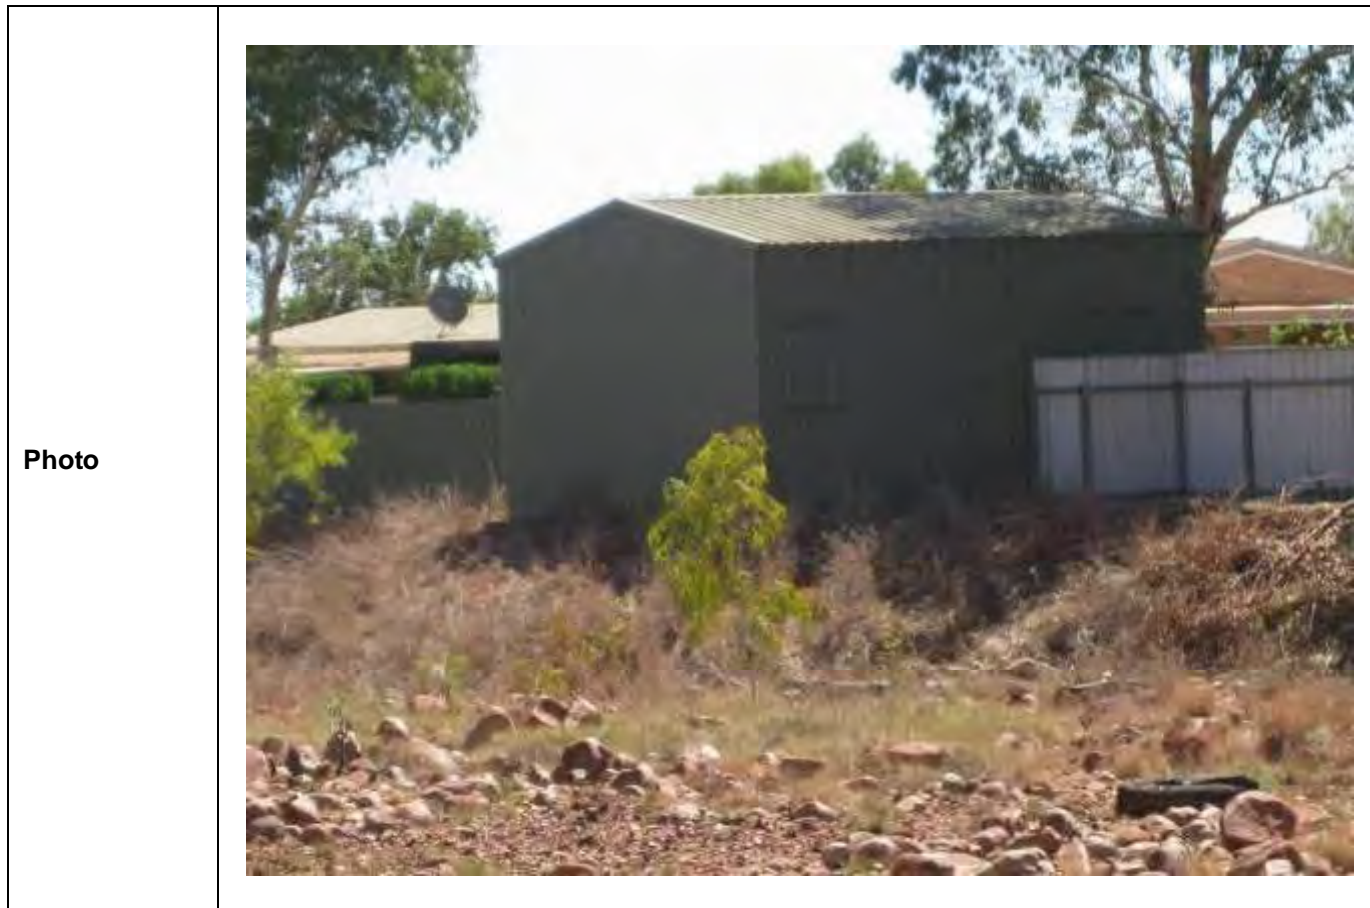
**5.1 Lot No. 209 Roe Crescent**

<b>Category</b>	Encroachment
<b>Type</b>	Boundary extension
<b>Description</b>	Shed
<b>Photo ID</b>	7341
<b>Scope of Works</b>	L - Remove shed extension

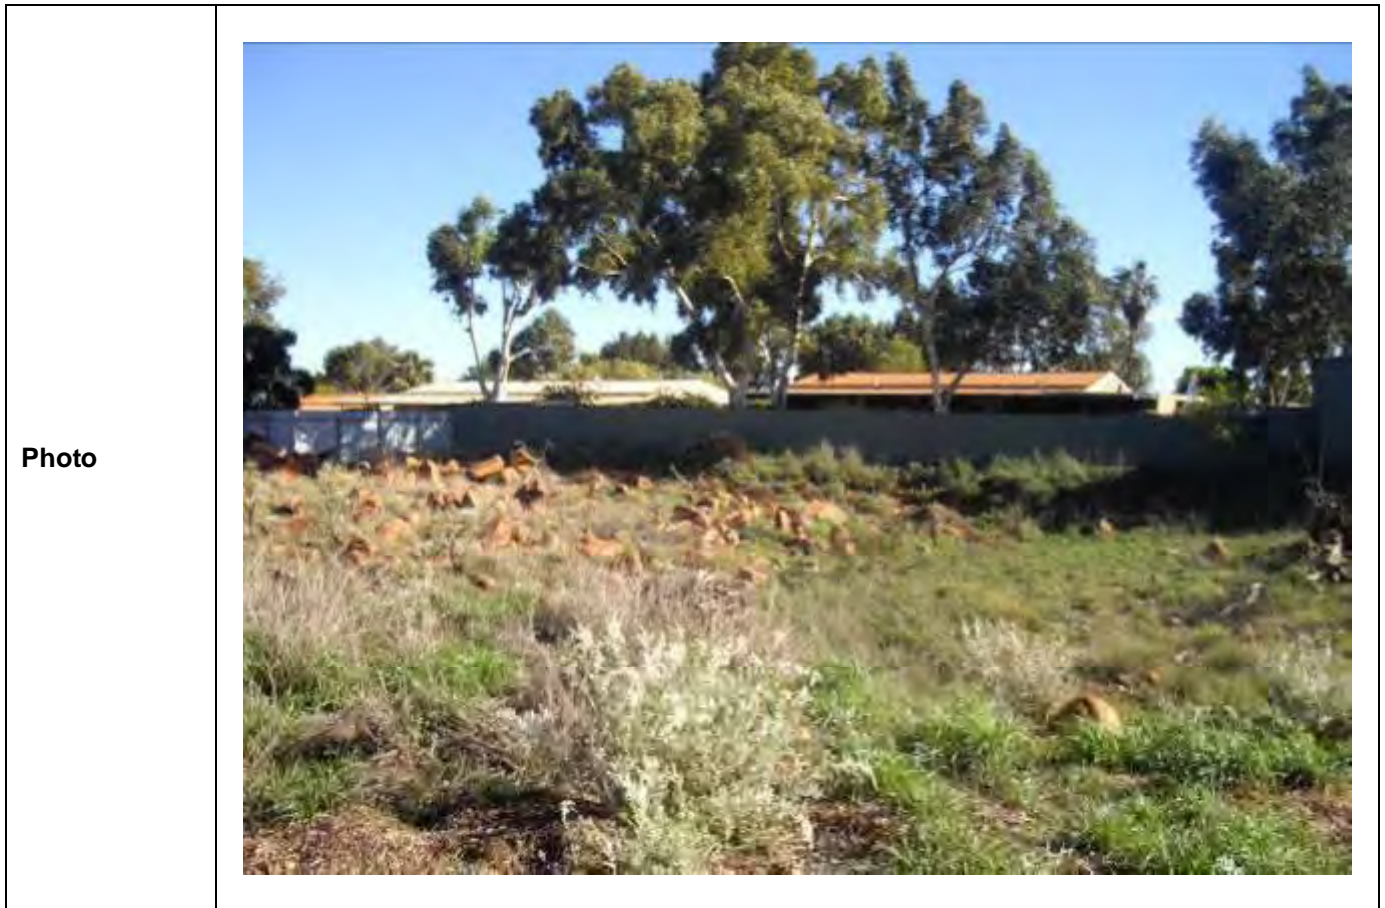
## 5.2 Lot No. 210 Roe Crescent

<b>Category</b>	Drain Maintenance
<b>Type</b>	Rocks
<b>Description</b>	Dumped rocks reduce capacity
<b>Rank</b>	-
<b>Photo ID</b>	842
<b>Scope of Works</b>	H – Remove rocks and reinstate drainage flow path as defined by the natural capacity and invert of channel of downstream lot

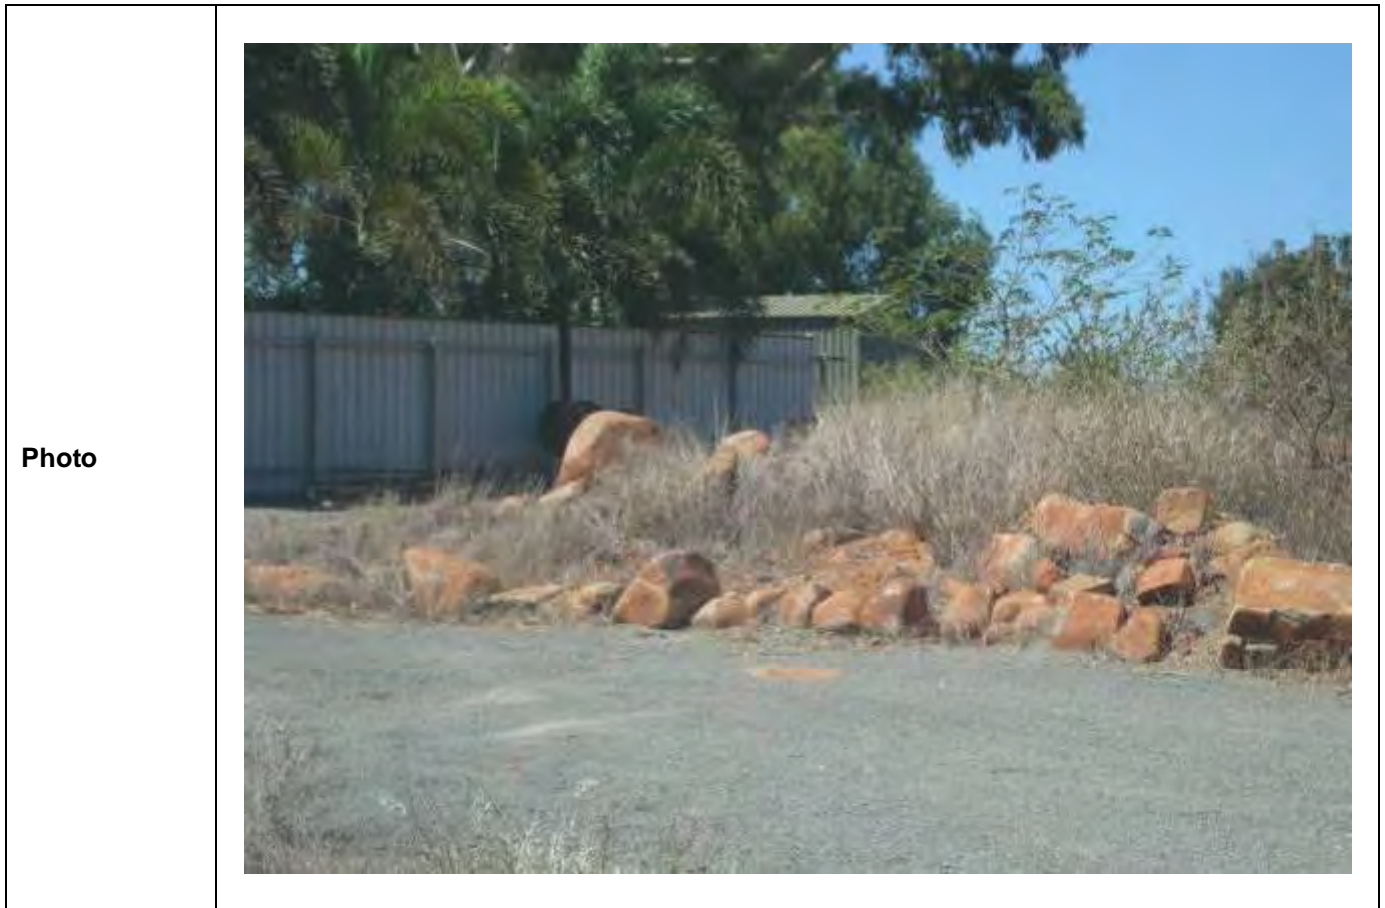
### 5.3 Lot No. 211 Roe Crescent

<b>Category</b>	Encroachment
<b>Type</b>	Rear access
<b>Description</b>	Filled in rear access sends drainage to road
<b>Rank</b>	H
<b>Photo ID</b>	7340
<b>Scope of Works</b>	H - Remove access way and reinstate drainage flow path as defined by the natural capacity and invert of channel of downstream lot

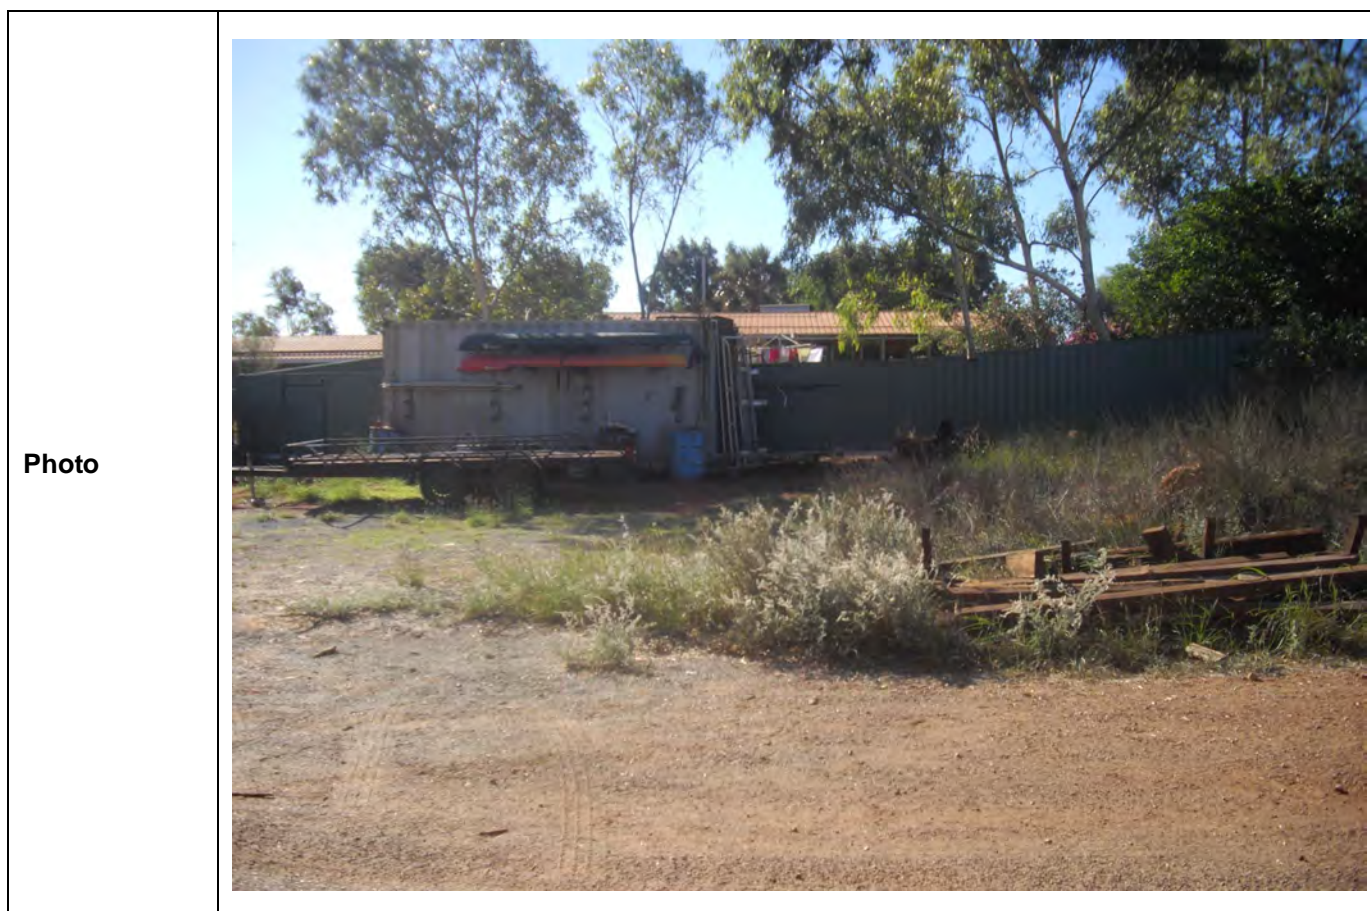
## 5.4 Lot No. 212 Roe Crescent

<b>Category</b>	Encroachment / Drain Maintenance
<b>Type</b>	Rear access General items Modified drainage reserve
<b>Description</b>	Rear access impedes flow Container, trailer Fill material.
<b>Photo ID</b>	7340
<b>Scope of Works</b>	H – Remove rear access and reinstate drainage flow path as defined by the natural capacity and invert of channel of downstream lot L – Remove container and trailer

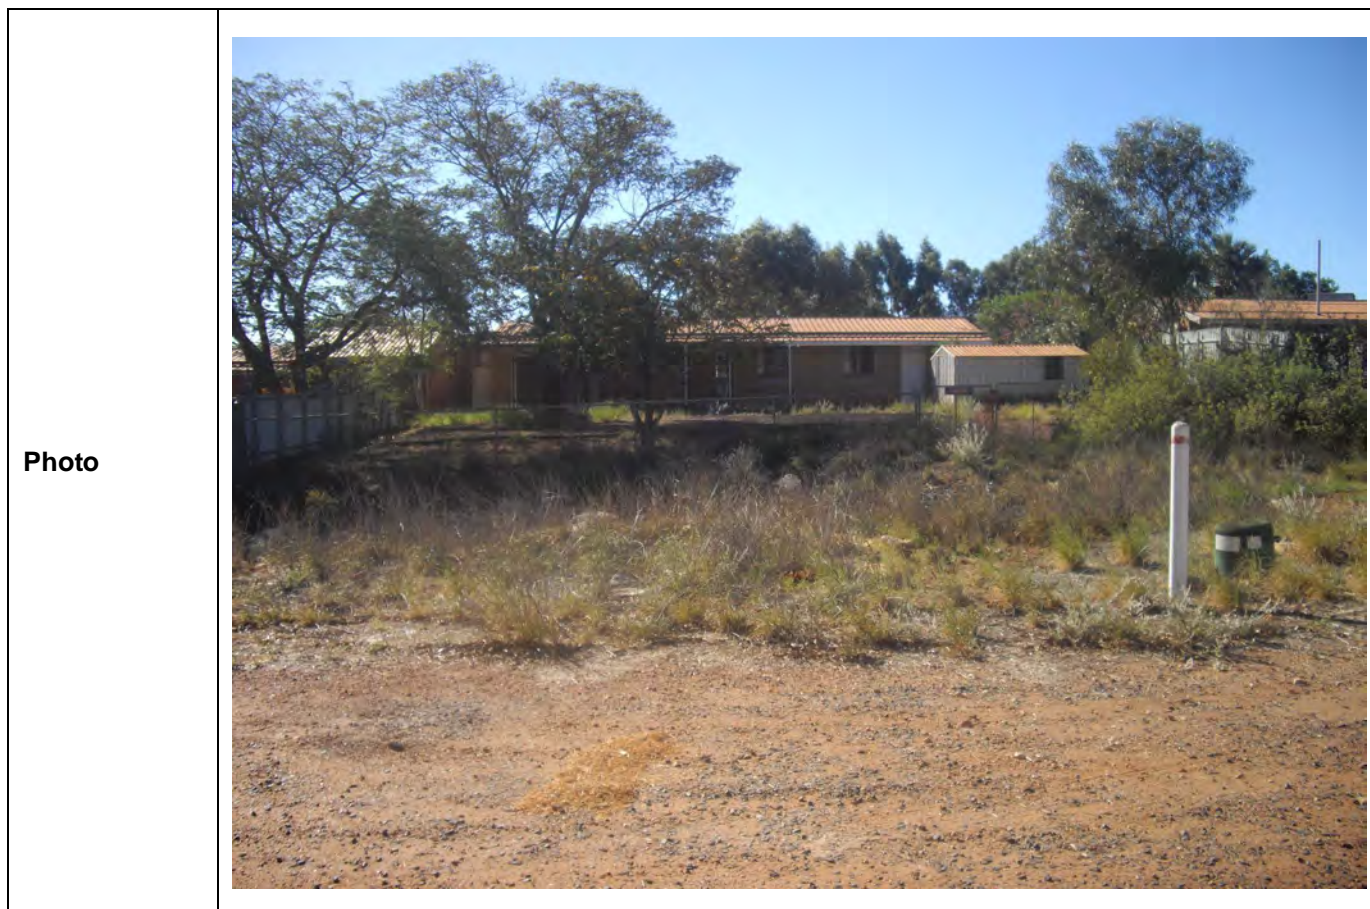
## 5.5 Lot No. 213 Roe Crescent

<b>Category</b>	Encroachment / Drain maintenance
<b>Type</b>	Rear access Rocks
<b>Description</b>	Rear access and rocks impeding flow
<b>Photo ID</b>	1062
<b>Scope of Works</b>	H – Remove rear access and reinstate drainage flow path as defined by the natural capacity and invert of channel of downstream lot M - Remove rock obstructing drain.

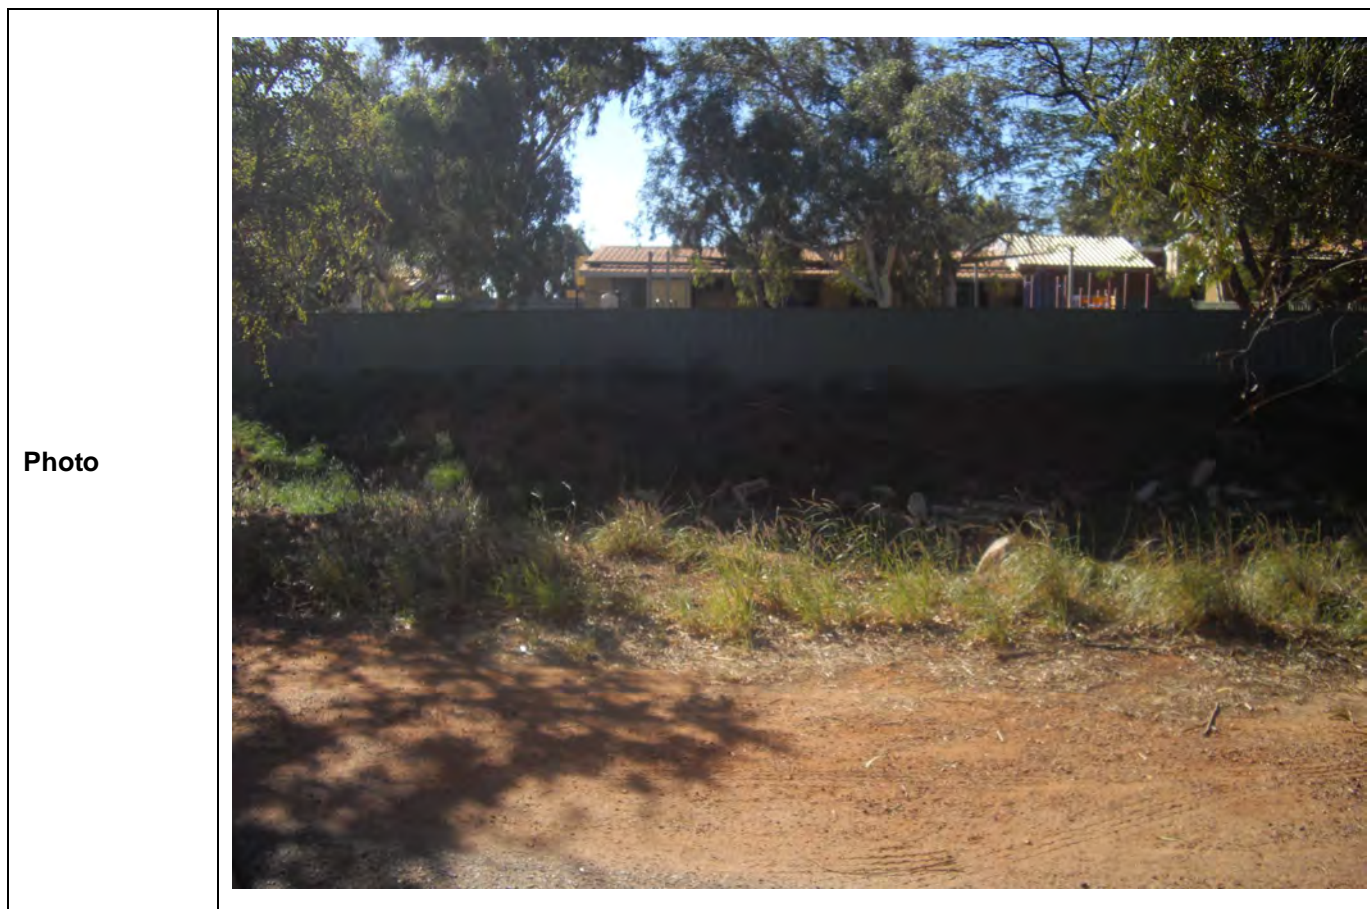
## 5.6 Lot No. 214 Roe Crescent

<b>Category</b>	Drain Maintenance
<b>Type</b>	
<b>Description</b>	Water main reducing cross sectional capacity Flow path adequate
<b>Photo ID</b>	393
<b>Scope of Works</b>	Water main note – no works required

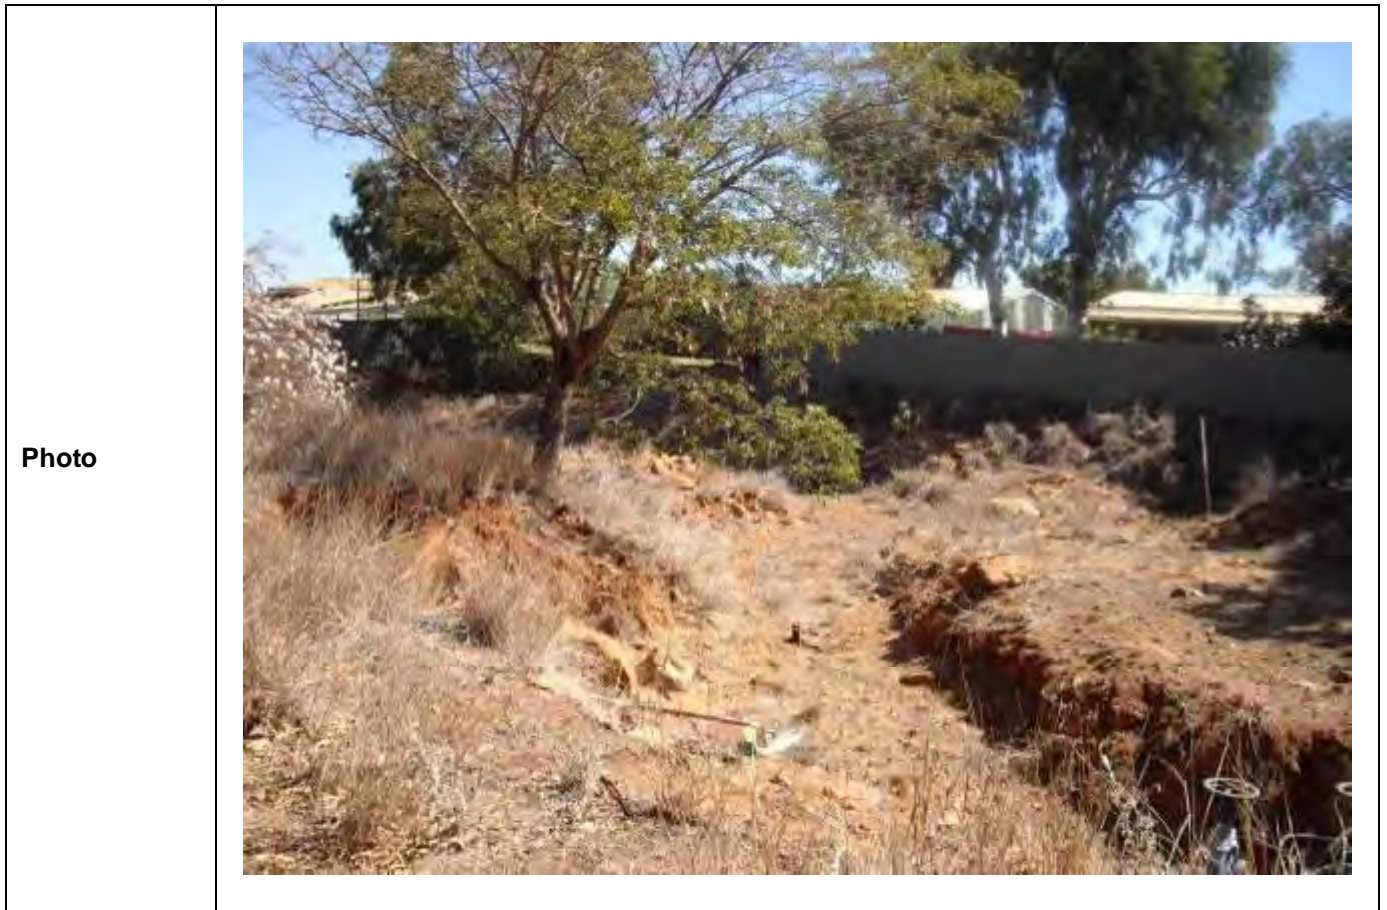
## 5.8 Lot No. 216 Roe Crescent

<b>Category</b>	None
<b>Type</b>	None
<b>Description</b>	None - drain flow path and capacity adequate
<b>Photo ID</b>	396, 1065
<b>Scope of Works</b>	N/A

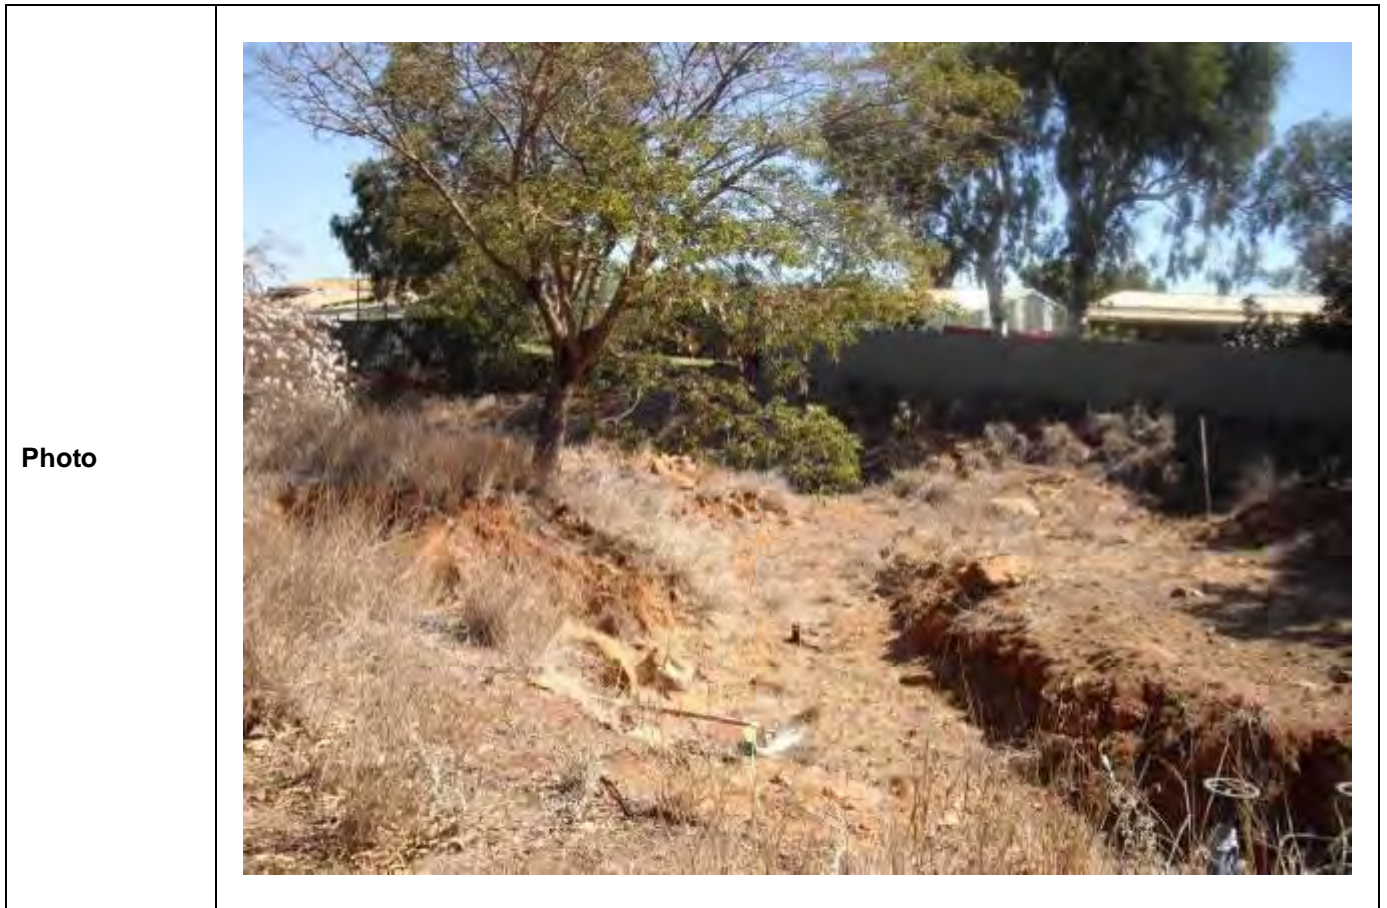
**5.9 Lot No. 217 Roe Crescent**

<b>Category</b>	None
<b>Type</b>	None
<b>Description</b>	None - drain flow path and capacity adequate
<b>Photo ID</b>	396, 1066
<b>Scope of Works</b>	N/A

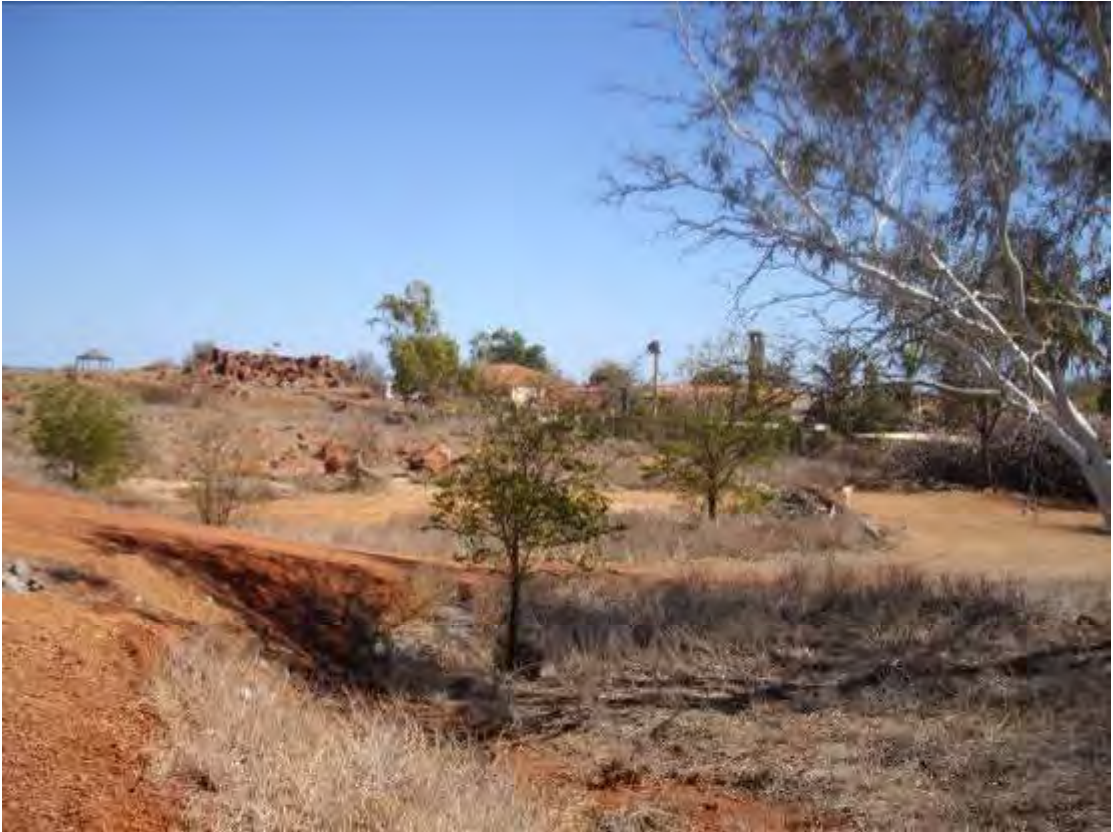
## 6.1 Lot No. 1,218 Fremantle Crescent

<p><b>Category</b></p>	<p>None</p>
<p><b>Type</b></p>	<p>Rear access</p>
<p><b>Description</b></p>	<p>Hard stand area. Overland flow path at this point at the top of the catchment. There is no concentration of flow.</p>
<p><b>Photo ID</b></p>	<p>397</p>
<p><b>Scope of Works</b></p>	<p>None</p>

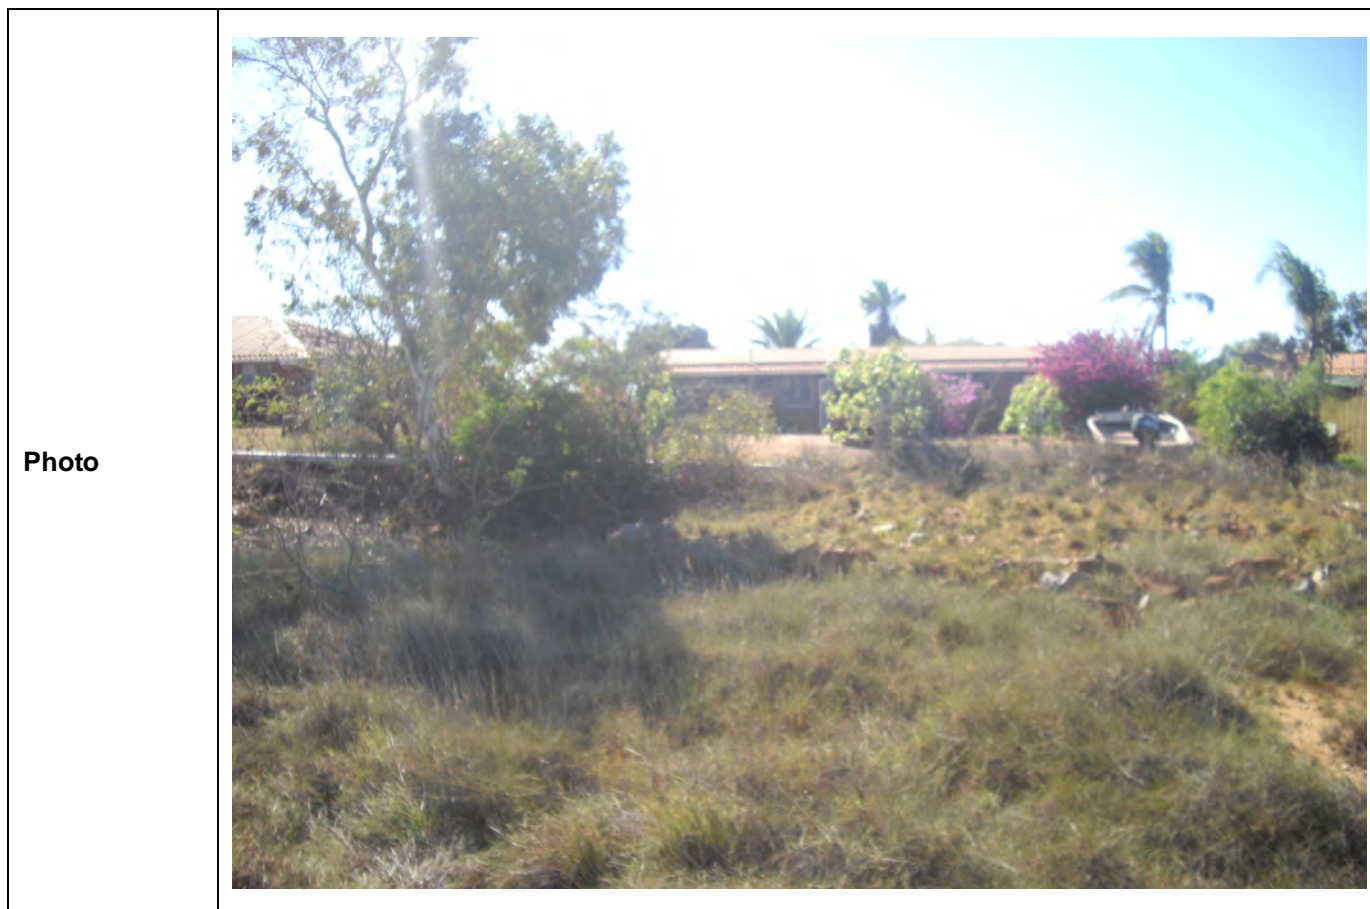
## 6.2 Lot No. 218 Fremantle Crescent

<b>Category</b>	Drain Maintenance/ Encroachment
<b>Type</b>	Flow path
<b>Description</b>	Flow directed towards lots
<b>Photo ID</b>	1059, 397
<b>Scope of Works</b>	M – Redefine flow path to within drainage reserve.

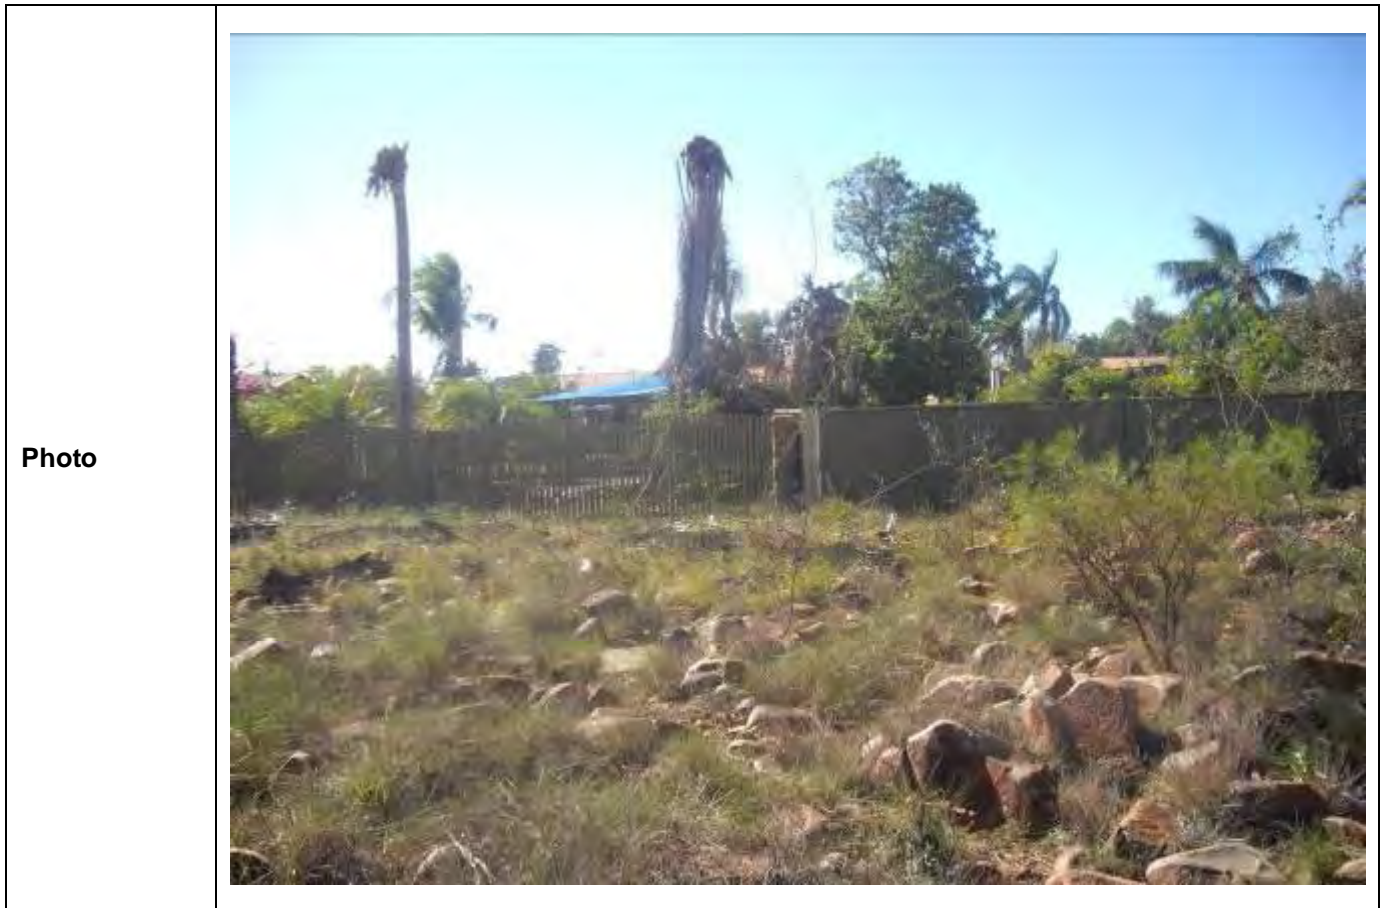
### 6.3 Lot No. 219 Fremantle Crescent

<b>Category</b>	Drain Maintenance
<b>Type</b>	Flow path
<b>Description</b>	Flow directed towards lots
<b>Photo ID</b>	1058, 841
<b>Scope of Works</b>	M – Redefine flow path to within drainage reserve.

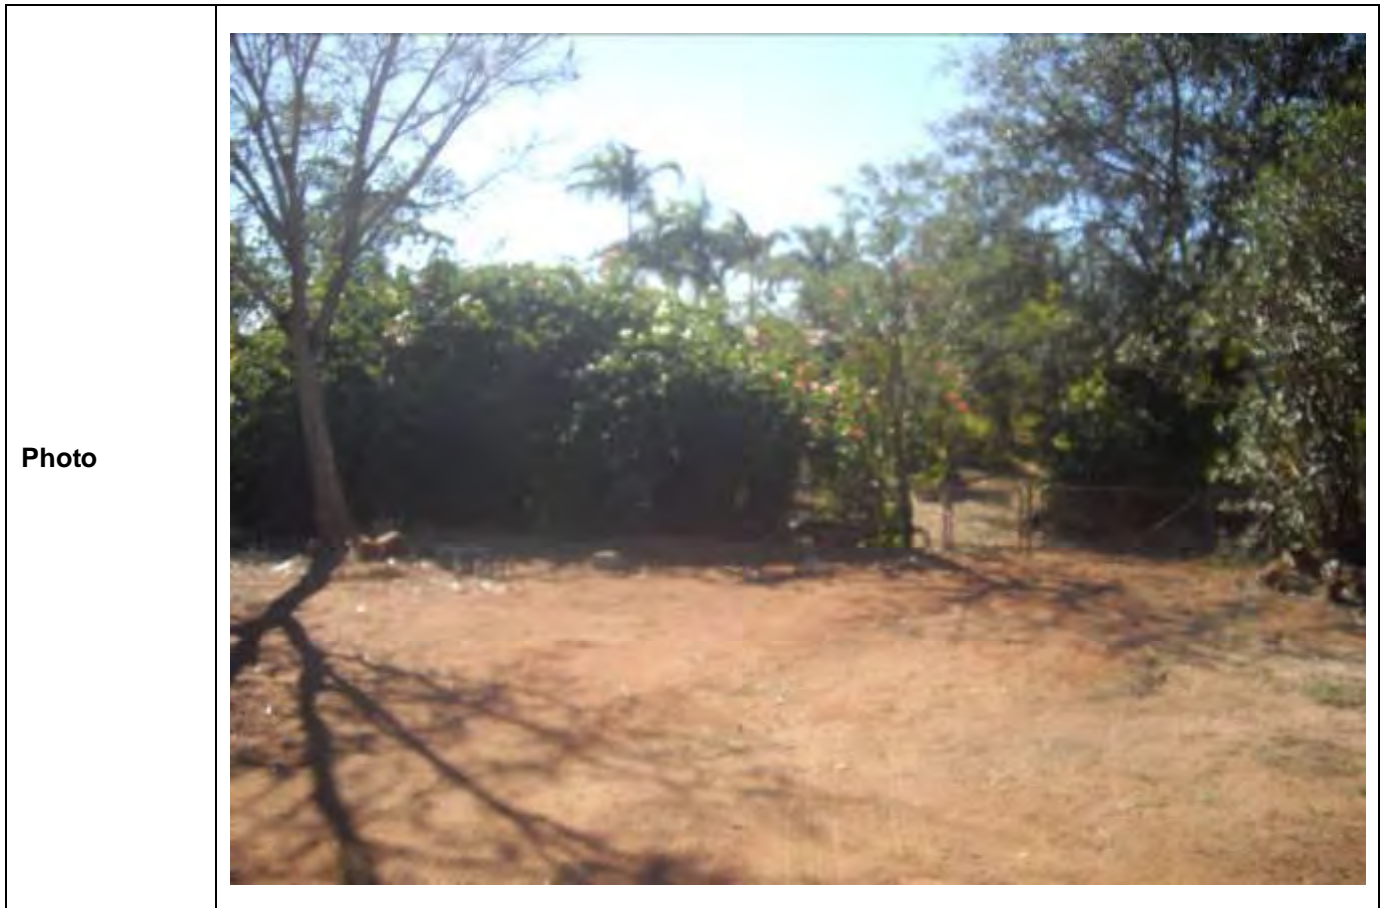
## 6.4 Lot No. 220 Fremantle Crescent

<b>Category</b>	Encroachment
<b>Type</b>	Rear access
<b>Description</b>	Rear access and modified topography impedes flow and directs towards lots
<b>Photo ID</b>	592
<b>Scope of Works</b>	H – Remove rear access and reinstate drainage flow path as defined by the natural capacity and invert of channel of downstream lot
