City of Karratha  
Dampier Stormwater Management Study  
Report  
Part B  
June 2015

## Appendix **C** – 2010 encroachment reviews

**Rio Tinto Iron Ore**  
Report on Dampier Drainage  
Review  
Block 1 Encroachments  
June 2010

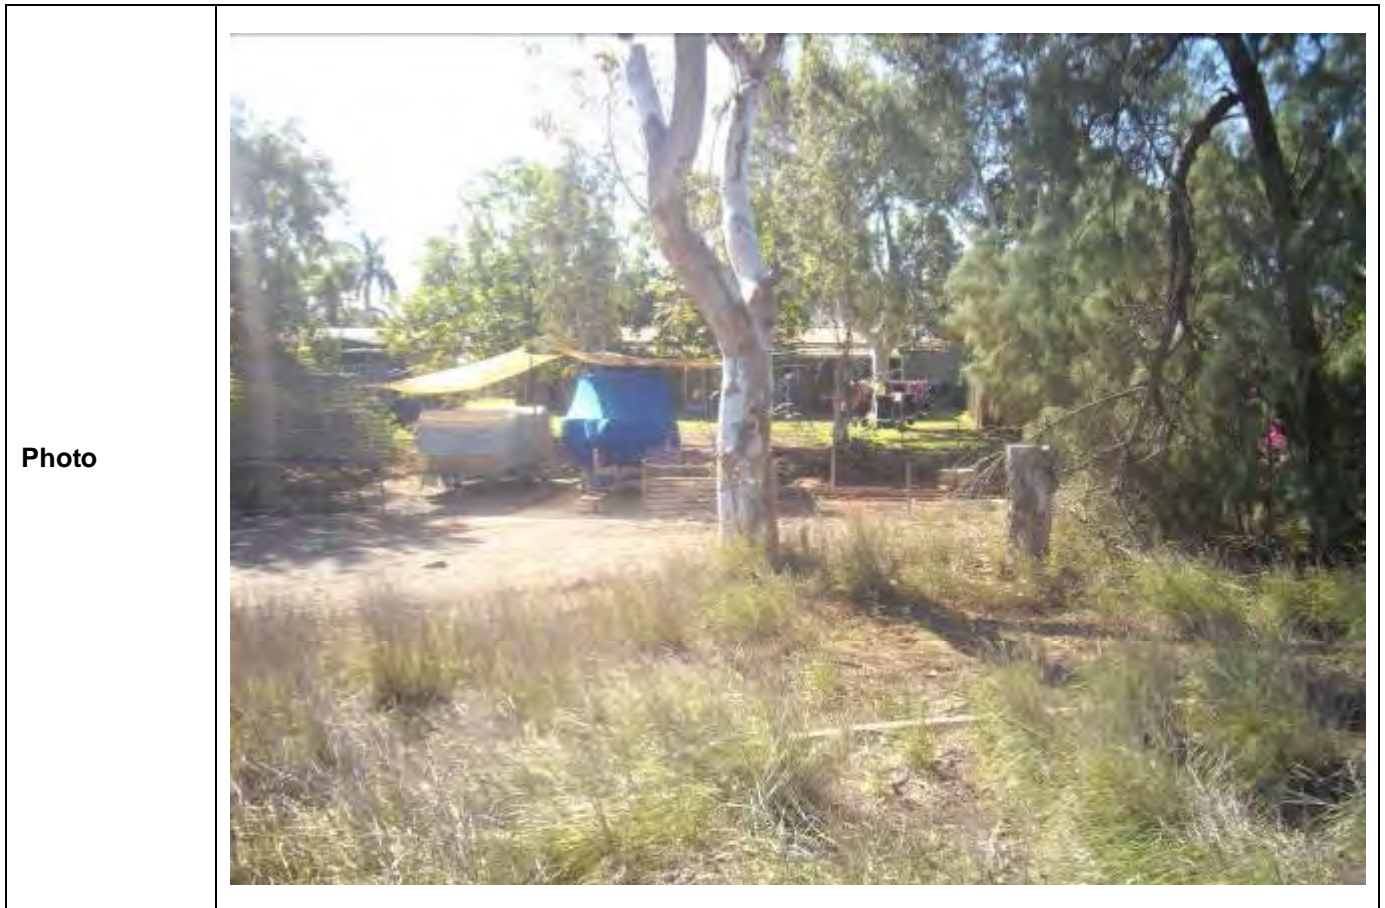
## 6.5 Lot No. 221 Fremantle Crescent

<b>Category</b>	Encroachment
<b>Type</b>	Rear access
<b>Description</b>	Rear access follows natural topography Receives stormwater runoff from road via kerb break
<b>Photo ID</b>	1056, 592
<b>Scope of Works</b>	L – Remove rear access reinstate drainage flow path as defined by the natural capacity and invert of channel of downstream lot

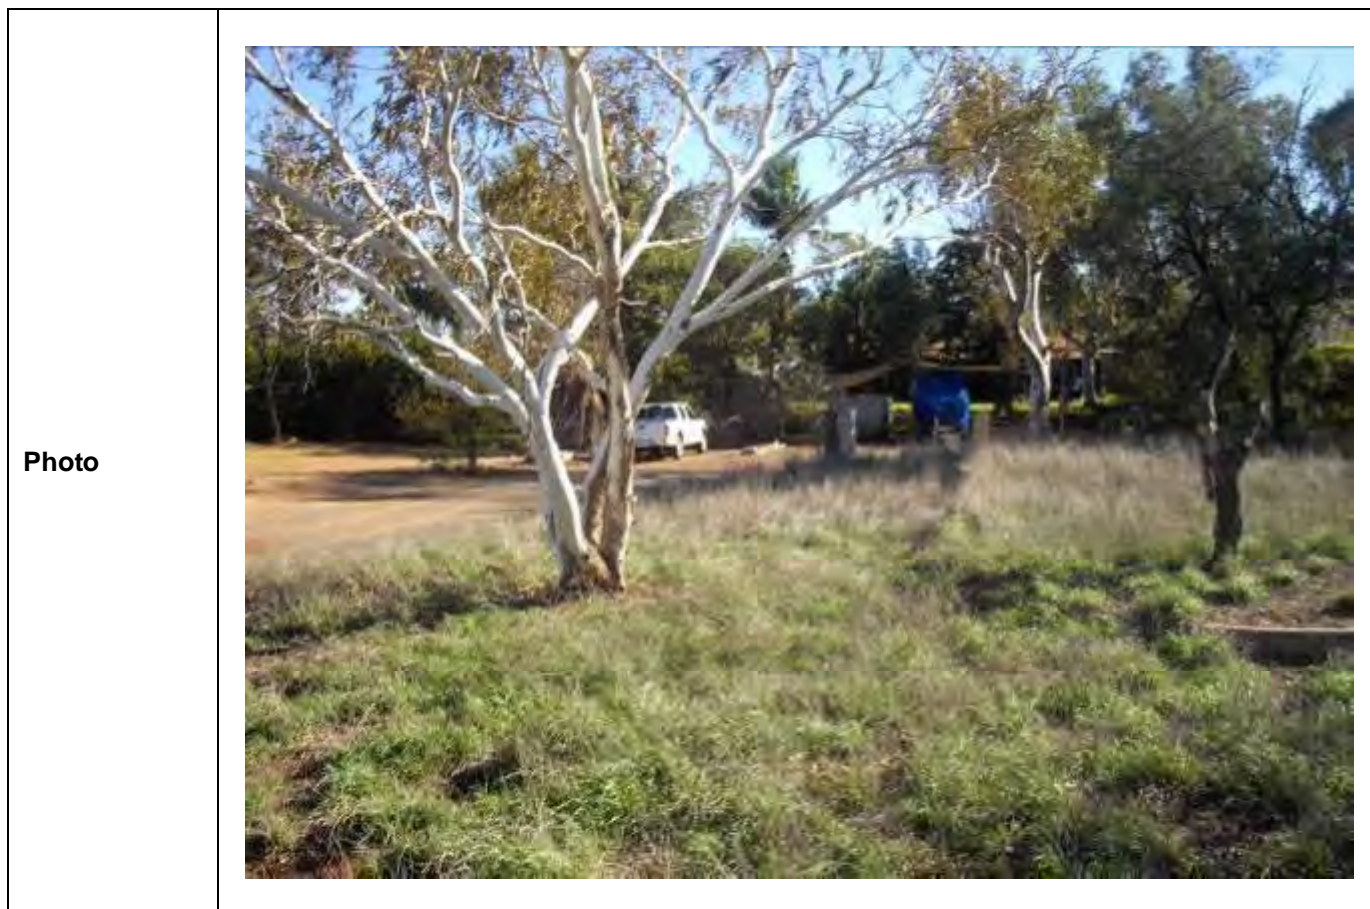
## 6.6 Lot No. 222 Fremantle Crescent

<b>Category</b>	Drain Maintenance/ Encroachment
<b>Type</b>	Flow path
<b>Description</b>	Flows towards lots
<b>Photo ID</b>	1055, 840
<b>Scope of Works</b>	M – Redefine flow path to within drainage reserve.

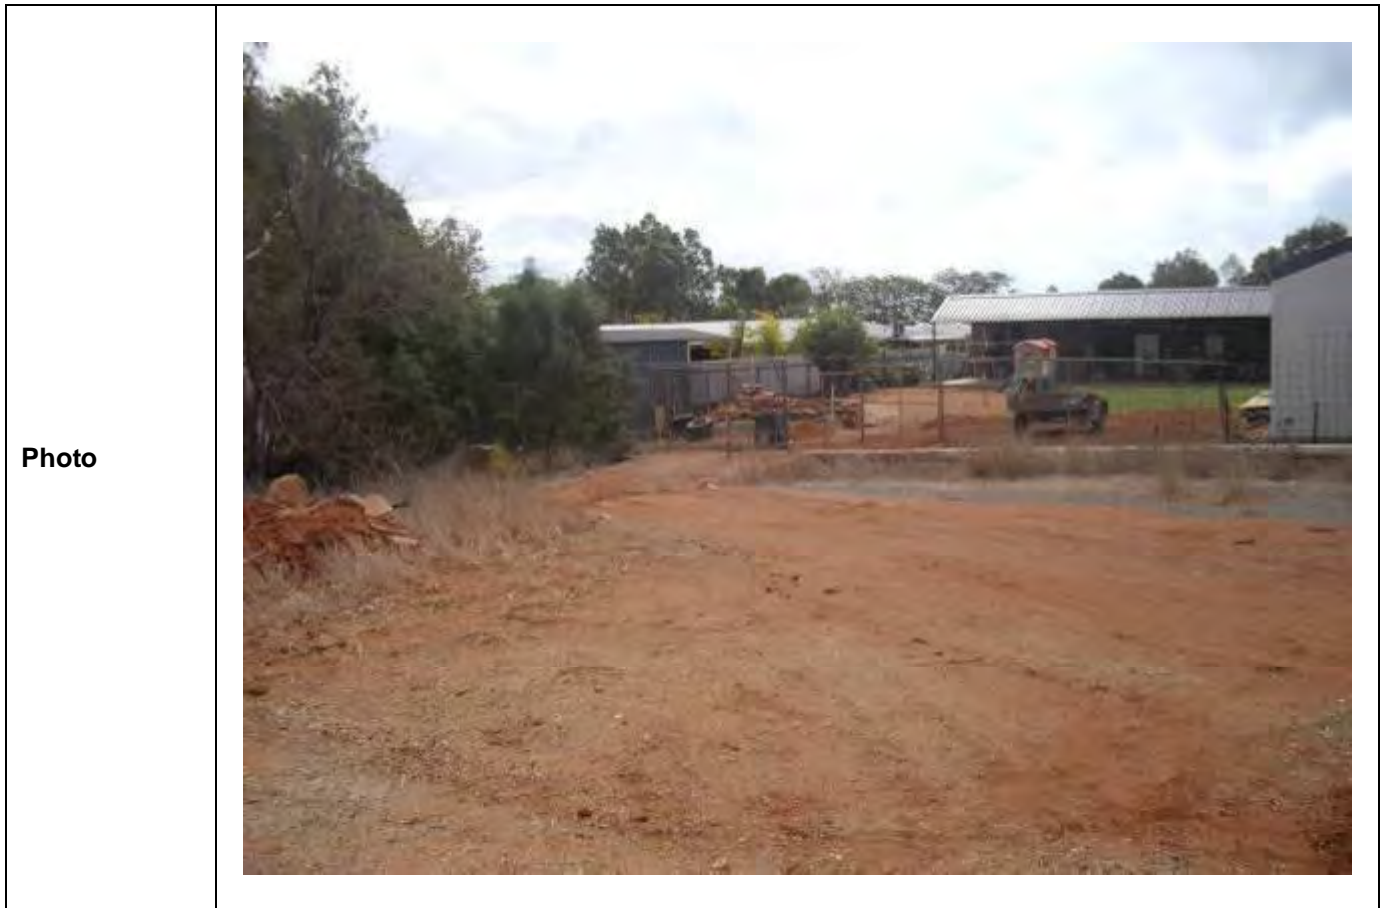
## 6.7 Lot No. 223 Fremantle Crescent

<b>Category</b>	Encroachment
<b>Type</b>	Rear access
<b>Description</b>	Rear access over existing water main impeding flow
<b>Photo ID</b>	591
<b>Scope of Works</b>	H – Remove rear access and reinstate drainage flow path as defined by the natural capacity and invert of channel of downstream lot

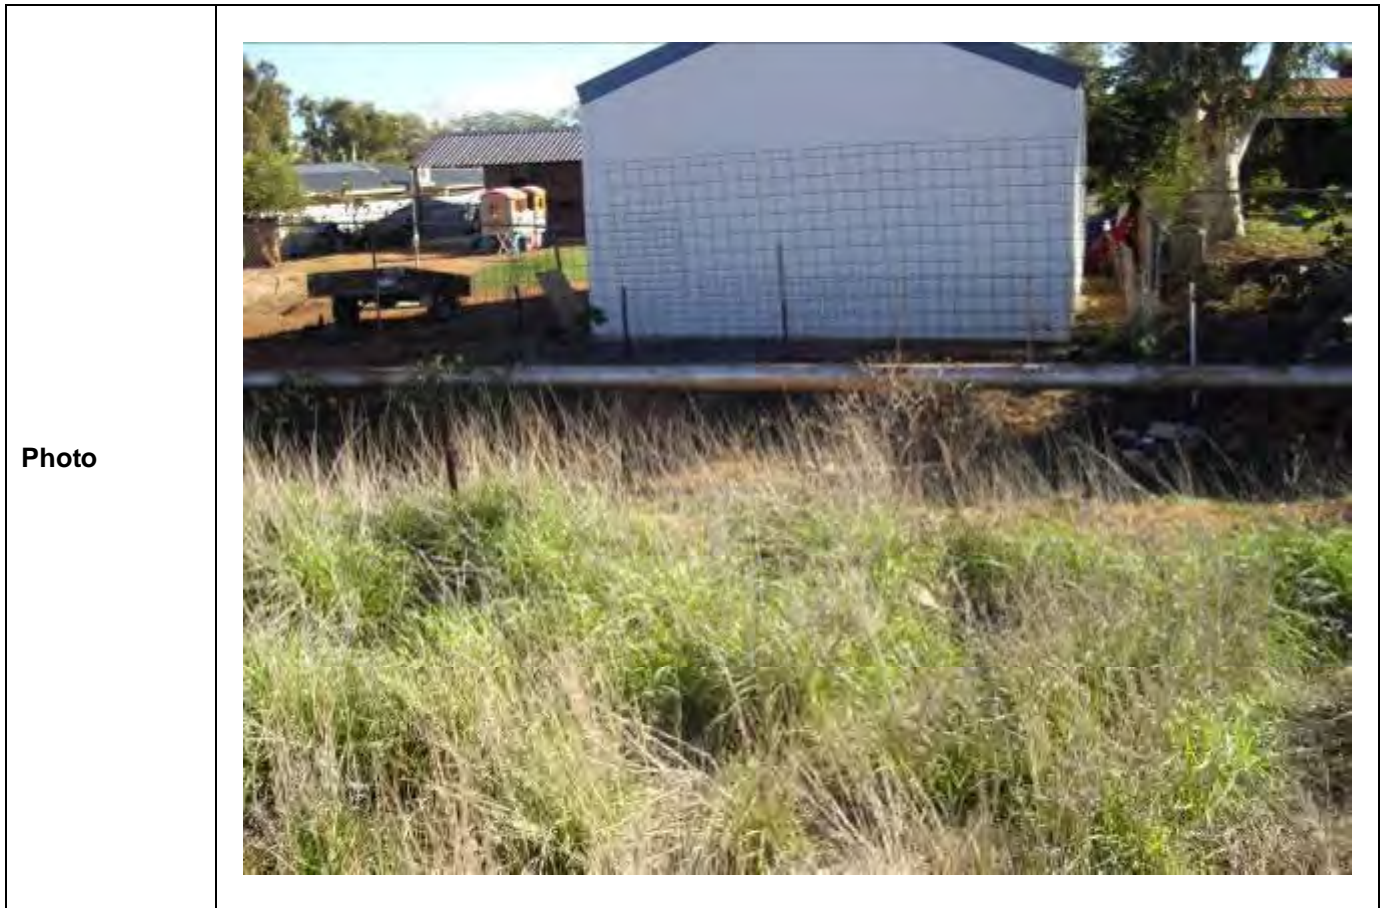
## 6.8 Lot No. 224 Fremantle Crescent

<b>Category</b>	None
<b>Type</b>	None
<b>Description</b>	Small cut off drain preventing flow towards lot.
<b>Photo ID</b>	839
<b>Scope of Works</b>	None required.

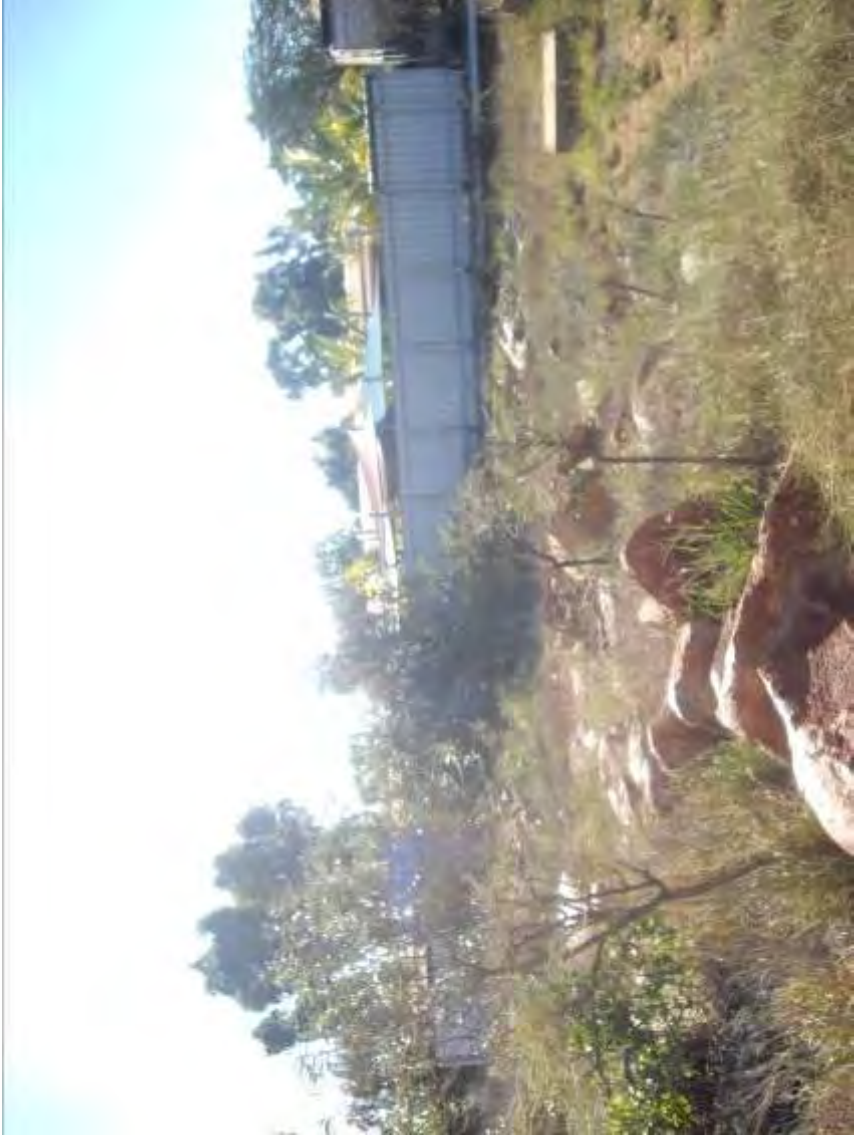
**6.9 Lot No. 225 Fremantle Crescent**

<b>Category</b>	Encroachment
<b>Type</b>	Rear access; Modified reserve.
<b>Description</b>	Rear access follows natural topography; Fill.
<b>Photo ID</b>	590
<b>Scope of Works</b>	L – Remove rear access M – Remove fill material and reinstate drainage flow path as defined by the natural capacity and invert of channel of downstream lot

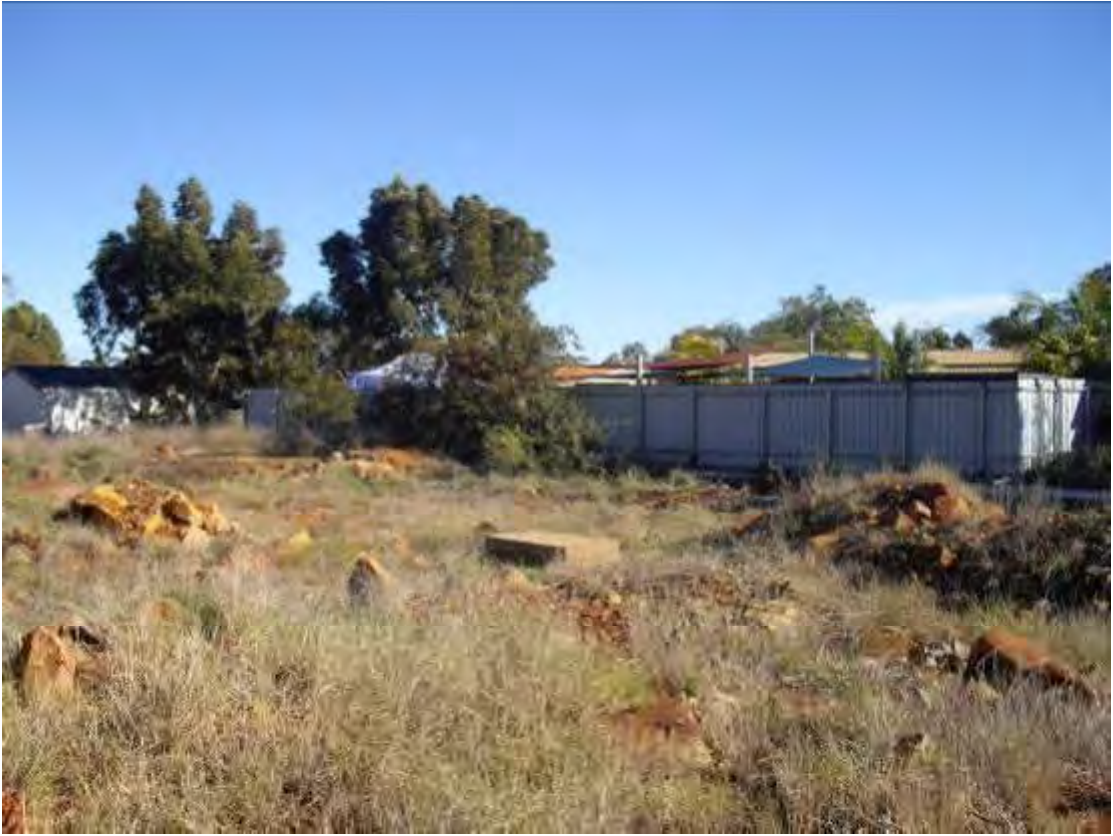
### 6.10 Lot No. 226 Fremantle Crescent

<p><b>Category</b></p>	<p>Encroachment</p>
<p><b>Type</b></p>	<p>Rear access</p>
<p><b>Description</b></p>	<p>Rear access follows natural topography.</p>
<p><b>Photo ID</b></p>	<p>1053, 838</p>
<p><b>Scope of Works</b></p>	<p>L – Remove rear access.</p>

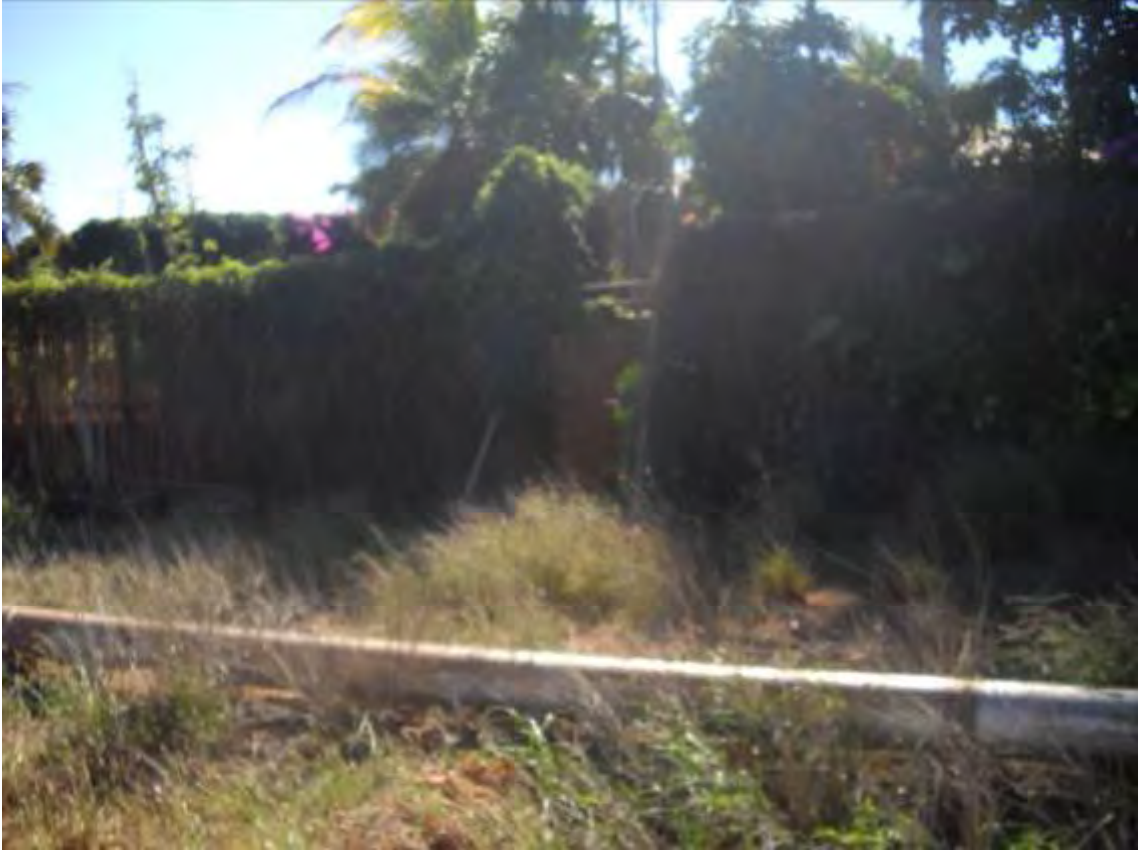
**6.12 Lot No. 2,226 Fremantle Crescent**

<p><b>Category</b></p>	<p>None</p>
<p><b>Type</b></p>	<p>None</p>
<p><b>Description</b></p>	<p>None</p>
<p><b>Photo ID</b></p>	<p>1051, 835</p>
<p><b>Scope of Works</b></p>	<p>None required.</p>

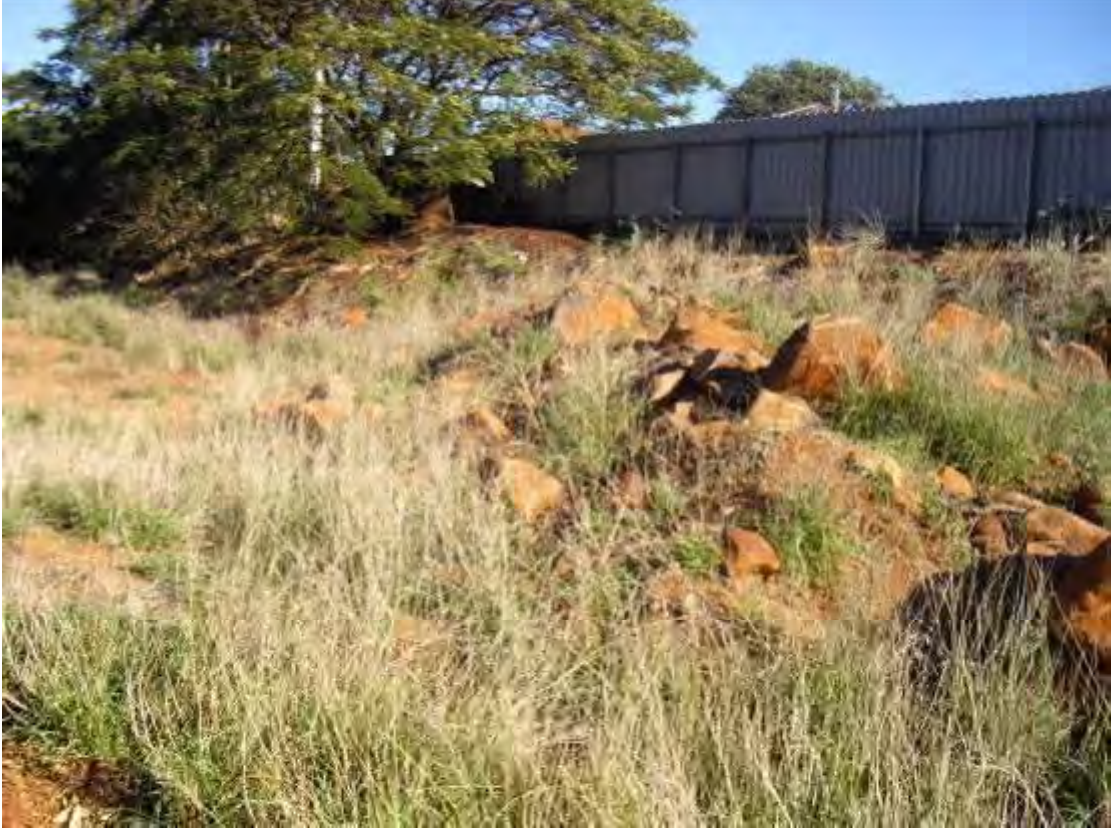
**6.13 Lot No. 3,226 Fremantle Crescent**

<p><b>Category</b></p>	<p>None</p>
<p><b>Type</b></p>	<p>None</p>
<p><b>Description</b></p>	<p>None</p>
<p><b>Photo ID</b></p>	<p>834</p>
<p><b>Scope of Works</b></p>	<p>None required.</p>

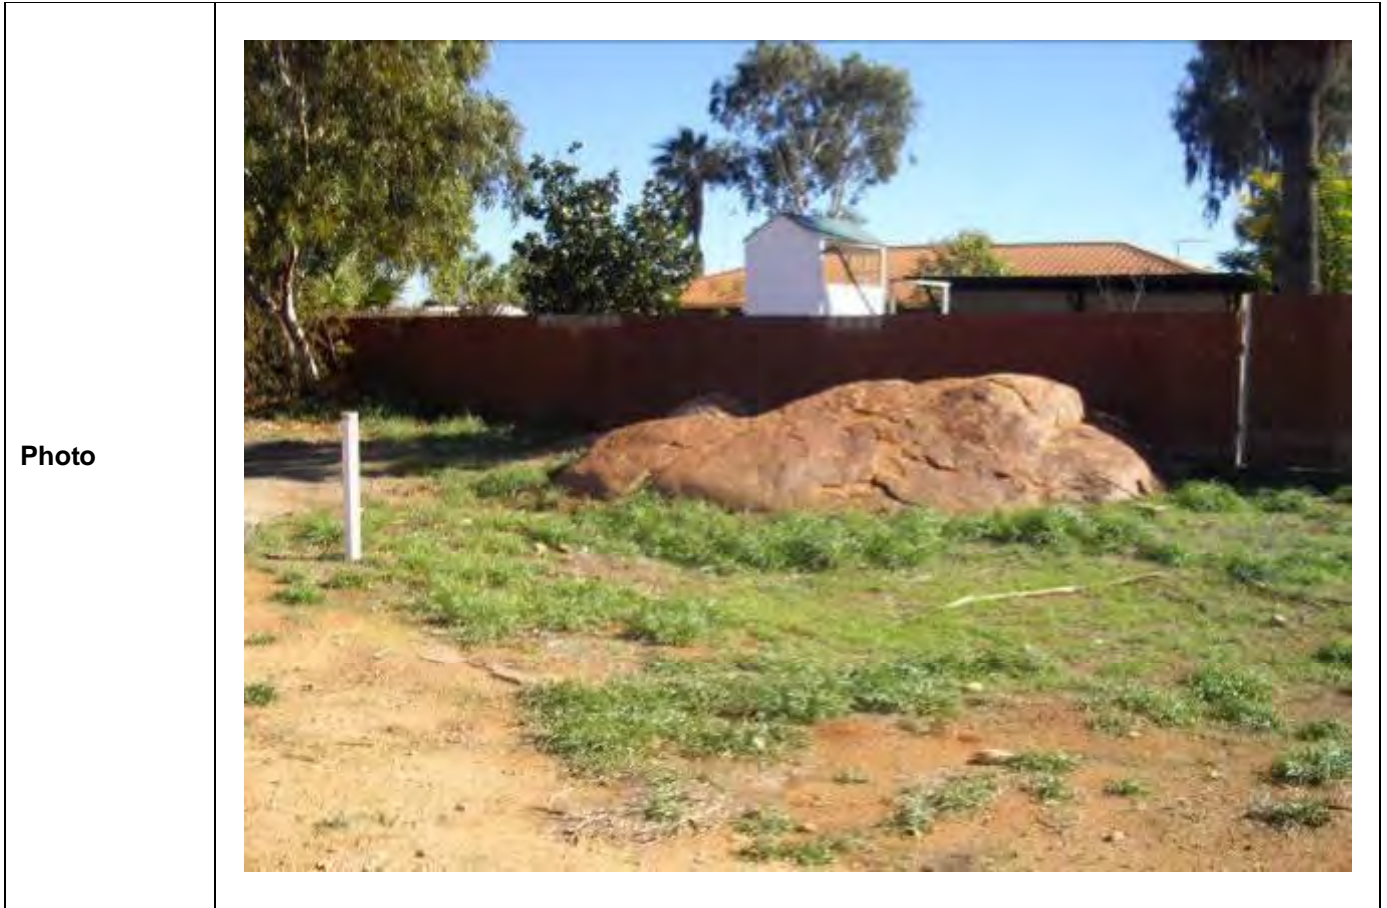
**2.1 Lot No. 96 Oakover Crescent**

<b>Category</b>	Encroachment
<b>Type</b>	Rear access Large rock
<b>Description</b>	Drainage reserve flows towards road Rear access - not impeding flow Insitu bed rock not impeding flow
<b>Photo ID</b>	859
<b>Scope of Works</b>	L – Remove rear access

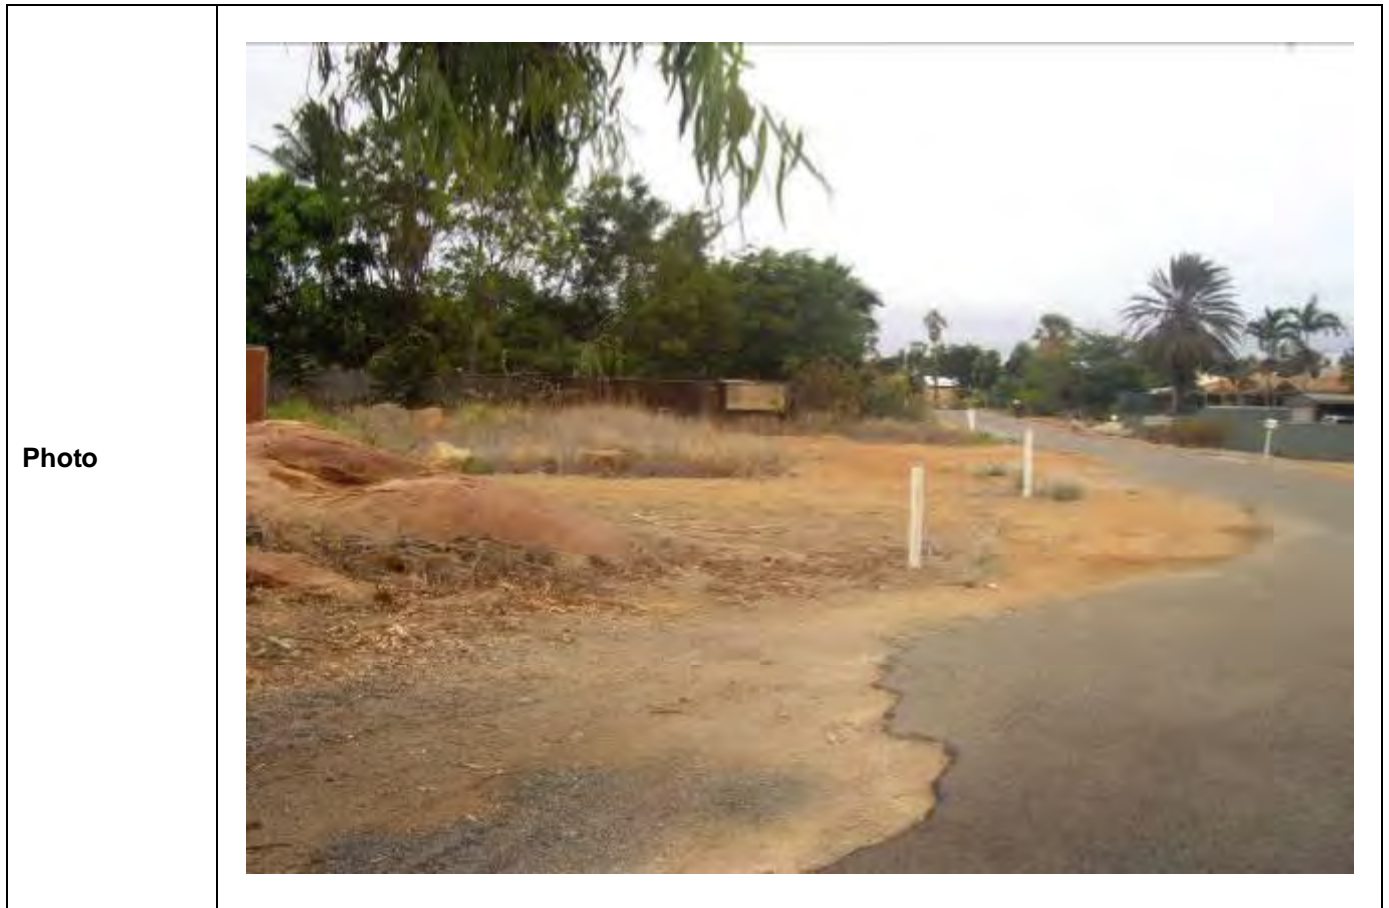
### 2.3 Lot No. 98 Oakover Crescent

<b>Category</b>	Encroachment
<b>Type</b>	Boundary extension Vegetation
<b>Description</b>	Backyard extends into drainage reserve but not impeding flow. Road acts as main drainage flow path Lot 99 impedes flow from reserver behind lot 98
<b>Photo ID</b>	631
<b>Scope of Works</b>	L - Remove backyard extension and relocate to within property boundary. H - Reinstate drainage flow path as defined by the natural capacity and invert of downstream lot (99) channel

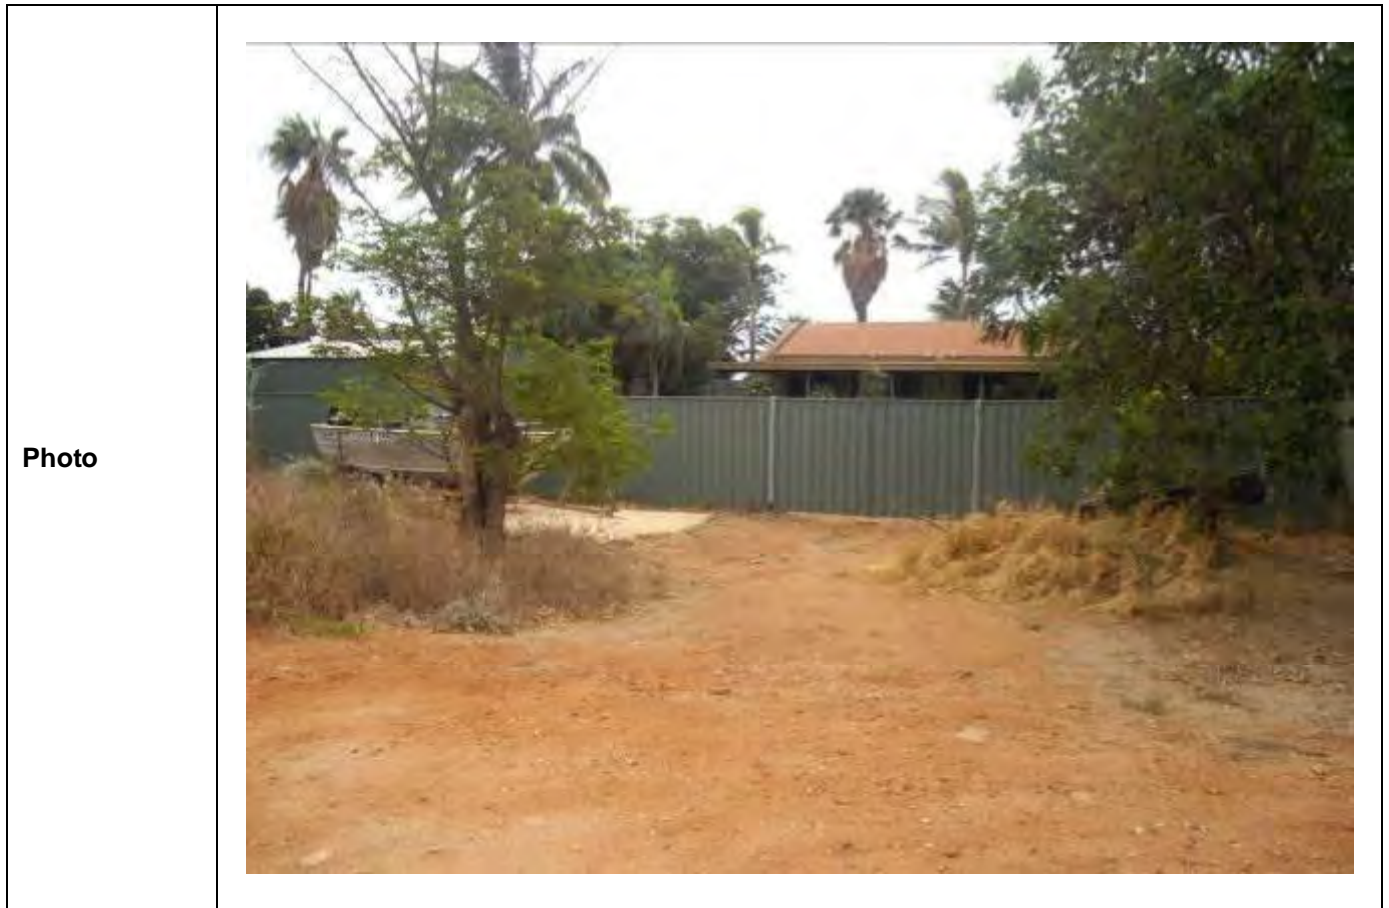
## 2.4 Lot No. 99 Oakover Crescent

<b>Category</b>	Encroachment
<b>Type</b>	Rear access; General items.
<b>Description</b>	Rear access driveway impedes flow from lot 98. Boat
<b>Photo ID</b>	630
<b>Scope of Works</b>	H – Remove rear access and reinstate drainage flow path as defined by the natural capacity and invert of downstream lot (100) channel L – Remove boat.

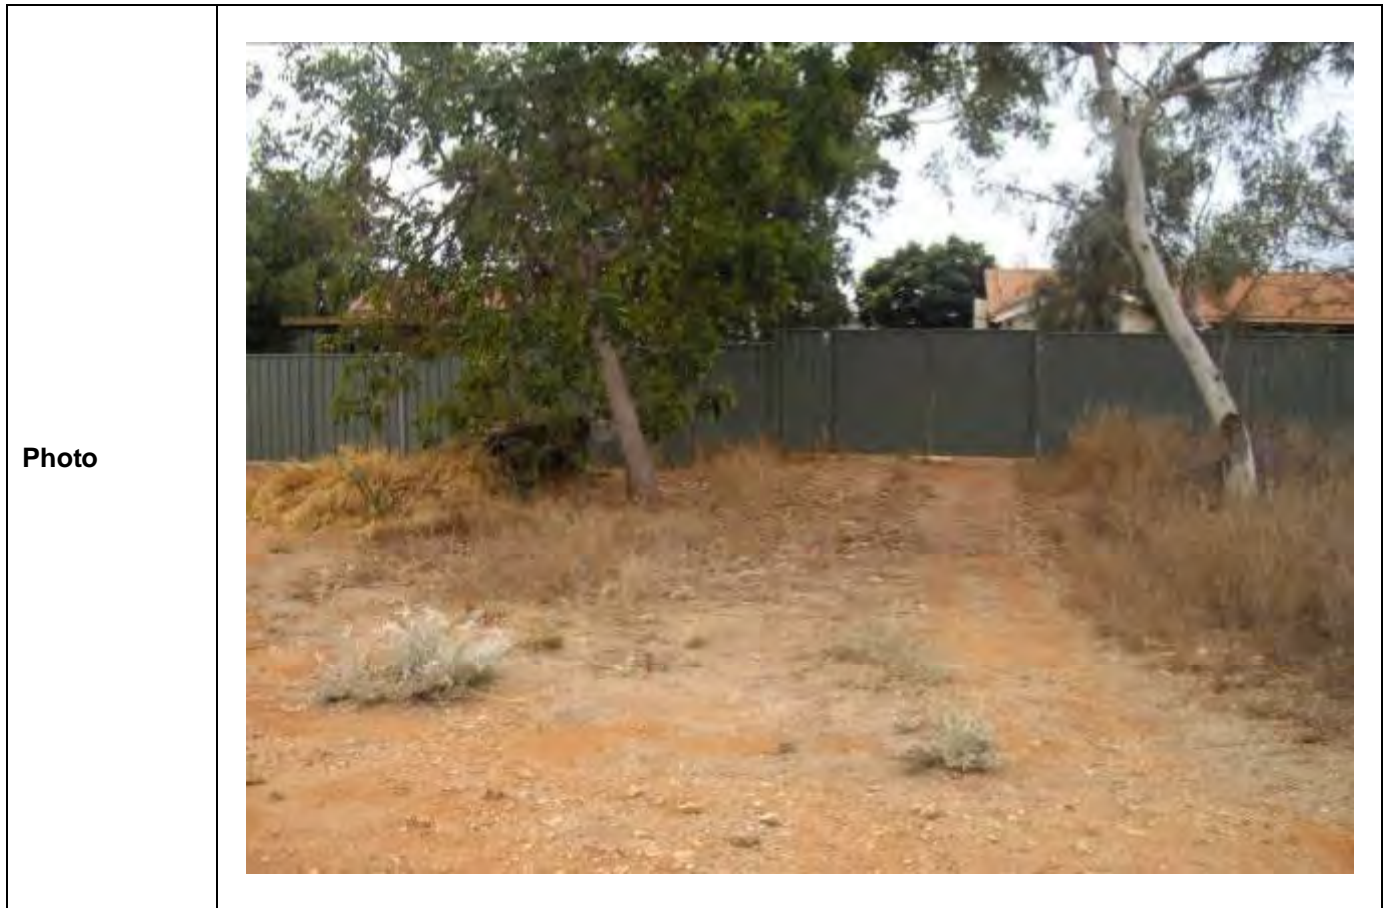
## 2.5 Lot No. 100 Oakover Crescent

<b>Category</b>	Encroachment
<b>Type</b>	Rear access
<b>Description</b>	Rear access impedes flow from lots 98 and 99
<b>Photo ID</b>	629
<b>Scope of Works</b>	H – Remove rear access and reinstate drainage flow path as defined by the natural capacity and invert of downstream lot (101) channel to flow east

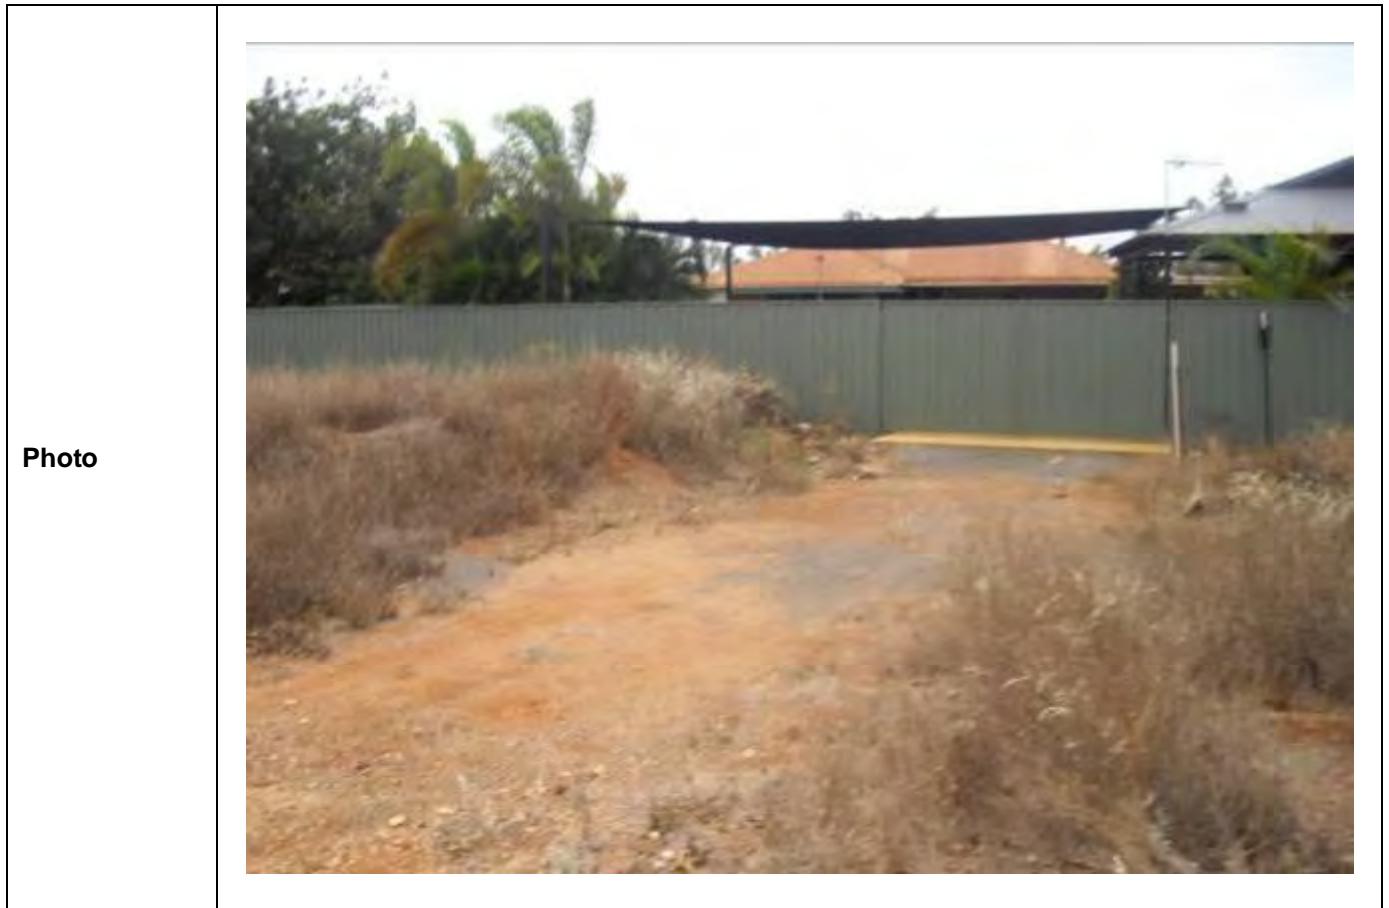
## 2.6 Lot No. 101 Oakover Crescent

<b>Category</b>	Encroachment
<b>Type</b>	Rear access
<b>Description</b>	Rear access impedes flow from lots 98, 99 and 100 Road acts as the main stormwater conveyor.
<b>Photo ID</b>	628
<b>Scope of Works</b>	H – Remove rear access and reinstate drainage flow path as defined by the natural capacity and invert of downstream lot (1101) channel to flow east

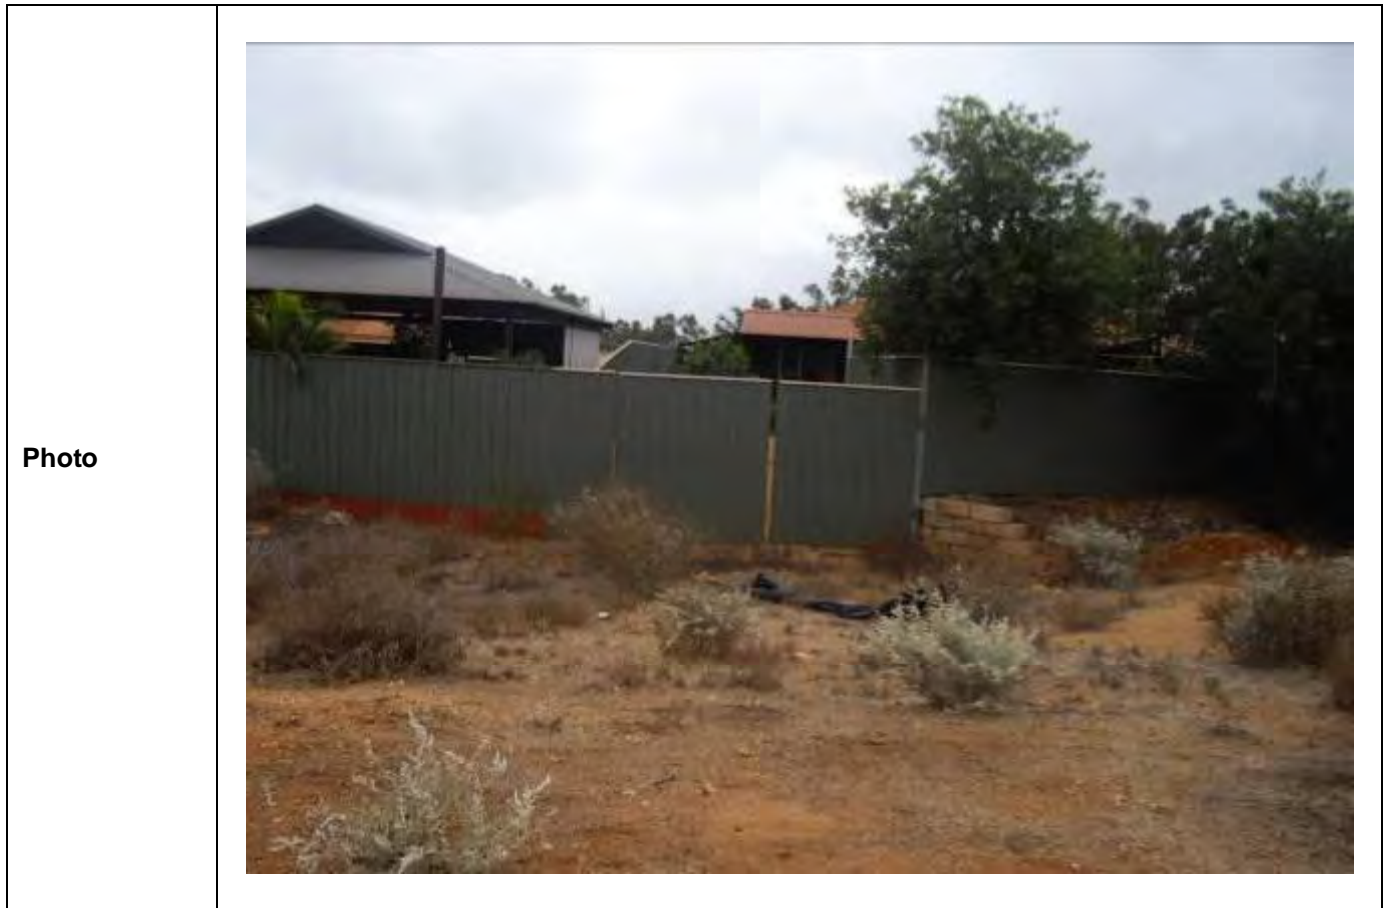
## 2.7 Lot No. 1,101 Oakover Crescent

<b>Category</b>	Encroachment
<b>Type</b>	Rear access
<b>Description</b>	Rear access impedes flow from lots 98, 99, 100 and 101
<b>Photo ID</b>	627
<b>Scope of Works</b>	H – Remove rear access and reinstate drainage flow path as defined by the natural capacity and invert of downstream lot (east of 1101) channel

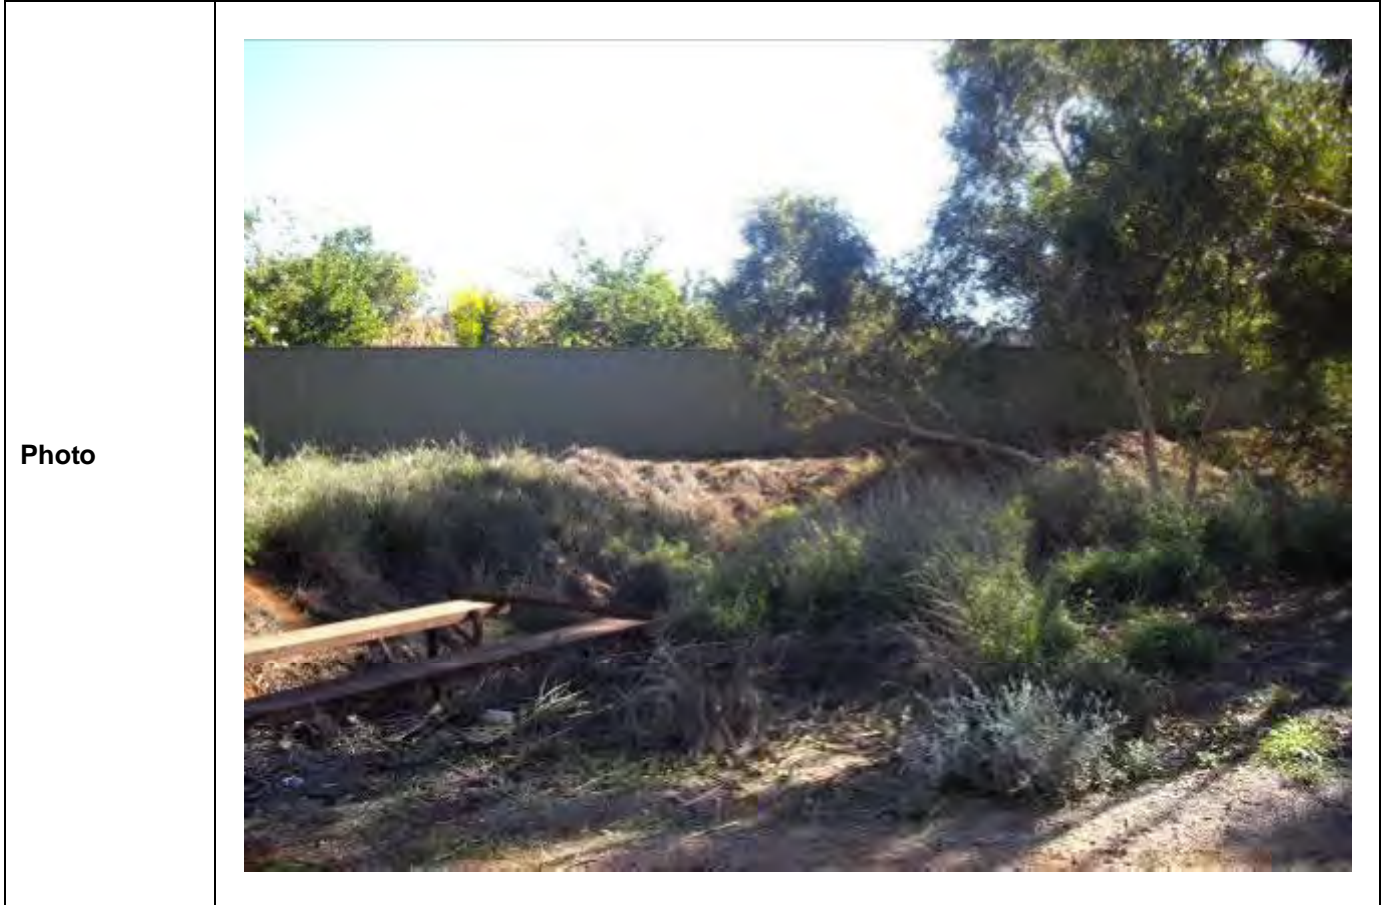
### 3.1 Lot No. 102 Murchinson Crescent

<b>Category</b>	Drain Maintenance
<b>Type</b>	Vegetation; General item.
<b>Description</b>	Low lying semi-dense vegetation; Vehicle inspection ramps.
<b>Photo ID</b>	847
<b>Scope of Works</b>	M - Vegetation is to be slashed to a nominal height of 50 mm above ground with the exception of large, established trees of height in excess of 5 m, which shall remain L – Remove vehicle inspection ramp.

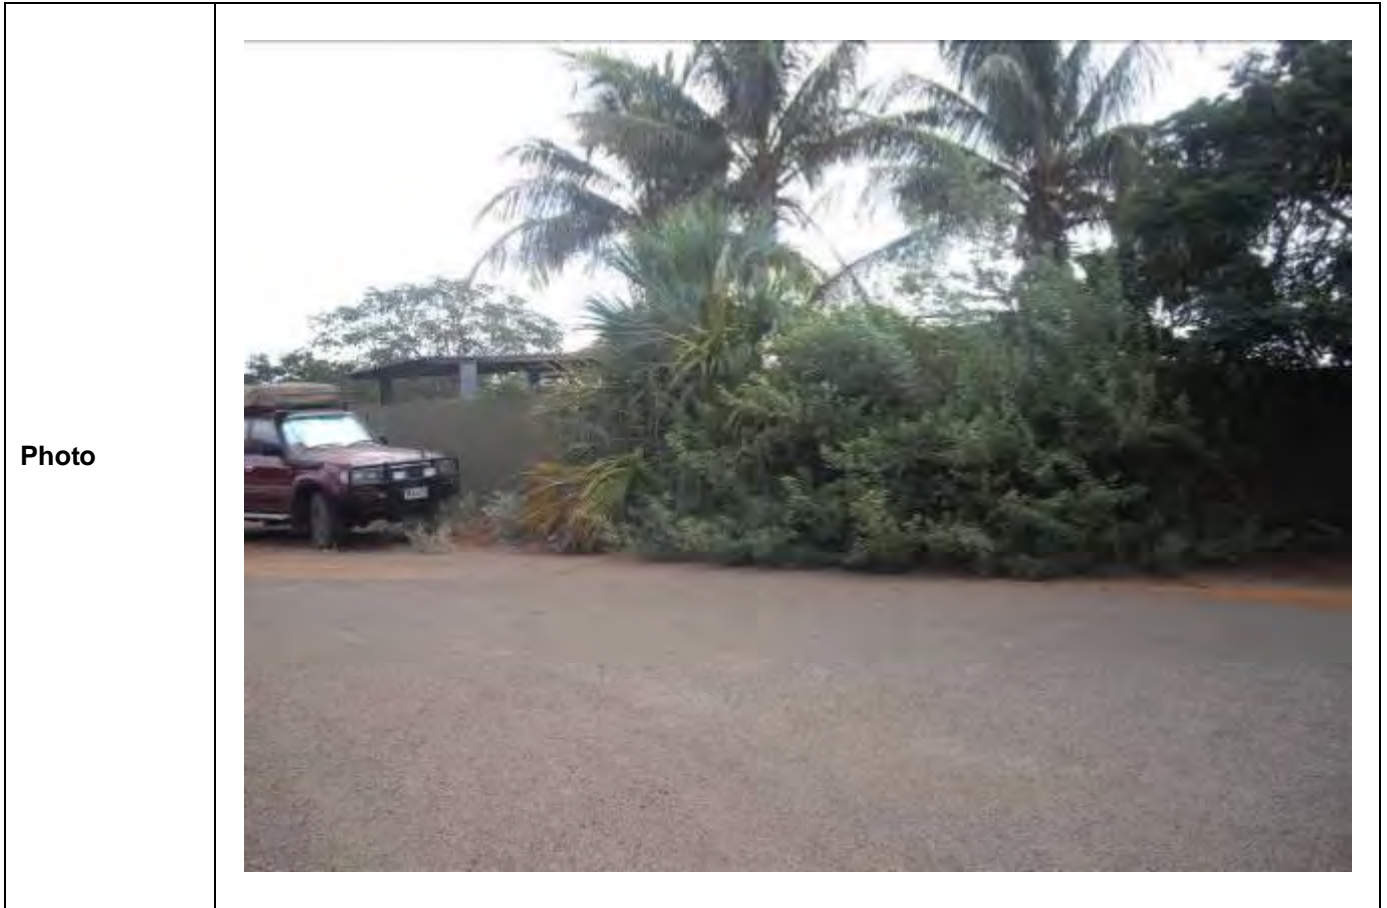
### 3.2 Lot No. 103 Murchinson Crescent

<b>Category</b>	Encroachment
<b>Type</b>	Boundary extension Fill
<b>Description</b>	Fence and property has extended to within the drainage reserve. Top of catchment No drainage reserve - road reserve acts as the main stormwater conveyer.
<b>Photo ID</b>	605
<b>Scope of Works</b>	L – Remove fence and reinstate property boundary. Reinstate drainage reserve to grade to the east or to the road reserve. M – Remove fill.

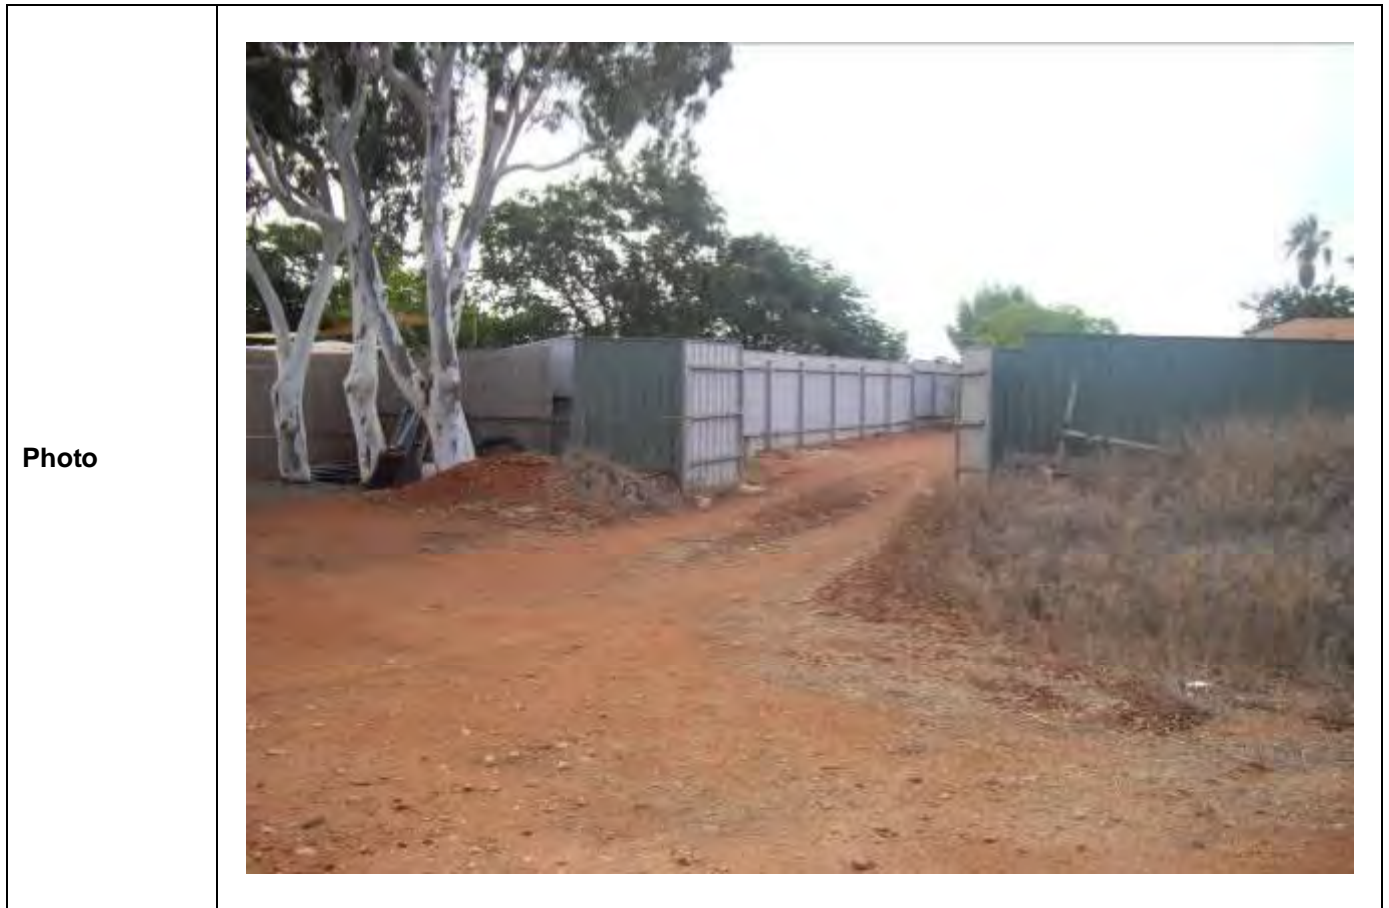
### 3.3 Lot No. 104 Murchinson Crescent

<b>Category</b>	Encroachment
<b>Type</b>	Rear access Boundary extension.
<b>Description</b>	Rear access and modified topography; Drainage reserve has area of fill. (Drainage reserve is higher than the road reserve). Fence is misaligned with the property boundary.
<b>Photo ID</b>	606
<b>Scope of Works</b>	L - Remove rear access H - Remove fill area and reinstate drainage flow path as defined by the natural capacity and invert of downstream lot (105) channel.

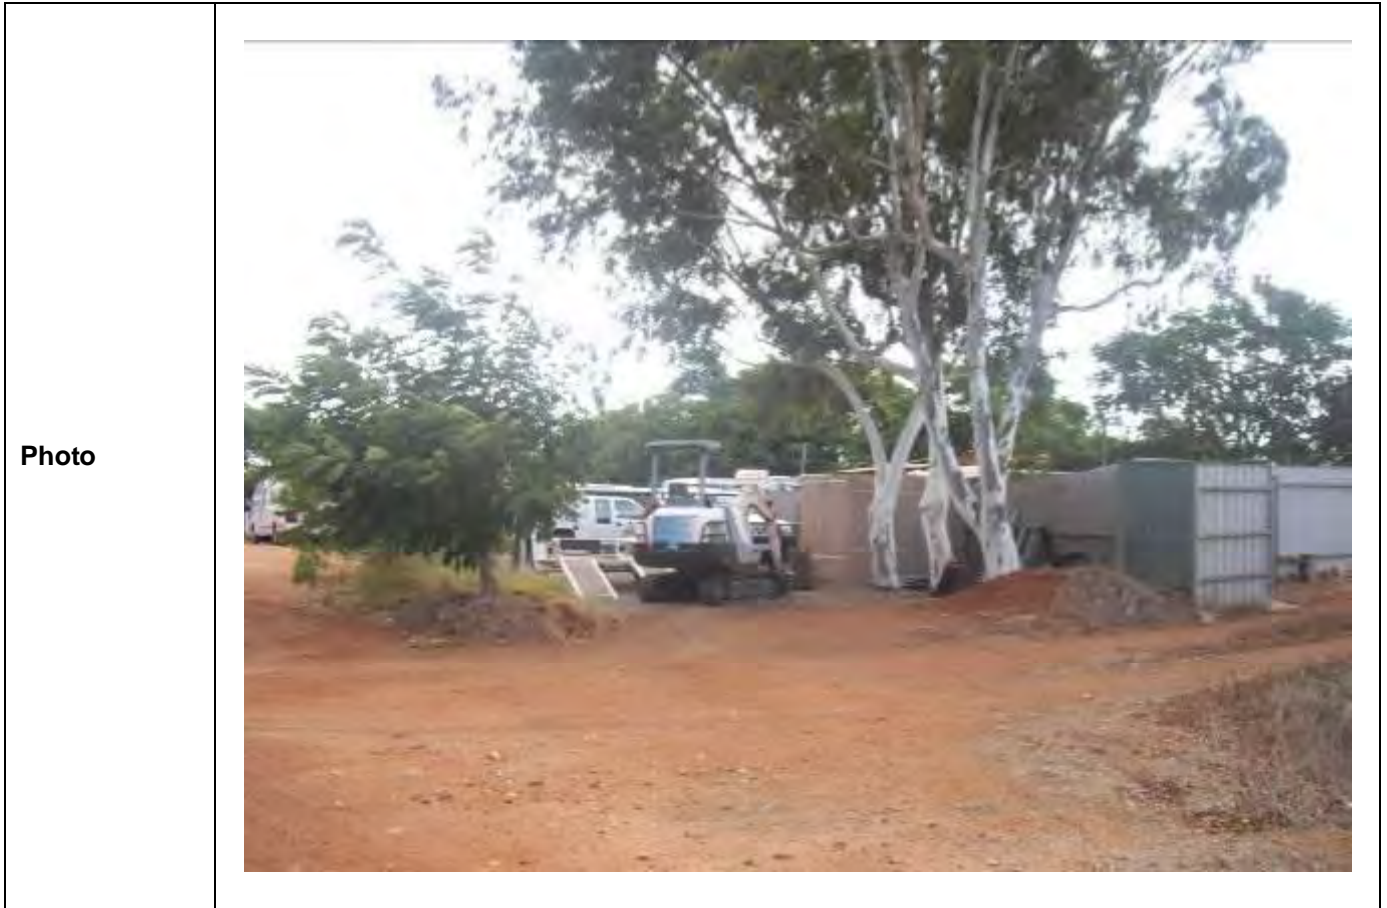
### 3.4 Lot No. 105 Murchinson Crescent

<b>Category</b>	Encroachment
<b>Type</b>	Modified drainage reserve; General items.
<b>Description</b>	Original intended design not apparent due to high level of modification. Drainage reserve is being used as a parking area. Road reserve acts as the main stormwater conveyor. Vehicles.
<b>Photo ID</b>	607
<b>Scope of Works</b>	L - Remove fill and reinstate drainage flow path as defined by the natural capacity and invert of downstream lot (106) channel. L – Remove vehicles.
