City of Karratha  
Dampier Stormwater Management Study  
Report  
Part B  
June 2015

## Appendix **C** – 2010 encroachment reviews

**Rio Tinto Iron Ore**  
Report on Dampier Drainage  
Review  
Block 1 Encroachments  
June 2010

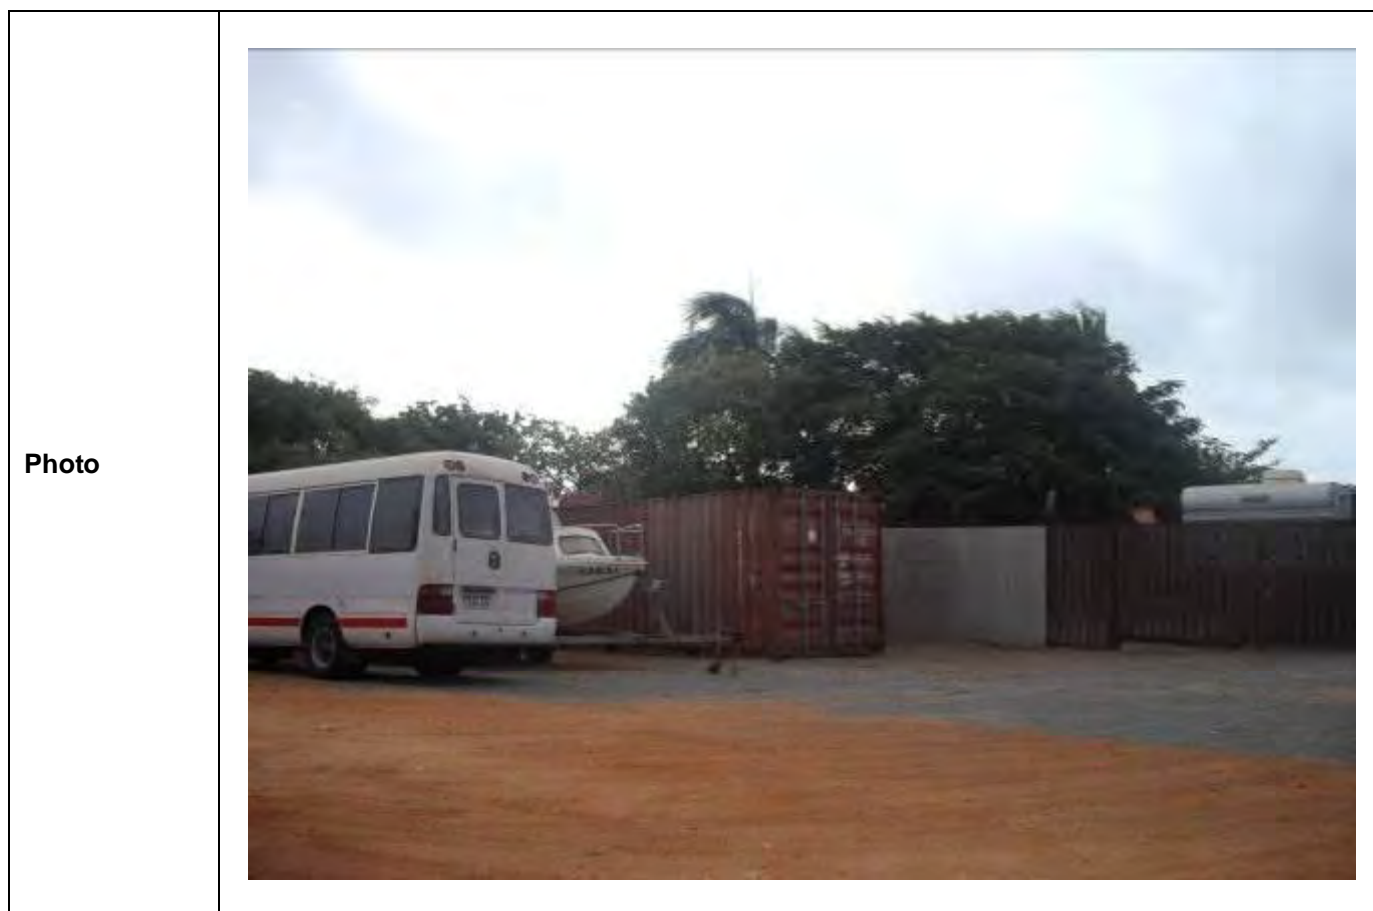
### 3.5 Lot No. 106 Murchinson Crescent

<b>Category</b>	Encroachment
<b>Type</b>	General items
<b>Description</b>	Sea container, bus, boat
<b>Photo ID</b>	608
<b>Scope of Works</b>	M - Remove items M - Reinststate drainage flow path as defined by the natural capacity and invert of downstream lot (107) channel

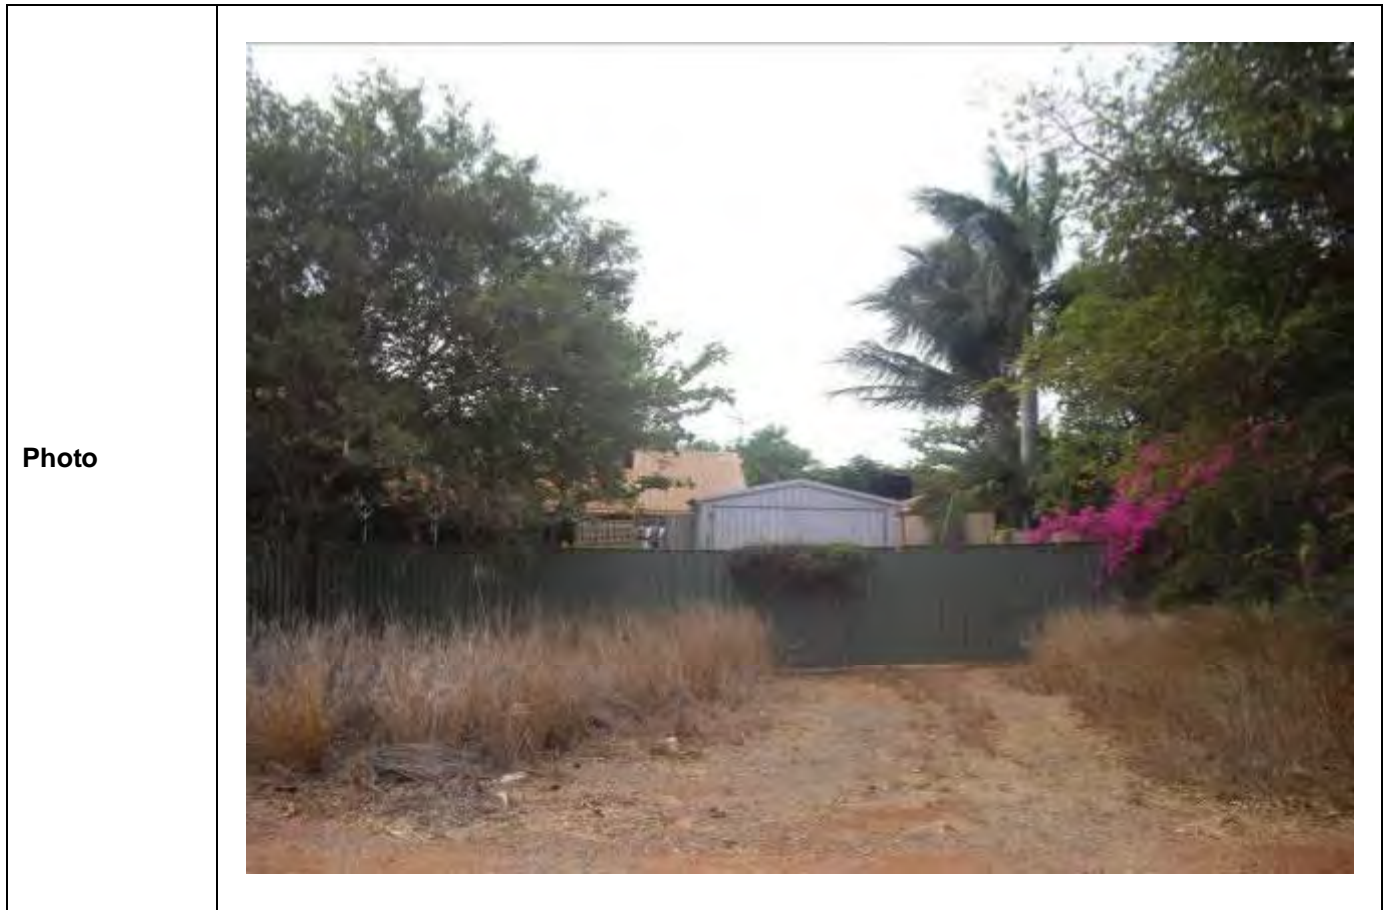
### 3.6 Lot No. 107 Murchinson Crescent

<b>Category</b>	Encroachment
<b>Type</b>	Rear access
<b>Description</b>	Rear access impedes flow, but drain ok
<b>Photo ID</b>	609
<b>Scope of Works</b>	H - Remove access driveway and reinstate drain

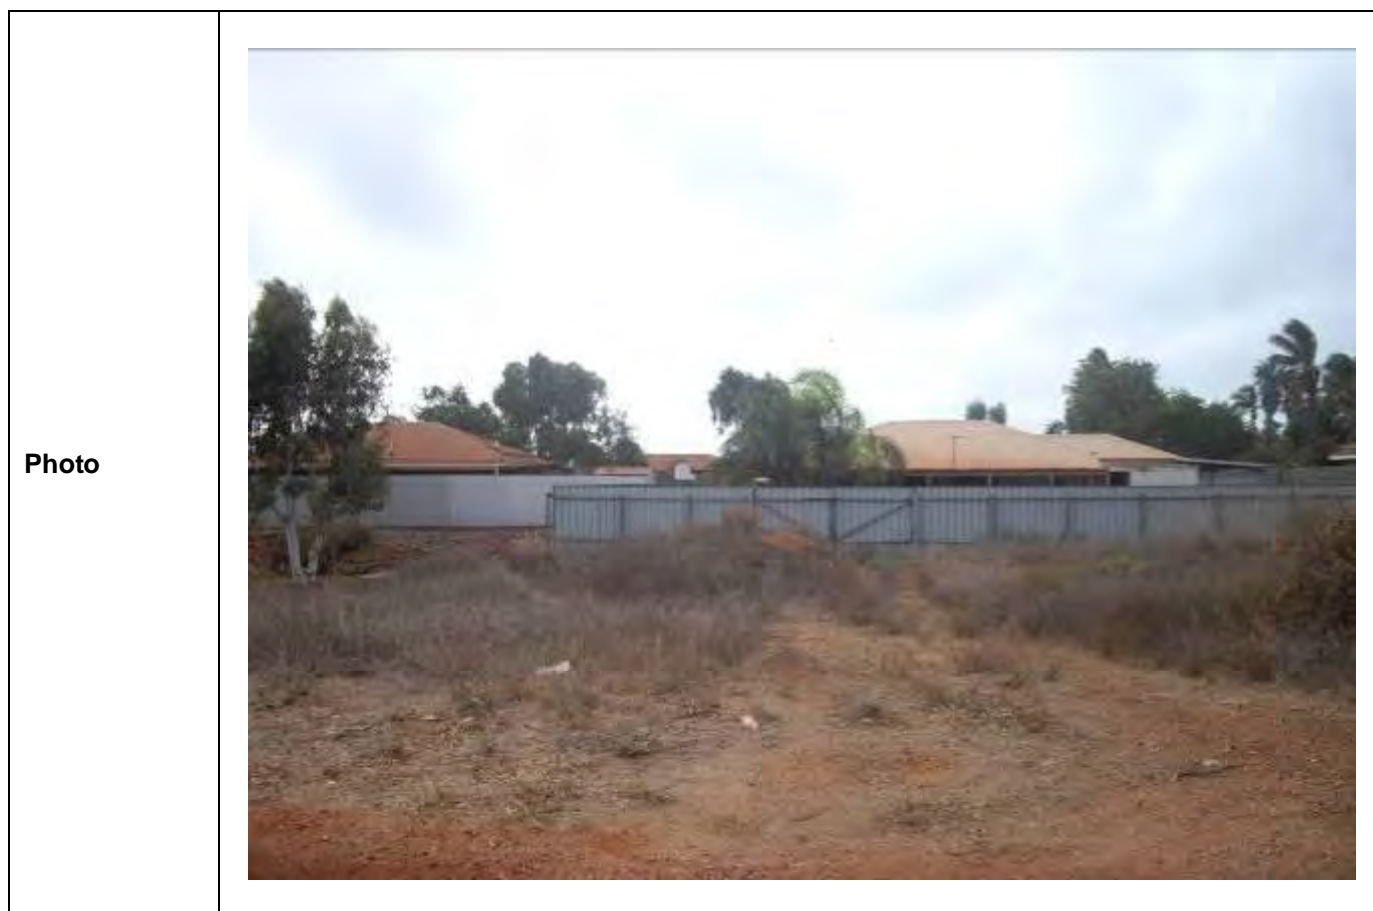
### 3.8 Lot No. 109 Murchinson Crescent

<b>Category</b>	Encroachment
<b>Type</b>	Rear access
<b>Description</b>	Rear access following natural contours – with small impediment to flow Fill material has been imported
<b>Photo ID</b>	611
<b>Scope of Works</b>	L - Remove access driveway and reinstate drainage flow path as defined by the natural capacity and invert of downstream lot (1109) channel H – Remove fill material

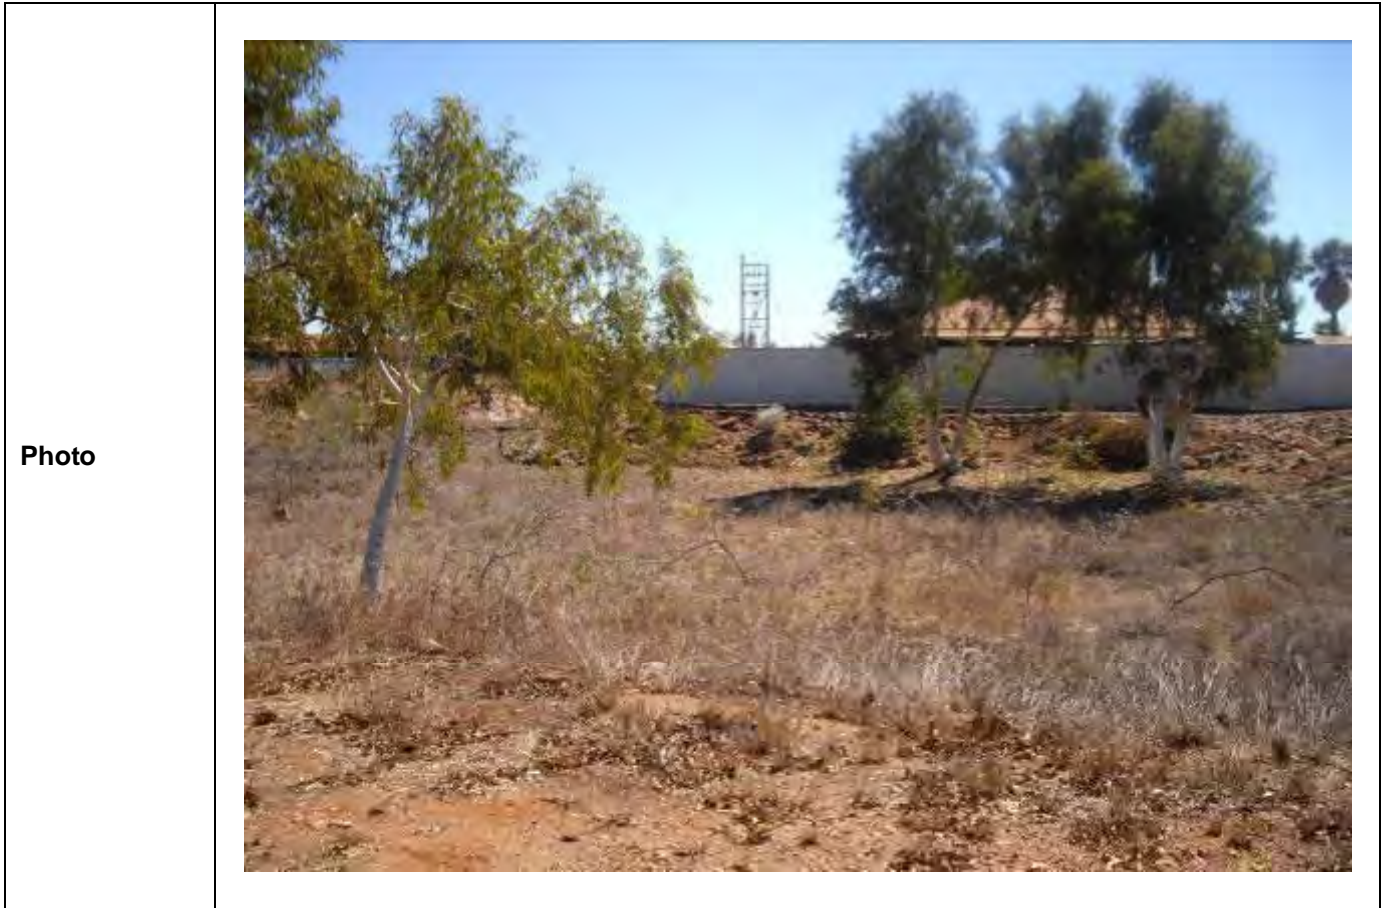
### 3.9 Lot No. 1,109 Murchinson Crescent

<b>Category</b>	None
<b>Type</b>	None
<b>Description</b>	None
<b>Photo ID</b>	400
<b>Scope of Works</b>	None required.

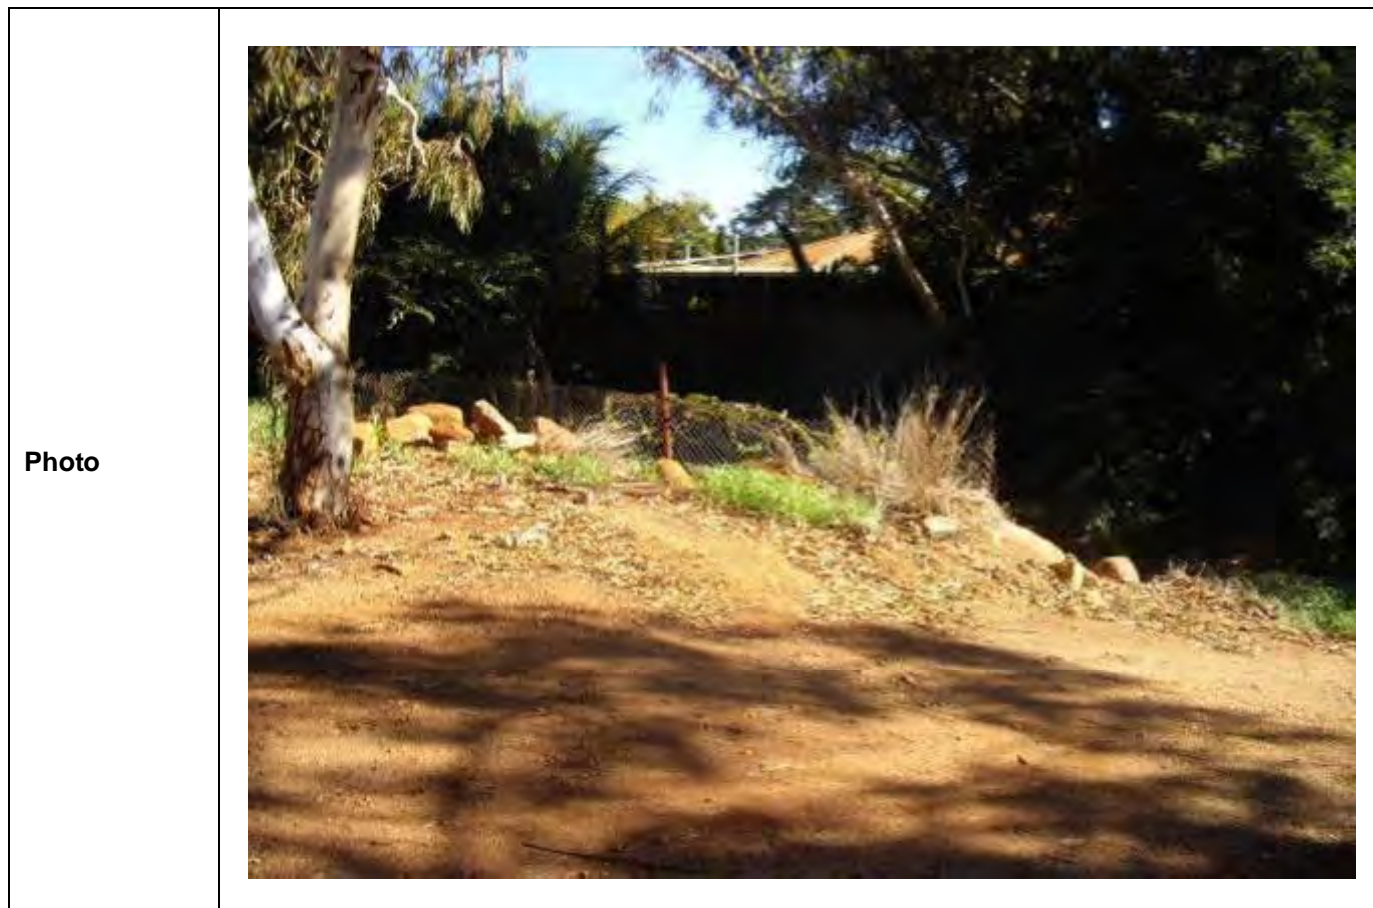
#### 4.1 Lot No. 110 Lyndon Crescent

<b>Category</b>	Encroachment / Drain maintenance
<b>Type</b>	Fence Vegetation
<b>Description</b>	Fence within drainage reserve Heavy vegetation
<b>Photo ID</b>	855
<b>Scope of Works</b>	H - Vegetation is to be slashed to a nominal height of 50 mm above ground with the exception of large, established trees of height in excess of 5 m, which shall remain M – Remove fence

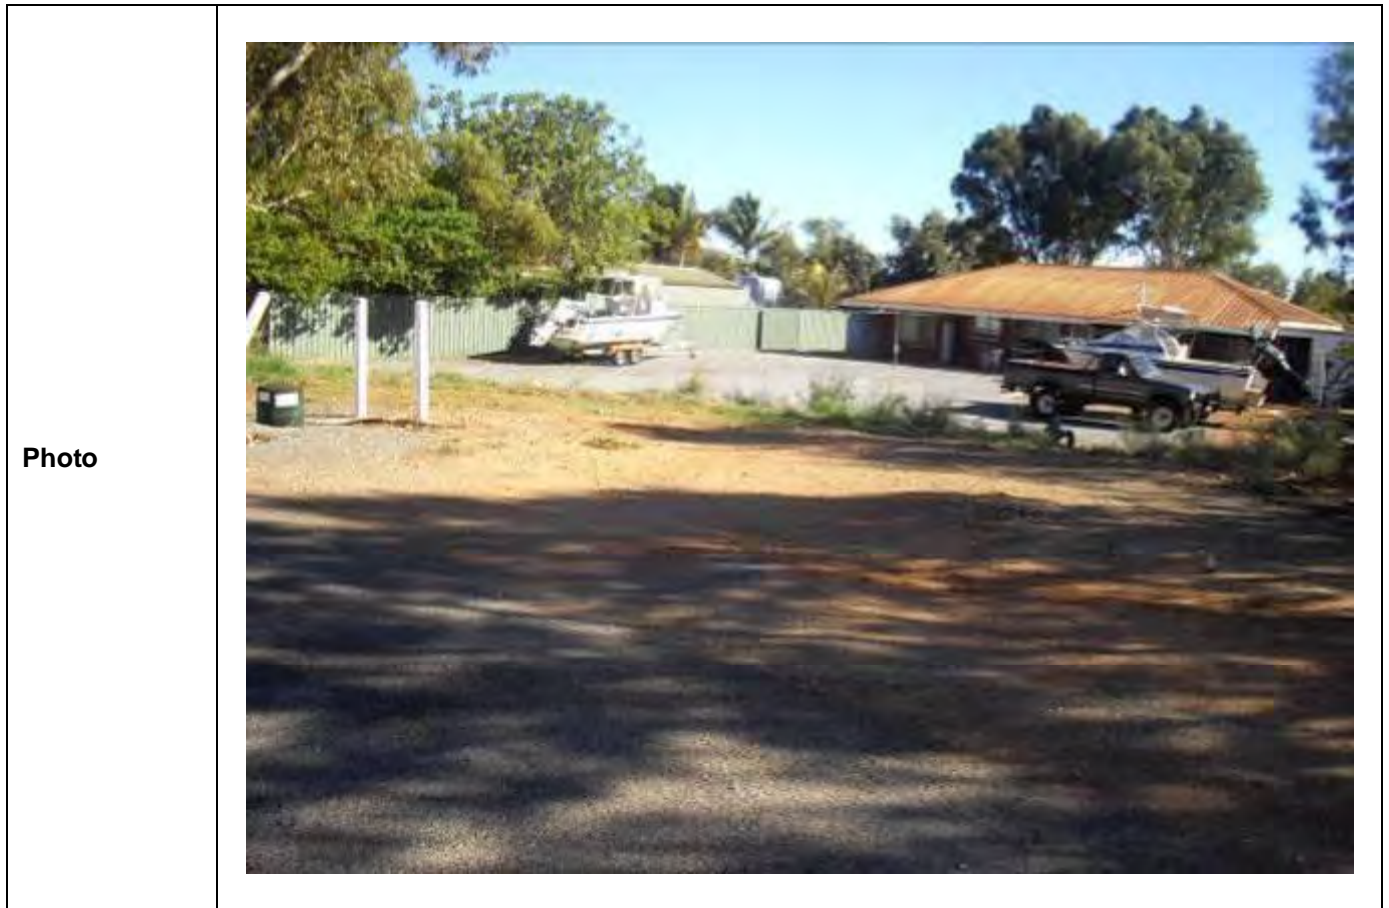
## 4.2 Lot No. 111 Lyndon Crescent

<b>Category</b>	Encroachment
<b>Type</b>	Rear access
<b>Description</b>	Rear access follows natural topography. Flow is easily directed towards lots.
<b>Photo ID</b>	854
<b>Scope of Works</b>	H - Remove access driveway and reinstate drainage flow path as defined by the natural capacity and invert of downstream lot (110) channel

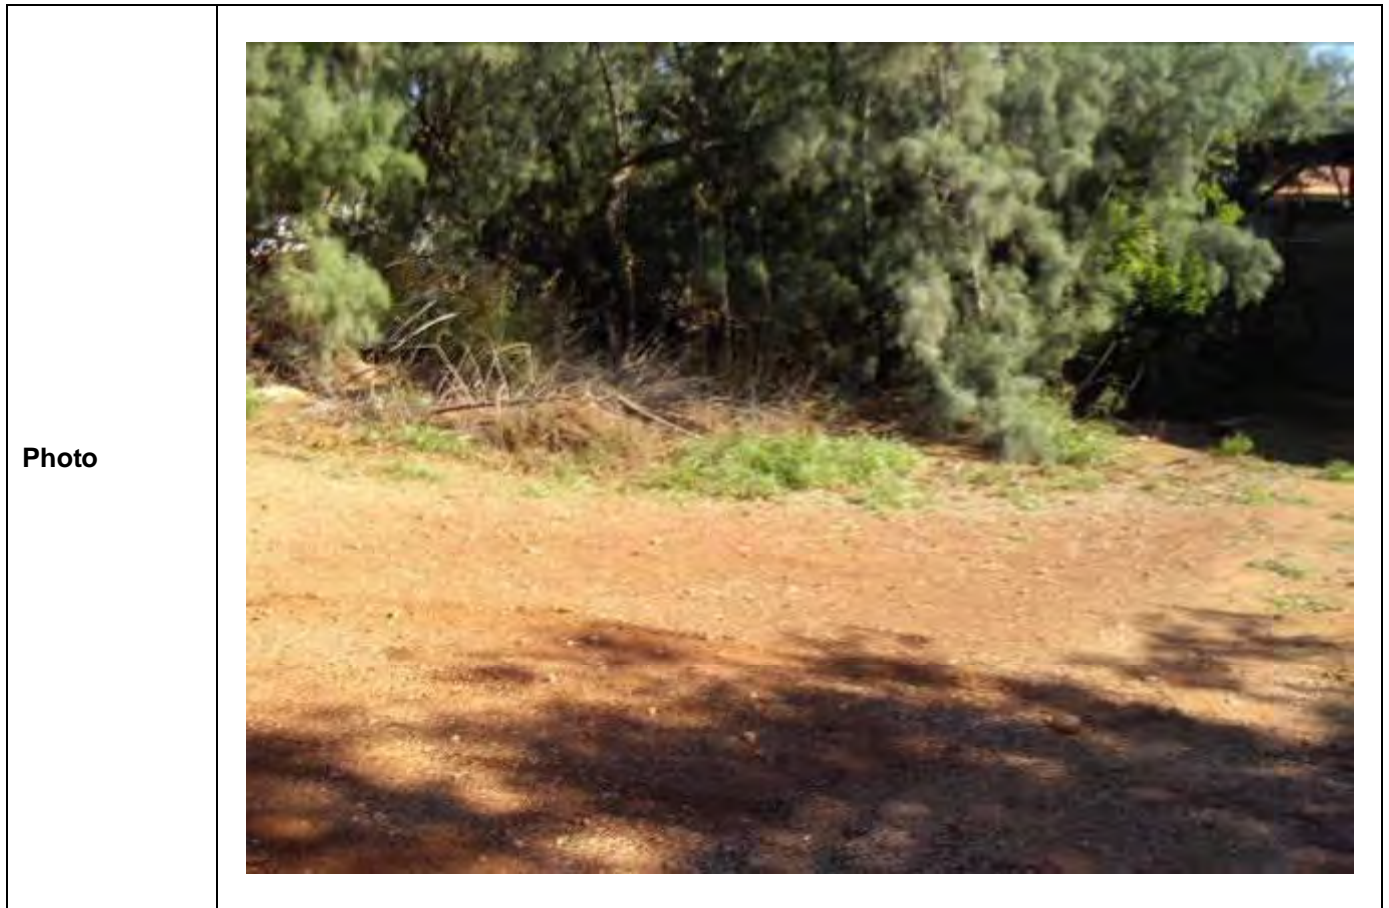
### 4.3 Lot No. 112 Lyndon Crescent

<b>Category</b>	Encroachment / Drain Maintenance
<b>Type</b>	Rear access No defined flow path Vegetation
<b>Description</b>	Rear access contributes to flow entering property; Dense vegetation impeding flow.
<b>Photo ID</b>	857
<b>Scope of Works</b>	H - Remove access driveway and reinstate drainage flow path as defined by the natural capacity and invert of downstream lot (111) channel H - Vegetation is to be slashed to a nominal height of 50 mm above ground with the exception of large, established trees of height in excess of 5 m, which shall remain.

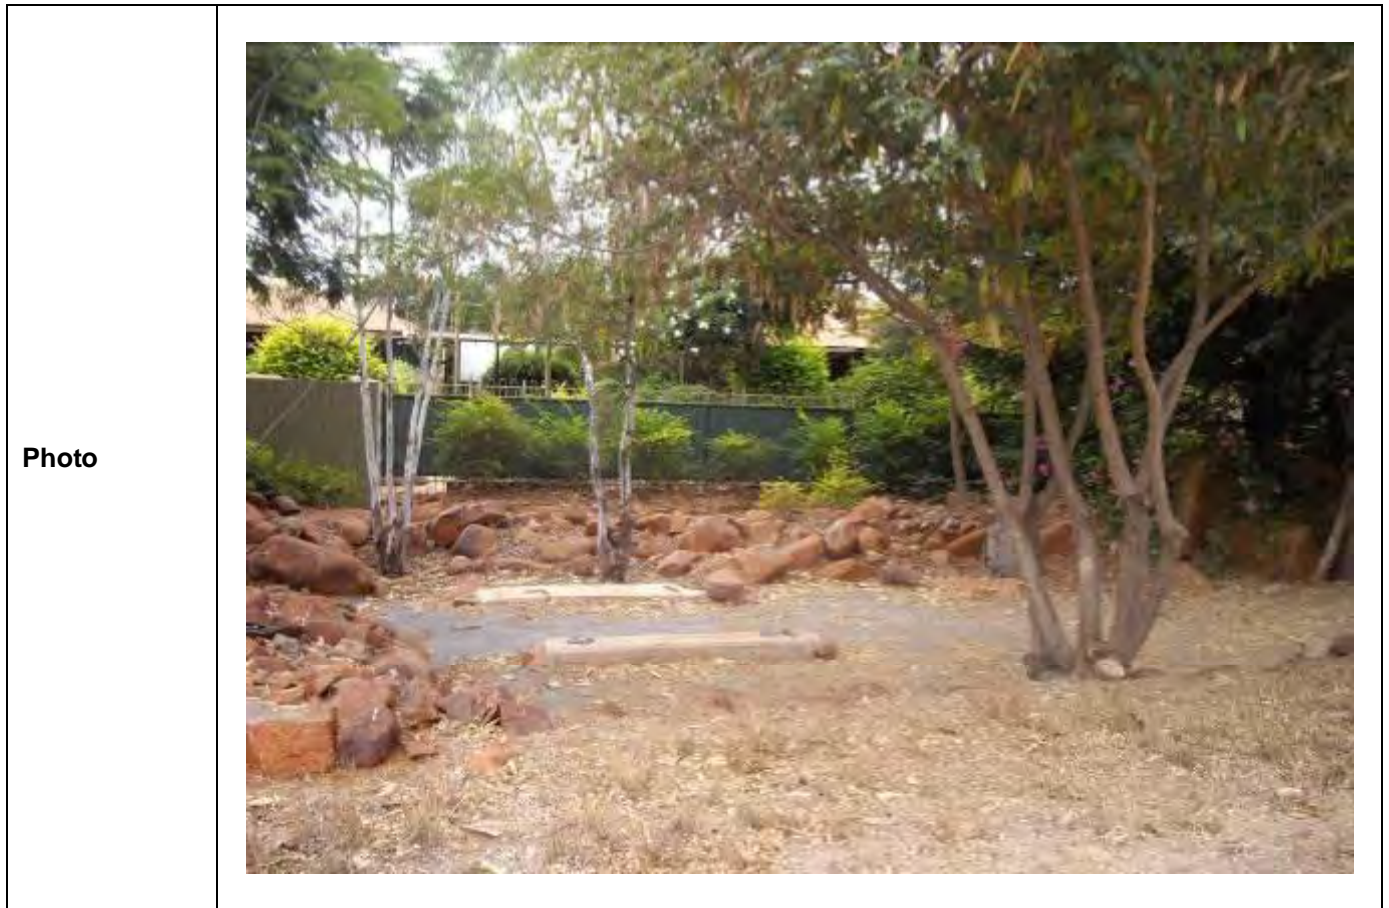
#### 4.4 Lot No. 113 Lyndon Crescent

<b>Category</b>	Encroachment
<b>Type</b>	Rear access Modified drainage reserve
<b>Description</b>	Rear access has culvert Collection of rocks but channel adequate
<b>Photo ID</b>	626
<b>Scope of Works</b>	H - Remove access driveway and reinstate drainage flow path as defined by the natural capacity and invert of downstream lot (114) channel L – Remove rocks from the “channel”.

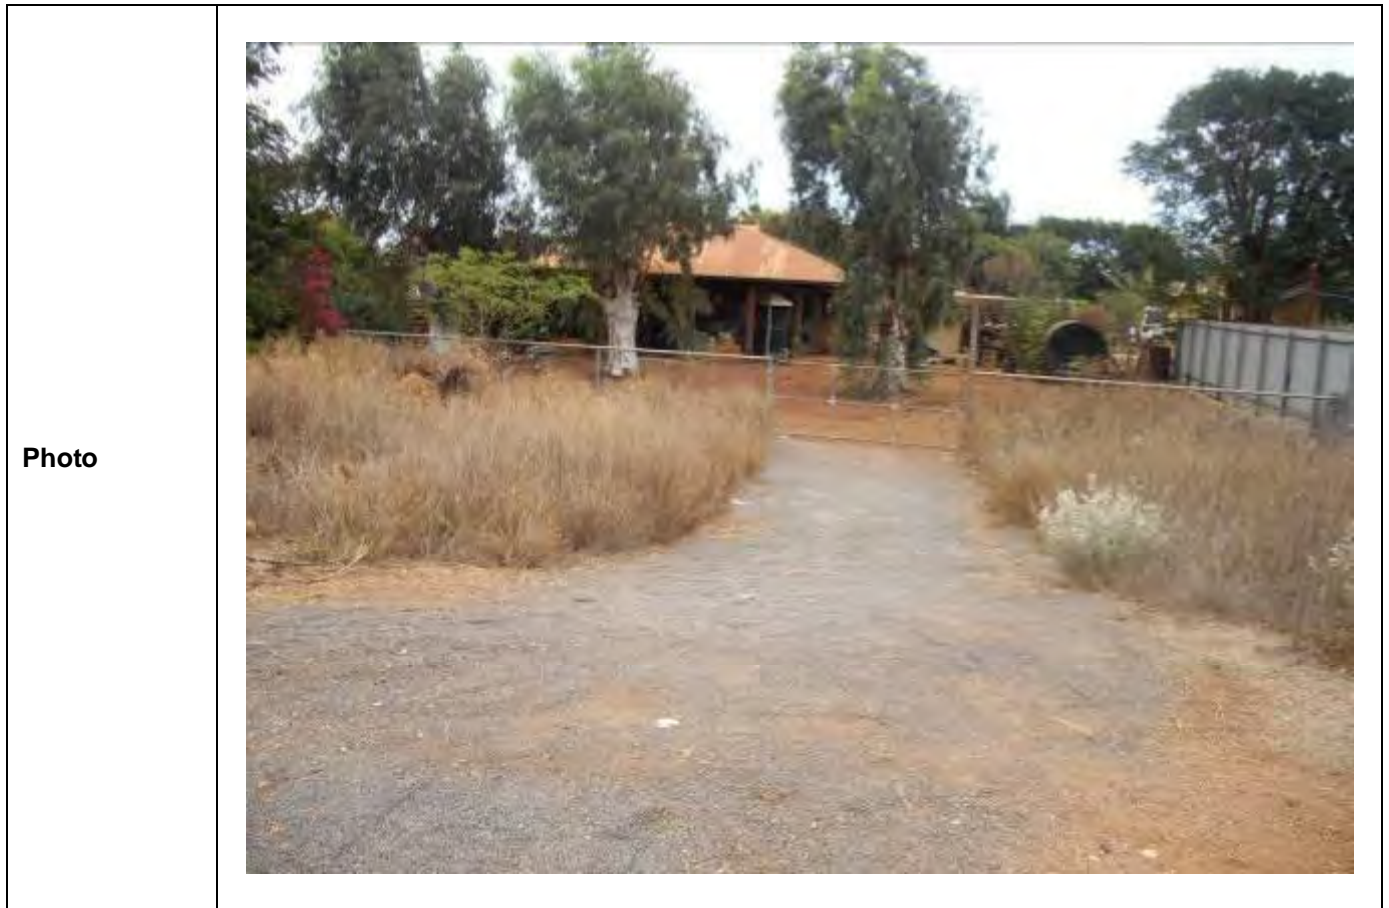
#### 4.5 Lot No. 114 Lyndon Crescent

<b>Category</b>	Encroachment
<b>Type</b>	Rear access Modified flow path Vegetation
<b>Description</b>	Rear access and modified topography Flow of water is directed towards the property.
<b>Photo ID</b>	625
<b>Scope of Works</b>	H - Remove access driveway and reinstate drainage flow path as defined by the natural capacity and invert of downstream lot (113) channel M - Vegetation is to be slashed to a nominal height of 50 mm above ground with the exception of large, established trees of height in excess of 5 m, which shall remain.

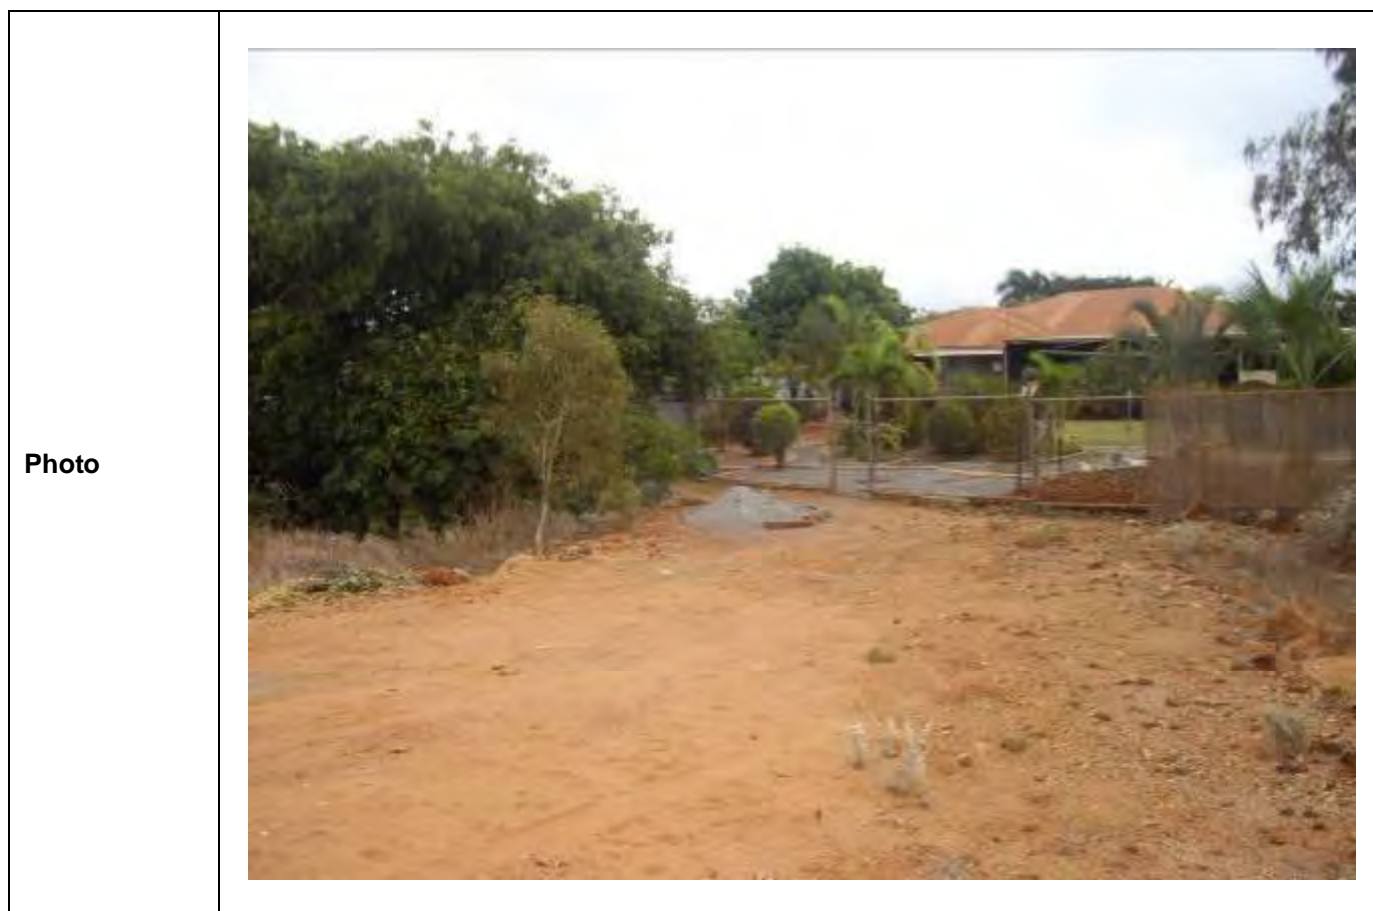
#### 4.7 Lot No. 116 Lyndon Crescent

<b>Category</b>	Encroachment/ Drain Maintenance
<b>Type</b>	Rear access Boundary extension Vegetation
<b>Description</b>	Top of catchment Rear access and modified topography Flow path is not defined due to extensive modifications to drainage reserve Fence is within the drainage reserve Semi-dense vegetation at downstream side of lot
<b>Photo ID</b>	624
<b>Scope of Works</b>	H - Remove access driveway and reinstate drainage flow path as defined by the natural capacity and invert of downstream lot (1116) channel L - Remove fence and relocate to within the property boundary – confirmation required from survey M - Vegetation is to be slashed to a nominal height of 50 mm above ground with the exception of large, established trees of height in excess of 5 m, which shall remain

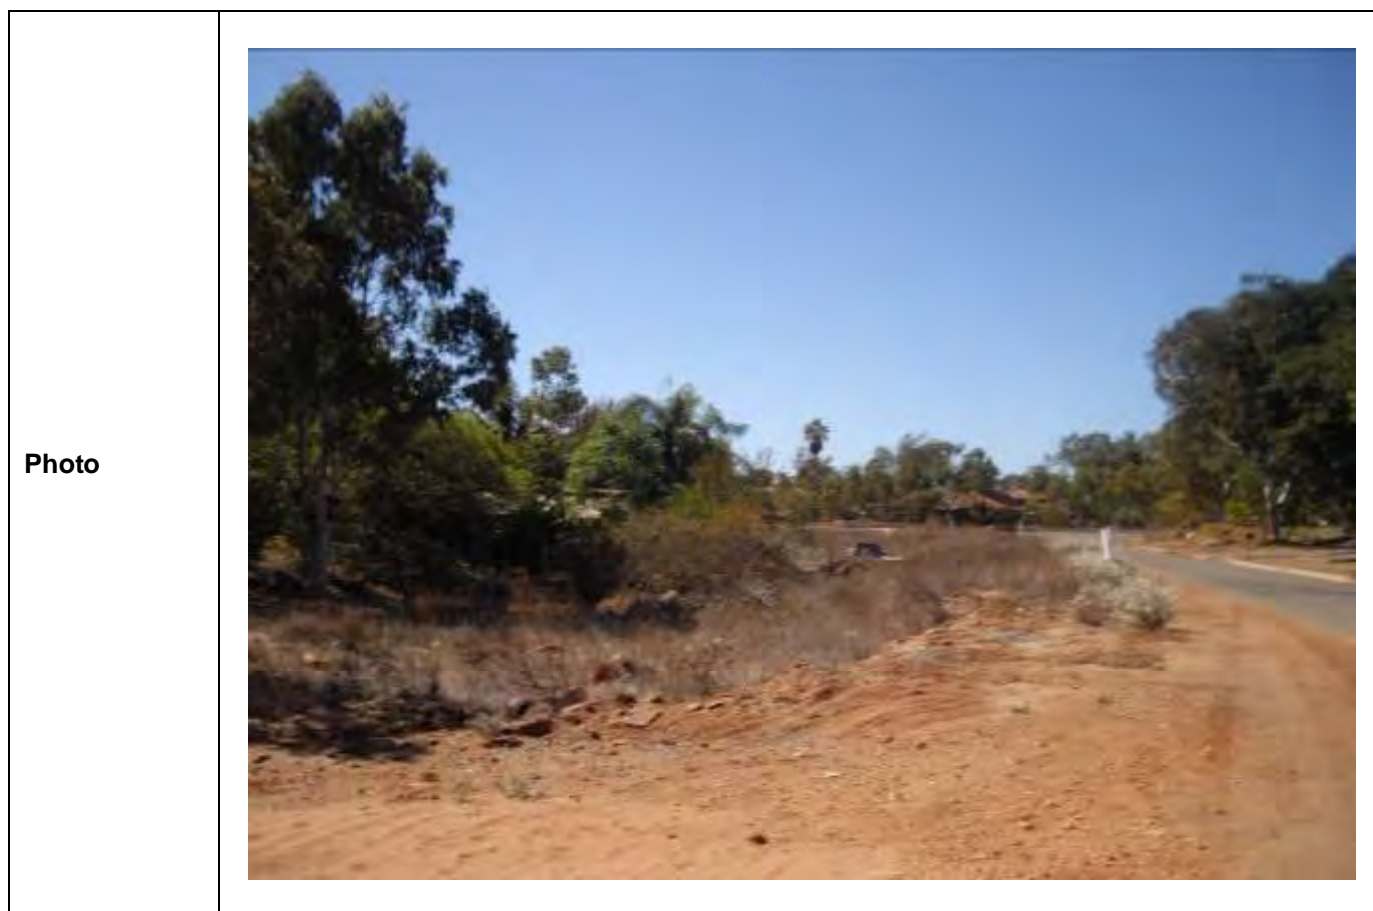
#### 4.8 Lot No. 1,116 Lyndon Crescent

<b>Category</b>	Drain Maintenance
<b>Type</b>	Vegetation
<b>Description</b>	Semi dense vegetation
<b>Photo ID</b>	403
<b>Scope of Works</b>	M - Vegetation is to be slashed to a nominal height of 50 mm above ground with the exception of large, established trees of height in excess of 5 m, which shall remain.

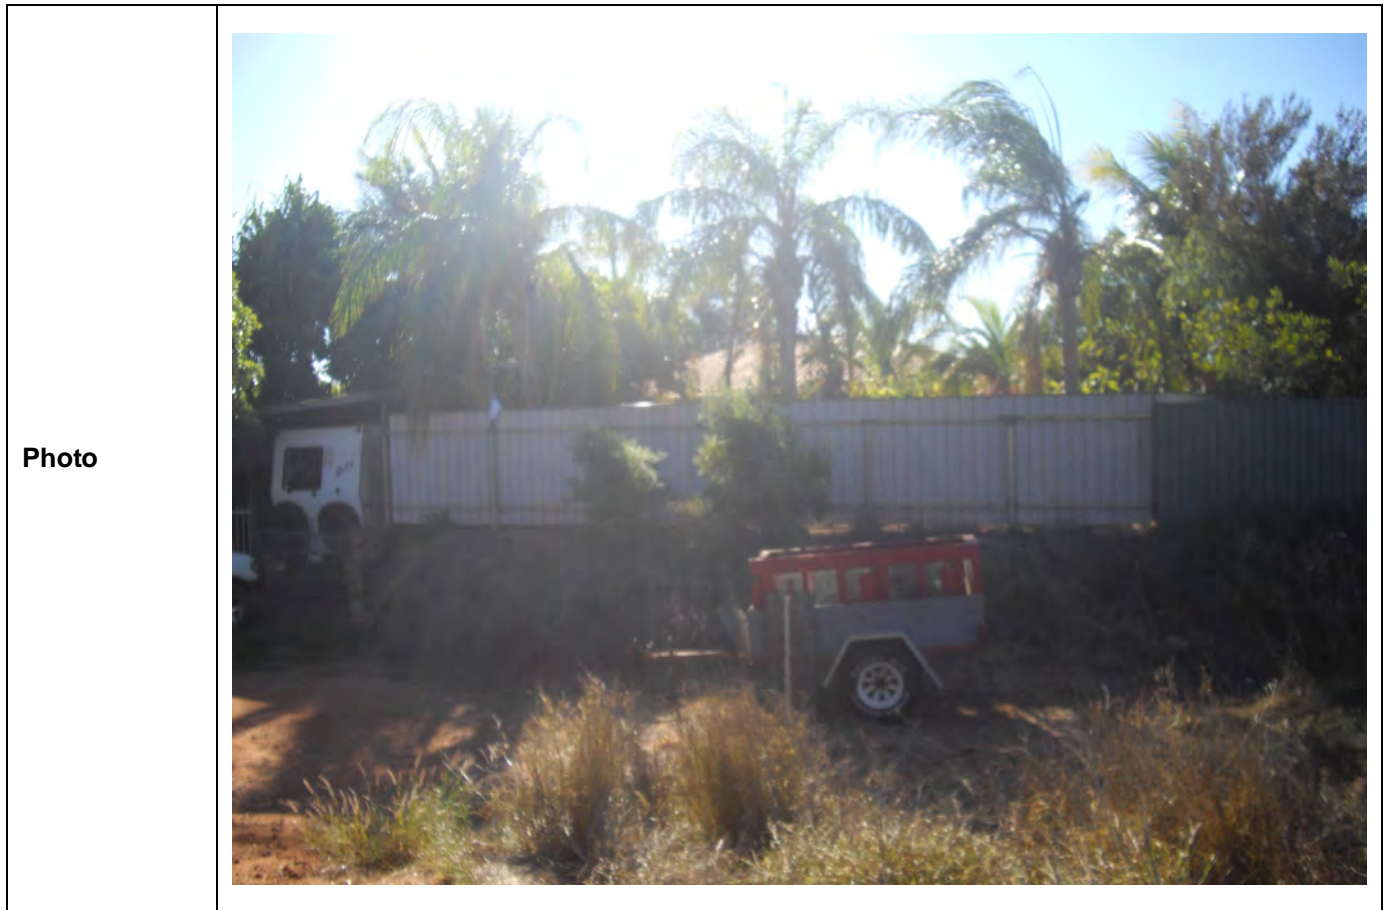
#### 4.9 Lot No. 2,116 Lyndon Crescent

<b>Category</b>	Encroachment
<b>Type</b>	Rear access General items
<b>Description</b>	Rear access follows natural topography Vehicle
<b>Photo ID</b>	1074 ,853
<b>Scope of Works</b>	L – Remove rear access L – Remove vehicle

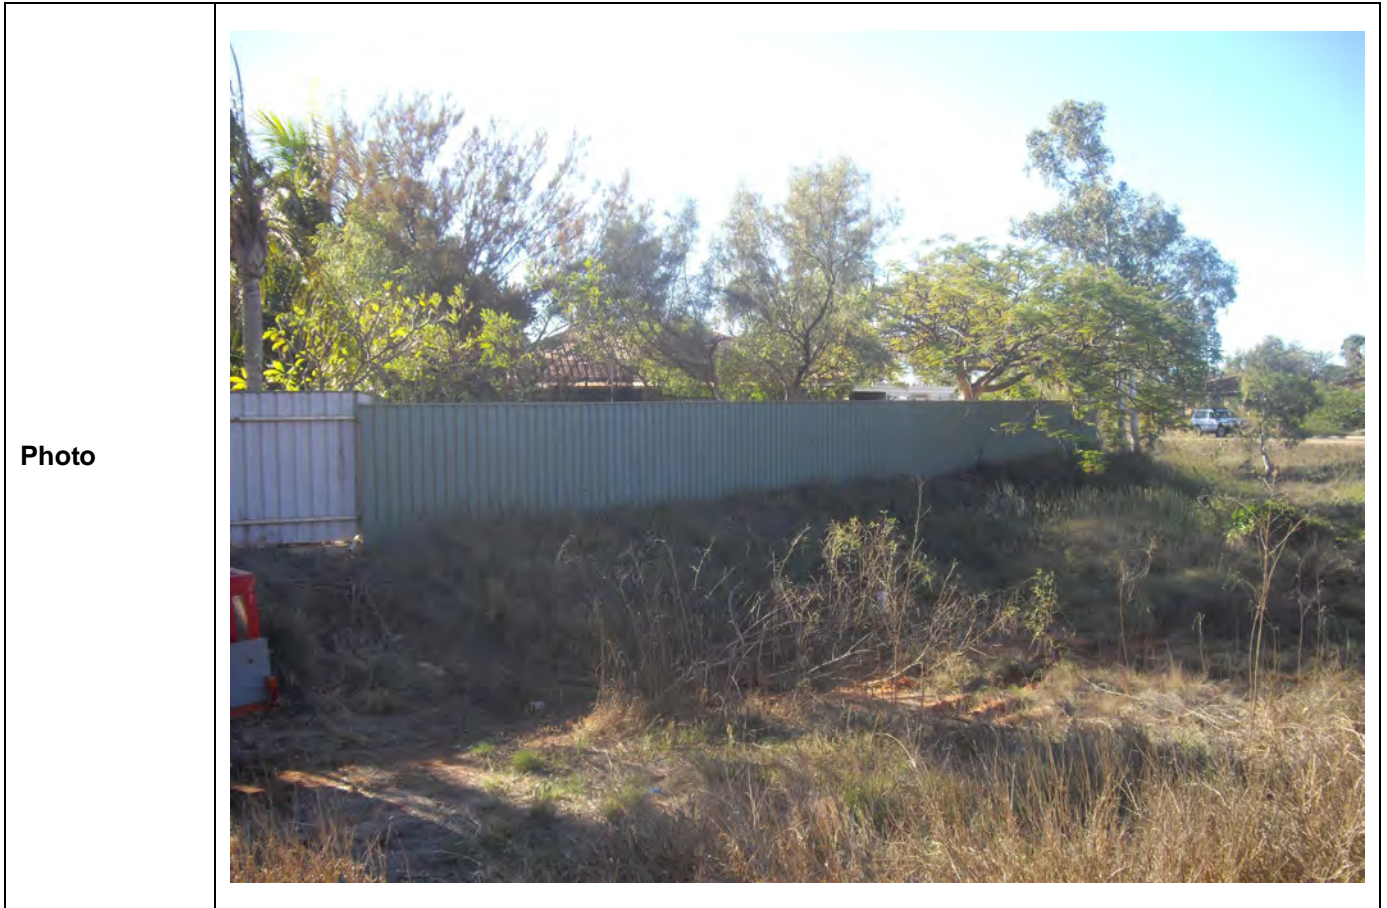
#### 4.10 Lot No. 3,116 Lyndon Crescent

<b>Category</b>	None
<b>Type</b>	None
<b>Description</b>	None
<b>Photo ID</b>	1073
<b>Scope of Works</b>	None required.

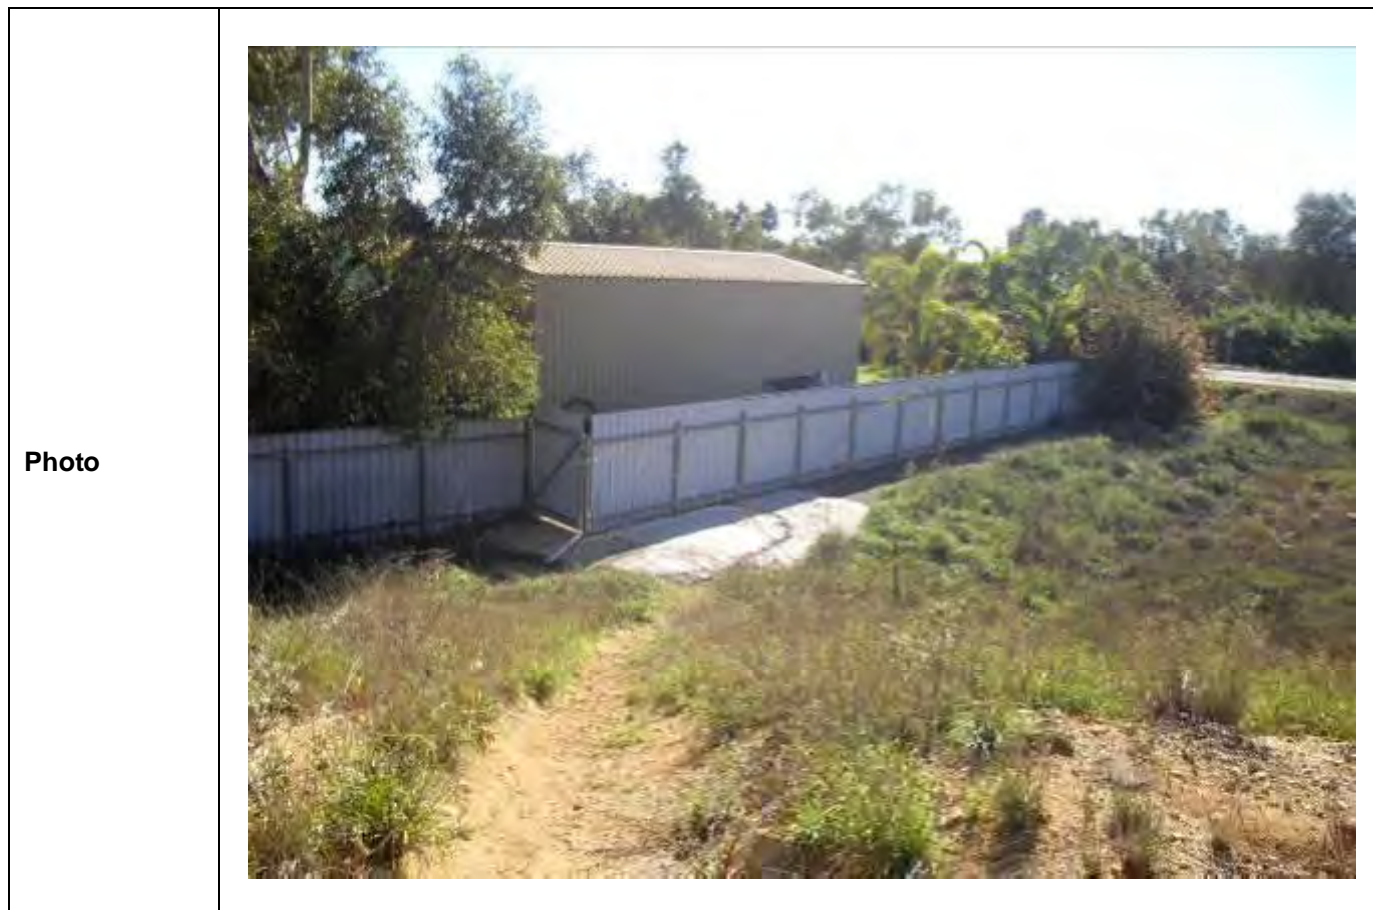
**5.1 Lot No. 117 Irwin Crescent**

<b>Category</b>	None
<b>Type</b>	None
<b>Description</b>	Overland flow directed to the East.
<b>Photo ID</b>	848
<b>Scope of Works</b>	None required.

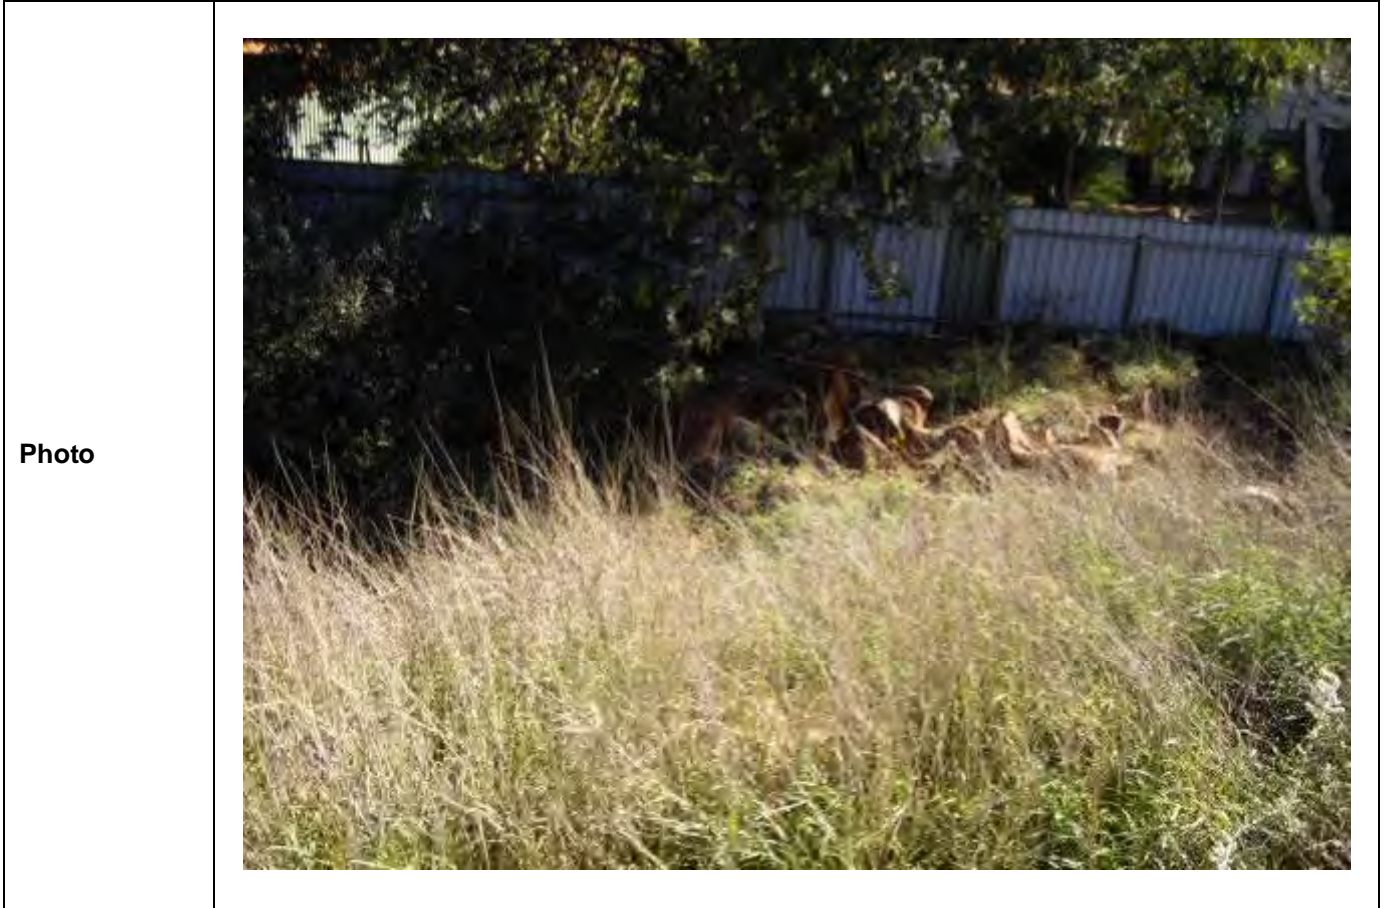
**5.2 Lot No. 118 Irwin Crescent**

<b>Category</b>	None
<b>Type</b>	None
<b>Description</b>	Overland flow is directed towards to the East.
<b>Photo ID</b>	849
<b>Scope of Works</b>	None required.

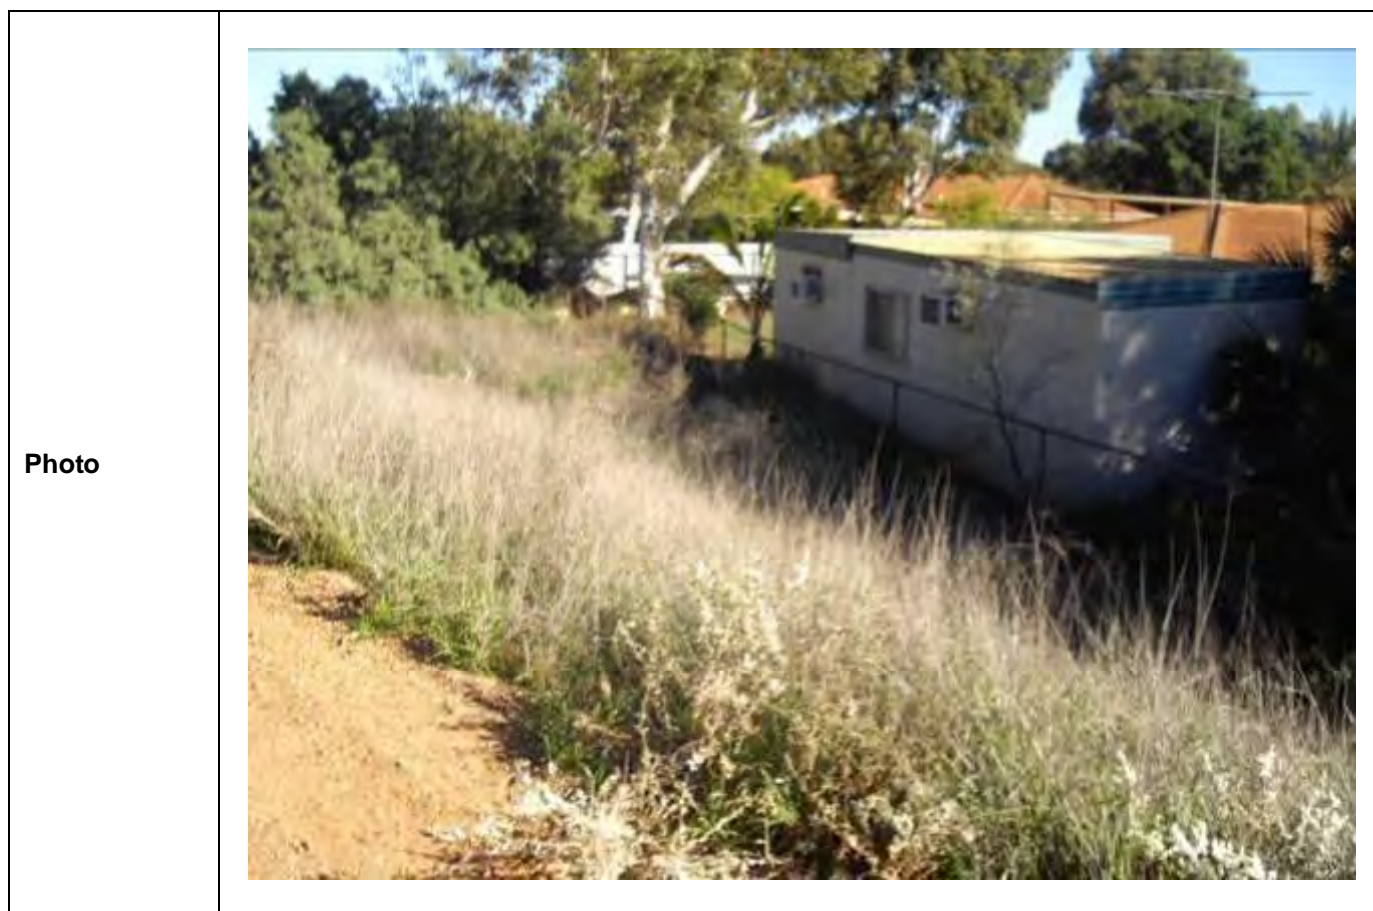
### 5.3 Lot No. 119 Irwin Crescent

<b>Category</b>	None
<b>Type</b>	None
<b>Description</b>	Top of catchment Overland flow is directed towards the East
<b>Photo ID</b>	850
<b>Scope of Works</b>	None required.

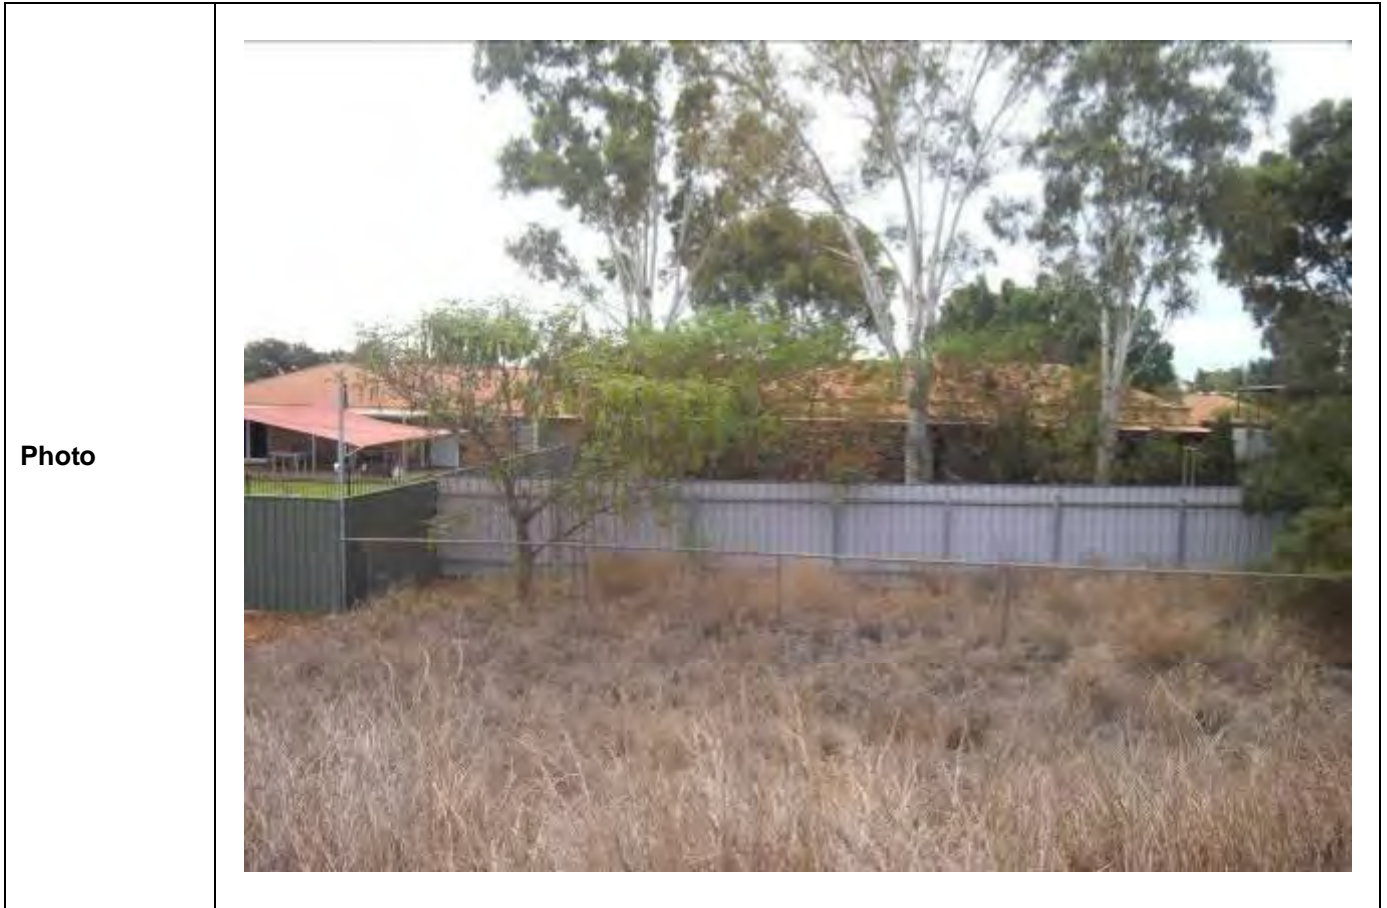
#### 5.4 Lot No. 120 Irwin Crescent

<b>Category</b>	Encroachment / Drain Maintenance
<b>Type</b>	Boundary extension Vegetation
<b>Description</b>	Old fence Semi dense vegetation
<b>Photo ID</b>	612
<b>Scope of Works</b>	L – Remove fence – confirmation required from survey M - Vegetation is to be slashed to a nominal height of 50 mm above ground with the exception of large, established trees of height in excess of 5 m, which shall remain
