City of Karratha  
Dampier Stormwater Management Study  
Report  
Part B  
June 2015

## Appendix **C** – 2010 encroachment reviews

**Rio Tinto Iron Ore**  
Report on Dampier Drainage  
Review  
Block 1 Encroachments  
June 2010

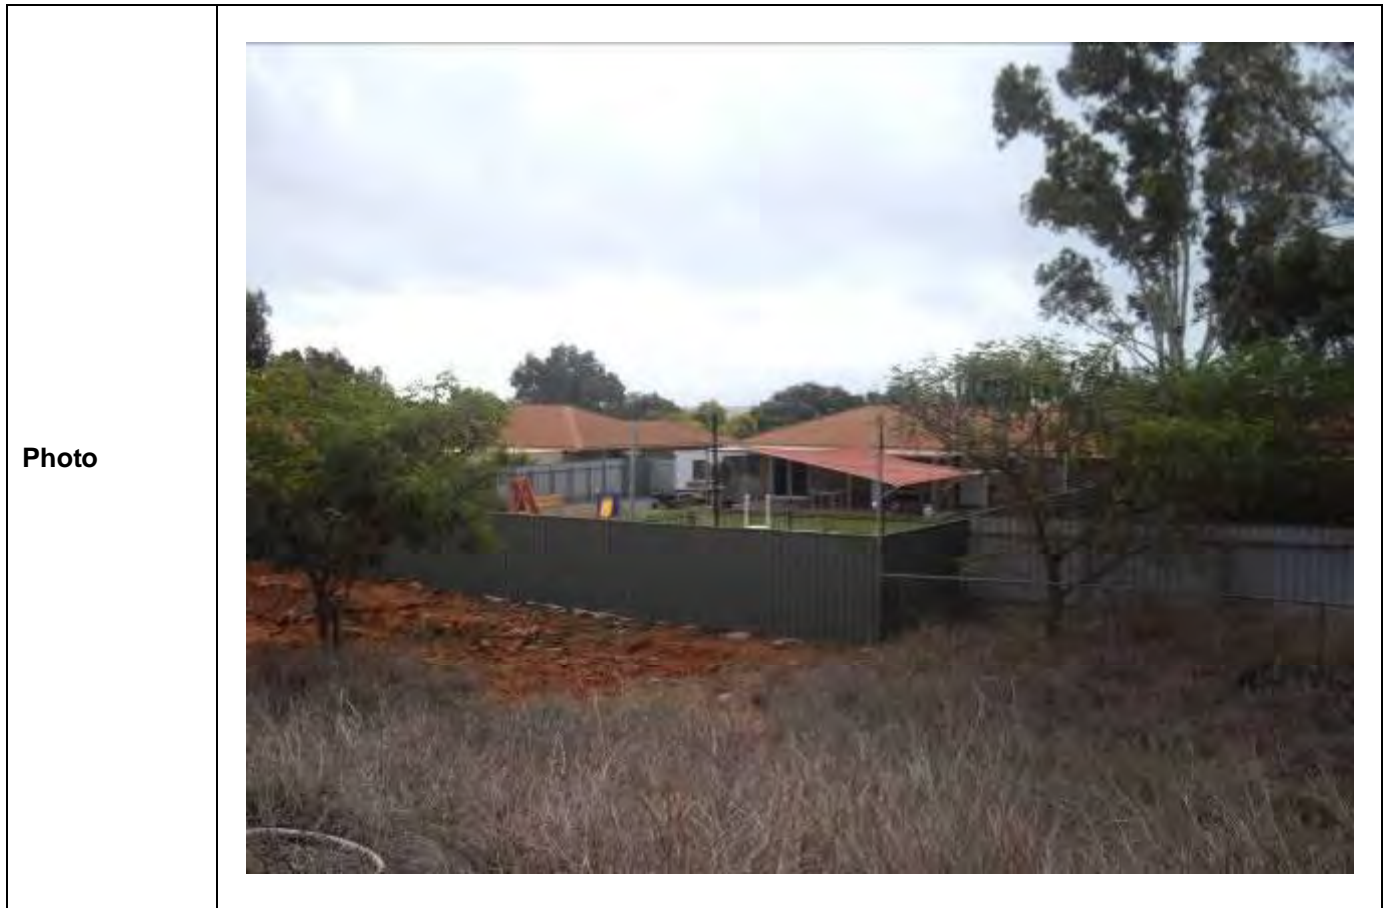
## 5.5 Lot No. 121 Irwin Crescent

<b>Category</b>	Encroachment
<b>Type</b>	Boundary extension
<b>Description</b>	Fence – does not impact flow. Channel adequate
<b>Photo ID</b>	613
<b>Scope of Works</b>	L – Remove fence – get confirmation from survey

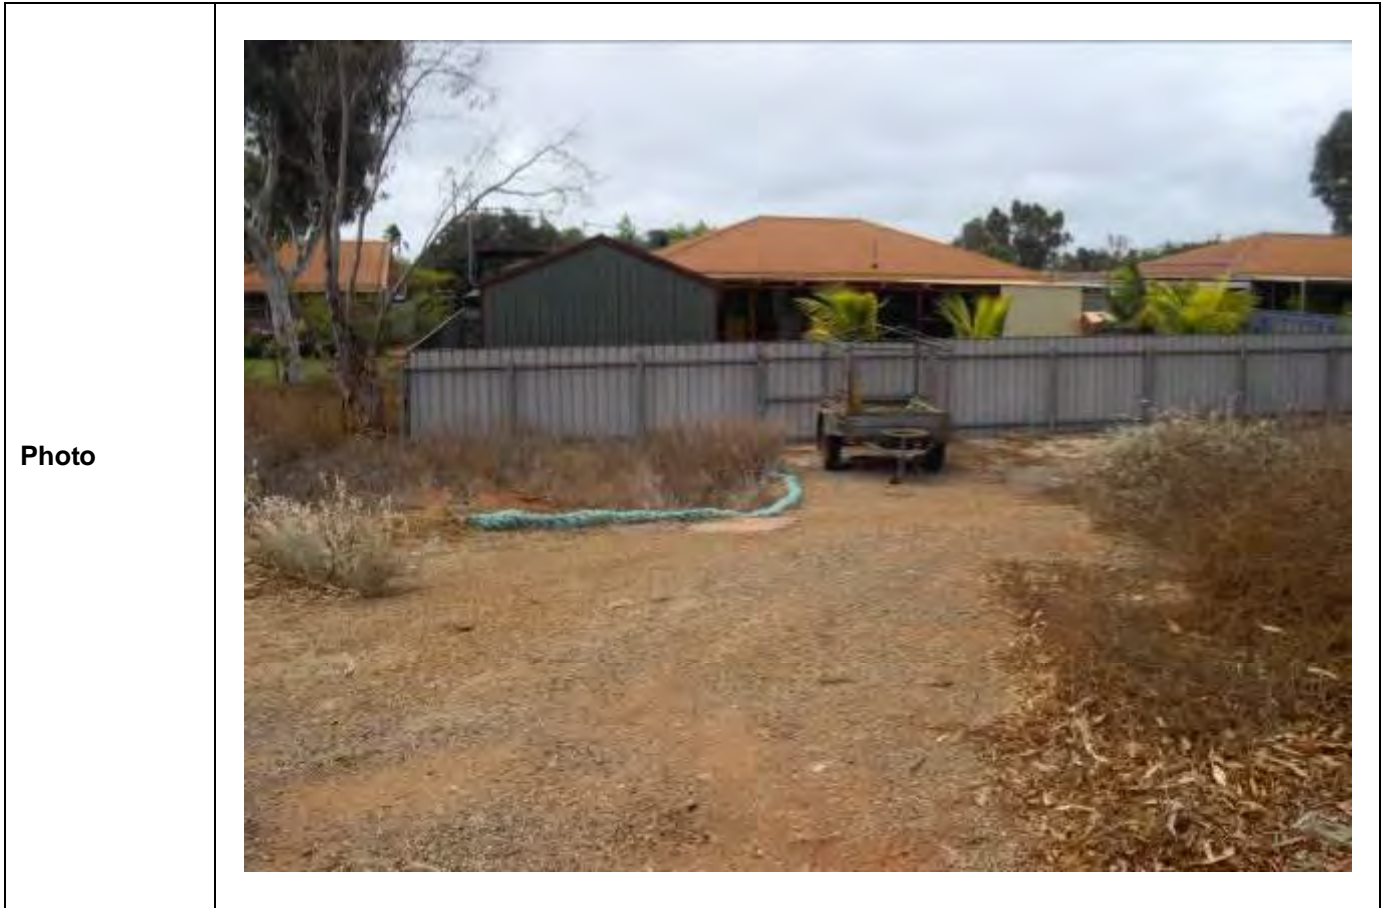
**5.6 Lot No. 122 Irwin Crescent**

<b>Category</b>	Encroachment
<b>Type</b>	Rear access
<b>Description</b>	Rear access with culvert
<b>Photo ID</b>	614
<b>Scope of Works</b>	H - Remove access driveway and reinstate drainage flow path as defined by the natural capacity and invert of downstream lot (123) channel

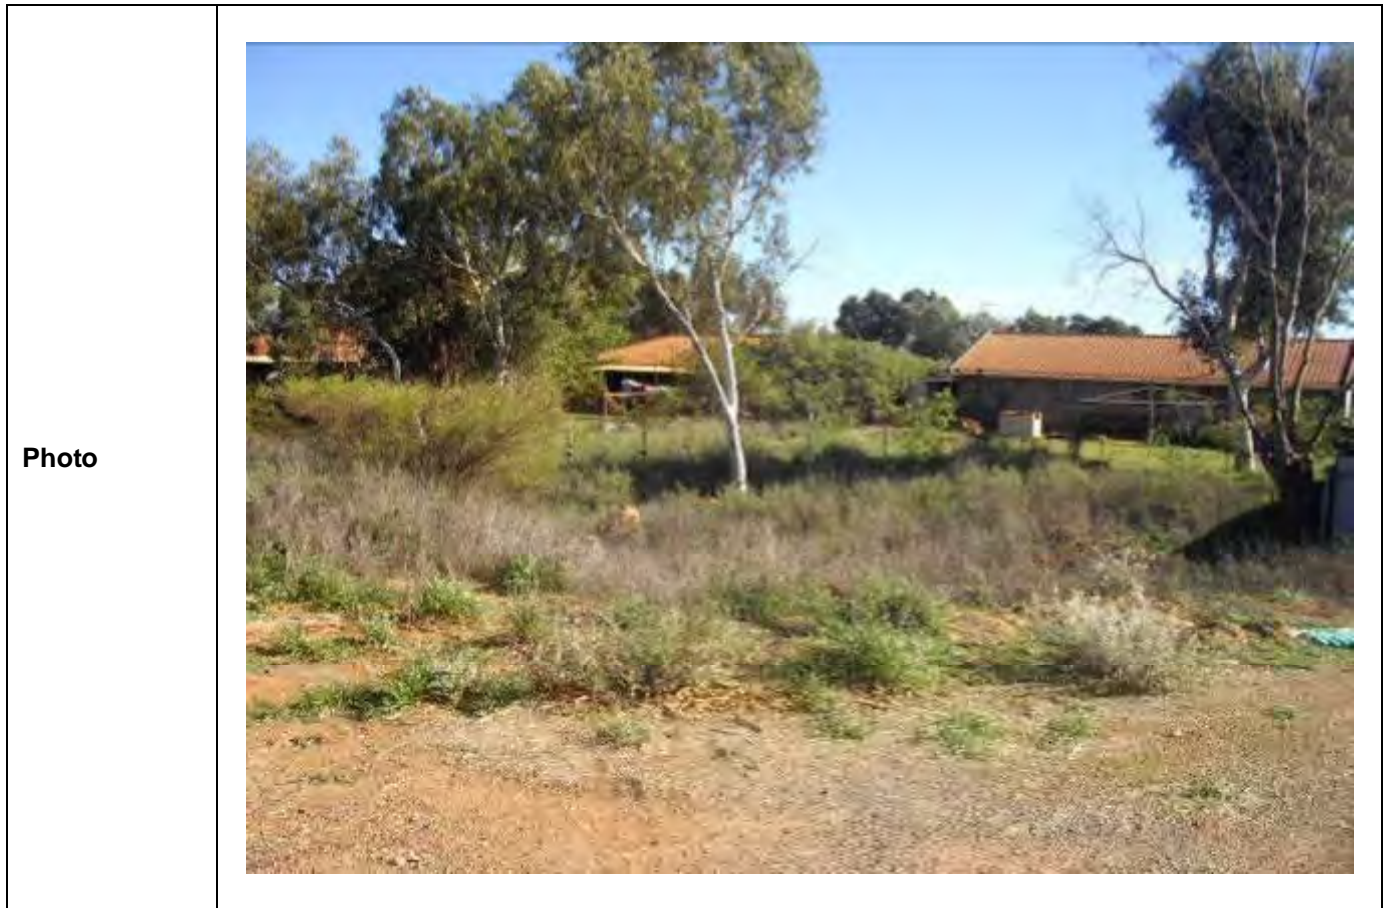
## 5.7 Lot No. 123 Irwin Crescent

<b>Category</b>	Drain Maintenance
<b>Type</b>	Vegetation
<b>Description</b>	Semi-dense low lying vegetation
<b>Photo ID</b>	851
<b>Scope of Works</b>	M - Vegetation is to be slashed to a nominal height of 50 mm above ground with the exception of large, established trees of height in excess of 5 m, which shall remain.

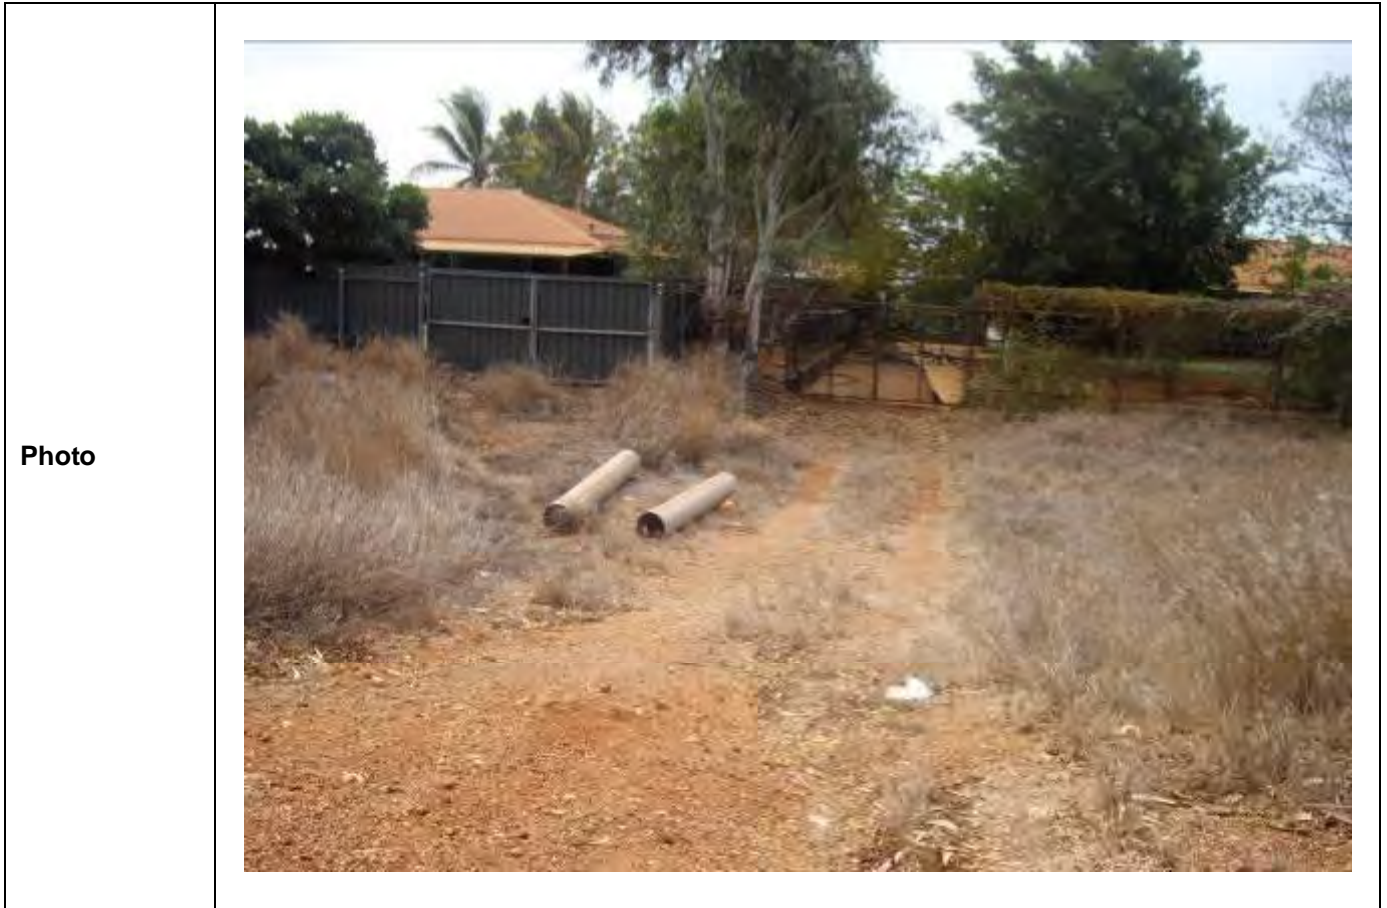
**5.8 Lot No. 124 Irwin Crescent**

<b>Category</b>	Encroachment
<b>Type</b>	Rear access; Ill defined.
<b>Description</b>	Rear access follows natural topography. Flow is directed towards lots.
<b>Photo ID</b>	615
<b>Scope of Works</b>	H - Remove access driveway and reinstate drainage flow path as defined by the natural capacity and invert of downstream lot (1,124) channel and within the drainage reserve.

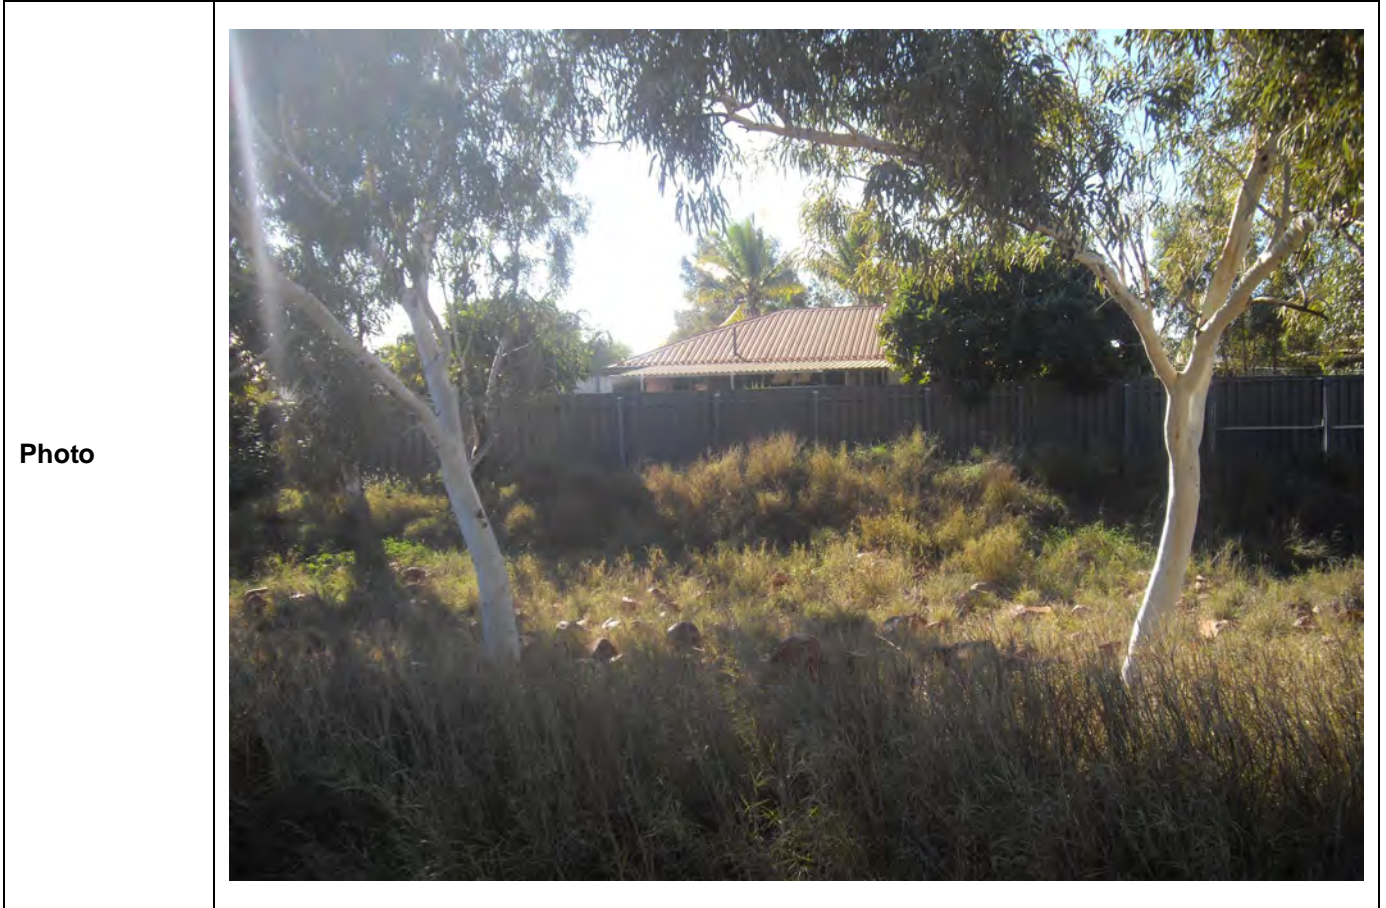
**5.9 Lot No. 1,124 Irwin Crescent**

<b>Category</b>	Encroachment
<b>Type</b>	Rear access
<b>Description</b>	Rear access and modified topography.
<b>Photo ID</b>	1070
<b>Scope of Works</b>	H - Remove access driveway and reinstate drainage flow path as defined by the natural capacity and invert of downstream lot (2,124) channel

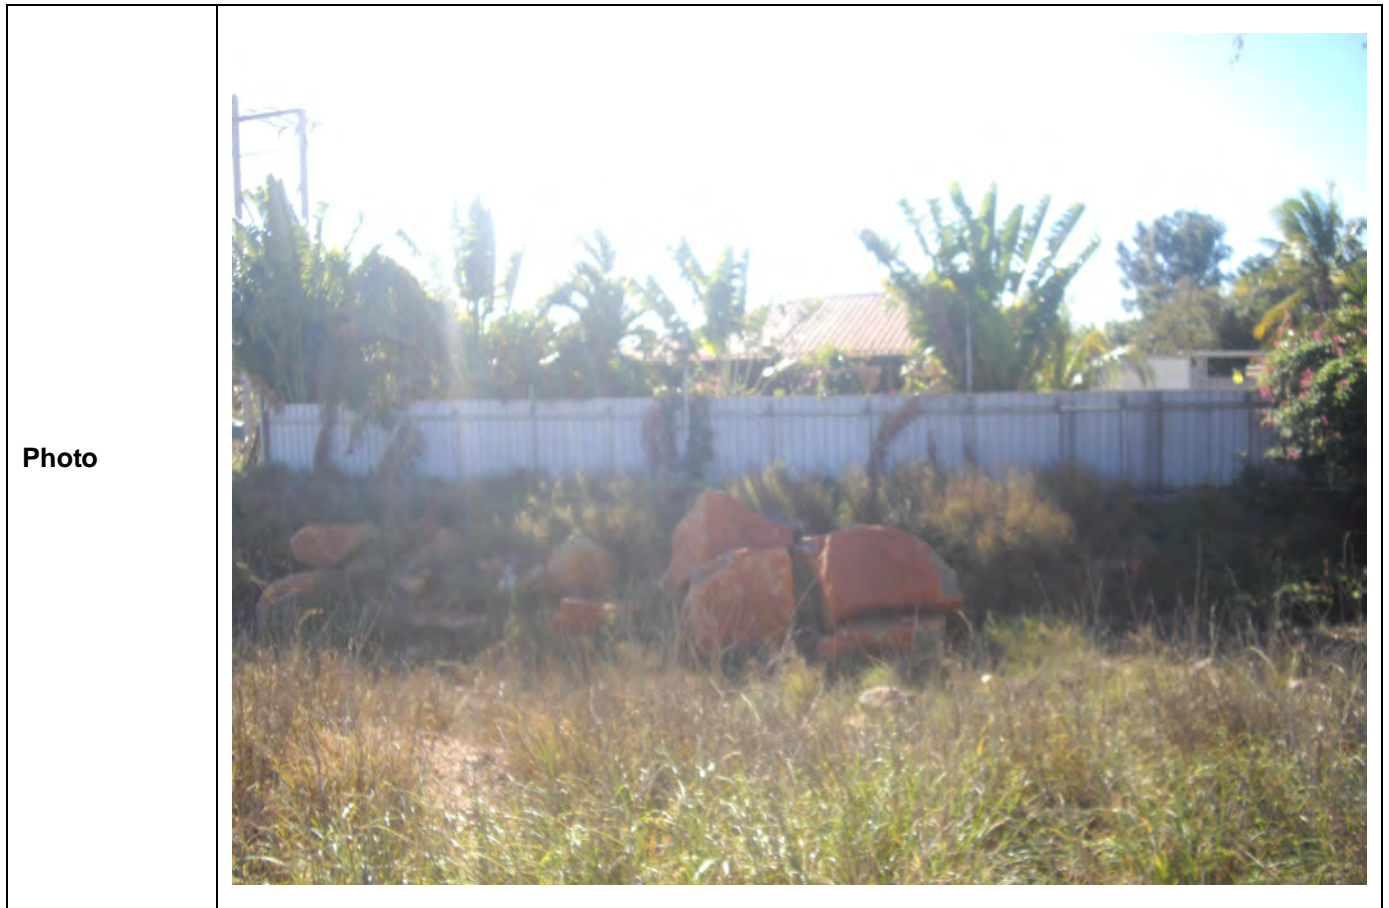
**5.10 Lot No. 2,124 Irwin Crescent**

<b>Category</b>	None
<b>Type</b>	None
<b>Description</b>	None
<b>Photo ID</b>	1071
<b>Scope of Works</b>	None required

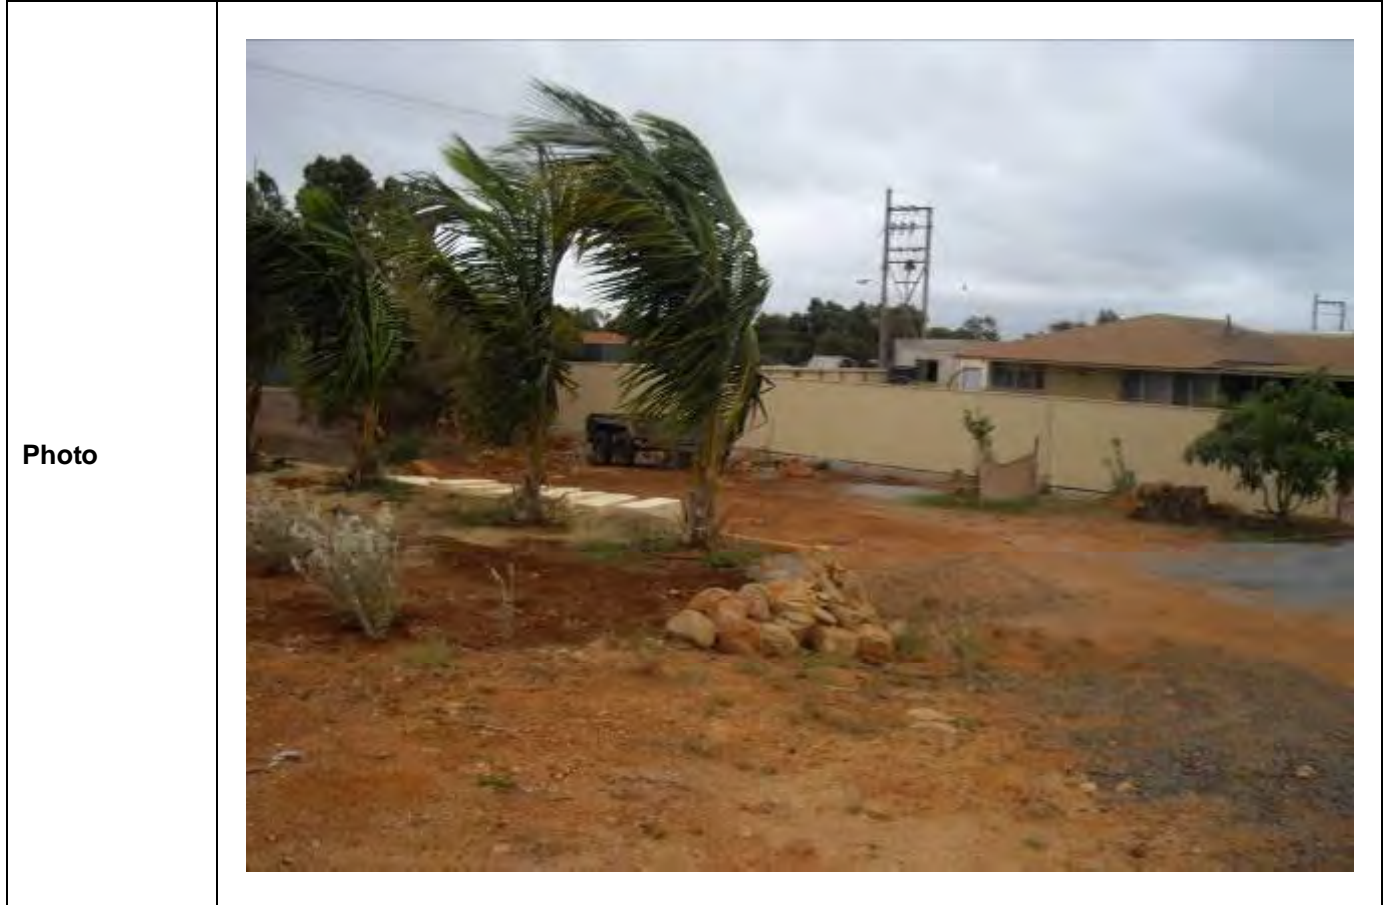
## 6.1 Lot No. 125 Meda Crescent

<b>Category</b>	Encroachment/ Drain Maintenance
<b>Type</b>	Rear access General item Boundary Encroachment Modified drain
<b>Description</b>	Rear access impedes flow Trailer not impeding flow Landscaping including retaining wall not impeding flow
<b>Photo ID</b>	623
<b>Scope of Works</b>	H - Remove access driveway and reinstate drainage flow path as defined by the natural capacity and invert of downstream channel L – Remove trailer L – Remove landscaping

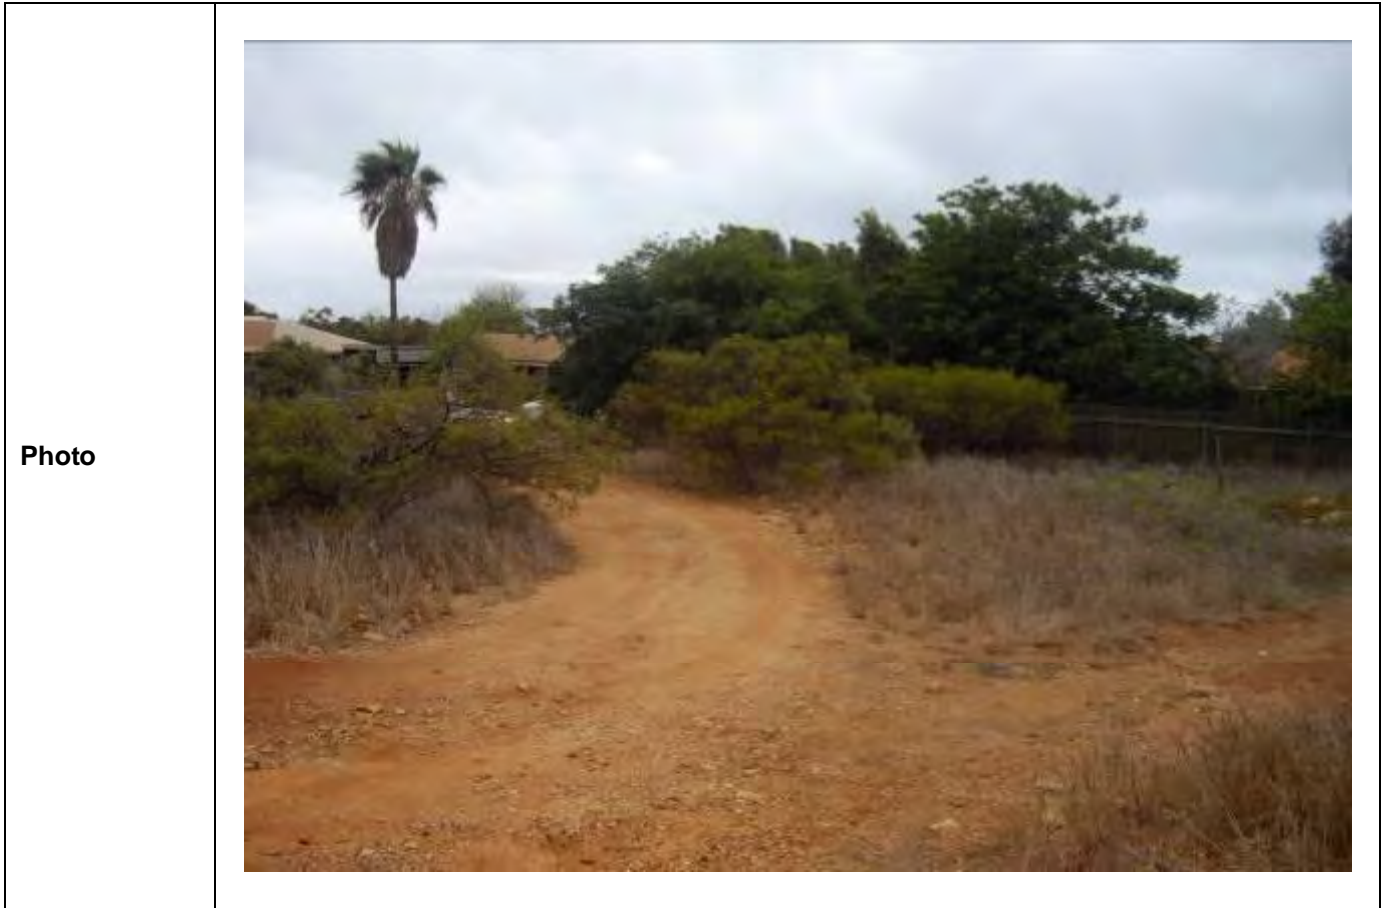
## 6.2 Lot No. 126 Meda Crescent

<b>Category</b>	Encroachment
<b>Type</b>	Rear access Modified flow path
<b>Description</b>	Rear access follows natural topography
<b>Photo ID</b>	622
<b>Scope of Works</b>	H - Remove access driveway and reinstate drainage flow path as defined by the natural capacity and invert of downstream lot (125) channel

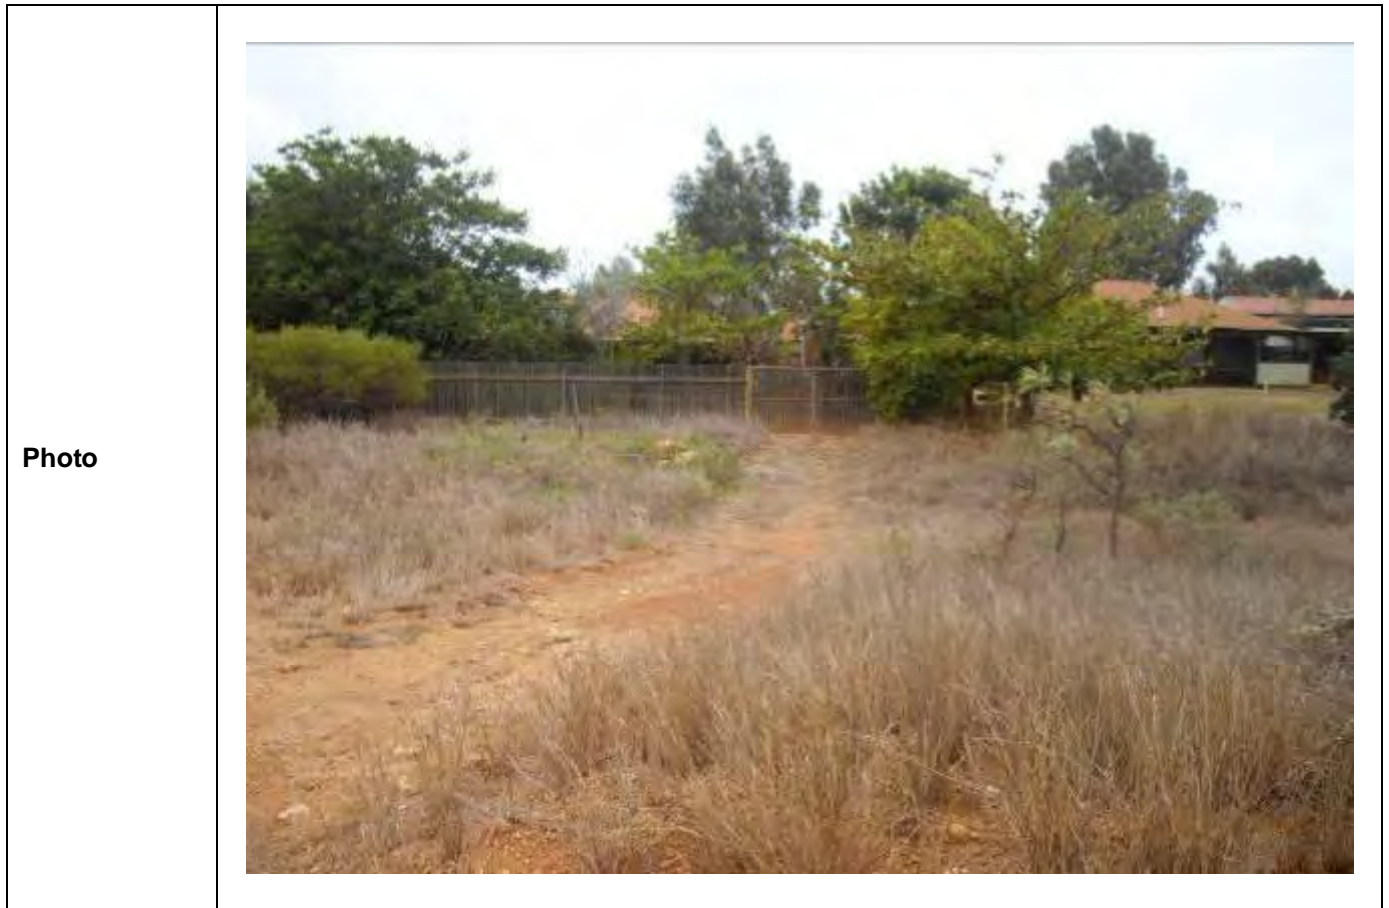
### 6.3 Lot No. 127 Meda Crescent

<b>Category</b>	Encroachment
<b>Type</b>	Rear access
<b>Description</b>	Rear access and modified topography
<b>Photo ID</b>	621
<b>Scope of Works</b>	H - Remove access driveway and reinstate drainage flow path as defined by the natural capacity and invert of downstream lot (126) channel

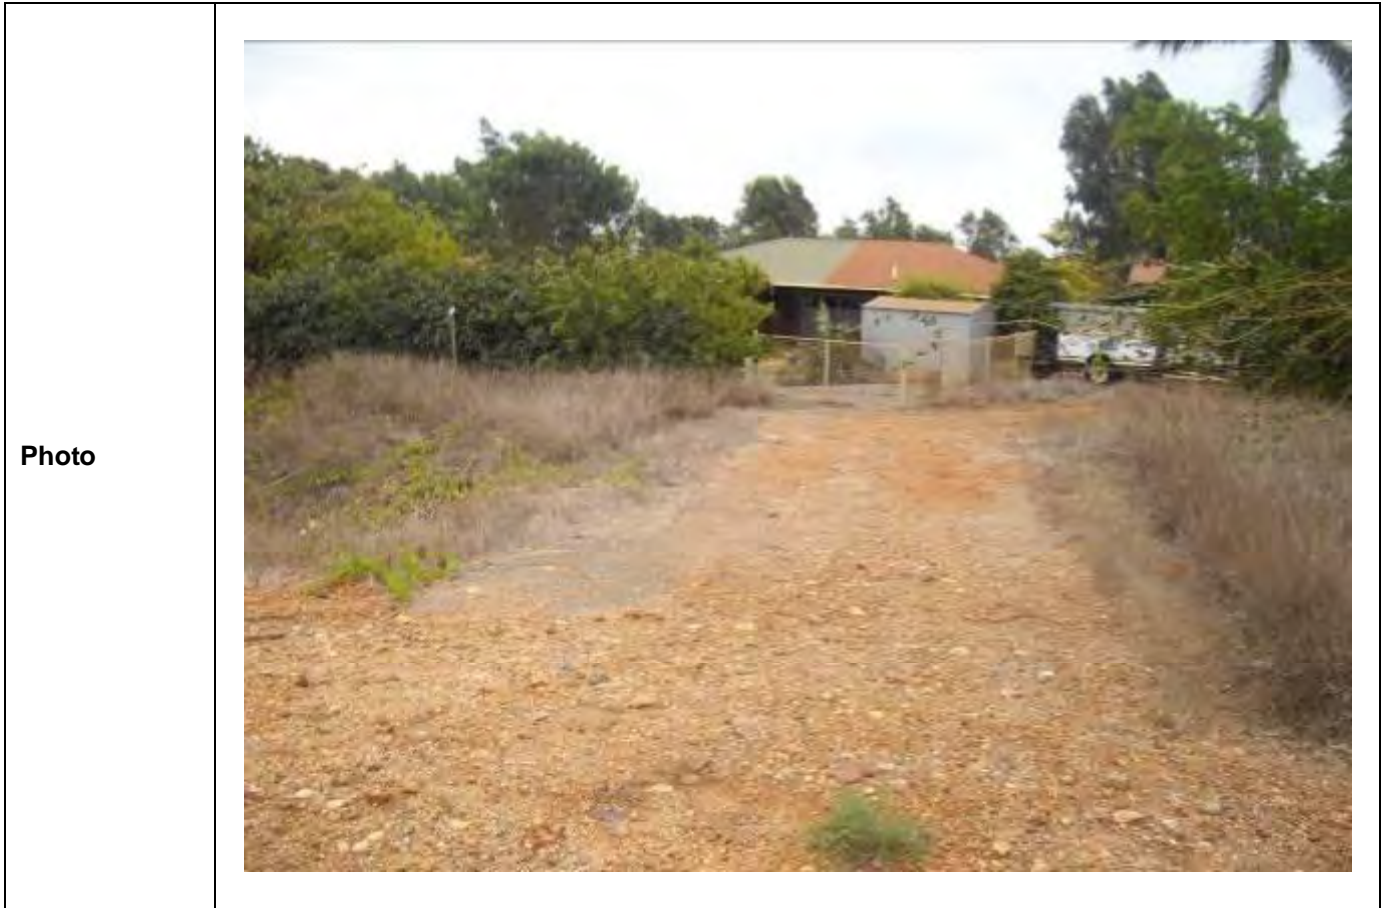
#### 6.4 Lot No. 128 Meda Crescent

<b>Category</b>	Encroachment
<b>Type</b>	Rear access
<b>Description</b>	Rear access and modified topography impedes flow
<b>Photo ID</b>	620
<b>Scope of Works</b>	H - Remove access driveway and reinstate drainage flow path as defined by the natural capacity and invert of downstream lot (127) channel

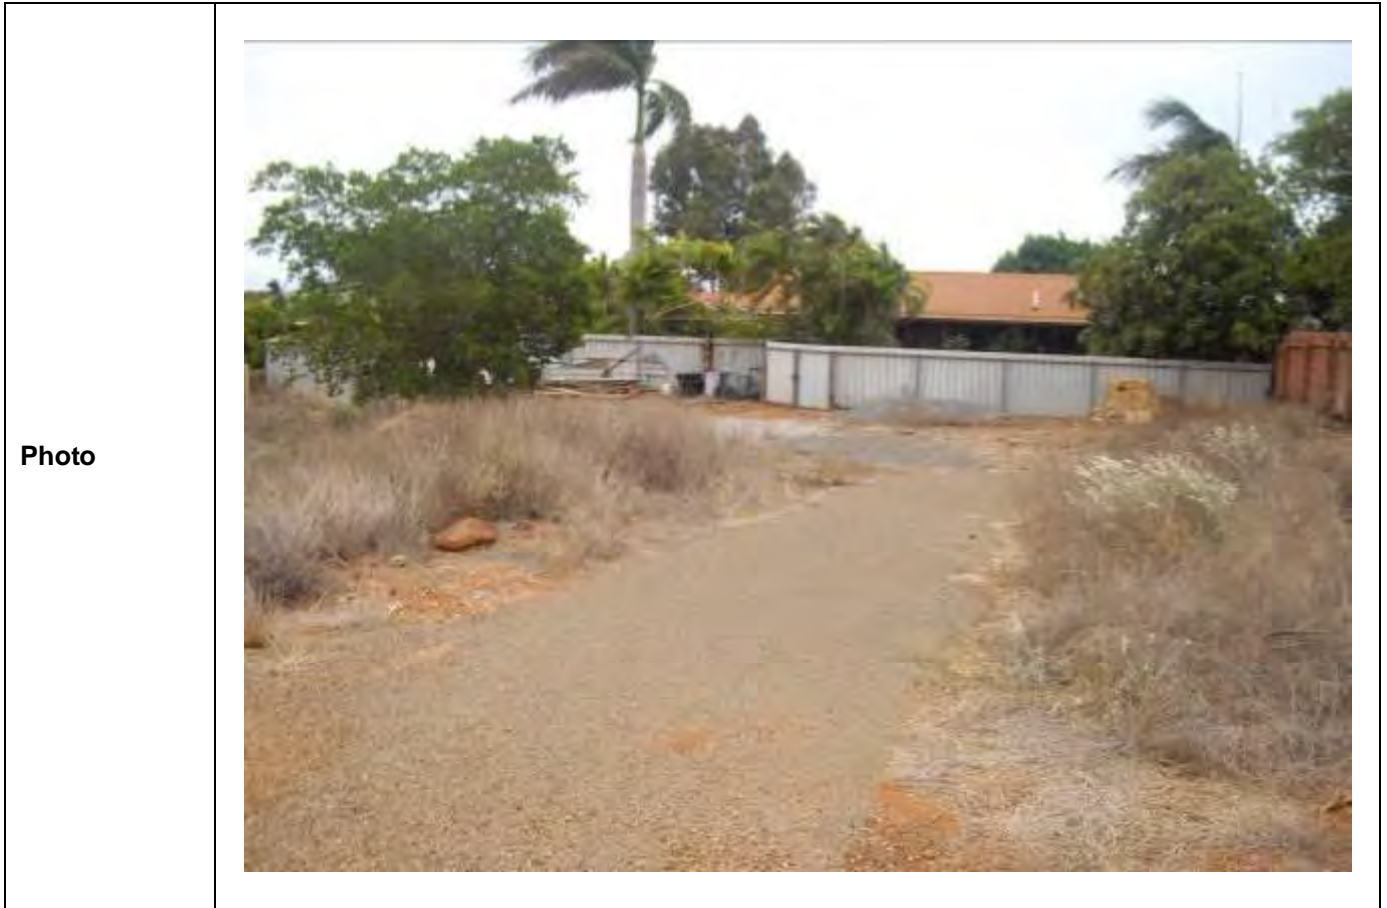
## 6.5 Lot No. 129 Meda Crescent

<b>Category</b>	Encroachment
<b>Type</b>	Rear access Modified flow path
<b>Description</b>	Rear access follows natural topography Drainage reserve is lower than the road reserve but slopes towards the property.
<b>Photo ID</b>	619
<b>Scope of Works</b>	H - Remove access driveway and reinstate drainage flow path as defined by the natural capacity and invert of downstream lot (128) channel

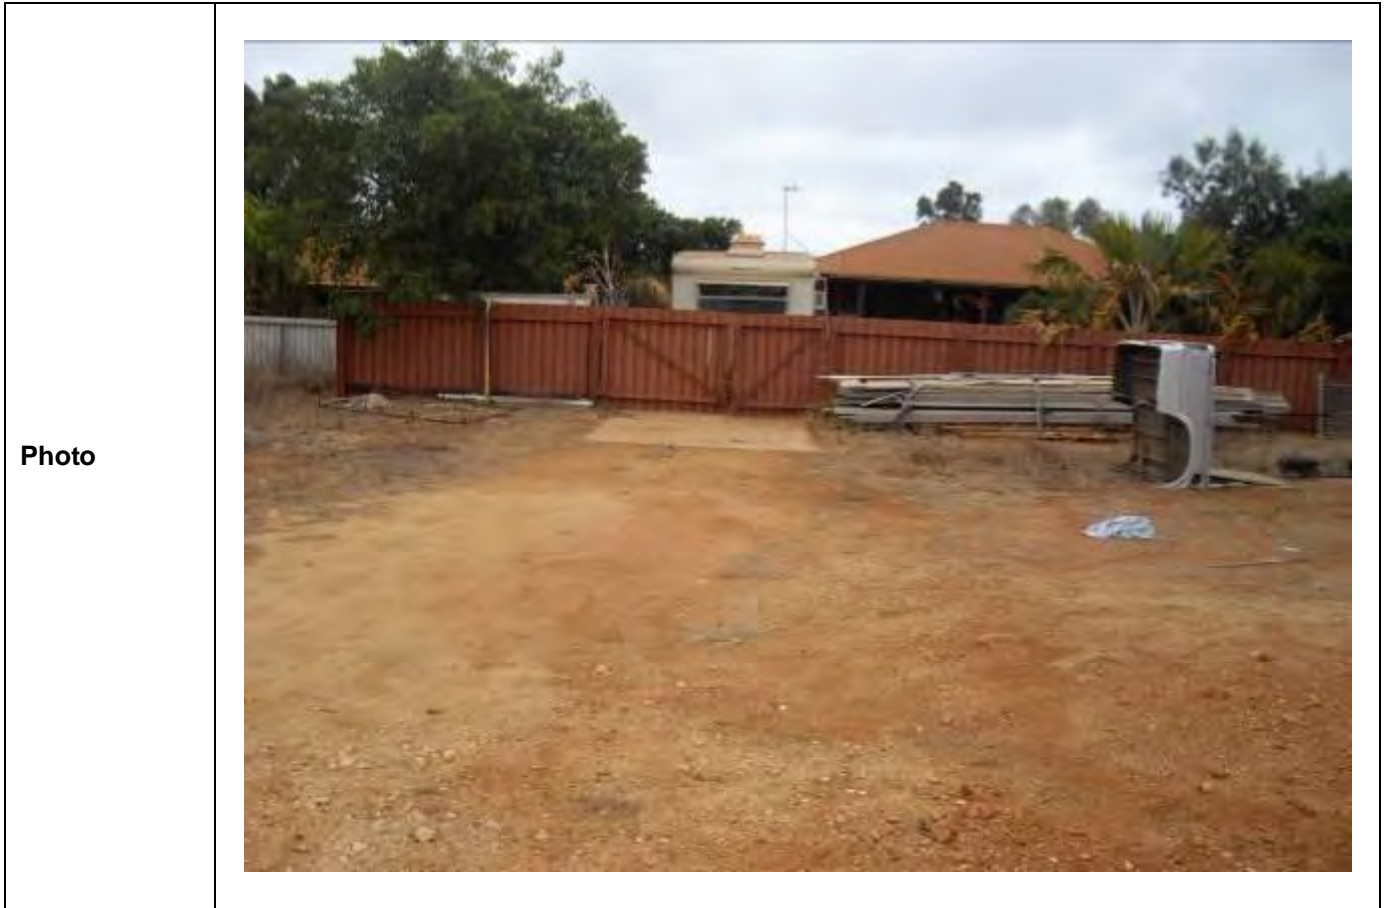
## 6.6 Lot No. 130 Meda Crescent

<b>Category</b>	Encroachment
<b>Type</b>	Rear access General items.
<b>Description</b>	Rear access impedes flow Building material and vehicle parts
<b>Photo ID</b>	618
<b>Scope of Works</b>	H - Remove access driveway and reinstate drainage flow path as defined by the natural capacity and invert of downstream lot (129) channel L – Remove building material and vehicle parts.

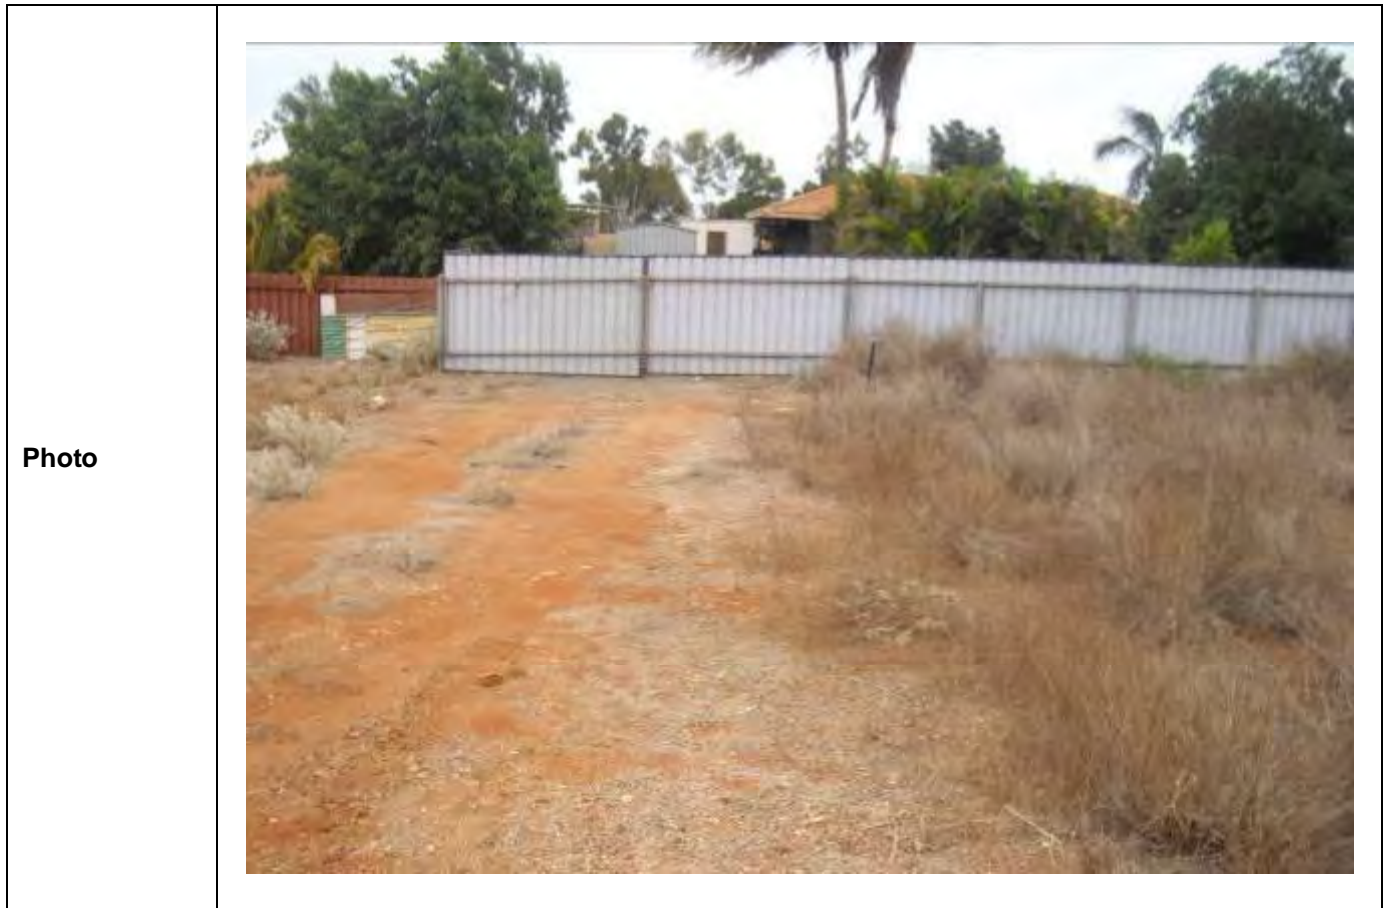
## 6.7 Lot No. 131 Meda Crescent

<b>Category</b>	Encroachment
<b>Type</b>	Rear access
<b>Description</b>	Rear access follows natural topography
<b>Photo ID</b>	617
<b>Scope of Works</b>	L – Remove rear access

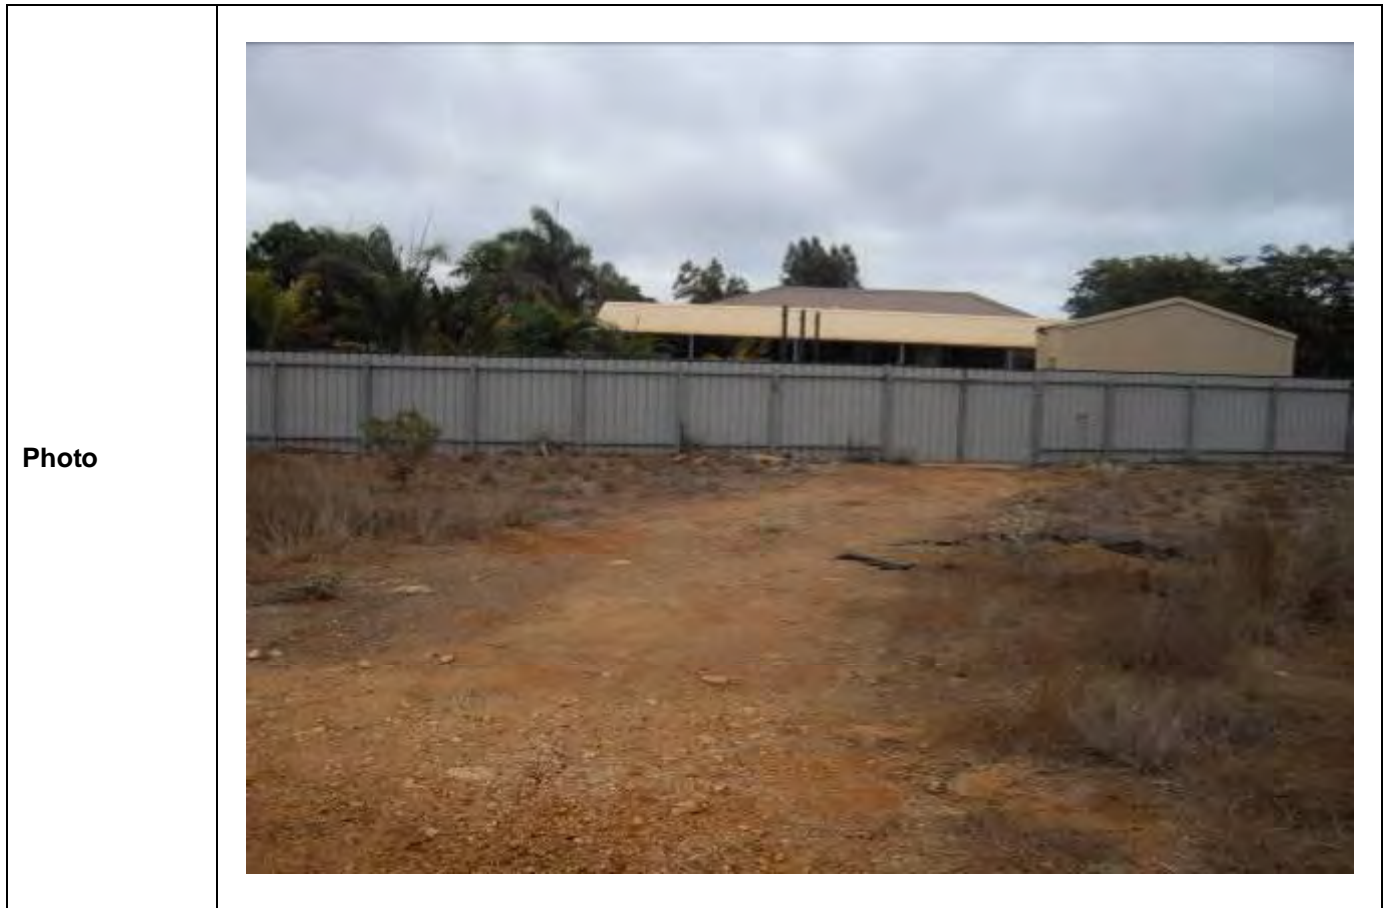
## 6.8 Lot No. 1,131 Meda Crescent

<b>Category</b>	Encroachment
<b>Type</b>	Rear access
<b>Description</b>	Rear access follows natural topography
<b>Photo ID</b>	616
<b>Scope of Works</b>	L – Remove rear access

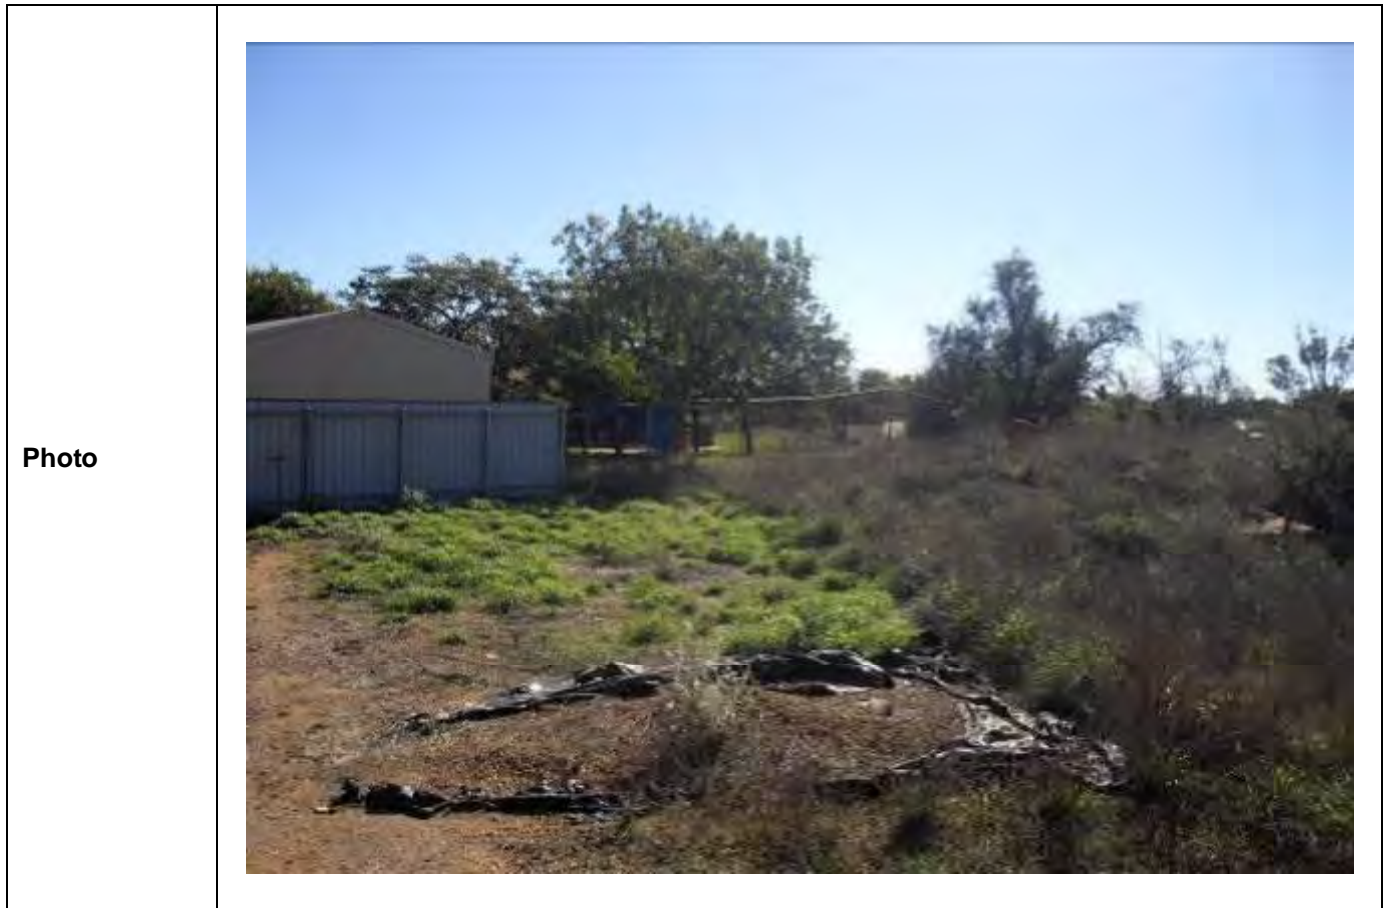
**6.9 Lot No. 2,131 Meda Crescent**

<b>Category</b>	Drain Maintenance
<b>Type</b>	Flow path
<b>Description</b>	Top of catchment flow path adequate.
<b>Photo ID</b>	852
<b>Scope of Works</b>	None required.

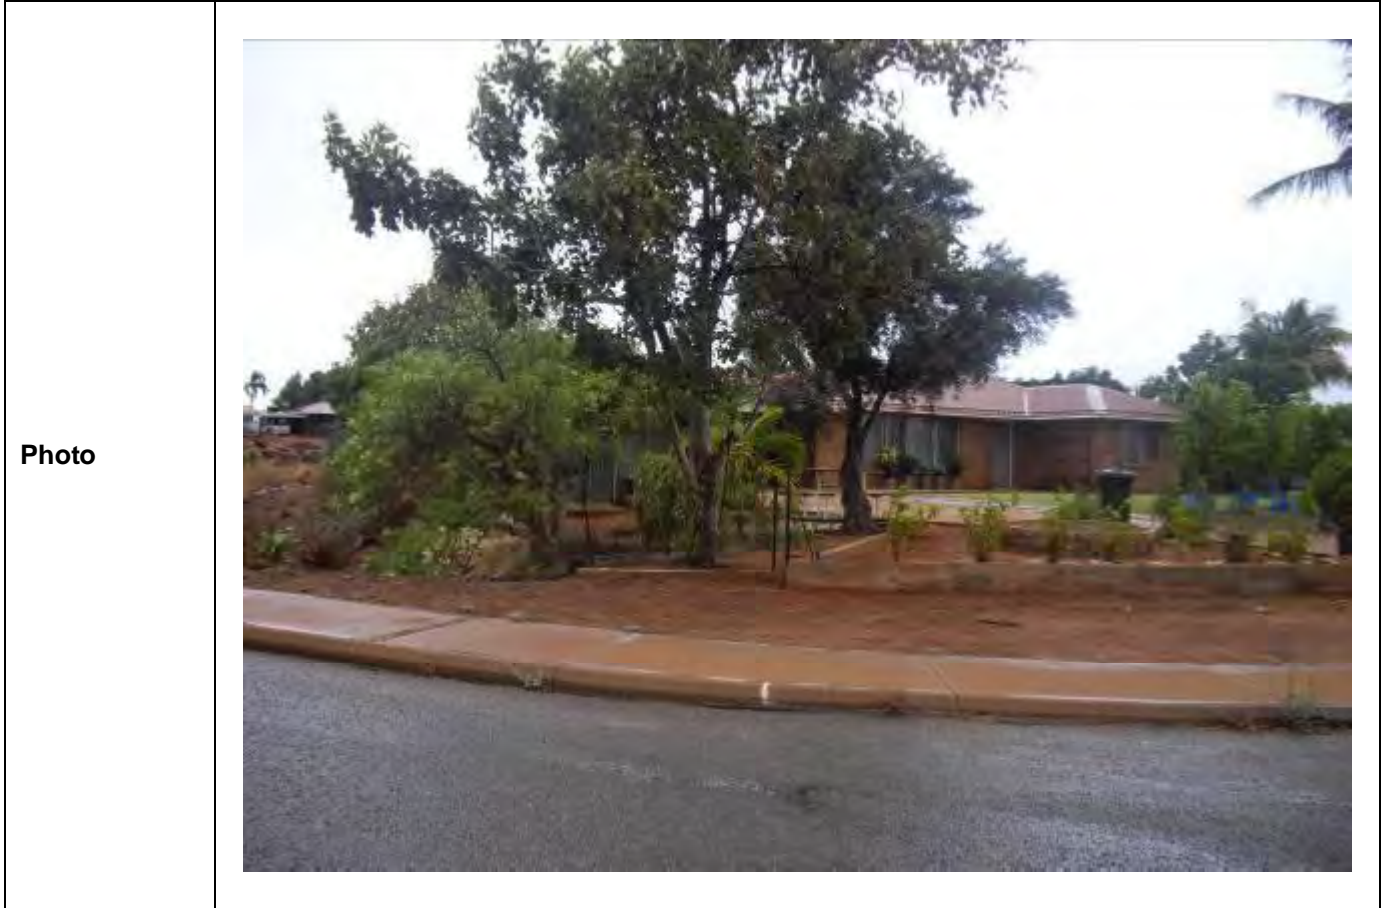
**2.1 Lot No. 3,156 Burke Crescent**

<b>Category</b>	Encroachment
<b>Type</b>	Boundary extension
<b>Description</b>	Landscaping on corner boundary Reserve flows to the east
<b>Photo ID</b>	638
<b>Scope of Works</b>	L - Remove landscaping to within property boundary.

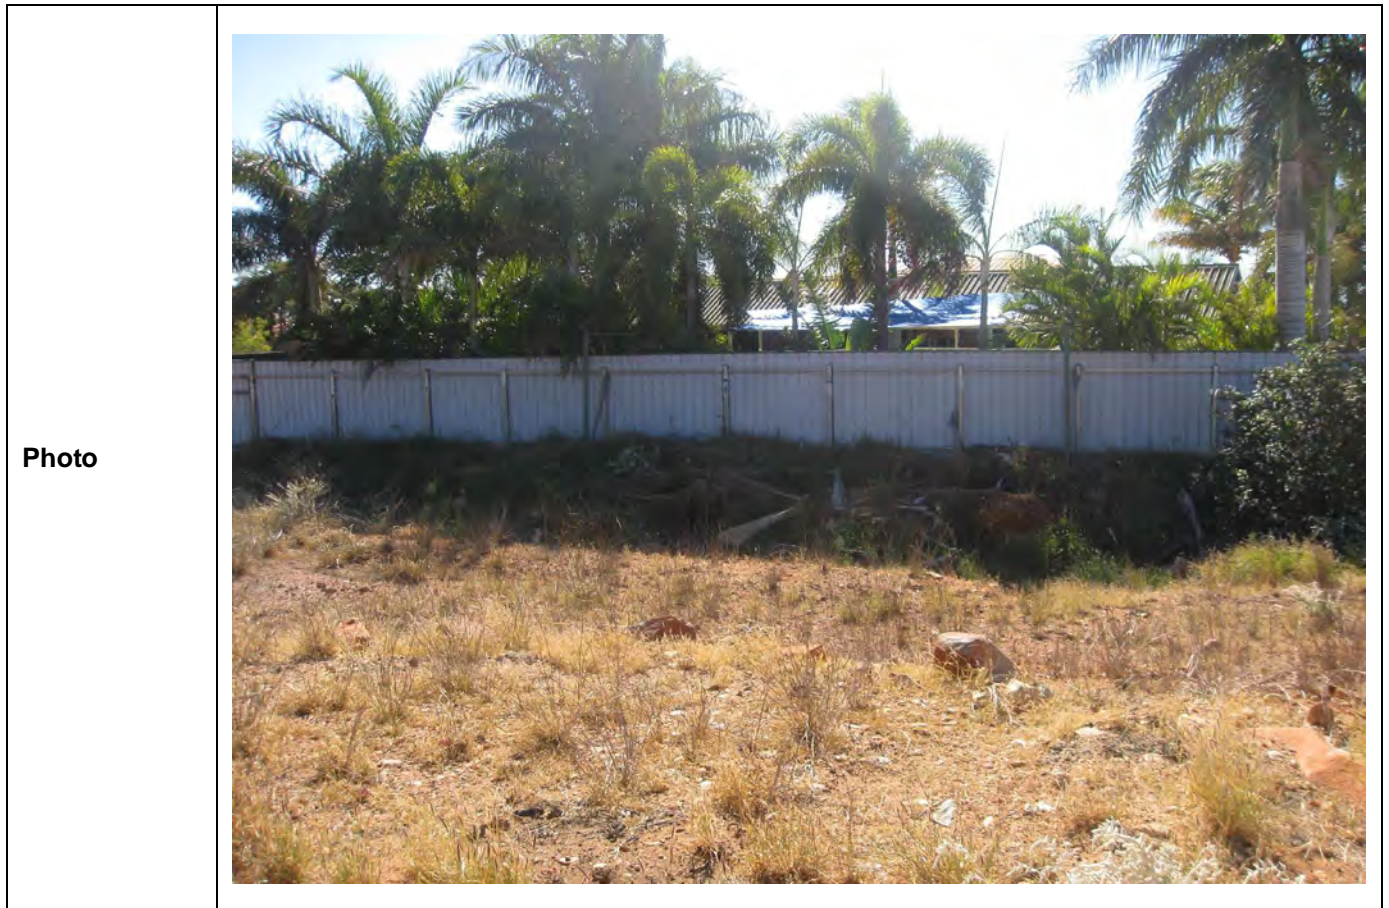
## 2.2 Lot No. 2,156 Burke Crescent

<b>Category</b>	Encroachment
<b>Type</b>	Rear access
<b>Description</b>	Rear access impeding flow
<b>Photo ID</b>	1079
<b>Scope of Works</b>	H – Remove rear access and reinstate to natural topography
