City of Karratha  
Dampier Stormwater Management Study  
Report  
Part B  
June 2015

## Appendix **C** – 2010 encroachment reviews

**Rio Tinto Iron Ore**  
Report on Dampier Drainage  
Review  
Block 1 Encroachments  
June 2010

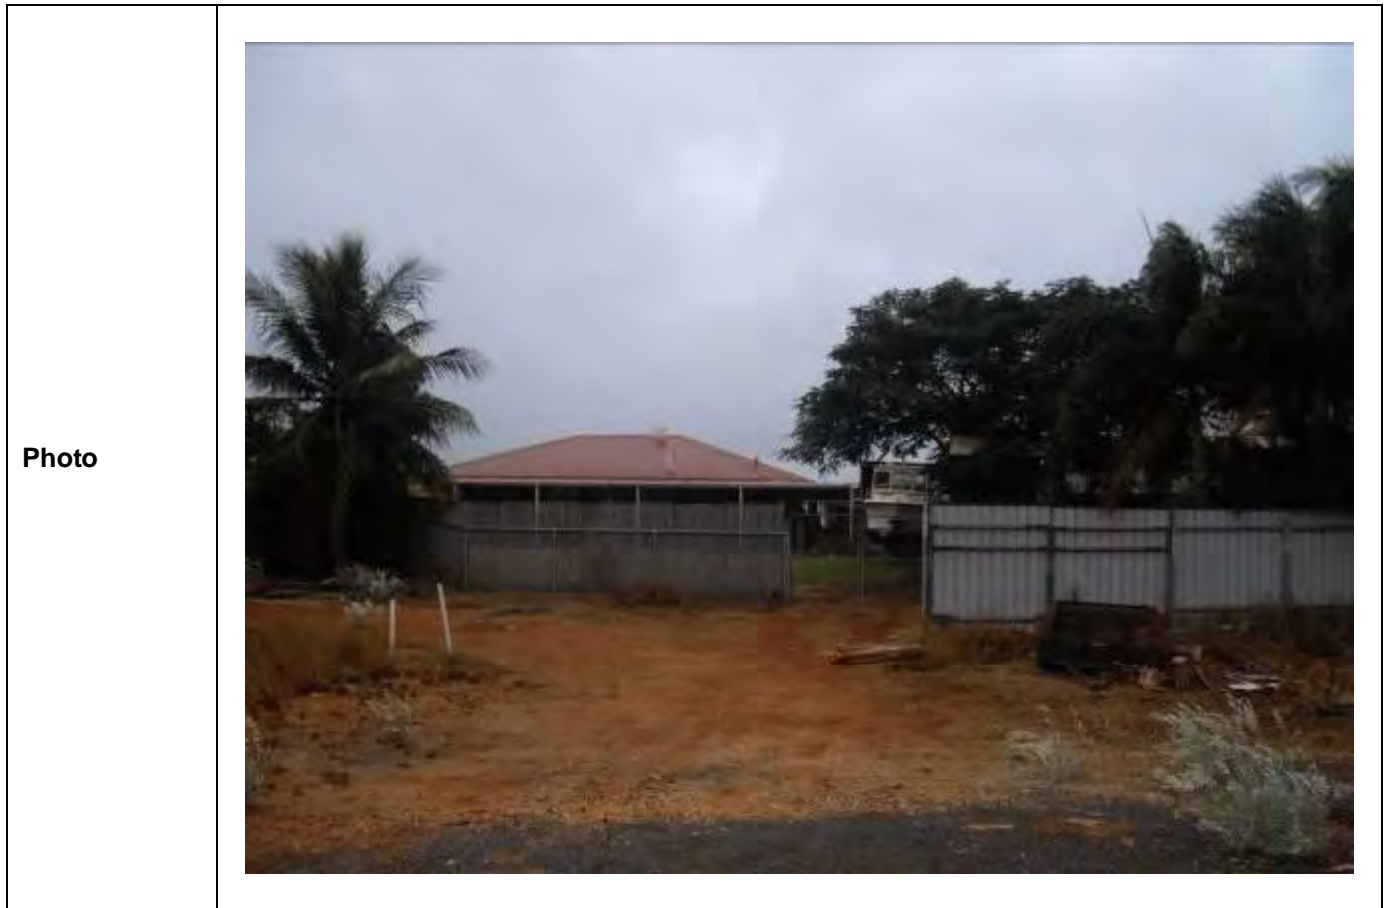
### 2.3 Lot No. 1,156 Burke Crescent

<b>Category</b>	Encroachment
<b>Type</b>	Rear access
<b>Description</b>	Rear access at top of catchment
<b>Photo ID</b>	635
<b>Scope of Works</b>	M - Remove rear access and reinstate to natural topography

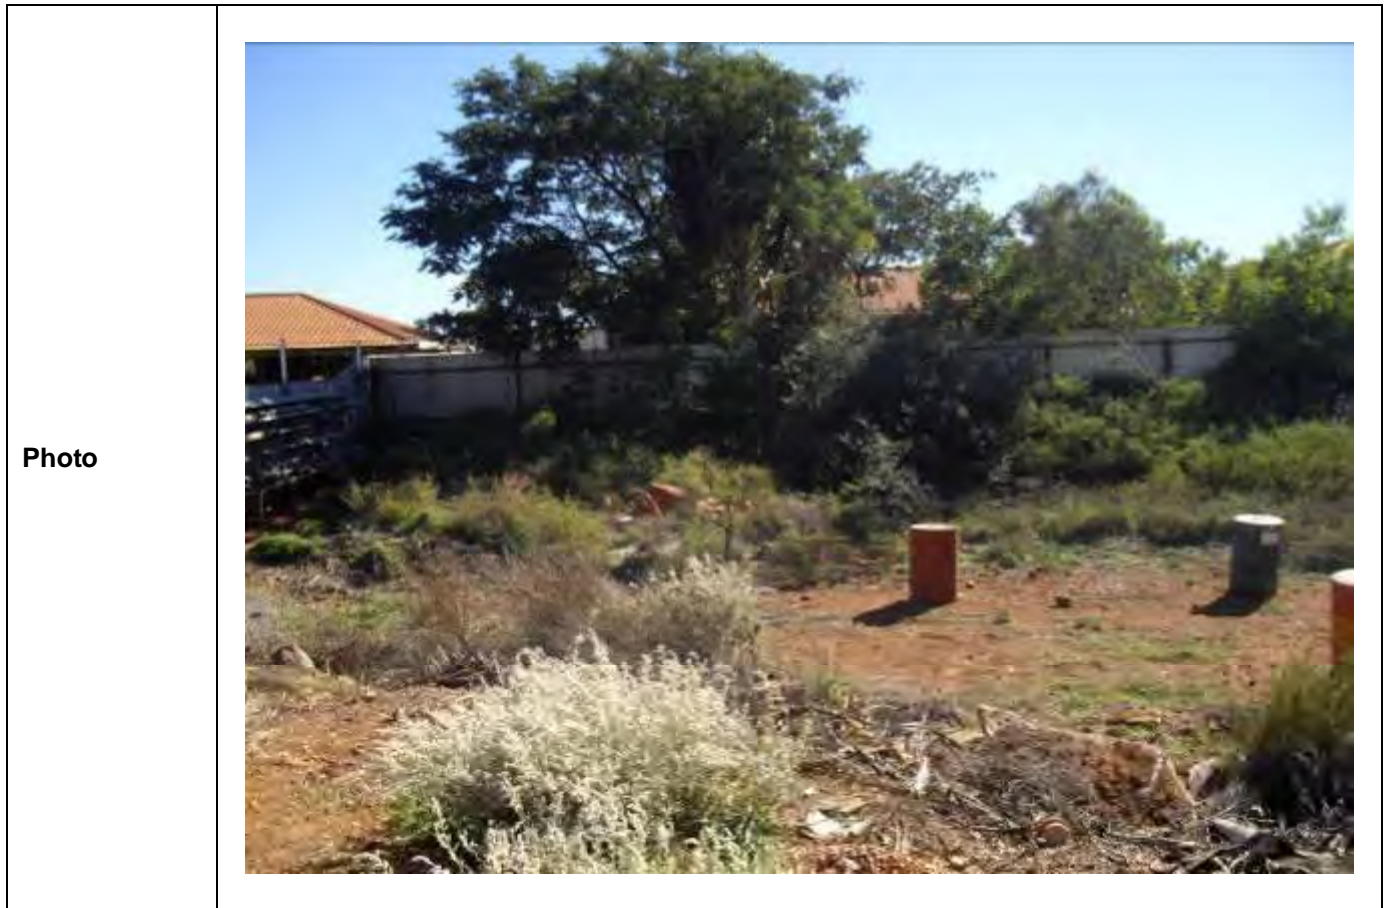
## 2.4 Lot No. 156 Burke Crescent

<b>Category</b>	Encroachment / Drain Maintenance
<b>Type</b>	Vegetation General items
<b>Description</b>	Vegetation not impeding flow Barrels not impeding flow
<b>Photo ID</b>	874
<b>Scope of Works</b>	L - Vegetation is to be slashed to a nominal height of 50 mm above ground with the exception of large, established trees of height in excess of 5 m, which shall remain L – Remove barrels

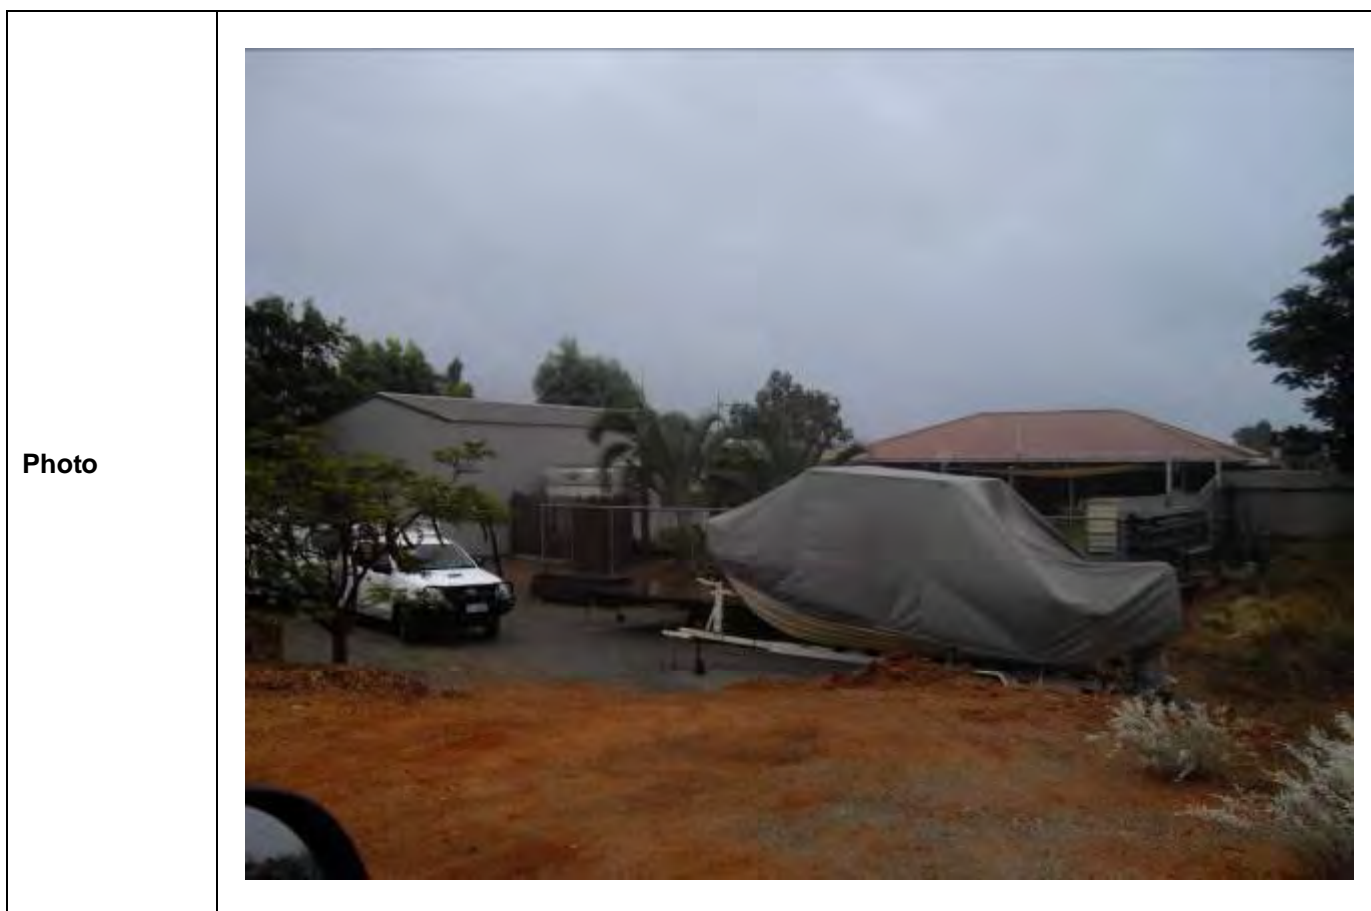
## 2.5 Lot No. 157 Burke Crescent

<b>Category</b>	Encroachment
<b>Type</b>	Flow path - modified Boundary extension General items
<b>Description</b>	Imported blue metal used for storage area and rear access follows natural topography Road level is extended out within the drainage reserve reducing cross-sectional capacity Boat and vehicles
<b>Photo ID</b>	636
<b>Scope of Works</b>	L – Remove blue metal and rear access M - Remove fill material and reinstate drainage flow path as defined by the natural capacity and invert of downstream lot (158) channel L – Remove boat and vehicles

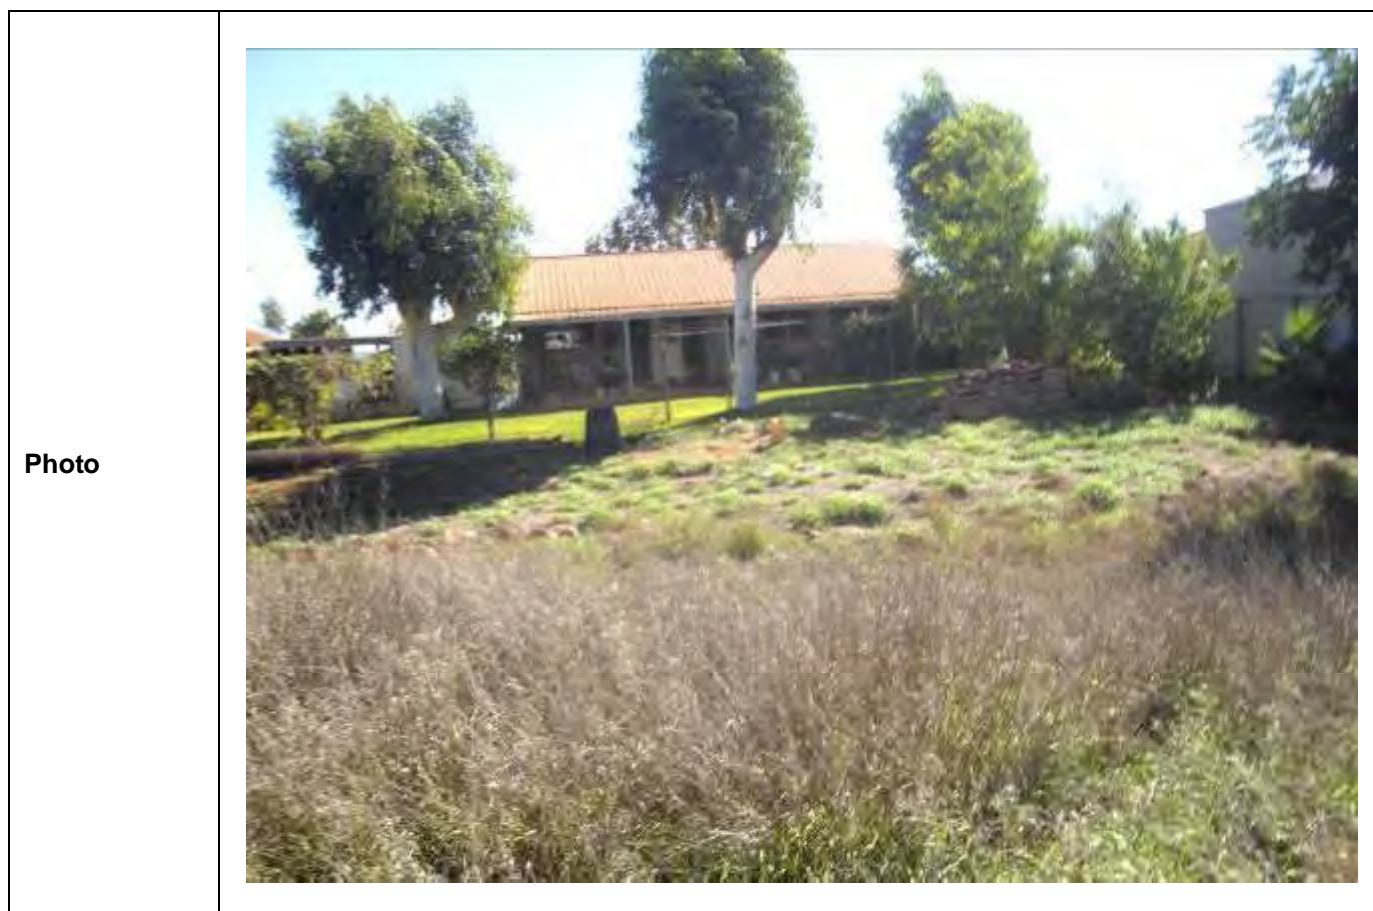
## 2.6 Lot No. 158 Burke Crescent

<b>Category</b>	Drain Maintenance
<b>Type</b>	Vegetation
<b>Description</b>	Semi-dense low lying vegetation
<b>Photo ID</b>	875
<b>Scope of Works</b>	L - Vegetation is to be slashed to a nominal height of 50 mm above ground with the exception of large, established trees of height in excess of 5 m, which shall remain

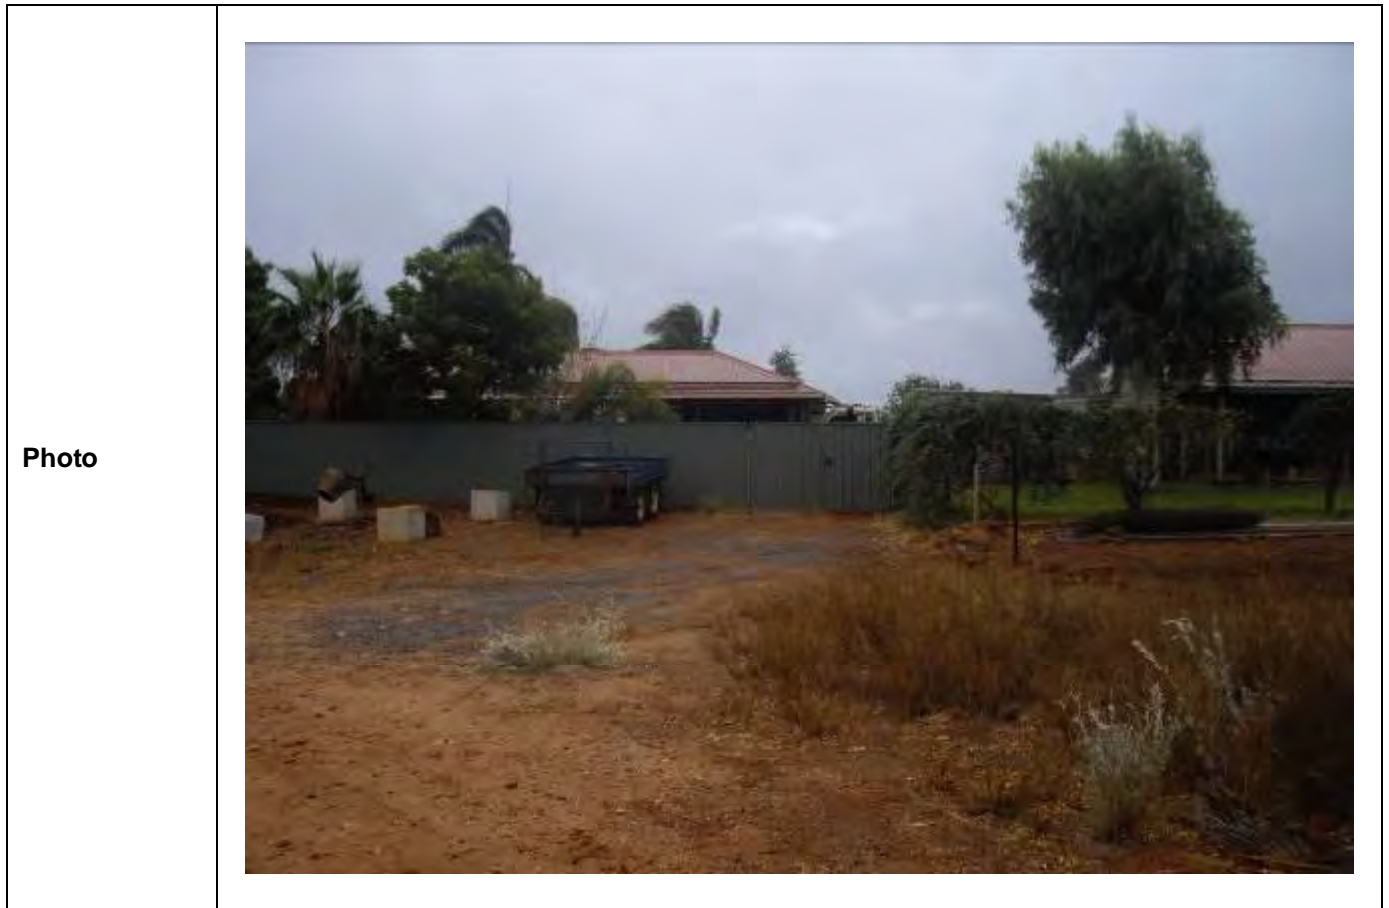
## 2.7 Lot No. 159 Burke Crescent

<b>Category</b>	Encroachment
<b>Type</b>	Rear access Modified drainage reserve
<b>Description</b>	Rear access and modified topography Fill material
<b>Photo ID</b>	637
<b>Scope of Works</b>	M - Remove access driveway H – Remove fill material and reinstate drainage flow path as defined by the natural capacity and invert of downstream lot (160) channel.

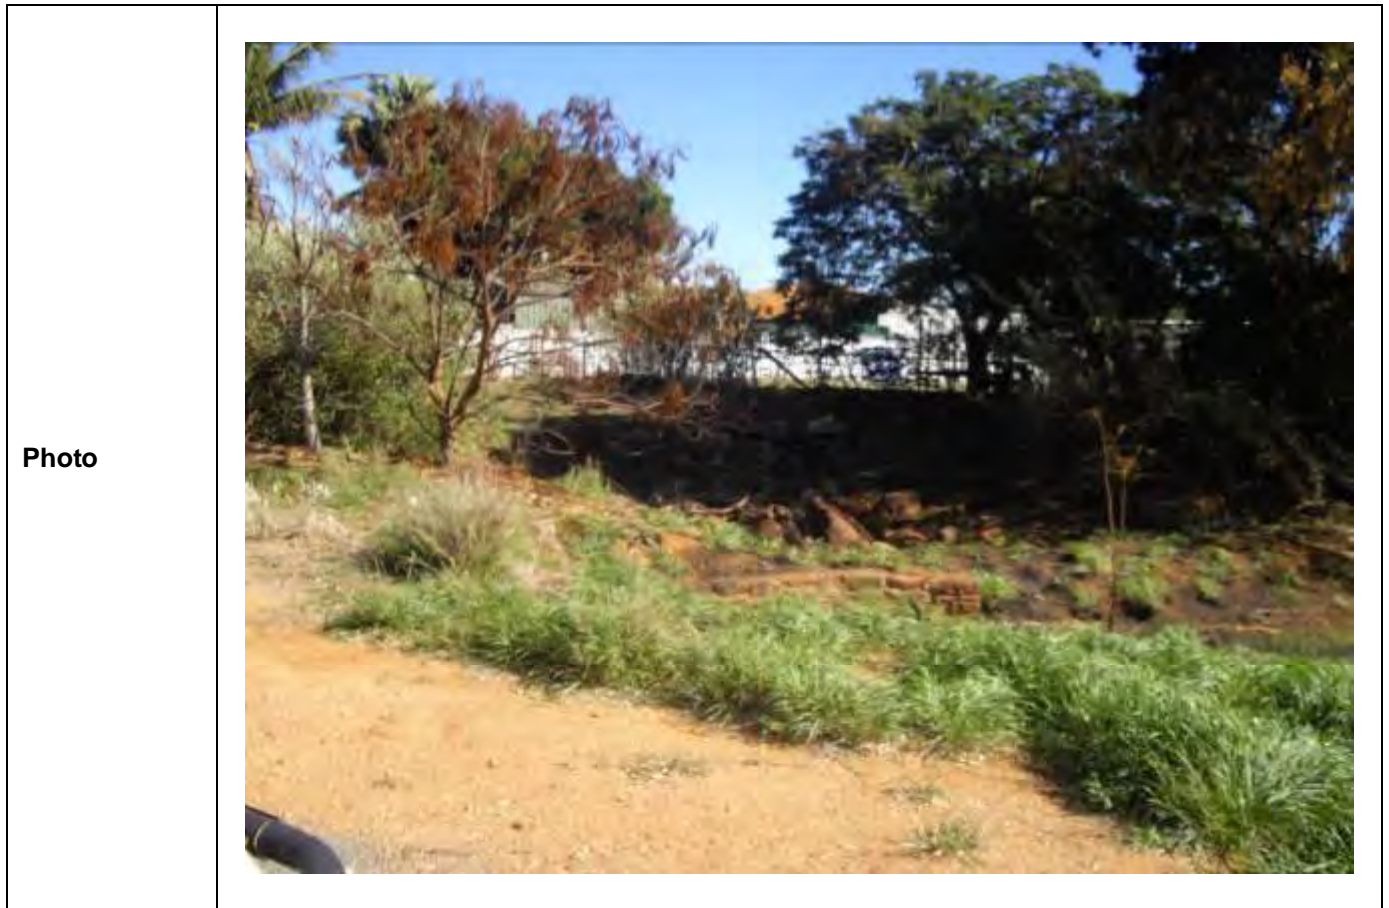
## 2.8 Lot No. 160 Burke Crescent

<b>Category</b>	Drain Maintenance
<b>Type</b>	Flow path
<b>Description</b>	No defined flow path due to fill
<b>Photo ID</b>	876
<b>Scope of Works</b>	M – Remove fill and reinstate drainage flow path as defined by the natural capacity and invert of downstream lot (1,160) channel

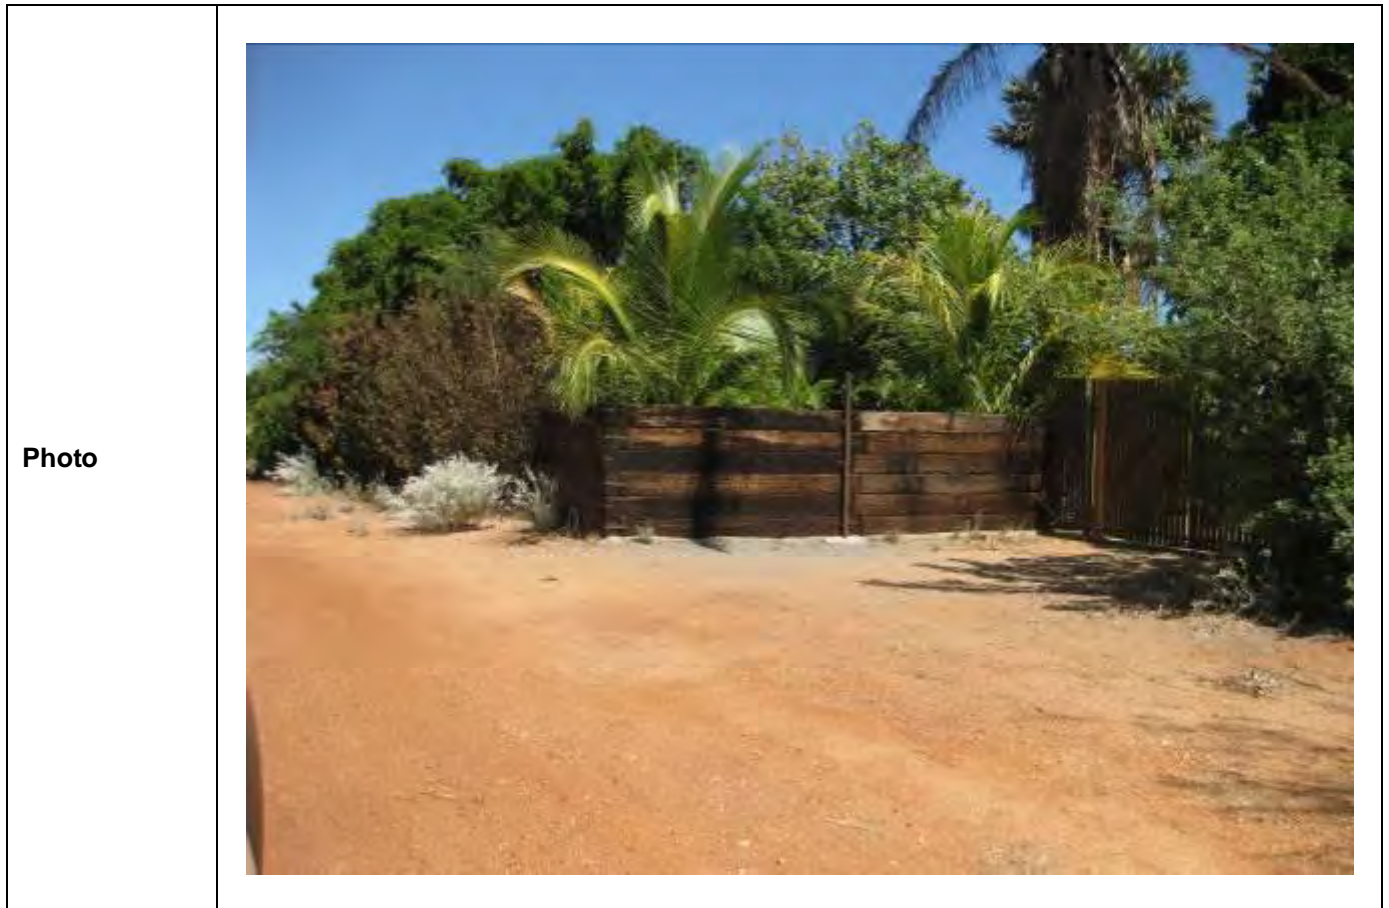
## 2.9 Lot No. 1,160 Burke Crescent

<b>Category</b>	Encroachment
<b>Type</b>	Boundary extension Modified drainage reserve Rear access
<b>Description</b>	Property and landscaping extends into the drainage reserve Modified drainage reserve due to large amounts of fill which impedes flow ( it is assumed here that part of the flow is to be directed west and partly to go through the culvert situated on lot 159) Rear and follows the modified topography
<b>Photo ID</b>	7314
<b>Scope of Works</b>	H - Remove backyard extension to within property boundary. H – Remove fill and rear access and reinstate drainage flow path as defined by the natural capacity and invert of downstream lot (2,610) channel

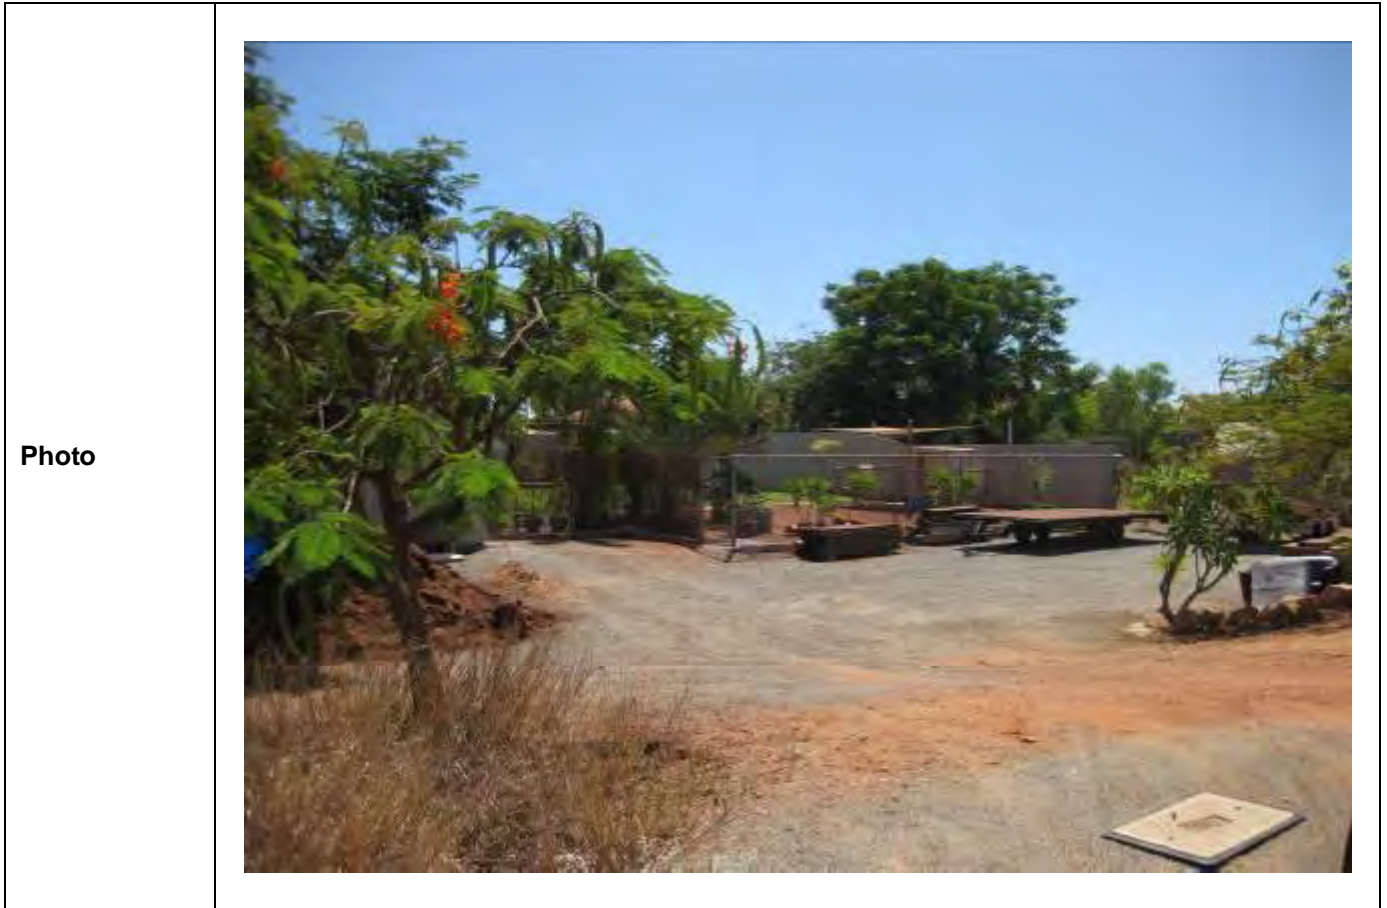
## 2.10 Lot No. 2,160 Burke Crescent

<b>Category</b>	Encroachment
<b>Type</b>	Boundary extension Modified drainage reserve Rear access General items
<b>Description</b>	Property and landscaping extends into the drainage reserve Modified drainage reserve due to large amounts of fill which impedes flow ( it is assumed here that part of the flow is to be directed west and partly to go through the culvert situated on lot 159) Rear access and modified topography Trailer and building materials
<b>Photo ID</b>	7315
<b>Scope of Works</b>	M – Remove landscaping; H – Remove fill and reinstate drainage flow path as defined by the natural capacity and invert of downstream lot (west of 2,160) channel L – Remove trailer and building materials.

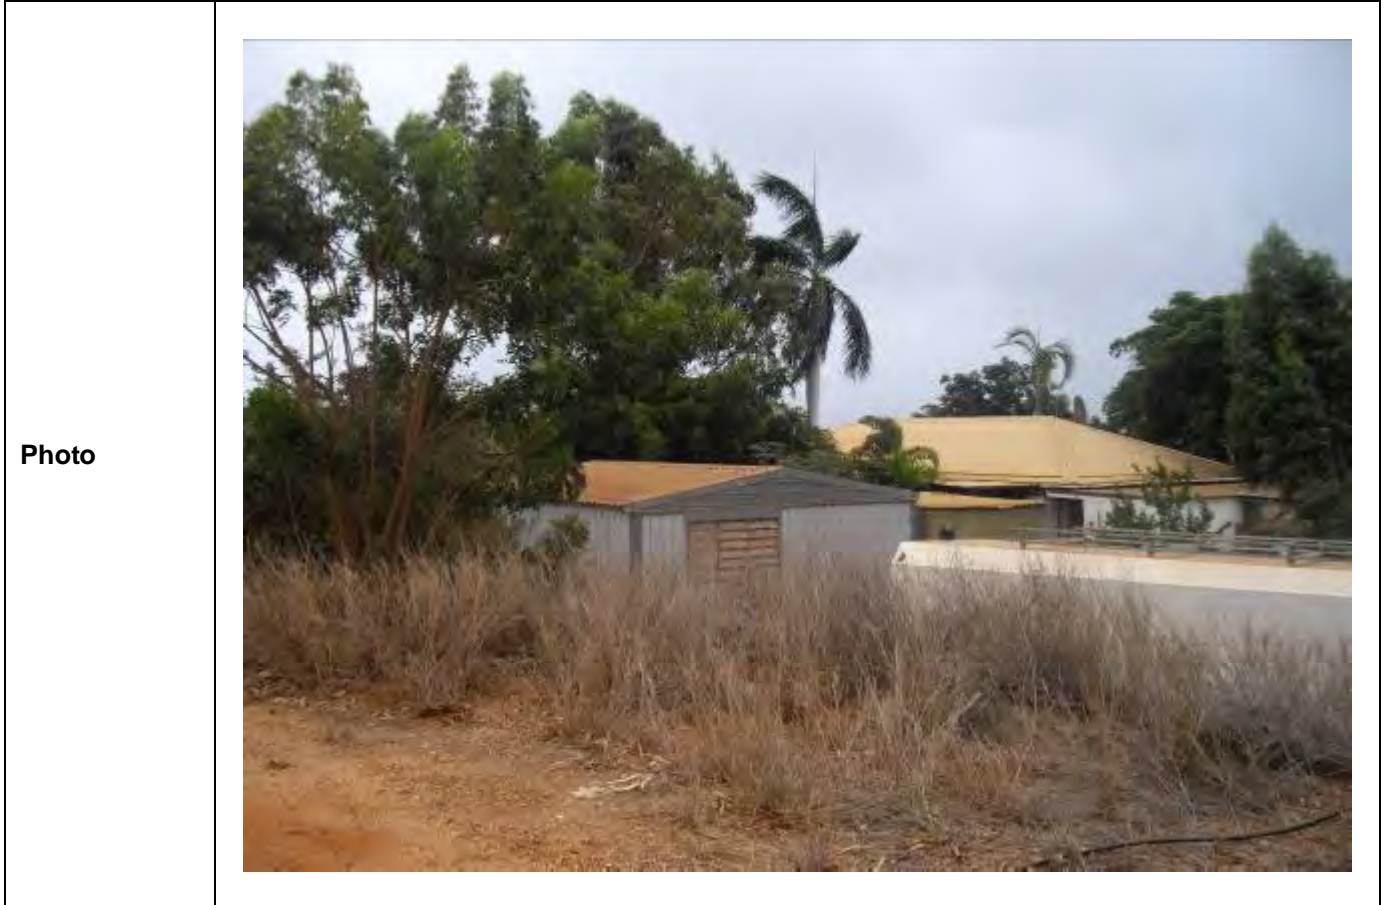
### 3.1 Lot No. 161 Flinders Crescent

<b>Category</b>	Encroachment / Drain maintenance
<b>Type</b>	Boundary extension Flow path
<b>Description</b>	Shed Drainage flow path low point is within the property boundary
<b>Photo ID</b>	633
<b>Scope of Works</b>	H - Remove shed – confirmation required from survey M – Redefine drainage flow path to be contained within the drainage reserve and match downstream channel. Confirmation from survey. If encroaching, remove boundary extension to within property boundary; M - Vegetation is to be slashed to a nominal height of 50 mm above ground with the exception of large, established trees of height in excess of 5 m, which shall remain

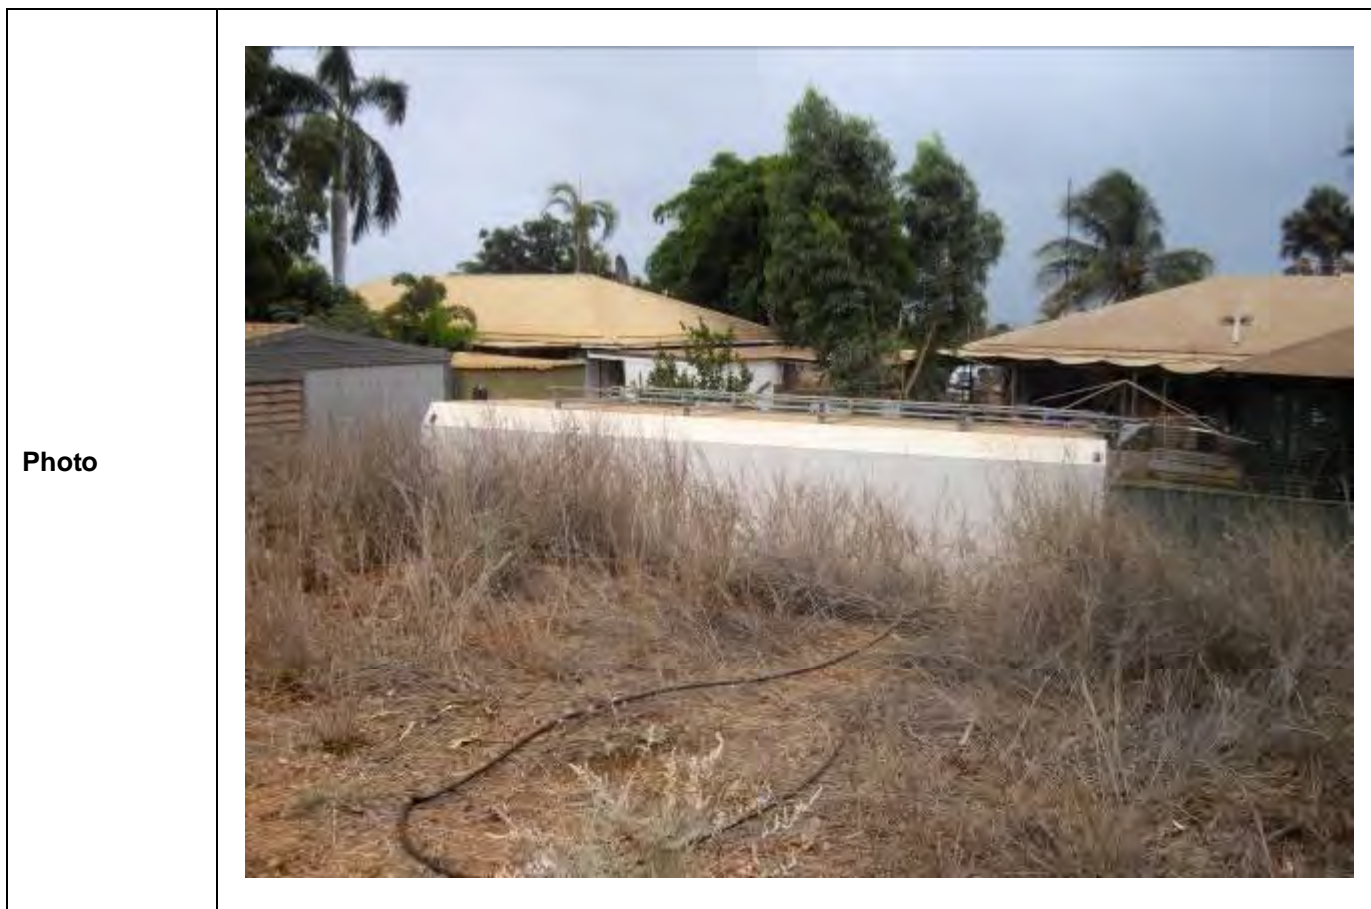
### 3.2 Lot No. 162 Flinders Crescent

<b>Category</b>	Encroachment
<b>Type</b>	General item Flow path.
<b>Description</b>	Trailer; Note road embankment encroaches on drainage reserve
<b>Photo ID</b>	634
<b>Scope of Works</b>	M - Remove trailer H - Vegetation is to be slashed to a nominal height of 50 mm above ground with the exception of large, established trees of height in excess of 5 m, which shall remain

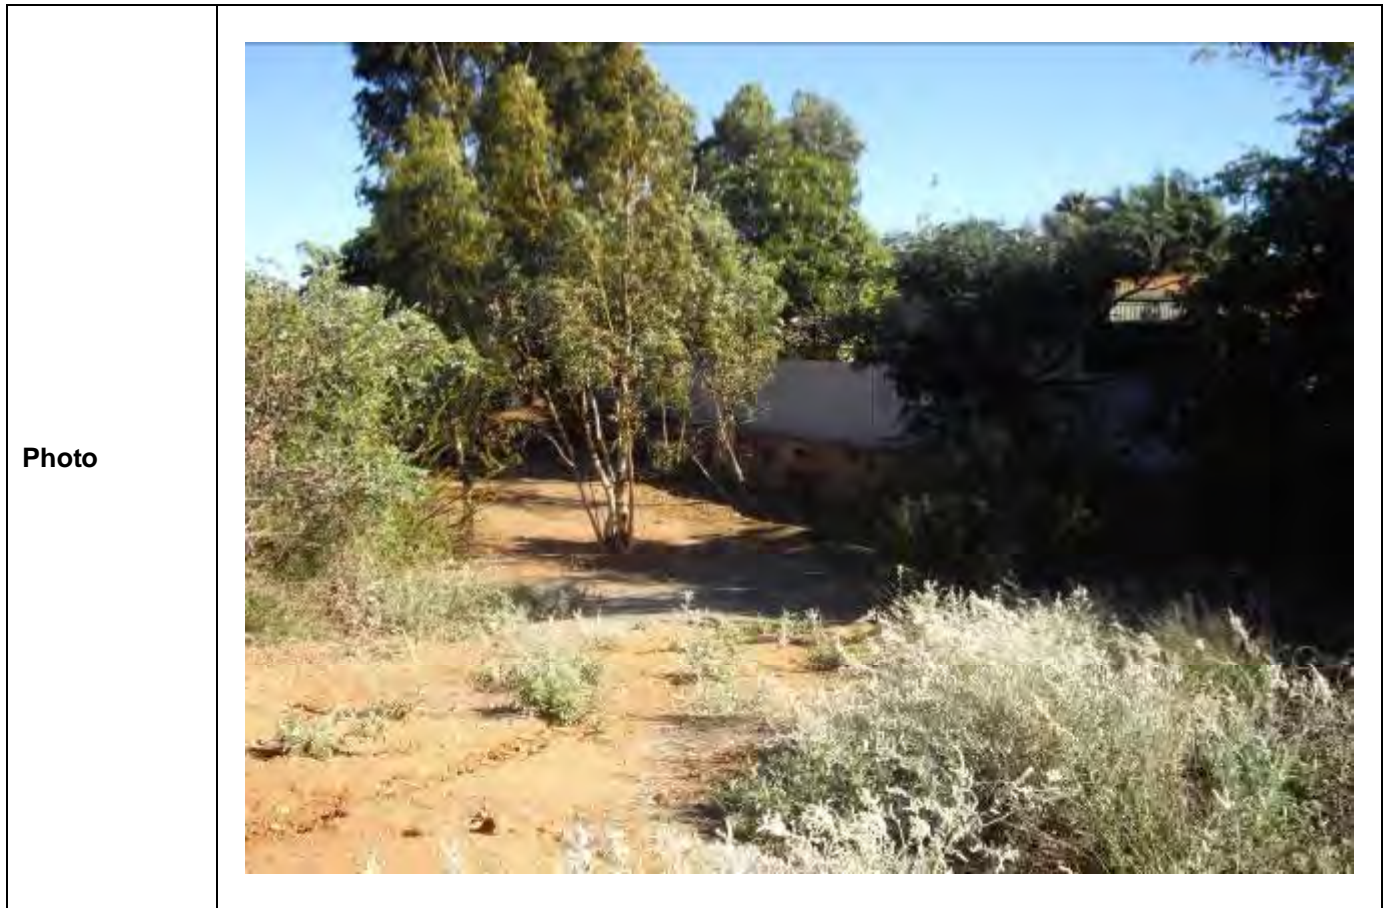
### 3.3 Lot No. 163 Flinders Crescent

<b>Category</b>	None
<b>Type</b>	None
<b>Description</b>	None – drain adequate
<b>Photo ID</b>	867
<b>Scope of Works</b>	N/A

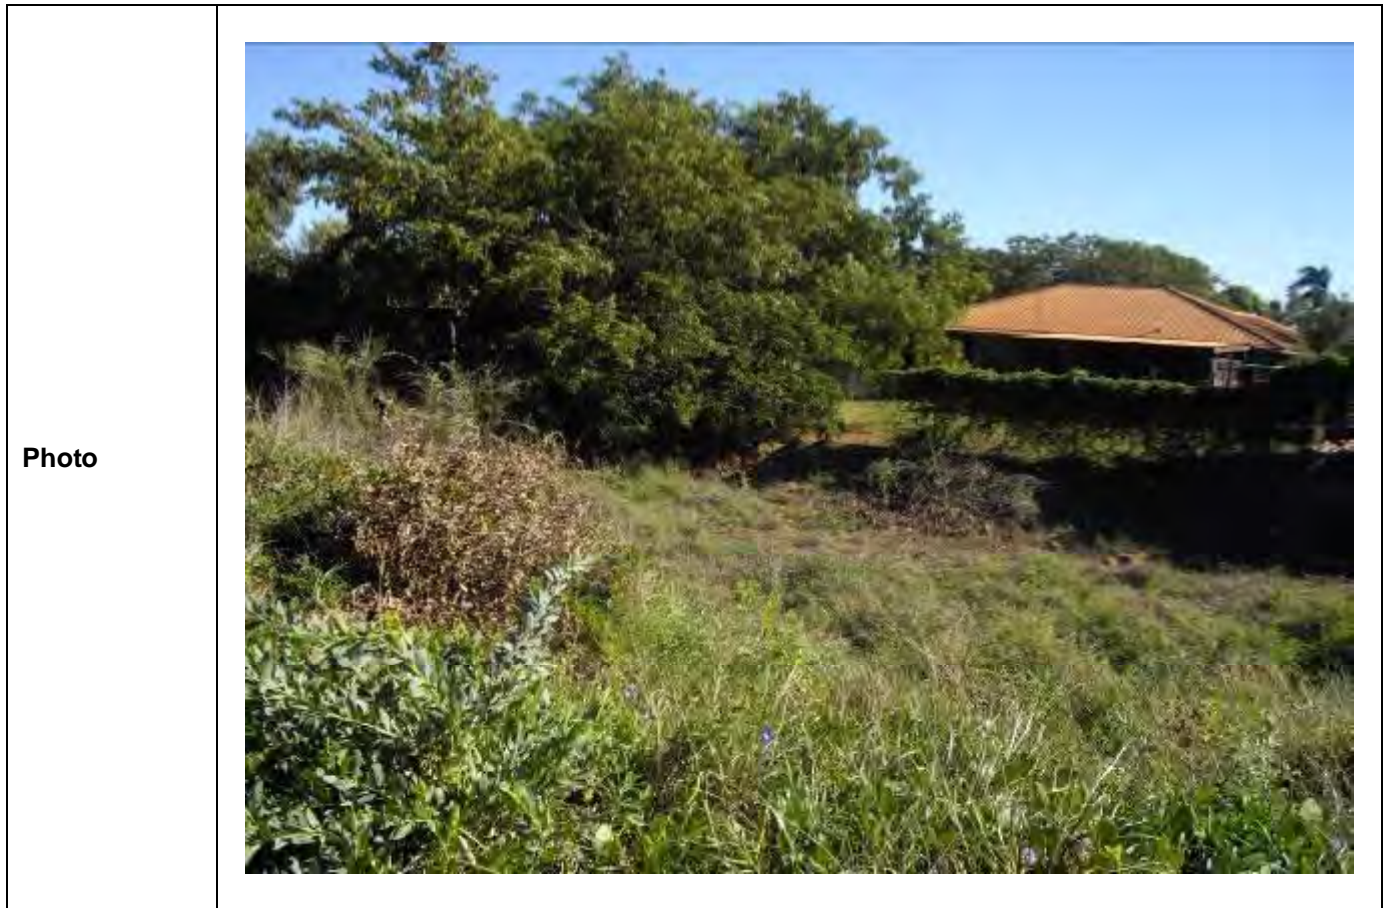
### 3.4 Lot No. 164 Flinders Crescent

<b>Category</b>	Drain maintenace
<b>Type</b>	Vegetation
<b>Description</b>	None – drain adequate
<b>Photo ID</b>	866
<b>Scope of Works</b>	L - Vegetation is to be slashed to a nominal height of 50 mm above ground with the exception of large, established trees of height in excess of 5 m, which shall remain

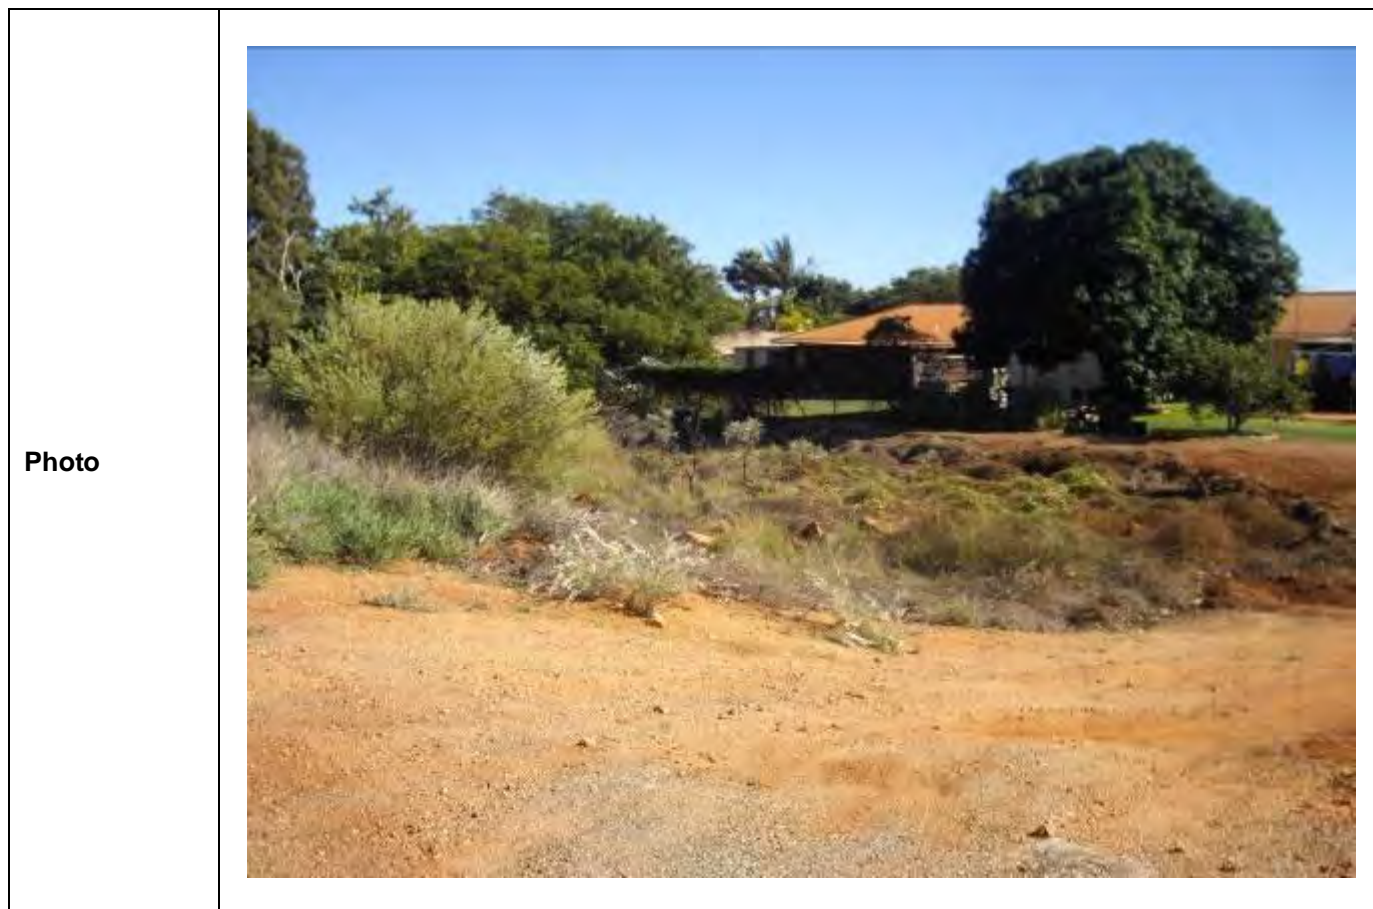
### 3.5 Lot No. 165 Flinders Crescent

<b>Category</b>	Encroachment
<b>Type</b>	Rear access
<b>Description</b>	Rear access follows natural topography.
<b>Photo ID</b>	865
<b>Scope of Works</b>	L - Remove access driveway

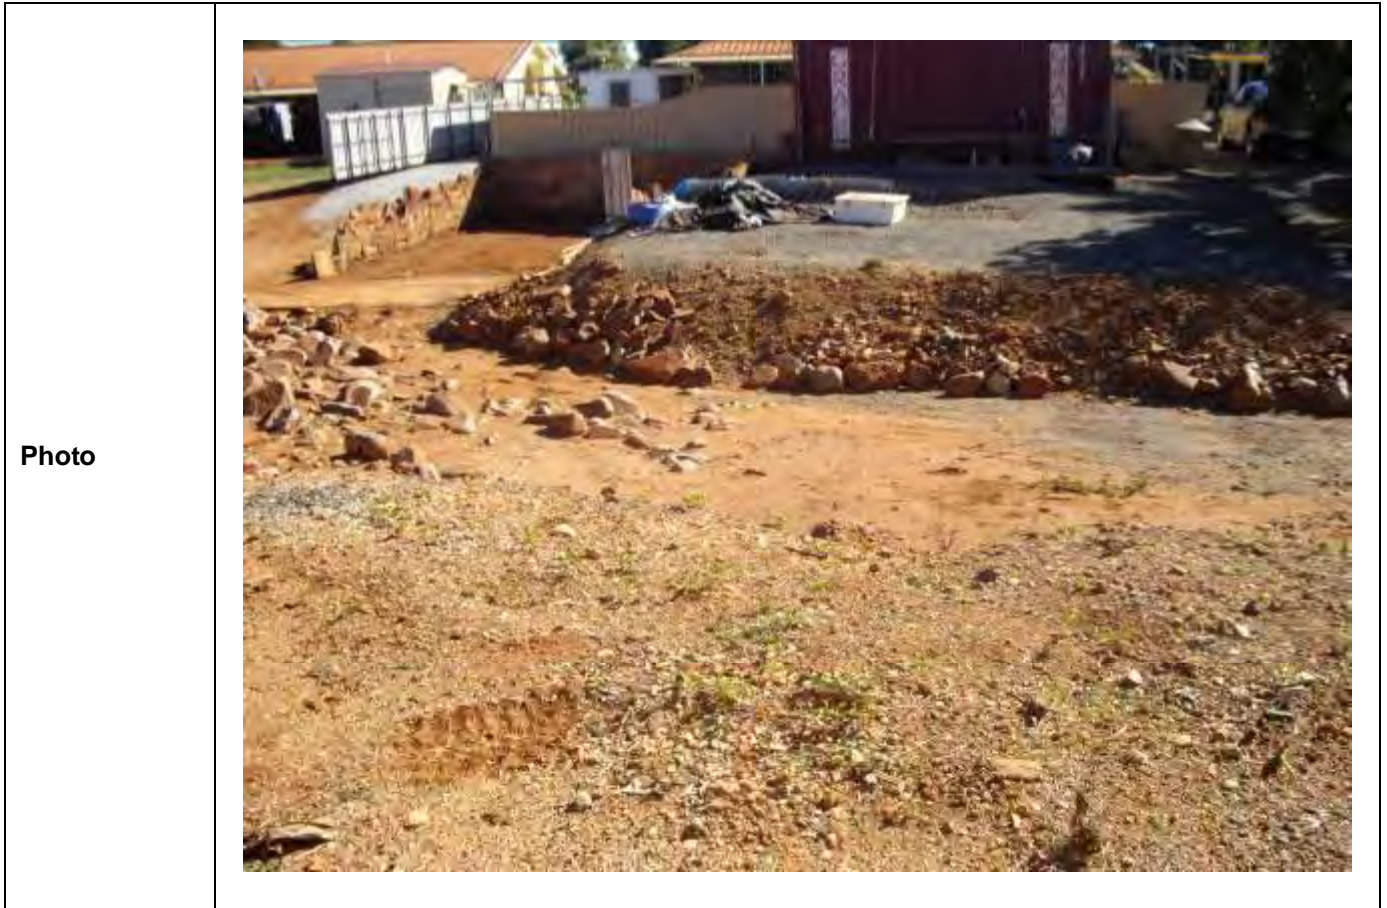
### 3.6 Lot No. 166 Flinders Crescent

<b>Category</b>	Encroachment
<b>Type</b>	Rear access Boundary extension
<b>Description</b>	Rear access follows natural topography Batter encroachment within the drainage reserve – drain flow path is adequate
<b>Photo ID</b>	864
<b>Scope of Works</b>	L - Remove access driveway; M - Remove batter – confirmation required from survey.

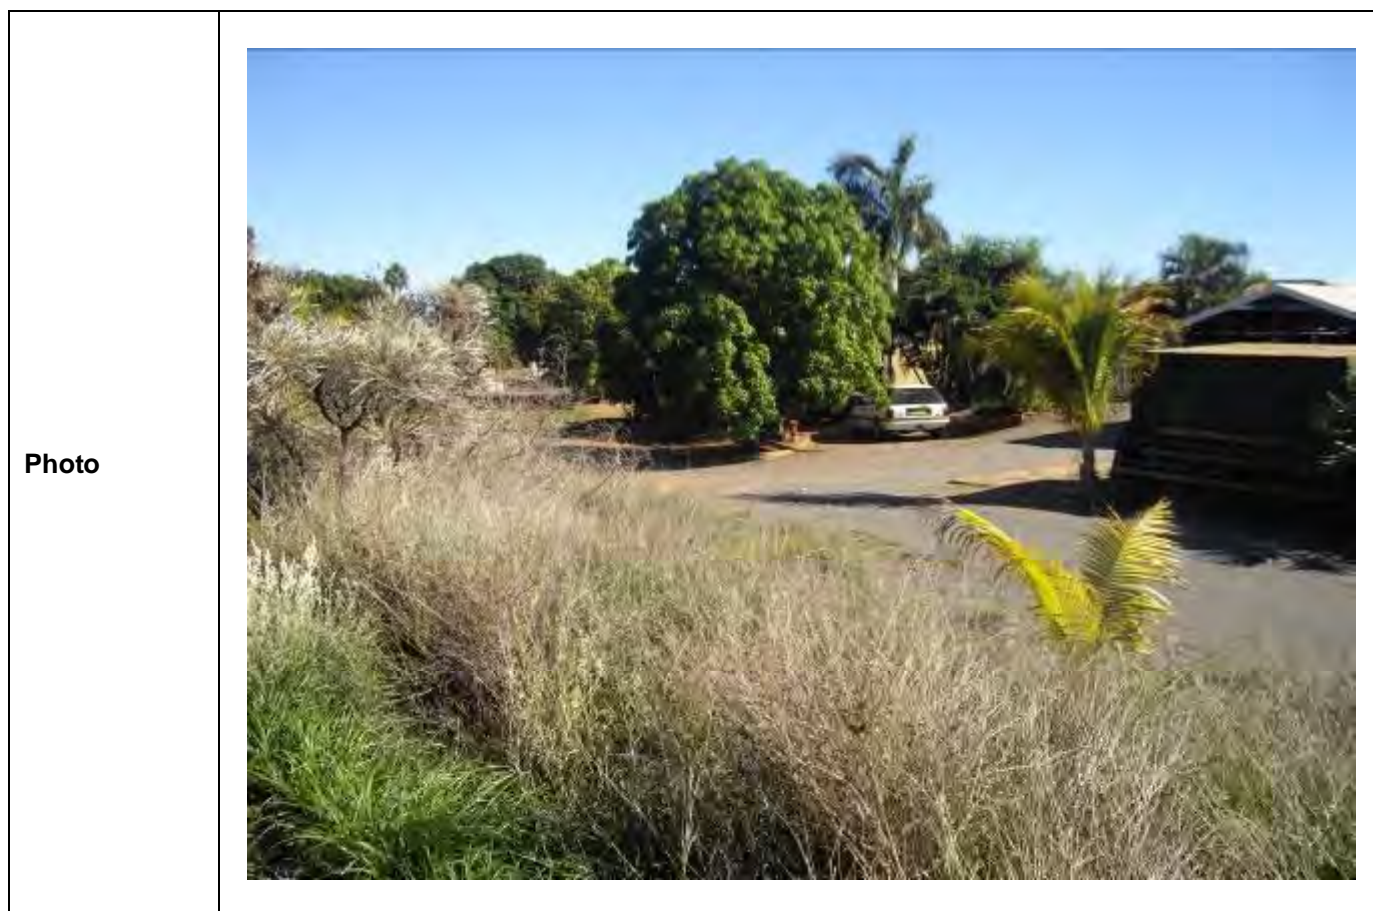
### 3.7 Lot No. 167 Flinders Crescent

<b>Category</b>	Encroachment
<b>Type</b>	Rear access
<b>Description</b>	Rear access follows natural topography
<b>Photo ID</b>	863
<b>Scope of Works</b>	L – Remove rear acces and reinstate drainage flow path as defined by the natural capacity and invert of downstream lot (166) channel

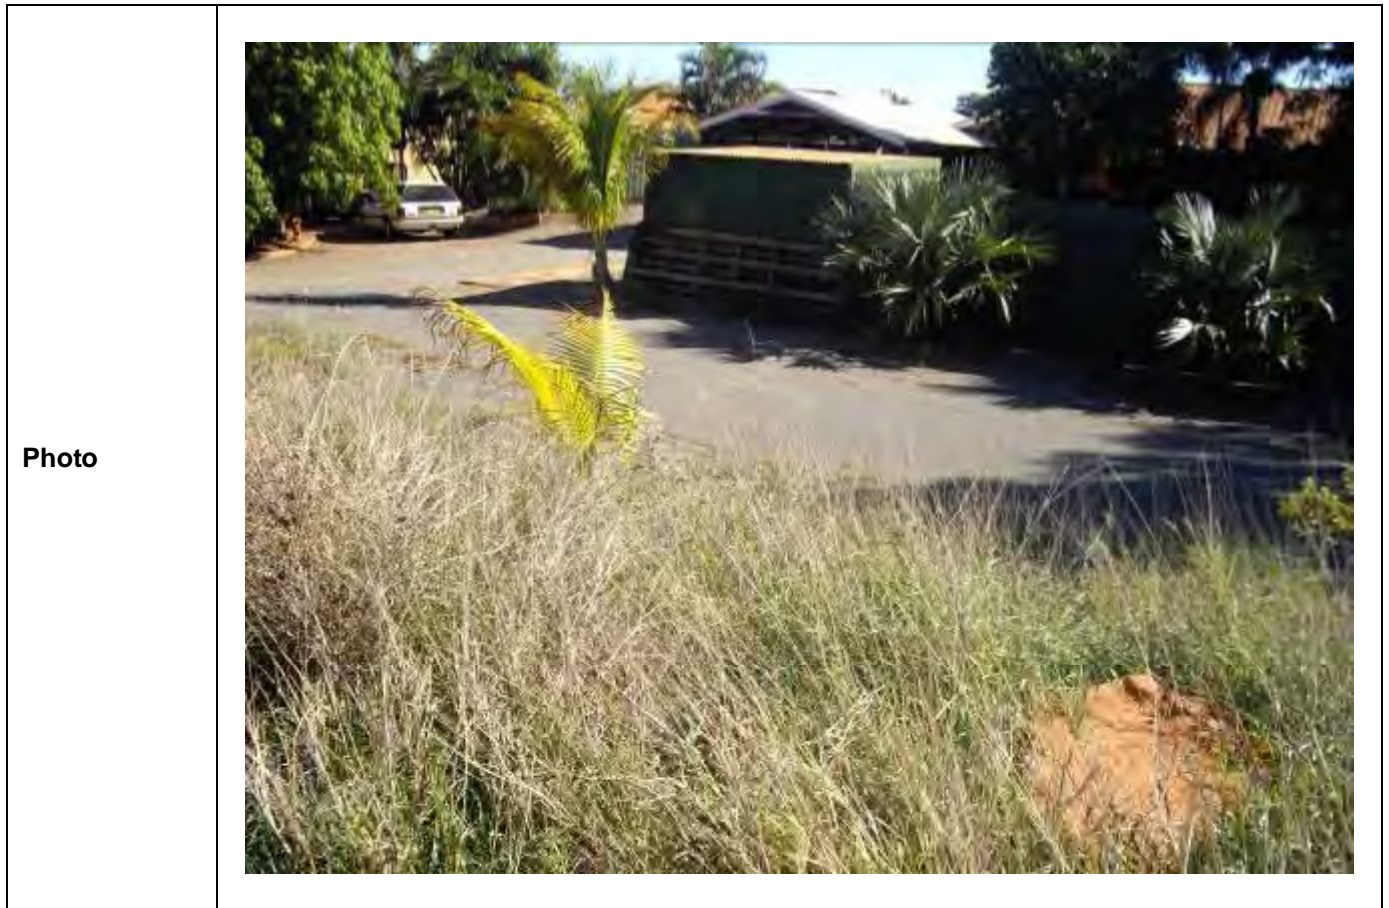
### 3.8 Lot No. 168 Flinders Crescent

<b>Category</b>	Encroachment
<b>Type</b>	Rear access
<b>Description</b>	Rear access follows natural topography.
<b>Photo ID</b>	862
<b>Scope of Works</b>	L - Remove access driveway and reinstate drainage flow path as defined by the natural capacity and invert of downstream lot (west of 167) channel
