City of Karratha  
Dampier Stormwater Management Study  
Report  
Part B  
June 2015

## Appendix **C** – 2010 encroachment reviews

**Rio Tinto Iron Ore**  
Report on Dampier Drainage  
Review  
Block 1 Encroachments  
June 2010

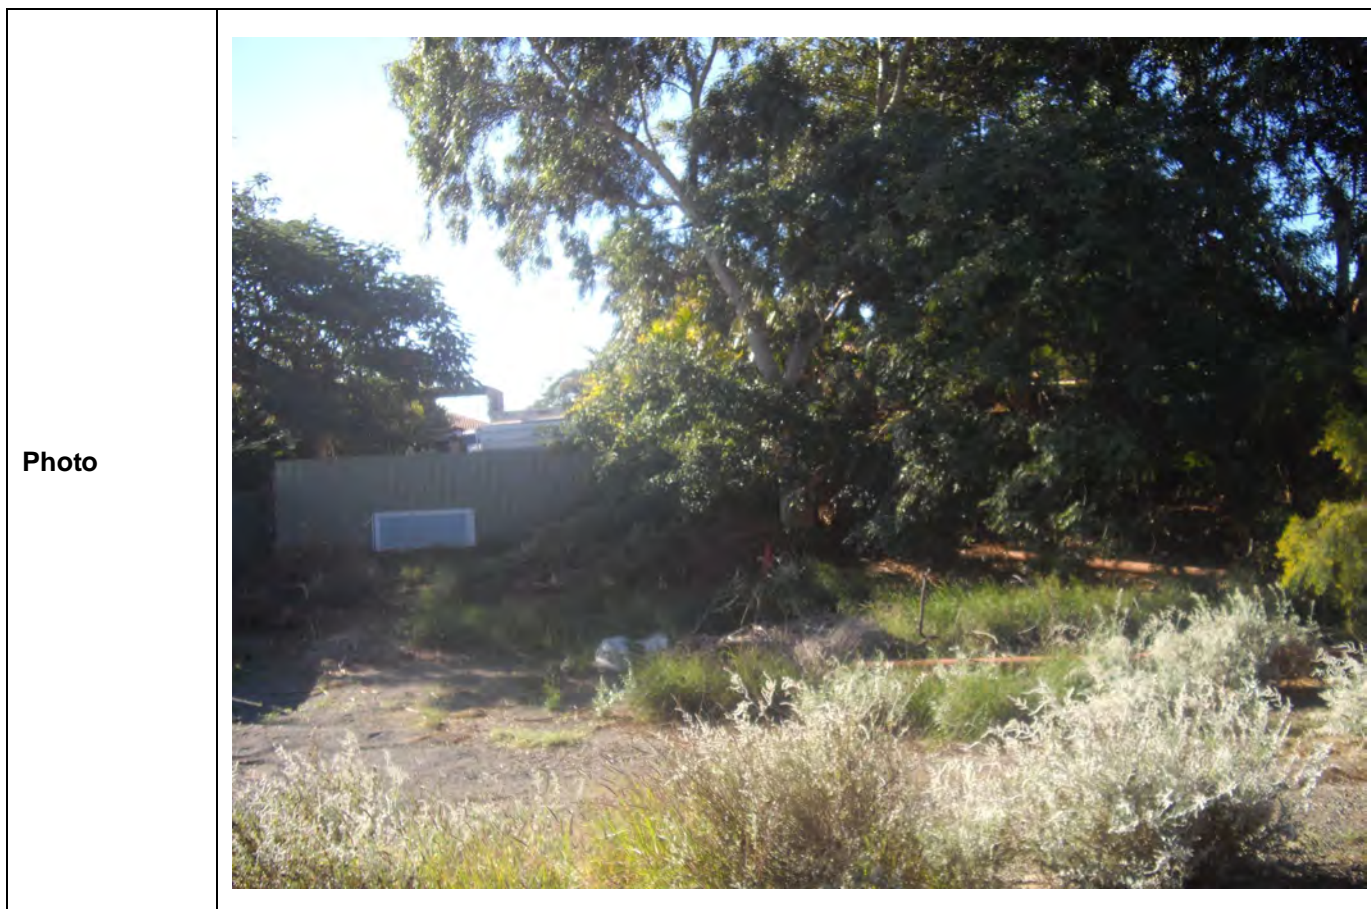
### 3.9 Lot No. 169 Flinders Crescent

<b>Category</b>	Drain Maintenance
<b>Type</b>	Vegetation
<b>Description</b>	Semi-dense vegetation
<b>Photo ID</b>	7318
<b>Scope of Works</b>	M - Vegetation is to be slashed to a nominal height of 50 mm above ground with the exception of large, established trees of height in excess of 5 m, which shall remain

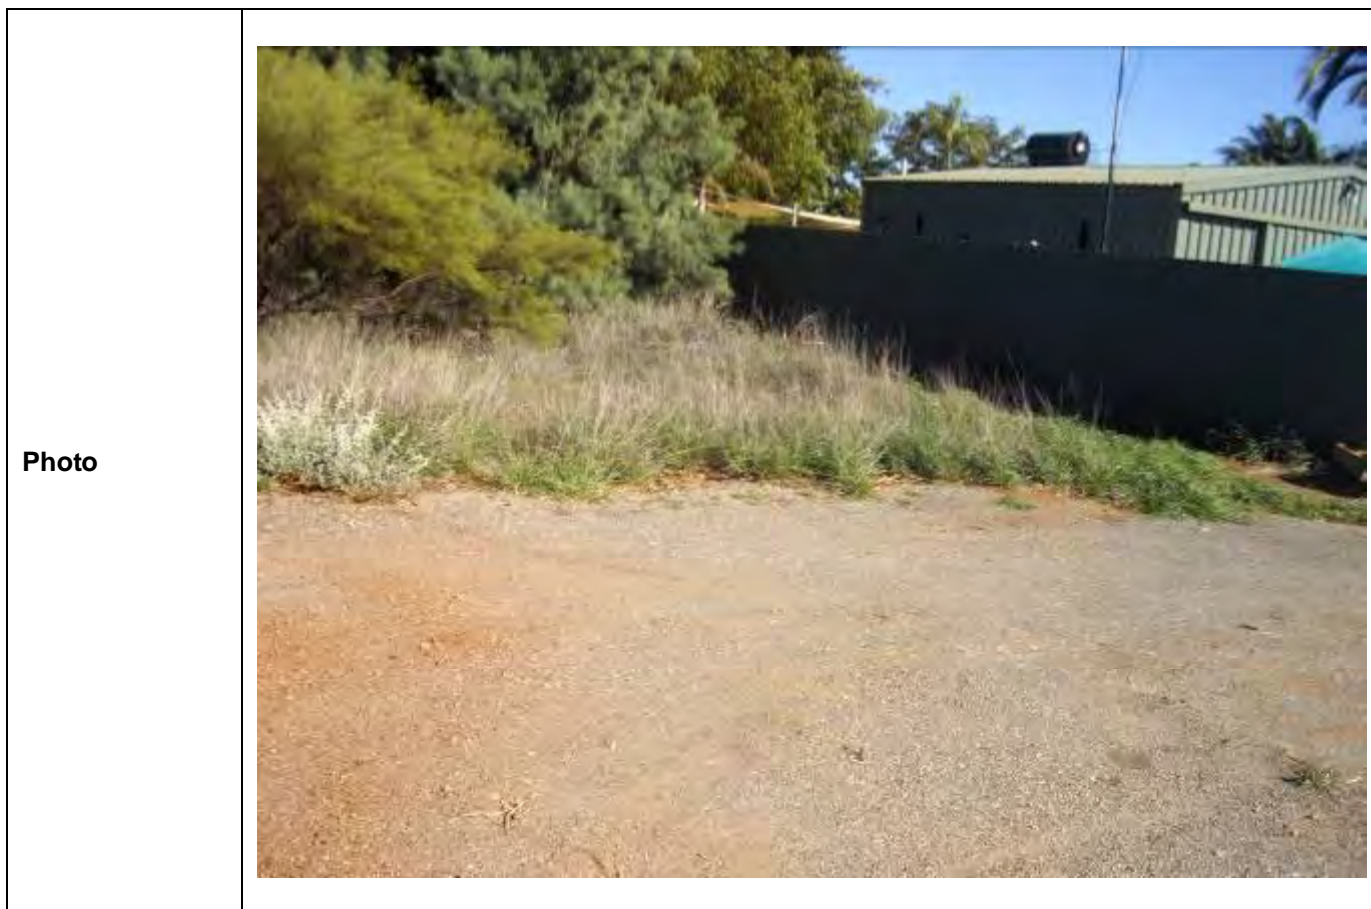
### 3.10 Lot No. 1,169 Flinders Crescent

<b>Category</b>	Encroachment / Drain Maintenance
<b>Type</b>	Flow path Rear access Side access Vegetation
<b>Description</b>	No drainage flow path due to extensive modifications to drainage reserve Rear access and modified topography Side access follows natural topography with some impediment to flow
<b>Photo ID</b>	861
<b>Scope of Works</b>	H – Remove fill material and reinstate drainage flow path as defined by the natural capacity and invert of downstream lot (169) channel. M – Remove rear access M – Remove side access M - Vegetation is to be slashed to a nominal height of 50 mm above ground with the exception of large, established trees of height in excess of 5 m, which shall remain

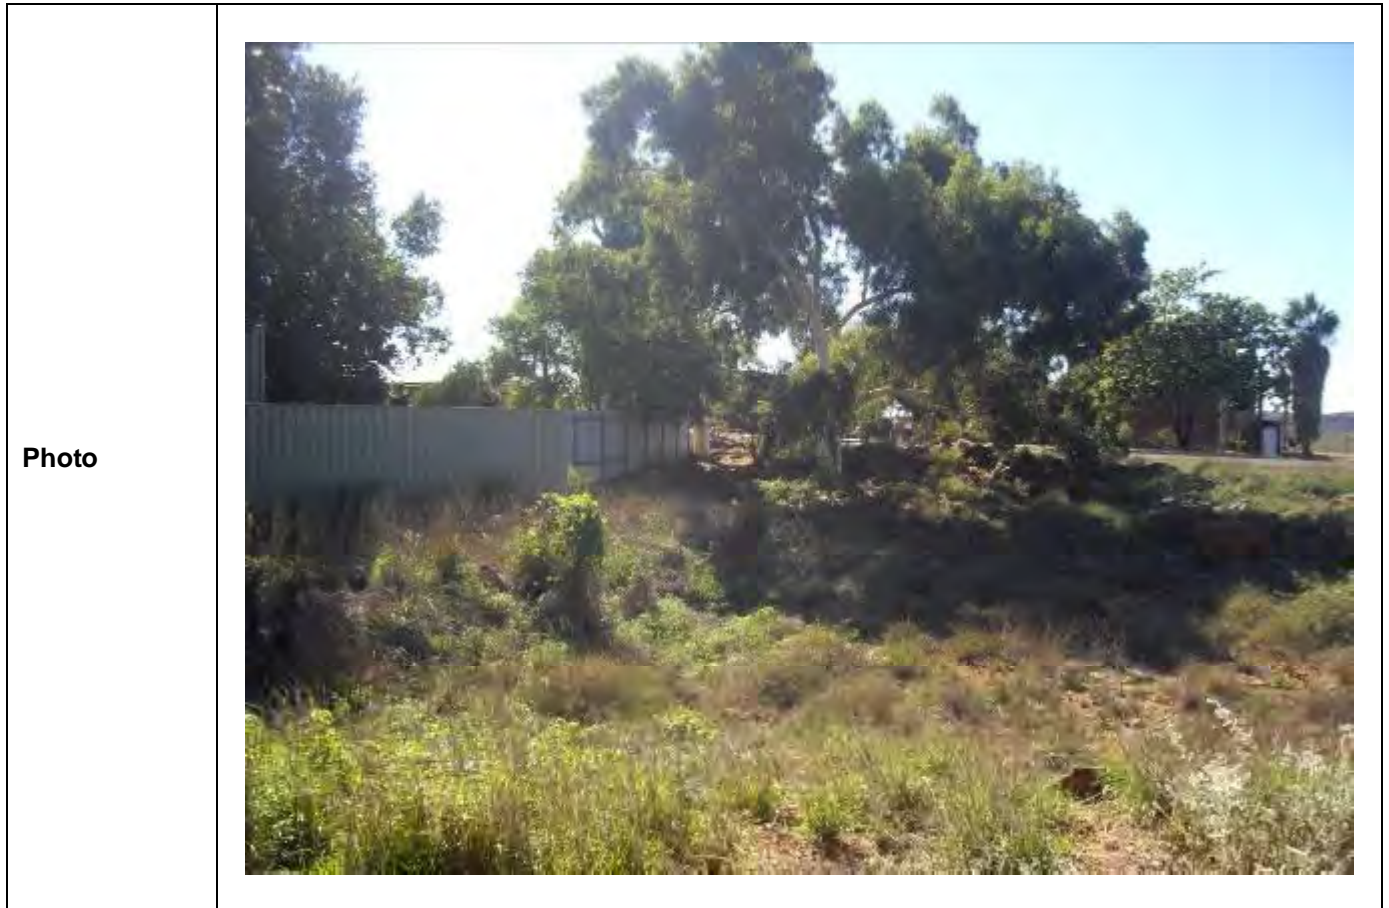
#### 4.1 Lot No. 1,170 Warburton Crescent

<b>Category</b>	Drain Maintenance
<b>Type</b>	Vegetation
<b>Description</b>	Semi-dense low lying vegetation
<b>Photo ID</b>	868
<b>Scope of Works</b>	M - Vegetation is to be slashed to a nominal height of 50 mm above ground with the exception of large, established trees of height in excess of 5 m, which shall remain

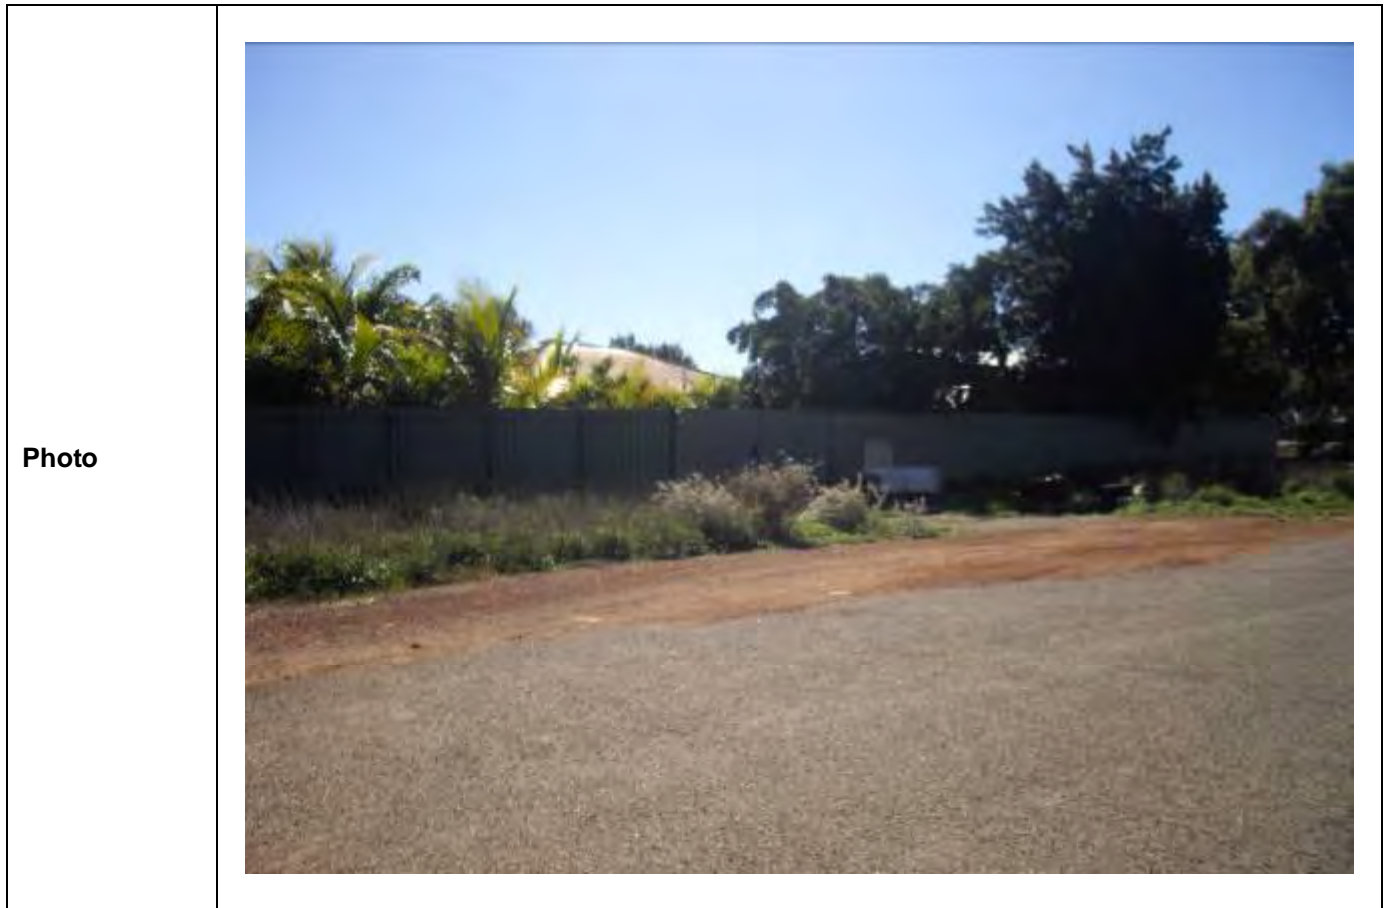
## 4.2 Lot No. 170 Warburton Crescent

<b>Category</b>	Encroachment
<b>Type</b>	Rear access Flowpath
<b>Description</b>	Rear access follows natural topography Drainage flowpath within reserve flows towards the property although it should not be large flow
<b>Photo ID</b>	871
<b>Scope of Works</b>	L - Remove rear access and reinstate drainage flow path as defined by the natural capacity and invert of downstream lot (east 170) channel

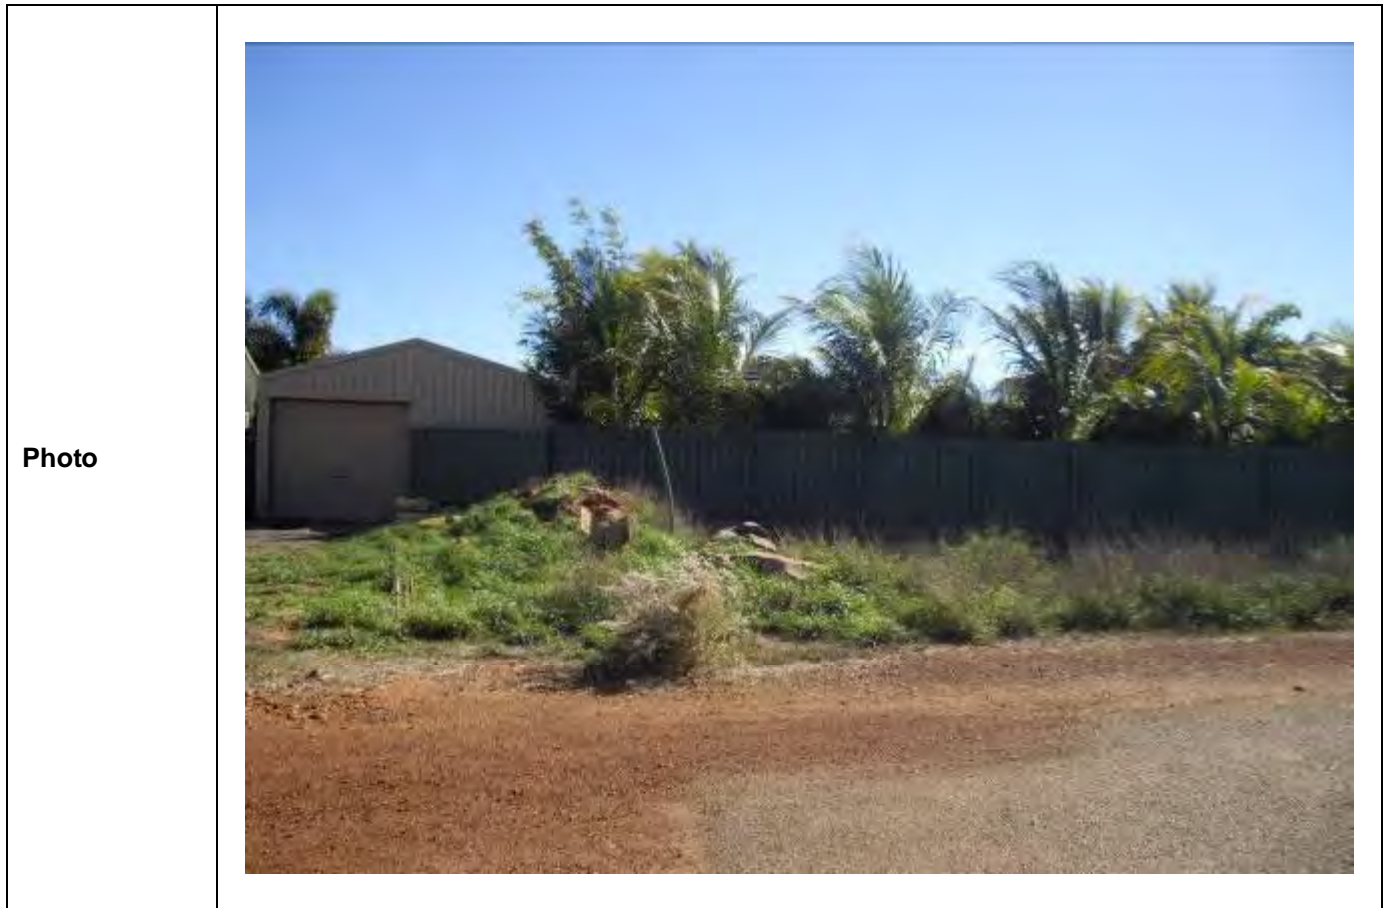
### 4.3 Lot No. 171 Warburton Crescent

<b>Category</b>	Encroachment
<b>Type</b>	Rear access Boundary extension Fill
<b>Description</b>	Top of catchment Rear access and modified topography Shed is within the drainage reserve Fill material dumped in drainage reserve
<b>Photo ID</b>	872
<b>Scope of Works</b>	M - Remove access driveway L – Remove shed – confirmation required from survey H - Remove fill material and reinstate drainage flow path to the east

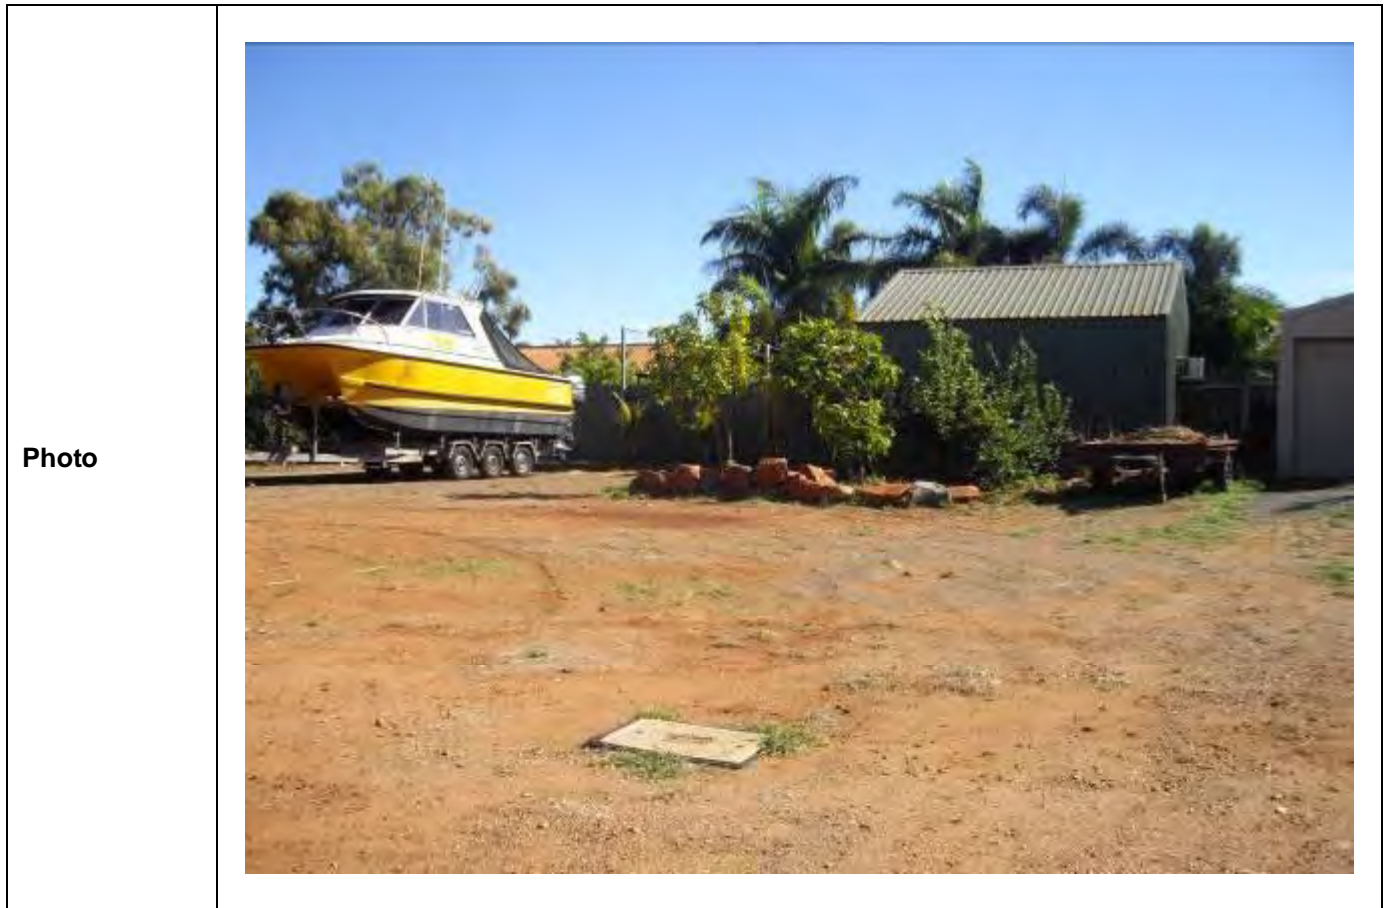
#### 4.4 Lot No. 172 Warburton Crescent

<b>Category</b>	Encroachment
<b>Type</b>	Rear access No defined flow path
<b>Description</b>	Rear access follows modified topography Flow path has been extensively modified due to many changes
<b>Photo ID</b>	873
<b>Scope of Works</b>	H – Remove rear access reinstate drainage flow path as defined by the natural capacity and invert of downstream lot (173) channel.

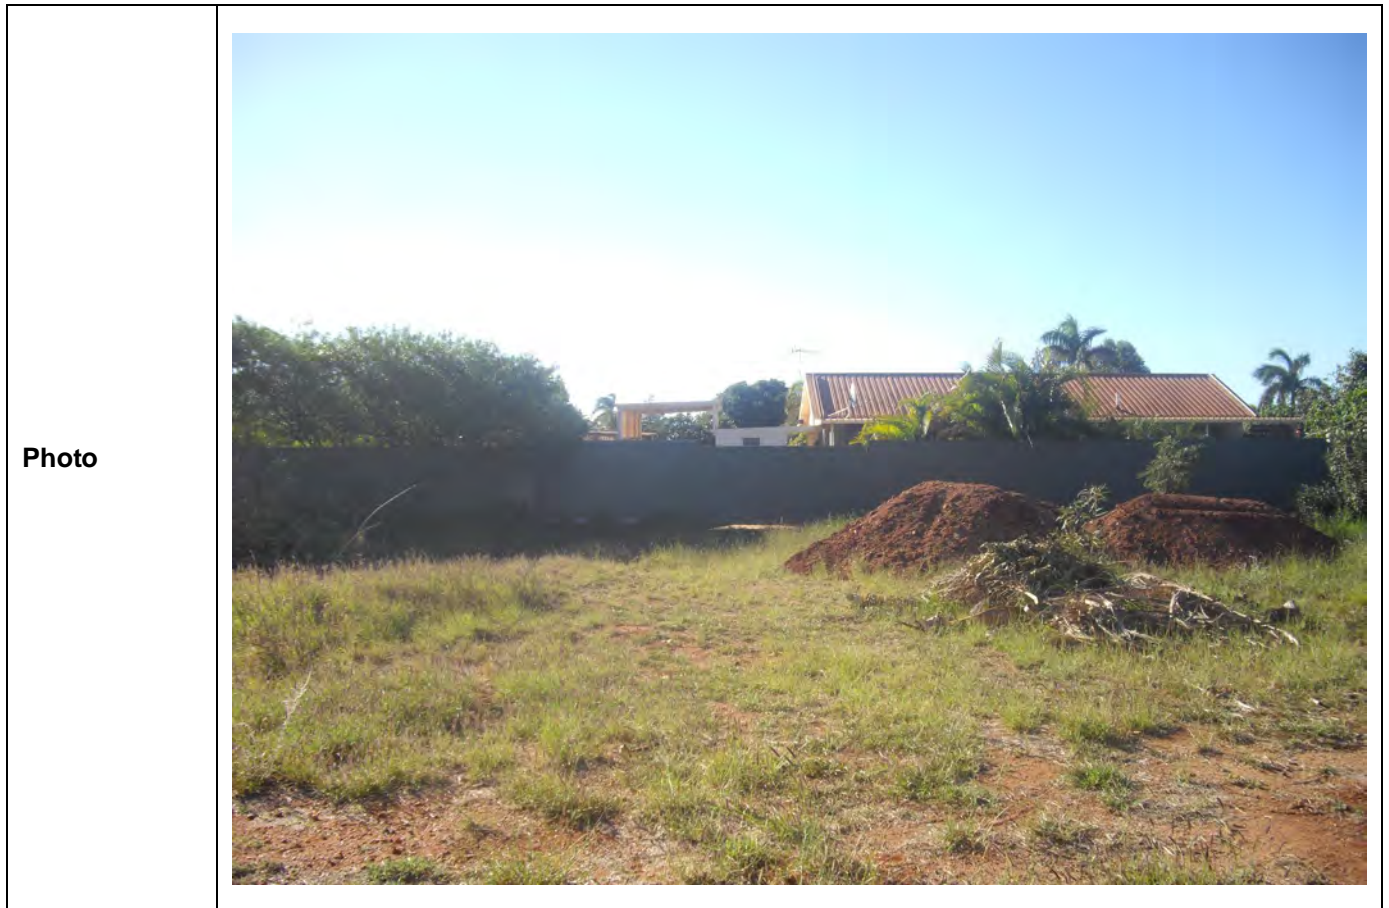
#### 4.5 Lot No. 173 Warburton Crescent

<b>Category</b>	Encroachment
<b>Type</b>	Rear access Flow path
<b>Description</b>	Rear access follows modified topography Drainage flow path is not defined and natural flow is towards the property Fill dumped in drainage reserve
<b>Photo ID</b>	1076, 405
<b>Scope of Works</b>	H – Remove rear access reinstate drainage flow path as defined by the natural capacity and invert of downstream lot (174) channel. M – Remove fill

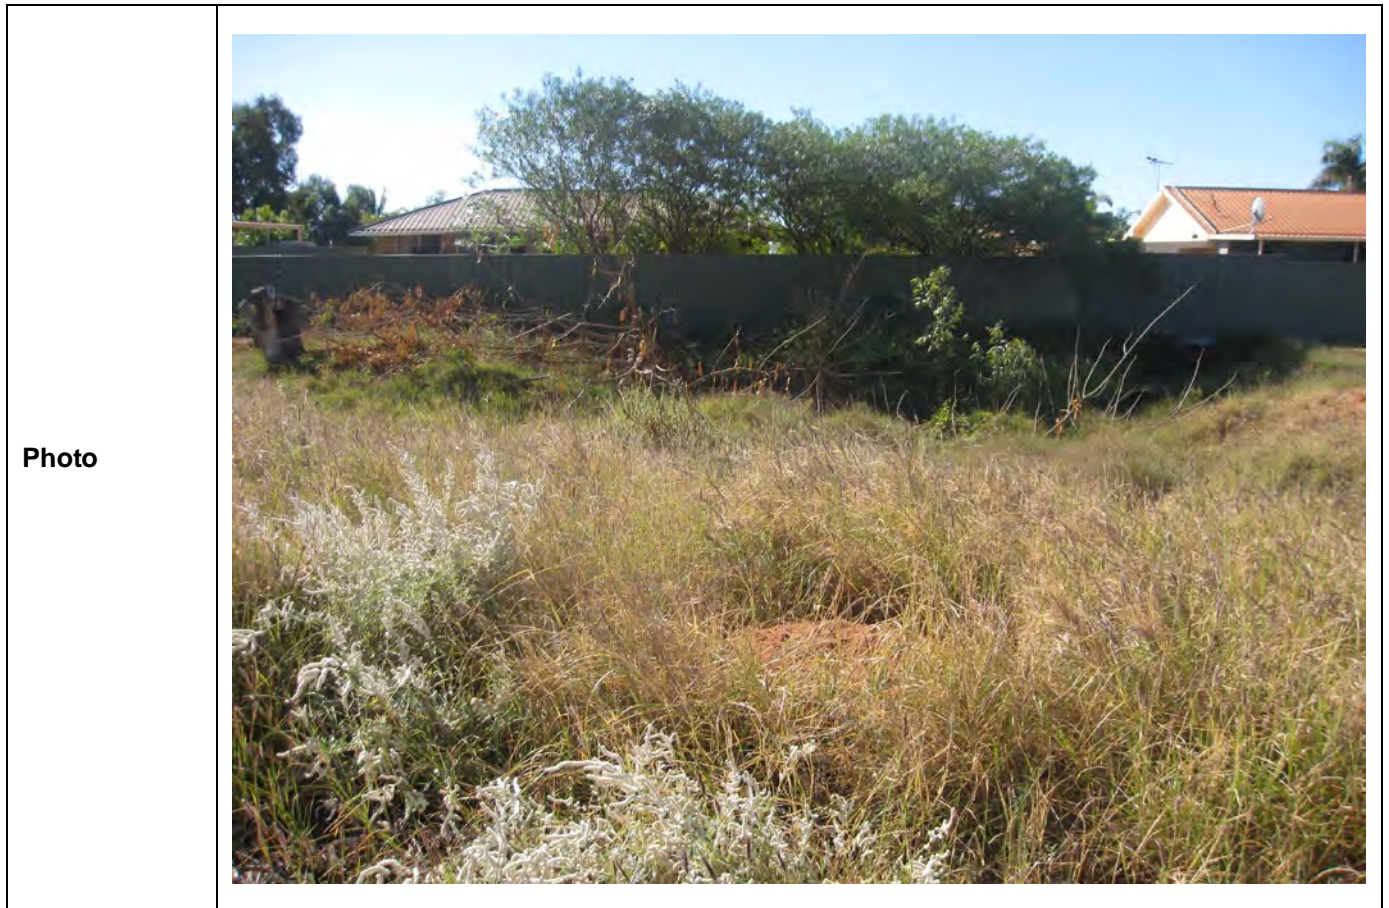
#### 4.6 Lot No. 174 Warburton Crescent

<b>Category</b>	Encroachment / Drain Maintenance
<b>Type</b>	Rear access Vegetation
<b>Description</b>	Rear access follows natural topography Semi-dense vegetation Sump in drainage reserve
<b>Photo ID</b>	1077
<b>Scope of Works</b>	L – Remove rear access and reinstatate to natural topography H - Vegetation is to be slashed to a nominal height of 50 mm above ground with the exception of large, established trees of height in excess of 5 m, which shall remain M – clean out sump and check pipework

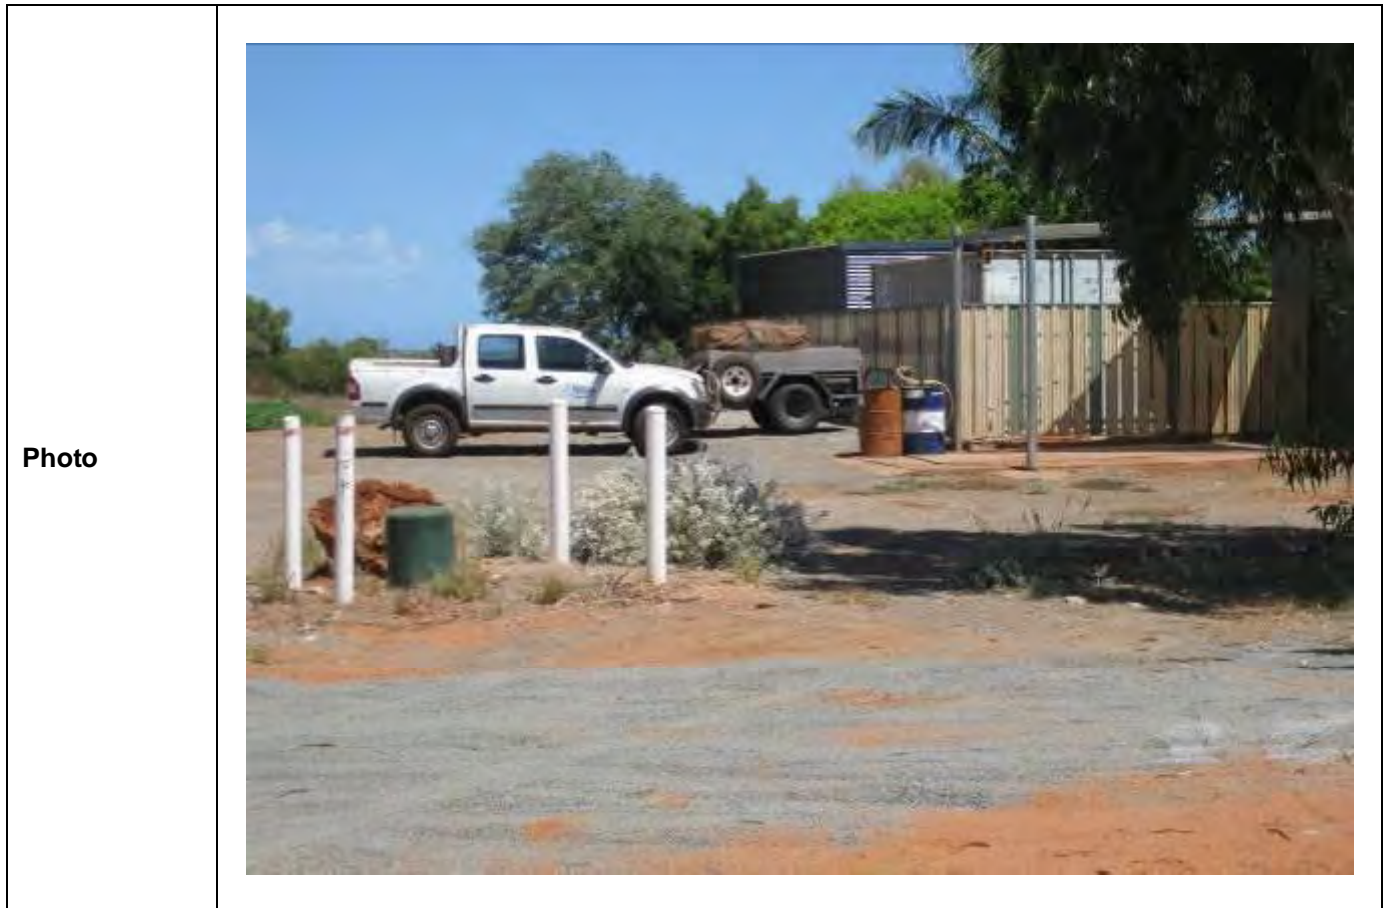
#### 4.7 Lot No. 1 Warburton Crescent

<b>Category</b>	Encroachment
<b>Type</b>	Boundary extension Rear access Flow path
<b>Description</b>	Fence is within the drainage reserve Rear access follows natural/modified topography Drainage flow path has been extensively modified
<b>Photo ID</b>	7317
<b>Scope of Works</b>	L – Remove fence – get confirmation from survey; M – Remove rear access and reinstate drainage flow path as defined by the natural capacity and invert of downstream lot (2) channel.

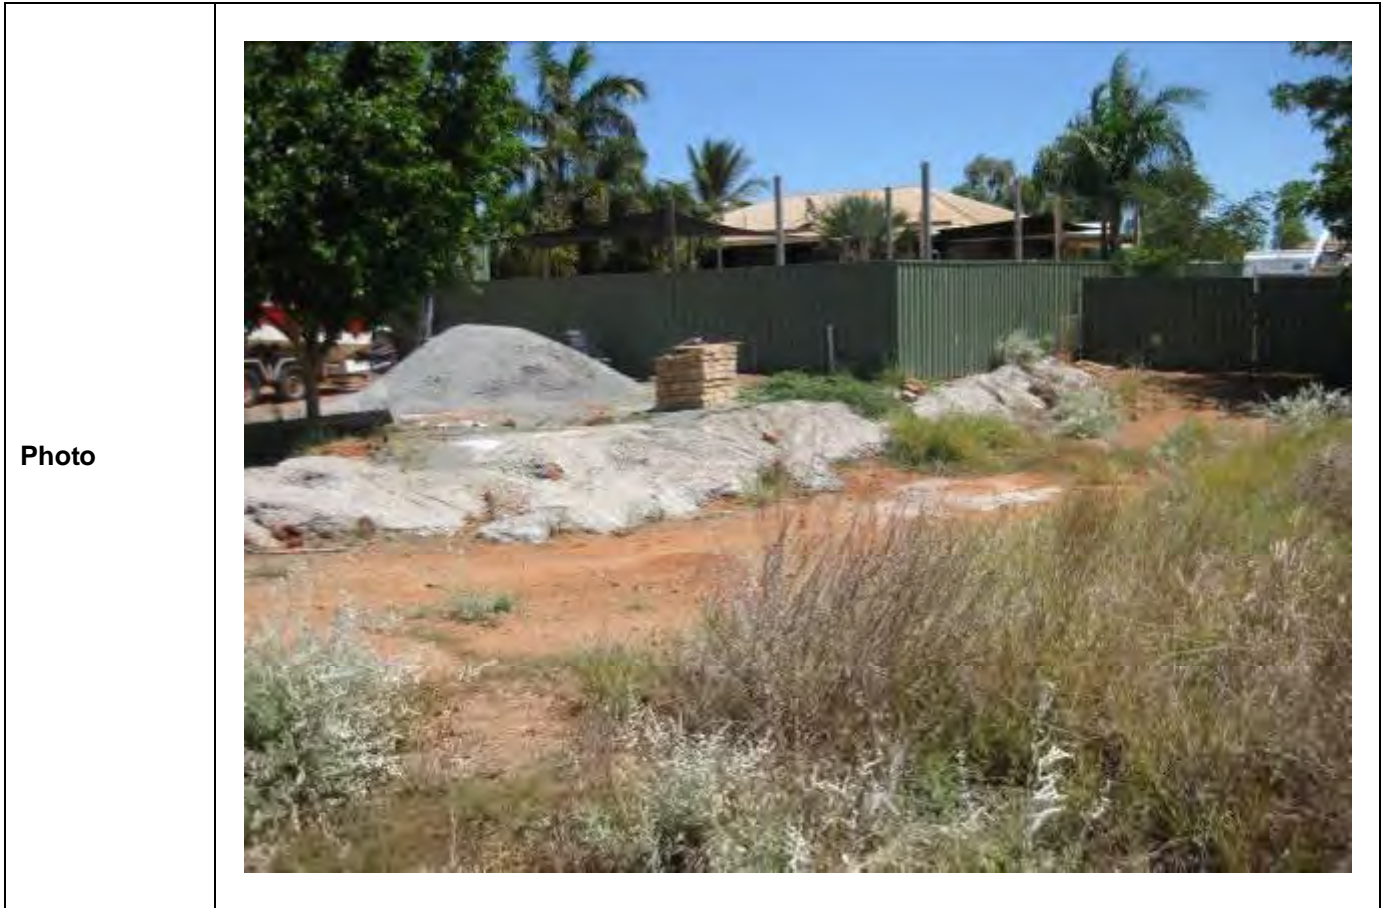
#### 4.8 Lot No. 2 Warburton Crescent

<b>Category</b>	Encroachment
<b>Type</b>	Boundary extension Rear access General items
<b>Description</b>	Property has been extended to within the drainage reserve Rear access follows modified topography Boat, vehicles, building equipment
<b>Photo ID</b>	7316
<b>Scope of Works</b>	H – Remove property extensions and relocate to within property boundary – confirmation required from survey M – Remove rear access reinstate drainage flow path as defined by the natural capacity and invert of downstream lot (west of 2) channel. L – Remove boat, vehicles and building equipment

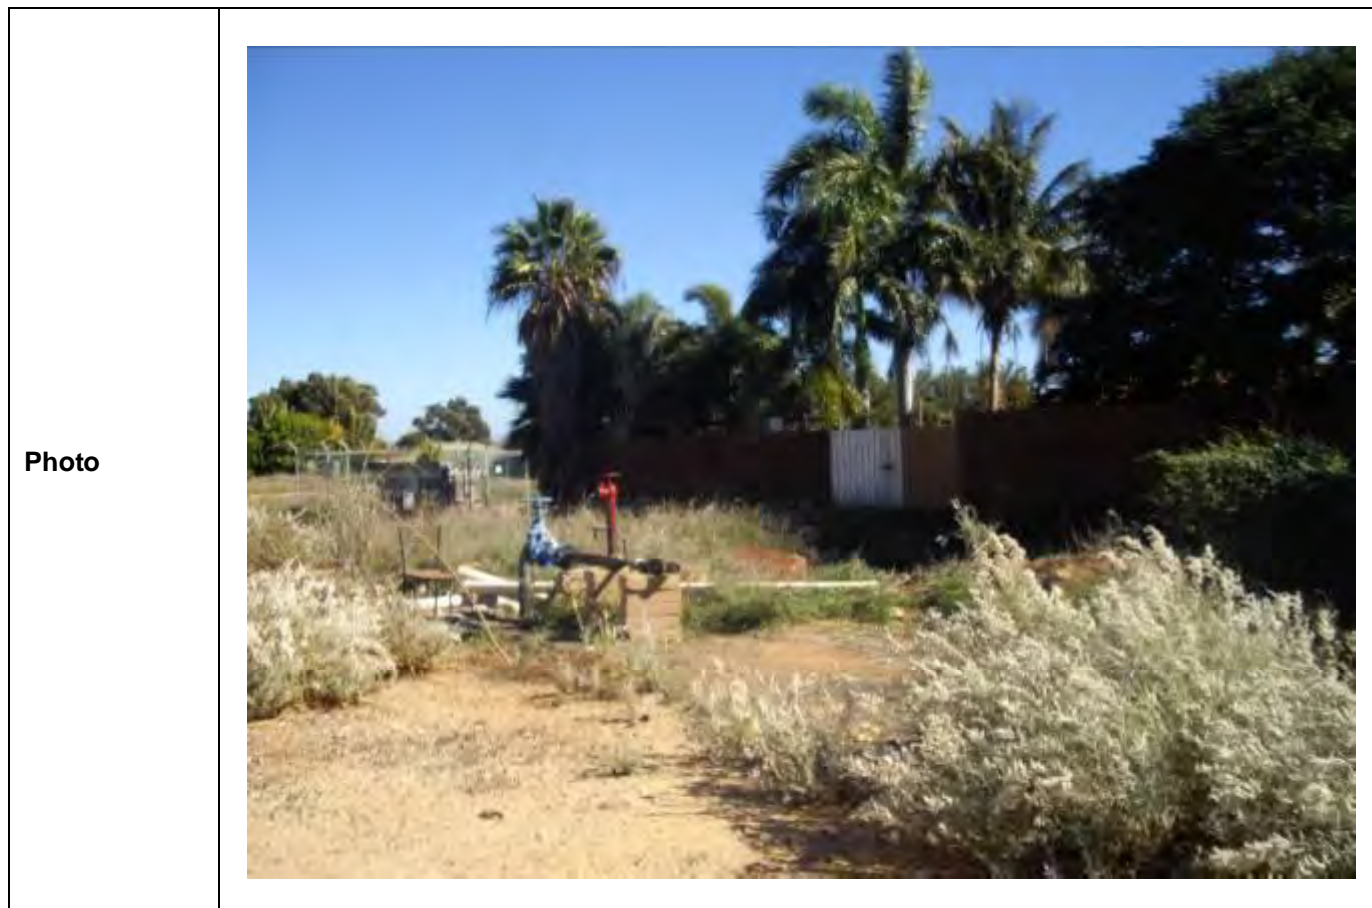
## 5.1 Lot No. 177 Thyssen Crescent

<b>Category</b>	Drain Maintenance
<b>Type</b>	Vegetation
<b>Description</b>	Dense vegetaion
<b>Photo ID</b>	882
<b>Scope of Works</b>	M - Vegetation is to be slashed to a nominal height of 50 mm above ground with the exception of large, established trees of height in excess of 5 m, which shall remain

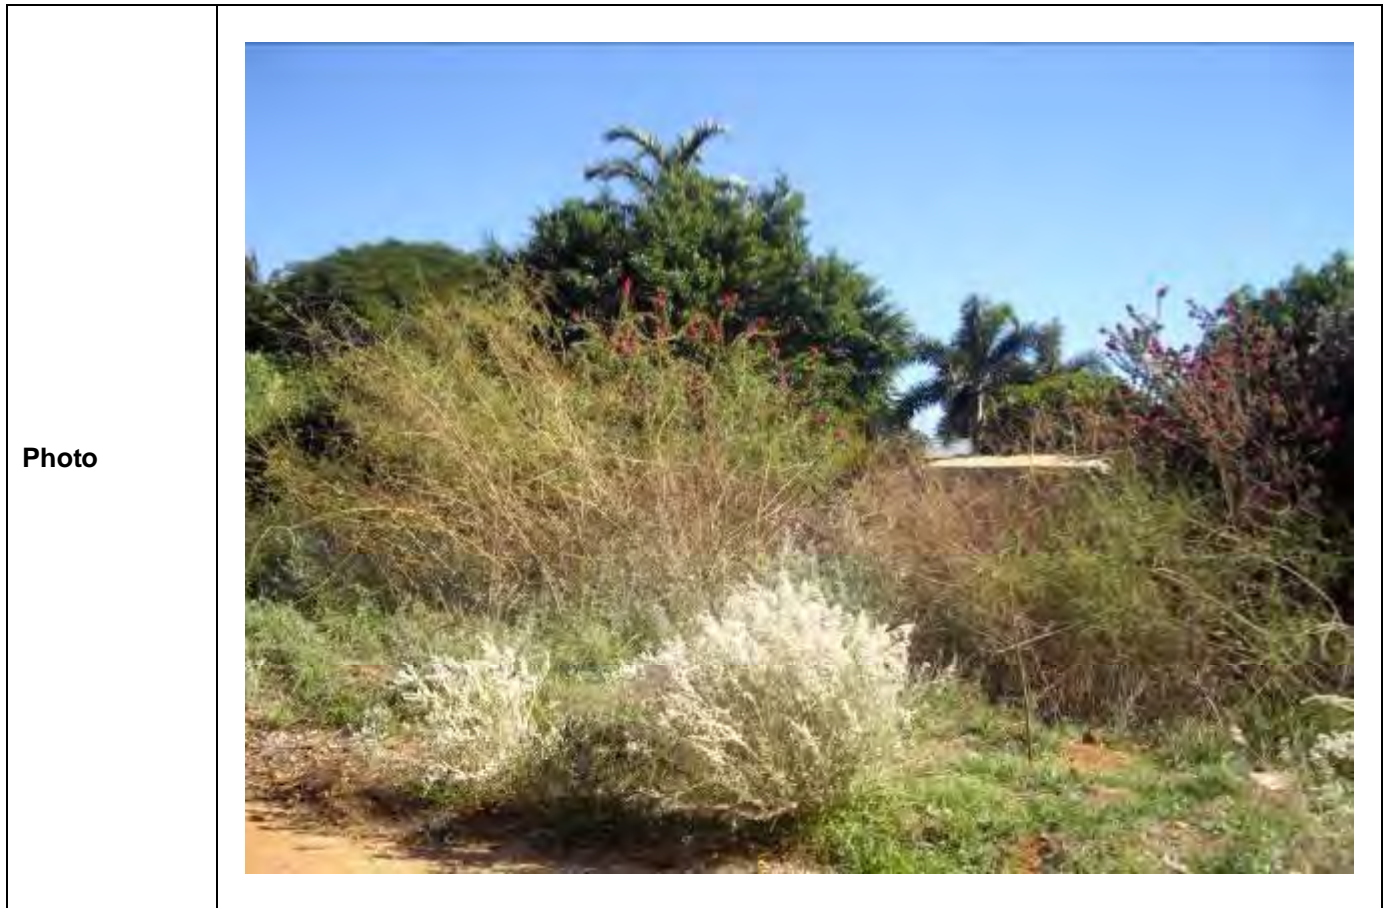
## 5.2 Lot No. 178 Thyssen Crescent

<b>Category</b>	Drain Maintenance/ Encroachment
<b>Type</b>	Vegetation Rear access
<b>Description</b>	Dense vegetation Rear access impeding flow
<b>Photo ID</b>	881
<b>Scope of Works</b>	M - Vegetation is to be slashed to a nominal height of 50 mm above ground with the exception of large, established trees of height in excess of 5 m, which shall remain M – Remove rear access and reinstate to natural drain

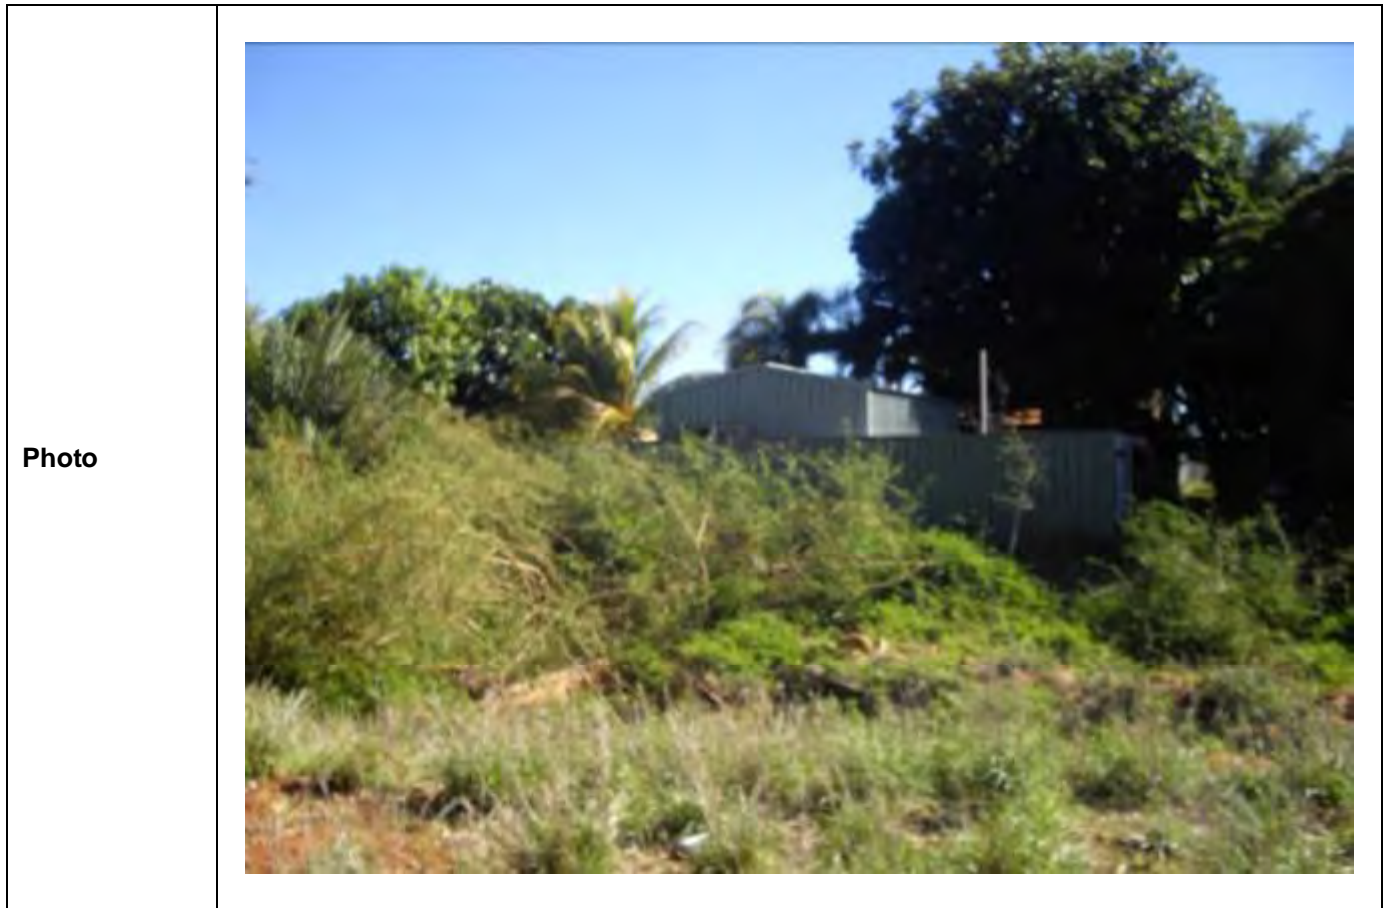
### 5.3 Lot No. 179 Thyssen Crescent

<b>Category</b>	Drain Maintenance
<b>Type</b>	Vegetation
<b>Description</b>	Dense bush
<b>Photo ID</b>	880
<b>Scope of Works</b>	M - Vegetation is to be slashed to a nominal height of 50 mm above ground with the exception of large, established trees of height in excess of 5 m, which shall remain

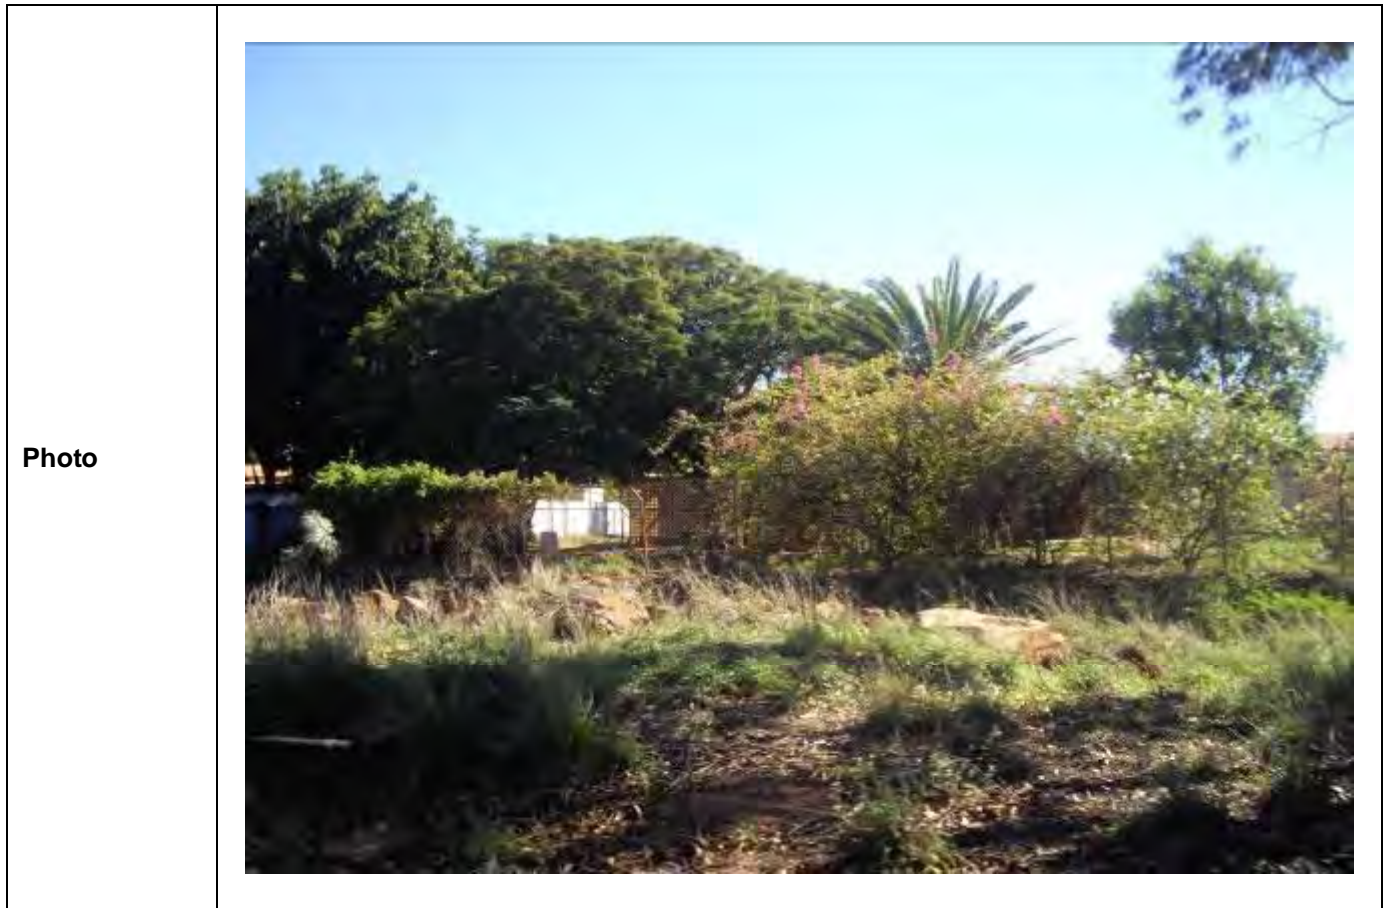
#### 5.4 Lot No. 180 Thyssen Crescent

<b>Category</b>	Drain Maintenance
<b>Type</b>	Vegetation
<b>Description</b>	Dense Vegetation
<b>Photo ID</b>	879
<b>Scope of Works</b>	M - Vegetation is to be slashed to a nominal height of 50 mm above ground with the exception of large, established trees of height in excess of 5 m, which shall remain

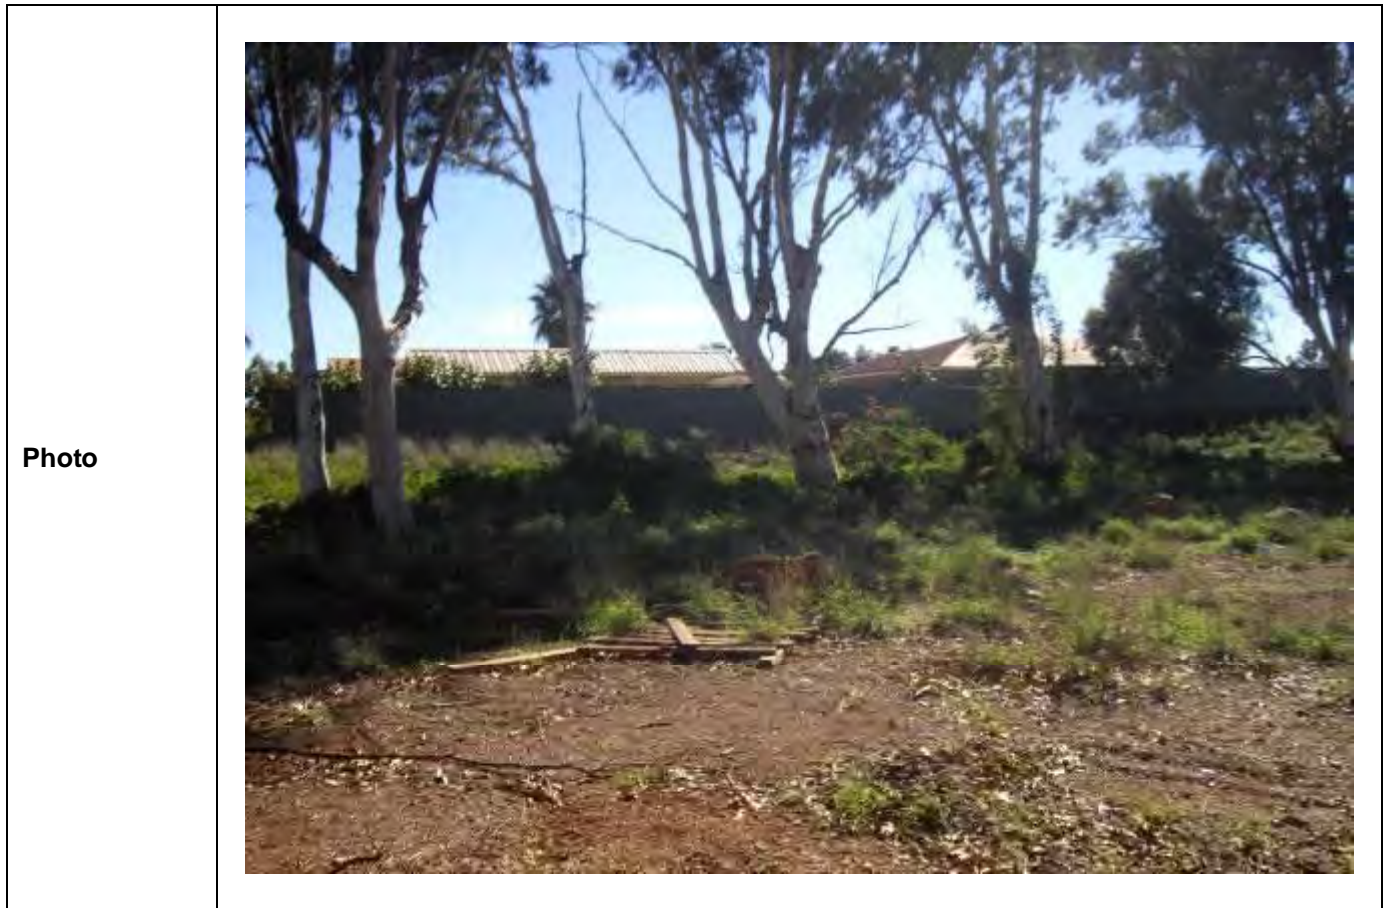
## 5.5 Lot No. 181 Thyssen Crescent

<b>Category</b>	Drain Maintenance
<b>Type</b>	Vegetation
<b>Description</b>	Dense vegetation
<b>Photo ID</b>	878
<b>Scope of Works</b>	M - Vegetation is to be slashed to a nominal height of 50 mm above ground with the exception of large, established trees of height in excess of 5 m, which shall remain

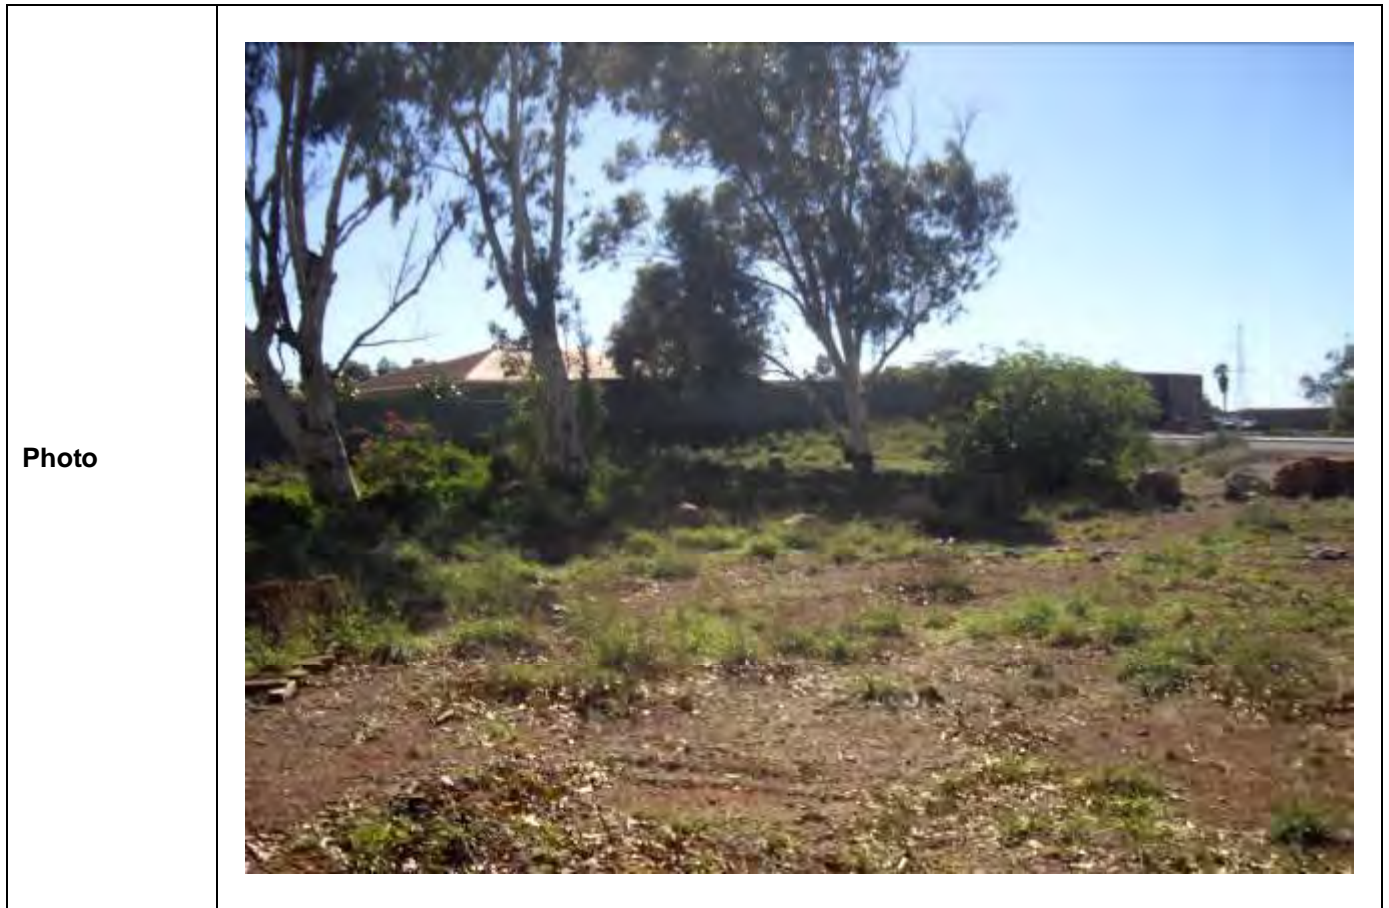
## 5.6 Lot No. 1,181 Thyssen Crescent

<b>Category</b>	Drain Maintenance
<b>Type</b>	Vegetation
<b>Description</b>	M - Dense vegetation
<b>Photo ID</b>	877
<b>Scope of Works</b>	Vegetation is to be slashed to a nominal height of 50 mm above ground with the exception of large, established trees of height in excess of 5 m, which shall remain
