City of Karratha  
Dampier Stormwater Management Study  
Report  
Part B  
June 2015

## Appendix **C** – 2010 encroachment reviews

**Rio Tinto Iron Ore**  
Report on Dampier Drainage  
Review  
Block 1 Encroachments  
June 2010

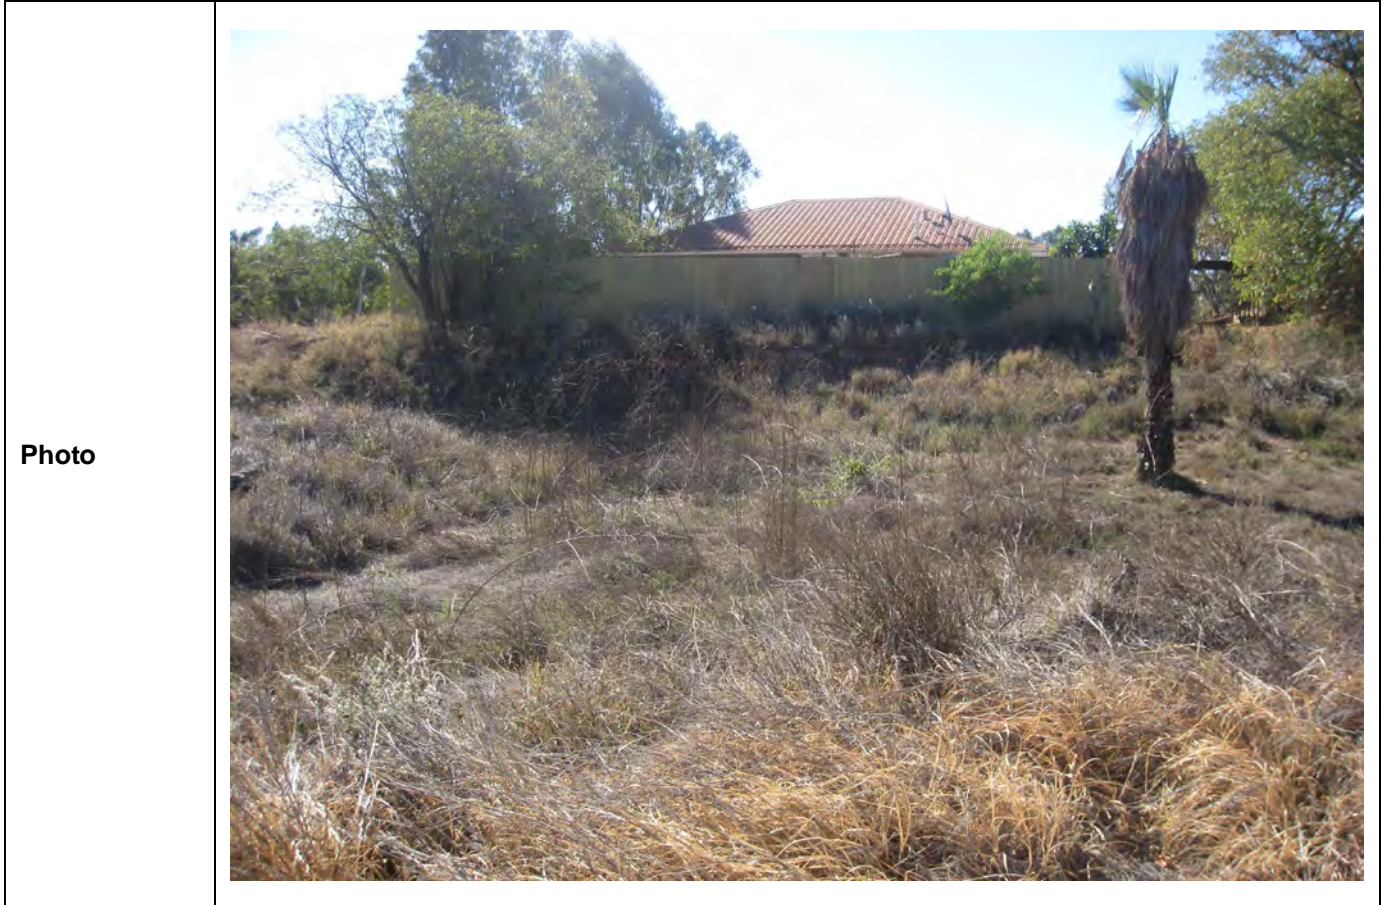
**2.1 Lot No. 1,132 Tachikawa Crescent**

<b>Category</b>	Drain Maintenance
<b>Type</b>	Vegetation
<b>Description</b>	Semi-dense vegetation
<b>Photo ID</b>	1080
<b>Scope of Works</b>	M - Vegetation is to be slashed to a nominal height of 50 mm above ground with the exception of large, established trees of height in excess of 5 m, which shall remain.

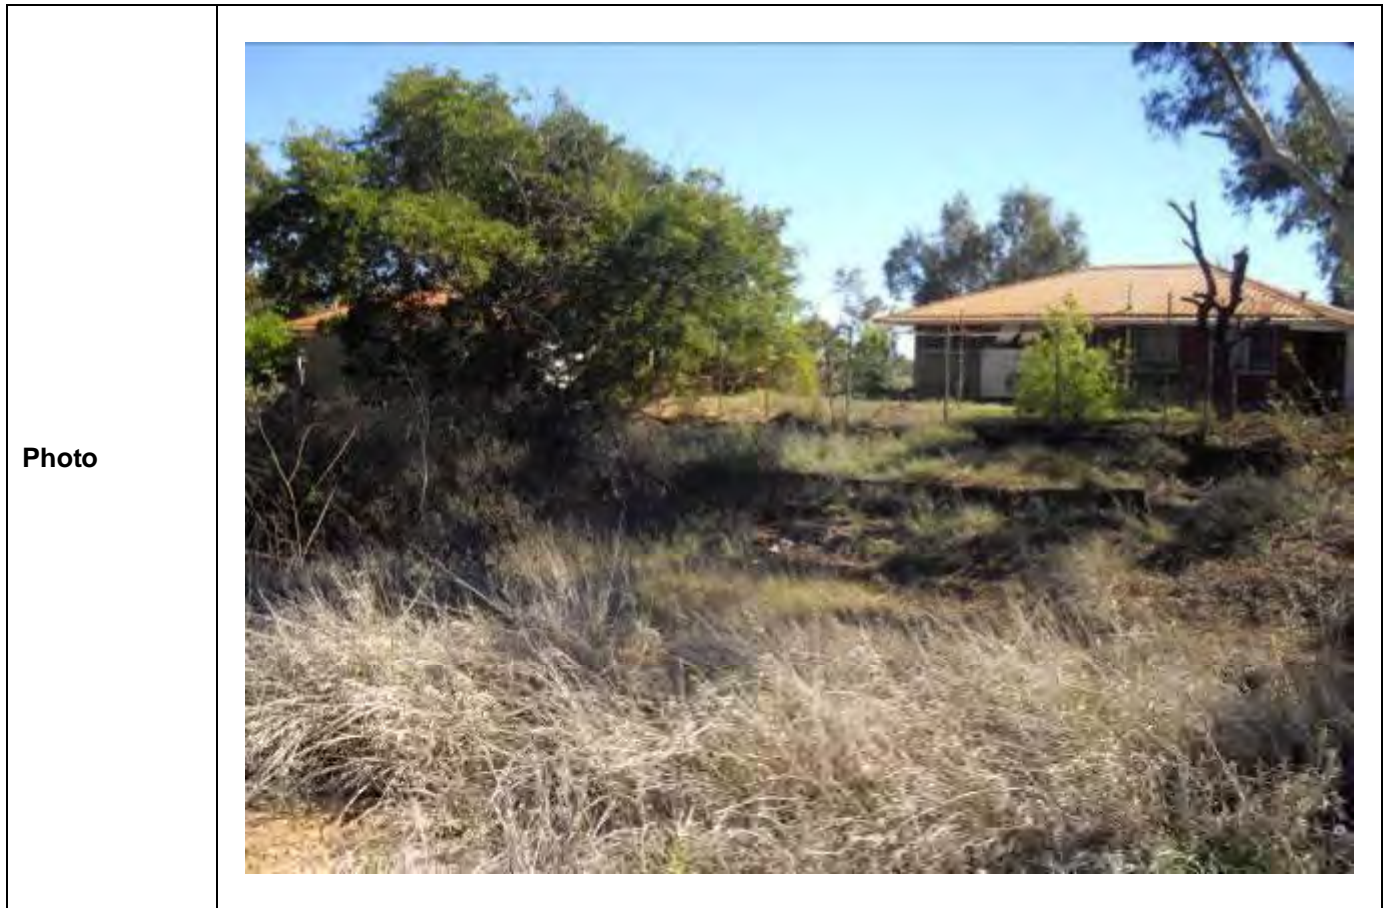
## 2.2 Lot No. 2,132 Tachikawa Crescent

<b>Category</b>	Drain Maintenance
<b>Type</b>	Vegetation
<b>Description</b>	Semi-dense vegetation
<b>Photo ID</b>	904
<b>Scope of Works</b>	M - Vegetation is to be slashed to a nominal height of 50 mm above ground with the exception of large, established trees of height in excess of 5 m, which shall remain.

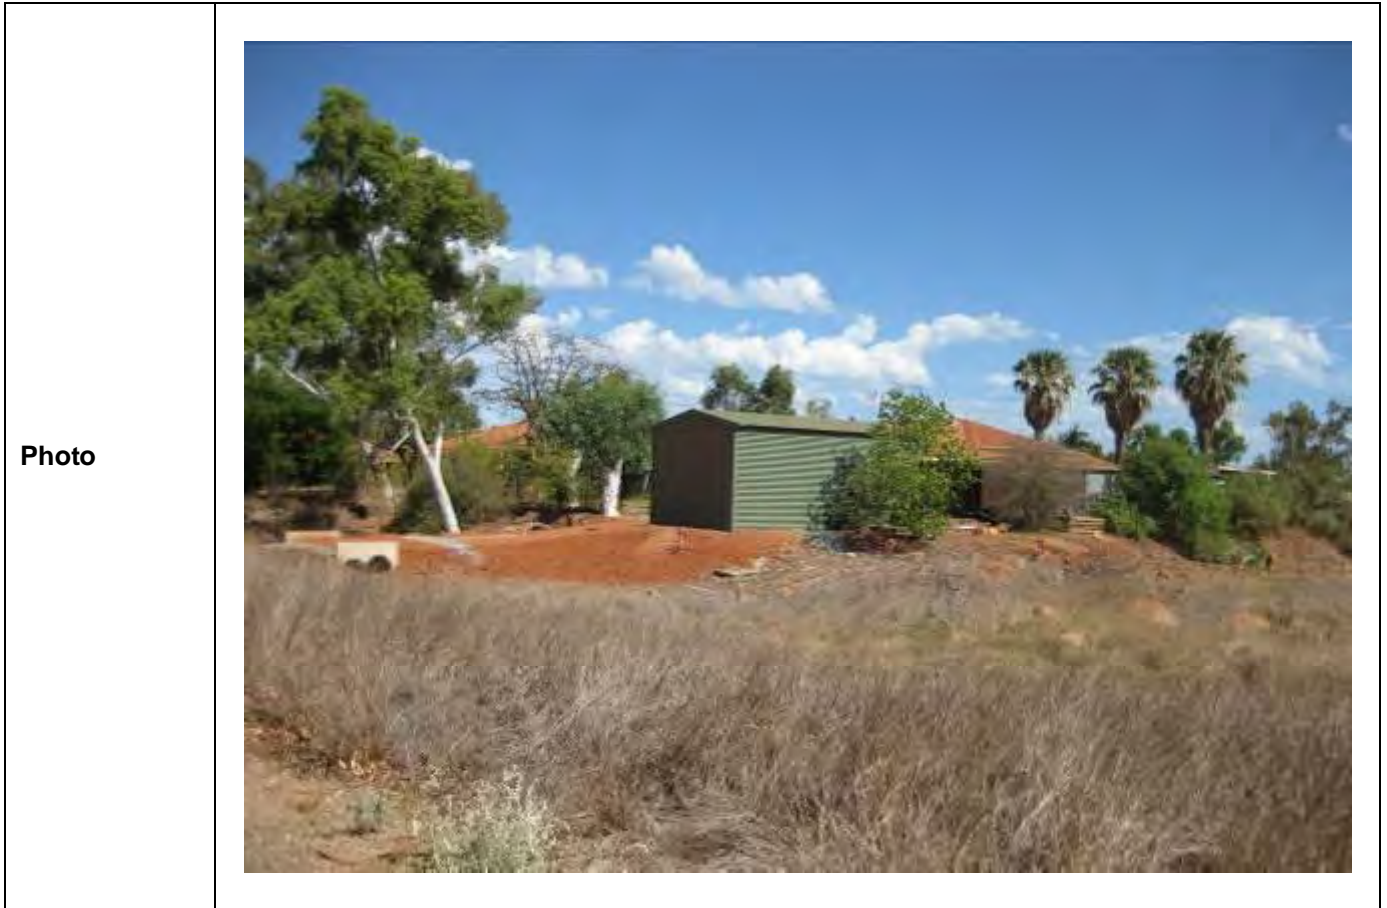
### 2.3 Lot No. 3,132 Tachikawa Crescent

<b>Category</b>	Encroachment
<b>Type</b>	Rear access; Boundary extension.
<b>Description</b>	Rear access with culverts impeding flow; Green shed within drainage reserve.
<b>Photo ID</b>	7302
<b>Scope of Works</b>	M - Remove rear acces and reinstate drainage flowpath as defined by the upstream and down stream cross section and uniform grade; L – Remove shed and relocate to within property boundary – confirmation required from survey.

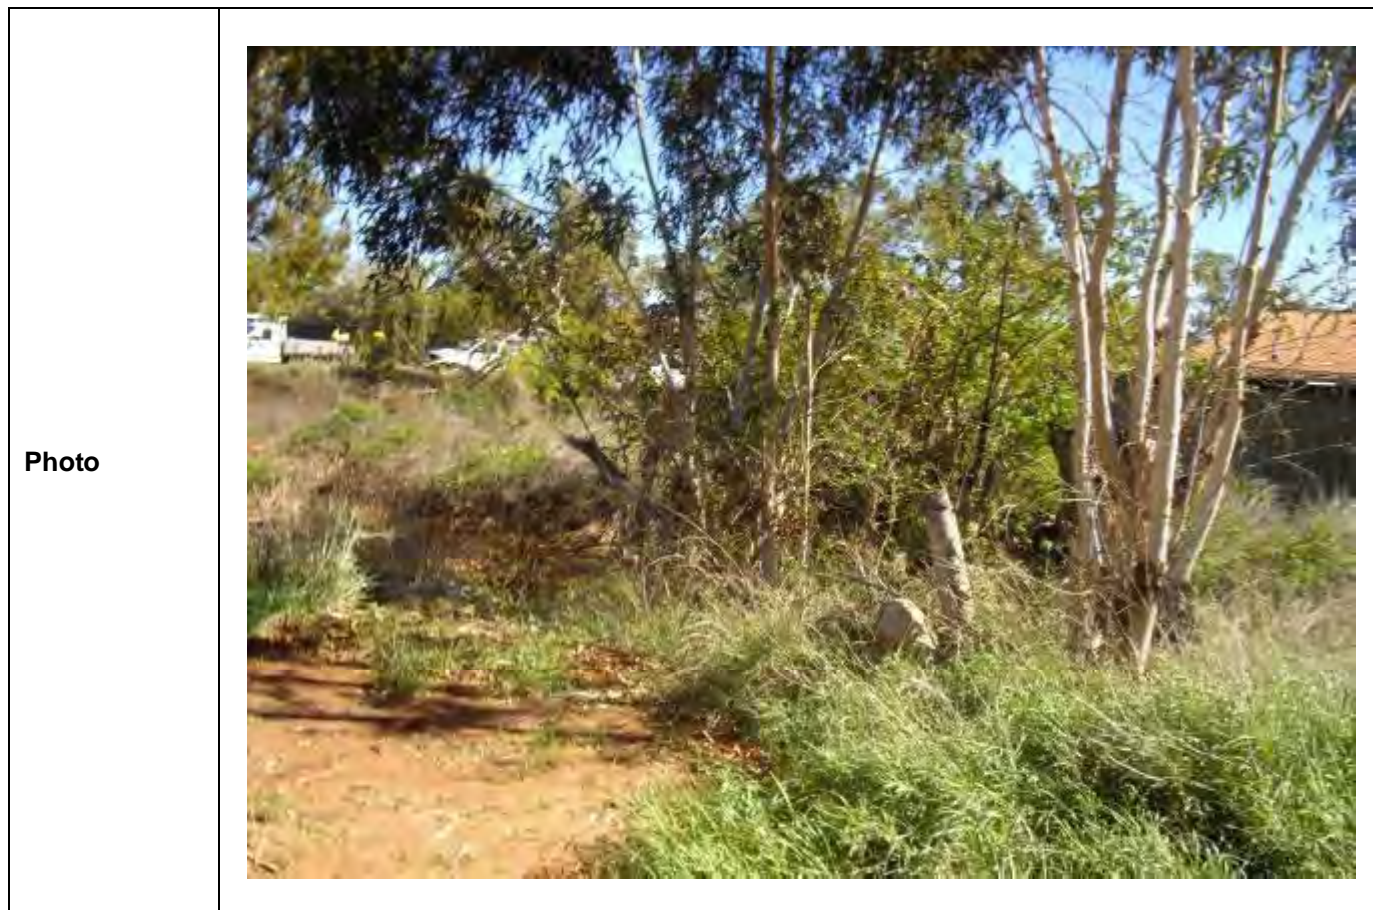
### 3.1 Lot No. 132 Prinsep Crescent

<b>Category</b>	Drain Maintenance
<b>Type</b>	Vegetation,
<b>Description</b>	Dense vegetation Flow path adequate.
<b>Photo ID</b>	903
<b>Scope of Works</b>	H - Vegetation is to be slashed to a nominal height of 50 mm above ground with the exception of large, established trees of height in excess of 5 m, which shall remain

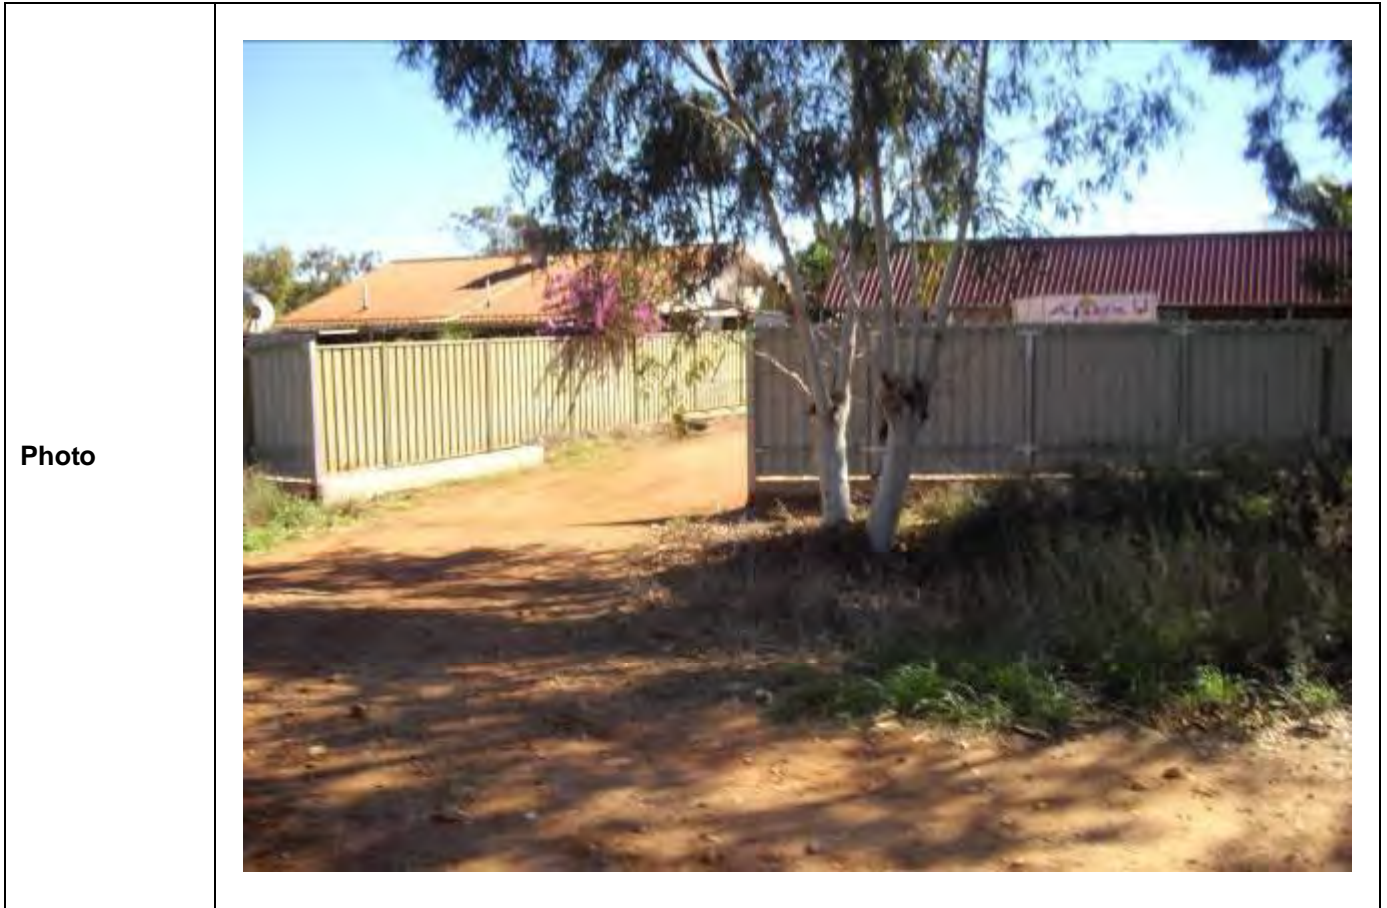
### 3.2 Lot No. 133 Prinsep Crescent

<b>Category</b>	Encroachment
<b>Type</b>	Rear access
<b>Description</b>	Rear access with culvert impeding flow.
<b>Photo ID</b>	902
<b>Scope of Works</b>	H – Remove rear access and reinstate drainage flow path as defined by the natural capacity and invert of downstream lot (132) channel

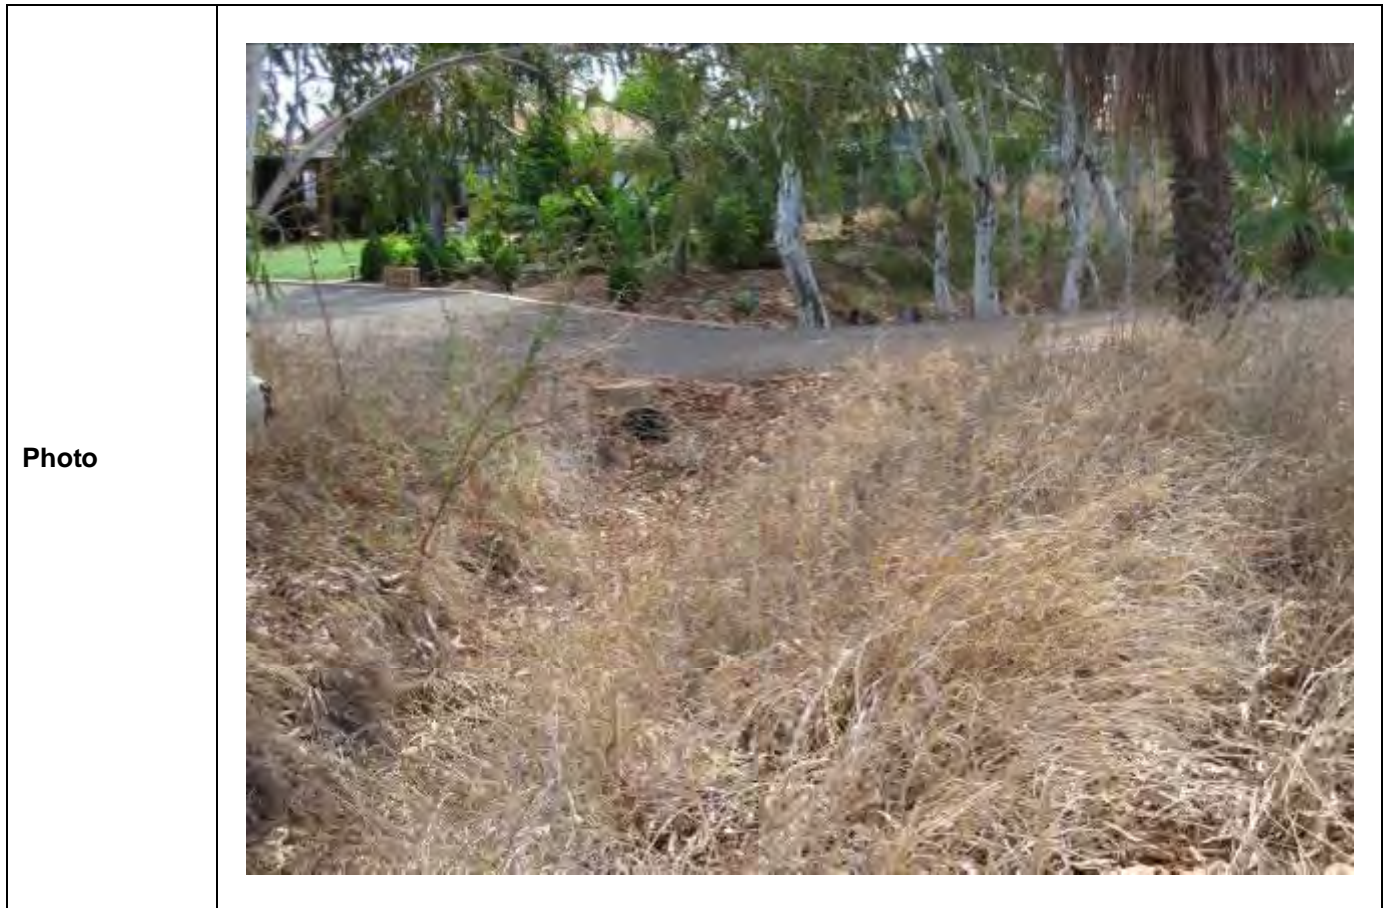
### 3.3 Lot No. 134 Prinsep Crescent

<b>Category</b>	Encroachment/ Drain maintenance
<b>Type</b>	Rear access; Vegetation.
<b>Description</b>	Rear access with culvert; Semi-dense vegetation.
<b>Photo ID</b>	7301
<b>Scope of Works</b>	H – Remove rear access and reinstate drainage flow path as defined by the natural capacity and invert of downstream lot (133) channel M - Vegetation is to be slashed to a nominal height of 50 mm above ground with the exception of large, established trees of height in excess of 5 m, which shall remain.

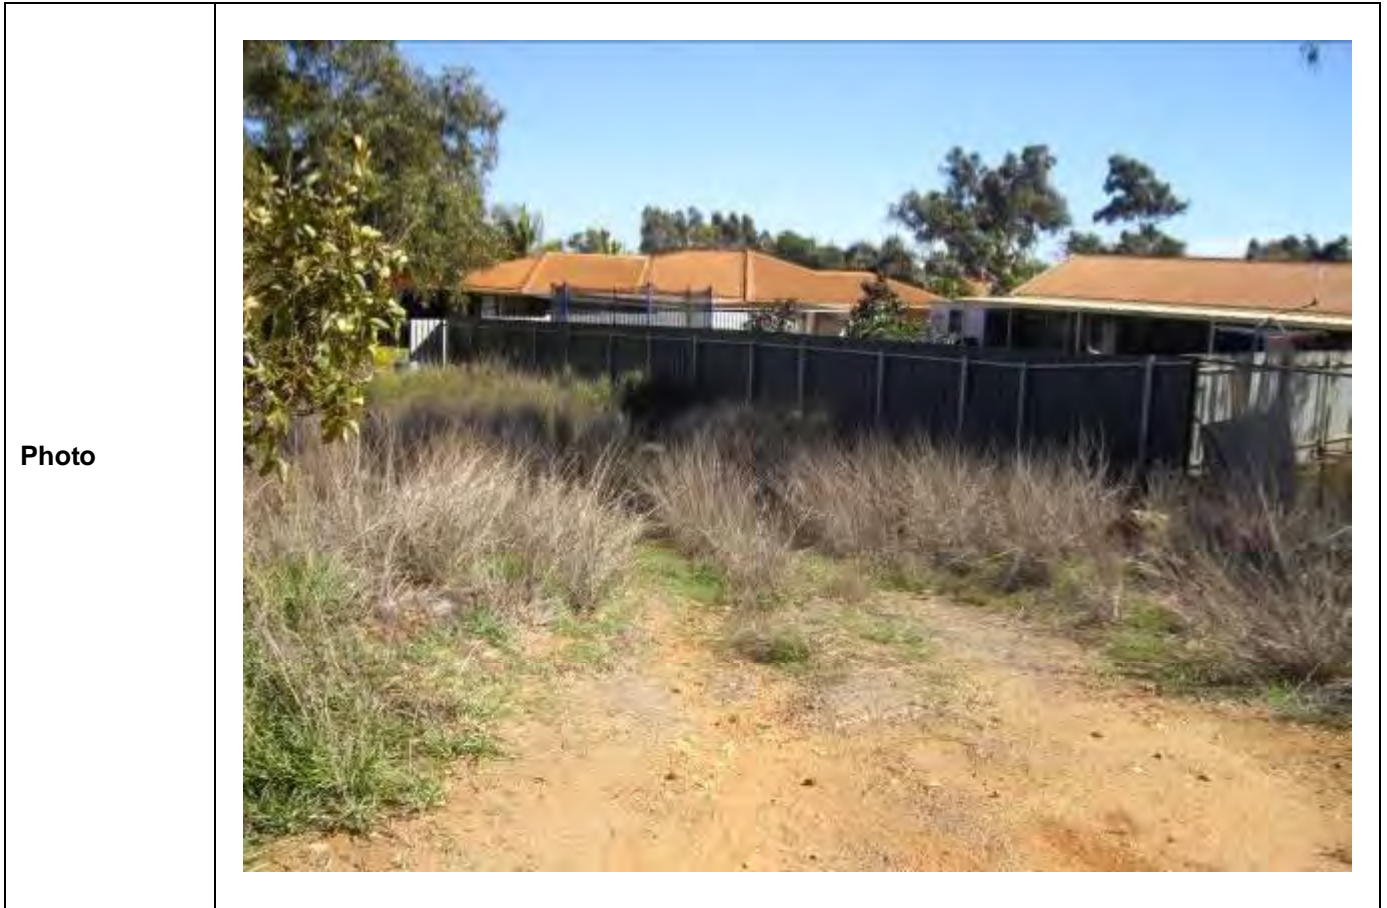
### 3.4 Lot No. 135 Prinsep Crescent

<b>Category</b>	Encroachment / Drain Maintenance
<b>Type</b>	Rear access Vegetation
<b>Description</b>	Rear access follows natural topography Semi-dense vegetation
<b>Photo ID</b>	891
<b>Scope of Works</b>	L – Remove rear access M - Vegetation is to be slashed to a nominal height of 50 mm above ground with the exception of large, established trees of height in excess of 5 m, which shall remain.

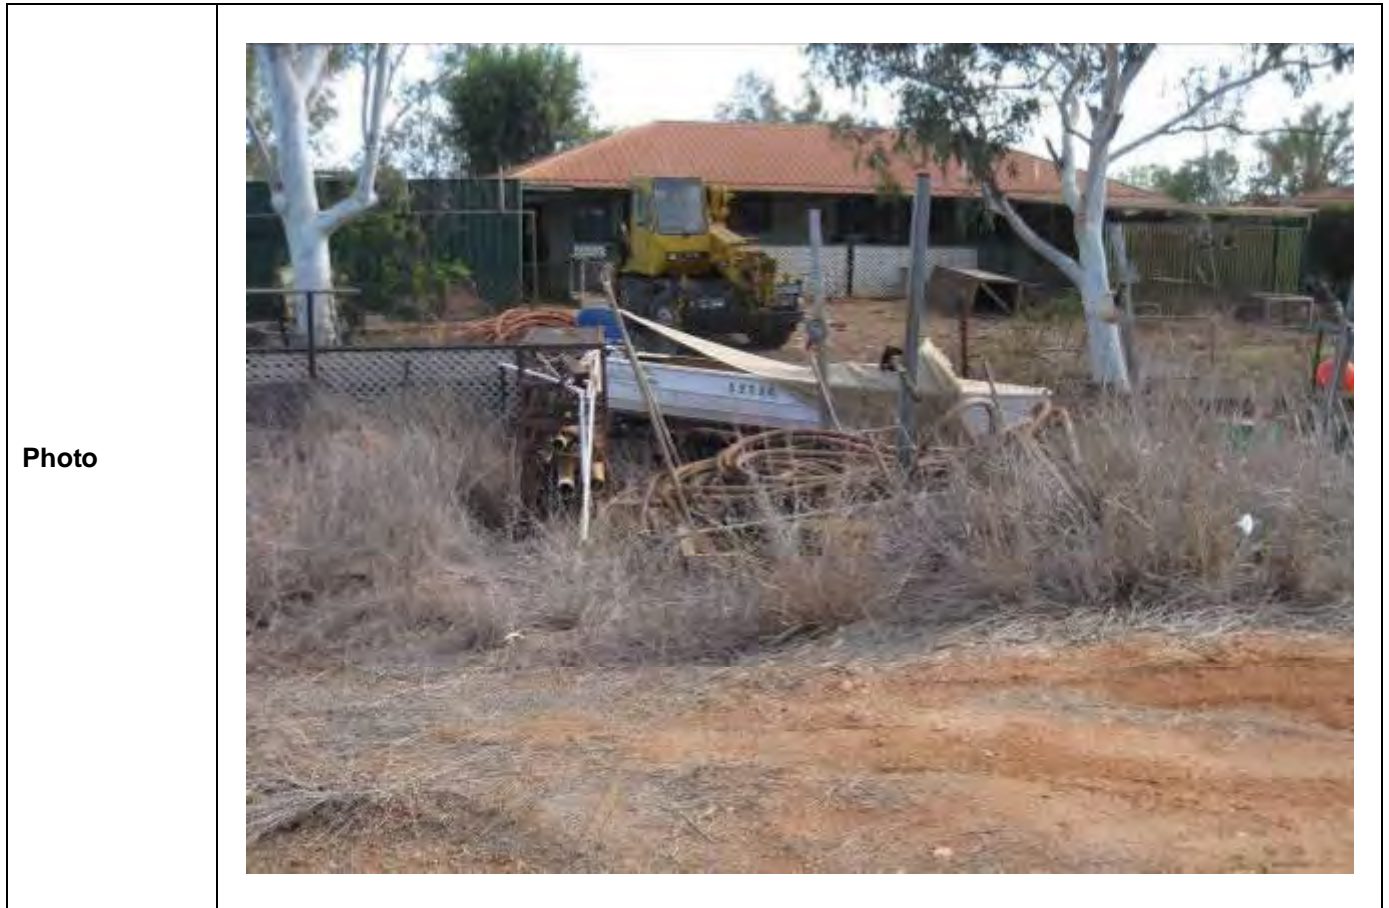
#### 4.1 Lot No. 136 Prinsep Crescent

<b>Category</b>	Encroachment / Drain Maintenance
<b>Type</b>	General items Vegetation
<b>Description</b>	Boat, trailer, drums and building materials Semi densi vegetation
<b>Photo ID</b>	7295
<b>Scope of Works</b>	M – Remove boat, trailer, drums and building materials M - Vegetation is to be slashed to a nominal height of 50 mm above ground with the exception of large, established trees of height in excess of 5 m, which shall remain

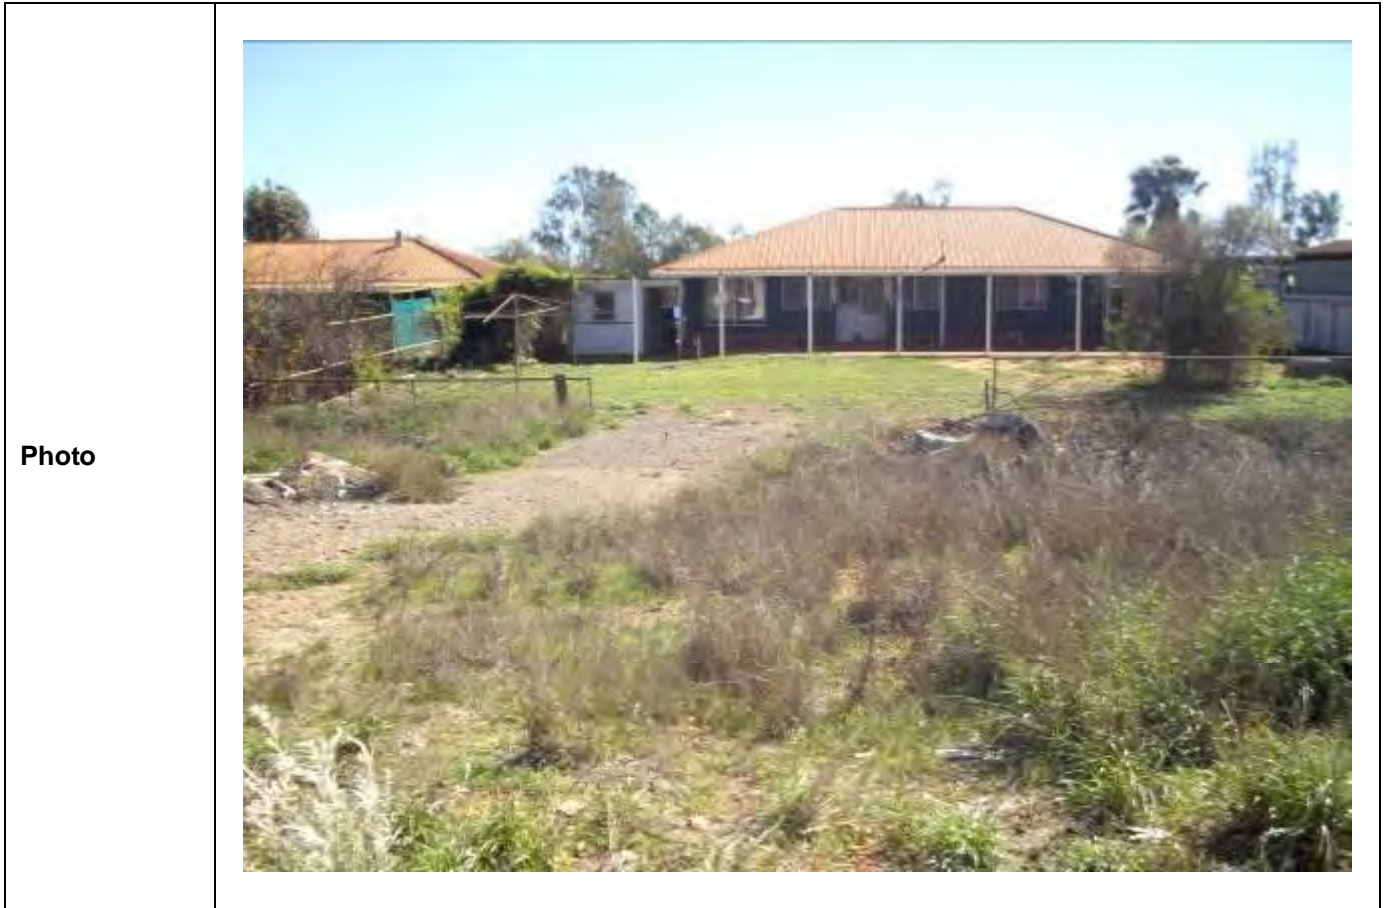
## 4.2 Lot No. 137 Prinsep Crescent

<b>Category</b>	Encroachment / Drain maintenance
<b>Type</b>	Rear access Vegetation
<b>Description</b>	Rear access follows natural topography with some impedance to flow Semi dense vegetation
<b>Photo ID</b>	890
<b>Scope of Works</b>	M – Remove rear access and reinstate drainage flow path as defined by the natural capacity and invert of downstream lot (136) channel. M - Vegetation is to be slashed to a nominal height of 50 mm above ground with the exception of large, established trees of height in excess of 5 m, which shall remain

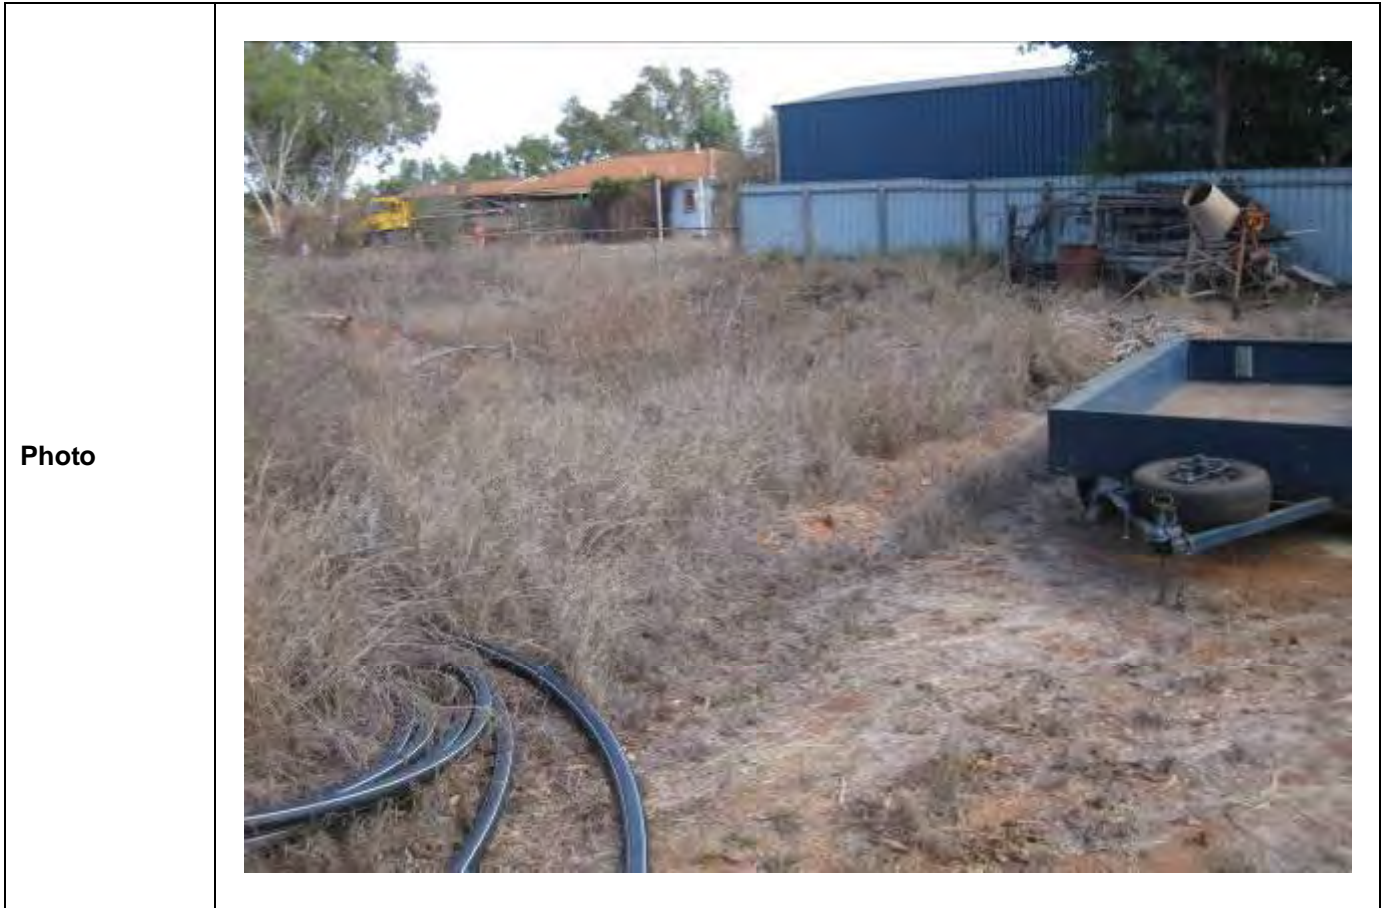
### 4.3 Lot No. 138 Prinsep Crescent

<b>Category</b>	Encroachment
<b>Type</b>	General items Rear access Flow path.
<b>Description</b>	Trailer, rubbish, building materials; Rear access driveway follows modified topography Ill defined due to extensive modifications to drainage resere.
<b>Photo ID</b>	7294
<b>Scope of Works</b>	L – Remove trailer, rubbish and building materials; M - Remove rear access; H – Reinststate drainage flow path as defined by the natural capacity and invert of downstream lot (137) channel

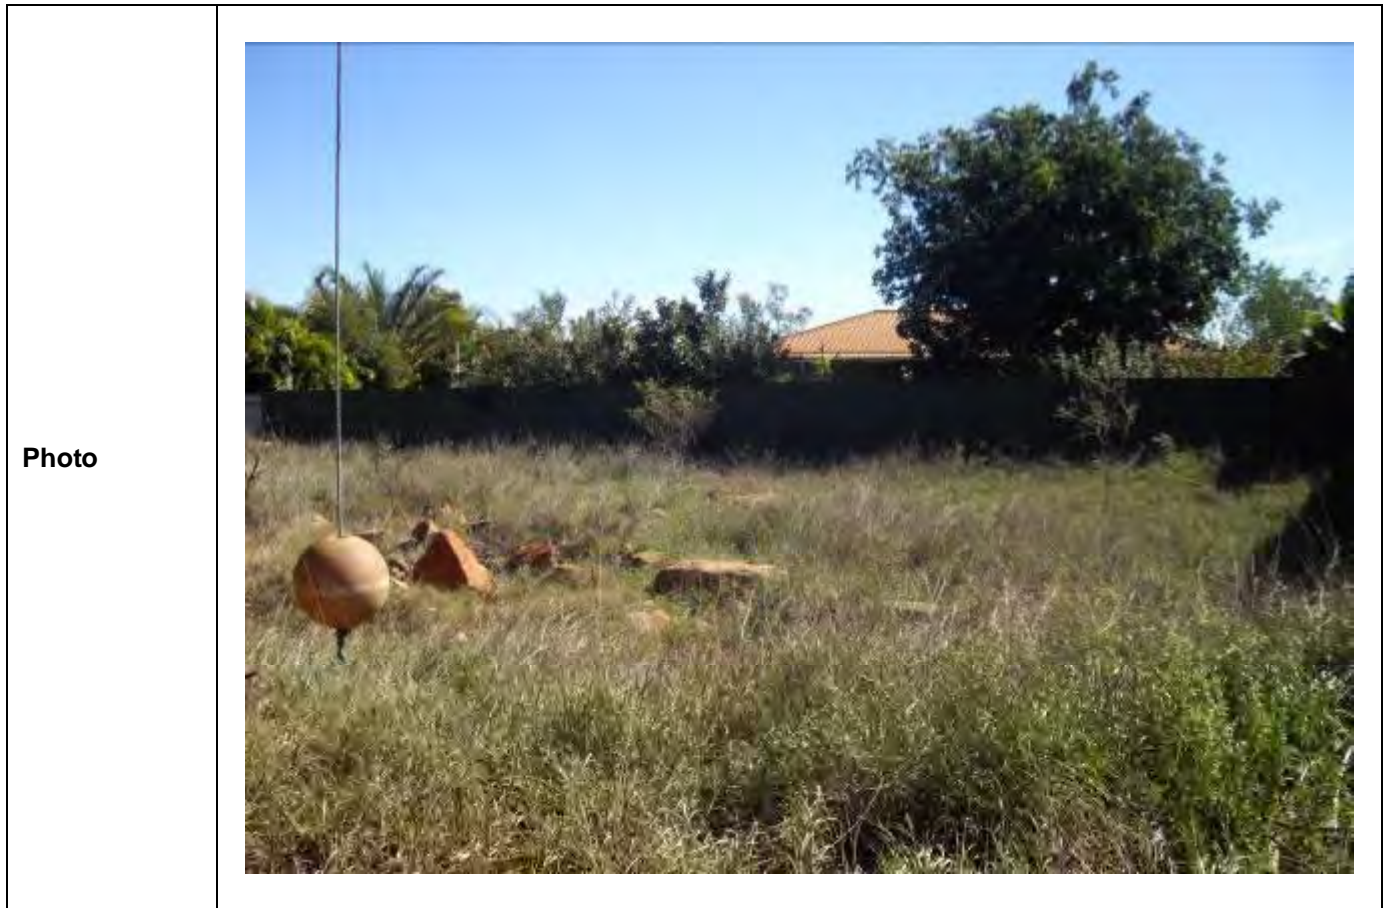
#### 4.4 Lot No. 139 Prinsep Crescent

<b>Category</b>	Drain Maintenance
<b>Type</b>	Vegetation Rocks
<b>Description</b>	Semi dense low lying vegetation; Semi - large rocks do not impede flow
<b>Photo ID</b>	888
<b>Scope of Works</b>	M - Vegetation is to be slashed to a nominal height of 50 mm above ground with the exception of large, established trees of height in excess of 5 m, which shall remain

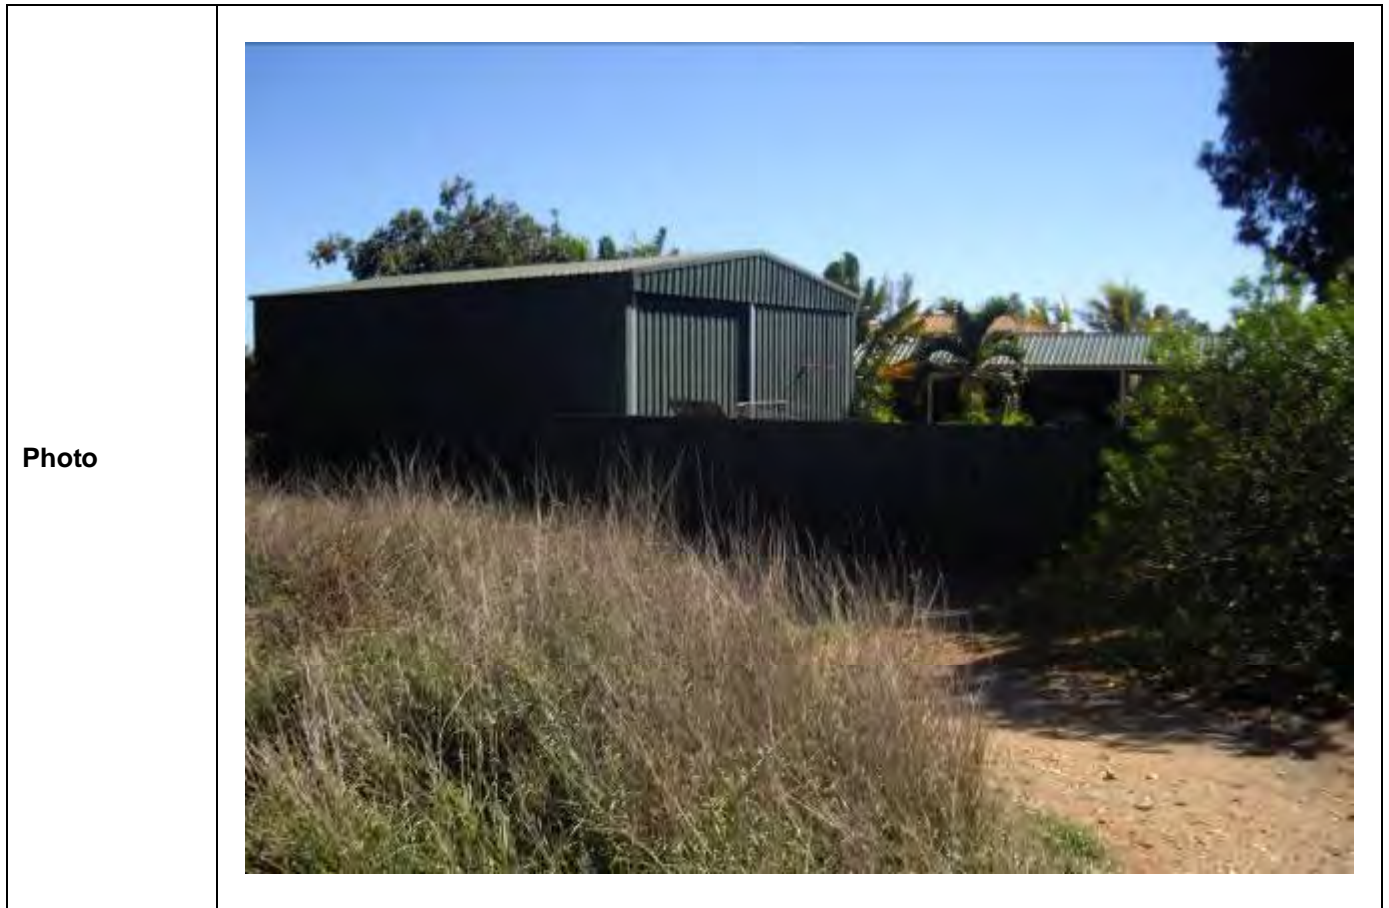
#### 4.5 Lot No. 1,139 Prinsep Crescent

<b>Category</b>	Encroachment
<b>Type</b>	Boundary extension Rear access Modified drainage reserve Vegetation
<b>Description</b>	Shed Rear access follows natural topography Fill material making drainage reserve higher than road reserve Semi dense vegetation
<b>Photo ID</b>	887
<b>Scope of Works</b>	L – Remove shed and relocate to within property boundary L – Remove rear access M - Remove fill material M - Vegetation is to be slashed to a nominal height of 50 mm above ground with the exception of large, established trees of height in excess of 5 m, which shall remain

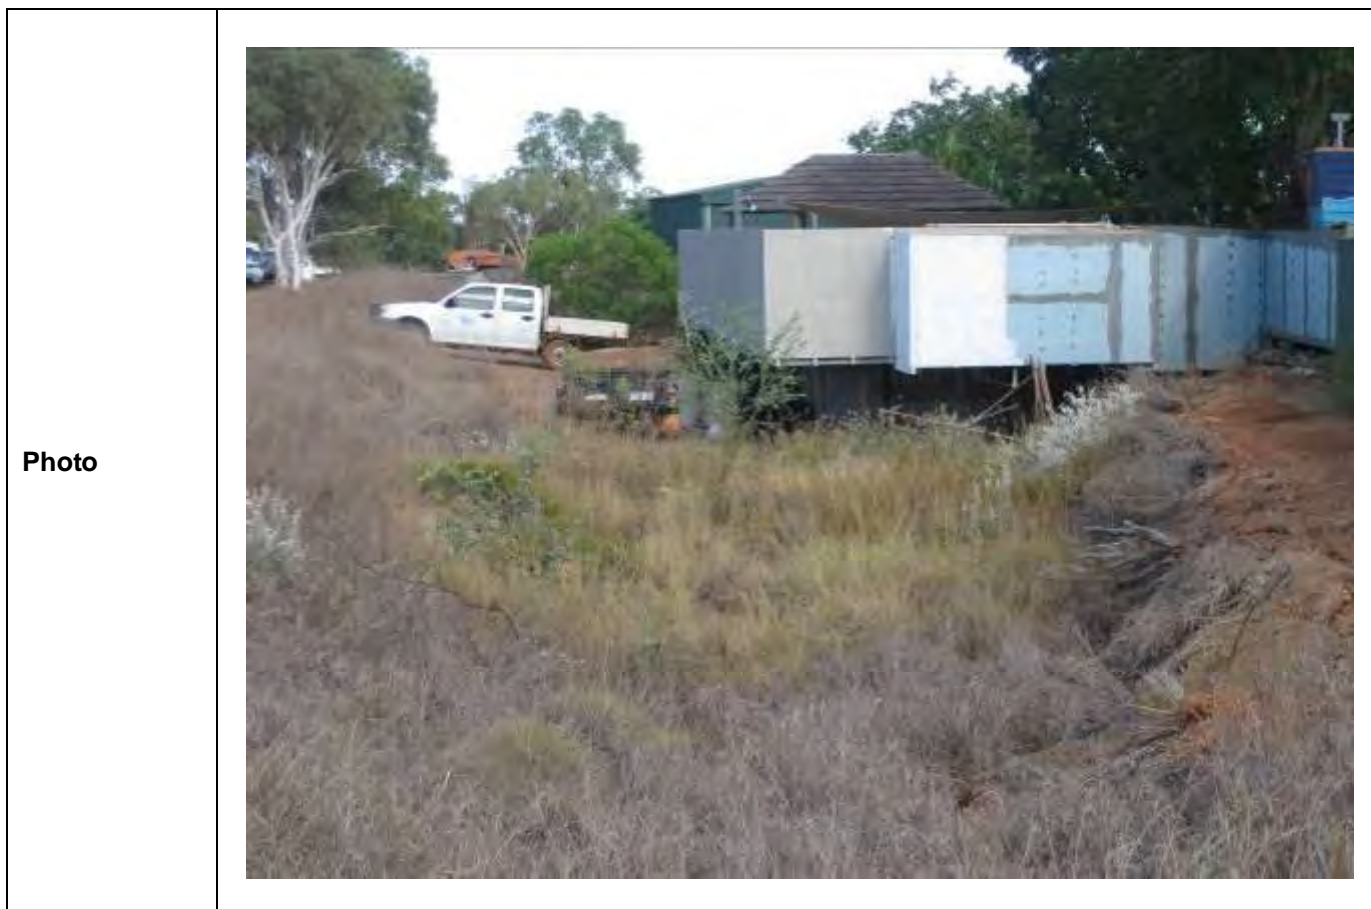
#### 4.6 Lot No. 2,139 Prinsep Crescent

<b>Category</b>	Encroachment
<b>Type</b>	Boundary extension General items Rear access.
<b>Description</b>	Above ground pool within drainage reserve/ drainage reserve is within the property boundary Trailers, vehicles Rear access follows natural topography
<b>Photo ID</b>	7293
<b>Scope of Works</b>	H – Remove above ground pool – confirmation required from survey L – Remove trailers and vehicles M - Vegetation is to be slashed to a nominal height of 50 mm above ground with the exception of large, established trees of height in excess of 5 m, which shall remain.

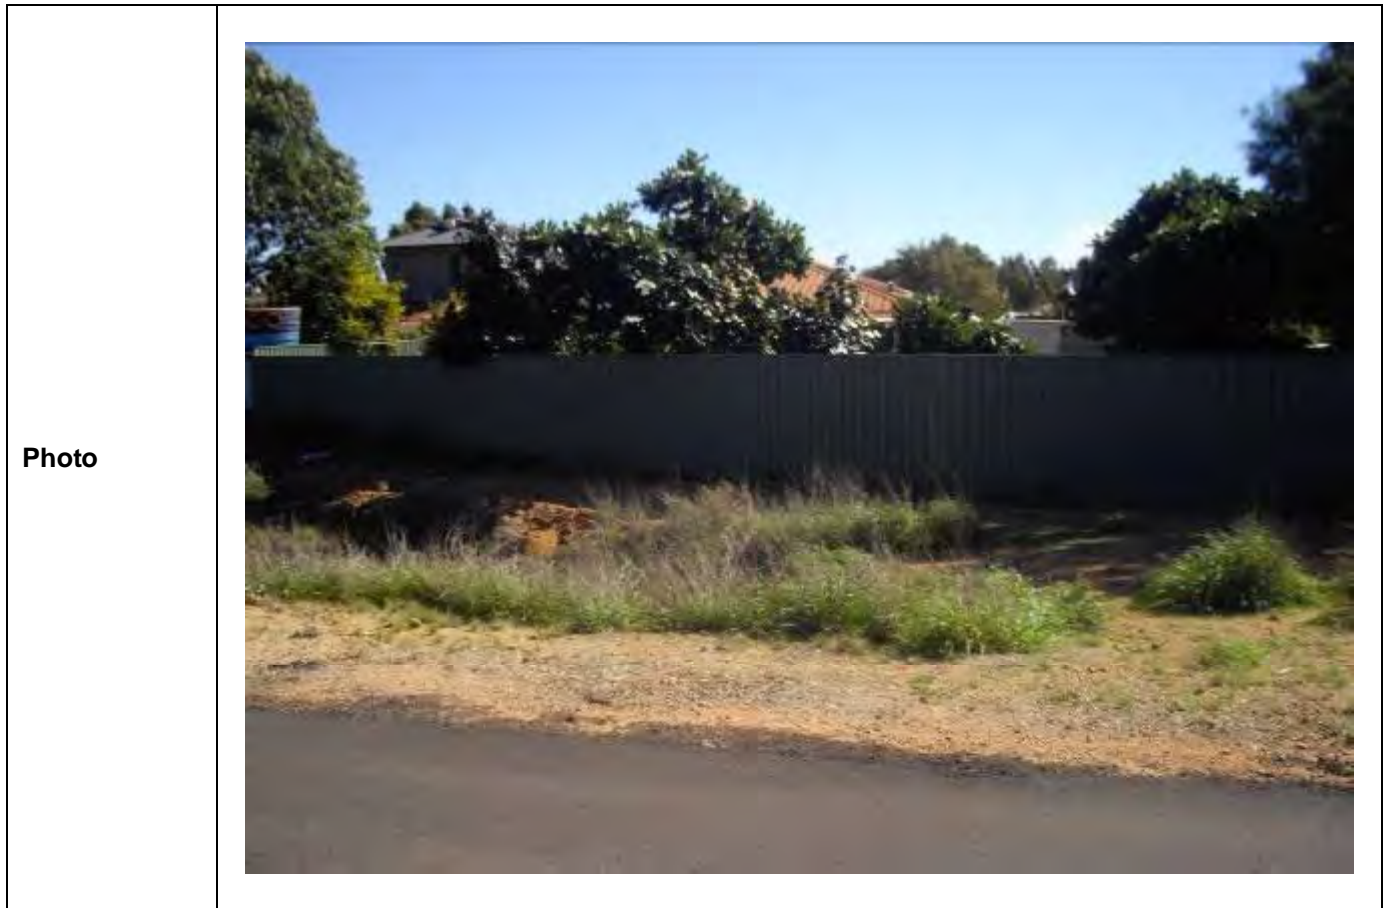
#### 4.7 Lot No. 3,139 Prinsep Crescent

<b>Category</b>	Drain Maintenance
<b>Type</b>	Modified drainage reserve Rear access
<b>Description</b>	Modified drainage reserve has essentially blocked the existing culvert; Rear access impedes flow
<b>Photo ID</b>	886
<b>Scope of Works</b>	H - Remove modifications and reinstate drainage flow path as defined by the natural capacity and invert of downstream lot (2,139) channel H – Remove rear access

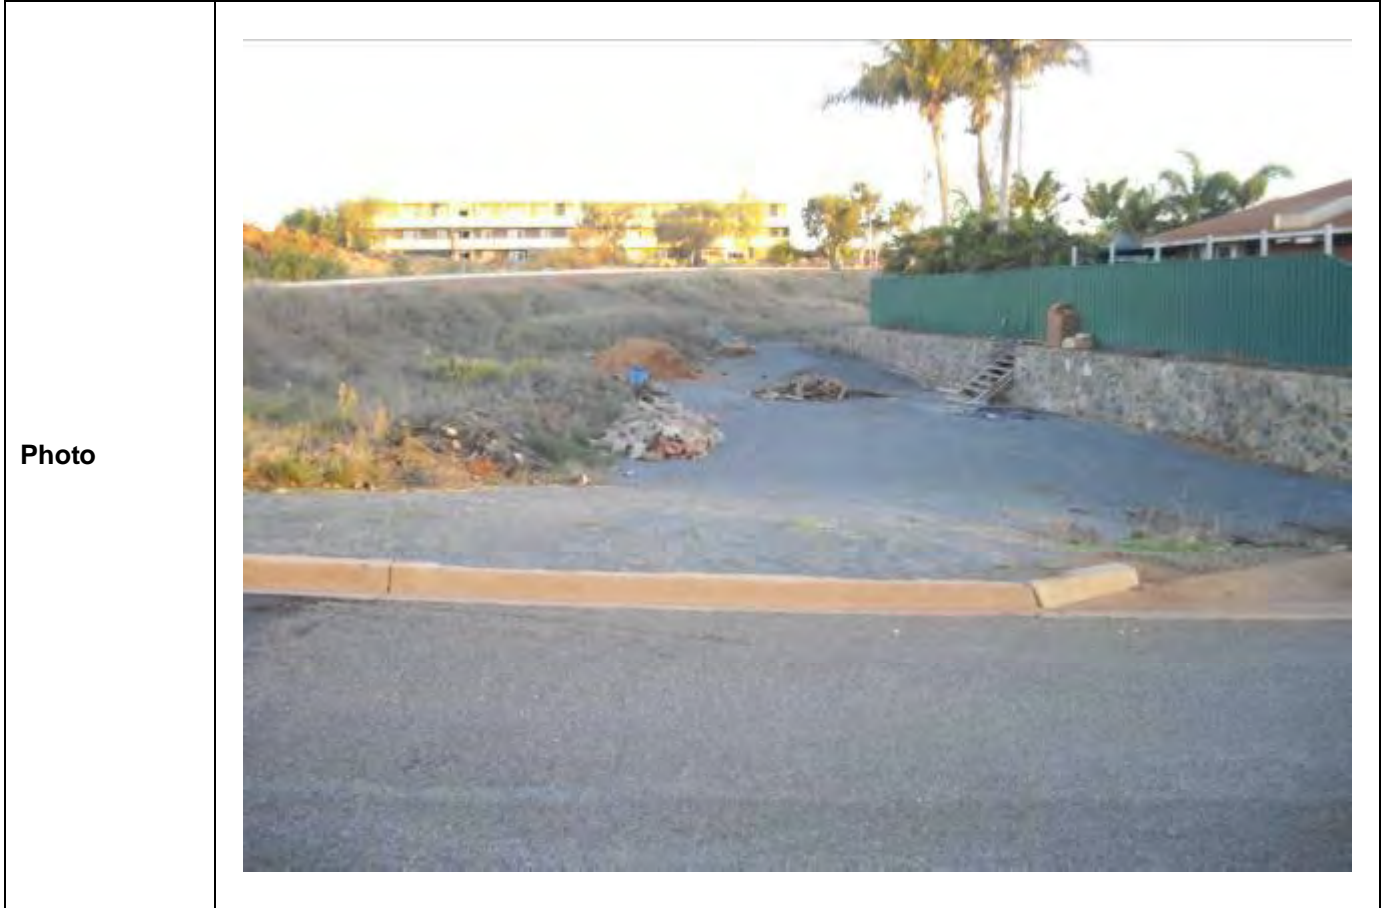
**5.1 Lot No. 140 Drummond Crescent**

<b>Category</b>	Encroachment
<b>Type</b>	Modified drain reserve
<b>Description</b>	Mound of dirt, organic matter and created parking area. Potential contributions to blocking the culvert under Drummond Crescent.
<b>Photo ID</b>	685
<b>Scope of Works</b>	M – Remove mound of dirt, organic matter and created parking area.

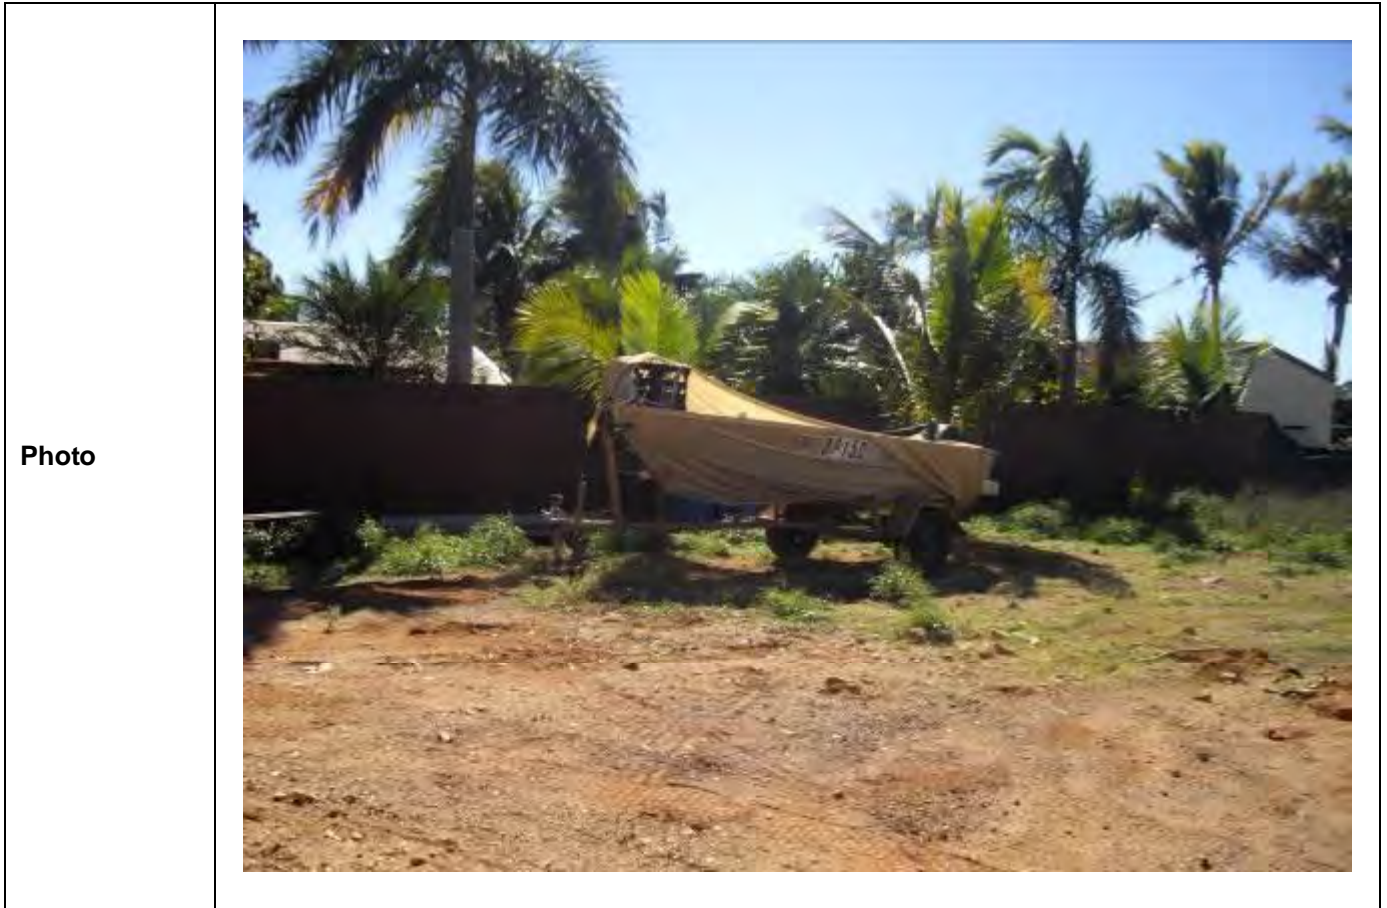
## 5.2 Lot No. 141 Drummond Crescent

<b>Category</b>	Encroachment
<b>Type</b>	Boundary extension; General item; Rear access.
<b>Description</b>	Fence; Boat; Rear access follows natural topography. Overland flow is towards lots but is not a collected concentrated flow.
<b>Photo ID</b>	896
<b>Scope of Works</b>	L - Remove fence to within property boundary – confirmation required from survey; L – Remove boat; L – Remove rear access and reinstate drainage flow path as defined by the natural capacity and invert of downstream lot (140) channel
