City of Karratha  
Dampier Stormwater Management Study  
Report  
Part B  
June 2015

## Appendix **C** – 2010 encroachment reviews

**Rio Tinto Iron Ore**  
Report on Dampier Drainage  
Review  
Block 1 Encroachments  
June 2010

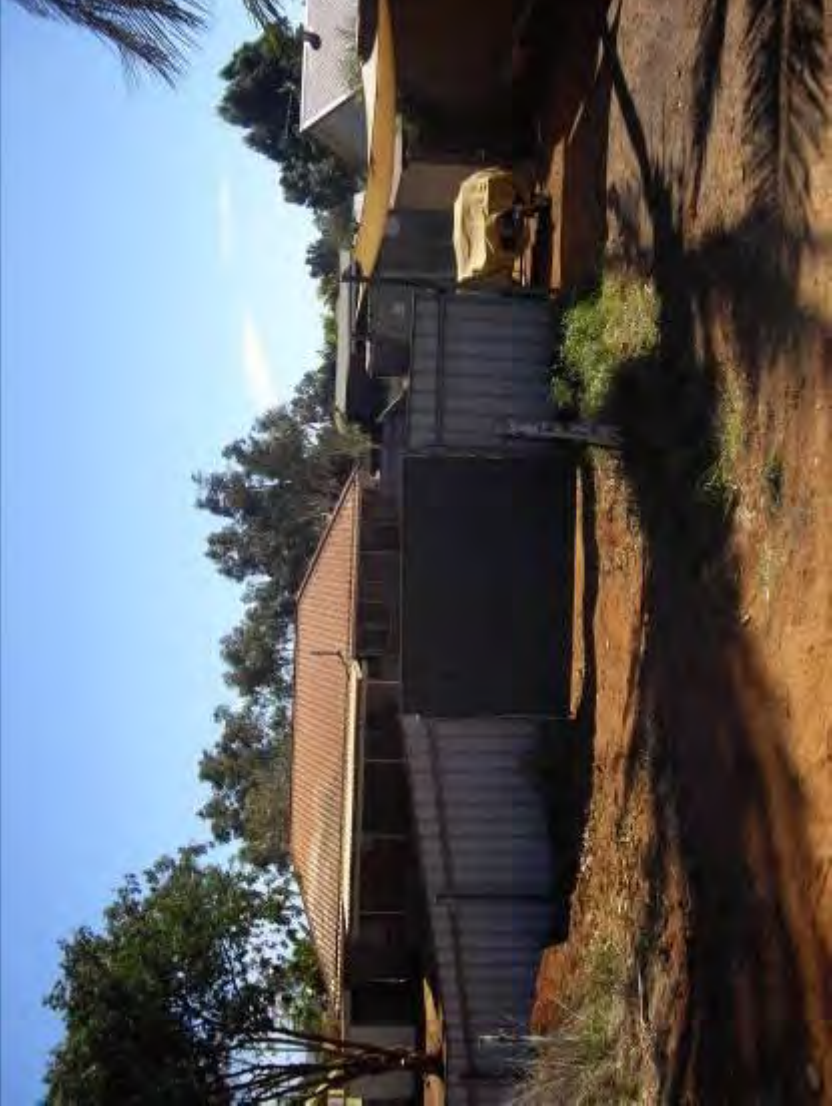
**5.3 Lot No. 142 Drummond Crescent**

<p><b>Category</b></p>	<p>Encroachment</p>
<p><b>Type</b></p>	<p>Rear access</p>
<p><b>Description</b></p>	<p>Rear access follows natural topography. Overland flow is towards lots but is not a collected concentrated flow.</p>
<p><b>Photo ID</b></p>	<p>897</p>
<p><b>Scope of Works</b></p>	<p>L – Remove rear access and reinstate drainage flow path as defined by the natural capacity and invert of downstream lot (141) channel</p>

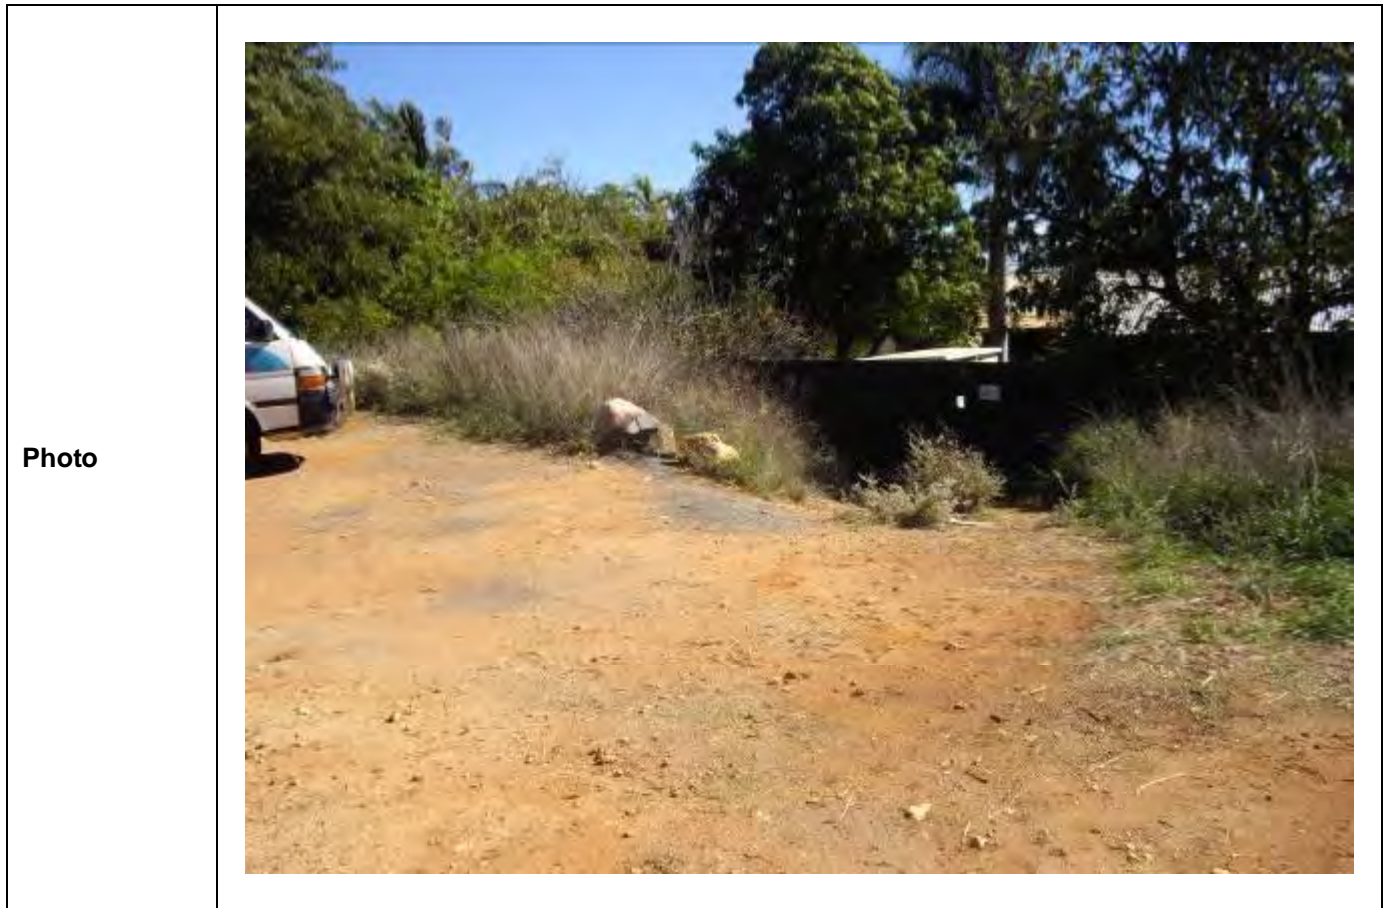
#### 5.4 Lot No. 143 Drummond Crescent

<b>Category</b>	Encroachment
<b>Type</b>	Rear access
<b>Description</b>	Rear access follows natural topography. Overland flow is towards lots but is not a collected concentrated flow.
<b>Photo ID</b>	898
<b>Scope of Works</b>	L – Remove rear access and reinstate drainage flow path as defined by the natural capacity and invert of downstream lot (142) channel

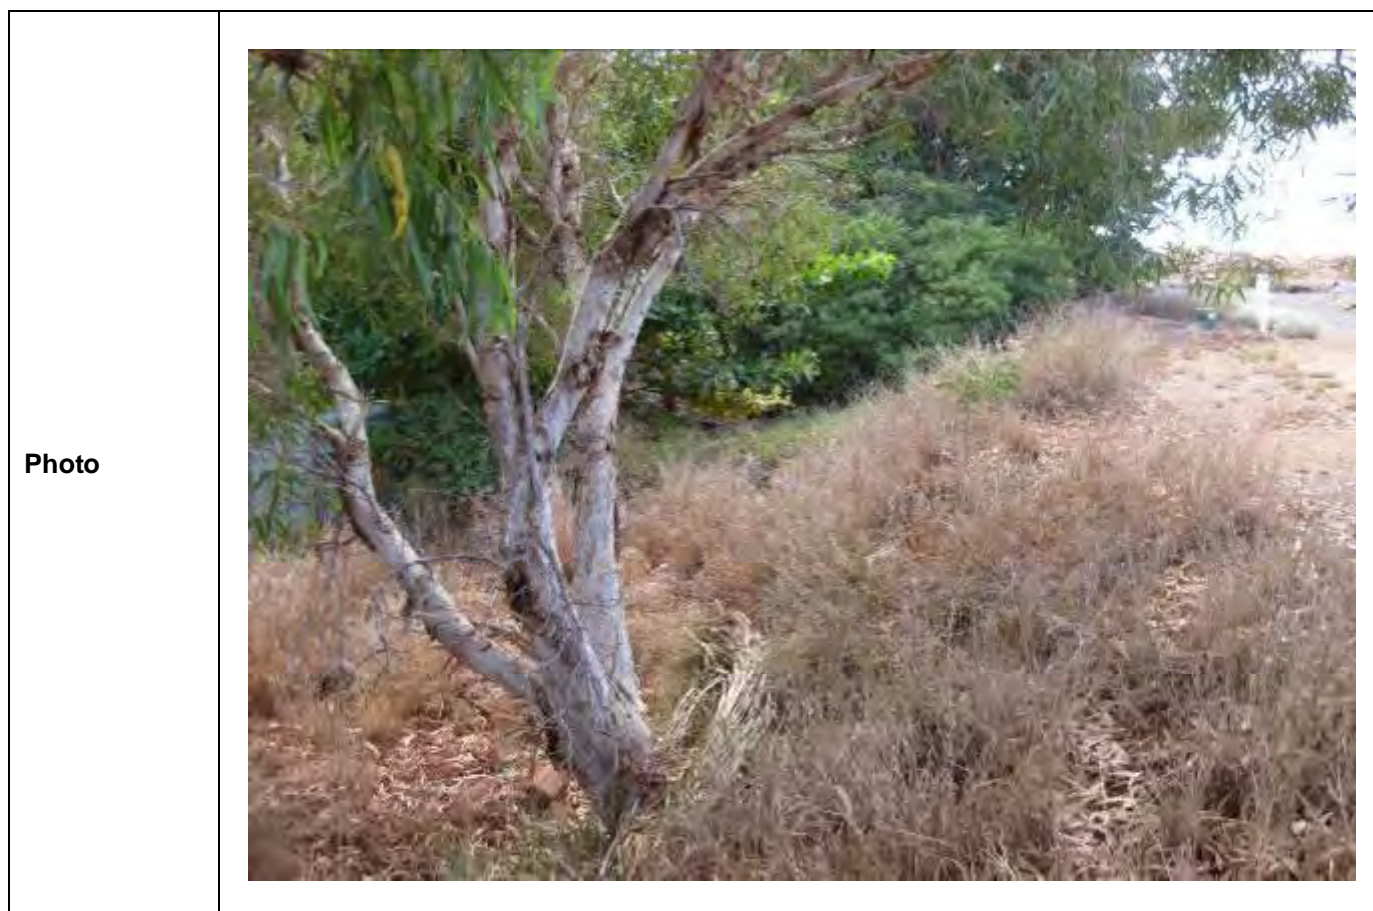
## 5.5 Lot No. 144 Drummond Crescent

<b>Category</b>	Encroachment / Drain maintenance
<b>Type</b>	Boundary extension Vegetation
<b>Description</b>	Fence within drainage boundary Semi-dense vegetation
<b>Photo ID</b>	7300
<b>Scope of Works</b>	M – Remove fence and relocate to within property boundary M - Vegetation is to be slashed to a nominal height of 50 mm above ground with the exception of large, established trees of height in excess of 5 m, which shall remain

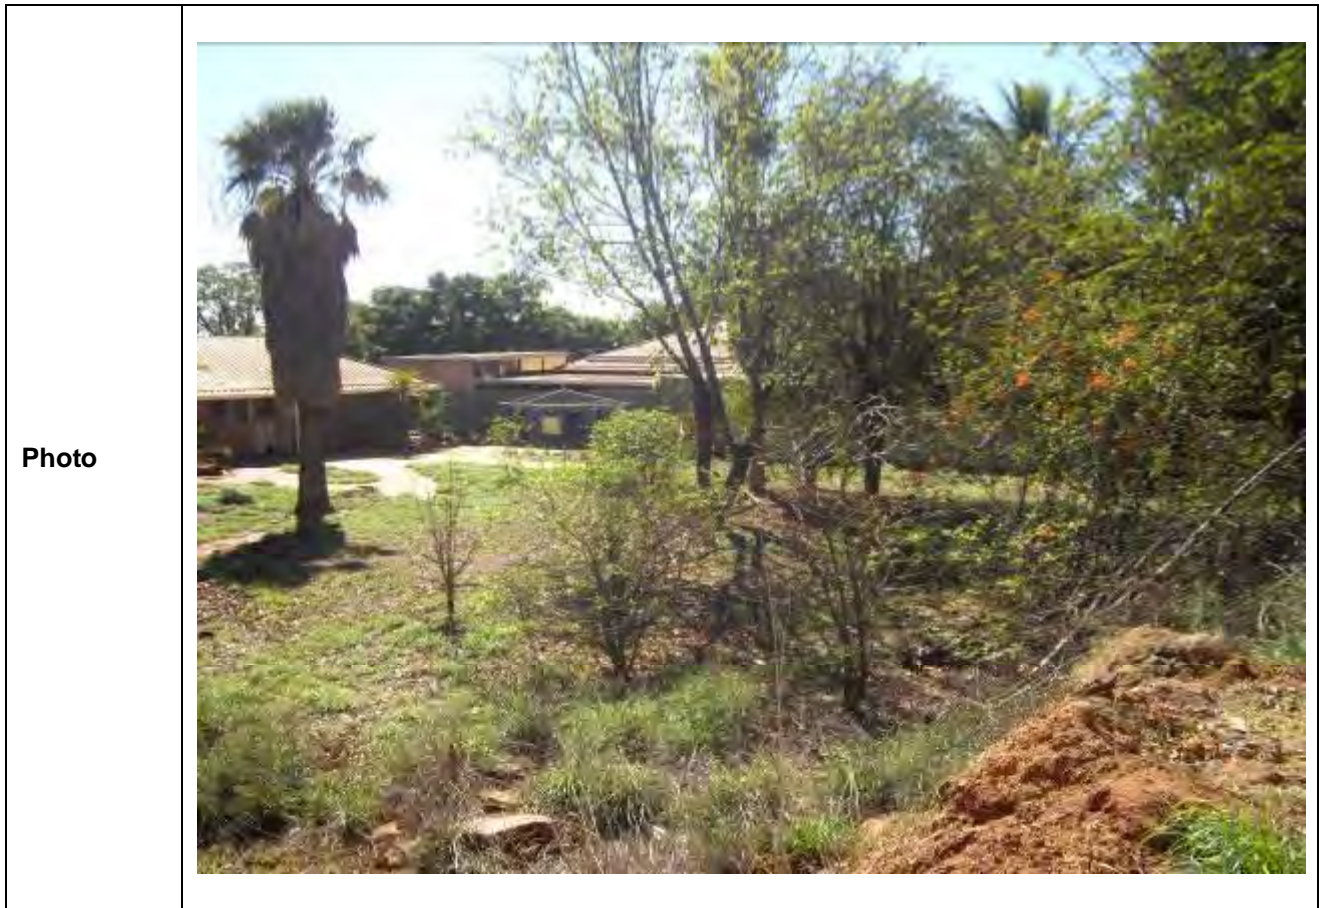
## 5.6 Lot No. 145 Drummond Crescent

<b>Category</b>	Drain Maintenance
<b>Type</b>	Flow path Vegetation
<b>Description</b>	Flow path channel ok Semi dense vegetation
<b>Photo ID</b>	899
<b>Scope of Works</b>	L - Vegetation is to be slashed to a nominal height of 50 mm above ground with the exception of large, established trees of height in excess of 5 m, which shall remain

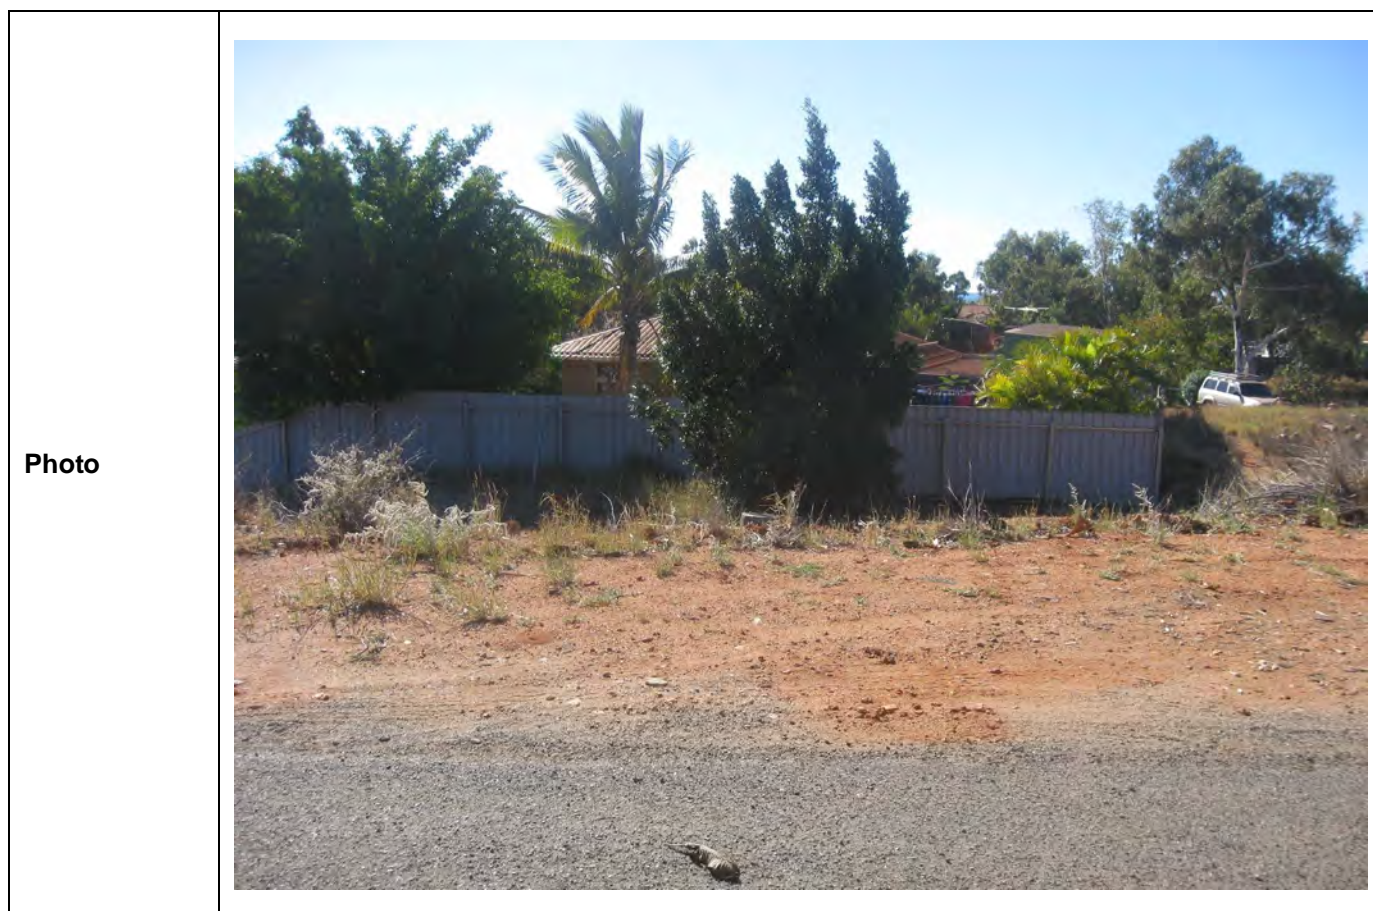
## 5.7 Lot No. 1,145 Boolgeeda Court

<b>Category</b>	Drain Maintenance
<b>Type</b>	Flow path
<b>Description</b>	Overland flow is towards lots but is not a collected concentrated flow.
<b>Photo ID</b>	6
<b>Scope of Works</b>	L - reinstate drainage flow path as defined by the natural capacity and invert of downstream lot (drainage reserve between lots 1,145 and 145) channel

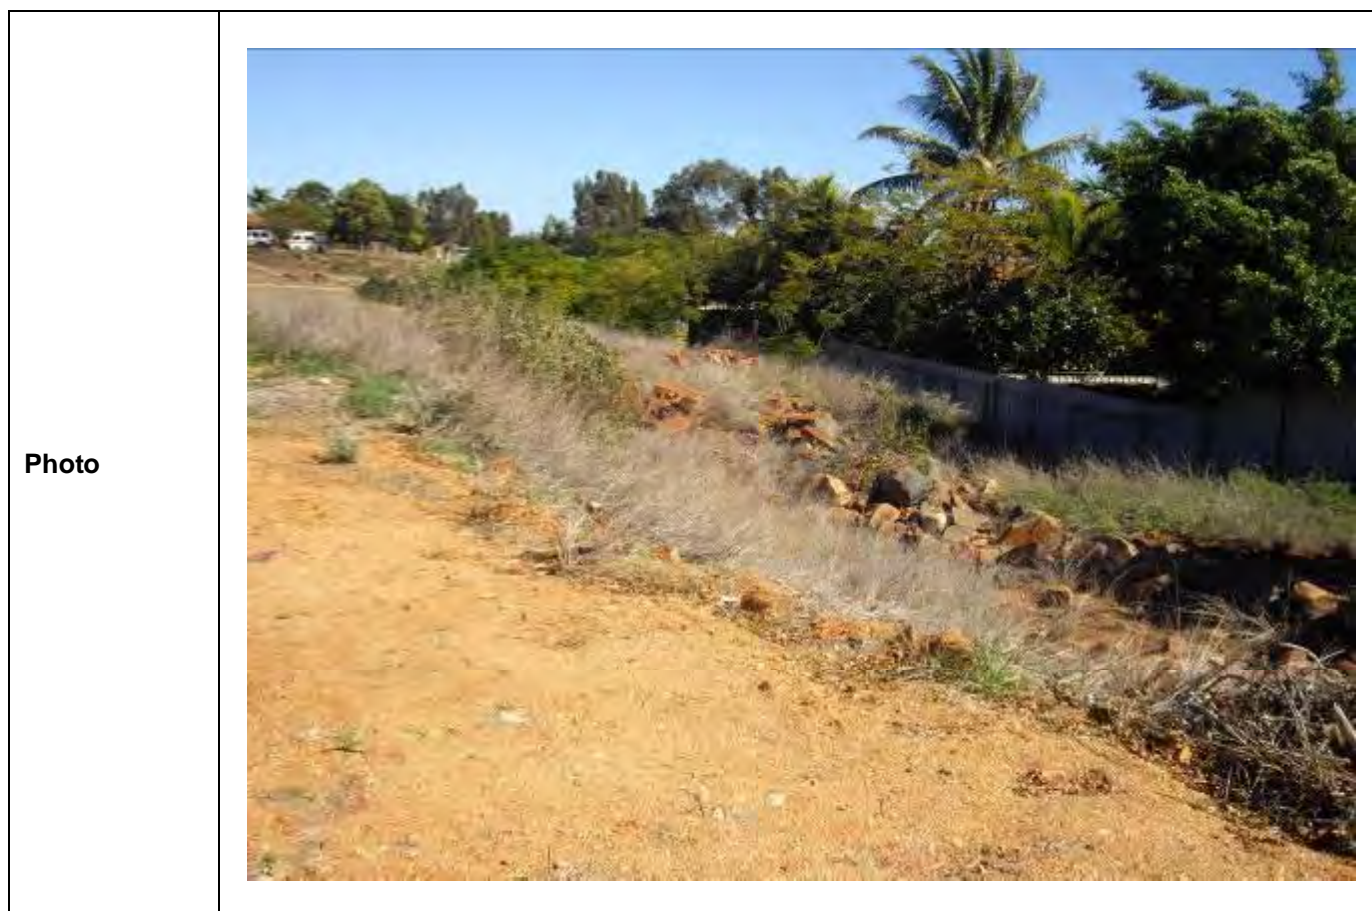
## 5.8 Lot No. 2,145 Boolgeeda Court

<b>Category</b>	Drain maintenance
<b>Type</b>	Flow path
<b>Description</b>	Overland flow is towards lots but is not a collected concentrated flow. Fill
<b>Photo ID</b>	7
<b>Scope of Works</b>	L - reinstate drainage flow path as defined by the natural capacity and invert of downstream lot (lot 1,145) channel M – remove fill

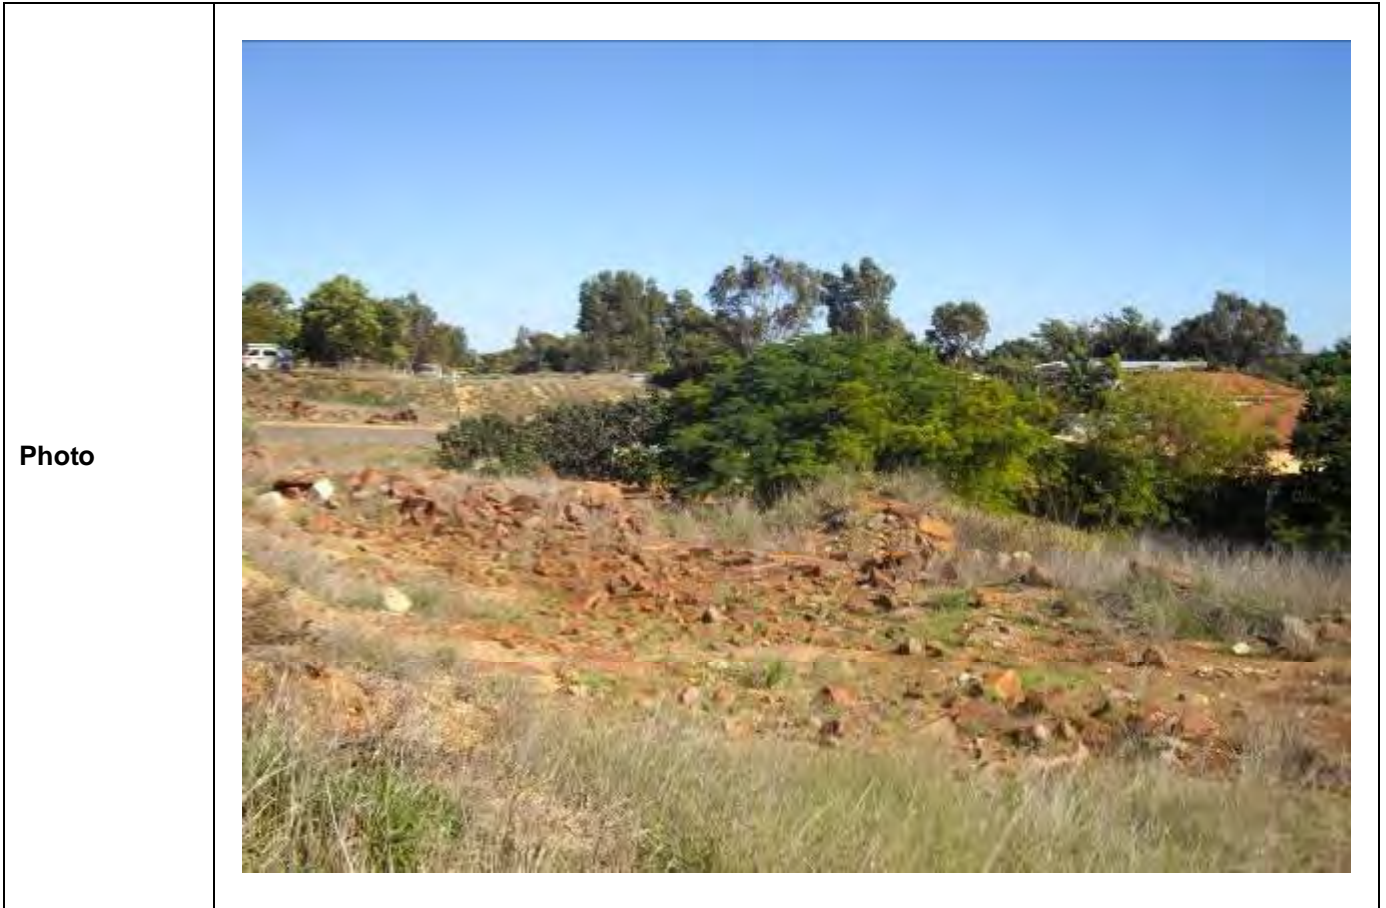
**5.9 Lot No. 3,145 Boolgeeda Court**

<b>Category</b>	Drain Maintenance
<b>Type</b>	Flow path
<b>Description</b>	Overland flow is towards lots but is not a collected concentrated flow. Fill
<b>Photo ID</b>	8
<b>Scope of Works</b>	L - reinstate drainage flow path as defined by the natural capacity and invert of downstream lot (East Ave drainage reserve) channel M – remove fill

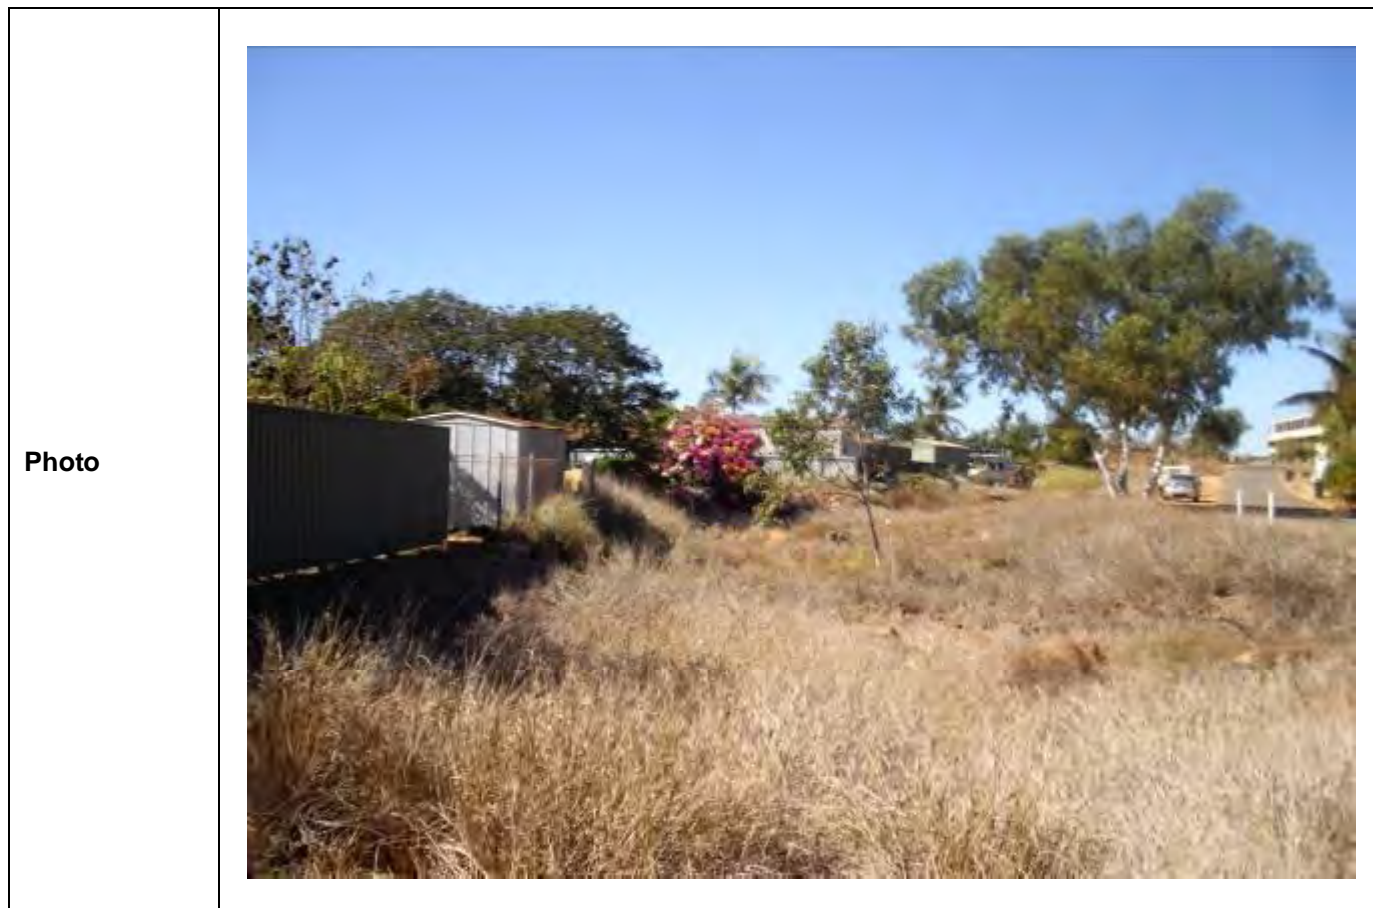
## 6.1 Lot No. 146 Hannan Crescent

<b>Category</b>	Encroachment / Drain maintenance
<b>Type</b>	Rear access
<b>Description</b>	Rear access impeding flow Semi-dense vegetation
<b>Photo ID</b>	414
<b>Scope of Works</b>	H – Remove rear access and reinstate to natural channel M – Vegetation is to be slashed to a nominal height of 50 mm above ground with the exception of large, established trees of height in excess of 5 m, which shall remain

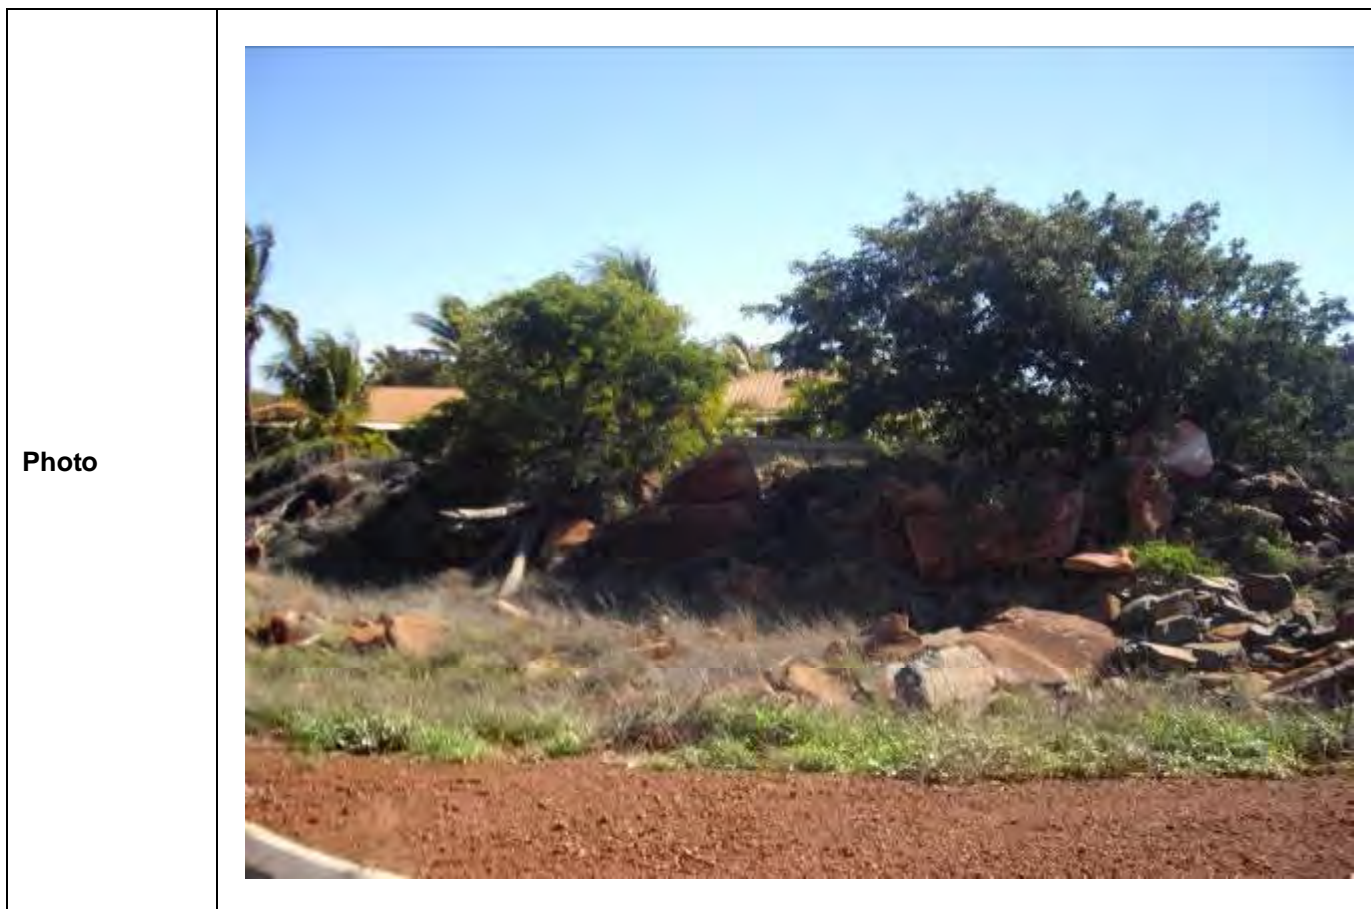
## 6.2 Lot No. 147 Hannan Crescent

<b>Category</b>	Drain Maintenance
<b>Type</b>	Vegetation Rocks
<b>Description</b>	Semi-dense low lying vegetation Rocks do not impede flow
<b>Photo ID</b>	892
<b>Scope of Works</b>	M - Vegetation is to be slashed to a nominal height of 50 mm above ground with the exception of large, established trees of height in excess of 5 m, which shall remain

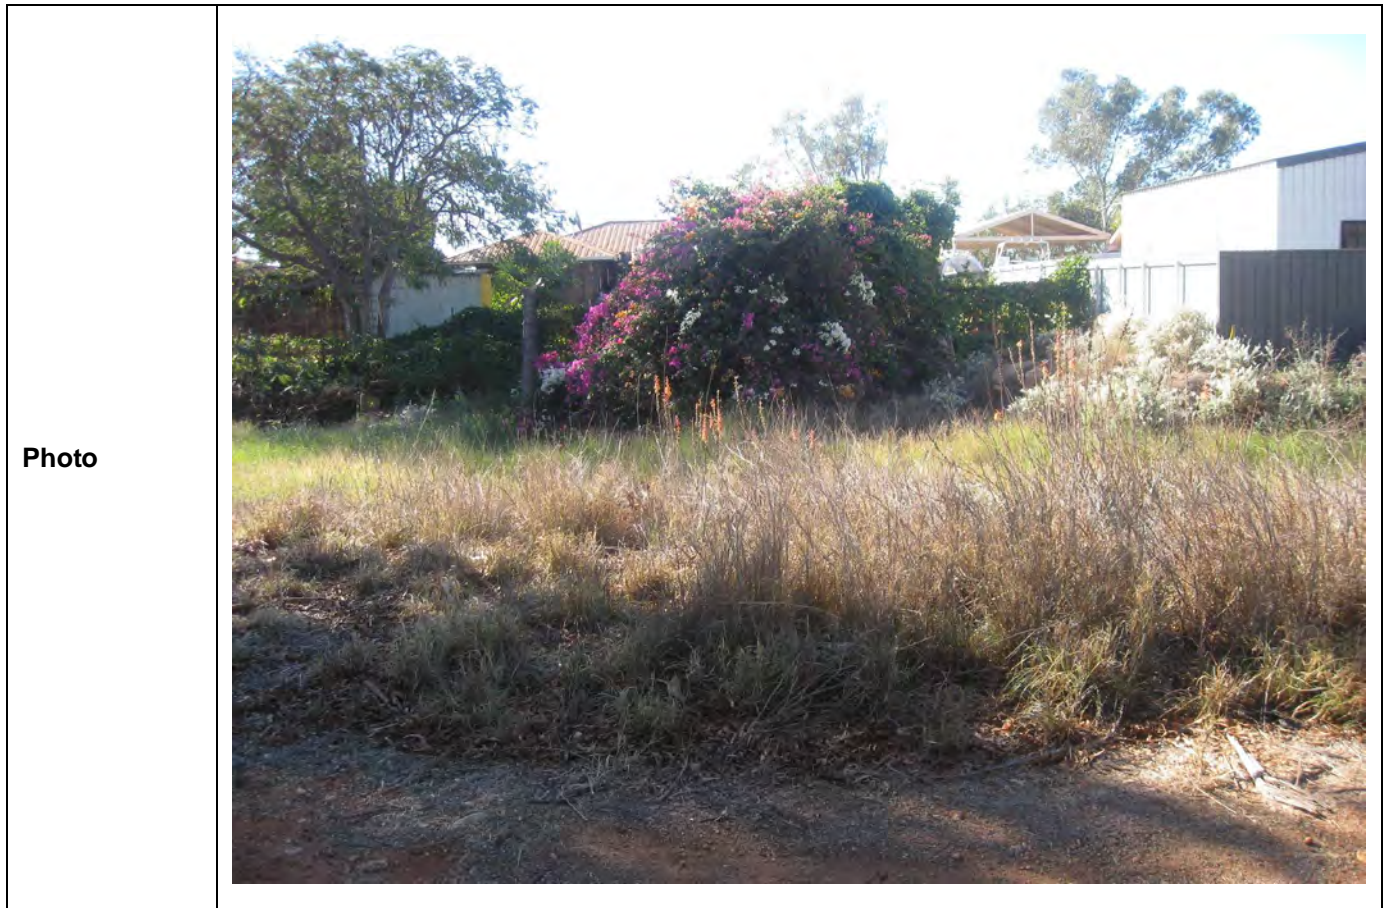
### 6.3 Lot No. 148 Hannan Crescent

<b>Category</b>	Drain Maintenance
<b>Type</b>	Vegetation
<b>Description</b>	Semi dense vegetation
<b>Photo ID</b>	893
<b>Scope of Works</b>	M - Vegetation is to be slashed to a nominal height of 50 mm above ground with the exception of large, established trees of height in excess of 5 m, which shall remain

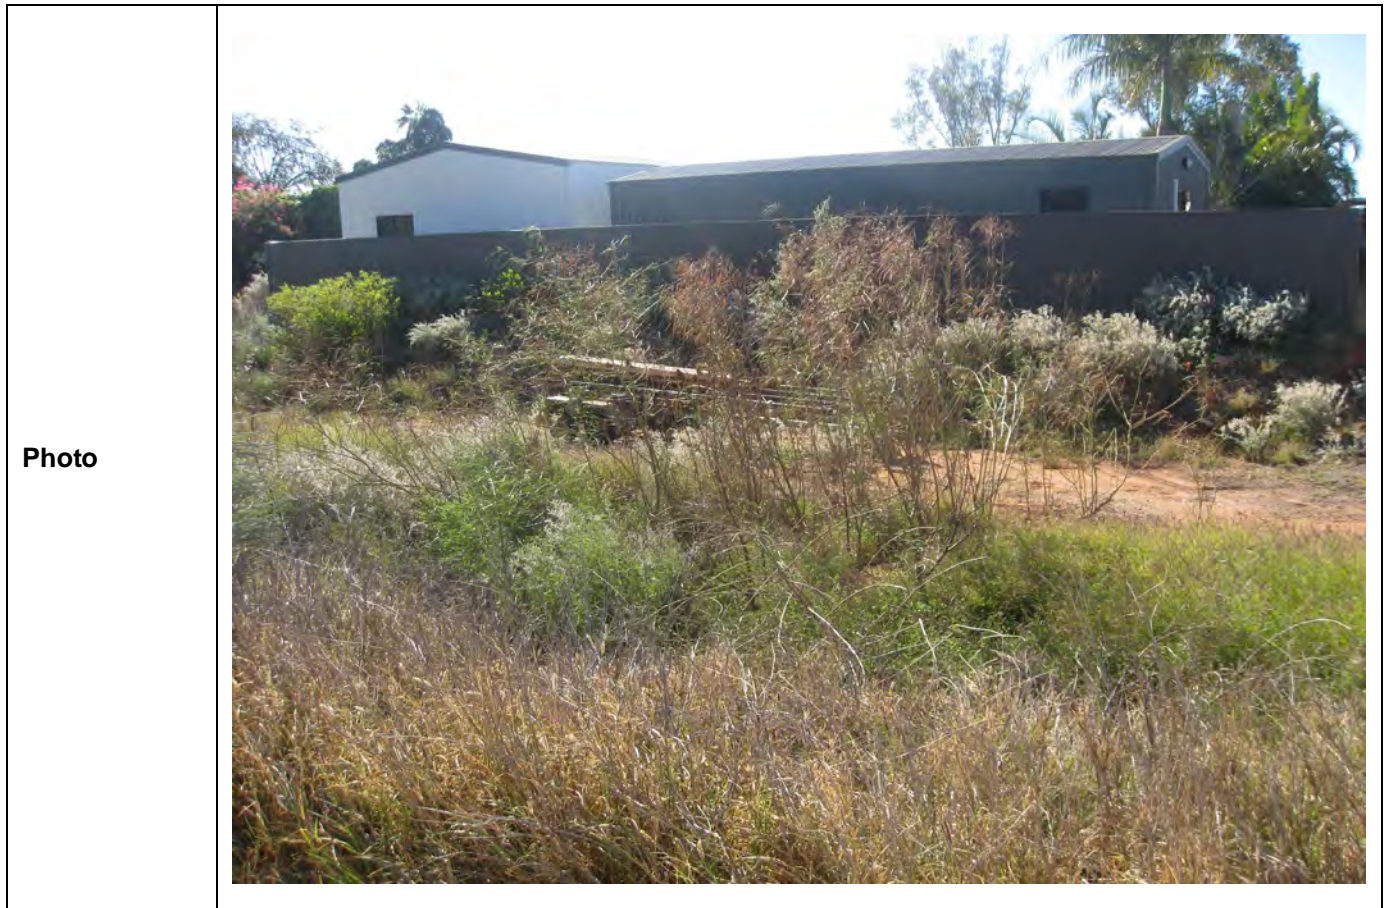
## 6.4 Lot No. 149 Hannan Crescent

<b>Category</b>	Encroachment
<b>Type</b>	General item
<b>Description</b>	Trailer
<b>Photo ID</b>	10
<b>Scope of Works</b>	L - Remove trailer

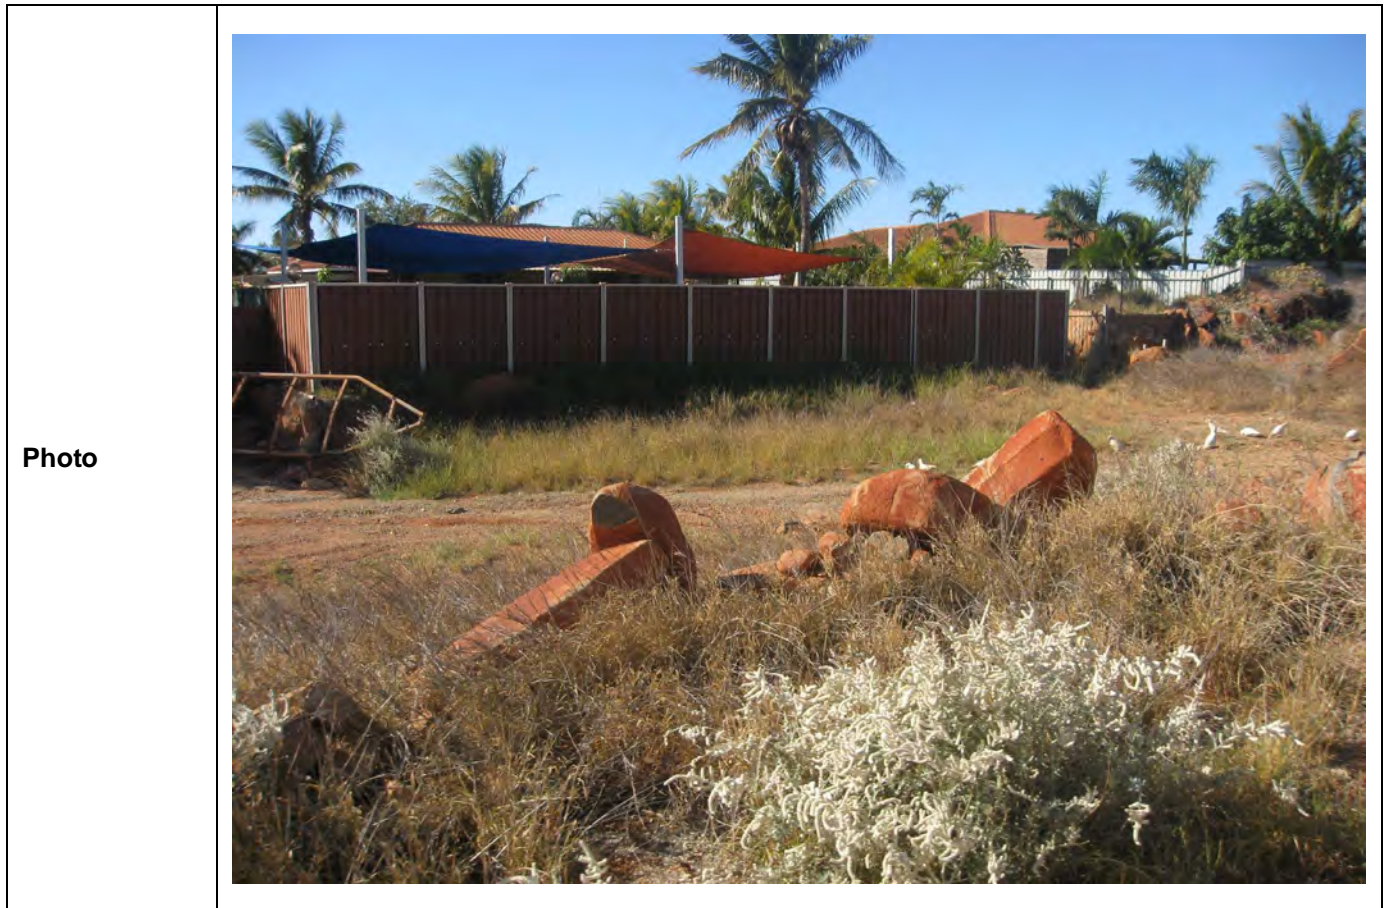
## 6.6 Lot No. 151 Hannan Crescent

<b>Category</b>	Drain maintenance
<b>Type</b>	Rocks
<b>Description</b>	Rocks do not impede flow
<b>Photo ID</b>	12
<b>Scope of Works</b>	None

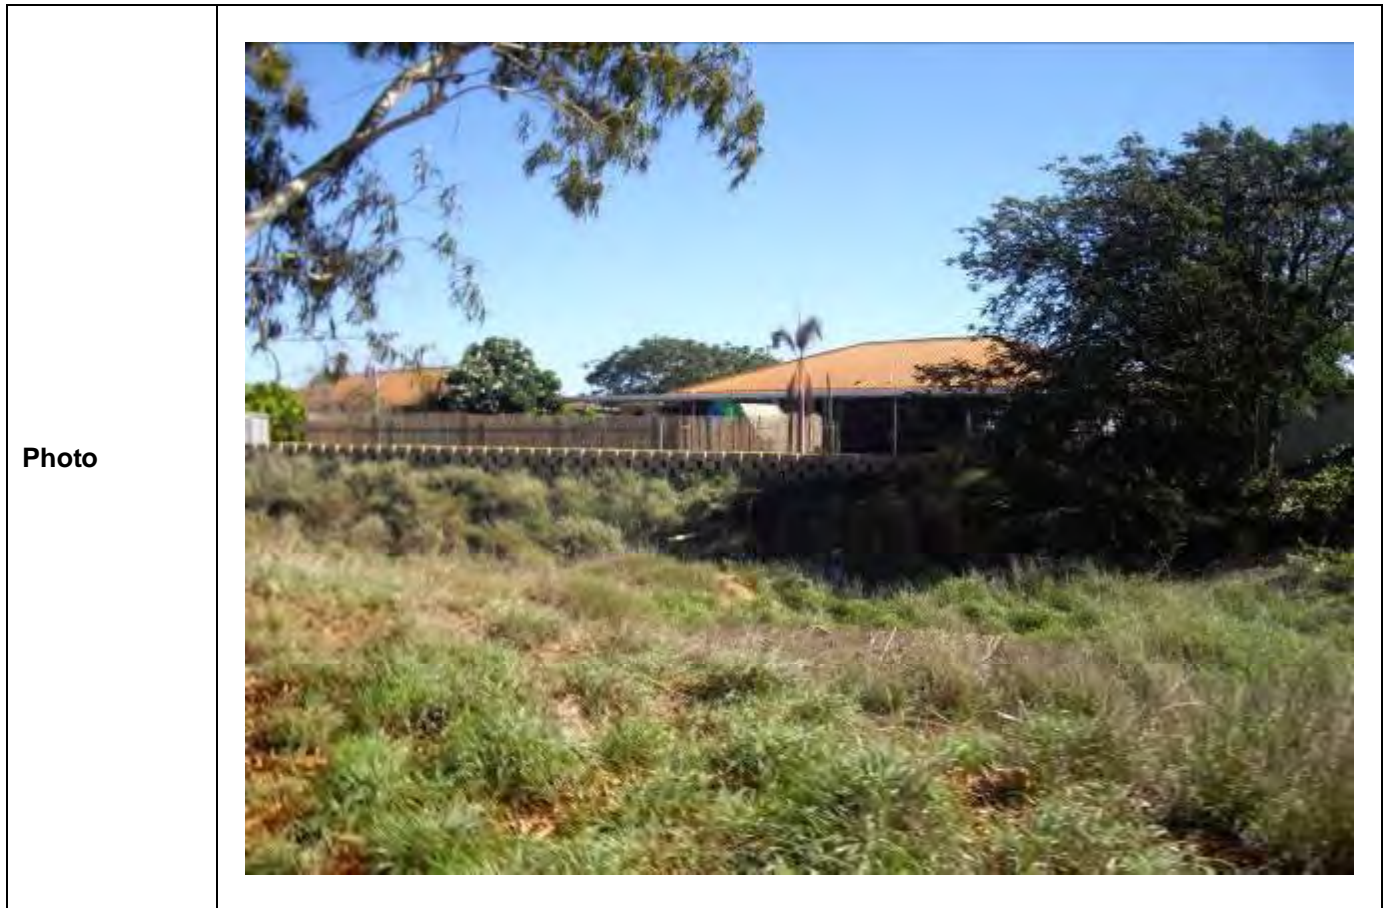
## 6.7 Lot No. 1,151 Hannan Crescent

<b>Category</b>	Drain Maintenance
<b>Type</b>	Vegetation
<b>Description</b>	Vegetation impeding flow
<b>Photo ID</b>	895
<b>Scope of Works</b>	M - Vegetation is to be slashed to a nominal height of 50 mm above ground with the exception of large, established trees of height in excess of 5 m, which shall remain

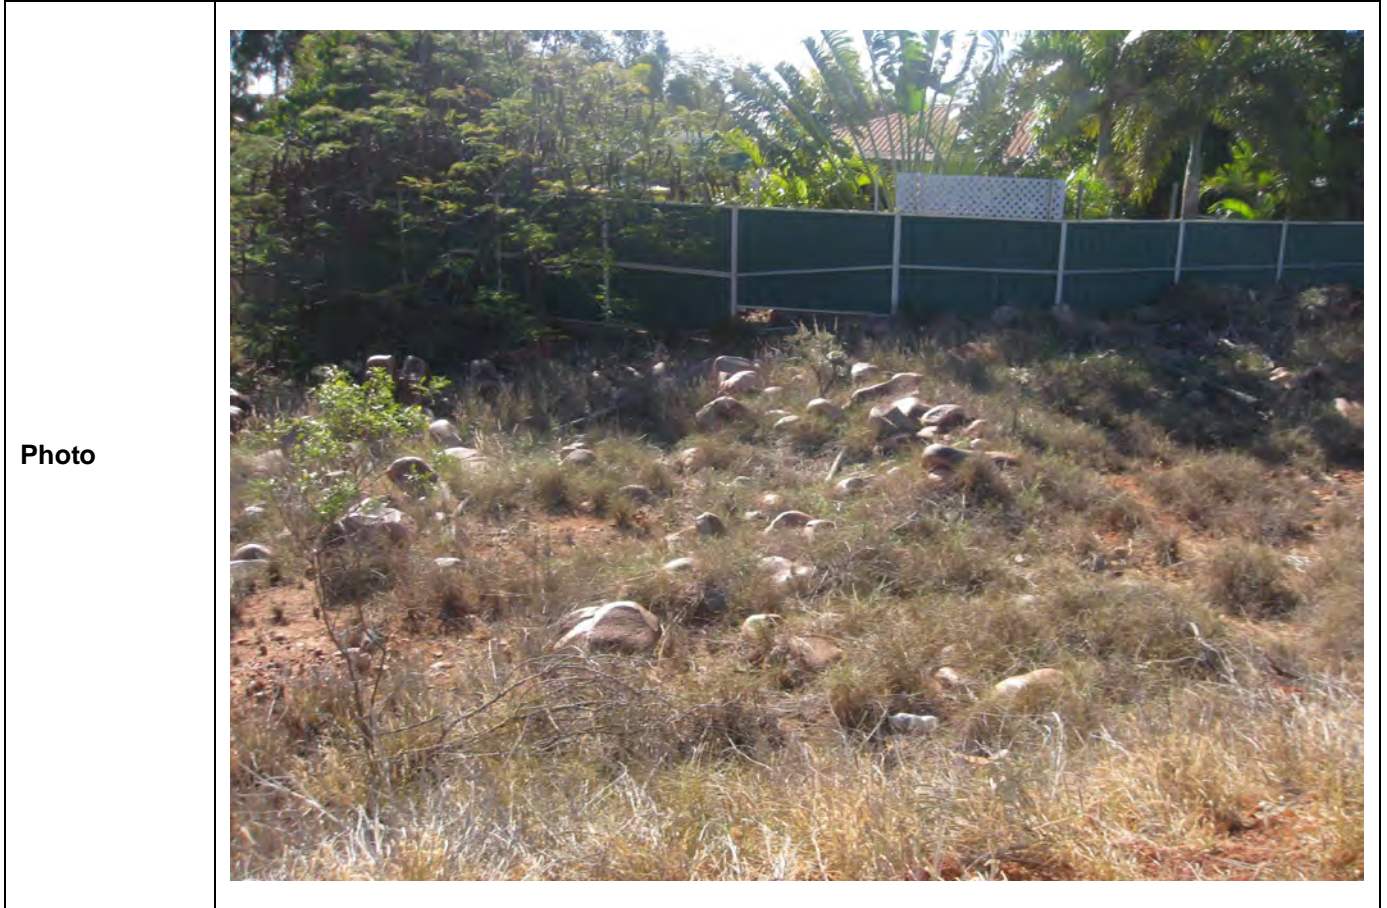
**7.1 Lot No. 1,152 Giles Crescent**

<b>Category</b>	Encroachment
<b>Type</b>	Boundary extension
<b>Description</b>	Fence
<b>Photo ID</b>	14
<b>Scope of Works</b>	L – Remove fence and relocate to within the property boundary.

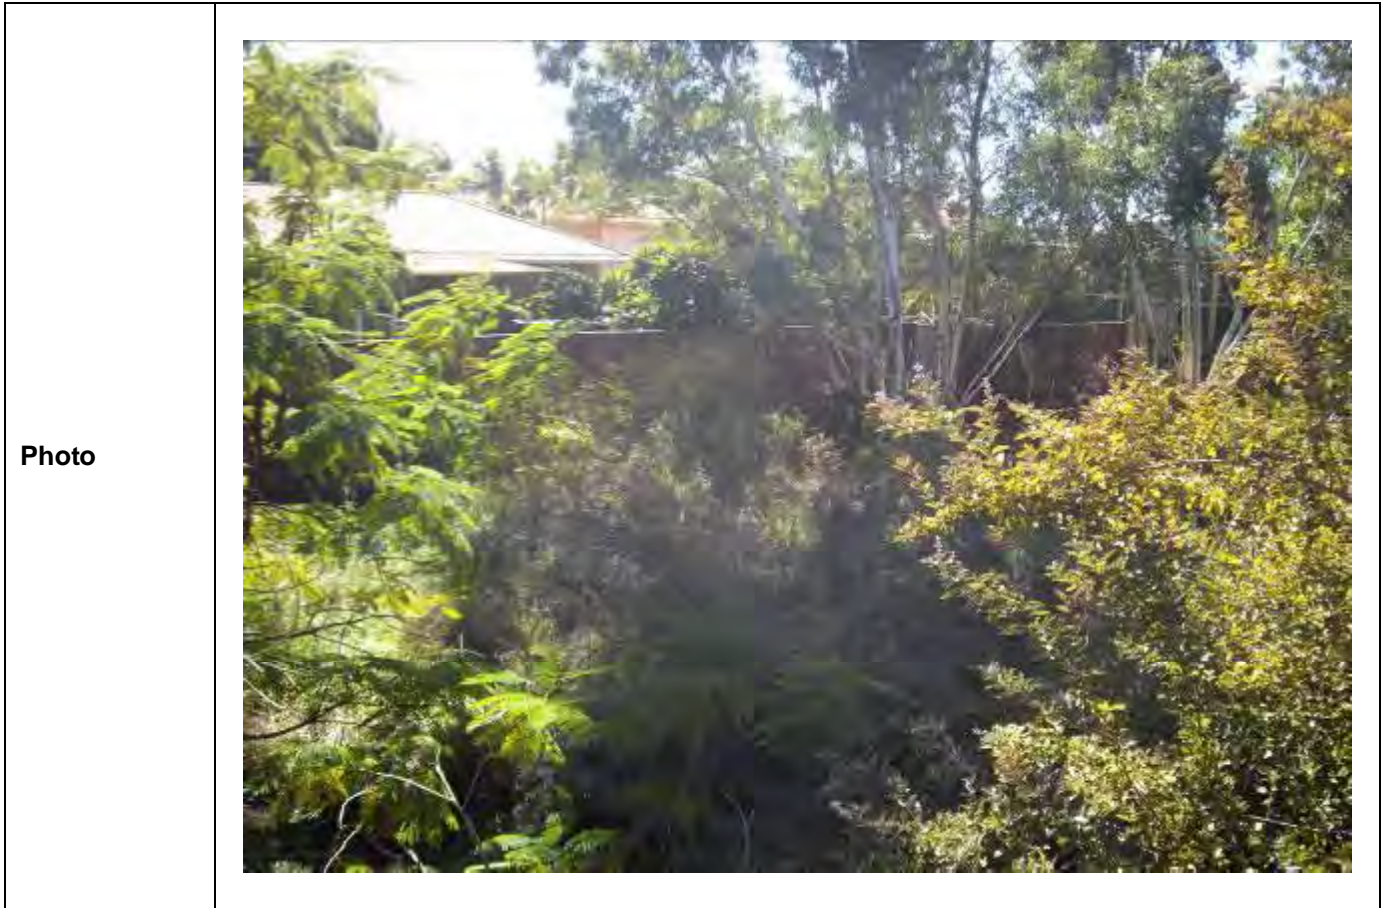
## 7.2 Lot No. 152 Giles Crescent

<b>Category</b>	Drain Maintenance
<b>Type</b>	Flow path Vegetation
<b>Description</b>	Drainage path is not defined Semi-dense low lying vegetation
<b>Photo ID</b>	883
<b>Scope of Works</b>	M - reinstate drainage flow path as defined by the natural capacity and invert of downstream lot (153) channel M - Vegetation is to be slashed to a nominal height of 50 mm above ground with the exception of large, established trees of height in excess of 5 m, which shall remain.

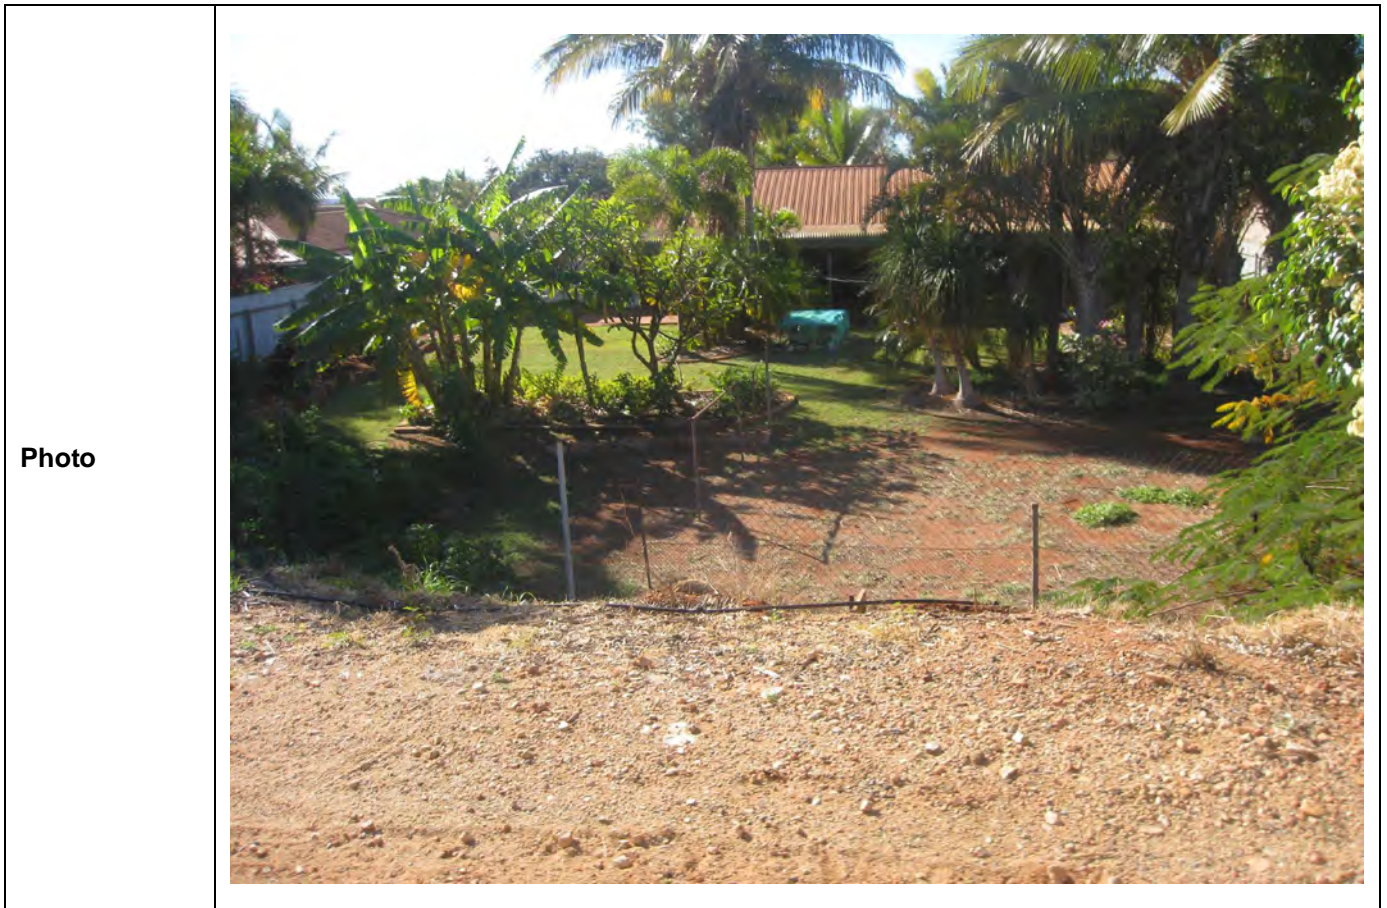
### 7.3 Lot No. 153 Giles Crescent

<b>Category</b>	Drain Maintenance / Encroachment
<b>Type</b>	Flow path Boundary encroachment.
<b>Description</b>	Drainage flow path within property boundary; Fence.
<b>Photo ID</b>	13
<b>Scope of Works</b>	M – reinstate drainage flow path as defined by the natural capacity and invert of downstream lot (154) channel M – Remove fence and relocate to within the property boundary.

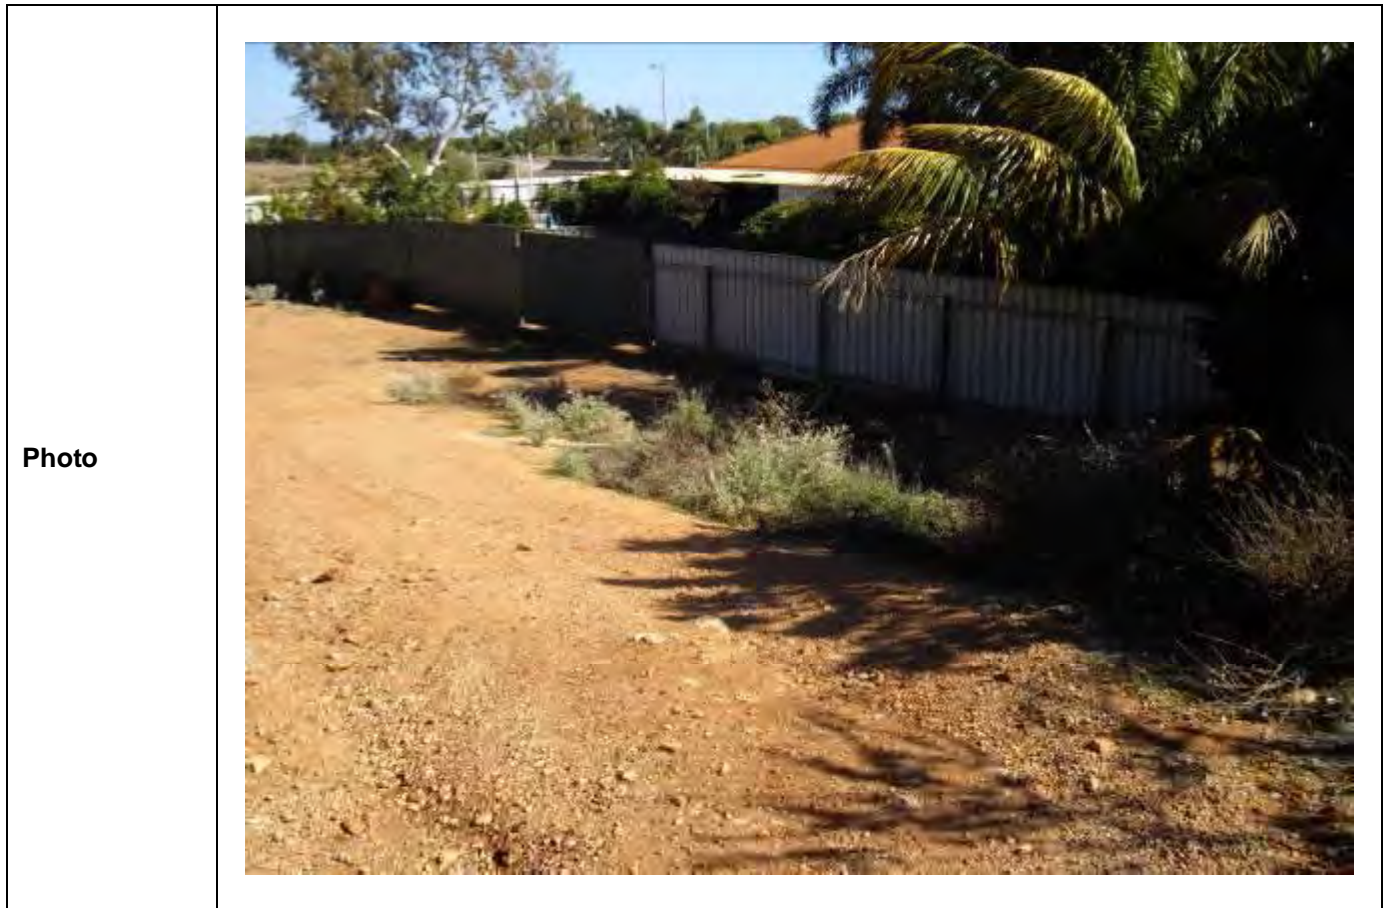
## 7.4 Lot No. 154 Giles Crescent

<b>Category</b>	Drain Maintenance
<b>Type</b>	Flow path Rear access
<b>Description</b>	Drainage flow path low point is within the property boundary Rear access has reduced the cross sectional capacity
<b>Photo ID</b>	884
<b>Scope of Works</b>	H – reinstate drainage flow path as defined by the natural capacity and invert of downstream lot (155) channel to be contained within the drainage reserve H – Remove rear access
