City of Karratha  
Dampier Stormwater Management Study  
Report  
Part B  
June 2015

## Appendix **C** – 2010 encroachment reviews

**Rio Tinto Iron Ore**  
Report on Dampier Drainage  
Review  
Block 1 Encroachments  
June 2010

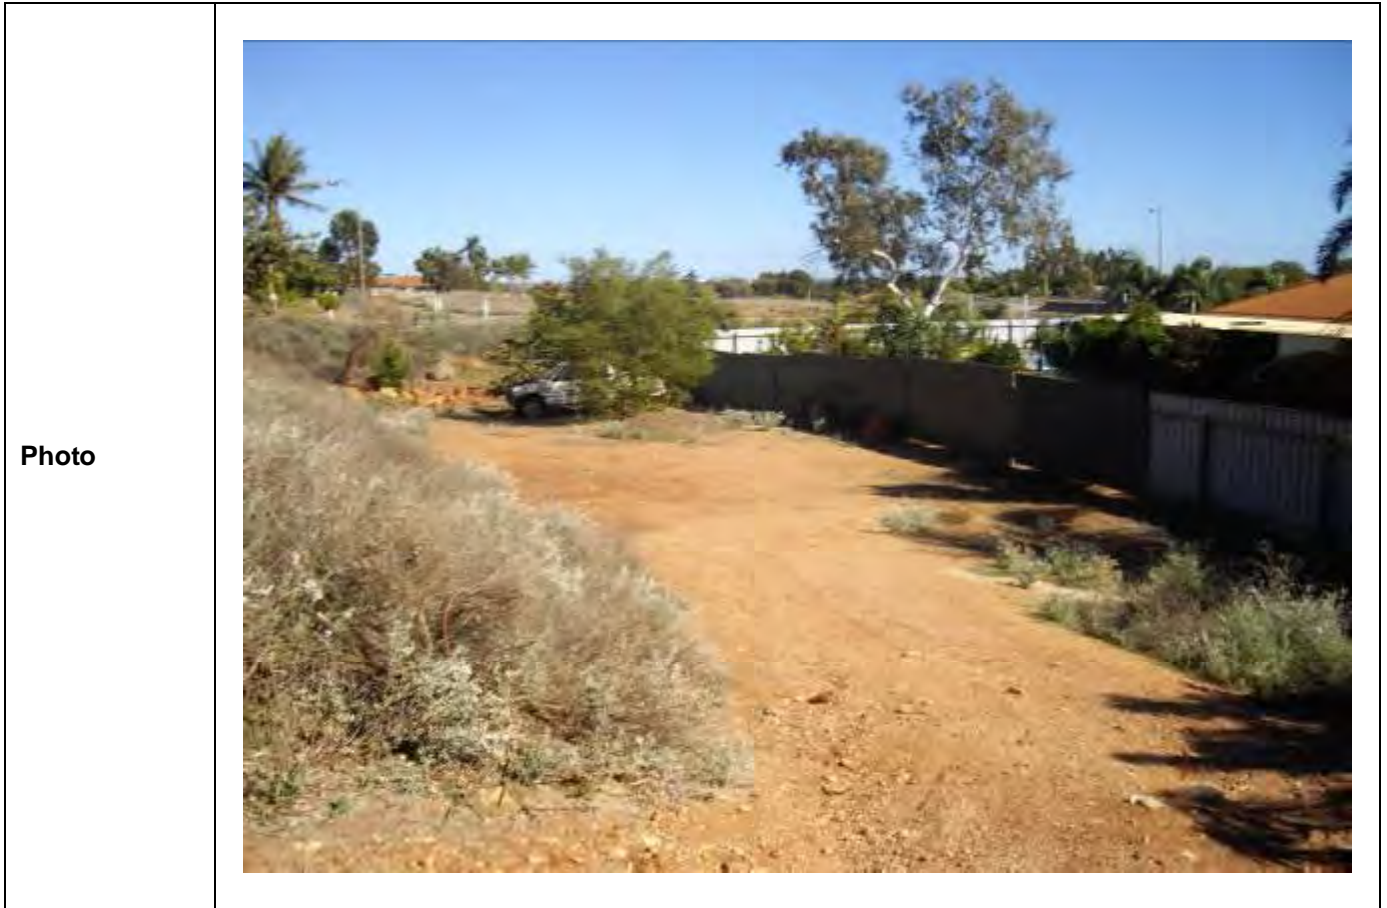
## 7.5 Lot No. 155 Giles Crescent

<b>Category</b>	Encroachment
<b>Type</b>	Rear access General item.
<b>Description</b>	Rear access follows natural topography Vehicle.
<b>Photo ID</b>	885
<b>Scope of Works</b>	H - Remove rear access and reinstate to natural drainage channel L – Remove vehicle

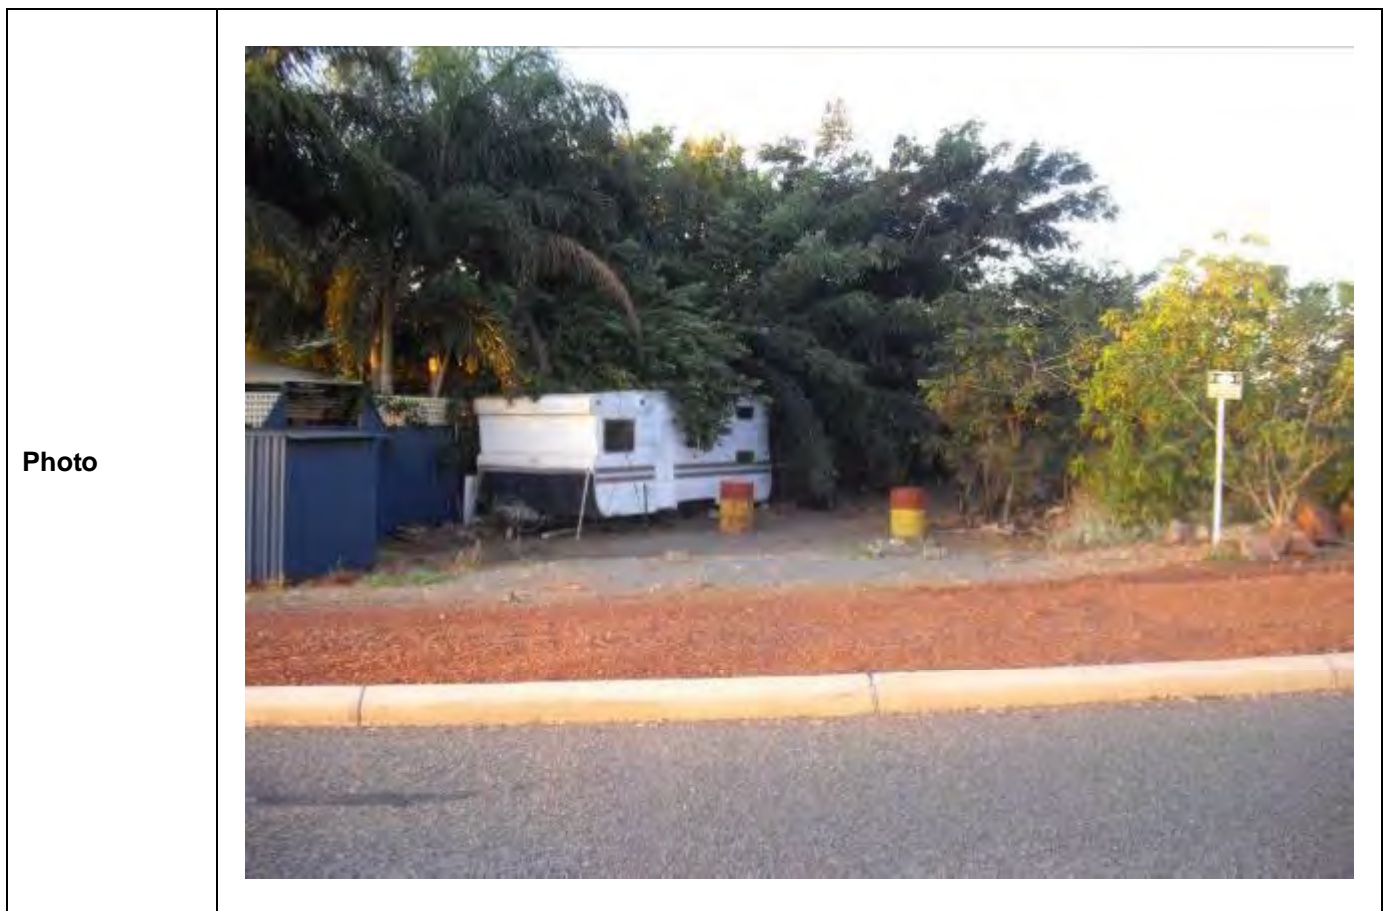
### 8.1 Lot No. 1,155 Eyre Court

<b>Category</b>	Encroachment
<b>Type</b>	General items
<b>Description</b>	Caravan is in the drainage reserve but not impeding flow.
<b>Photo ID</b>	686
